Formation of oxides in the interior of friction stir welds

Judy Schneider (UAH)
Po Chen (Jacobs ESSSA)
Arthur C. Nunes, Jr. (NASA-MSFC)

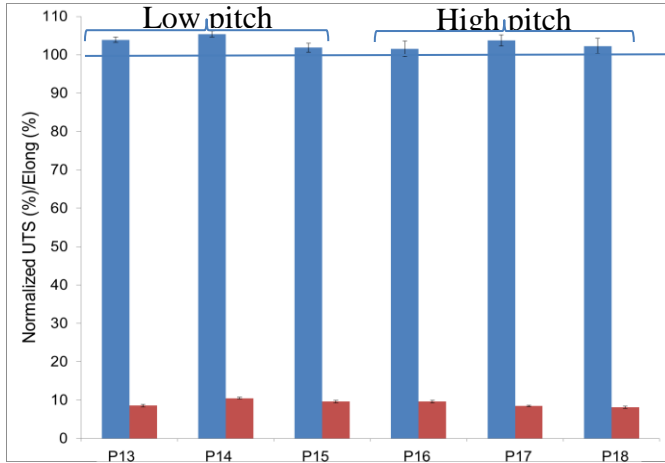
Figure 2. Summary of mechanical properties of the 0.95 cm thick SR-FSW panels tested RT.

Figures 2, 3, and 4 present the mechanical property data for the 0.95, 1.27, and 1.59 cm panel thickness, respectively. These figures compare the data for high vs low weld pitch for the panels tested at room temperature (RT). With the exception of Figure 4 for the 1.59 cm thick panels, little variation is noted in the mechanical properties at either weld pitch. Representative specimens for metallurgical analysis were selected on the basis of nominal and lowest properties and are summarized in Table II normalized to the acceptance values for the UTS of each thickness panel [32]. Low properties of specimens found within these weld panels are highlighted.

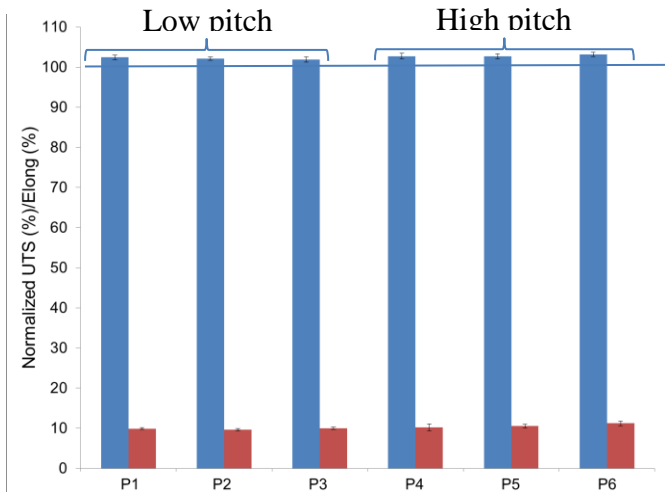
Figure 3. Summary of mechanical properties of the 1.27 cm thick SR-FSW panels tested at RT.

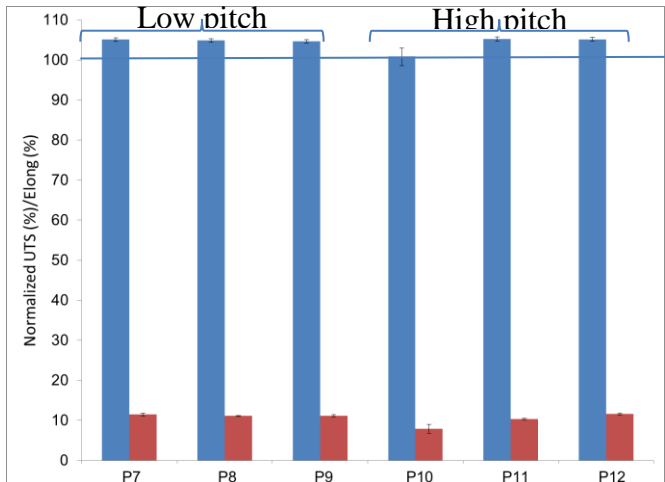
Figure 4. Summary of mechanical properties of the 1.59 cm thick SR-FSW panels tested at RT.

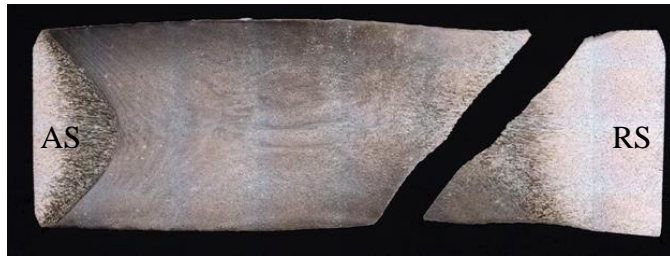
Figure 10. (a) Metallograph for the M02 specimen in panel #500-02 and (b) corresponding fracture location in tensile specimen RT-5.

Similar characteristics were observed in the high and low property specimens for the 1.27 cm thick SR-FSW as shown in Figure 10 and 11. Further metallurgical examination of the low property weld is shown in Figure 12 which also shows the presence of the line feature.

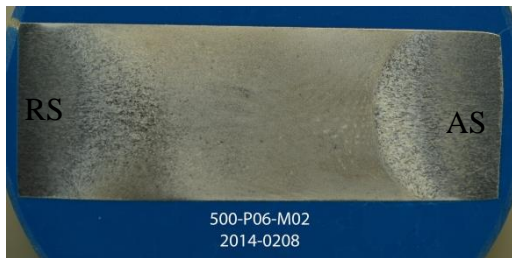
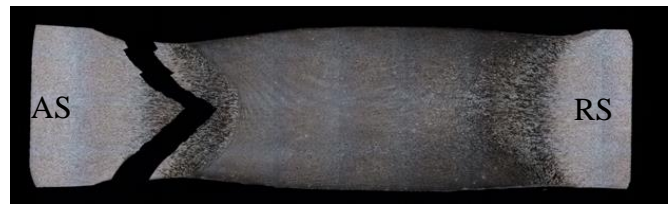
Figure 11. (a) Metallograph for the M02 specimen in panel #500-P06 and (b) corresponding fracture location in tensile specimen RT-2.

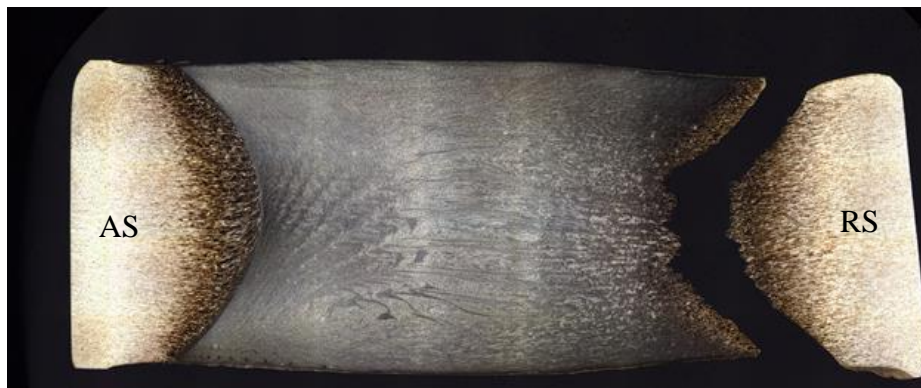
Figure 13. Fracture location in specimen #625-P07-RT6 [33].

The largest mechanical property variation was observed in the 1.59 cm thick SR-FSWs. Figure 13 shows a nominal property specimen which failed on the desired RS. The line indications were also observed within this weld nugget as shown in Figure 14. A close-up of this region in Figure 14b shows a region of very fine grains which give rise to this dark line appearance in Figure 14a.

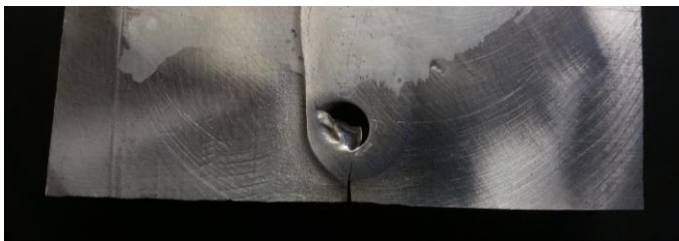
Figure 18. Root side image of the gap in a 3.18 cm thickness weld panel in advance of the weld tool at the end of the weld.

An observation, illustrated by Figure 18, is that as the weld panel increase in thickness there is an increasing gap ahead of the weld tool. A gap in advance of the weld tool can form as the force differential between the pin/root shoulder force and the crown shoulder force results in a load on the panels at the location of the joint. As the clamps are approximately 3.18 cm from the weld seam, the AS and RS side of the weld seam can be considered as a cantilever beam illustrated in Figure 19. The deflection of the cantilever beam assembly is given by y in equation 1 and the angle of deflection given by θ in equation 2. The resulting load (P) on the workpiece is the pinch force, or delta between the applied crown shoulder force and the pin/root shoulder force, and L is the distance from the weld seam to the clamp. $E = 69$ GPa, the elastic modulus of aluminum.
