MICROMETEORITE IMPACT TEST OF FLEX SOLAR ARRAY COUPON

K. H. Wright⁽¹⁾, T. A. Schneider⁽²⁾, J. A. Vaughn⁽²⁾, B. Hoang⁽³⁾, F. Wong⁽³⁾, G. Gardiner⁽³⁾

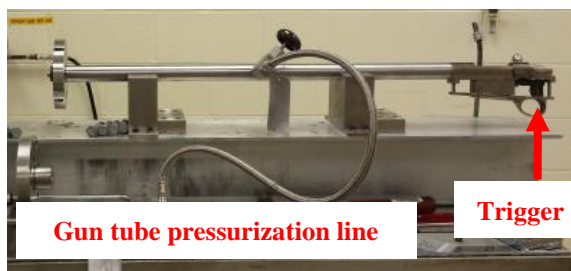
Figure 3. Close-up view of firing line.

Testing was conducted at the Micro Light Gas Gun (MLGG) facility at MSFC. Figures 2-5 show the various components of the MLGG facility. The force from a blank 22-caliber shell is captured by a piston which impacts a helium pressurized chamber. The pressure pulse accelerates a 1.76 mm diameter Nylon projectile to velocities > 5 km/s. The particle velocity is determined from timing signals from a diode at the beginning of the drift tube and a diode in the target chamber.

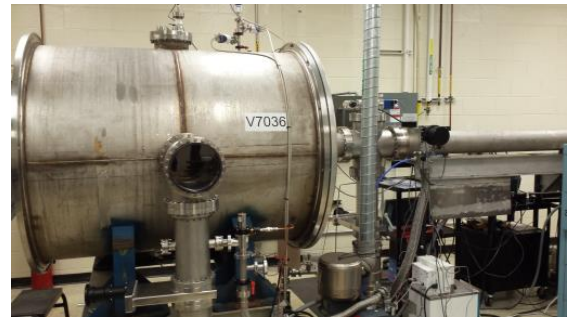
Figure 4. Side view of target chamber showing pumping system.

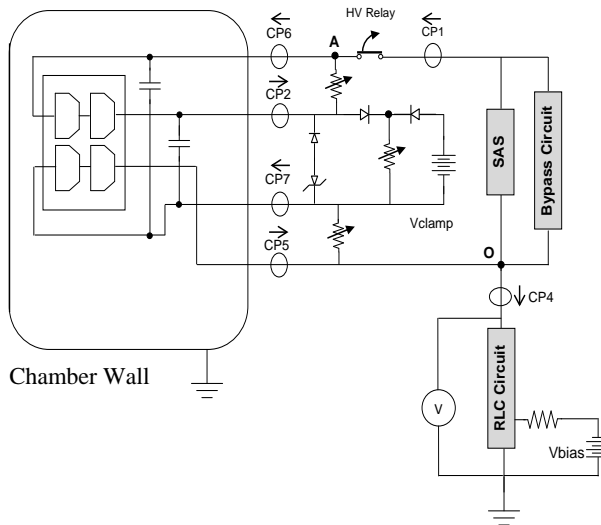
Figure 8. Electrical Schematic of Coupon A during Micrometeoroid Impact Test

Fig. 8 shows the electrical schematic of the test circuit used during impact testing of Coupon A. This test schematic is based on ISO-11221. The key difference of this schematic from that of previous ESD testing [2, 3] is that the ROSA coupon has no substrate. Only the strings are electrically biased by the Solar Array Simulator (SAS). The electrical currents and differential voltage between the strings are controlled by a network of bypass resistors and voltage clamp (Vclamp), respectively. These components control the proper biased voltage across the solar cells as well as the differential voltages between strings under test. A network of capacitance in the test circuit simulated the capacitance of the missing cells in the strings since only 4 cells were under test during each shot. An arc interruption circuit is used to open the High Voltage (HV) relay after 3 milli-sec to

limit the duration of any sustained arc. Three oscilloscopes were used to capture the current and voltage probe data.

A special circuit (noted as RLC circuit in Fig. 8) is employed to shape a primary arc pulse. The generic attributes of the pulse were modeled after consideration of an early ROSA array application. Fig. 9 shows the primary arc pulse obtained with the proxy coupon test. V_{bias} was set to -650 V for all impact tests.

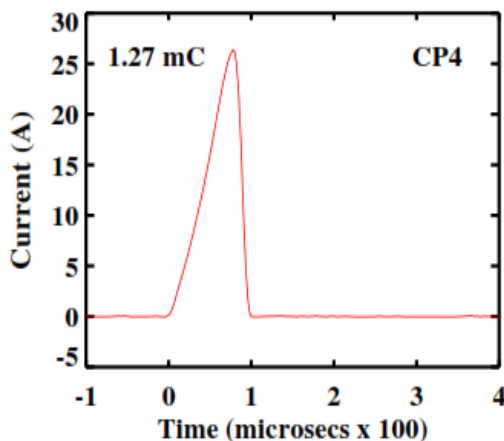
Figure 9. Primary Arc pulse used in the ESD testing. Nominal peak at ~ 25 A for ~ 100 μ secs. Total charge contained in the pulse is ~ 1.3 mC.

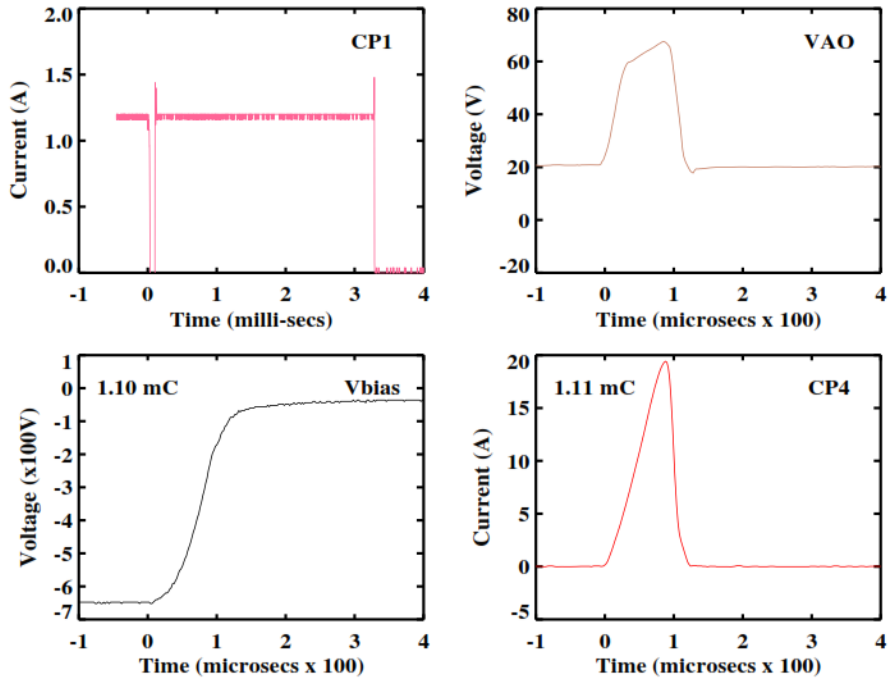
Figure 11. Current and voltage probe data for impact 2B. CP1 shows SAS current flow and is stopped by the arc interruption circuit at ~ 3 milli-sec. The charge contained in the primary arc is calculated via two methods and is noted on the Vbias and CP4 panels. A small difference in primary arc amplitude and duration is noted between the proxy coupon with copper plates and Coupon A.

In Figs. 11-13, current and voltage probe data is presented for impact 2B on String C. Circuit conditions for this shot were 15 V between string C and string B (1mm gap) with the SAS set to 1.1 A. No current activity on the strings beyond the duration of the primary arc was observed. In Fig. 14, the path of the primary arc current within the circuit is illustrated.

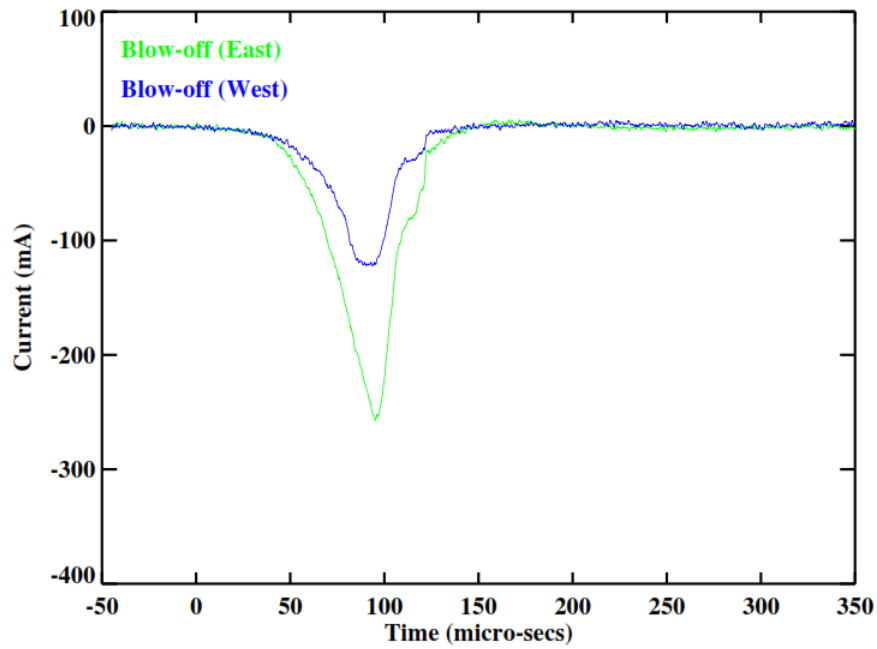
Figure 13. Blow-off plate data during impact 2B.
