10-14 July 2016, Vienna, Austria

Z-2 Threaded Insert Design and Testing

Amy Ross¹ and Richard Rhodes²
NASA Johnson Space Center, Houston, TX 77058

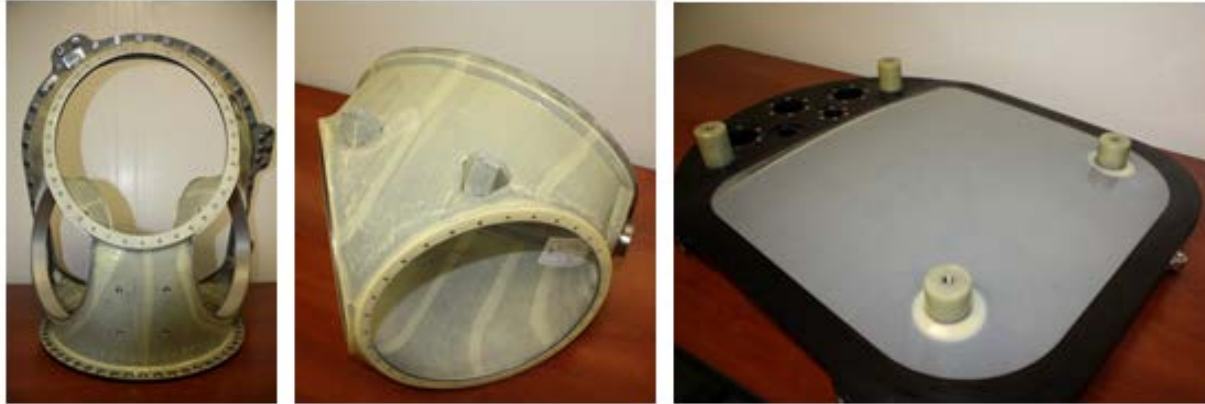
Figure 1. Z-2 Composite Components As Fabricated. *The HUT, Brief and Hatch.*

Three requirements drove the design of the Z-2 suit to have composite upper torso, hatch and brief: (1) the structures interfaces, such as bearings and body seal closures, need to be precisely controlled, (2) incorporation of several life support interfaces, such as the portable life support system, relief valve, and purge valve, and the internal line routing of these components, and (3) the need for a lightweight and robust structure (Figure 1). Composite elements are also advantageous because they are resistant to damage from dust and debris and they can be designed to offer protection to the crew member in the event of a fall onto a hard object. A trade selection was performed to determine the proper fiber and resin system to construct the composite. Several goals were derived in order to down select to a final system. The goals included a desire to have high strength and stiffness to weight ratios, high impact resistance, advance the technology, -250°F to 250°F temperature compatibility, good hot/wet properties since the suit would be used in the Neutral Buoyancy Lab (NBL), and be at a reasonable cost and lead time. Also desired was picking a system that potentially already had MATCO data available (already be space qualified), A&B design allowable values available and able to be processed out of autoclave (OOA). The team investigated over 30 resins and several fiber combinations. Ultimately, a hybrid layup of S-2 fiberglass and IM10 carbon fiber with epoxy resin in prepreg form was selected.

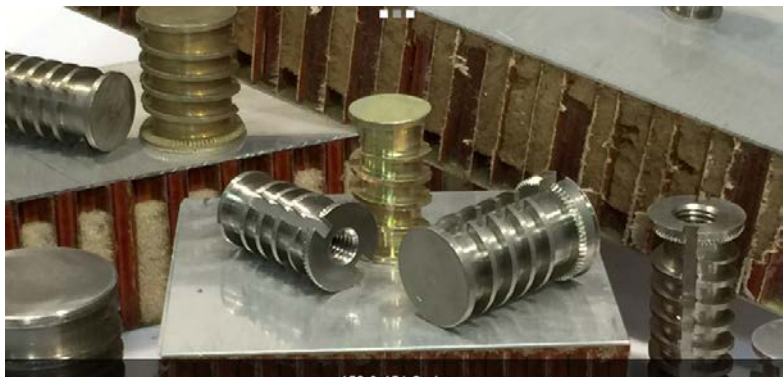
Investigation into industry standards revealed that Witten inserts have either a diamond knurl or an annular ring or flange to resist pull-out. Some also have flats on the bottom flange to resist torque-out. The heavy duty Witten fastener inserts have a spiral rib for pull-out (Figure 4).

Figure 4. Whiten Inserts. Benchmarking shows COTS inserts have features on the outside of the cylinder to provide more locking interfaces.

Witten and Henkle, the manufacturer of Hysol, were contacted to discuss this failure and determine what recommendations they had to improve the results of the bond strength. Witten recommended media blasting the inserts with 300-500 grit alumina oxide powder and adding either a knurling or groove features to the outside of the inserts. Henkle recommended only adding 0.5% microspheres to the epoxy and commented that anything higher would reduce the adhesive strength. Henkle also recommended preparing the bonded surfaces with an IPA wipe to both degrease and clean and that a bond line thickness of 0.005" to 0.040" would be acceptable to achieve the full strength of the adhesive.
