Resurrected DSCOVR Propulsion System – Challenges and Lessons Learned

Apurva P. Varia¹ and Ashley R. Scroggins²
NASA Goddard Space Flight Center, Greenbelt, MD 20771

The Deep Space Climate Observatory (DSCOVR), formerly known as Triana, is a unique mission, not because of its objectives but because of how long it was in storage before launch. The Triana spacecraft was built in the late 90s and later renamed as DSCOVR, but the project was canceled before the spacecraft was launched. The nearly-complete spacecraft was put in controlled storage for 10 years, until the National Oceanic and Atmospheric Administration (NOAA) provided funding for the National Aeronautics and Space Administration (NASA) to refurbish the spacecraft. On February 11, 2015, DSCOVR was launched on a Falcon 9 v1.1 from launch complex 40 at Cape Canaveral Air Force Station. This paper describes the DSCOVR propulsion system, which utilizes ten 4.5 N thrusters in blowdown mode to perform Midcourse Correction (MCC) maneuvers, Lissajous Orbit Insertion (LOI) at Lagrangian point L1, momentum unloading maneuvers, and station keeping delta-v maneuvers at L1. This paper also describes the testing that was performed, in

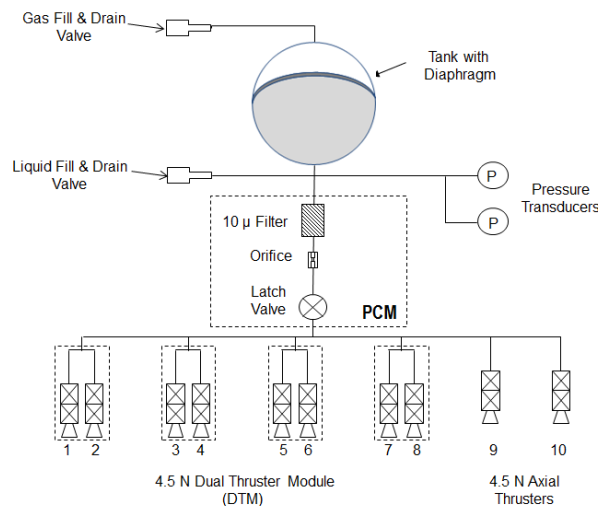
Figure 3. DSCOVR Propulsion Schematic

The DSCOVR propulsion system is a monopropellant blowdown system that consists of ten 4.5 N thrusters, one 0.71 m spherical tank with 145 kg of hydrazine, two fill and drain valves (FDV), and Propellant Control Module (PCM) which includes one latch valve, two pressure transducers, one filter, and one orifice. Tubing sizes are 1/4 and 3/8 inch. The fluid schematic is shown in Figure 3

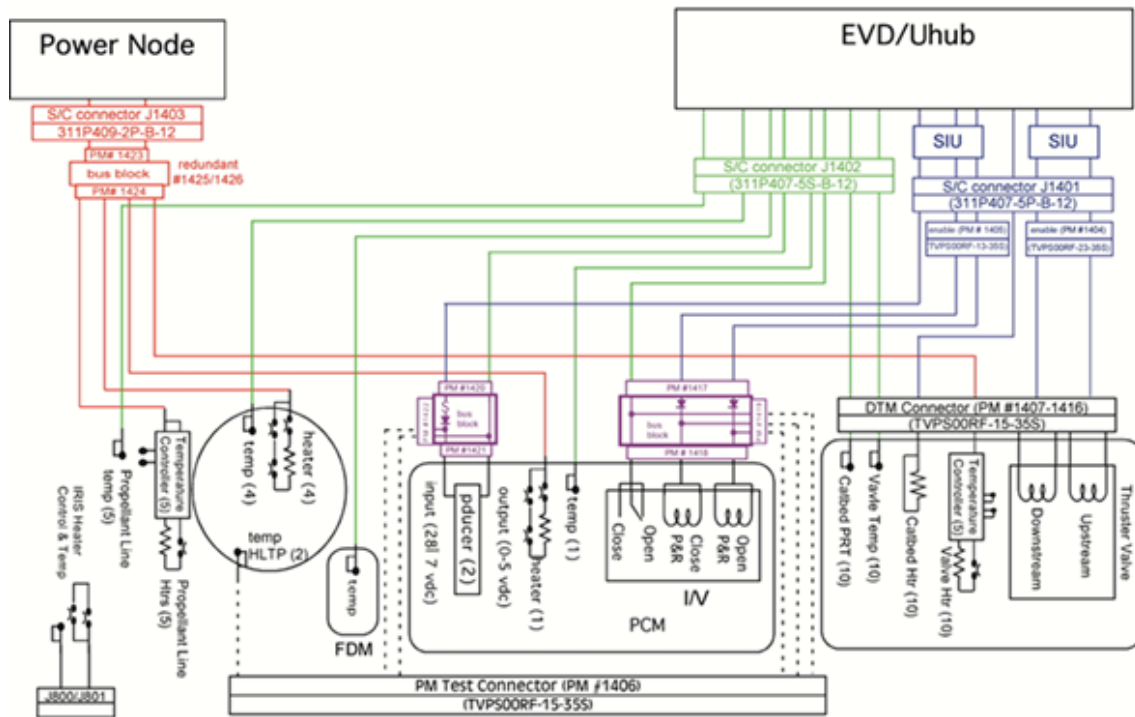
Figure 7. Propulsion Electrical Interface Schematic

As shown in Figure 7, the thrusters, latch valve, and pressure transducers receive power from the Power Node (PN) electrical box via the Utility HUB (UHUB) electrical box. The PN also provides power to the line heaters, tank heaters, and thruster valve and catalyst bed heaters. When a command to fire a thruster is received in the UHUB, the UHUB switches the power to the thrusters. Upon completion of firing, the UHUB removes power from the thruster valve, which in turn closes it. Likewise, the latch valve is actuated and the pressure transducers are turned on when a command is received in the UHUB to turn on these components. In addition, the UHUB receives analog data for the latch valve position, tank pressure, and propulsion module temperatures (propellant lines, PCM, FDV, tank, thruster valves).

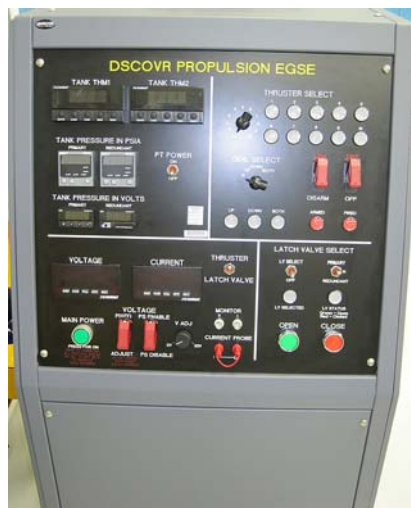
Figure 10. EGSE Panel

An electrical ground support equipment (EGSE) panel was built for DSCOVOR propulsion to actuate the flight component during testing. This panel, shown in Figure 10, accesses the propulsion components through the propulsion test connector and the thruster enable connector, located next to the fill and drain valves. The EGSE capabilities are as follows.

- Actuate upstream, downstream, or both thruster valve seats on any of the 10 thrusters. The thruster valve seats can be actuated using adjustable voltage, which allows the user to reduce to hold-open voltage to protect the valve coils.

- Actuate primary or redundant coils for the latch valve to open or close the valve.
- Read latch valve status without powering the valve. This was an important safety control for use during propellant loading so that the state of the latch valve could be verified without the possibility of inadvertently opening the valve and allowing hydrazine to flow into the thruster manifolds.

- Power both pressure transducers at nominal voltage.
- Display tank pressure readings in psia and in volts from both the primary and redundant pressure transducers.

- Display thruster valve coil current upon actuation.
- Display temperature readings for the propellant tank from two GSE thermistors, one located on the gas side of the tank and the other located on the propellant side of the tank.

- Allow for electrical traces of the thruster valves and latch valve using a current probe.

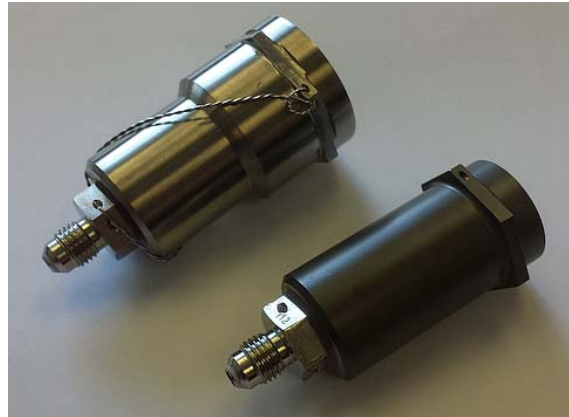
Figure 11. Special Test Caps

In order to determine the integrity of the O-rings, a special test was included in the propulsion functional and leak test sequence. Propulsion technicians installed a test port in external caps that fit the fill and drain valves. The special test caps are shown in Figure 11. During testing, the secondary AN cap was installed on each FDV, and the primary valve seat on each valve was opened. The test caps were torqued onto the fill and drain valves, and a helium leak detector was installed on the test port located in each cap. These caps isolated the secondary cap and seals in order to check for leakage through the O-rings.

Each time propulsion functional and leak testing was completed, this special test was performed. The O-ring seals did not show any leakage, so the integrity of the seals was intact.
