IMPACT BEHAVIOR OF COMPOSITE FAN BLADE LEADING EDGE SUBCOMPONENT WITH THERMOPLASTIC POLYURETHANE INTERLEAVE

Sandi G. Miller¹, Gary D. Roberts¹, Lee W. Kohlman¹, Paula J. Heimann², J. Michael Pereira¹, Charles R. Ruggeri¹, Richard E. Martin³, Linda S. McCorkle²

¹NASA Glenn Research Center, Cleveland, OH 44135

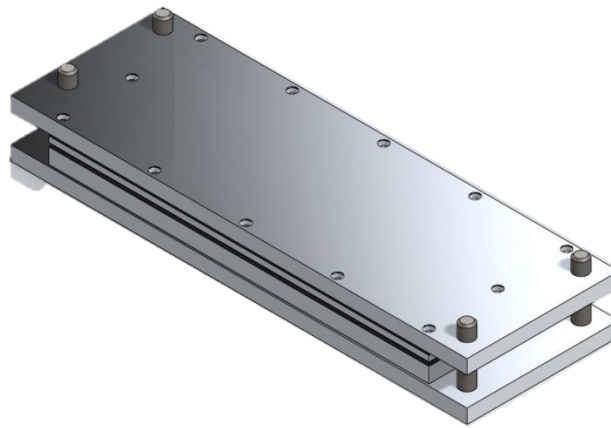
Figure 1. 3-D model of mated die mold

A simple subcomponent impact test article was designed to represent the leading edge of a fan blade as documented in Reference 15. The IM7/8551-7 pre-impregnated tape was cut according to the ply lay-up and configuration specifications for the subcomponent. An aluminum tool was custom designed to fabricate the leading edge specimen described in this paper. The mold was a mated 7075 Aluminum die, which was fitted with a vacuum pump venting attachment and a channel to capture excess resin flow (Fig. 1). All blade coupons were processed in an autoclave and followed the vendor recommended cure cycle. Cured blades dimensions were 15.24 cm (6 in) wide by 45.7 cm (18 in) long and, following removal from the tool, were machined on the 45.7 cm (18 in) sides for a smooth surface to secure in the impact test fixture.

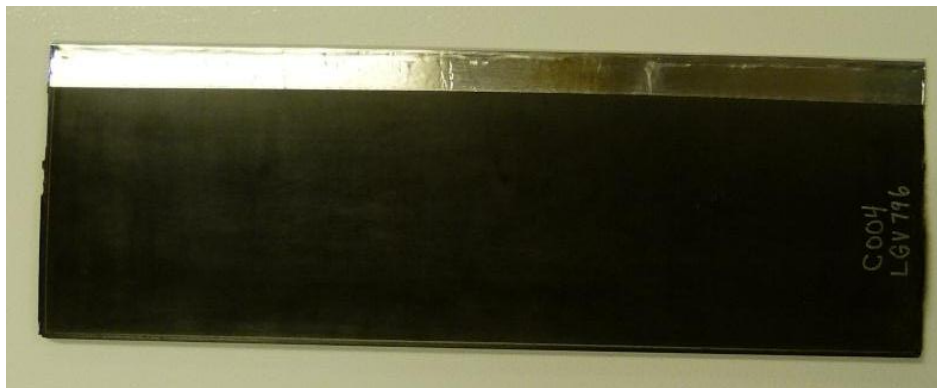
Figure 2: Prepared leading edge test article

In an effort to protect the leading edge from extensive break-out damage during impact, leading edge protection was applied in the form of an industrial aluminum foil adhesive tape. The aluminum foil tape was 0.25 mm (0.01 in) thick and 5.1 cm (2 in) wide and added approximately 20 g of mass to the edge of the blade. The adhesive tape was placed 2.5 cm (1 in) from the leading edge on the concave side of the blade, rolled over onto the convex side, then smoothed and flattened. A fully prepared test article is shown (Fig. 2).

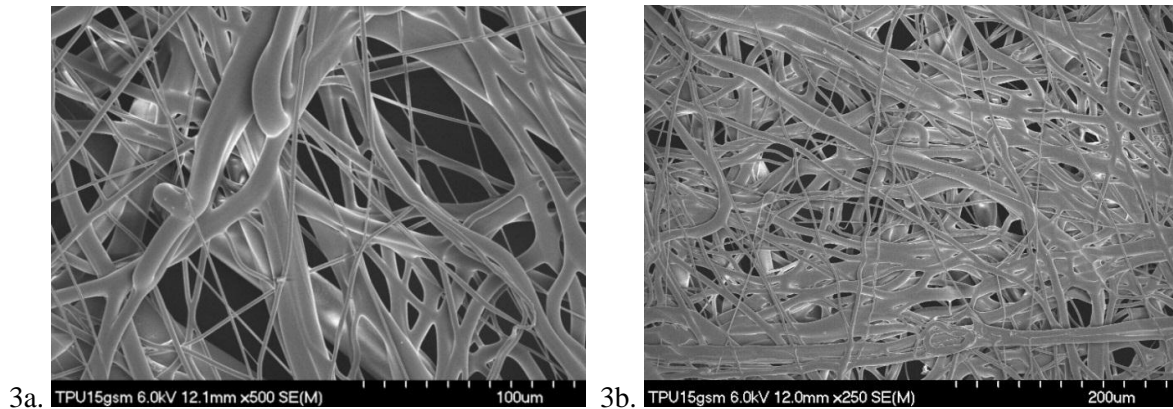
Figures 3a-b illustrate the variation in fiber diameter and packing within the 15 gsm veil.

Two separate veil areal weights, 15gsm and 45gsm, were evaluated. Representative SEM images (Figs 3, 4), show variation in fiber packing within regions of the 15 gsm (Figs 3a-3b) and the 45 gsm material (Figs 4a-4b). Literature has reported an increase in fracture toughness with increasing interleave thickness[16], however, tension and compression strength tended to decrease with increased areal weight, i.e., thickness. Thus, moving forward with fracture toughness and blade subcomponent work only the 15 gsm material was used.

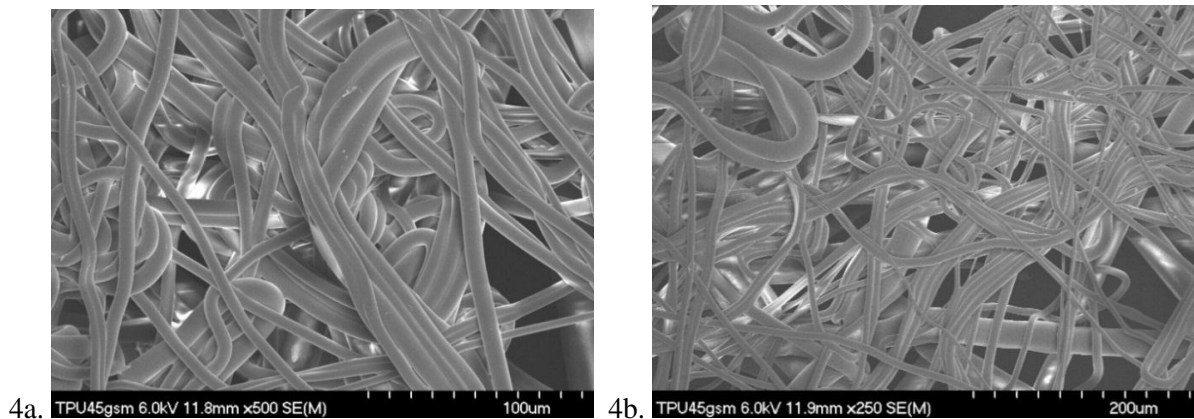
Figures 4a and 4b illustrate the variation in fiber diameter and packing within the 45 gsm veil.

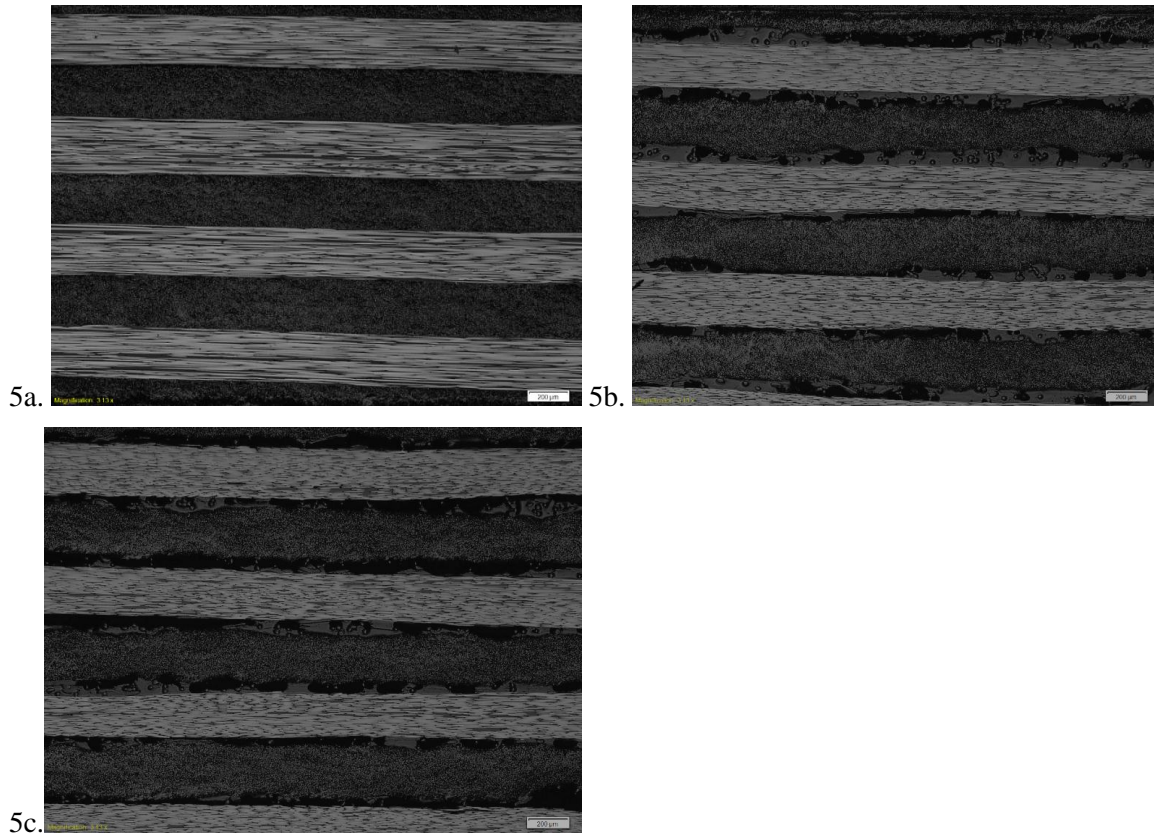
Figures 5a-5c: Optical Microscopy of the cross-section of a- baseline composite, b- 15 gsm interleave, and c- 45 gsm interleave coupon.

The process to cure the material was not modified following incorporation of the veil within the laminate. Optical microscopy of the cured panel cross-section (Figs 5a-5c) showed excessive voids at the interface, due to the added porous material, (Figs 5b and 5c). Voids are seen as the black areas at the ply interfaces. Future cure studies are recommended to mitigate consolidation issues such as void formation. A distinct increase of interlaminar interface thickness was also observed, from $\sim 5 \mu\text{m}$ in the baseline composite, to $10\text{-}70 \mu\text{m}$ in the 15 gsm veil coupon, and $30\text{-}70 \mu\text{m}$ in the 45 gsm veil coupon.

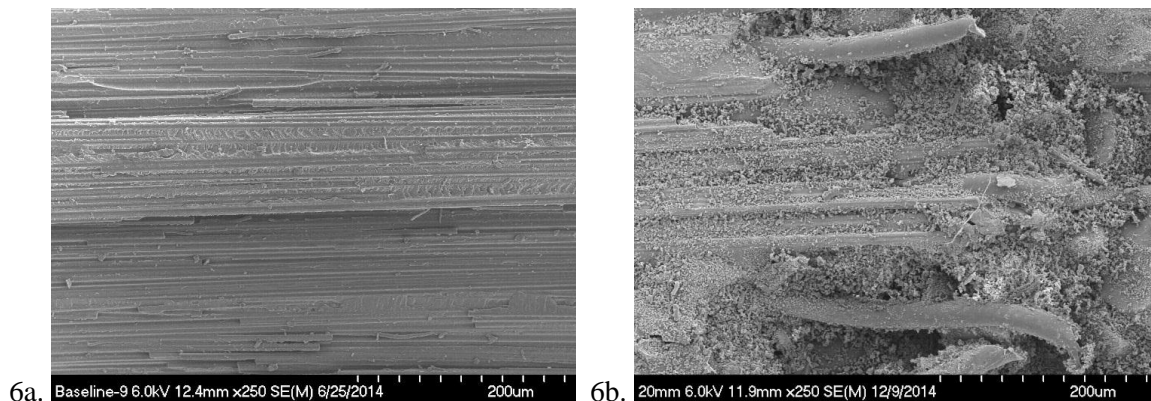
Figures 6a-b: Mode I fracture surface of 6a- baseline panel, 6b- 15 gsm interleave.

Mode I fracture toughness tests showed a 40% increase in G_{IC} following addition of the TPU veil. The mechanism of improvement has been attributed to crack deflection, where the veil increases the path length of crack propagation. This is illustrated in the images of the fracture surfaces Figs (6a and 6b). Figure 6a show matrix failure in the baseline material, and a clean fracture surface. The failure of the toughened panels, Figure 6b, is obscured from the debris left from the interleave, but an increased amount of fiber pull out is observed. The benefit to Mode II fracture toughness was negligible; 5%.

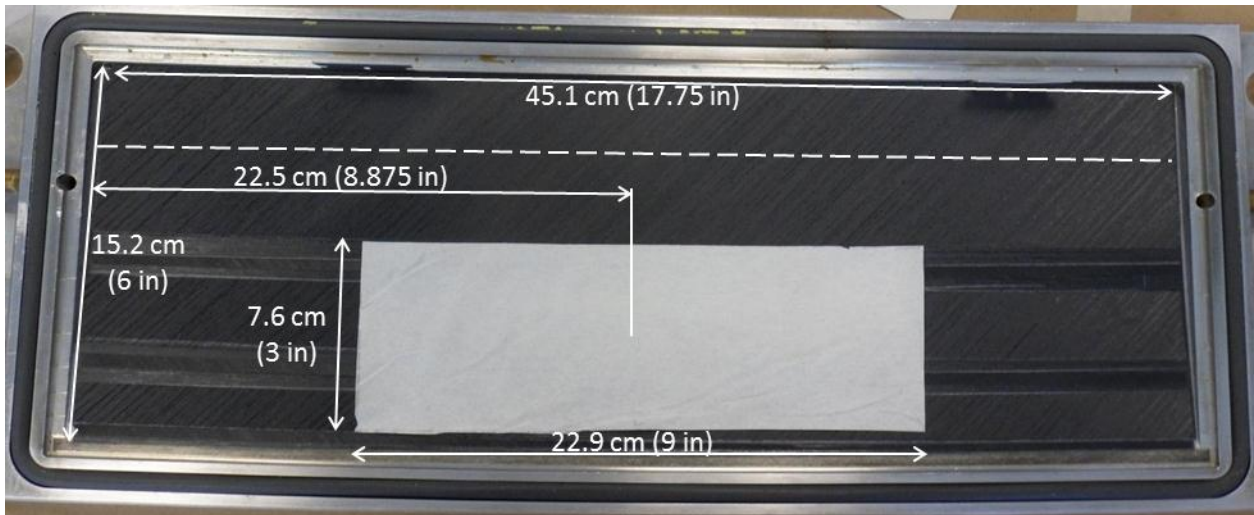
Figure 7. Location of 7.6 cm (3in) polyurethane veil layer.

Baseline and thermoplastic polyurethane (TPU) veil toughened blades were prepared to evaluate the effects of increased interlaminar strain-release capability of the structure on impact resistance. The toughening veil was 22.9 cm (9 in) long and placed in the midsection of the blade length (Fig 7). Three layers of TPU were added to the blade in the locations labeled in Fig. 8. Two of the layers were 7.6 cm (3 in) wide and the other was 5.1 cm (2 in) wide. The veil placement was chosen to cover a significant portion of ply terminations; reducing free edge stresses.

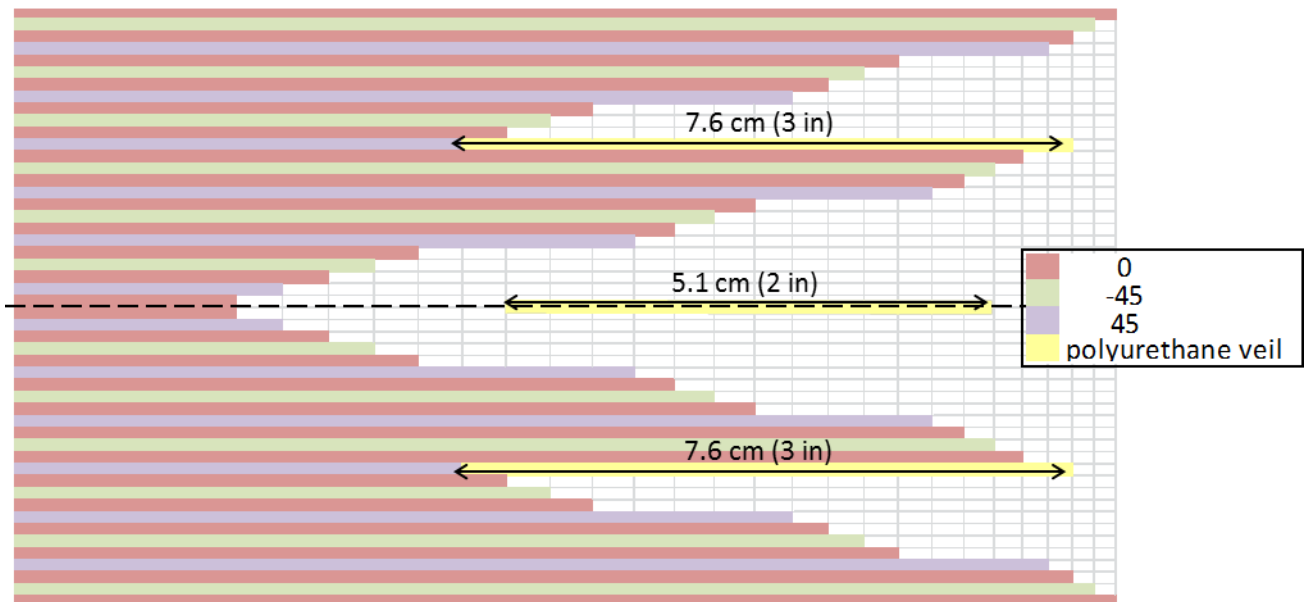
Figure 8. Polyurethane veil toughened specimen.

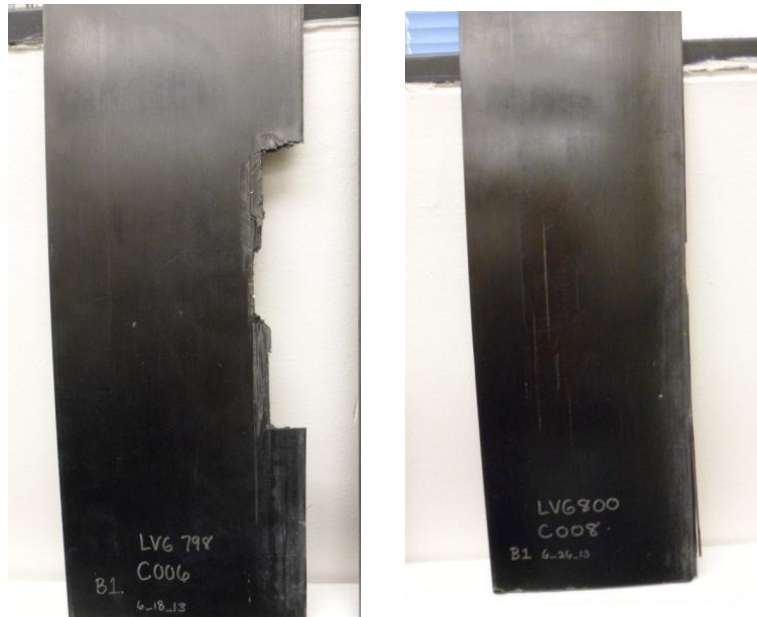
Figure 9. Photos of baseline (left) and toughened (right) panels after impact

The results of the impact test are shown (Fig. 9). Impact of the baseline blade (C006) led to considerable damage at the leading edge, with complete break-out at the impact location. There was no break-out of material for the veil toughened blades (C008) and no delamination at the leading edge was noted; in the interleave region. In both tests, a small delamination was observed near one end of the leading edge in an unmodified region due to flexural wave reflection. This failure mode was observed in other leading edge tests and is considered an artifact of boundary conditions, occurring

after the initial impact. Permanent deformation at the leading edge of the blade tip in actual fan blades is common in bird strike events.

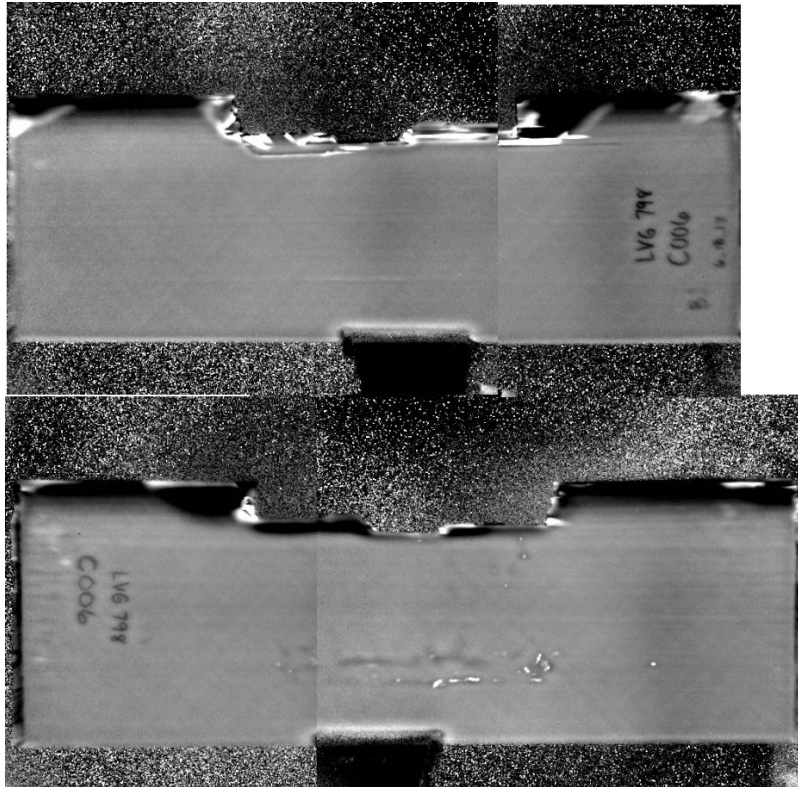
Figure 10a. Thermography images of the baseline composite blade. Upper image corresponds to the back surface and the lower image corresponds to the front surface.

Thermography images were used to characterize the impact-induced damage to the blade, (Figs 10a – 10b). The thermal image in Figure 10a indicates that damage to the baseline blade was limited to break-out at the impact site. The dark area along the leading edge is an artifact of the test, due to the thinness of the blade at the leading edge. In the toughened blade the leading edge maintained its integrity, allowing a greater amount of energy to be transferred into the blade, resulting in increased overall deformation in the form of large oscillatory flexing. The increased bending of the blade appeared to result in some delamination just beyond the placement of the toughening veil, as evidenced by the thermal image of the toughened blade (Fig. 10b). Increased flexing and bending was observed in the toughened blade, relative to the baseline, in high speed videos of the experiments. As a result, the mid-blade delamination appeared to only occur in the ‘toughened’ blade.

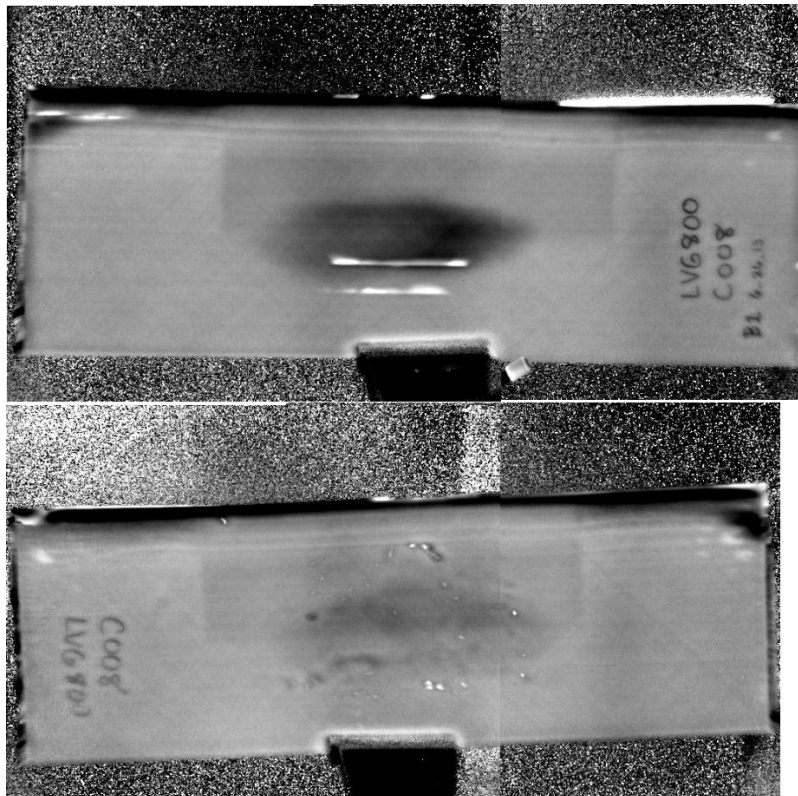
Figure 10b. Thermography images of the thermoplastic veil incorporated blade. Upper image corresponds to the back surface and the lower image corresponds to the front surface.
