NASA/CR—2015–218215

Marking Tests to Certify Part Identification Processes for Use in Low Earth Orbit

D.L. Roxby
Viking Consulting, Gurley, Alabama

October 2015

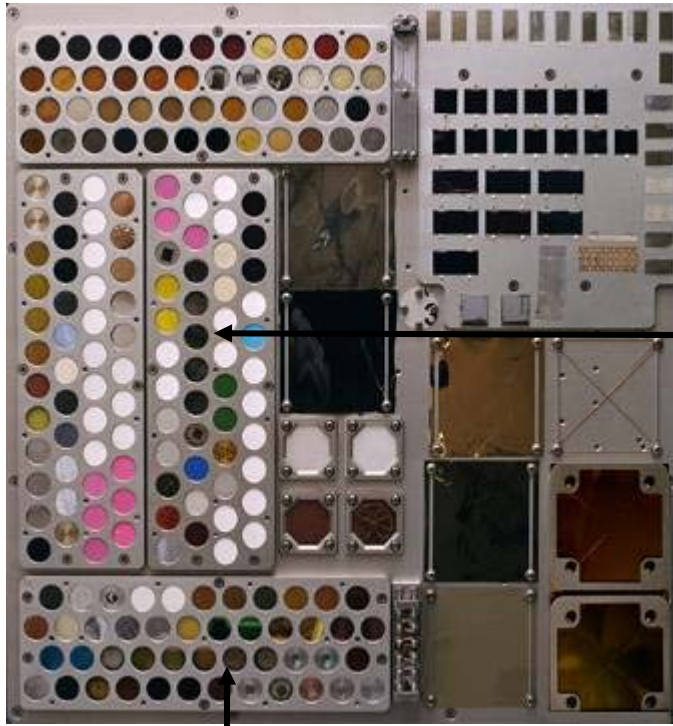
MISSE 1, Tray 1, Top

E3-27
E3-28
E3-29
E3-30
E3-31

EOIM 3 Holder

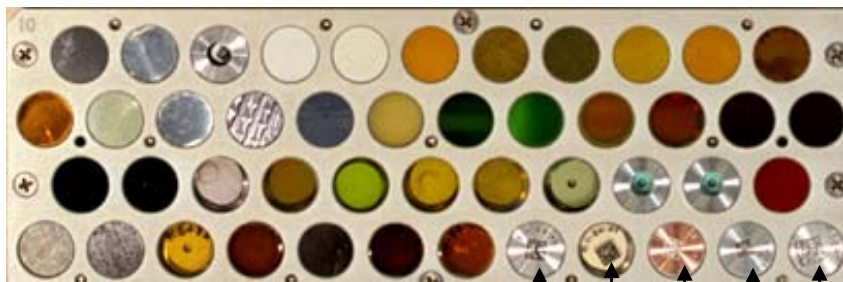
EOIM 4 Holder

E4-42
E4-43
E4-44
E4-45
E4-46

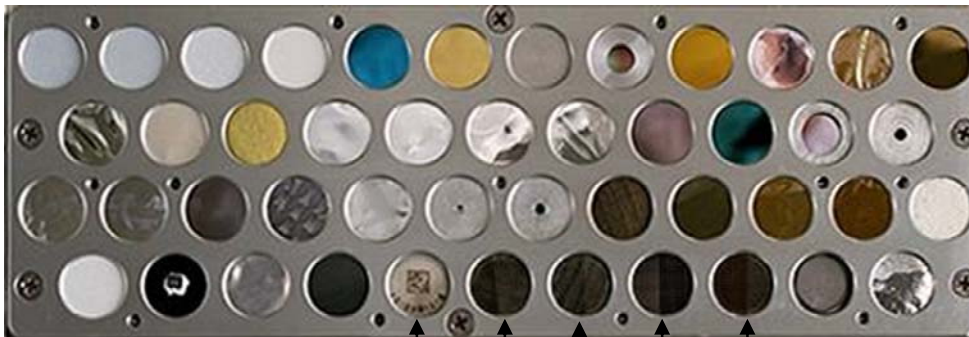
EOIM 10 Holder (Flipped Horizontally)

E10-07
E10-06
E10-05
E10-04
E10-05

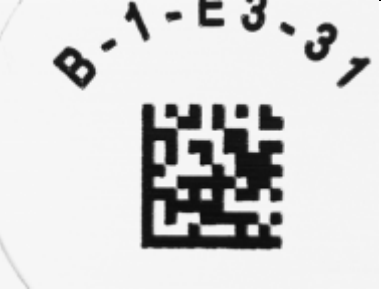
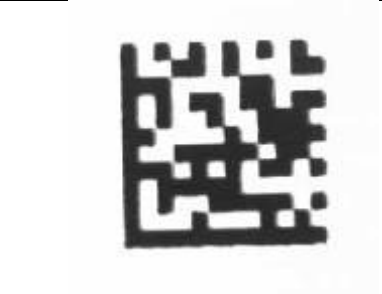
Sample Number	Marking Comparison			
	Pre-Flight Mark Photograph	Pre-Flight Verification Grade	Post-Flight Mark Photograph	Post-Flight Verification Grade
B-1-E3-27 LIVD - Brass	Line Pattern	Good Contrast – Excellent Line Resolution	Sample being Evaluated by Boeing Phantom Works	N/A
B-1-E3-28 LIVD - Tin	Line Pattern	Good Contrast – Excellent Line Resolution	Sample being Evaluated by Boeing Phantom Works	N/A
B-1-E3-29 Laser Bonding	Line Pattern	Good Contrast – Excellent Line Resolution	Sample being Evaluated by Boeing Phantom Works	N/A
B-1-E3-30 VAVD - Copper	Line Pattern	Good Contrast – Excellent Line Resolution	Sample being Evaluated by Boeing Phantom Works	N/A
B-1-E3-31 LIVD - Tin

% Contrast A Axial Uniformity A Print Growth A Error Correction A Overall Grade A

% Contrast A Axial Uniformity A Print Growth A Error Correction A Overall Grade A
B-1-E4-42 Laser Bonding

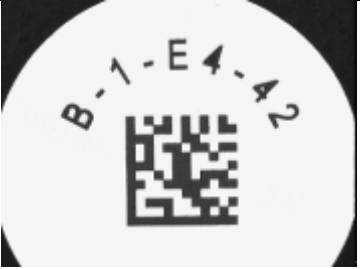
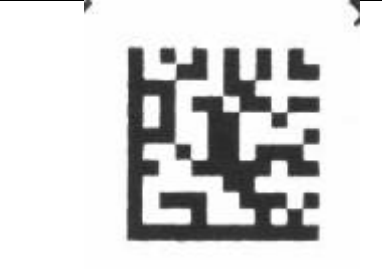
% Contrast A Axial Uniformity A Print Growth A Error Correction A Overall Grade A

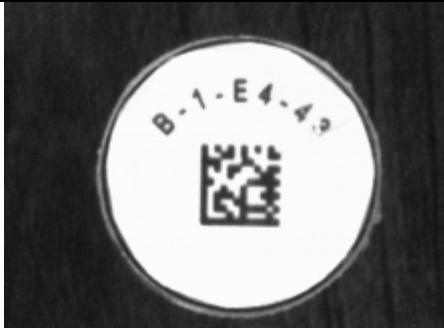
Sample Number	Marking Comparison			
	Pre-Flight Mark Photograph	Pre-Flight Verification Grade	Post-Flight Mark Photograph	Post-Flight Verification Grade
B-1-E4-43 Laser Bonding

% Contrast A Axial Uniformity A Print Growth A Error Correction A Overall Grade A

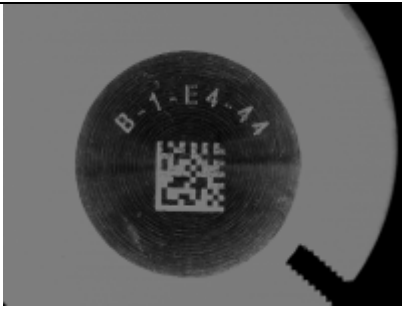
% Contrast B Axial Uniformity A Print Growth Error Correction A Overall Grade B
B-1-E4-44 Laser Coat & Remove - VAVD

% Contrast A Axial Uniformity A Print Growth A Error Correction A Overall Grade A

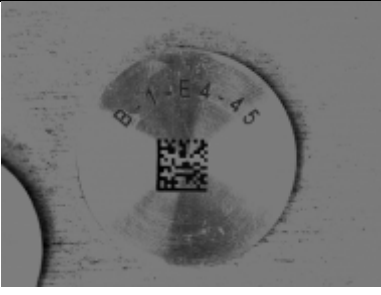
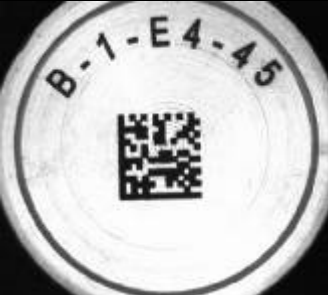
% Contrast A Axial Uniformity A Print Growth A Error Correction A Overall Grade A
B-1-E4-45 GALE

% Contrast A Axial Uniformity A Print Growth A Error Correction A Overall Grade A

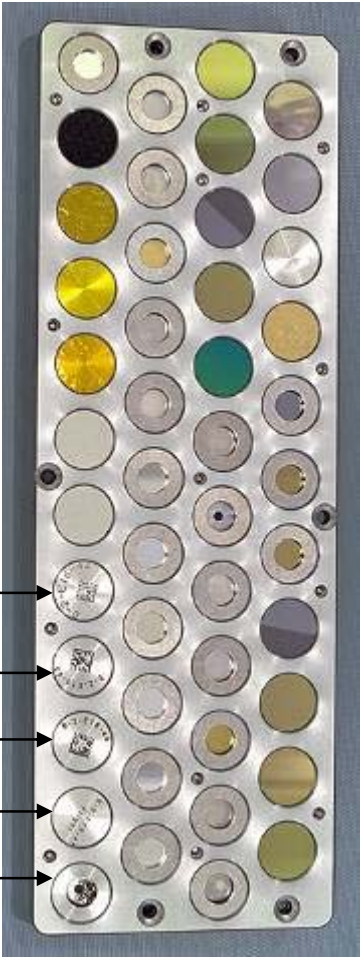
E16 Holder

- 2-E16-42
- 2-E16-43
- 2-E16-44
- 2-E16-45
- 2-E16-46

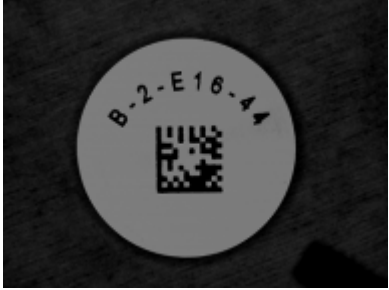
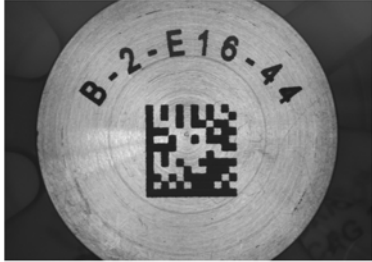
Sample Number	Marking Comparison			
	Pre-Flight Mark Photograph	Pre-Flight Verification Grade	Post-Flight Mark Photograph	Post-Flight Verification Grade
B-2-E16-44 LISI

% Contrast A Axial Uniformity A Print Growth A Error Correction A Overall Grade A

% Contrast A Axial Uniformity A Print Growth A Error Correction A Overall Grade A
B-2-E16-45 Laser Shotpeen

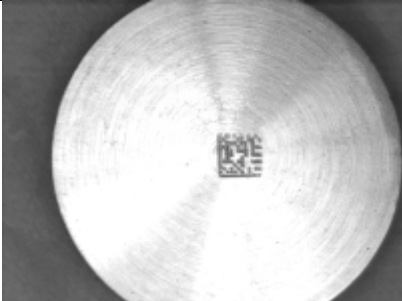
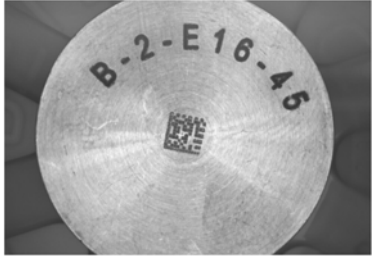
% Contrast A Axial Uniformity A Print Growth B Error Correction A Overall Grade B

Mark Unchanged - Symbol too small to decode or grade using latest Verification Standards. No visible degradation of marking
B-2-E16-46 LIVD - Tin

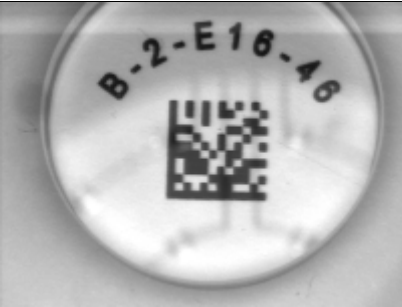
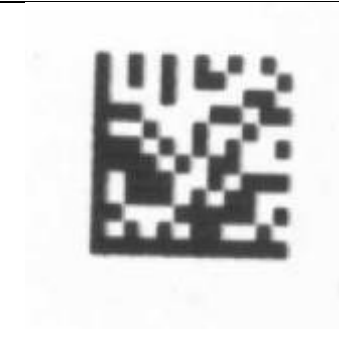
% Contrast A Axial Uniformity A Print Growth A Error Correction A Overall Grade A

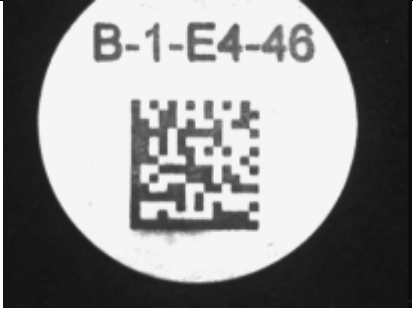
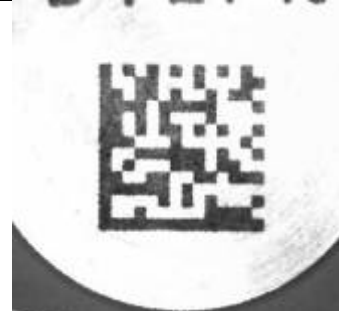
Sample Number	Marking Comparison			
	Pre-Flight Mark Photograph	Pre-Flight Verification Grade	Post-Flight Mark Photograph	Post-Flight Verification Grade
B-1-E4-46 Electro-Chemical Coloring

% Contrast A Axial Uniformity A Print Growth A Error Correction A Overall Grade A

% Contrast A Axial Uniformity A Print Growth A Error Correction A Overall Grade A
B-1-D4-28 VAVD - Copper	Line Pattern	Excellent Contrast and Line Resolution	Sample being Evaluated by Boeing Phantom Works	N/A
B-1-D4-29 VAVD - Copper	Line Pattern	Good Contrast – Excellent Line Resolution	Sample being Evaluated by Boeing Phantom Works	N/A
B-1-D6-2 (Identified as B-1-E10-07)

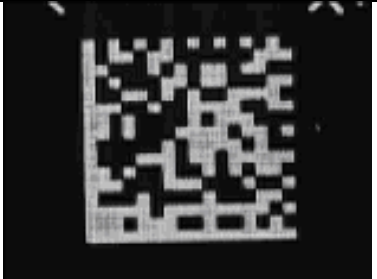
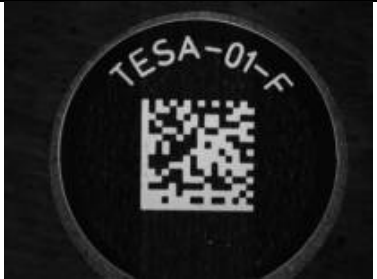
Sample Number	Marking Comparison			
	Pre-Flight Mark Photograph	Pre-Flight Verification Grade	Post-Flight Mark Photograph	Post-Flight Verification Grade
UV6-B-B4-6 Exposed Side of Coupon

% Contrast A Axial Uniformity A Print Growth B Error Correction A Overall Grade B

% Contrast A Axial Uniformity A Print Growth A Error Correction A Overall Grade A
Frame of M6A AO & UV B3, Sample 1

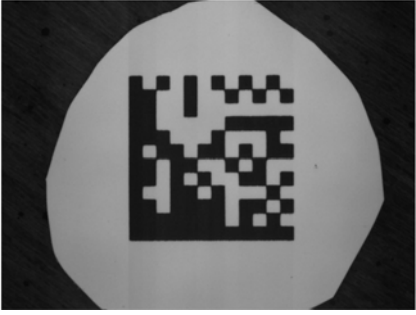
Sample Number	Marking Comparison			
	Pre-Flight Mark Photograph	Pre-Flight Verification Grade	Post-Flight Mark Photograph	Post-Flight Verification Grade
M8B-15 3M Thermal Transfer Printed Label

% Contrast A Axial Uniformity A Print Growth A Error Correction A Overall Grade A
