DSCOVR Contamination Lessons Learned

Contamination, Coatings, Materials and Planetary Protection Conference

NASA Goddard Space Flight Center

July 2015

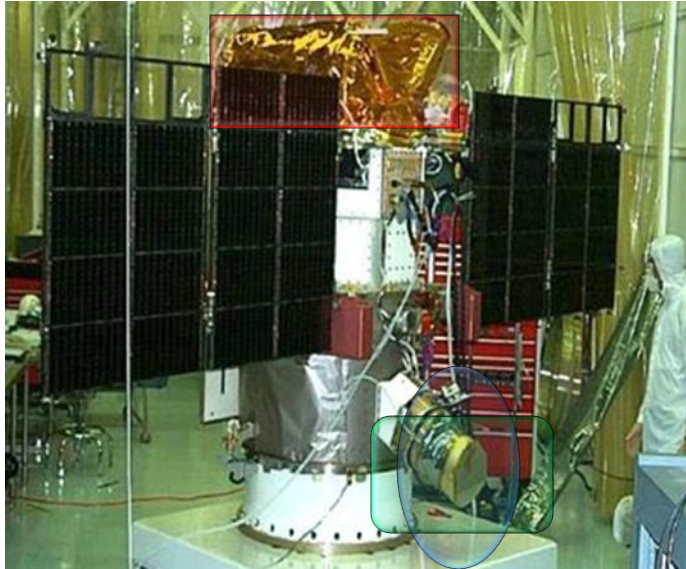
Triana in 2001

Magnetometer placed on angled cone at end of boom

Electron Spectrometer moved from boom to spacecraft bus

Camera and radiometer MLI outer layers changed from ITO-coated Kapton to Germanium-coated Black Kapton (GBK)

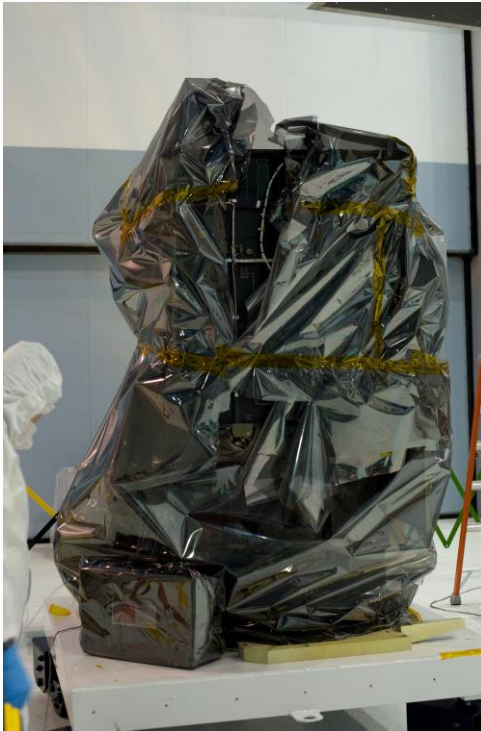
- Triana was double bagged and placed in a metal container. Container was placed in a cleanroom and purged with nitrogen.
- Some GSE was dispersed to functional groups
- Most GSE was boxed and placed in warehouse storage.
- Documents and drawings that were in configuration management control were maintained well. Background information under personal or vendor control was sometimes lost.

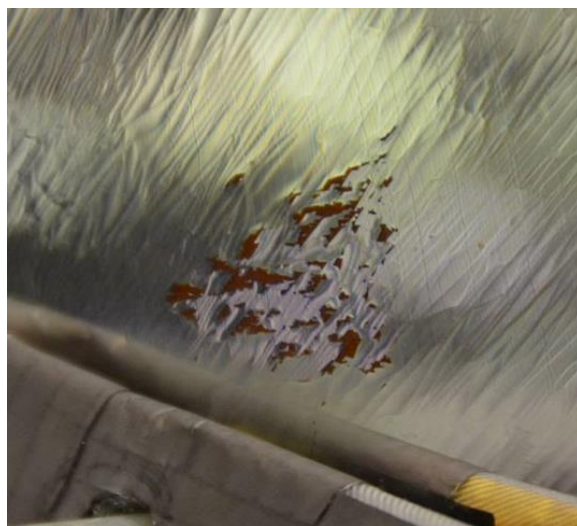
Thermal Control Surfaces

- Most thermal control surfaces degraded quickly with handling
 - NS43C paint powdered throughout I&T; repaired with Z93C55
 - Germanium flaked from some tape surfaces
 - High temperature MLI frayed at edges; backed with SS mesh to strengthen
 - Phosphoric-acid etched nickel inside radiometer began flaking. Stripped and recoated with Z306
 - ITO conductivity questioned, noticeable cracks seen on some surfaces. ITO Kapton outer layer replaced with GBK layer
 - All produced conductive particles, which were a problem for the high-voltage Faraday Cup
- Root cause not clear: time alone, too dry for too long or a combination

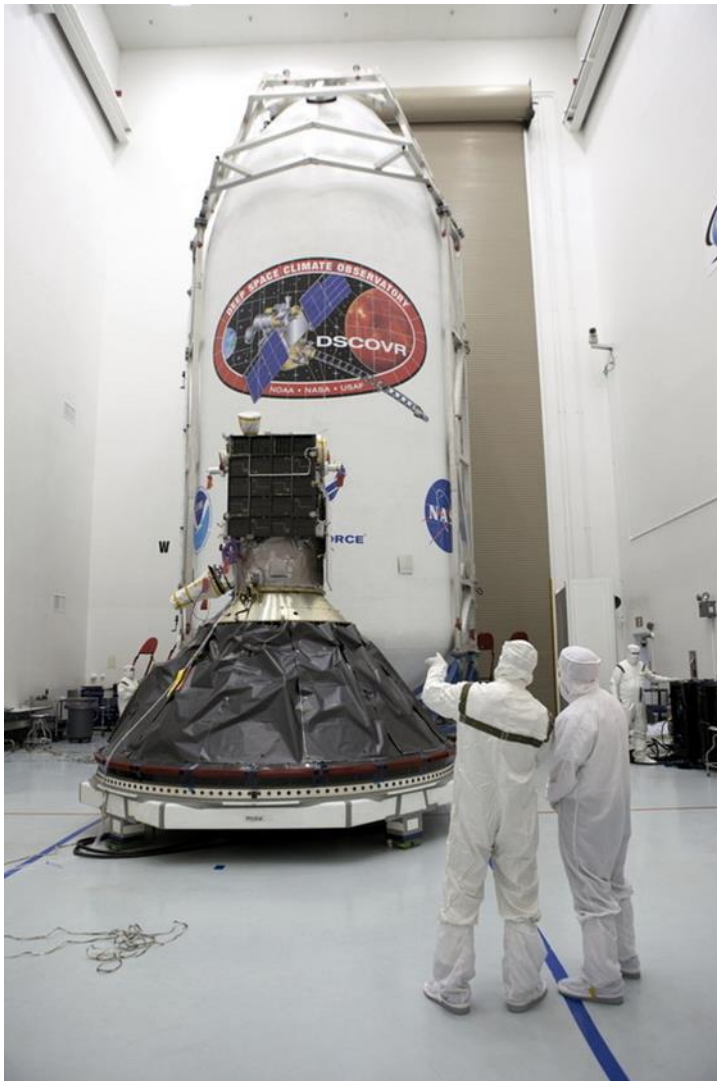
First NASA Mission on Falcon 9

- DSCOVR launched on a Space X Falcon 9
- Instituted magnetic, particulate and molecular cleanliness requirements.
- Fairing was cleaned to an acceptable level
- “Diving boards” used to access observatory for closeouts
- Purge gas certified to Grade B. Purge operated well throughout Falcon 9 operations. Disconnected ~16hours prior to launch during final closeouts.
- Magnetic controls successful: flight magnetometer sees very little background noise.
- Contamination controls successful: camera and radiometer are operating well.
