Fretting Wear of Ti-48Al-2Cr-2Nb

Kazuhisa Miyoshi,* Bradley A. Lerch, and Susan L. Draper

National Aeronautics and Space Administration

Glenn Research Center

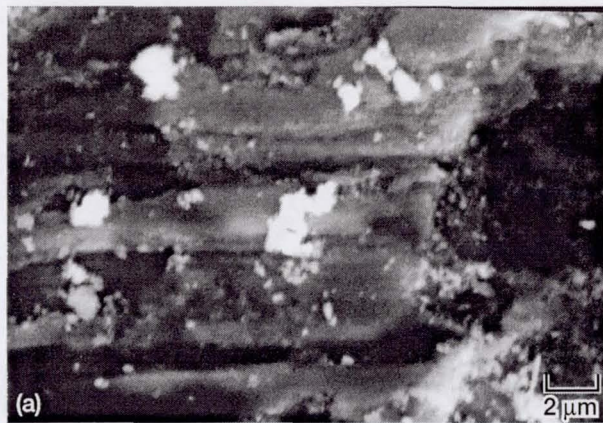
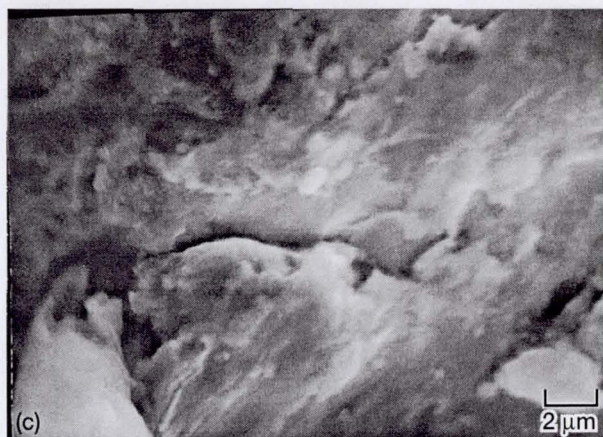
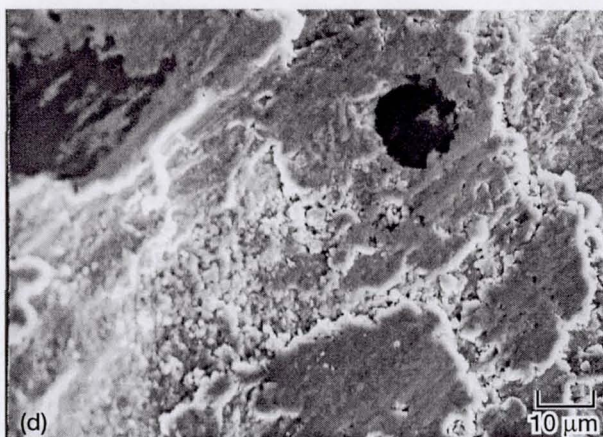
Fig. 9 Surface and subsurface damage in superalloy pin in contact with Ti-48Al-2Cr-2Nb flat. (a) Scratches. (b) Cracks in oxide layers. (c) Cracks in metal. (d) Fracture pits and plastic deformation. Fretting conditions: load, 1 N; frequency, 80 Hz; slip amplitude, 50 μm ; number of fretting cycles, 1 million; environment, air; and temperature, 823 K.

Figure 9 shows examples of surface damage produced on superalloy: metallic wear debris of superalloy and Ti-48Al-2Cr-2Nb, oxides, scratches (grooves), small craters, plastically deformed asperities, and cracks, all of which are similar to those observed on Ti-48Al-2Cr-2Nb. The scratches (Fig. 9 (a)) can be caused by hard, oxidized wear particles of superalloy and Ti-48Al-2Cr-2Nb, which are trapped between the interacting surfaces or are adhered to or embedded in the counterpart Ti-48Al-2Cr-2Nb surface. In Fig. 9 (a) scratches, craters, and fracture pits were produced by abrasion, a severe form of wear. The trapped wear particles and the adhered (or embedded) wear particles plow or cut the superalloy surface. The trapped wear particles have a scratching effect on both surfaces; and because they carry part of the load, they cause concentrated pressure peaks on both surfaces. The pressure peaks may well be the origin of crack nucleation in the oxide layers and the bulk alloys.

Oxide layers readily form on the superalloy surfaces at 823 K and are often a favorable solution to wear problems. However, cracks occurred in the oxide layers both within and around the contact areas, as shown in Fig. 9(b).

Fractures in the protective oxide layers produced cracks in the bulk superalloy (Fig. 9 (c)) and also produced wear debris, chemically active fresh surfaces, plastic deformation, craters, and fracture pits (Fig. 9(d)). This wear debris can cause third-body abrasive wear. Local, direct contacts between the fresh surfaces of Ti-48Al-2Cr-2Nb and superalloy resulted in increased adhesion and local stresses, which may cause plastic deformation, flakelike wear debris, craters, and fracture pits.

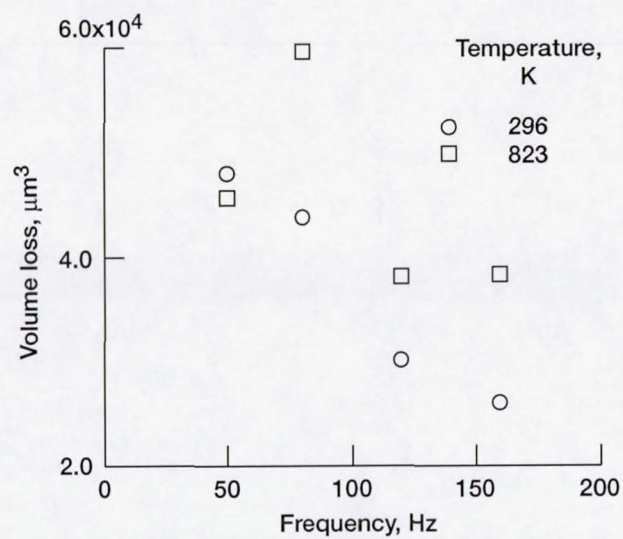
Fig. 11 Wear volume loss of Ti-48Al-2Cr-2Nb flat in contact with superalloy pin as function of fretting frequency. Fretting conditions: load, 30 N; slip amplitude, 50 μm ; number of fretting cycles, 1 million; environment, air; and temperature, 296 and 823 K.

Figure 11 shows the wear volume loss measured by the optical interferometer as a function of fretting frequency for Ti-48Al-2Cr-2Nb in contact with superalloy at different temperatures of 296 and 823 K, at a load of 30 N, with constant slip amplitude of 50 μm , and for a constant fretting duration of 1 million cycles.

The results indicate that fretting frequencies influence the volume loss of Ti-48Al-2Cr-2Nb. Although there were some exceptions, the wear volume loss generally decreased with increasing fretting frequency. A reasonable amount of material transfer from the Ti-48Al-2Cr-2Nb specimen to the superalloy specimen was observed at all frequencies. At lowest frequency of 50 Hz remarkable plastic deformation (grooving) and surface roughing in the Ti-48Al-2Cr-2Nb wear scar were observed. At high frequencies wear scars were noticeably smooth with bulk cracks in the Ti-48Al-2Cr-2Nb surface.

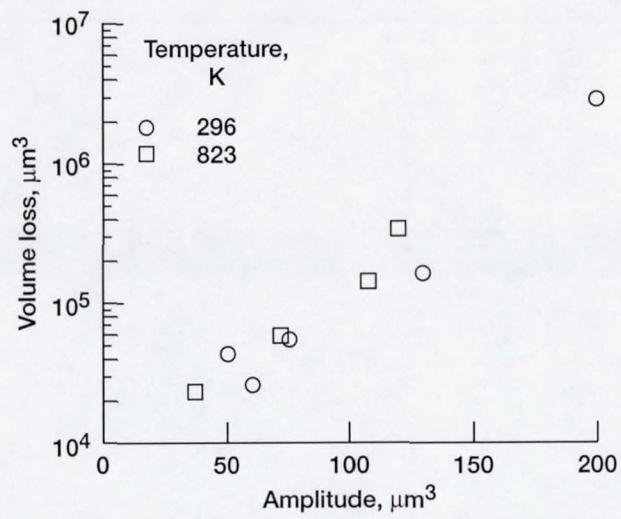
Fig. 12 Wear volume loss of Ti-48Al-2Cr-2Nb flat in contact with superalloy pin as function of slip amplitude. Fretting conditions: load, 30 N; frequency, 50 Hz; number of fretting cycles, 1 million; environment, air; and temperatures, 296 and 823 K.

Figure 12 shows the wear volume loss measured by optical interferometry as a function of slip amplitude for Ti-48Al-2Cr-2Nb in contact with superalloy. The fretting wear volume loss increased as the slip amplitude increased. Increases in slip amplitude tend to produce more metallic wear debris, causing severe abrasive wear in the contacting metals.

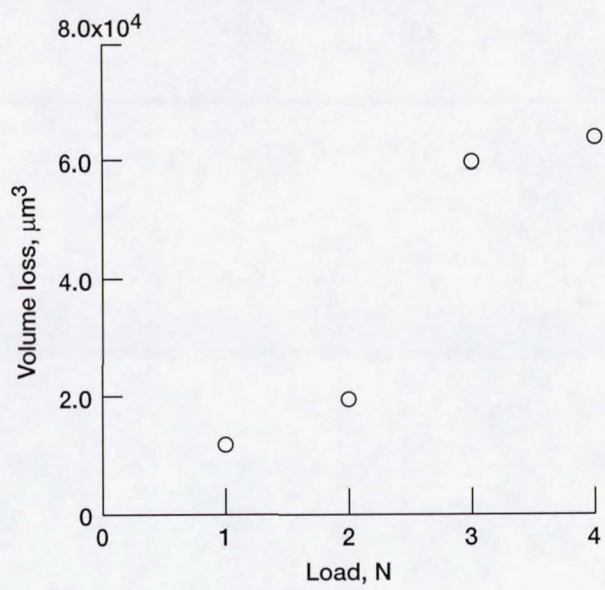
Fig. 13 Wear volume loss of Ti-48Al-2Cr-2Nb flat in contact with superalloy pin as function of load.
Fretting conditions: frequency, 80 Hz; slip amplitude, 50 μm ; number of fretting cycles, 1 million;
environment, air; and temperature, 823 K.

Figure 13 shows the wear volume loss as a function of load for Ti-48Al-2Cr-2Nb in contact with superalloy at a temperature of 823 K, a fretting frequency of 80 Hz, and a slip amplitude of 50 μm for 1 million cycles. The fretting wear volume loss generally increased as the load increased, generating more metallic wear debris in the contact area, the prime cause of the abrasive wear in both Ti-48Al-2Cr-2Nb and superalloy.
