# **A-1 LOX & LH Runline Contamination**

**RTG Meeting – December 2-3, 2014**  
**Nugent, Jacks and Hebert**

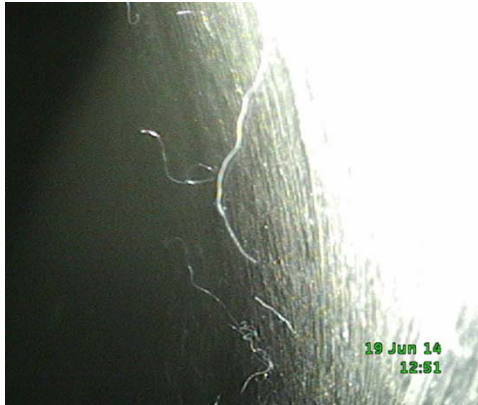
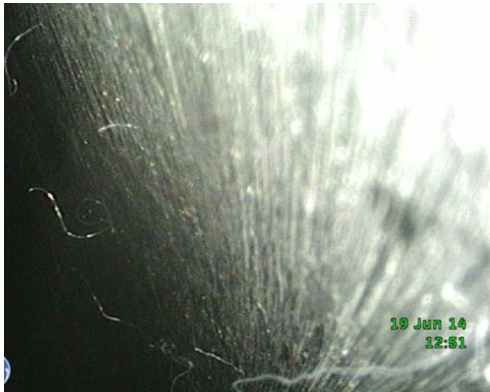
# A1 LOX Runline Inspection Results

- During LOX Lower Runline inspections on 6/19/14, numerous fibers were observed between the run line screen and O1 interface flange.
- Subsequent inspections of the LH Upper Runline on 6/26/14 revealed fibers between the LH Run Tank isolation valve and the runline screen (including the runline screen)
- All involved runlines/screens were installed new.
- Fiber sizes exceed cleanliness requirements as identified on the SSC piping schematics:
  - LOX: Drawings PSK-A1-2001-FAC & PSK-A1-2001-RS25
    - \*RPTSTD-8070-0001 Level 750A with a maximum particle size of 750 microns allowed
  - LH: Drawings PSK-A1-1001-FAC & PSK-A1-1001-RS25
    - RPTSTD-8070-0001 Level 400 with a maximum particle size of 400 microns allowed
  - Samples have indicated fibers up to 9000 microns long
    - RPTSTD-8070-0001 defines fibers as particulate

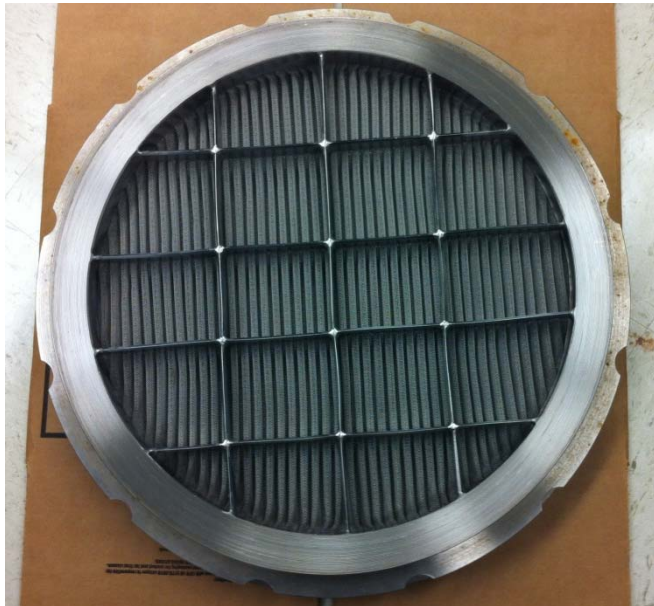
## 12" Screen

- **Original Runline screen removed and replaced with spare screen. Original Screen inspected:**
  - **Few cotton fibers located on inlet/outlet side.**
  - **Strong fluorescence under Black Light**
  - **Fibers appear to be resting on inlet surface and migrating towards outlet**
  - **304 SST particle with entrapped cotton fibers**
- **Screen manufacturer (Erbe) contacted**
  - **No cotton wipes used for processing or shipping**

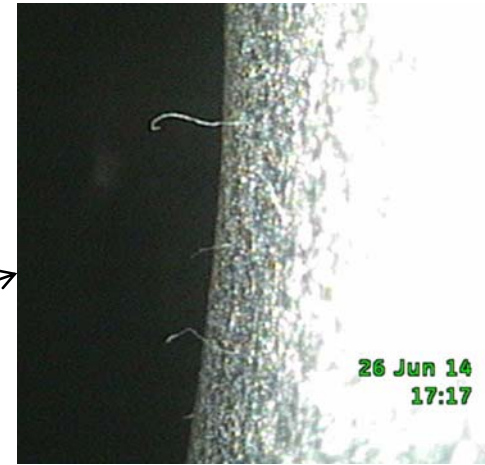
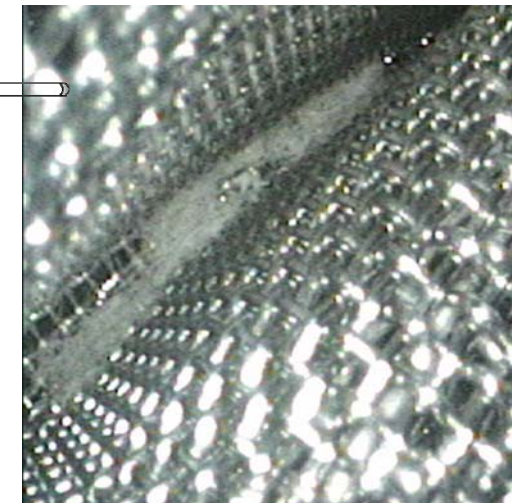
Borescope Photos

**FOD Size:** 2 Fibers removed: 1200X60 microns  
1 Fiber removed by NASA millipore: 1800 microns  
**Material:** Cotton (NASA millipore Fiber)  
**Color:** Blue and White

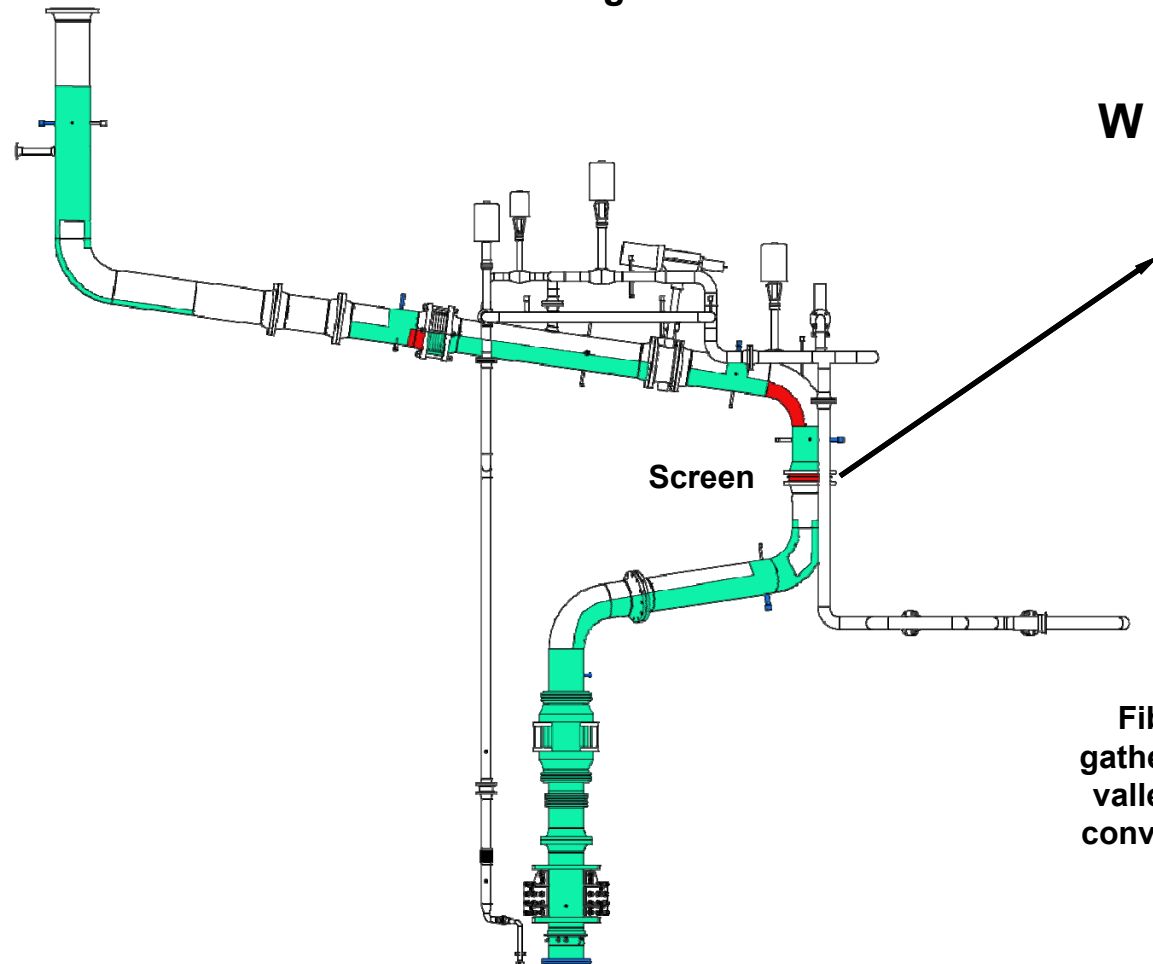
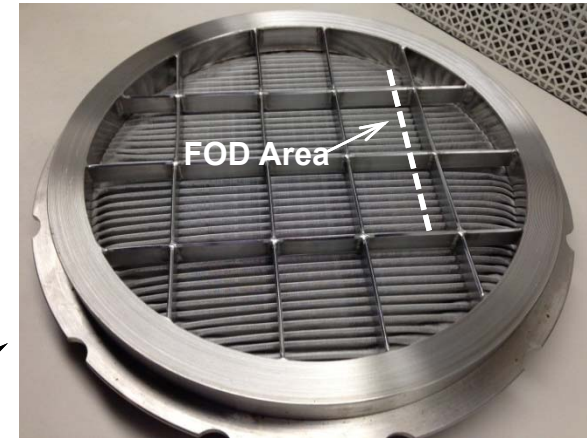
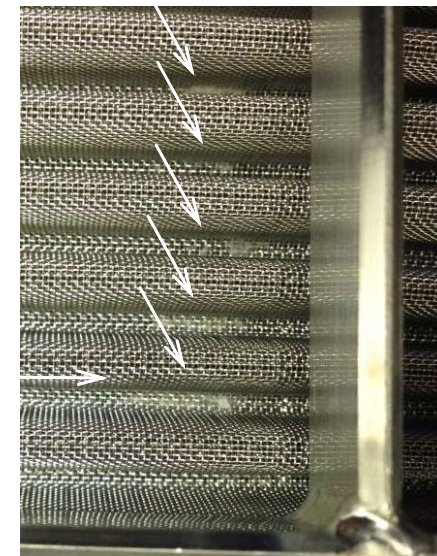
## 12" Screen

- Original screen remove and replaced with clean spare screen
- Numerous visible, cotton fibers located on original screen
- Fibers located on "east" edge of screen as installed

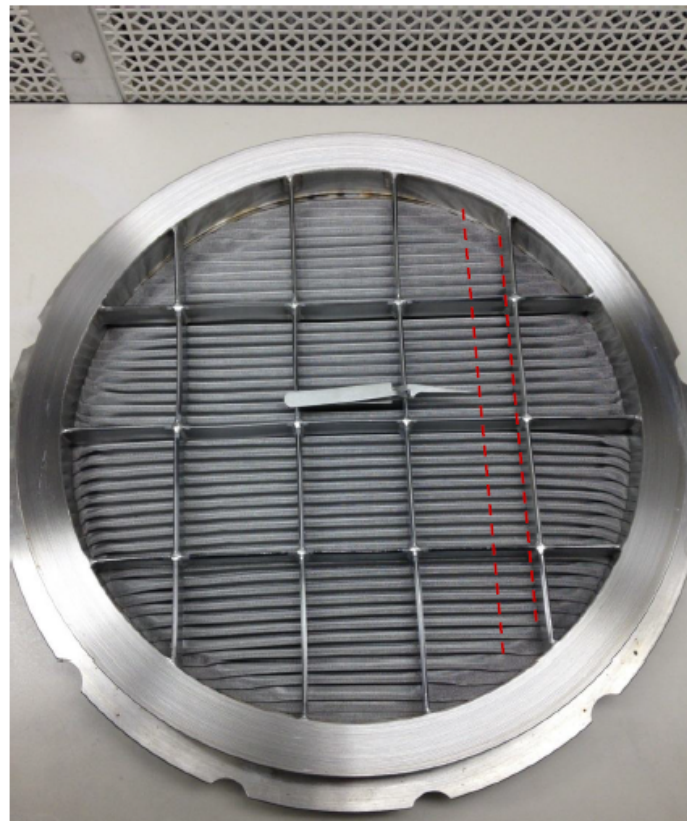
## A1/TS LH 12" Original Screen Inlet Side FOD (Non-Metallic Fibers) Delivered to GMSL 7/15/2014

The FOD fibers are mostly confined within the pleated valley regions as highlighted by the red dash lines.

Based on the Two Acid ( $H_2SO_4$  &  $HCl$ ) Tests, the Solubility and Color Changes are Consistent with Cellulose (e.g., cotton) Fibers.

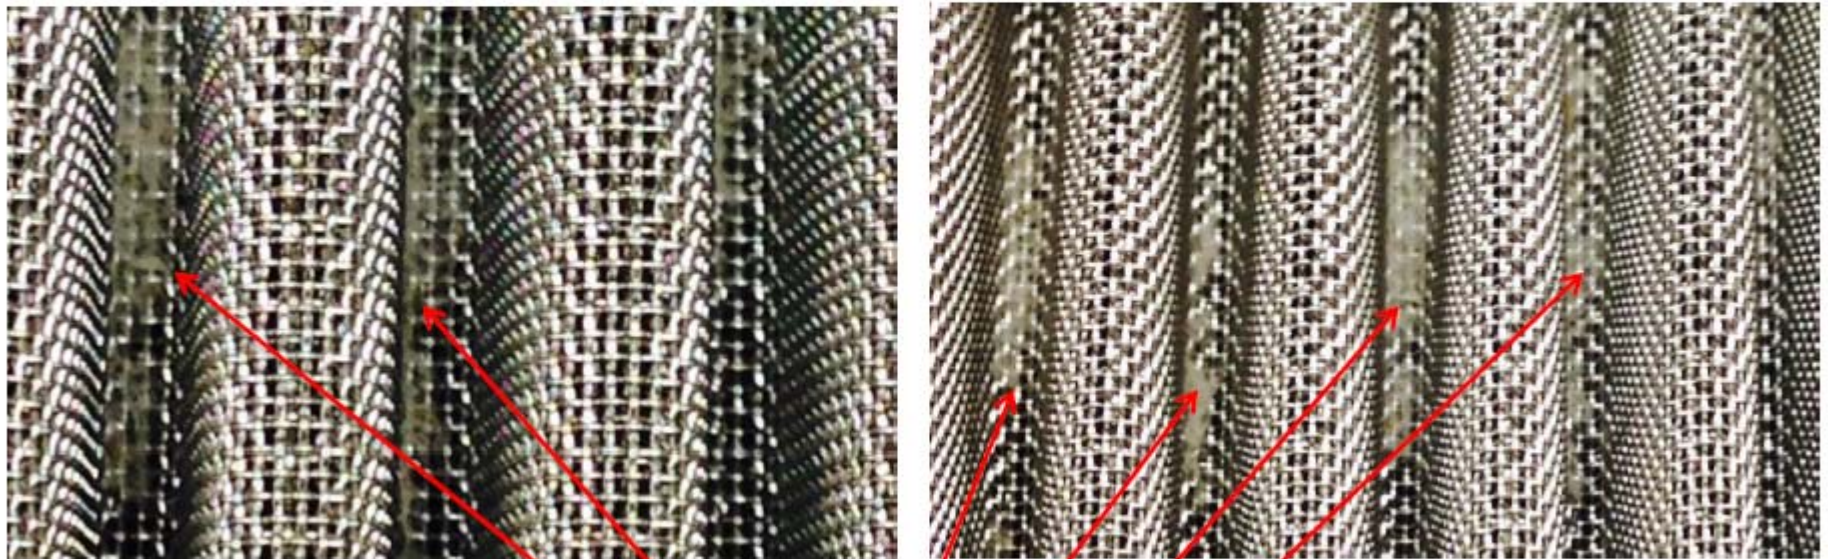
# A1/TS LH2 Original Frantz Screen

FOD (Fibers) in the Screen Valleys

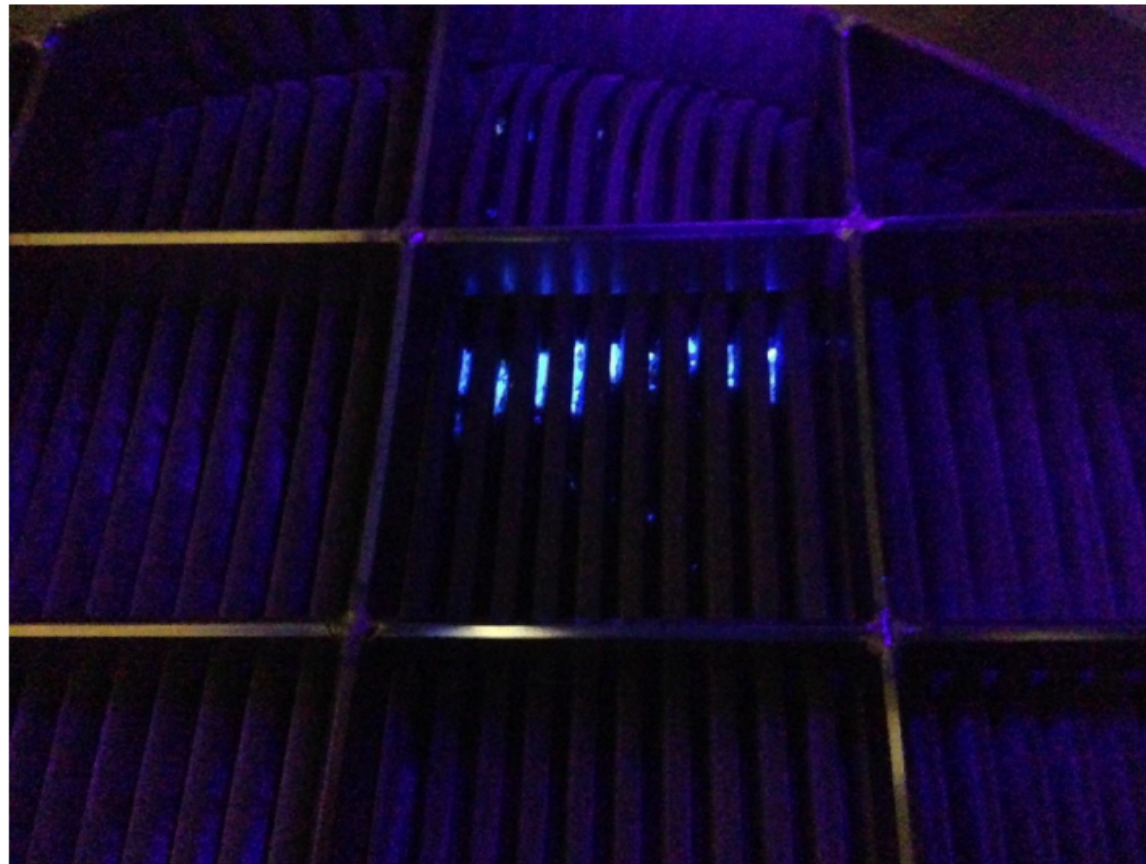
## A1/TS LH 12" Original Screen Inlet Side

UV Illuminated Image Shows the Accumulation of  
Fibers in the Pleated Valleys

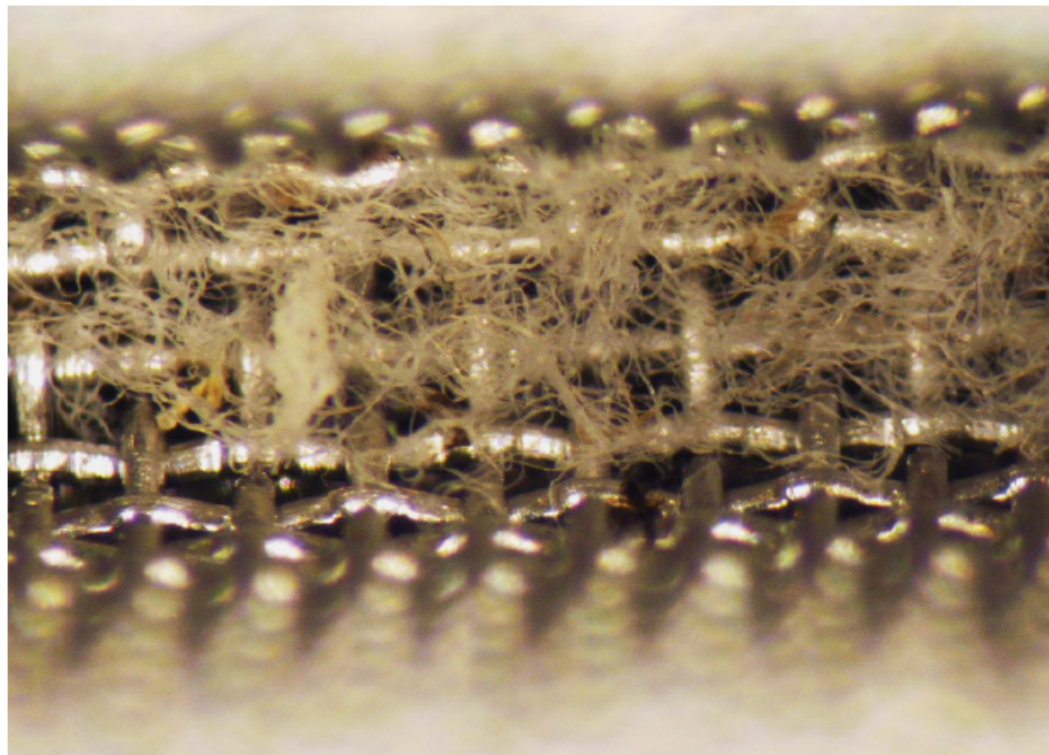
## A1/TS LH 12" Original Screen Inlet Side

Optical Microscope Image of the Inlet Side - The majority of the fibers are  $> 2000\mu$  and are confined to the screen valleys . The non metallic fibers are flexible ( diameter is  $< 50\mu$ ; consequently, several fibers have traveled below the surface.

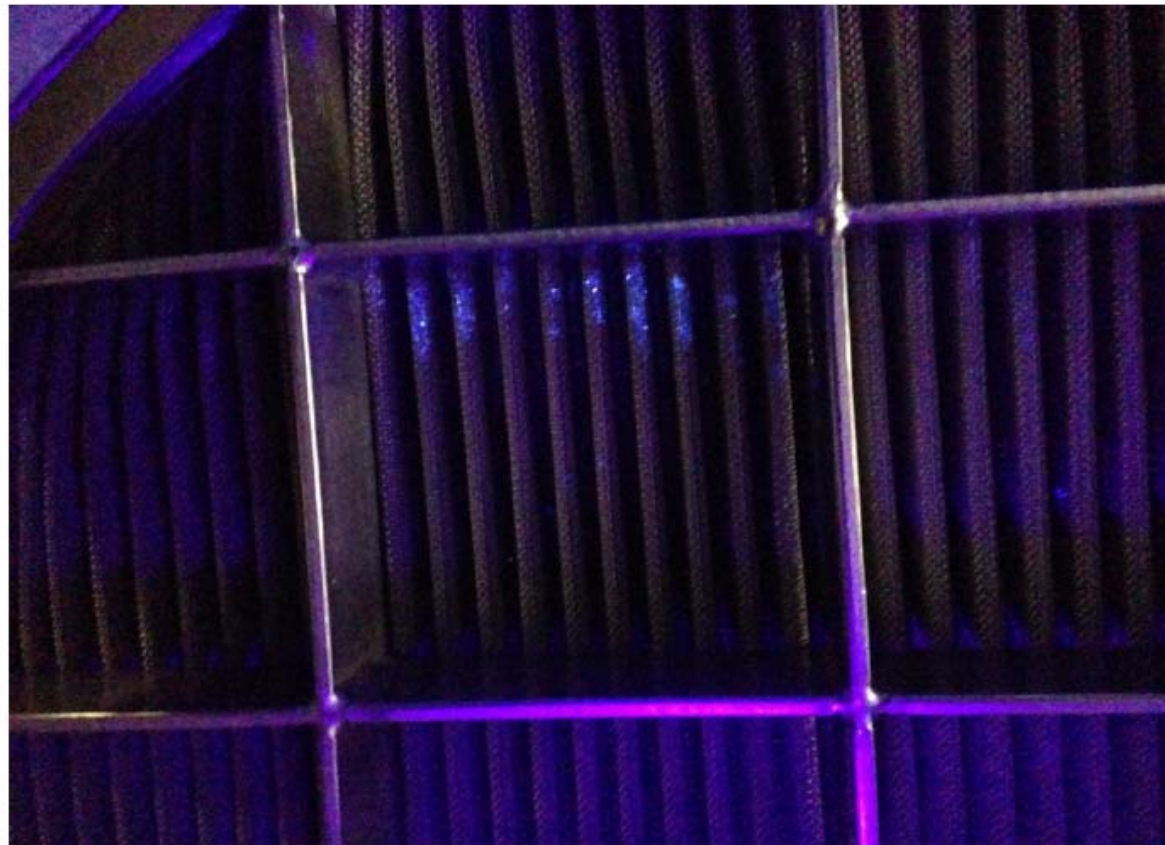
## A1/TS 12" LH Original Screen Outlet Side

UV Illuminated Image Shows the Fibers are  
Confined to the Crest Areas

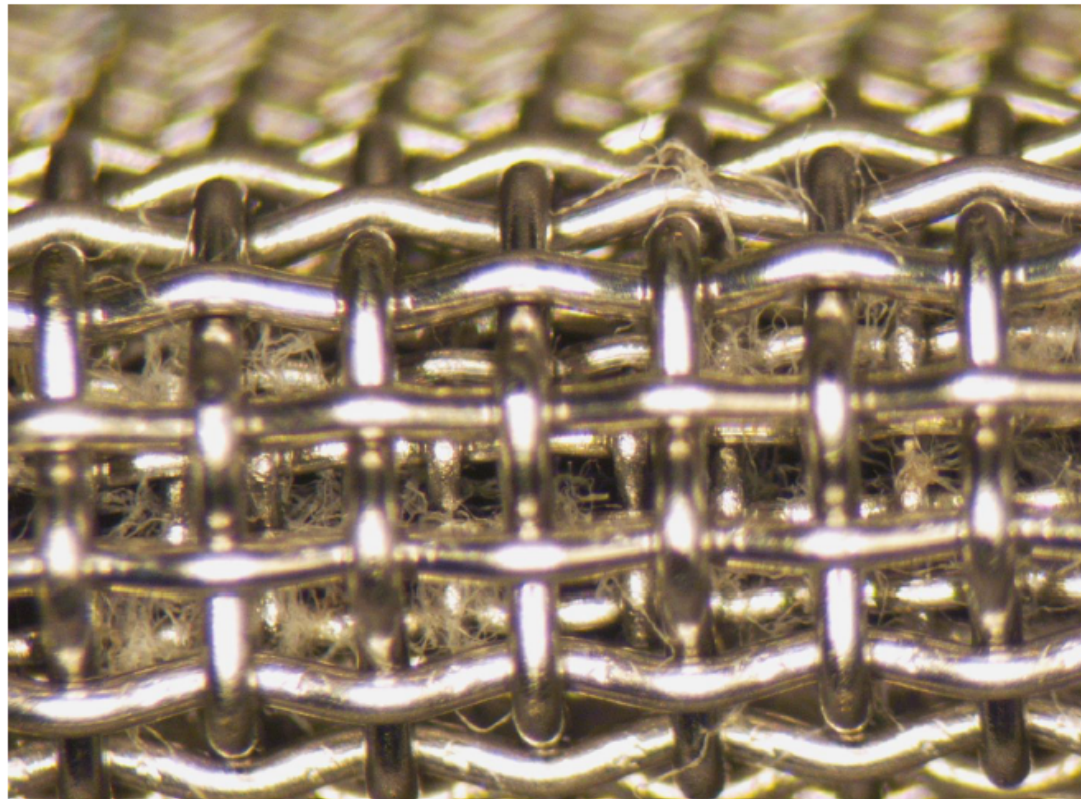
## A1/TS LH 12" Original Screen Outlet Side

Optical Microscope Image of the Screen Crest on the Outlet Side - The fibers are confined between the two pleated screens. The fibers are more concentrated on the inlet side (in the screen valleys). Some of the fibers have migrated through both filter screens and have traveled to the surface.

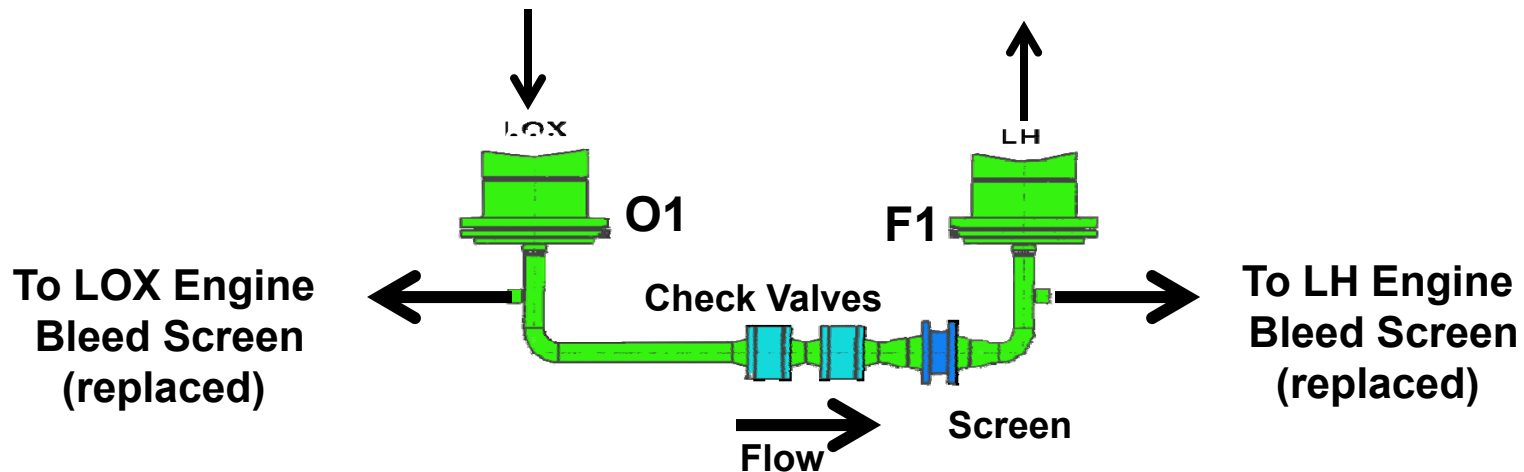
**3" LN Coldshock Crossover Spool**

- **LN Coldshock**
  - Major components utilized during coldshock removed and inspected:
    - Two (2) 3" crossover check valves: one white fiber, one blue fiber, all cotton,
    - 3" crossover screen: one blue cotton fiber
    - 3" LOX Engine bleed screen: one cotton fiber
    - 3" LH Engine bleed screen: Two (2) fibers, too small to characterize
  - Engine bleed screens replaced with cleaned hardware

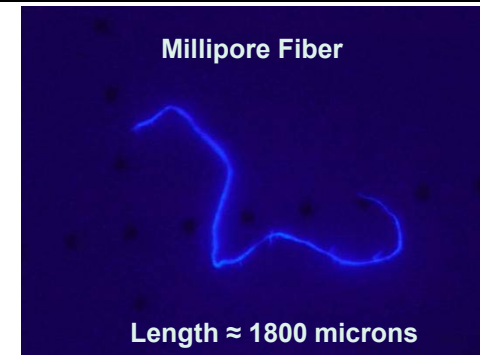
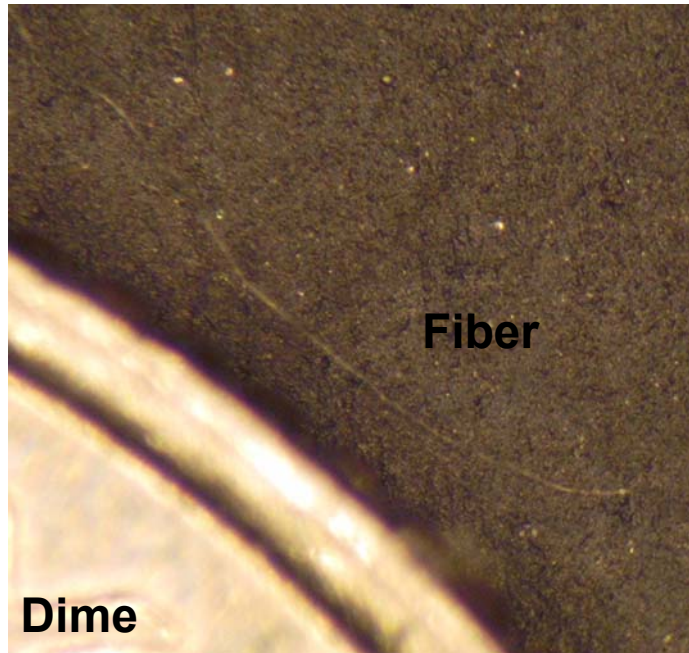
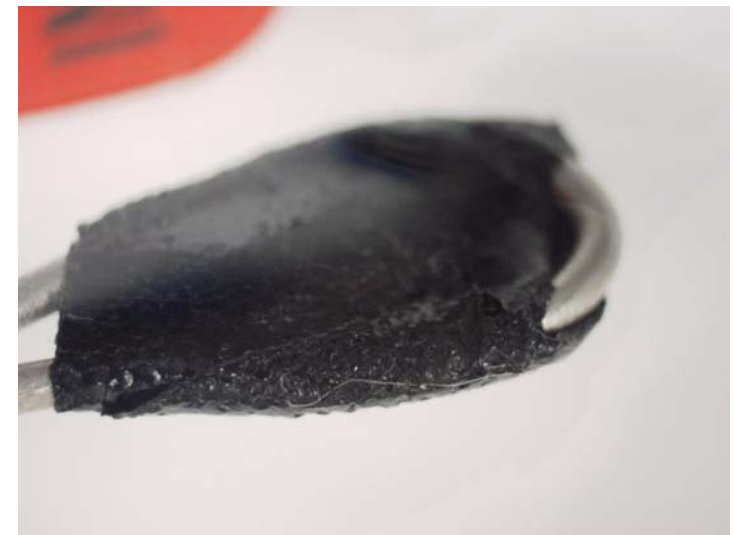
- **Fibers from Runline/Screens**
  - **White and Blue**
  - **Up to 9000 microns**
  - **Cotton**
  - **Highly Fluorescent**

The fiber fluoresces when examined by blacklight and has mechanically worked features (i.e. frayed and pulled areas). Under visible light, the thinner sections appear translucent while the thicker sections appear milky white. Material properties are consistent with a cellulose based fiber (e.g. cotton).

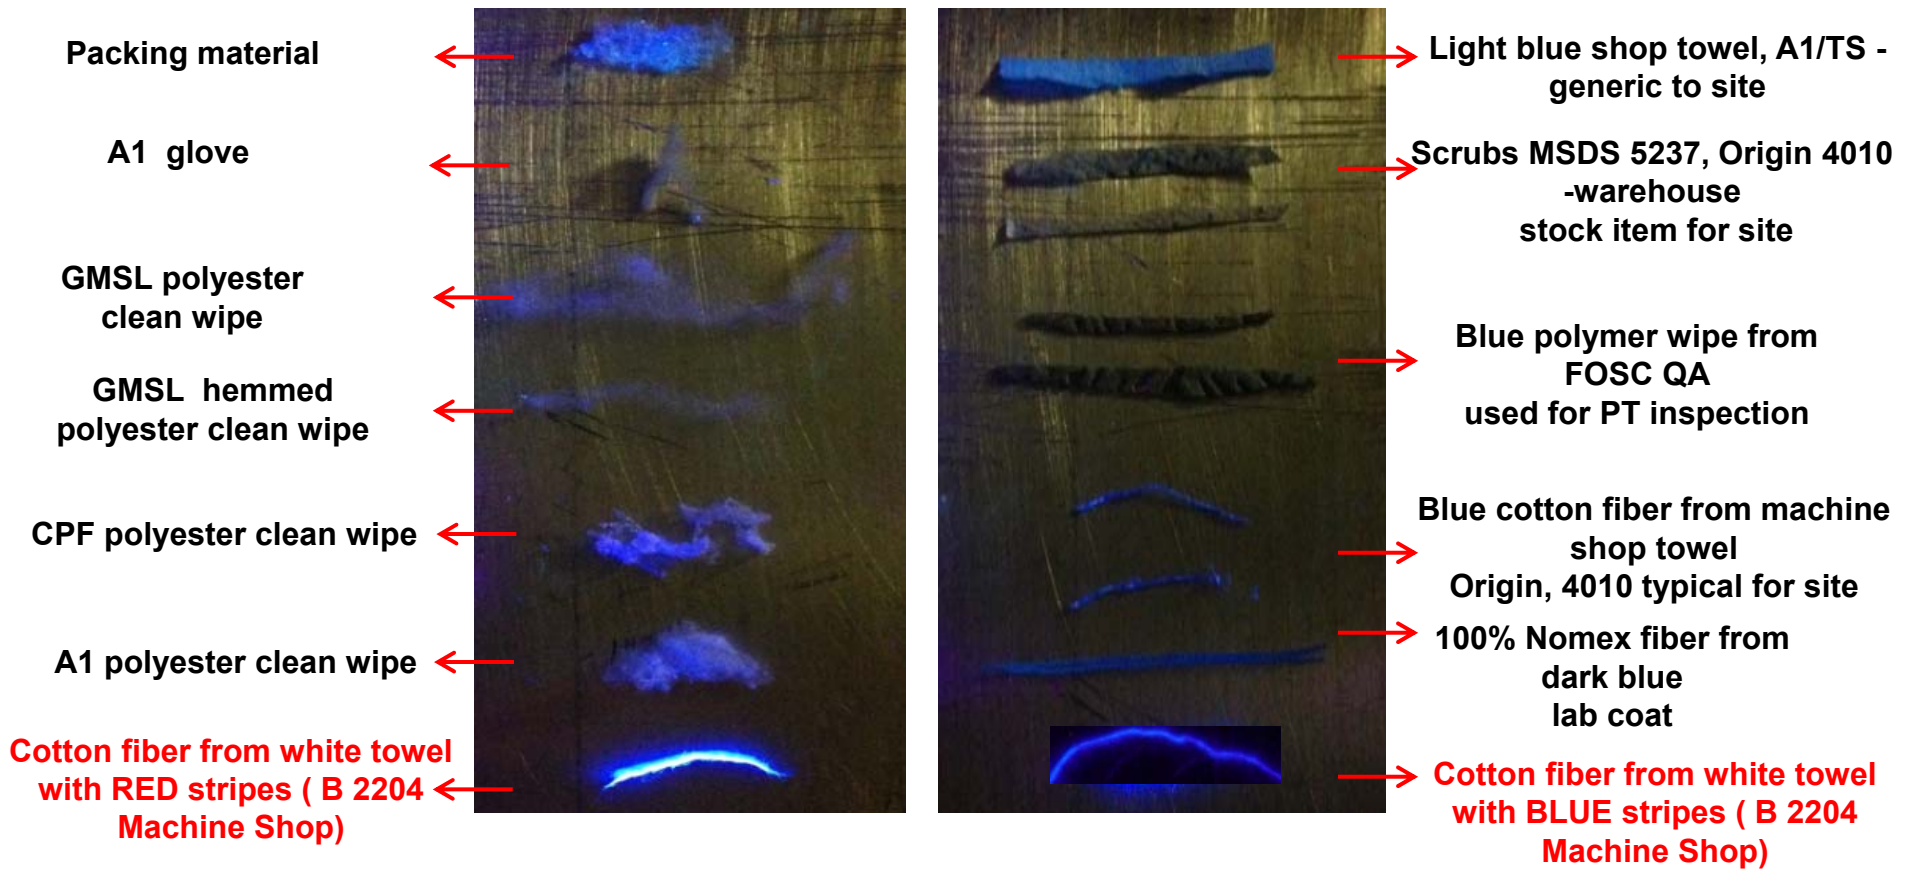
- Numerous on site fabrics/wipes were tested to compare fluorescence intensity to runline FOD
  - Two (2) wipes displayed similar intensity
    - White rag with red stripe (Cotton)
    - White rag with blue stripes (Cotton)
- These two (2) wipes selected for further testing

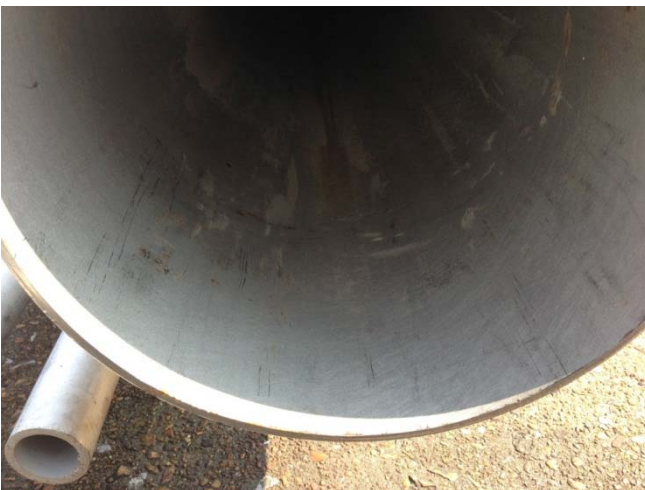
**Leftover LH Spool**

- One (1) remnant piping spool from same Lot# located in outside storage area and used as test specimen:
  - No fibers initially. Spool cleaned at CPF.
  - Spool then wiped with cotton wipe (white w/blue)
    - When using aggressive wiping, no long fibers indicated. Numerous smaller debris
    - When using normal wiping, fibers indicated on scoured/raised areas.
  - Sent to Component Processing Facility (CPF) for cleaning
    - Reinspected: All loose particulate removed. Fiber remained on scoured/raised area

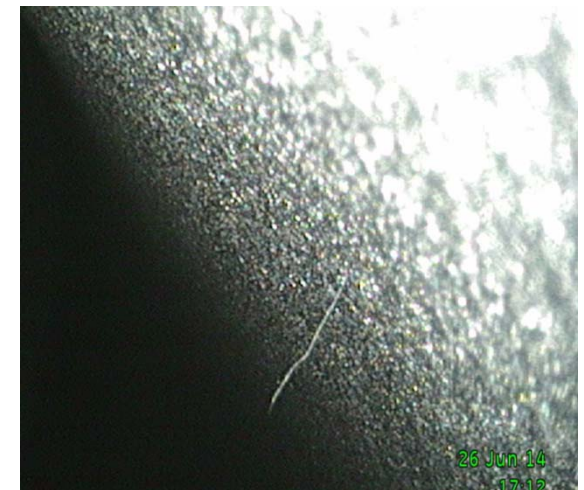
**A1 LH Runline**

- **After piping installation, some fibers dislodged by runline purges and/or coldshock**
- **Loose fibers in LH runline migrated to LH runline screen via purge flow.**

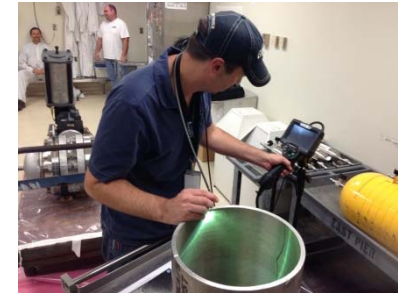
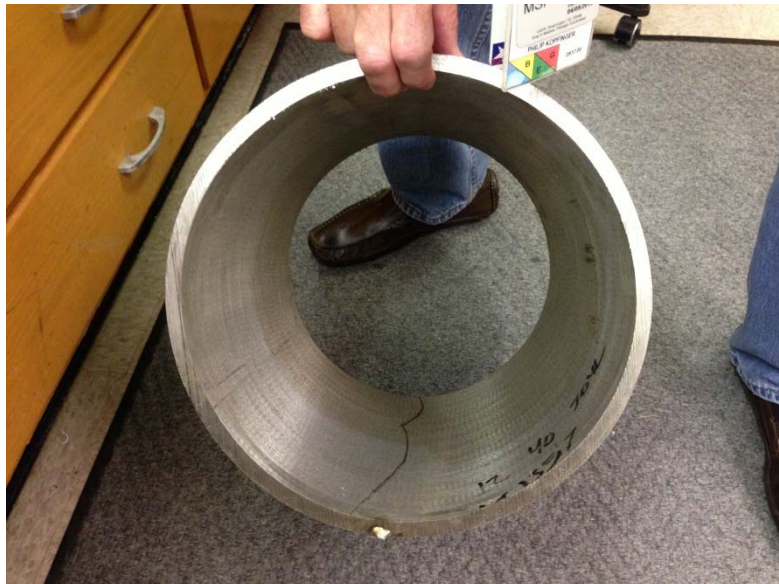
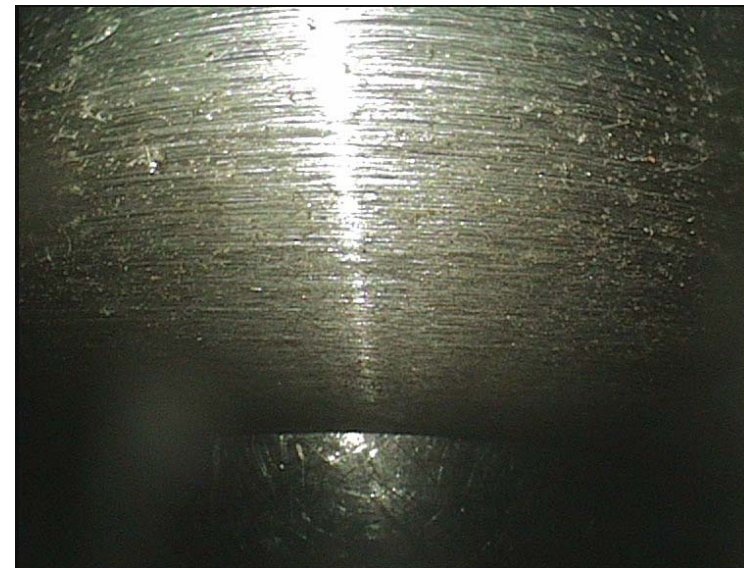
- Two (2) remnants piping spools from same A-1 LOX piping lot# located in outside storage area and used as test specimens:
  - Short LOX Spool (14'') and Long LOX Spool (6')
- Short spool:
  - Borescope Inspected: ~5-10 Cotton Fibers initially
    - Potentially from previous handling
  - Typical dirt and debris from being in storage yard

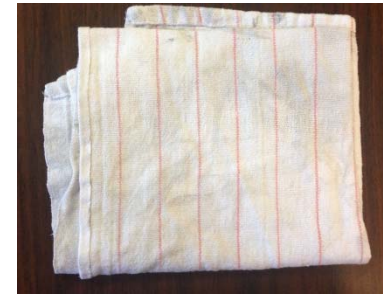
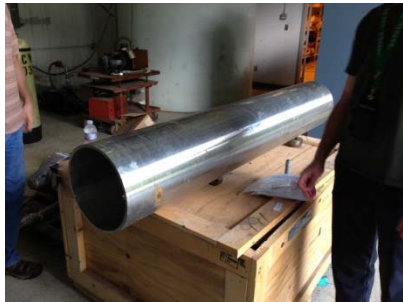
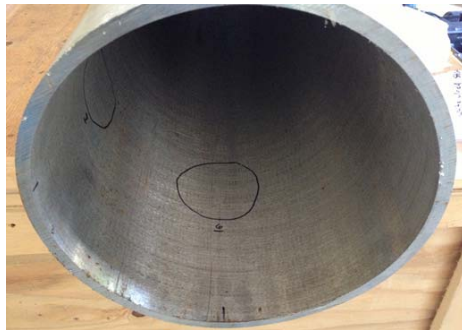
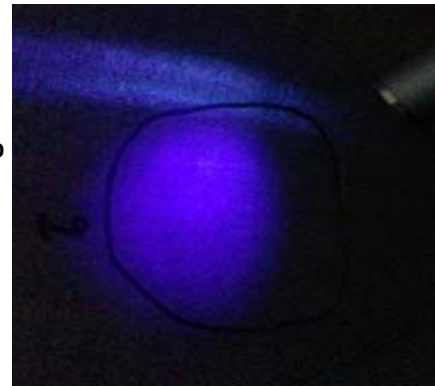
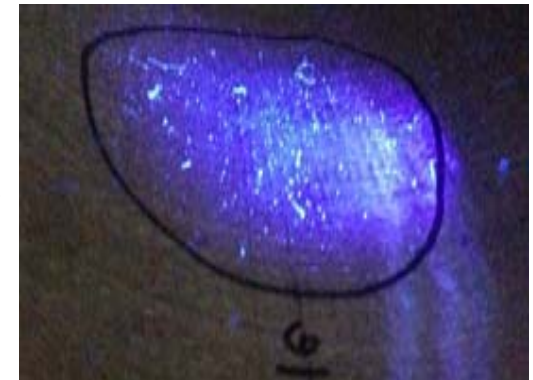
LOX Long Spool

- **Long Spool relocated from storage area to CPF**
  - Initial inspections: No fibers indicated
- **Long Spool wiped with white cotton rag w/red stripe**
  - Numerous fibers remained in spool
  - Fibers consistent with FOD from runline

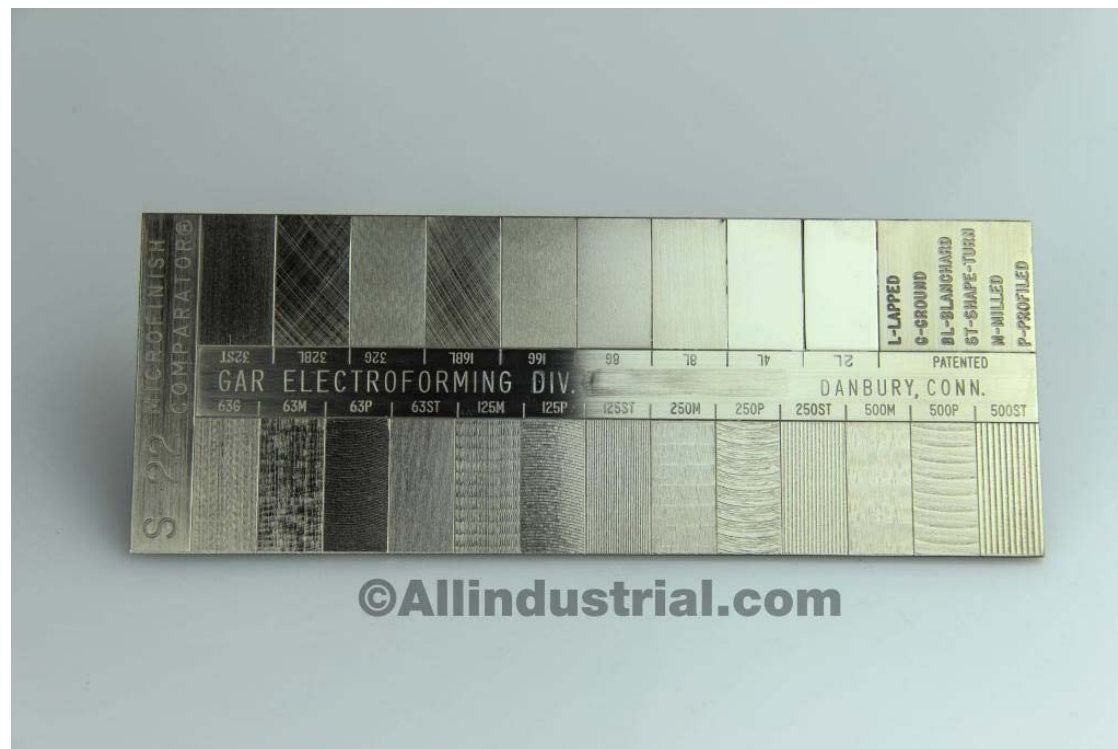
- SSC currently uses a micro finish comparator to gauge surface roughness
