Environmental Durability and Stress Rupture of EBC/CMCs

Matthew Appleby, Dr. Gregory N. Morscher – Department of Mechanical Engineering, The University of Akron, Akron, OH
Dr. Dongming Zhu - Durability and Protective Coatings Branch, NASA Glenn Research Center, Cleveland, OH

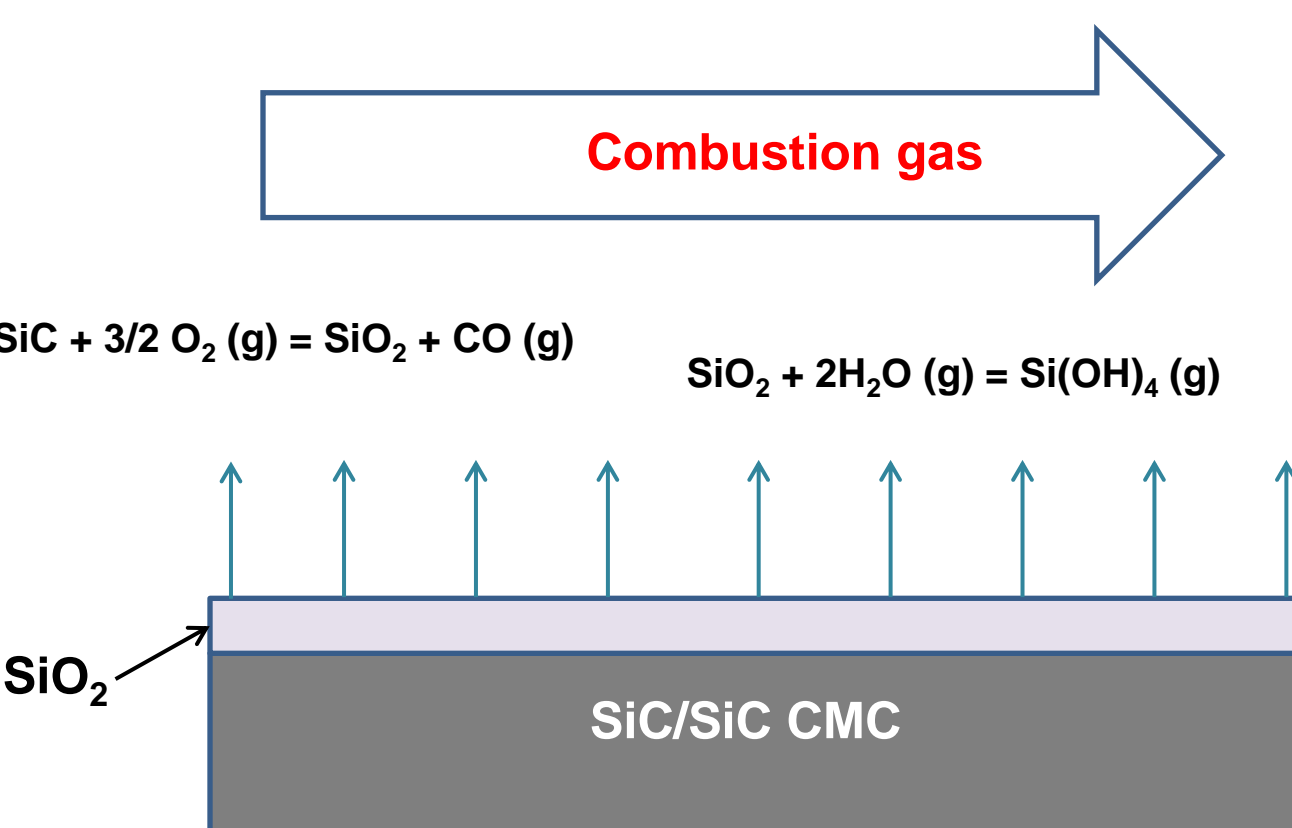
- **Si-based ceramics react with high temperature water vapor in combustion environments causing recession**
 - Boundary layer gas transport
 - Degradation dependent upon temperature, system pressure, water vapor pressure, and gas velocity

➔ Therefore, without a protected surface, rapid recession of SiC in a combustion environment will occur...drastically limiting component life.

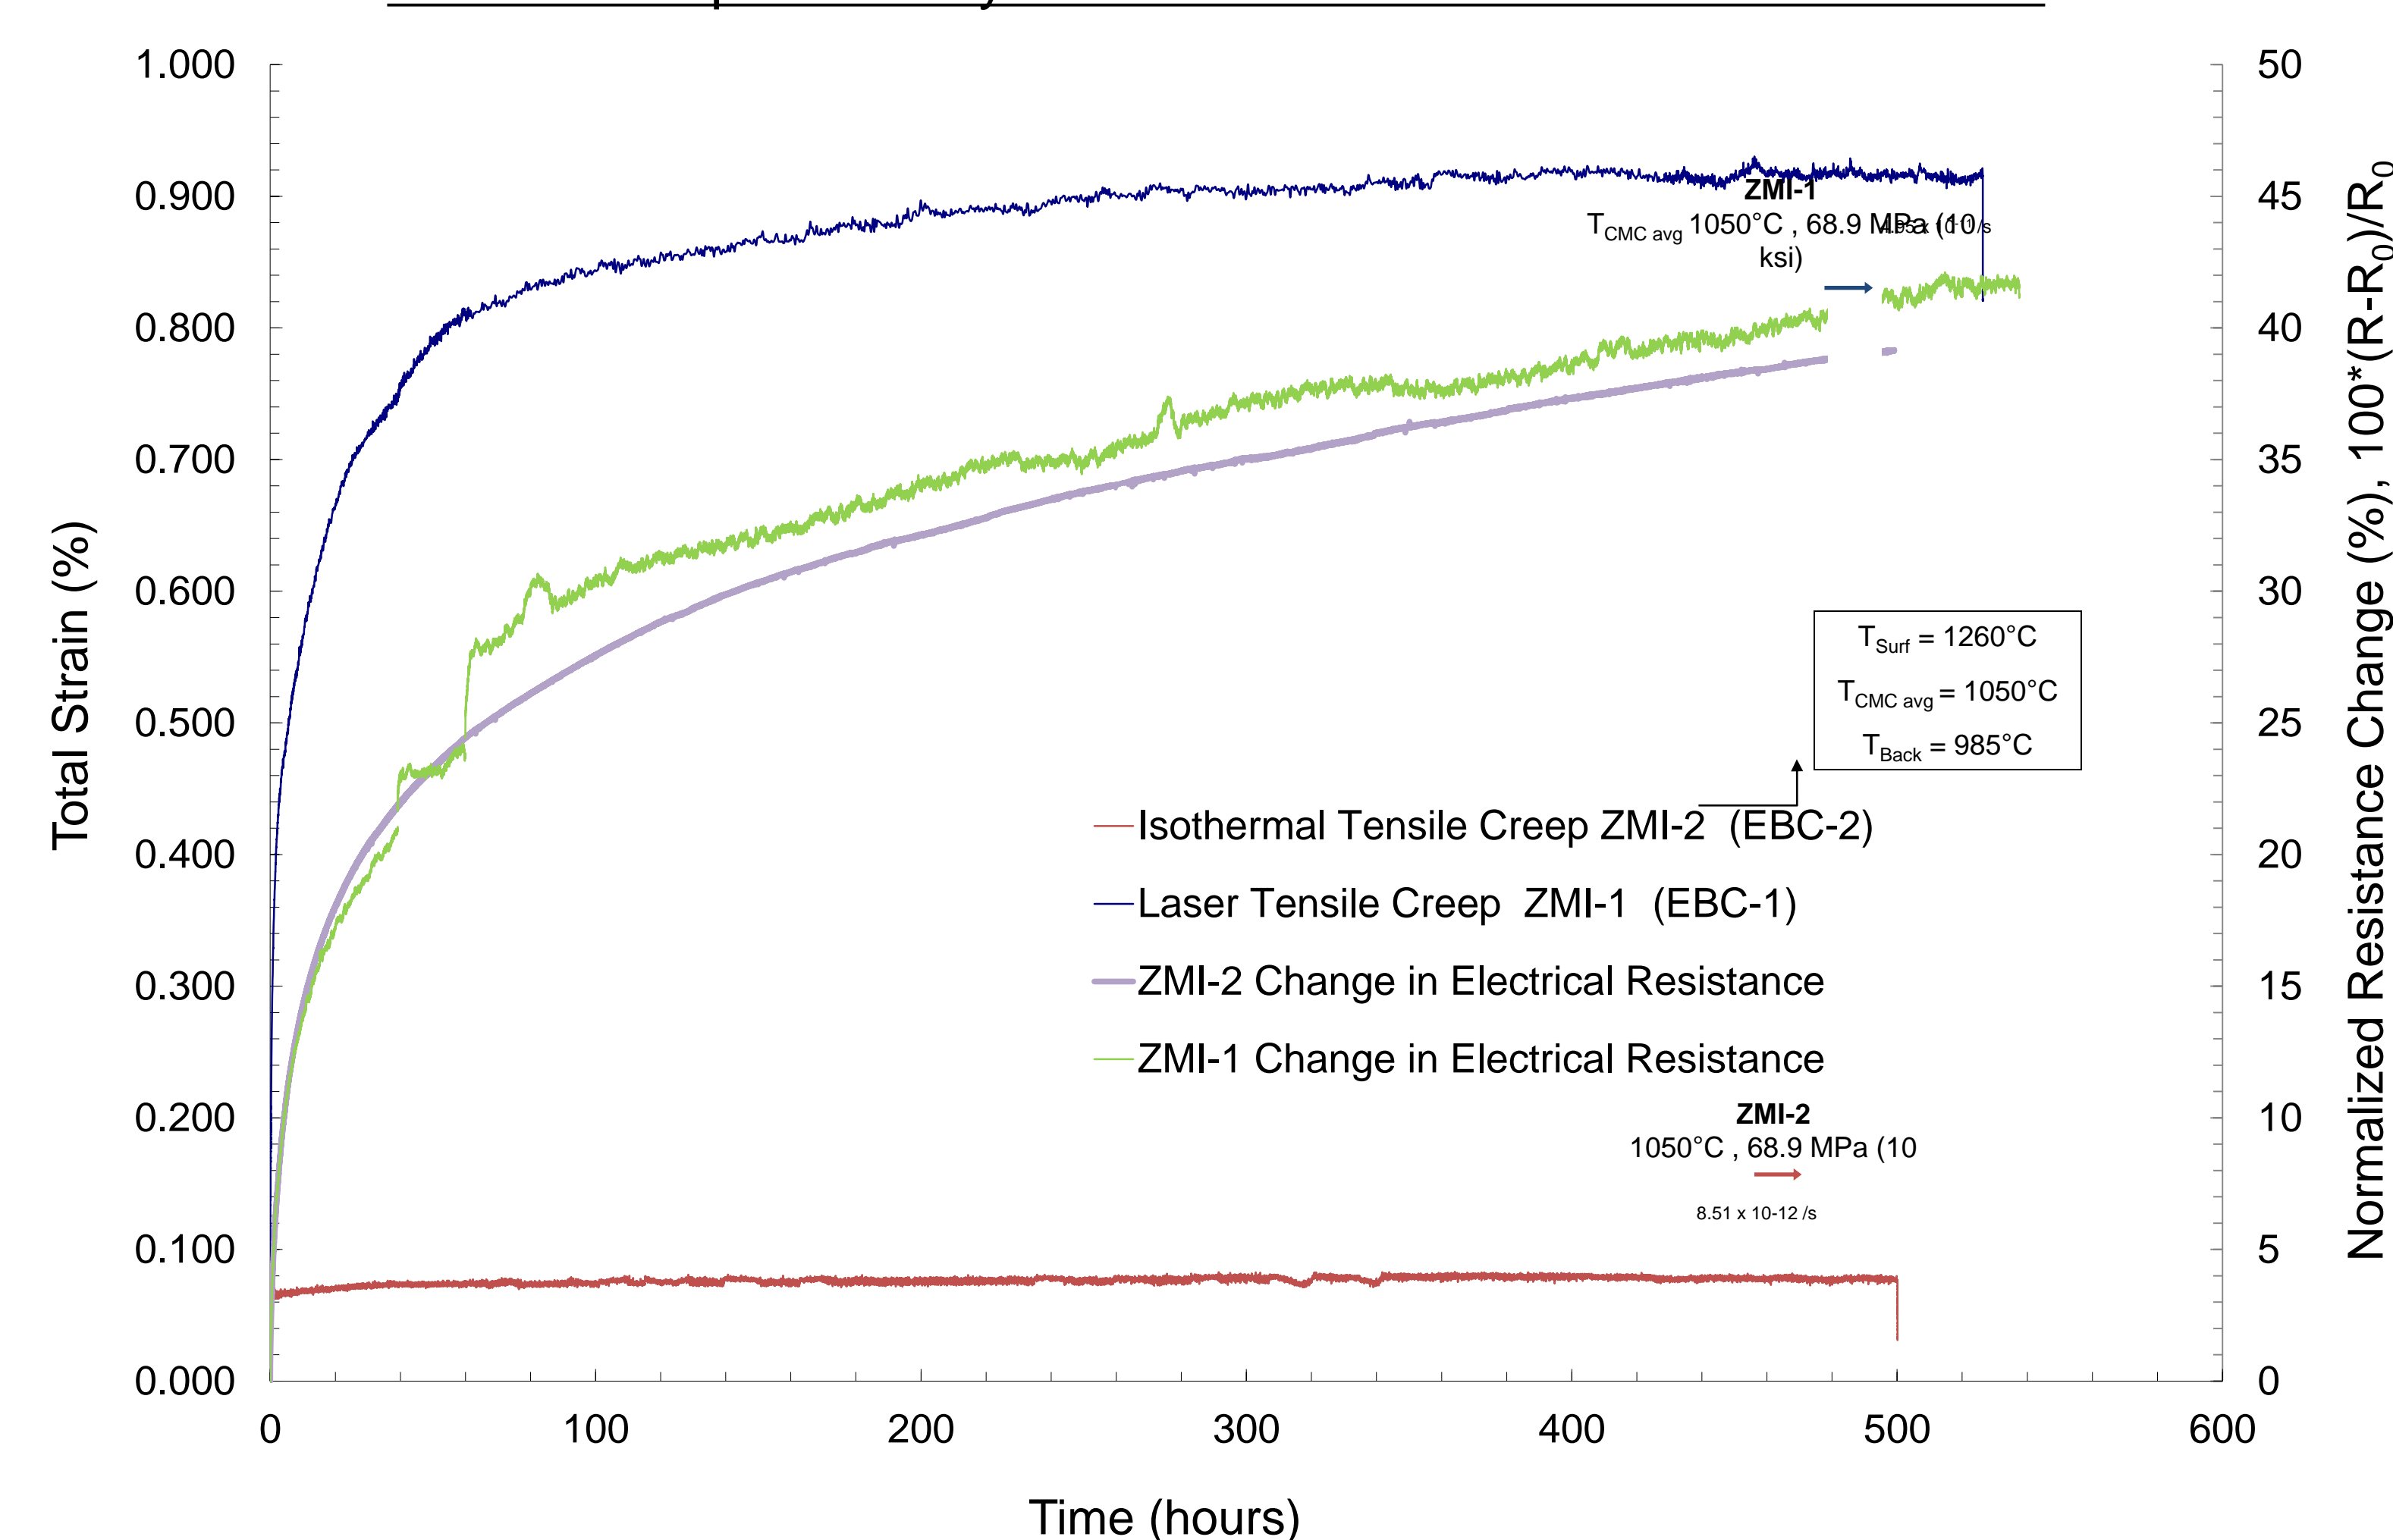
Tensile Creep Test of Tyranno ZMI fiber reinforced SiC/SiC CMC

Specimen	Test Conditions	$E_{@1050^\circ\text{C}}$ Initial, GPa	$E_{@1050^\circ\text{C}}$ Post 500hr Creep, GPa	σ_{UTS} , MPa	Failure Strain, %
ZMI-1	Thermal Gradient	30.3	76.6	114.9	0.2156
ZMI-2	Isothermal	153.2	173.6	137.8	0.1414

- Thermal gradients, common in many high temperature structural applications, appear to reduce material stiffness and creep resistance.
- This could be caused by a shifting of the neutral axis caused by stress relaxation in the hot side of the specimen.
- ER monitoring shows a change with time, we need to see how effective it is at correlating with damage mechanisms. Modeling of the mechanics behind this phenomenon are ongoing.
