Capacitor Failure Investigation Results for the NEXT Ion Thruster Power Processing Unit (PPU)

James F. Soeder, Luis Pinero, Robert Scheidegger
NASA Glenn Research Center
John Dunning – Alpha-port Inc.,
Art Birchenough – QinetiQ-NA Inc.

April 17, 2012

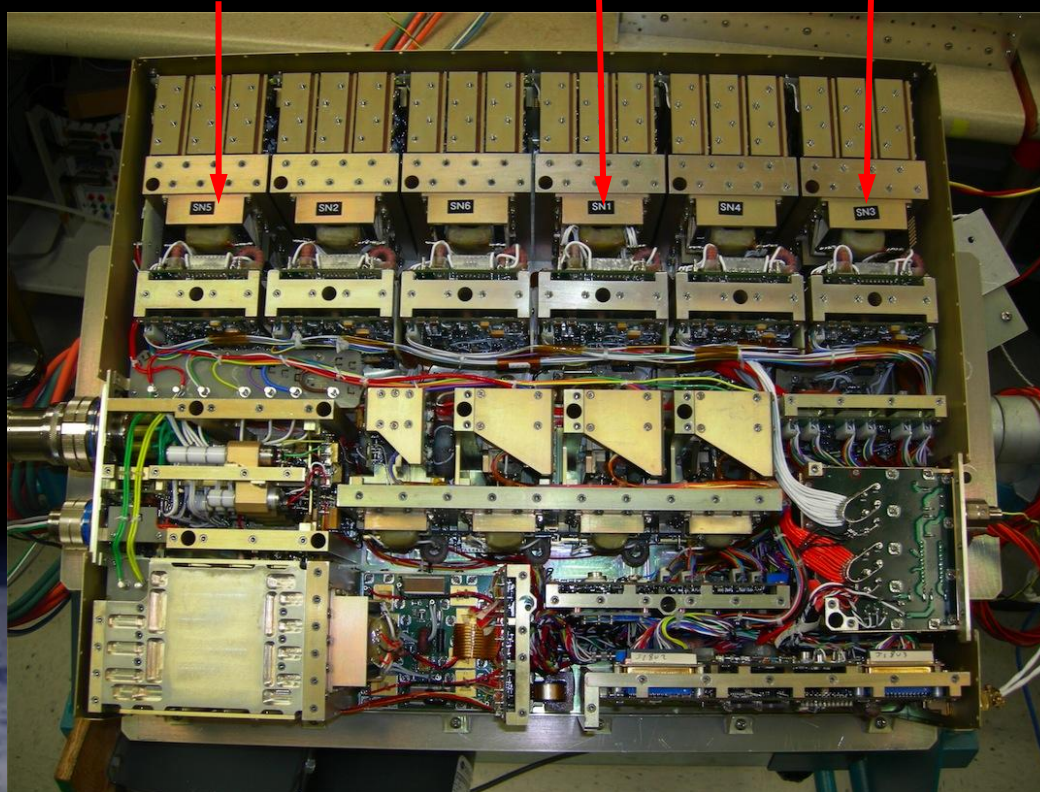
Background MLC Capacitor Failures

1st failure
Module #1
March 2008

3rd failure
Module #4
April 2010

2nd failure
Module #6
Feb 2009

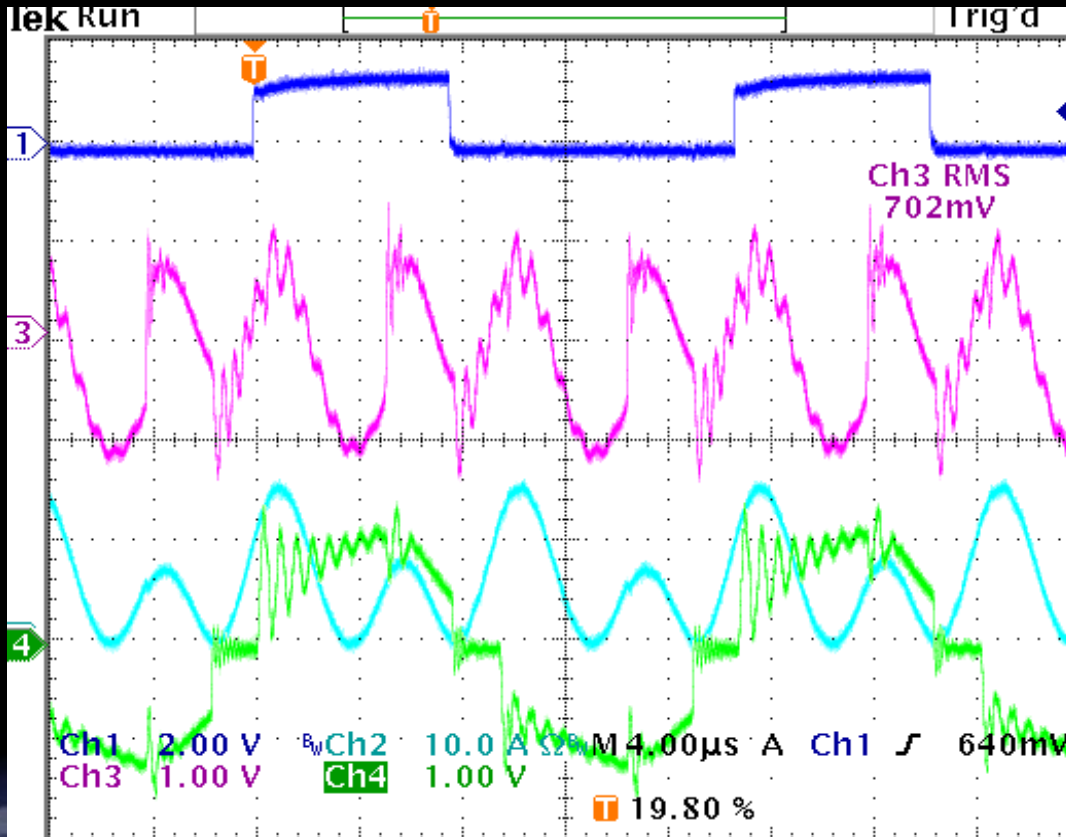
Cap Current and Circulating Current

Gate Drive

Capacitor Ripple Current is 20 A p-p @ 200 kHz

Capacitor Circulating Current is 16 A p-p @ 200 kHz

Transformer Current

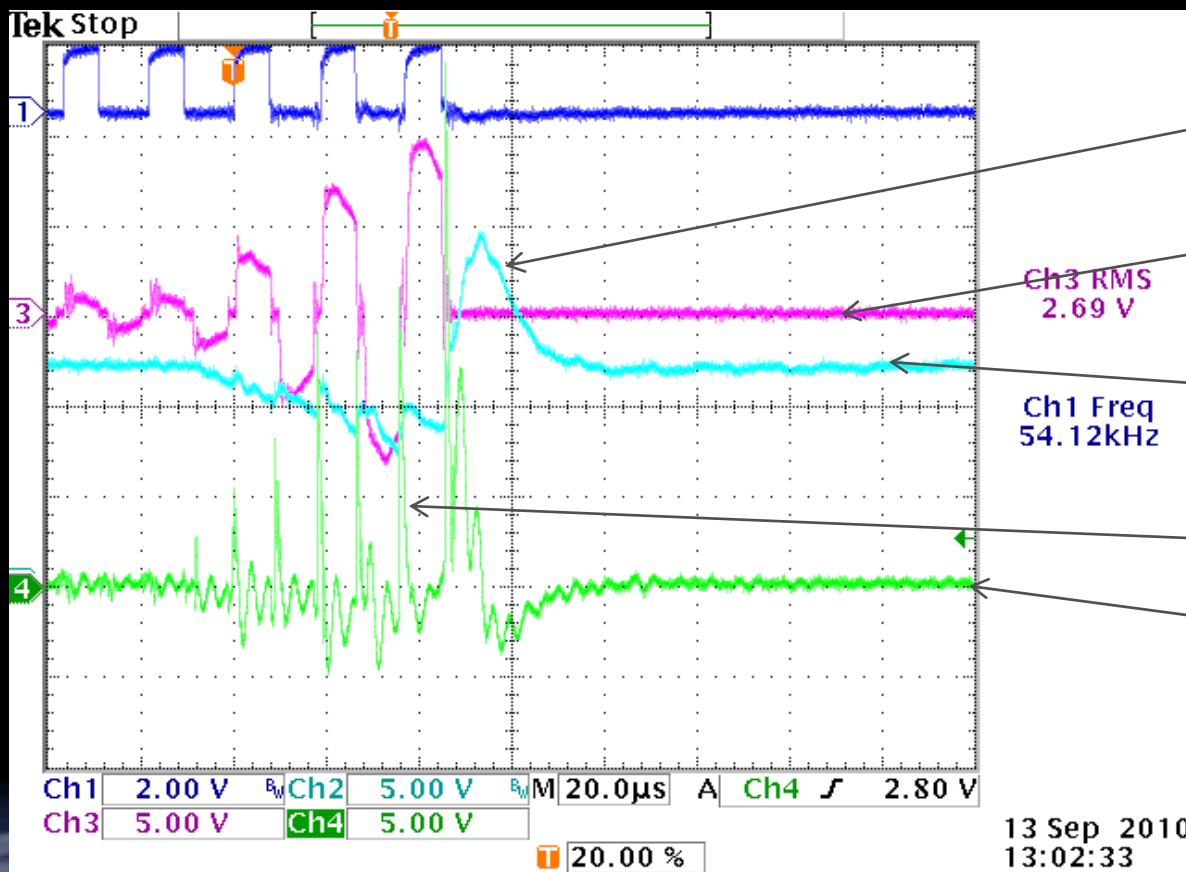
Capacitor Current and Voltage During a Fault

Voltage Hump

Transformer Current
50 amps / div

Cap Voltage
50 Volts/ div

Current Spikes

Cap Current
50 amps / div

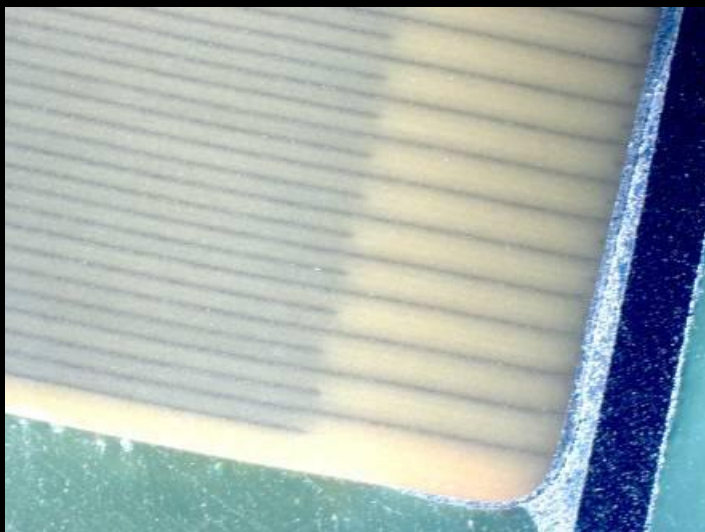
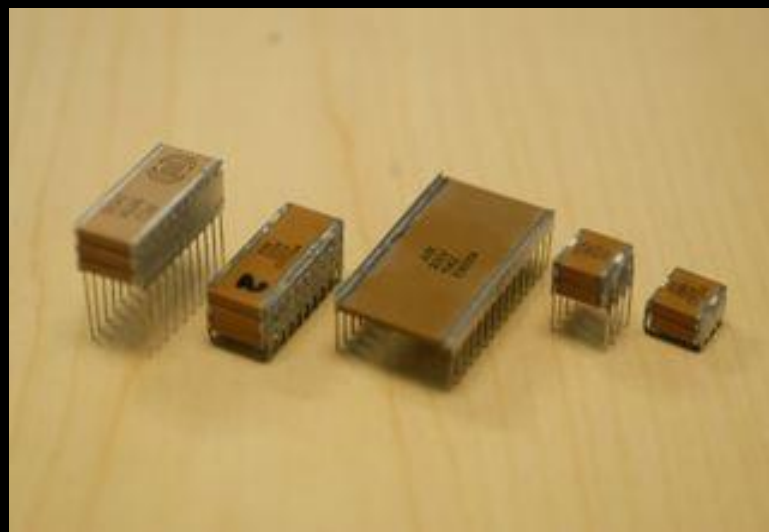
Ceramic Capacitors

- A ceramic capacitor is constructed of alternating layers of metal and ceramic, with the ceramic material acting as the dielectric.
- A typical dielectric material is X7R – a form of Barium Titanate
 - Minor Dopants change the electrical and mechanical properties
- Barium Titanate can be highly piezoelectric based on the additives used

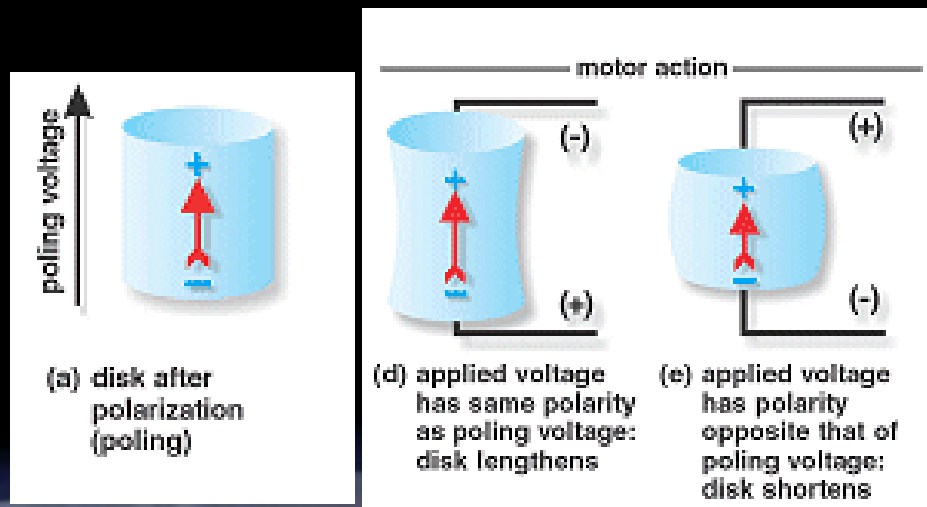
GRC Measured Data on Custom Capacitor

Barium Titanate (the capacitor dielectric) is piezoelectric

Displacement = f (Electric Field)

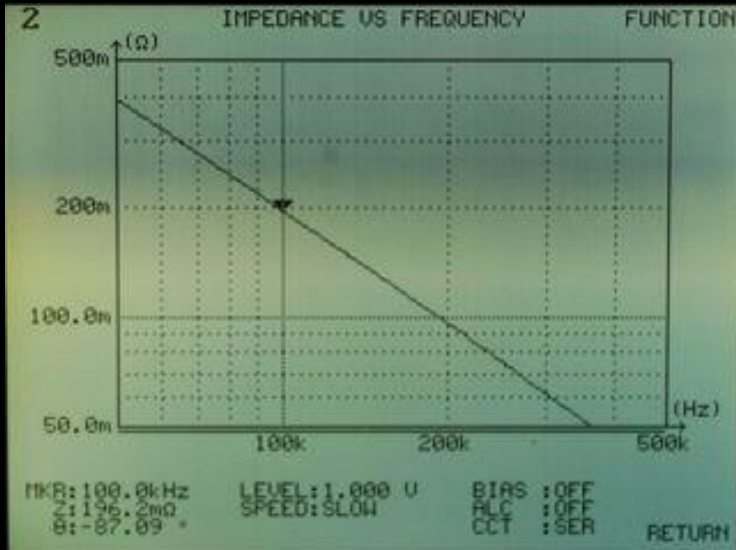
New Custom Caps from Stock

Not subjected to temperature or voltage

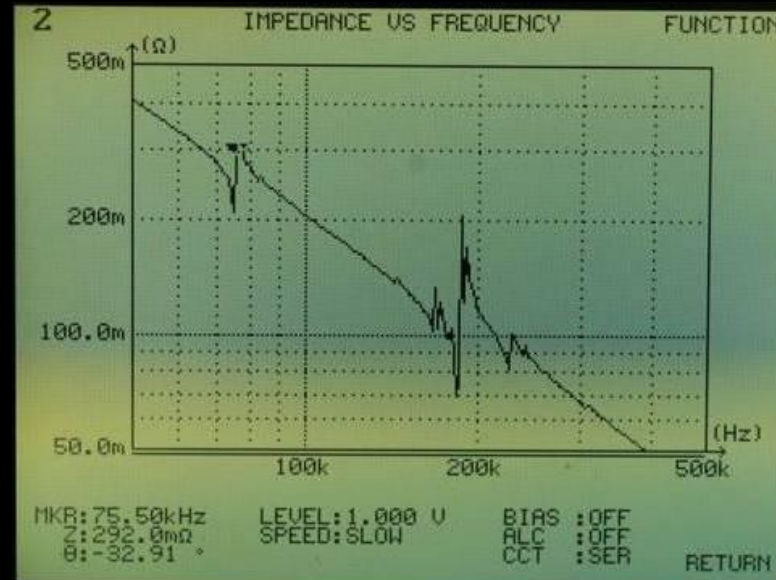
Custom Caps Burned-In @ 125°C and 600 V_{DC}

- Temperature and voltage polarizes the dielectric creating the piezoelectric effect.
- Spike in the impedance indicate piezoelectric resonant frequencies.
- Resonant frequencies are function of ceramic slab dimensions and material.

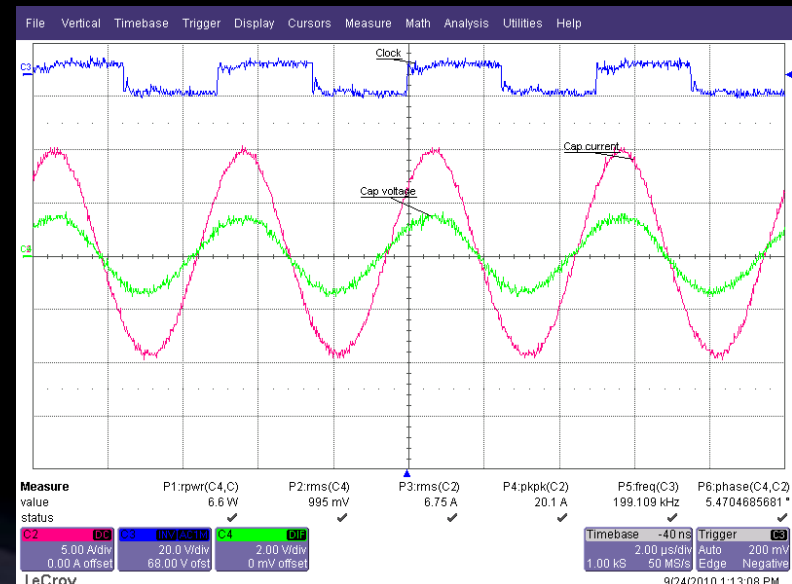
Growler 2

- 200kHz
- 5.47 degree phase lag

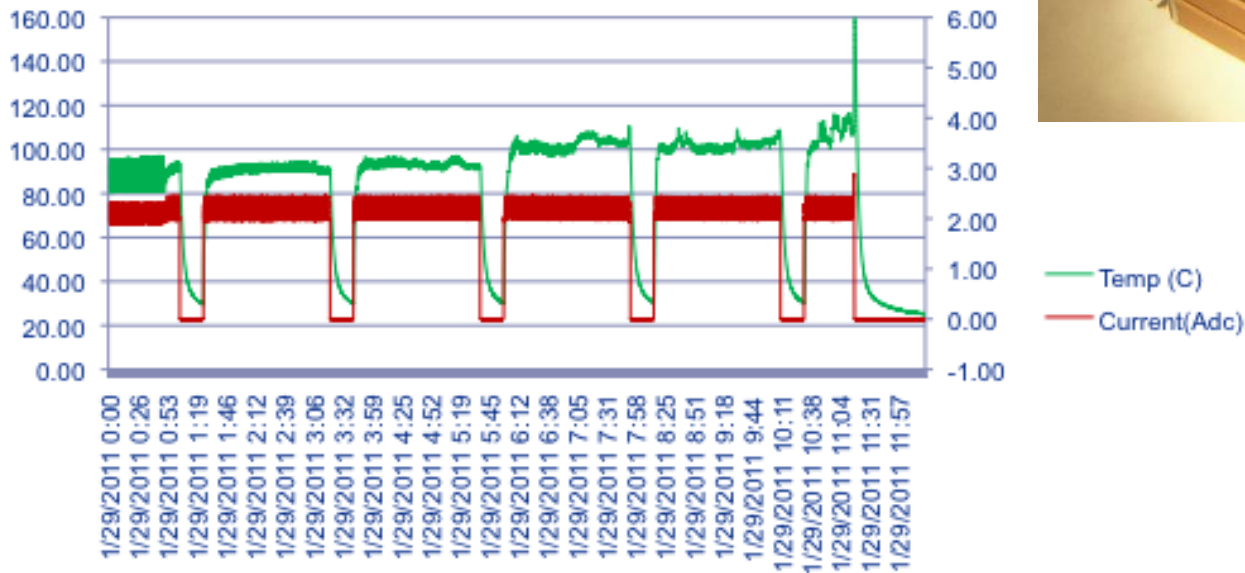
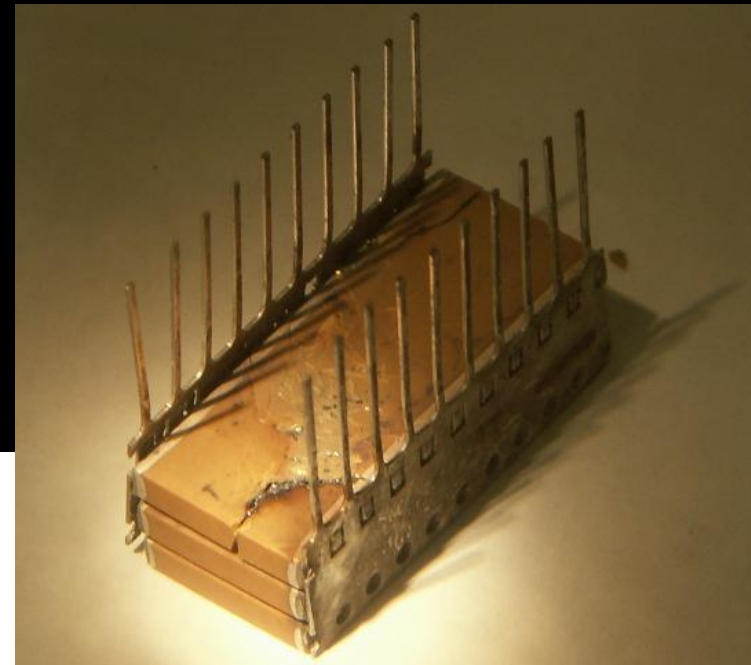
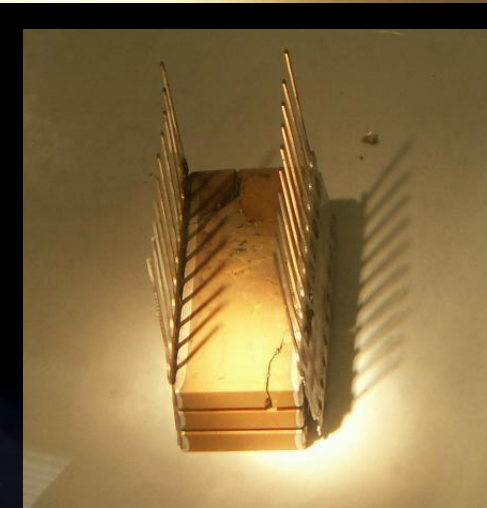
FRB Cap Failure #3

Failure Specifics

- 345 total hours
- In Vacuum & Air
- Exercised at 192-205 kHz
(90sec sweep)

Day of Failure Recorded Temp & Current

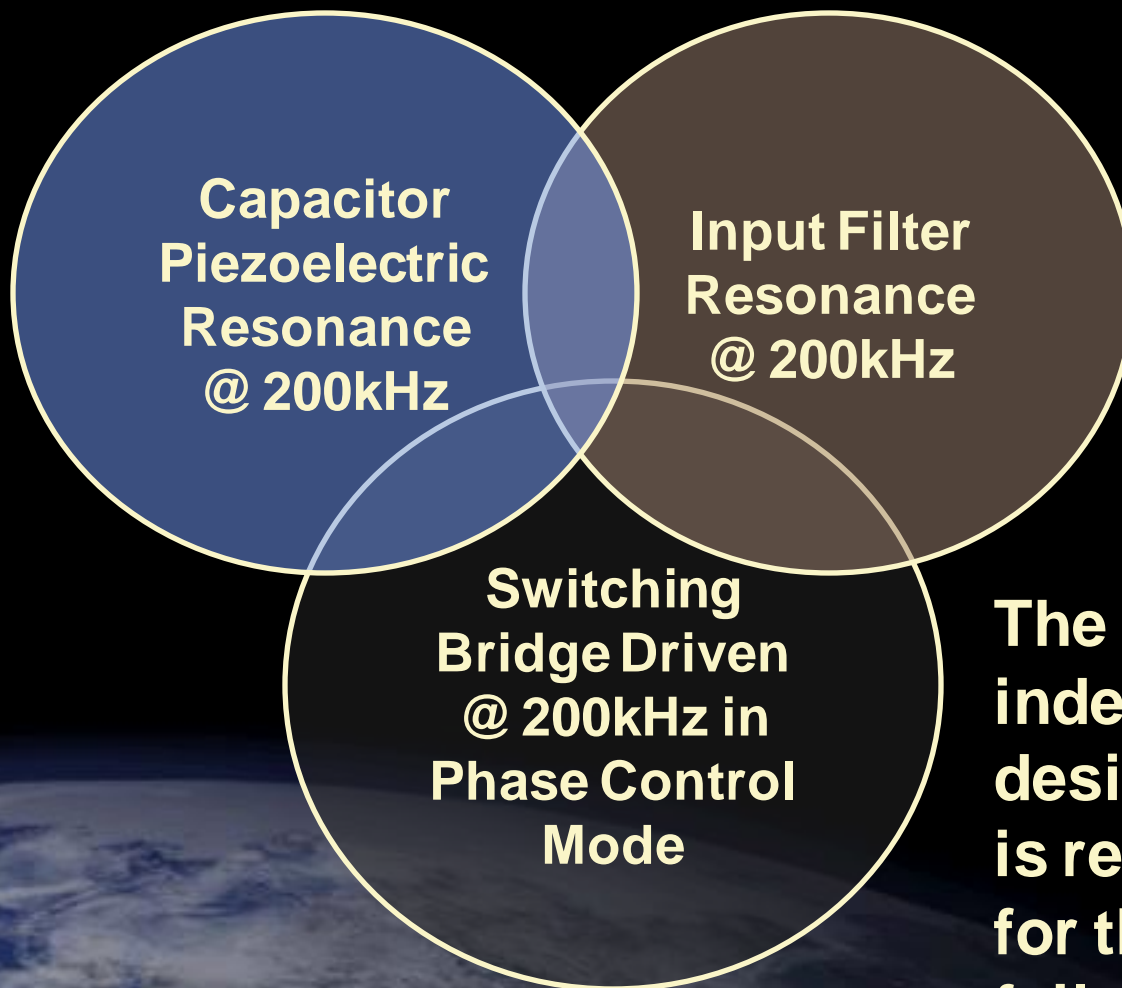
Summary of Failure Mechanism

The confluence of 3 independent design elements is responsible for the capacitor failure

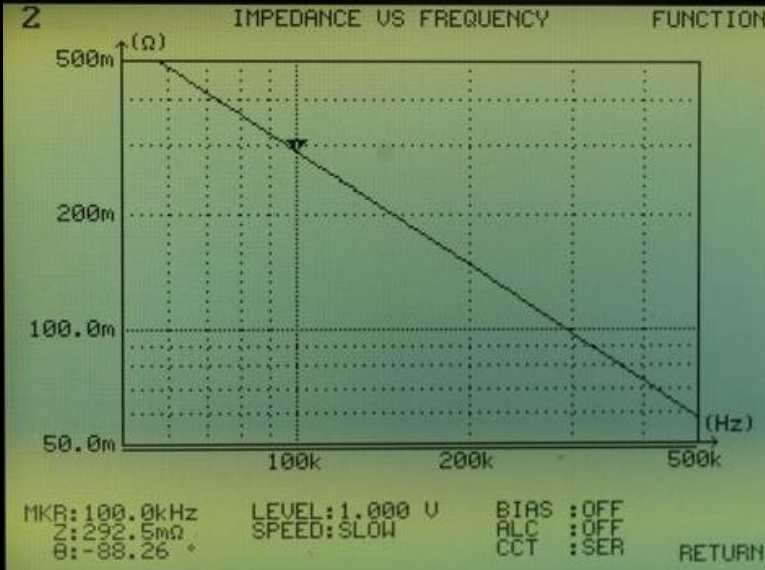
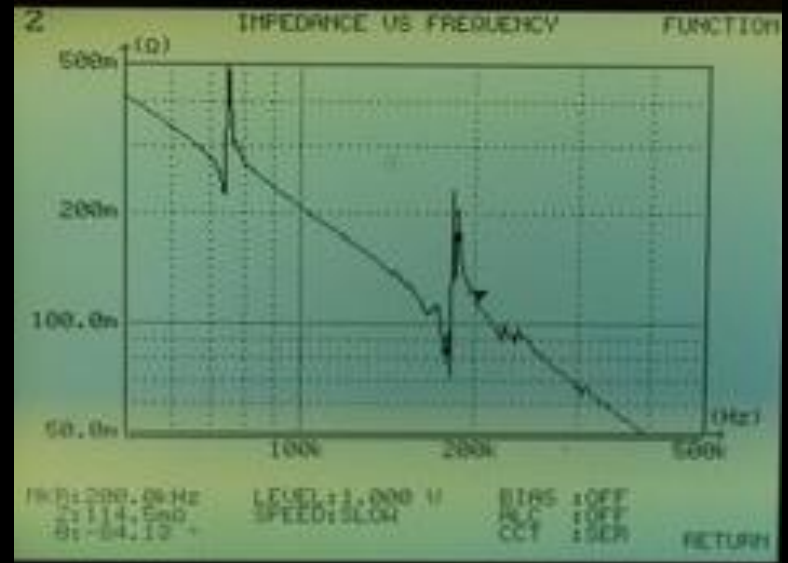
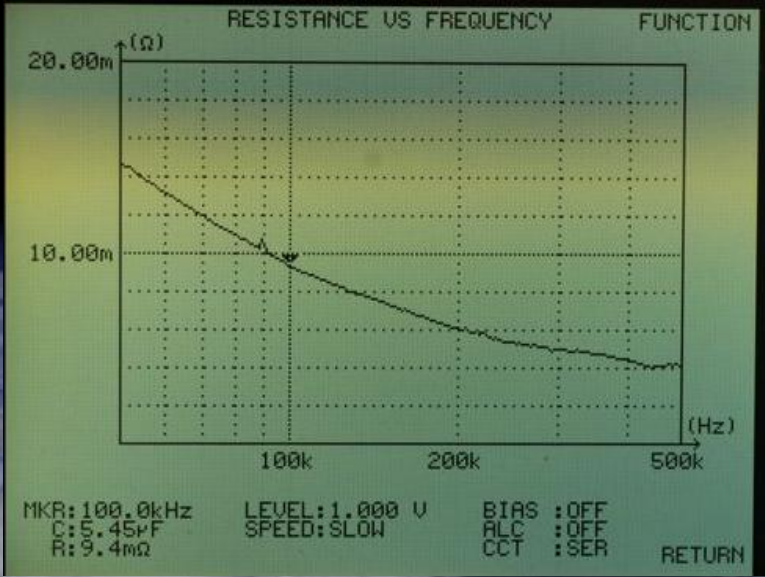
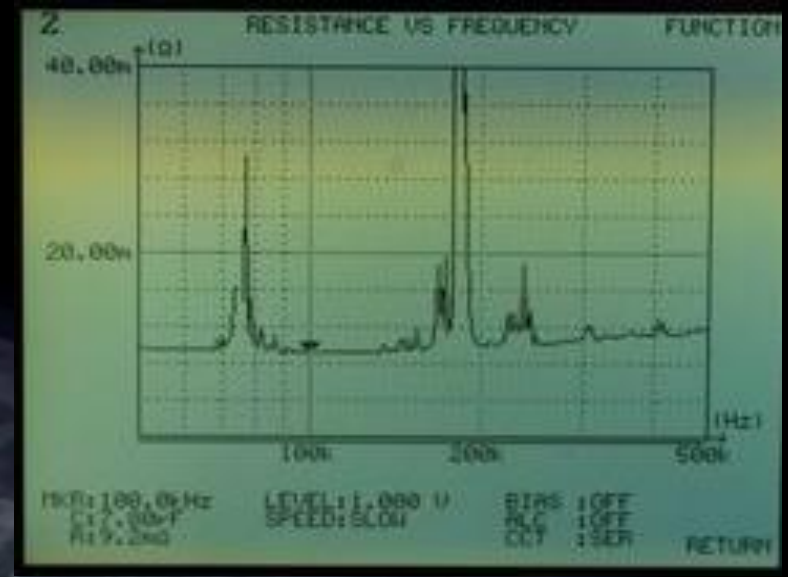
Replacement 5.6 μ F/500V

0 volt Bias

Custom 9 μ F/300V

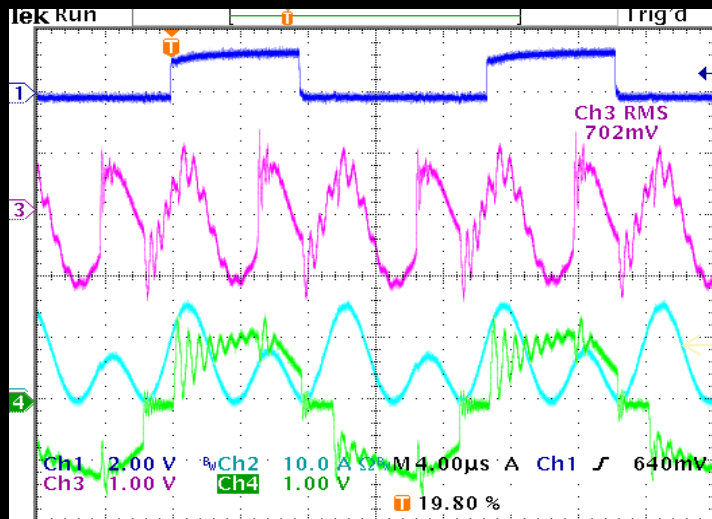
Before

Capacitor
Circulating
Current

Reduce Circulating Current

Added MPP* Core
Differential Mode Choke
