Paper Number: 1856

Title: Failure Predictions of Out-of-Autoclave Sandwich Joints with Delaminations under Flexure Loads

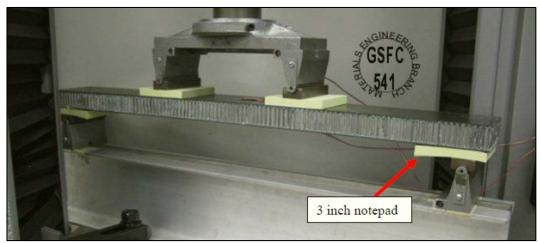
Figure 13. Four-Point-Bend Test.

For the actual test, notepads were used at the supports and load point to prevent local stresses from failing the composite core before the joint in the constant shear region could be properly loaded. The 4PB test setup can be seen in Figure 13.

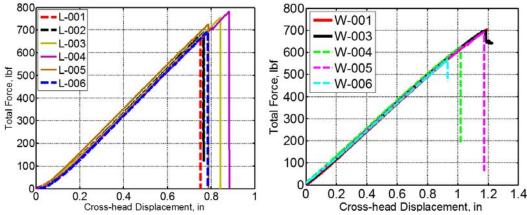
Figure 14. Load vs. deflection of 4PB samples for 34-inch specimens (left) and 38-inch specimens (right)

Six specimens of each configuration, 34-inch and 38-inch, were tested in 4PB. For each configuration, only half of the specimens included 1.6-inch diameter Teflon® debond inserts. The defect flaw size was selected based on analyses of the 4PB coupon, to ensure failure in the jointed region. Table I summarizes the test results for the 34-inch (L) and 38-inch (W) 4PB specimens. Maximum deflections were measured at the centerline midspans of the coupons using Digital Image Correlation (DIC), which follows features on the surface from frame to frame using image-based cross-correlation tracking. Load versus deflection curves of the 34-inch (L) and 38-inch (W) specimens are shown in Figure 14. It should be noted that regardless of failure mode (e.g., core shear failure or joint failure), the damage propagates relatively abruptly at the joint. The strength reduction from the pristine coupons to coupons with flaws was 9 to 10 percent.

^{**}Problem with Instron® crosshead data acquisition. Max load and displacement reported from DIC. No plot possible for W-4PB-002 in Figure 14.

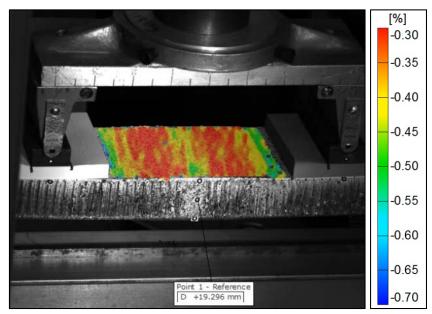
Figure 17. Axial strain of joint for 34-inch specimen with flaw.

In addition to measuring maximum centerline deflection and reaction load, surface strains were measured in the joint region using DIC as shown in Figure 17. A stochastic

The last metric for comparison between the performed tests and the analyses is that of surface strains at the joint. Figure 17 and Figure 18 showed test results for axial

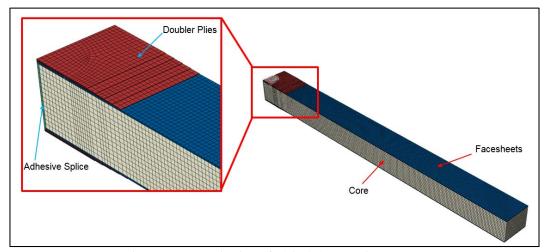
Figure 19. Isometric view of 34-inch 4PB specimen FEM.

To reduce analysis time, two-way symmetry was utilized for all 4PB models discussed here. In order to improve convergence of the solution, all models are displacement-controlled. Figure 19 illustrates the general model setup and mesh of the 34-inch specimen and Figure 20 shows the same model with dimensions and boundary conditions (BCs) labeled. Note that the symmetric boundary conditions for X-symmetry and Z-symmetry are labeled as $U_x = 0$ " and $U_z = 0$ ", respectively.

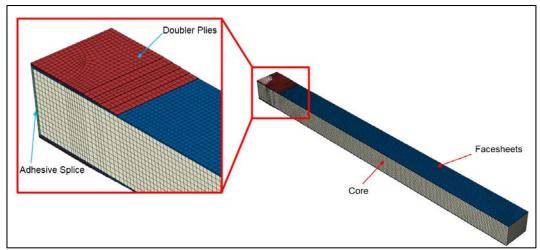
Figure 21. Isometric view of 38-inch 4PB specimen FEM.

Figure 21 illustrates the general model setup and mesh of the 38-inch specimen and Figure 22 shows the same model with dimensions and BCs labeled. For the 38-inch specimen, note that the global coordinate system (CSYS) remains the same, but a new local coordinate system was defined for the material orientation since those specimens were cut transverse to zero degrees.

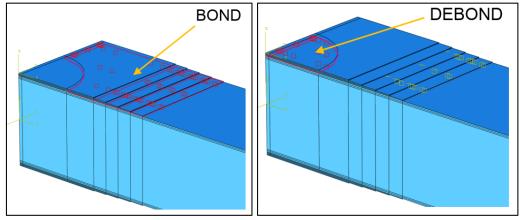
Figure 23. FEM schematics showing locations of bond (left) and debond (right).

Figure 23 shows the bond and debond regions in the models. Table II summarizes the cohesive bond and debond properties.

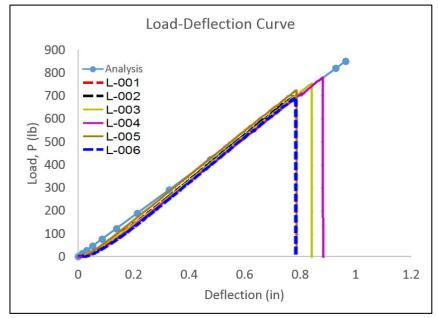
Figure 25. Test vs. Analysis Load-Deflection Results for undamaged 34-inch 4PB specimen.

Finite element results for 34-inch and 38-inch specimens without a flaw (i.e., undamaged) were first compared to test data. A graphical representation of this data is shown in Figure 25 and Figure 26, respectively. For the 34-inch specimen only L-003, L-004, and L-005 were the undamaged samples. For the 38-inch specimen only W-001 and W-003 were the undamaged samples.

The 34-inch analysis predicted joint failure would occur at a peak load of 852 lbf while the maximum load seen in test for that specimen was 781 lbf, so the model prediction was within 10 percent. The 38-inch analysis predicted that core shear failure would occur at a peak load of 882 lbf while the maximum load seen in test for that specimen was 702 lbf, so the model prediction was within 26 percent. This could indicate that the core strength properties were lower than the strength used in the analysis.

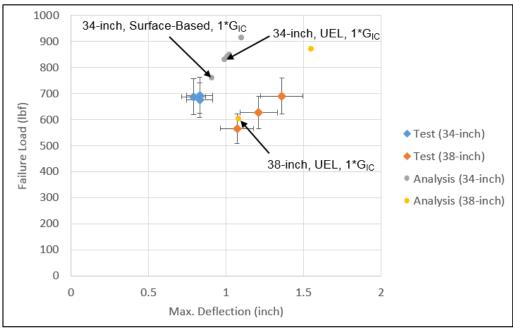
Figure 27. Failure load vs. max deflection of flawed 4PB tests and analyses.

maximum deflection of all the tests and analyses summarized in Tables IV and V are shown graphically in Figure 27, with \pm 10 percent error bars on the test data. It was found through the analyses that the UEL bond methodology had a better rate of convergence, but the surface-based cohesive methodology typically was closer to test results when it converged. G_{IIC} is typically two or three times that of G_{IC} , but since G_{IIC} was not measured this assumption could not be validated. A G_{IIC} value of $1 \cdot G_{IC}$ was closer to tests in all analyses.

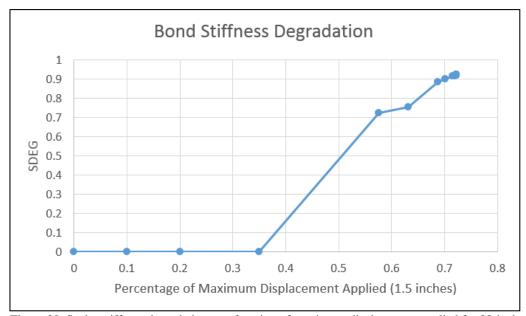
Figure 28. Scalar stiffness degradation as a function of maximum displacement applied for 38-inch specimen analysis (UEL) with flaw.

The analysis that proved closest to tests was the 38-inch W specimen, with UEL flaw and $G_{IIC} = 1 \cdot G_{IC}$, and was inspected for damage propagation at the joint doubler interface to the panels. The scalar stiffness degradation (SDEG) variable, a measure of an element's residual stiffness, was monitored at the interface through the analyses. The SDEG has a value from zero to one where a value of one corresponds to a fully damaged bond element. A plot of this variable through the analysis step is shown in Figure 28 for the element where bond failure is first initiated. From Figure 28 it can be concluded that bond failure initiates at 308 lbf, which is approximately 35 percent of the maximum displacement applied. Ultimate failure is predicted to occur at close to 72 percent of the maximum displacement applied. Figure 29 shows a contour plot of SDEG in the region of the specimen where bond failure is occurring.

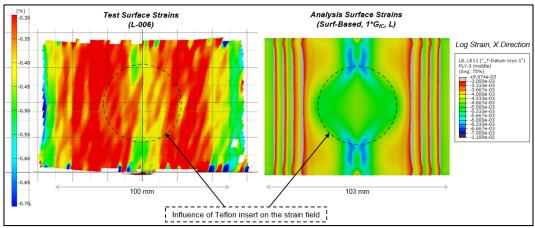
Figure 30. Axial surface strains observed during test with DIC (left) and FEM analysis (right) of 34-inch flawed specimens.

surfaces strains by DIC. Shown below in Figure 30 and Figure 31 are axial surface strains just before joint failure for test and analysis of 34-inch and 38-inch specimens, respectively. For the 34-inch specimens, strain in the circular debond region are 5 to 10 percent higher in analysis than in test, which corresponds to the roughly 11 percent higher peak load that the analysis predicted over the tests. For the 38-inch specimens, strains in the joint region match very well to the tests (approximately within 1 percent). The influence of the Teflon® inserts on the strain fields are noted in the figures.
