Thermal Behavior of Aerospace Spur Gears in Normal and Loss-of-Lubrication Conditions

Dr. Robert F. Handschuh

Chief, Rotating and Drive System Branch
NASA Glenn Research Center
Cleveland, Ohio U.S.

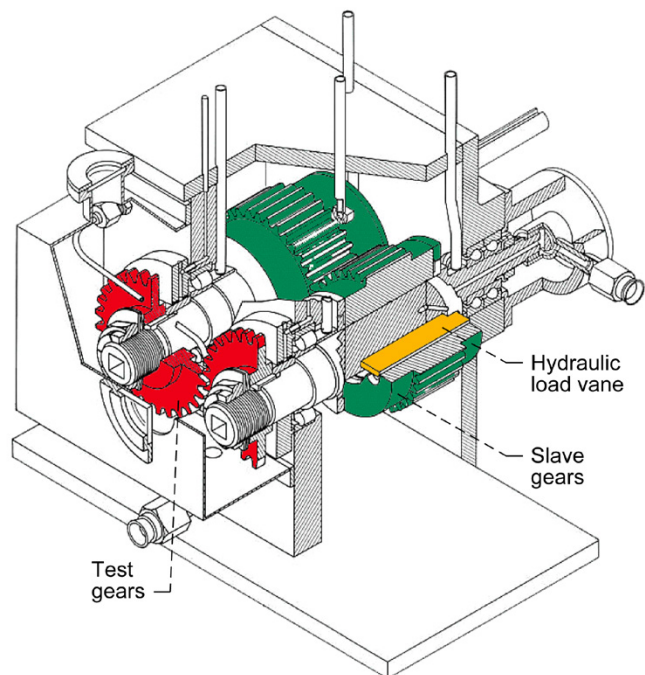
Figure 1. Cross-sectional sketch of the test gearbox used for loss-of-lubrication testing.

The test facility used for conducting all loss-of-lubrication simulation tests is the NASA Glenn Contact Fatigue Test Facility (Refs. 6 to 8). The facility is shown in the sketch illustrated in Figure 1. The facility is a closed-loop, torque regenerative test rig that locks torque in the loop via a rotating torque applier contained within one of the slave gears. The test gears have a 1:1 ratio. Facility speed and torque can be varied as needed during a test. The basic gear design information of the tested gears is listed in Table 1.

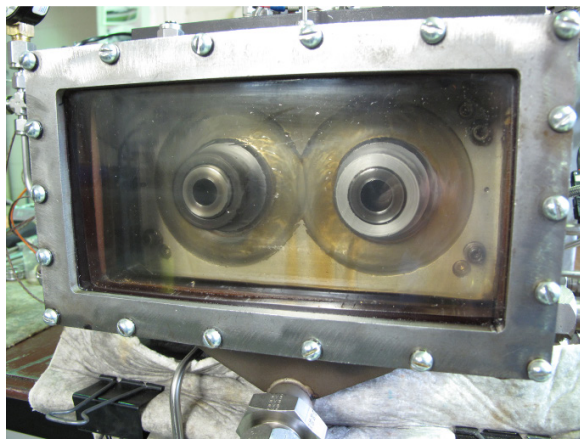
Figure 2. Top exit shrouds with normal lubrication conditions.

As previously mentioned, the facility went through an evolutionary period (Ref. 4) where shrouding, visual access, gearbox lubricant removal (sump), and instrumentation were added to the test section. A photograph of the current test gearbox arrangement is shown in Figure 2.

Three static shroud thermocouples were utilized during all tests. High temperature glass was also utilized as the outside shroud to encase the gears. Ballistic plastic and another layer of high temperature glass provided visual (and video) access to the gears during operation. Lubricant for normal operation was fed at the into-mesh location through part of the shroud (Figure 3). The normal operational flow rate was approximately 0.42 l/min (0.11 gpm) at 207 kPa (30 psig) jet pressure with the lubricant inlet temperature of ~ 110 °C (230 °F). The static instrumentation used and normal lubricant jet locations are shown in Figure 3. A turbine engine-drive system lubricant, MIL-L-85734, was used during the testing to be described in this report.

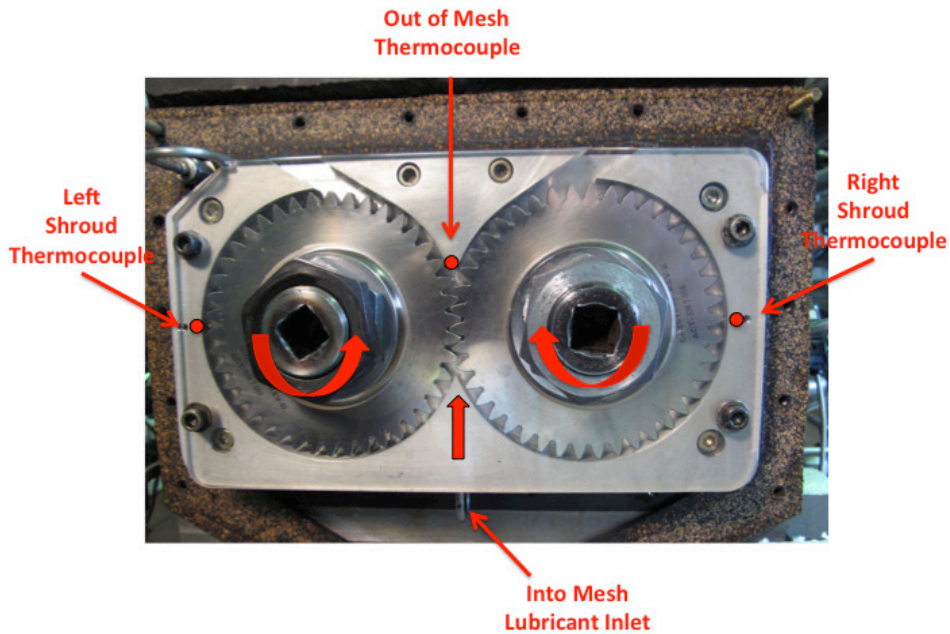
Figure 3. Example of test gear arrangement with outer gearbox cover removed, top exit shrouds shown (12 pitch gears shown).

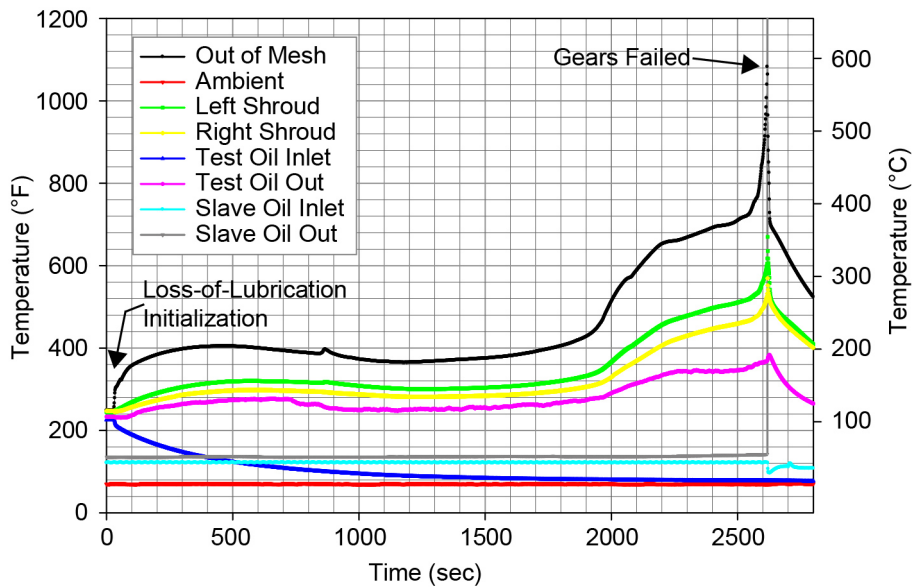
**Figure 4. Loss-of-lubrication data for 1.72 kPa (250 psi) load pressure
~ 59.3 N*m (540 in*lb) torque tested at 10000 rpm.**

An example of each of the two torque levels will now be described. At the lower torque level, two tests were conducted with the loss-of-lubrication times of 40.8 and 43.1 min in length. Note that in Figure 4, the gears reached another level of operating temperature that appeared to be a new “steady state” condition where the out-of-mesh temperature stabilized at around $\sim 200 \text{ }^\circ\text{C}$ (400 $^\circ\text{F}$). This elevated steady state condition is believed to be due to residual lubri-

cant left in the shroud. This occurs even though the shrouds effectively pump the excess lubricant out to the rest of the gearbox housing. The data from the static thermocouples imbedded in the shrouds along with other facility temperatures is shown in Figure 4.

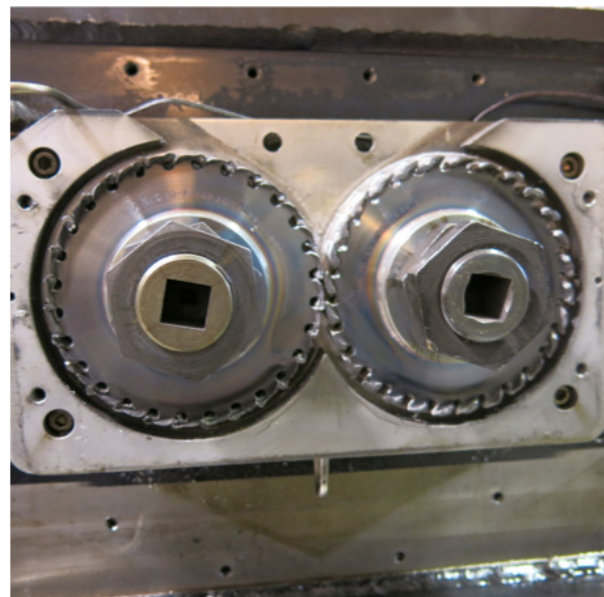
Figure 5. Post-test condition of the gears (gearbox cover and outer high temperature glass removed).

The gears in the post-test condition are shown in Figure 5. Note that the test was conducted until the meshing heat generation was enough to plastically deform the gear teeth. This type of post-test condition occurred whenever the test was permitted to continue until total loss of torque delivery was achieved. A typical loss-of-lubrication failure at this condition is shown in Figure 6.

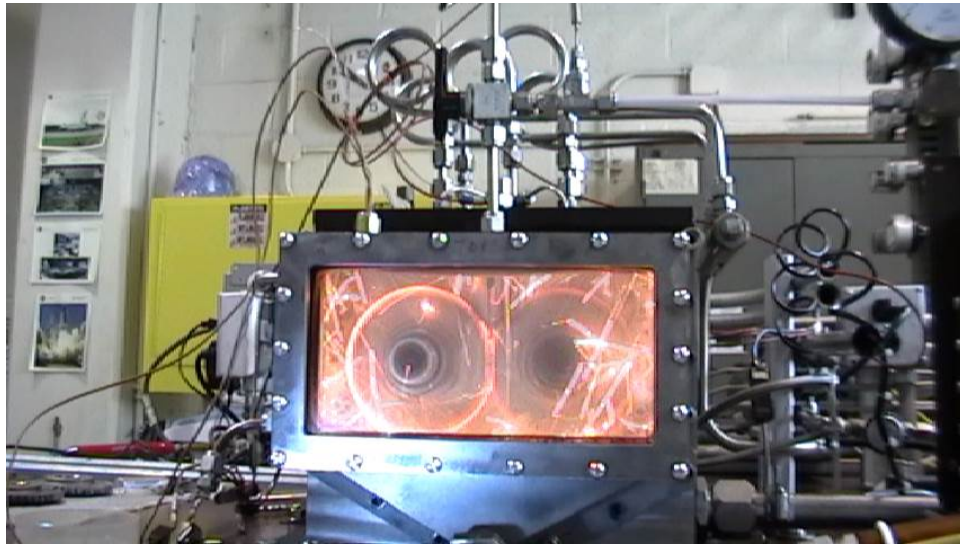
Figure 6. Example of loss-of-lubrication test during final seconds of operation.

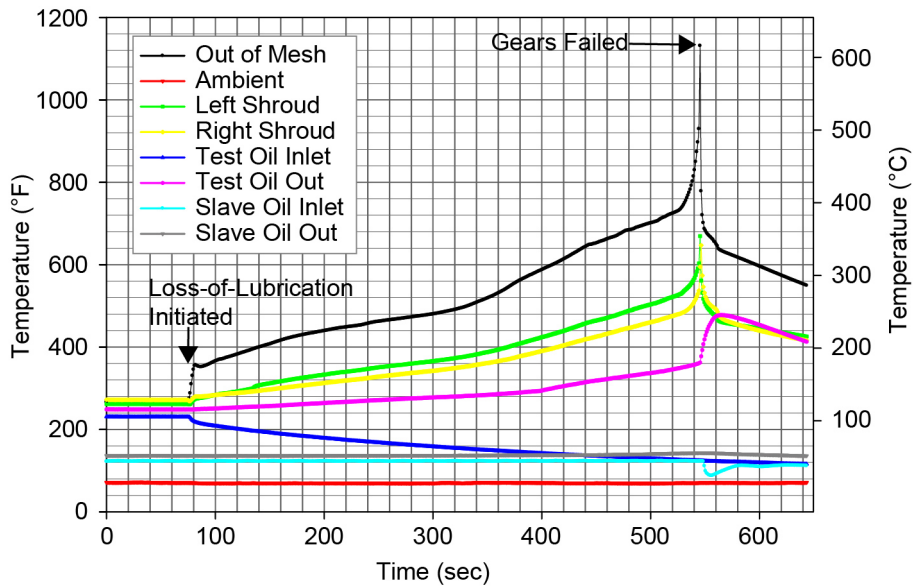
Figure 7. Loss-of-lubrication data from higher load test 83.6 N*m (740 in*lb).

Two other tests were conducted at an elevated level of torque (~83.6 N*m (740 in*lb)). These two tests, in the loss-of-lubrication mode, produced failures in 7.9 and 9.2 min. The test temperature data from the 7.9 min loss-of-lubrication test is shown in Figure 7. As can be seen from this data, the temperature did not reach an increased steady-

state condition prior to failure as it did in the test shown in Figure 4. After the primary lubrication system was disconnected the temperature just continued to rise. The post-test condition of the test gears is shown in Figure 8 with the gearbox cover removed.

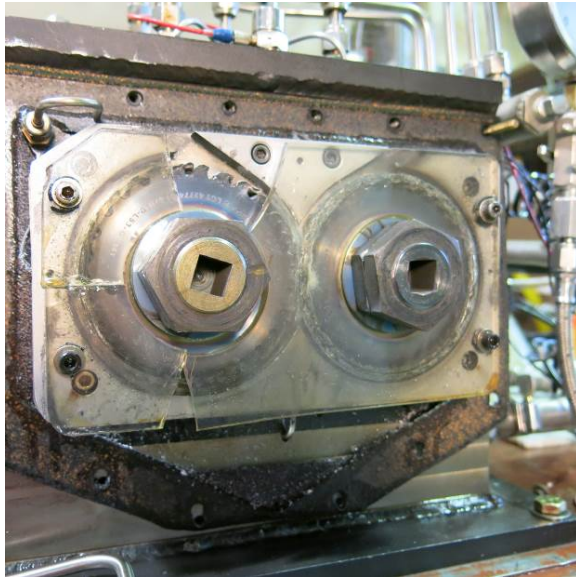
Figure 8. Post-test photograph of increased load test gears with outer shroud high temperature glass fractured.

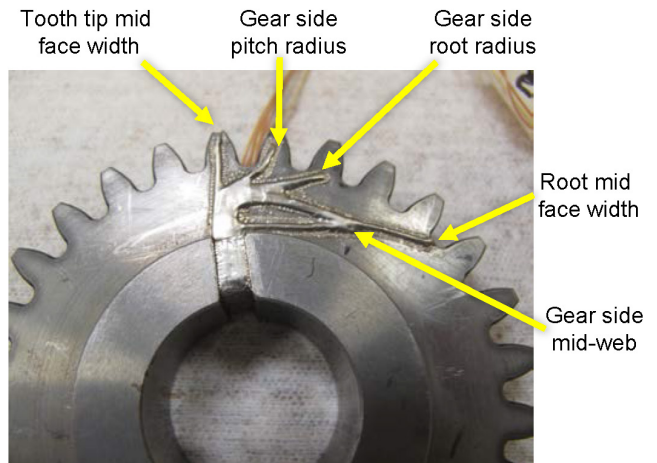
Figure 9. Instrumented loss-of-lubrication Test Specimen before testing.

An example of the gears used in these tests is shown in Figure 9. In both tests, the instrumented gear was installed in the left side of the gearbox. The left side gear acts as the driving gear of the test section of the facility. A total of five thermocouples were attached to the gear at the tooth tip mid-face width, root mid-face width, and on the side of the gear at the pitch radius, root radius and mid-web locations. As shown in Figure 9, the thermocouple wires were covered by a thin metal foil that was spot welded to the side of the gear to protect the instrumentation during high-speed operation. The rest of the required hardware is shown in Figure 10 prior to installation in the test rig. This included a special gear shaft, high-speed coupling, and high-speed slip ring. The assembly in the test rig is shown in Figure 11. Note that keeping the slip ring contacts in the same ambient condition is important to getting reliable data. Therefore the slip ring was insulated from the surroundings using a polycarbonate tube and an insulating material added to block the tube end.

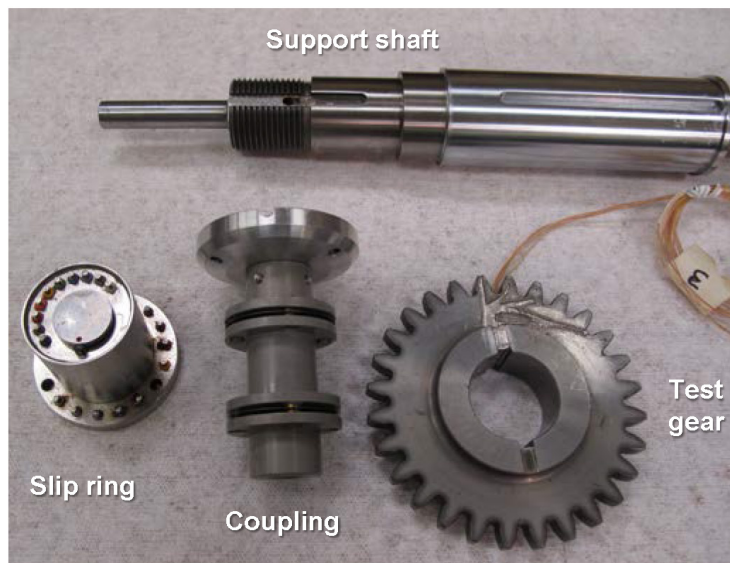
Figure 10. Loss-of-lubrication test specimen and related components.

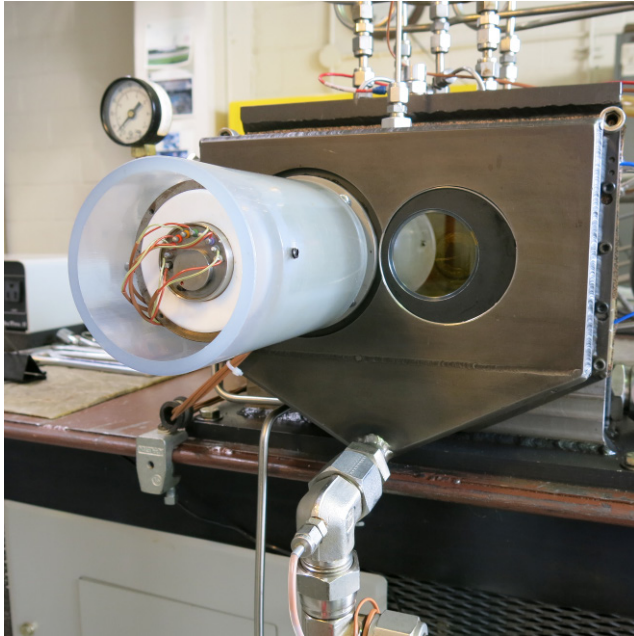
Figure 11. Test Set up for Instrumented Test Gear

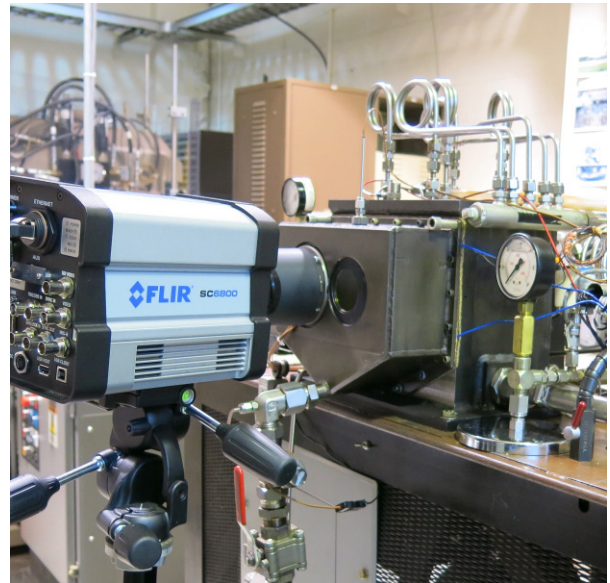
Figure 12. Infrared Camera in position for loss-of-lubrication test.

Also, on the second instrumented spur gear test, a full-field, high-speed, infrared thermal imaging system was used. This system had the potential to capture full-field thermal images at speeds over 500 Hz. A special lens was inserted into the gearbox cover to gain visual access to the gears operating in the unshrouded condition (Figure 12).

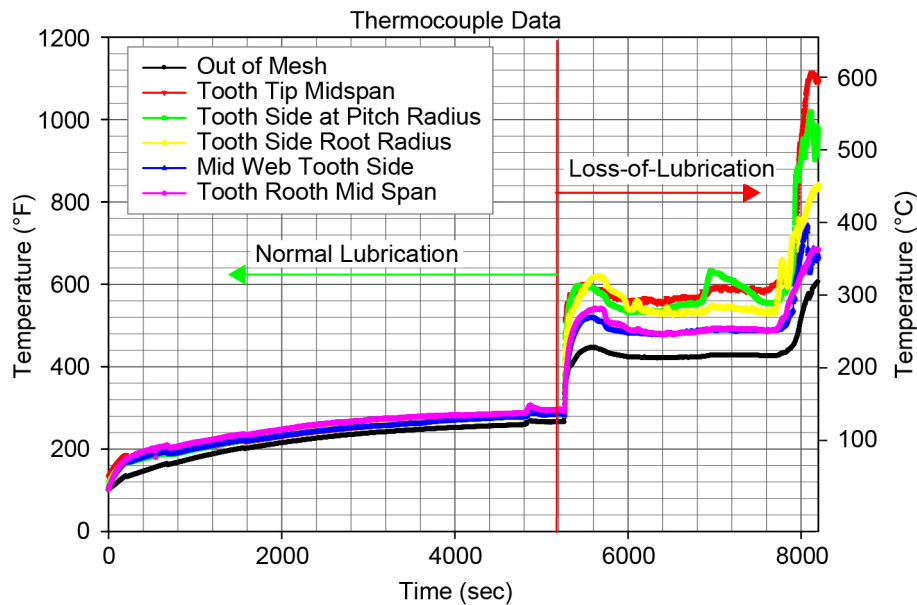
Figure 13. On-gear and out-of-mesh thermocouple data from start-up to instrumentation failure during loss-of-lubrication.

The data for operation of the facility in the shrouded, normal to loss-of-lubrication mode is shown in Figure 13. During this test the lubricant was shut off and the test run until failure. The data from loss-of-lubrication initiation to failure for the shroud (static) and other facility thermocouples is shown in Figure 14.

From the data in Figure 13 and Figure 14, the bulk temperatures of the gear were exceeding the temperature that was found from the static shroud thermocouples. In the normal lubrication condition this value was 11 to 22 °C (20 to 40 °F) depending on the location. In the loss-of-lubrication mode, this amount was as high as 275 °C (500 °F) higher on the gear than that of the static shroud thermocouples when the thermal run-away condition occurred. In Figure 13, the data beyond 8200 sec is believed to be invalid due to post-test inspection of the thermocouple wiring that was melted together at the common locations through the shaft.

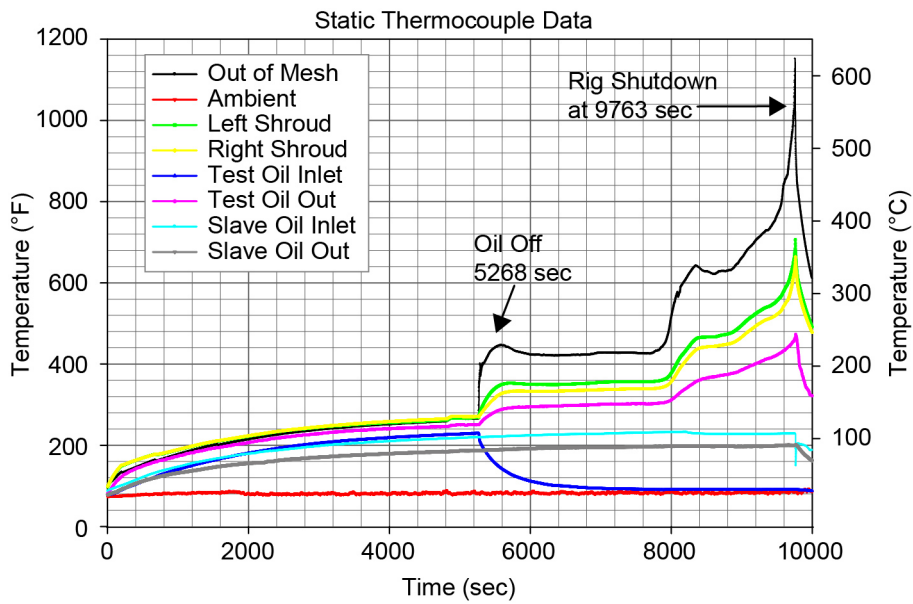
Figure 14. Data from shroud and facility (static) thermocouples.

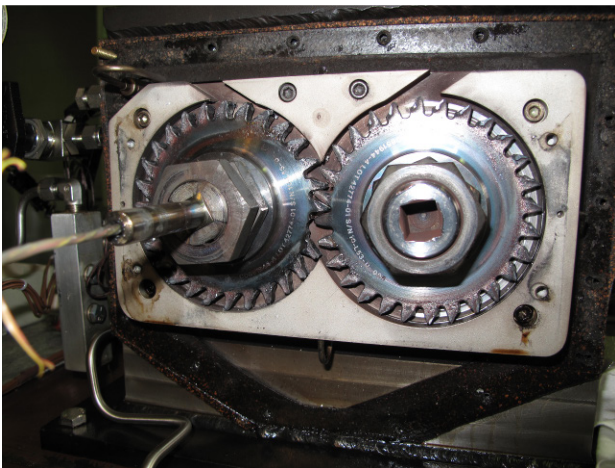
Figure 15. Post-test condition after loss-of-lubrication test was completed. Gearbox housing, slip ring and outer high temperature glass removed.

The post-test condition of the gears used in this test is shown in Figure 15. What can be noted is that a bending failure occurred before the loss-of-lubrication test, as the failed tooth has no evidence of running in this post-test

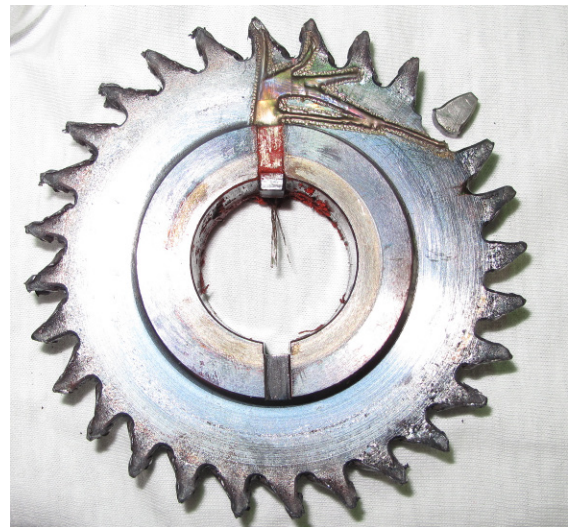
Figure 16. Instrumented spur gear post-loss-of-lubrication test condition.

condition. A hypothesis is that the failed tooth was initiated by a spot weld in the root-fillet region from the thin metal protection strap that was used to cover the thermocouple wiring as shown in Figure 16.

In Figure 16, the tooth that failed in bending shows no apparent damage due to loss-of-lubrication since it occurred before this lubrication condition was initiated. Upon closer examination, the thin metal strapping used to overcoat the wiring and spot-welded to the tooth, was found to be the initiation site of the bending failure. Future test hardware for this purpose will not have this as a hold-down feature for the tooth root-fillet area.

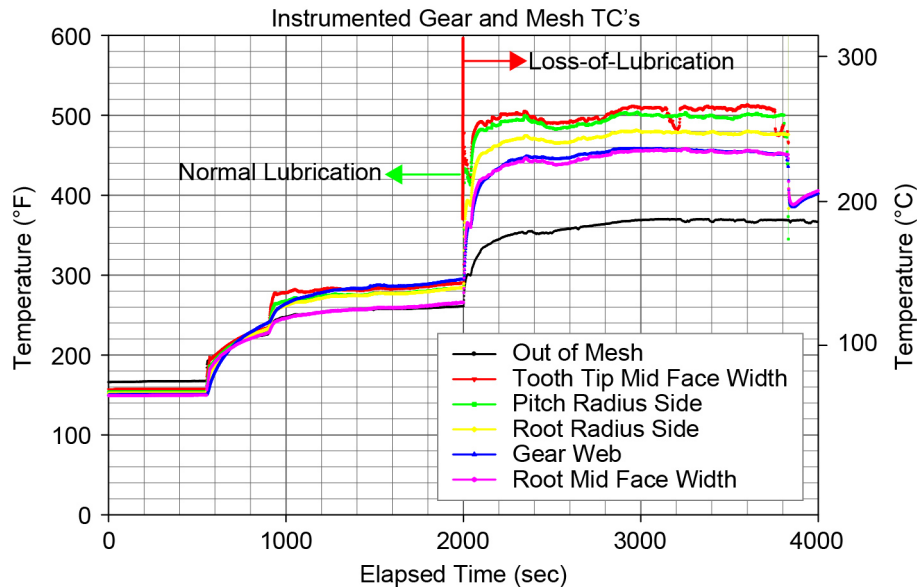
**Figure 17. Instrumented spur gear data (no shrouds).
Loss-of-lubrication initiated at 2000 sec.**

unshrouded data being slightly lower during the normal and loss-of-lubrication periods. For this test the thermocouple data failed at 3800 sec into the recorded data. This data is shown in Figure 17.

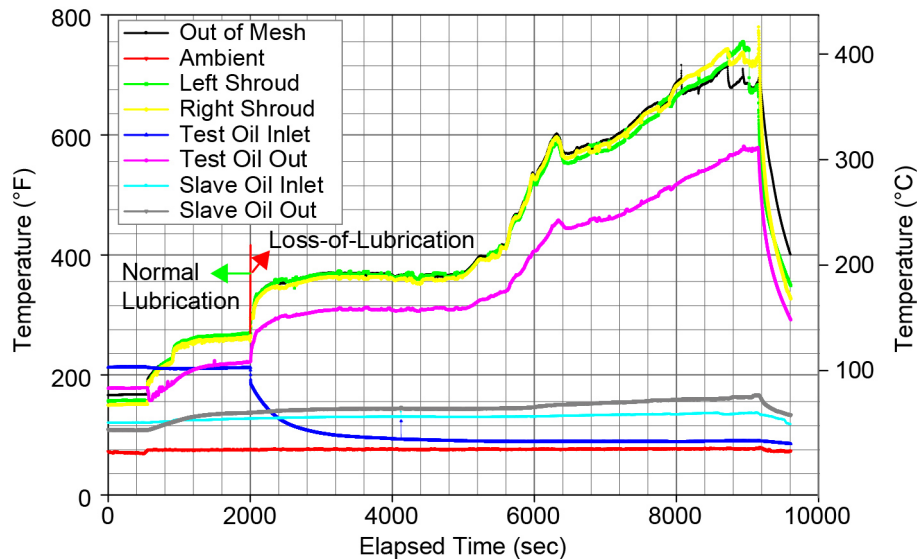
**Figure 18. Static thermocouple data from instrumented spur gear test
(no shrouds). Loss-of-lubrication initiated at 2000 sec.**

The results from the static thermocouples at the same locations as the shrouded gear tests are shown in Figure 18. As can be seen in Figure 18, the gears reached an elevated steady state, mesh fling-off temperature of approximately 180 °C (360 °F) before the temperature started increasing in a monotonic rate until the test was stopped.

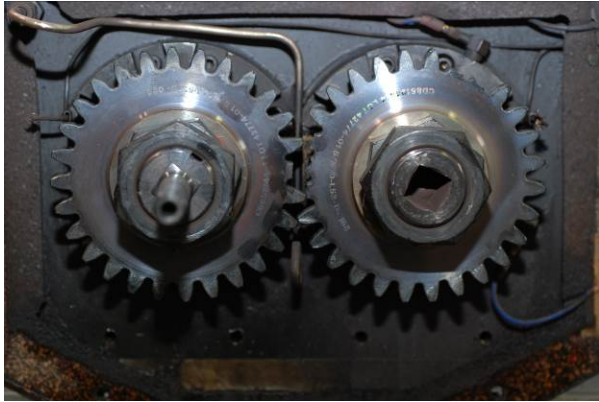
Figure 19. Post-test condition of unshrouded and instrumented spur gears.

The post-test condition of the test gears is shown in Figure 19. Note that several gear teeth had failed (one on the driver (instrumented) and five on the driven gear). A close up of the gear condition is shown in Figure 20. Also, the post-test condition of the gearbox cover is shown in Figure 21. Note that there is virtually no lubricant to be found.

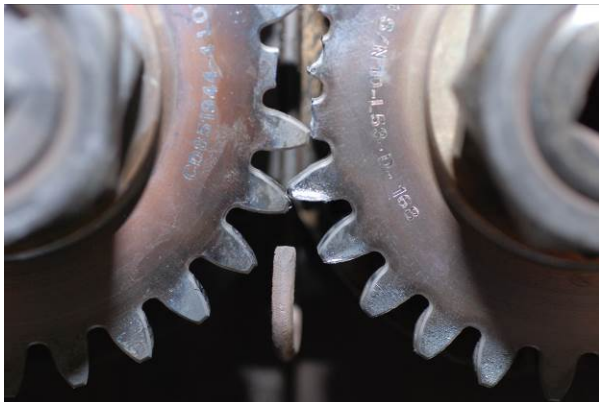
Figure 20. Close up of instrumented and unshrouded gears post-test.

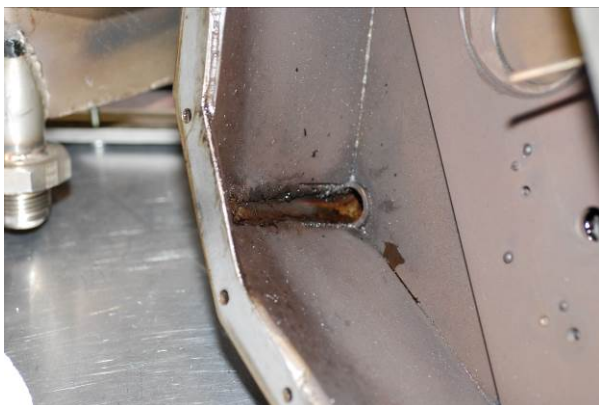
Figure 21. Close up of gearbox cover post-test for unshrouded gear test.

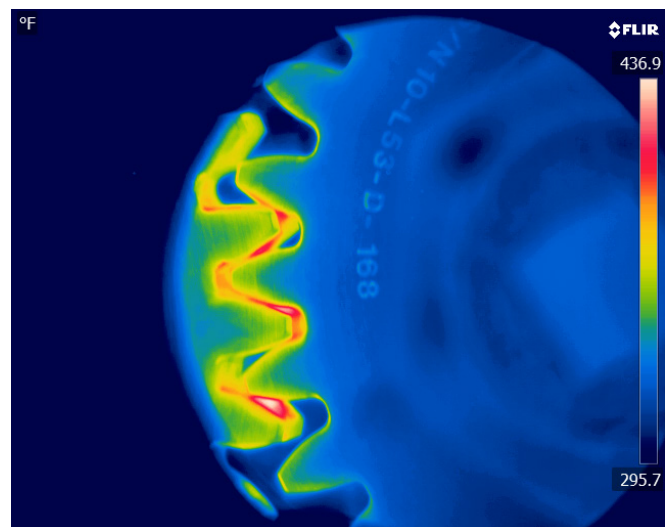
Figure 22. Thermal image of unshrouded gear a short time after initiation of loss-of-lubrication (10000 rpm, 59.3 N*m (525 in*lb)).

Data was taken only after operation in the loss-of-lubrication mode. This is when the lubricant being flung off the meshing gears did not obscure the lens located in the test gearbox cover. Also, the camera was synchronized to the rotational speed of the test gears (167 Hz) to essentially “strobe” the gear and then the images were recorded the full-field data at a rate of 1 Hz. Two examples of the data are shown in Figure 22 and Figure 23. Figure 22 was taken early in the loss-of-lubrication period. Figure 23 was taken later in the loss-of-lubrication period as the temperature recorded as the gear teeth temperatures were in excess of $370\text{ }^{\circ}\text{C}$ ($700\text{ }^{\circ}\text{F}$). The data taken appears to be in agreement with that taken via thermocouples as shown in Figure 17. Therefore, the use of this type of instrumentation will be invaluable for thermal models now under development, as full field information can be made available.

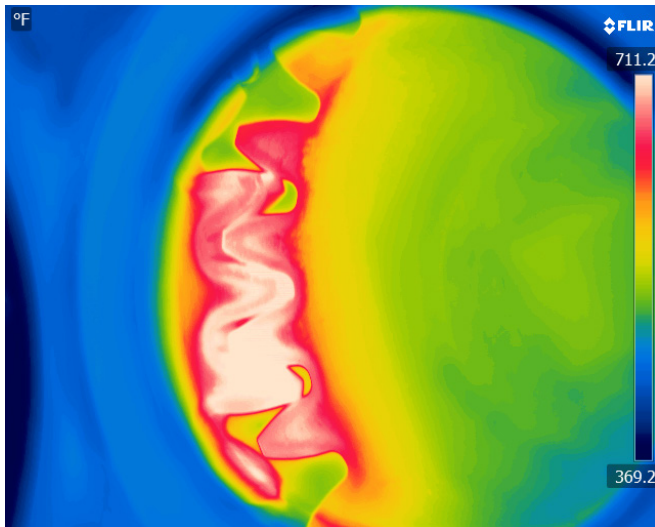
Figure 23. Thermal image of unshrouded gear nearer to test completion. (10000 rpm, 59.3 N*m (525 in*lb))
