# NASA CPAS Drogue Textile Riser Feasibility Study

Steel cable was chosen for the lower end of the drogue and main parachute risers on NASA's Orion Multi Purpose Crew Vehicle Parachute Assembly System (CPAS) to protect the risers from extreme temperatures and abrasion should they contact the crew module during deployment, as was done for Apollo. Due to the weight and deployment complexity inherent in steel, there was significant interest in the possibility of substituting textile for steel for the drogue and main parachute risers. However, textile risers could be damaged when subjected to high temperature and abrasion. Investigations were consequently performed by a subset of the authors to determine whether sacrificial, non-load-bearing textile riser covers could be developed to mitigate the thermal and abrasion concerns. Multiple material combinations were tested, resulting in a cover design capable of protecting the riser against severe riser/crew module contact interactions. A feasibility study was then conducted to evaluate the performance of the textile drogue riser cover in relevant abrasive environments. This paper describes the testing performed and documents the results

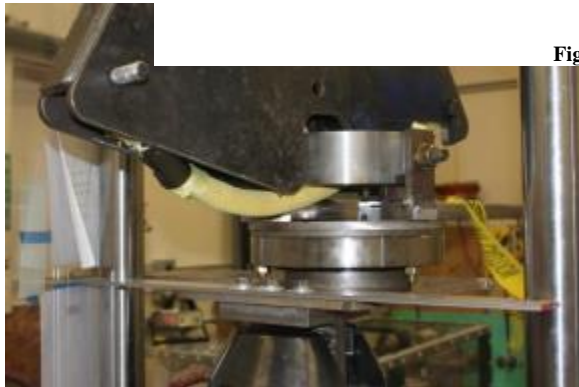
**Photo 3. Test fixture with protected riser and contact edge.**

Photos of the actual test setup are shown on Photo 3, Photo 4, and Photo 5.

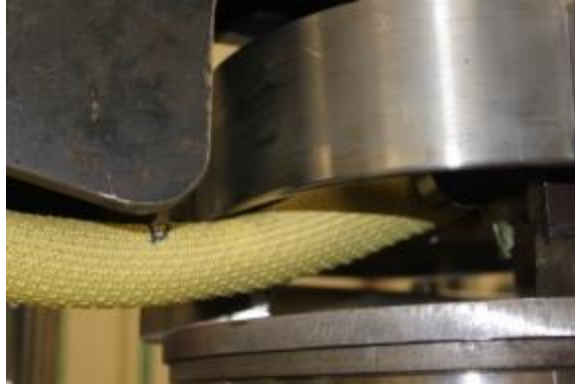
**Photo 4. Protected riser and contact edge (close-up view).**

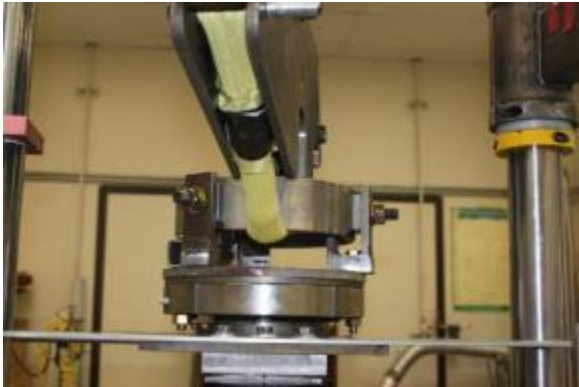
**Photo 5. Protected riser under load.**

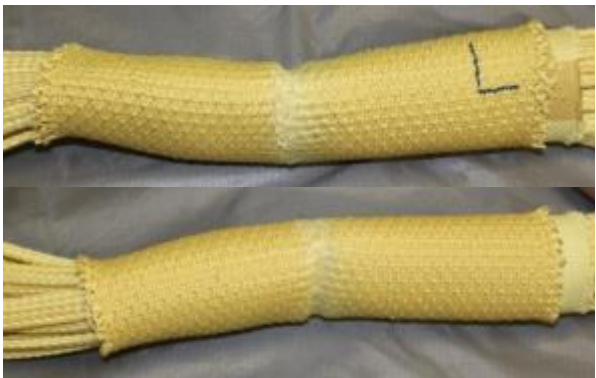
Photo 8. Post-test exterior, “L”.

Based on these test results, cover design “L” demonstrated the most effective abrasion protection and was selected for knockdown factor evaluation. Design “N” was an over-test of “L” and was also selected for comparison. Observable effects of abrasion on designs “L” and “N” are shown on Photo 8 through Photo 13.

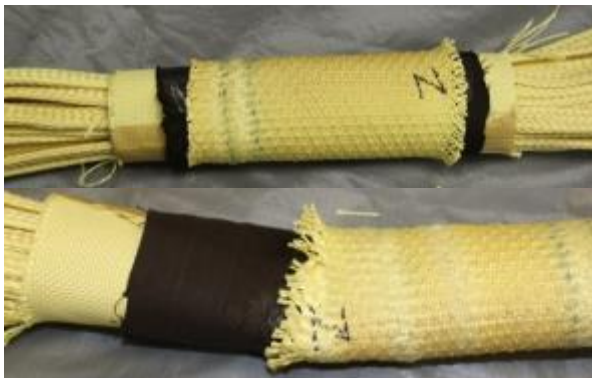
Photo 9. Post-test exterior, “N”.

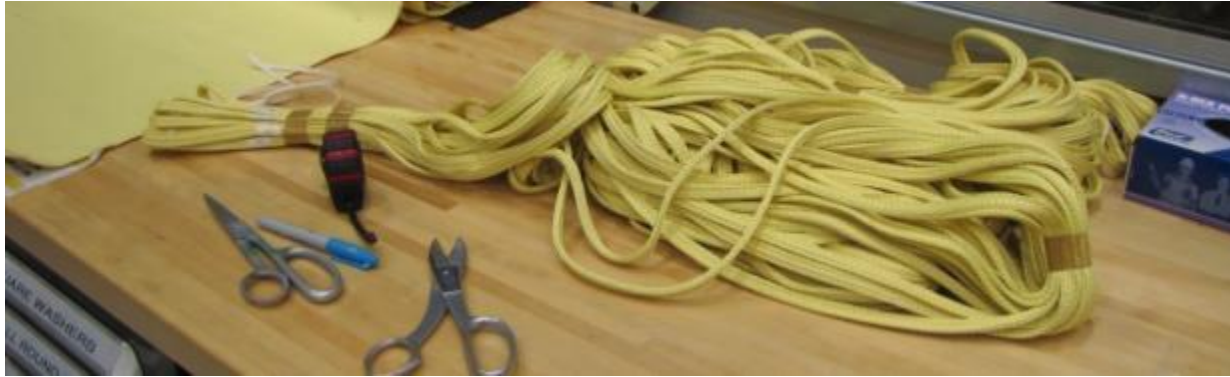
Photo 15. CPAS drogue riser sample.

A total of ten riser samples were fabricated for evaluation testing at JSC. Each riser was 17 ft long and composed of 12 continuous loops of 5000-lb Kevlar® rope. Each loop was numbered and labeled to aid assembly. One riser was set aside as a control. An example riser is shown on Photo 15.

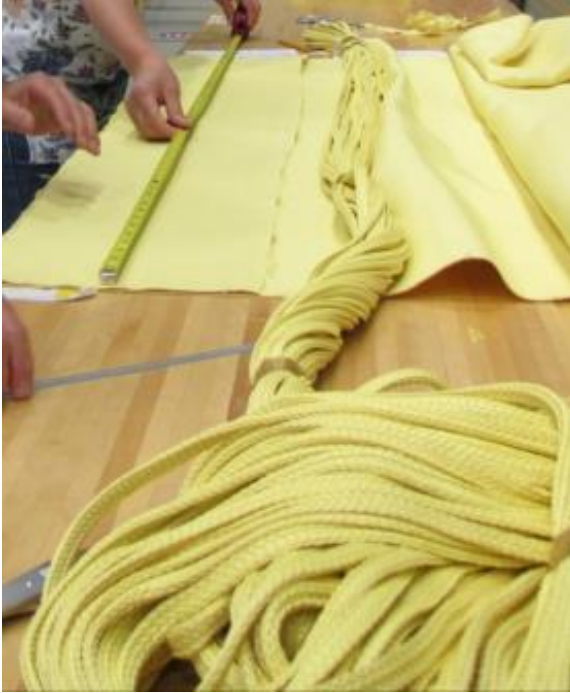
**Photo 16.** Riser sample about to be wrapped in Kevlar cloth.

Each riser sample was laid out on the assembly table atop the inner Kevlar sleeve cloth, as shown on Photo 16. The 10-oz plain-weave Kevlar cloth of the inner Kevlar sleeve was measured and cut to a width sufficient to wrap twice about the riser sample, thus forming two protective layers, as shown on Photo 17. The inner sleeve was sized to be evenly snug along its length. The inner Kevlar sleeve was then secured with Teflon tape, as shown on Photo 18. The Teflon cloth of the middle sleeve was cut to be slightly shorter than the inner Kevlar sleeve, wrapped about the inner Kevlar sleeve to form a single lubricating layer, and secured with Teflon tape, as shown by Photo 19. The Teflon sleeve was also sized to be evenly snug along its length. The sleeved riser sample was then inserted into the outer Kevlar sleeve, as shown on Photo 20. The inner Kevlar sleeve was taped to the riser and the Teflon sleeve taped to the inner sleeve on each end, with the outer sleeve left untaped to allow it to roll. The final assembly of the protected riser sample is shown on Photo 21 and its flexibility is demonstrated on Photo 22.

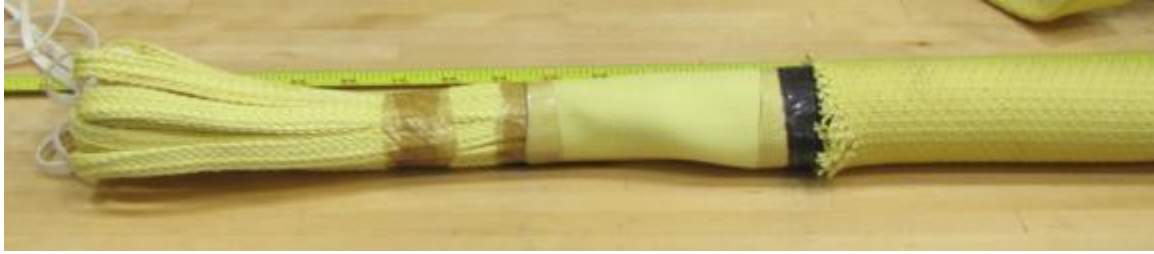
**Photo 21. Riser sample with protective textile cover.**

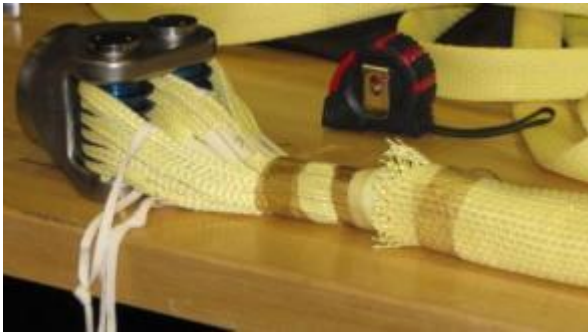
**Photo 23. Riser sample with hardware interface “knuckle” attached (abrasion fixture end).**

Two hardware interface “knuckles” were used to connect the riser sample to the test fixture. The knuckle used to simulate attachment to the capsule is shown on Photo 23, whereas the knuckle used to simulate the parachute load is shown on Photo 24. The riser sample was first attached to the capsule knuckle and installed in the abrasion fixture, as shown on Photo 25. The far end of the riser was then fed through the edge radius tube, as shown on Photo 26 and Photo 28. The riser cover was marked to provide visual indication of rotation. Finally, the far end of the riser sample was routed through safety ties, as shown on Photo 27 and attached to the parachute knuckle, load cell, and hydraulic ram assembly, as shown on Photo 29.

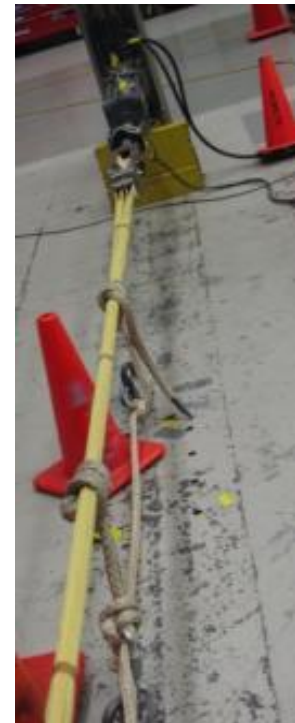
**Photo 29. Hydraulic ram and load cell attachment.**

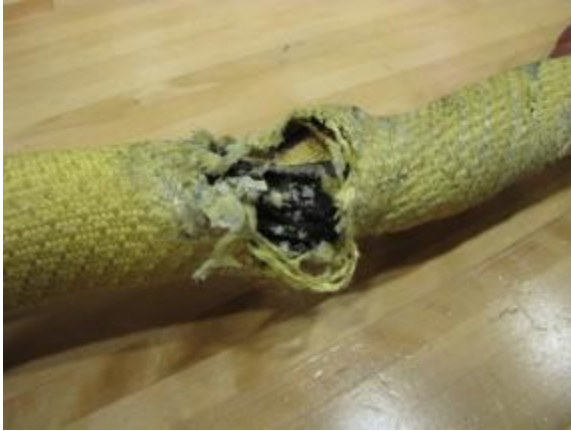
Photo 34. Test 1 effects (outer Kevlar sleeve).

The outer Kevlar sleeve and middle Teflon sleeves were torn, as shown on Photo 34 and Photo 35, respectively. The inner Kevlar sleeve, however, exhibited only a shiny spot and no visible damage, as shown on Photo 36. The lines were similarly devoid of visible damage, as shown on Photo 37.

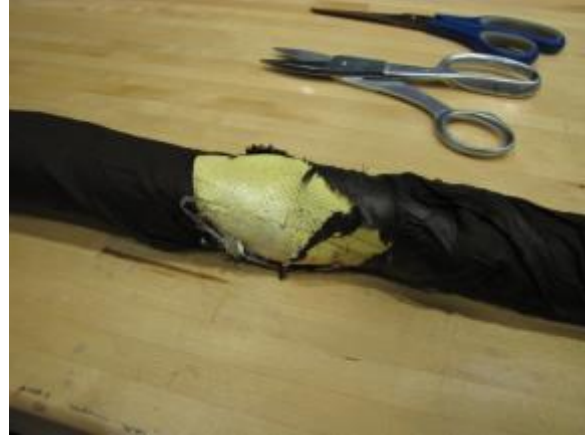
Photo 35. Test 1 effects (Teflon sleeve).

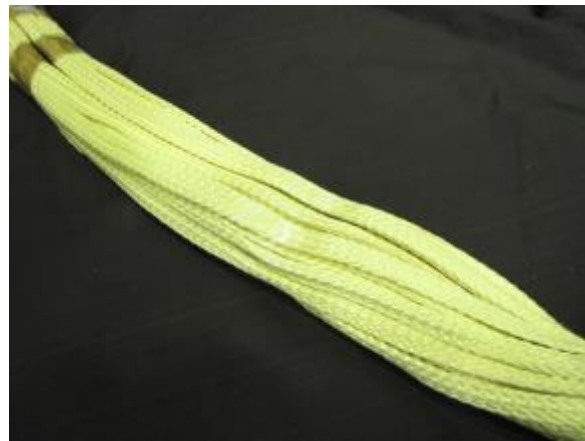
Photo 37. Test 1 effects (lines).

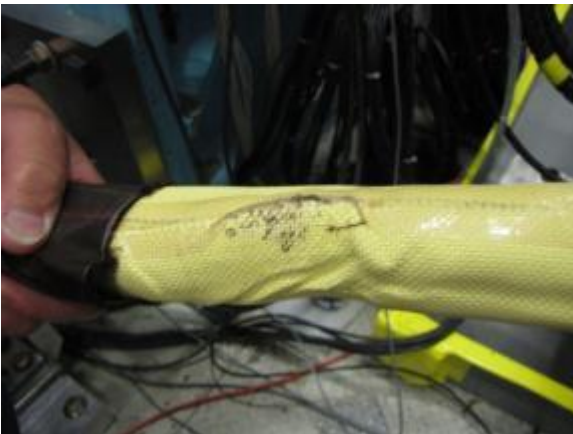
Photo 44. Test 2 effects (inner Kevlar sleeve).

The effect of abrasion on the riser cover was different from Test 1. The outer cover rotated during abrasive contact loading, but did not tear the outer Kevlar sleeve, as shown on Photo 38, Photo 39, Photo 40, Photo 41, and Photo 42. The middle Teflon sleeve was torn, as shown on Photo 43. The inner Kevlar sleeve and lines were compressed and shiny, but had no visible damage, as shown on Photo 44 and Photo 45.

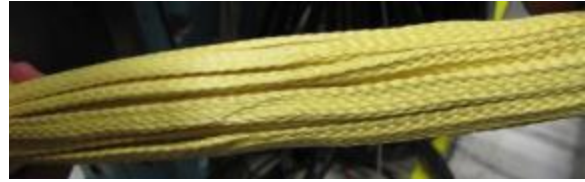
Photo 46. Test 4 effects (lines).

Test 4 was conducted in the same manner as Test 3, with similar results. The peak load was observed to be 42,800 lbs. The outer Kevlar sleeve did not rotate and had minor holes. The Teflon middle sleeve was torn, as usual. The inner Kevlar sleeve showed Teflon residue, but no damage. Line 7 was folded where the inner cover seam mashed it (Photo 46).

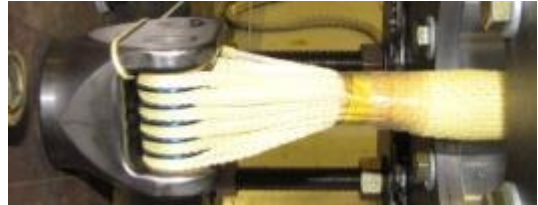
Photo 47. Test 5 taped outer sleeves.

Test 5 was conducted in the same manner as Test 3, with the outer Kevlar sleeve taped directly to the riser (Photo 47) to help limit rotation.

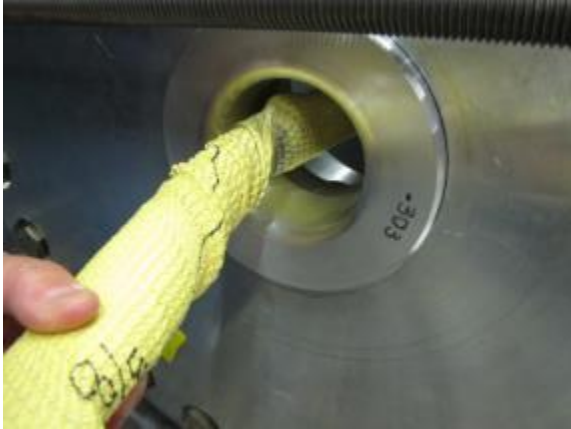
Photo 50. Test 7 results (outer sleeve).

The Kevlar outer sleeve rotated about a quarter turn and then slid. It appeared to receive some aluminum residue from the contact radius (Photo 50). The Teflon middle sleeve was torn about half the way around the sleeve (Photo 51). The Kevlar inner sleeve displayed some Teflon transfer, but had no visible damage (Photo 52). The lines likewise had slightly shiny areas, but no visible damage (Photo 53).

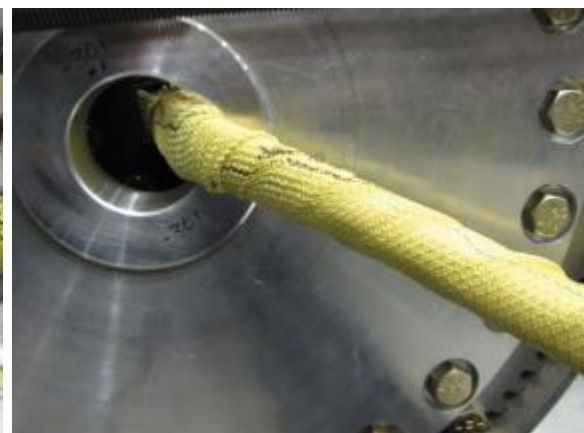
Photo 55. Test 8 results (twist).

The Kevlar outer sleeve twisted at least one complete rotation (Photo 55) and retained some Aluminum residue from the contact radius, but was otherwise undamaged (Photo 56). The middle sleeve was torn (Photo 57) and transferred Teflon residue to the inner sleeve (Photo 58); the inner sleeve was buffed but undamaged. The lines were also slightly shiny and undamaged (Photo 59).

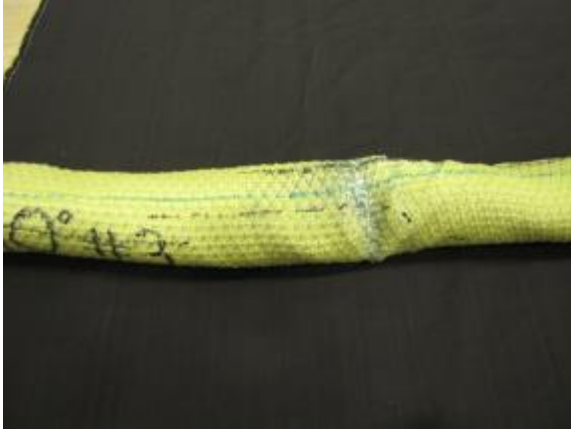
Photo 56. Test 8 results (outer sleeve).

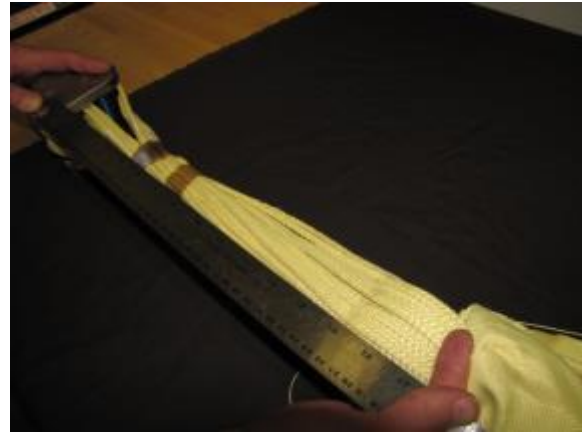
Photo 59. Test 8 results (lines).

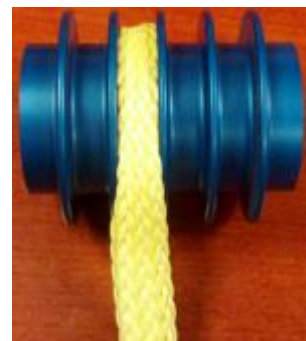
Photo 67. Drogue Knuckle Spool.

so than the 3/8-inch and 1/8-inch radius samples), while the control samples had no preload. Additionally, during abrasive testing the samples were attached to drogue knuckle spools (Photo 67), which constrain the width of the cord and increase its thickness. The control samples were never attached to knuckle spools and were only pulled to failure using 1-3/8-inch diameter pins.
