Evolvable Cryogenics (eCryo) Project Technology Workshop with Industry

Engineering Development Unit (EDU) Workshop

Thermal Venting System (TVS)

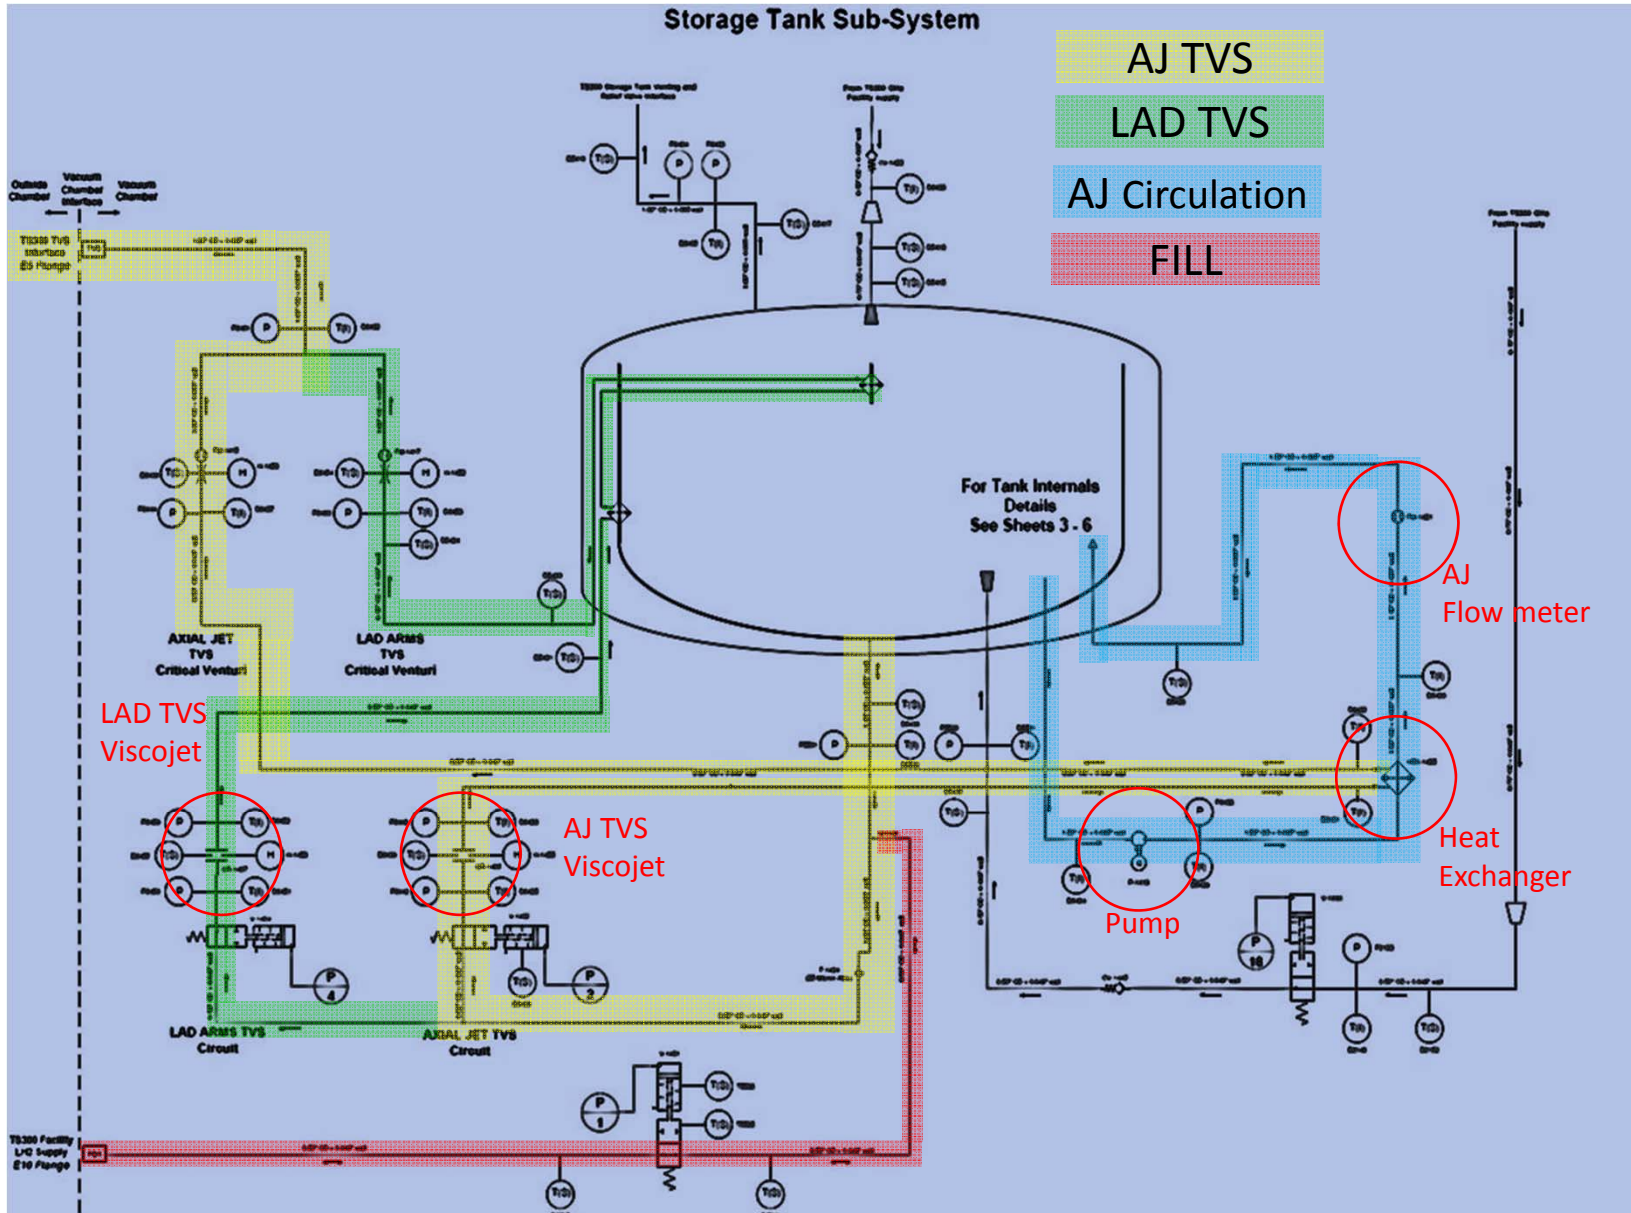
EDU TVS System

- Removes energy from a cryogenic propellant tank to prevent over-pressurization
- Avoids direct venting which could result in large propellant losses in a microgravity environment
- Typically has (3) elements: a cooling circuit with an expansion orifice, a heat exchanger, and a means to circulate/mix tank contents

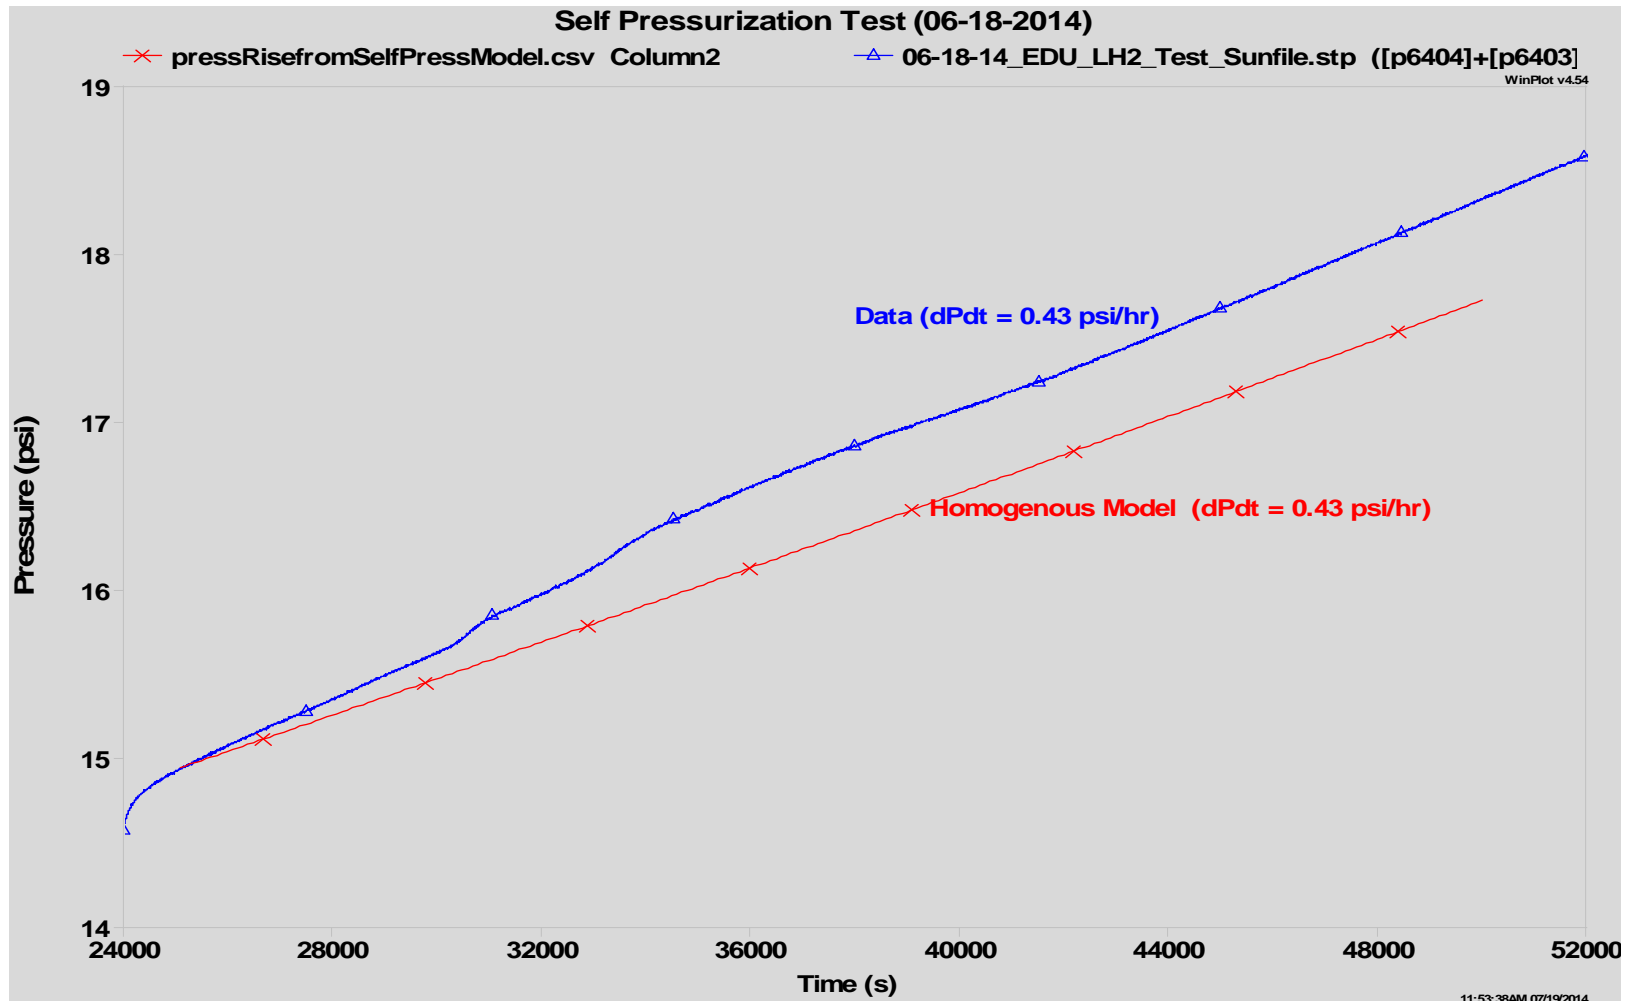
EDU Self-Pressurization Behavior

Slope after first hour is identical to homogenous model:

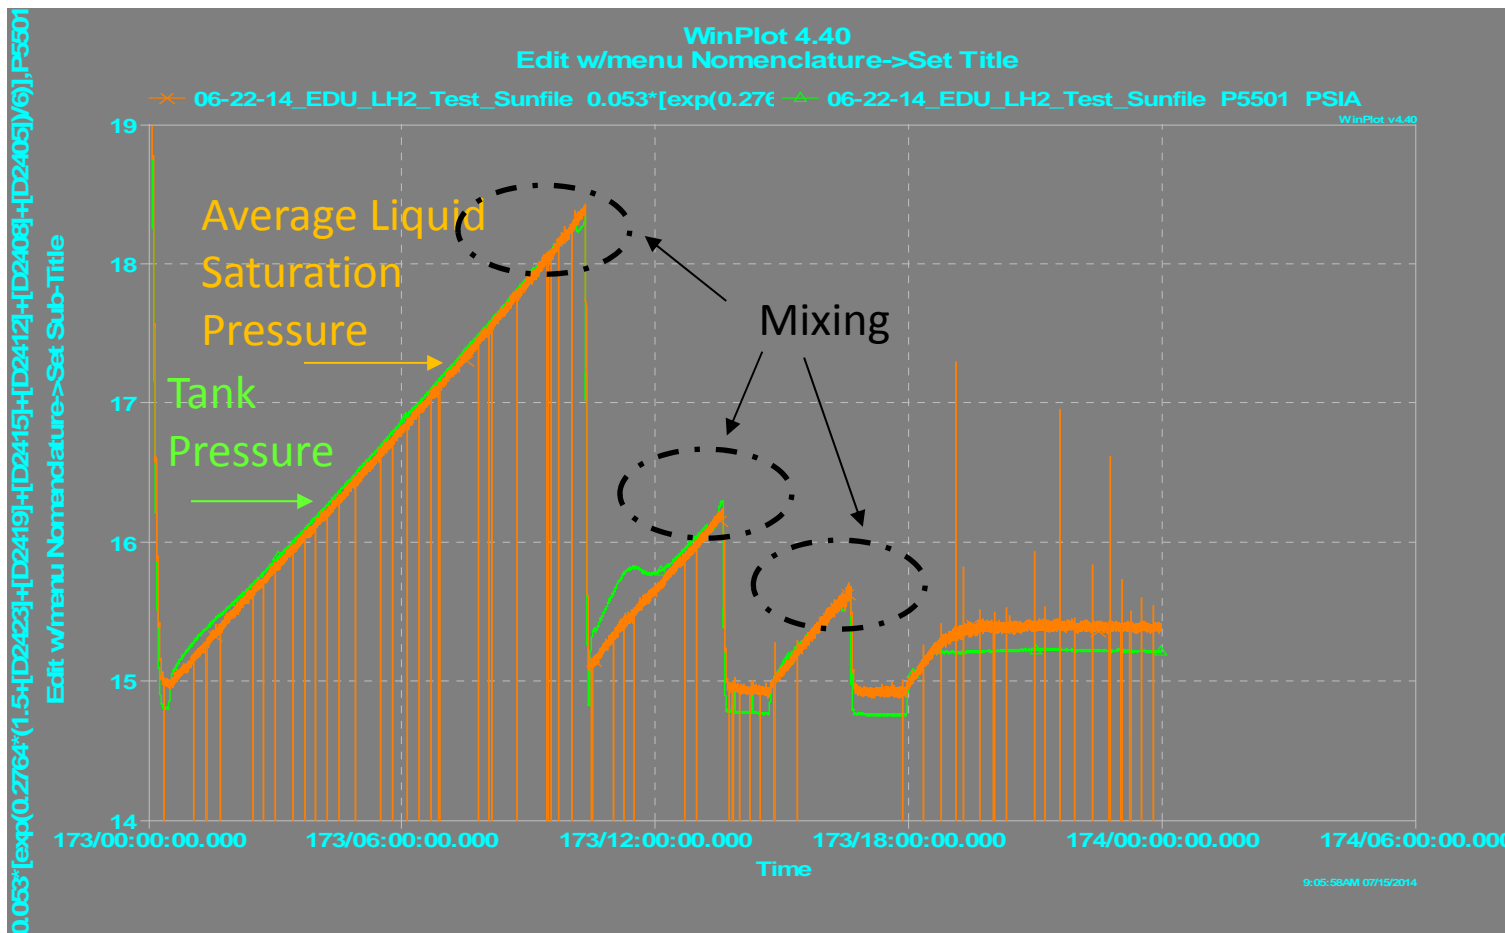
Axial jet mixing – hydrogen vapor only in ullage

Pump operation with hydrogen only in ullage generally produced little or no reduction in pressure. This is due to the nearly homogeneous pressure rise behavior, i.e., the tank pressure is closely following the saturation curve.

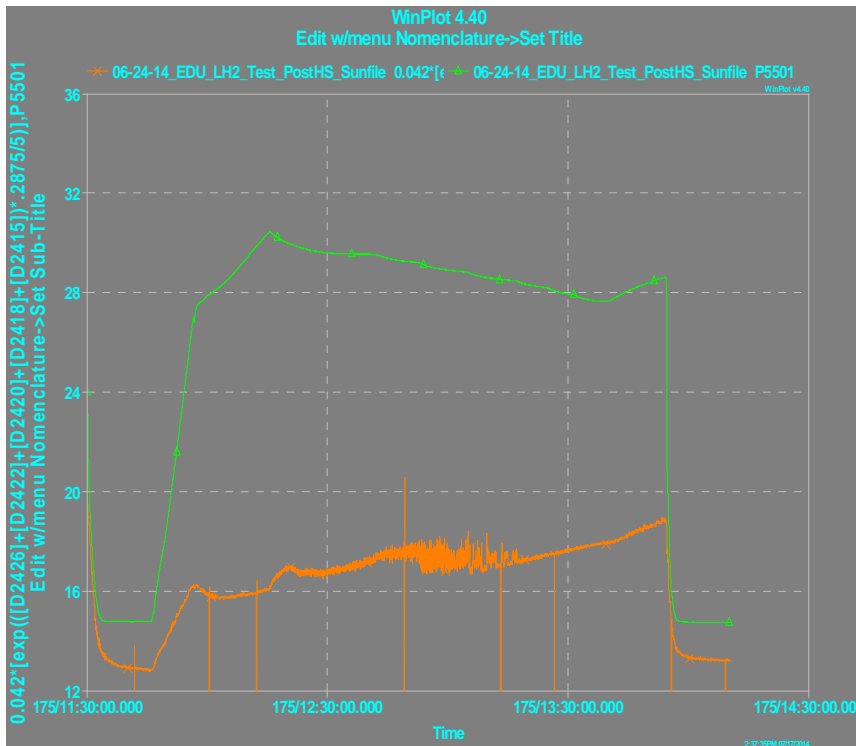
Pump operation with helium in ullage did produce pressure reduction, tending to return pressure to the initial helium pressurization level. Further pressure reduction requires cooling.

40% fill level, helium pressurization using fwd diffuser

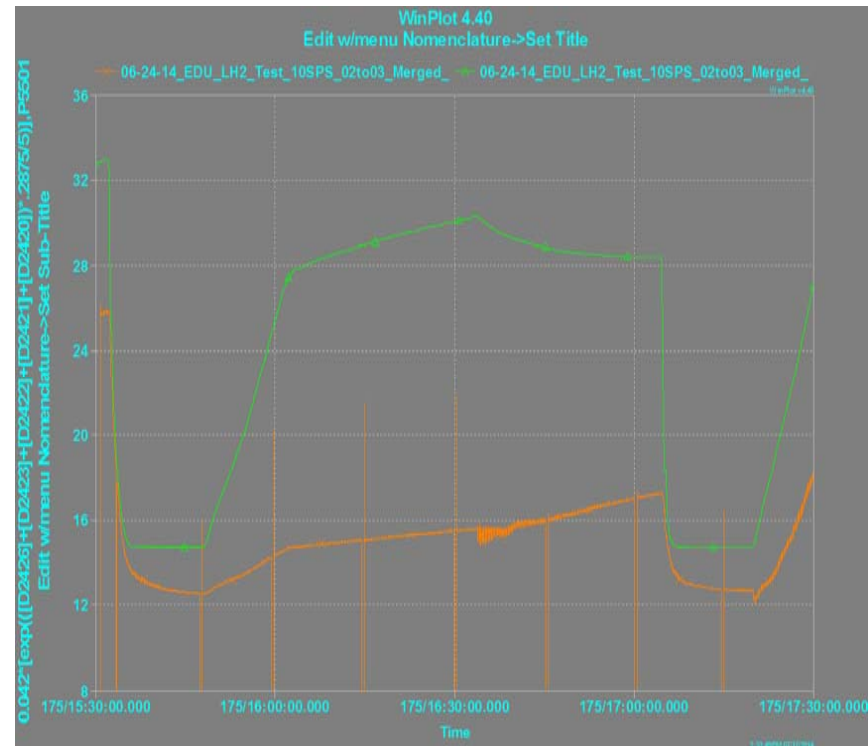
22% fill level, helium pressurization using fwd diffuser

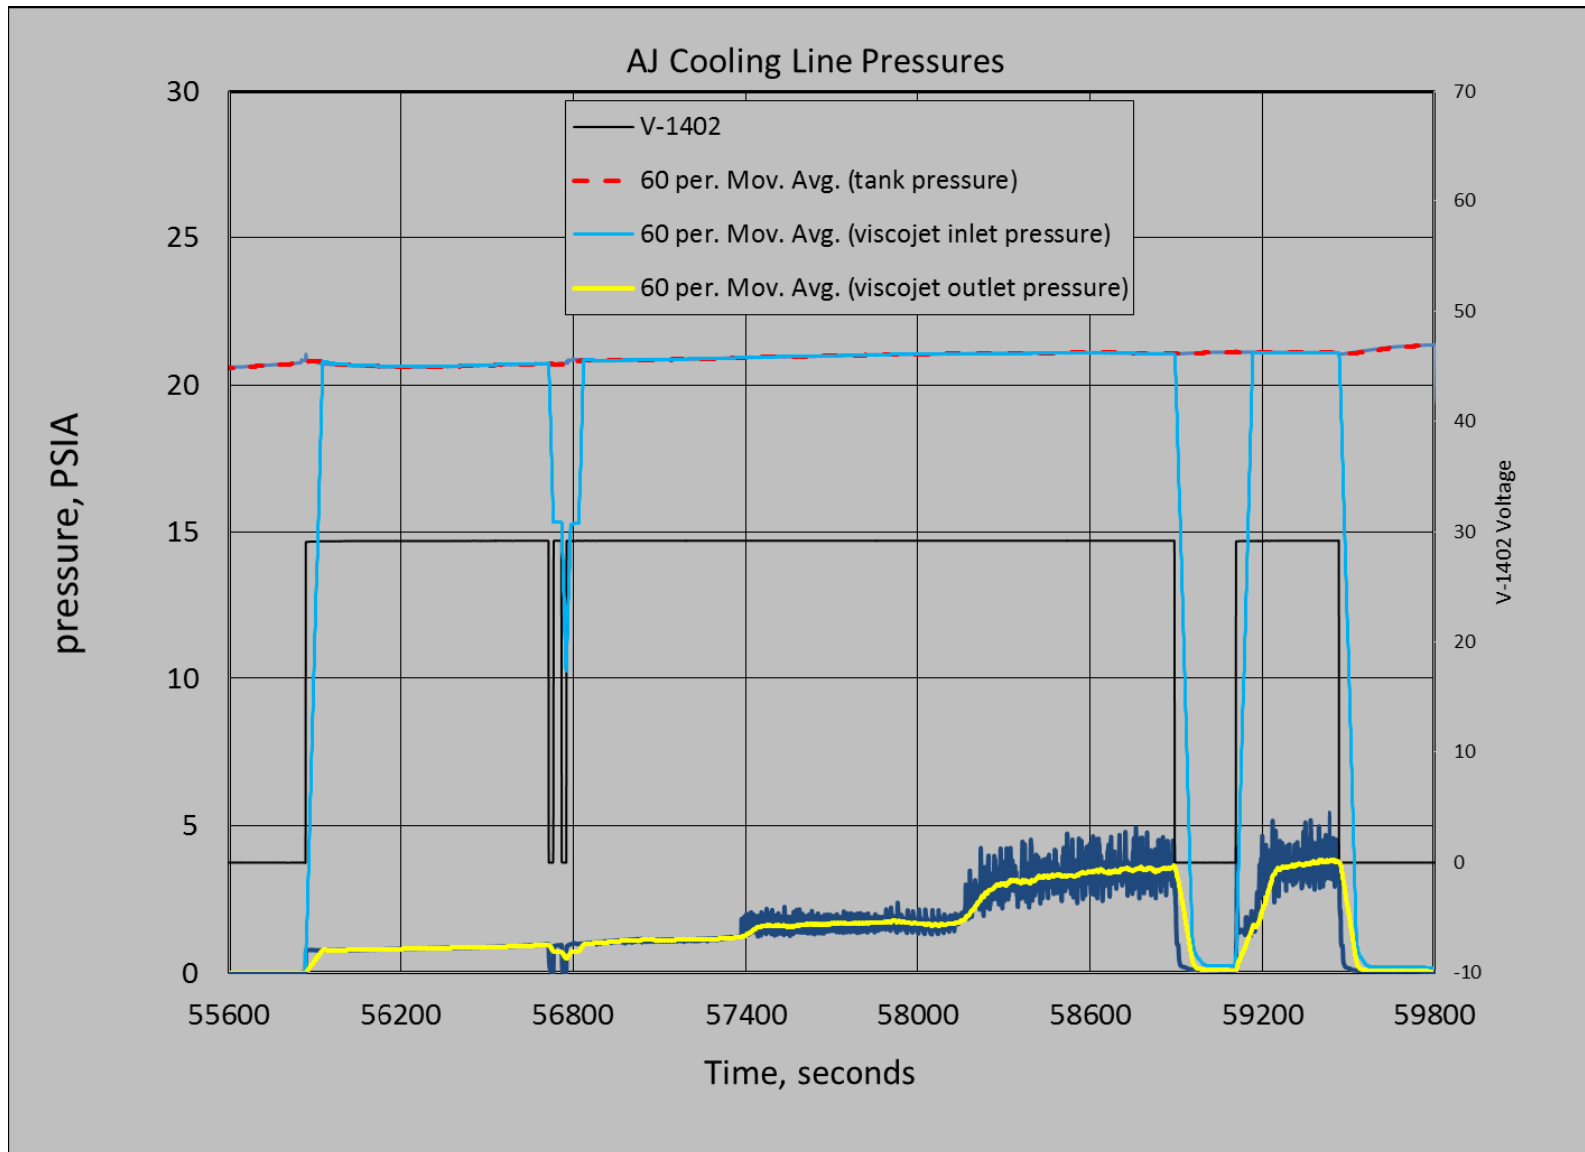
AJ TVS Cooldown Day 2

- The initial checkout of the axial jet cooling circuit was done by opening the valve and allowing saturated fluid to flow to the viscojet. The fluid vaporized upstream of the viscojet and therefore the flow rate was somewhat less than the nominal design flow rate. This reduced flow rate further extended the cool-down time.
- Attempts to run the axial jet pump during this checkout resulted in discovery that the axial jet flowmeter was not working. The pump motor also was thought to have malfunctioned, although it turned out that this was not the case. There was, however, a problem with the pump controller which resulted confusion as to what the motor was doing until the controller was replaced several days later.

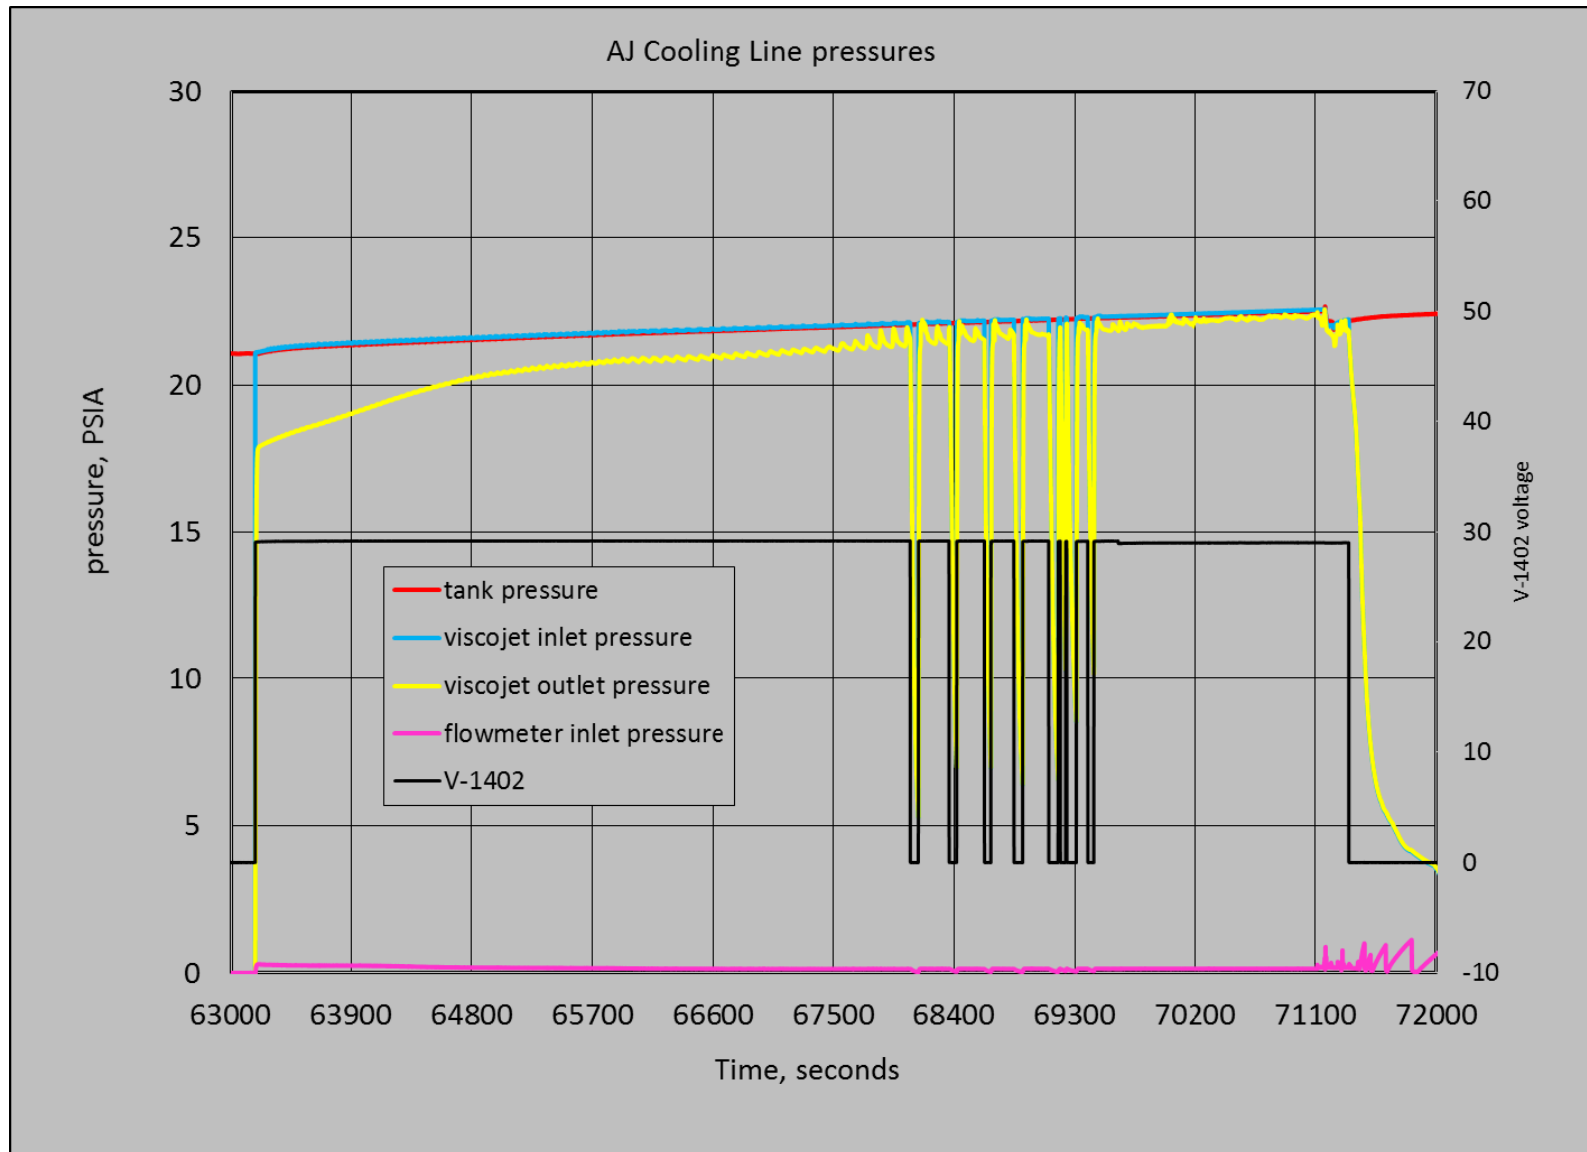
AJ TVS Cooldown Day 8: Heat Exchanger Blockage

- After the initial attempt at AJ TVS cooldown, the circuit was not operated for 6 days. When the next attempt was made to flow coolant, there was blockage at the heat exchanger which could not be cleared despite several attempts. This prevented the execution of several cooling/pressure reduction tests.

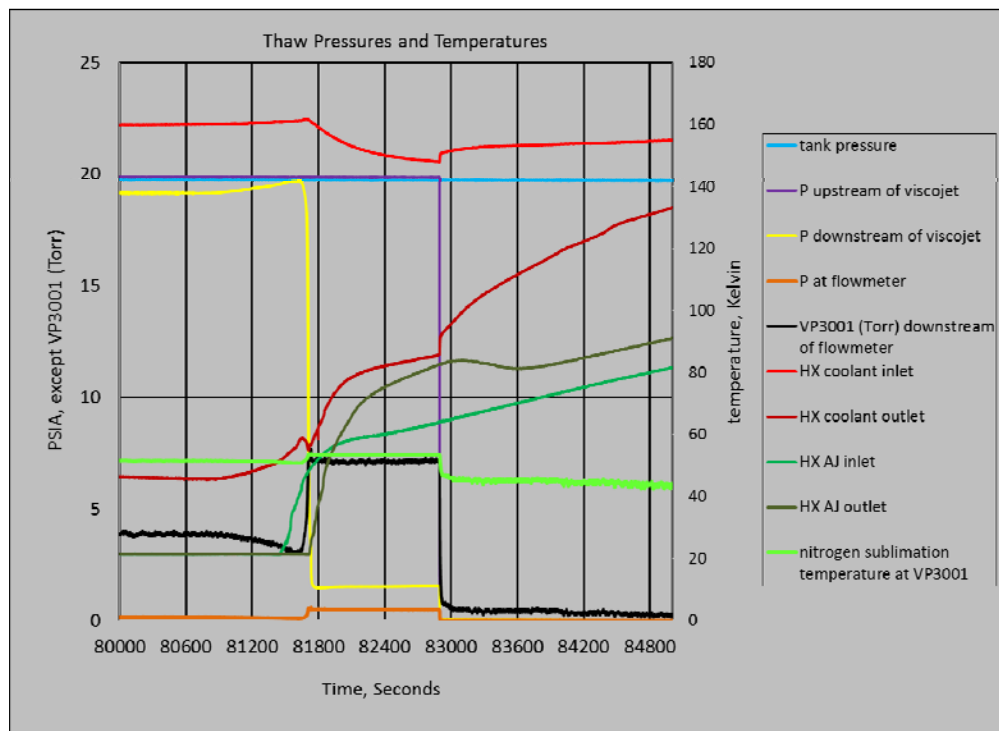
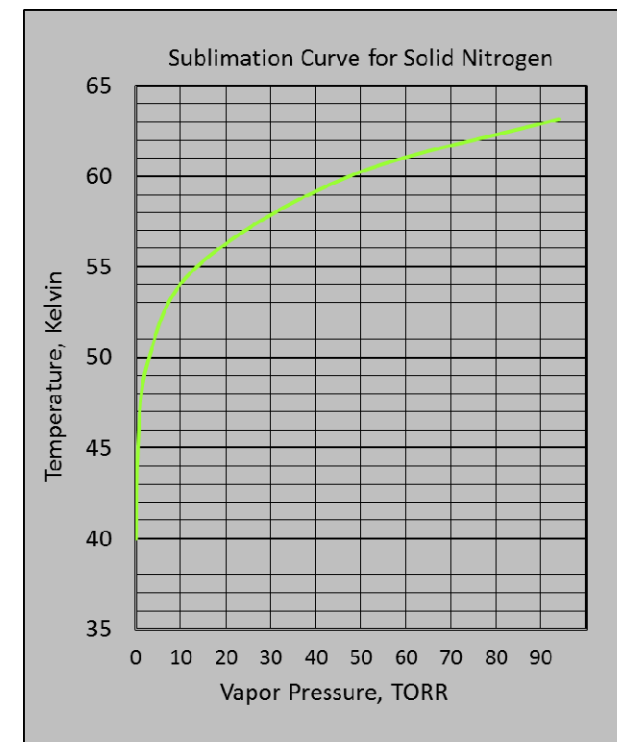
Heat Exchanger Blockage Clearance

- After final test shutdown and with a helium purge on the tank, the blockage cleared during warm up of the heat exchanger.
- The temperature traces at the time of blockage clearing suggest that nitrogen may have frozen in the cooling somewhere inside the heat exchanger. There may also have been some flow area reduction due to weld penetration at the ½ inch to ¼ inch heat exchanger connections which may have been aggravated by thermal contraction.

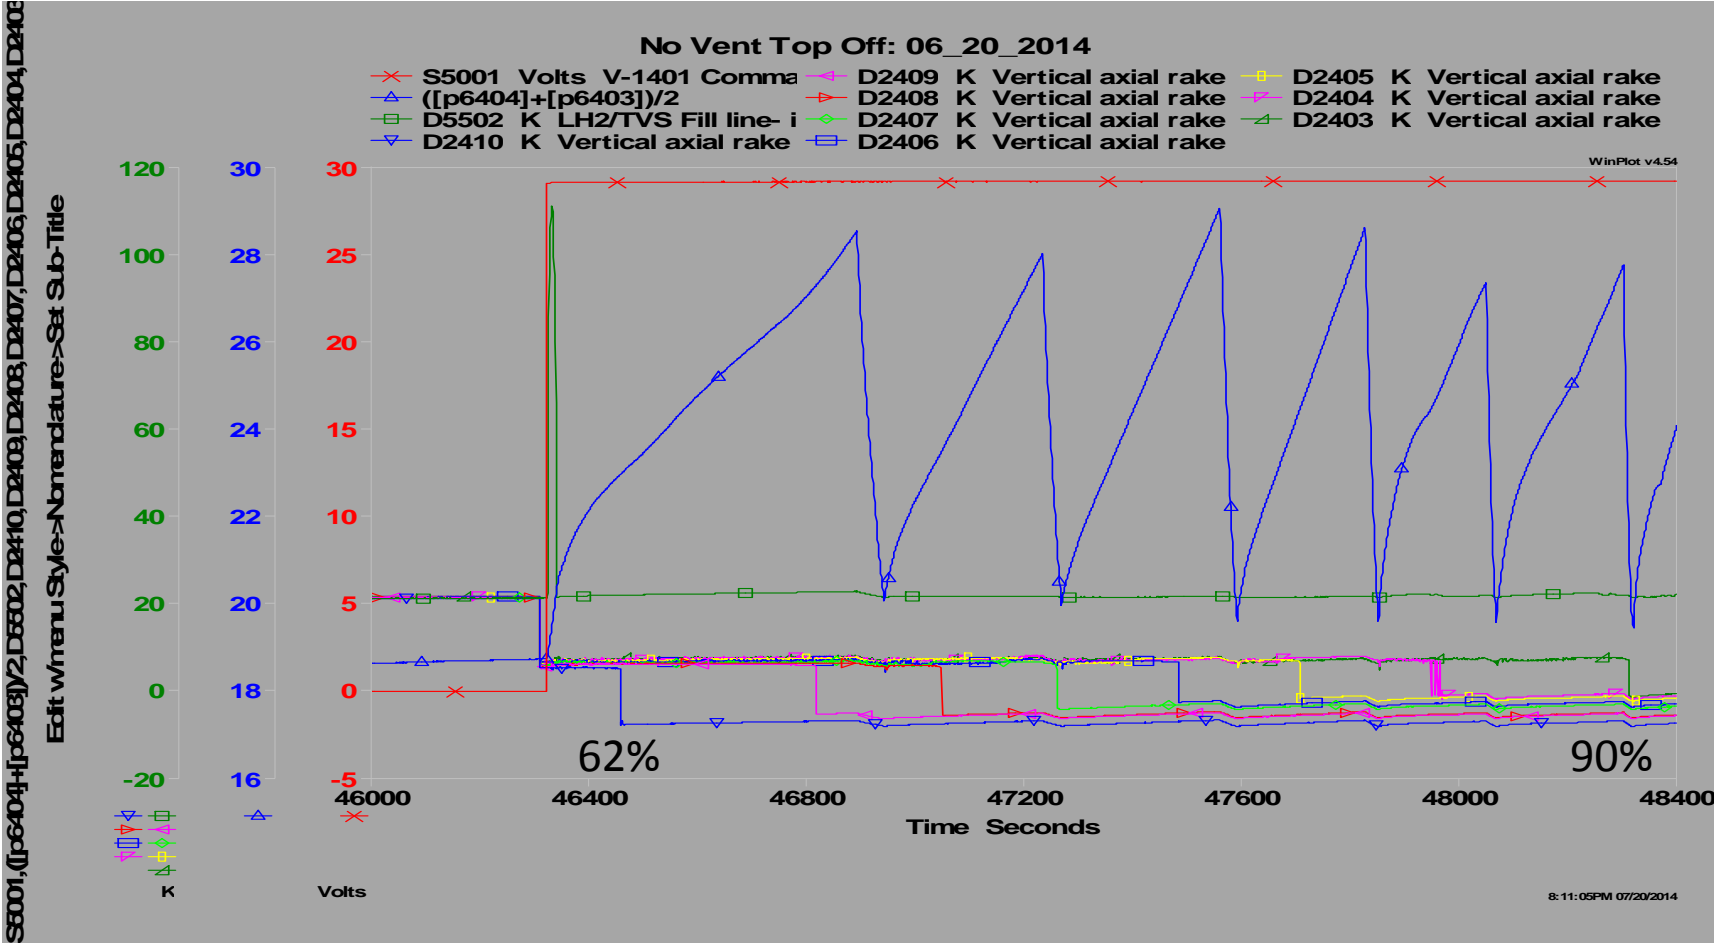
No Vent Fill Attempt, Day 9

- Top-off unsuccessful, vented 6 times to relieve pressure
- Fill valve remained open during each vent
- Tank wall was cold (< 24 K) prior to fill
- Slug of 100 K + gas entered tank when V1401 was opened

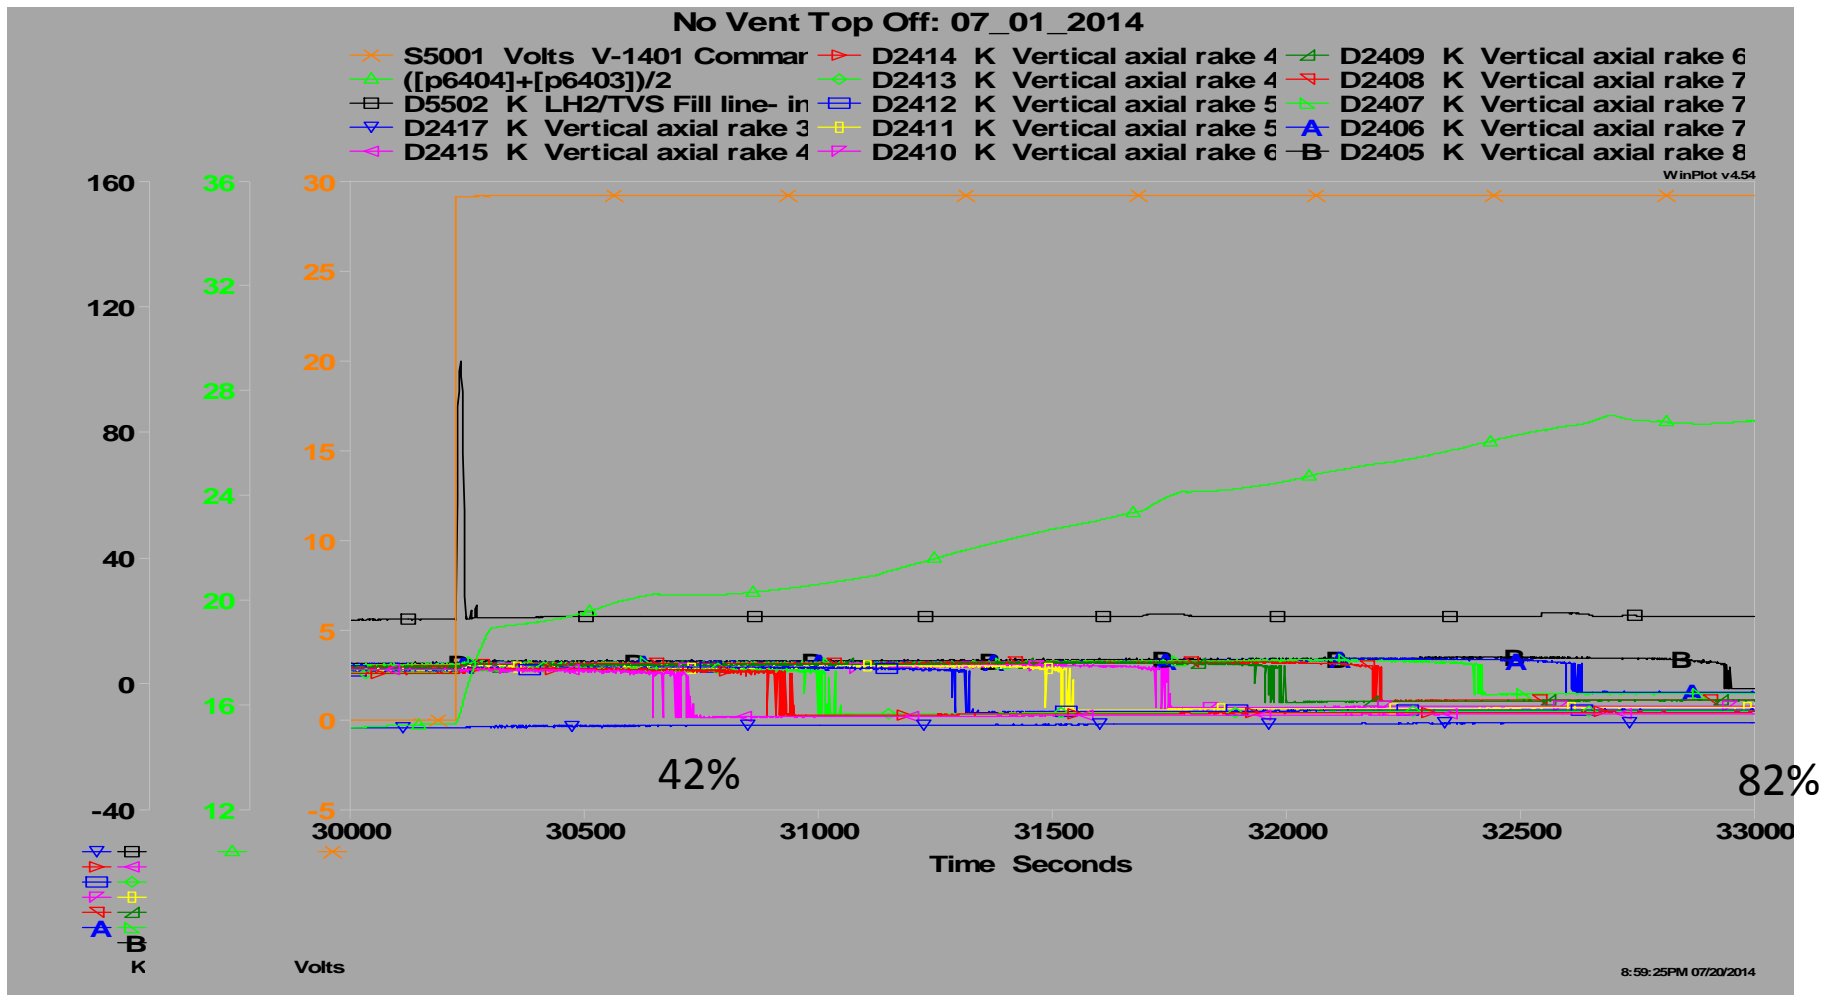
No Vent Fill Attempt, Day 20

- Operation was successful
- Pump was run to agitate the liquid during the fill
- Slug of 100 K + gas entered tank when V1401 was opened
- Tank wall was cold (<40 K), but warmer than day 9 attempt, prior to starting
