# James Webb Space Telescope (JWST) Integrated Science Instruments Module (ISIM) Cryo-Vacuum (CV) Testing at GSFC

Calinda Yew  
28<sup>th</sup> Space Simulation Conference  
NASA Goddard Space Flight Center  
(GSFC)

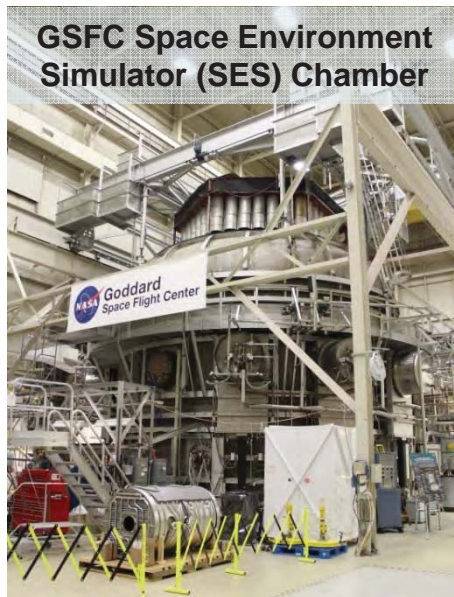
# ISIM CV Overall Test Configuration

**Chamber specifications**  
 Volume: 27' dia x 40' high  
 Pumping speed

- 7 cryopumps:  $2.1 \times 10^5$  l/s
- Turbomolecular pump: 6,000 l/s

Payload support: 40,000 lbs

*Nitrogen shroud*

*Helium shroud*

*ISIM hardware & support frames*

*JWST OTE Simulator (OSIM)*

*Vibration isolators*

*Upper and Lower Supports Assembly*

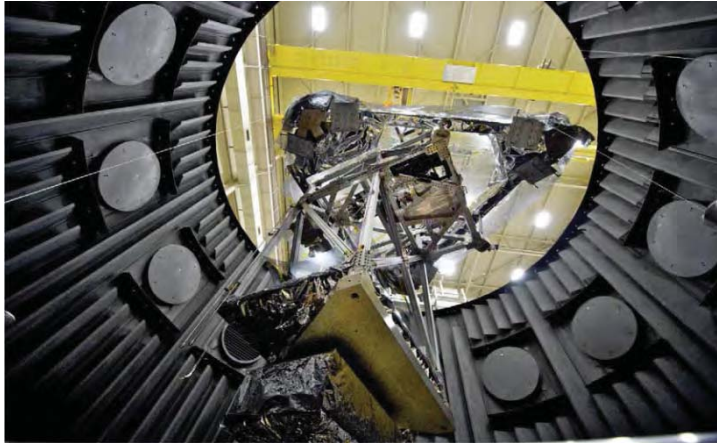
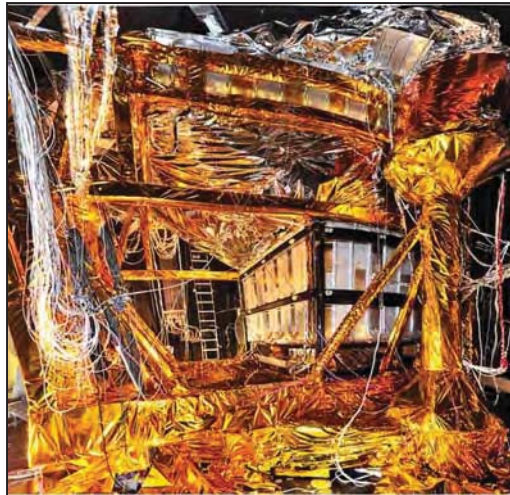
# Nitrogen Volume Test Configuration

GSFC Equipment Support Hardware Assembly (GESHA): triangular Al structure to alleviate motion between two aligned systems

- Upper GESHA held at around 90K (-183°C)
- Lower GESHA: held at ambient temperatures to alleviate CTE induced strains

Vibration Isolators System (VIS): pneumatic system isolates test articles from chamber induced jitter sources

- Chamber vibration measured amplitudes of 1 milli-G in all axes at 20 Hz – VIS provides minimum attenuation of 40 dB to these levels
- VIS vertical natural frequency is 1.0-1.3 Hz
- VIS horizontal natural frequency is 0.4-0.6 Hz

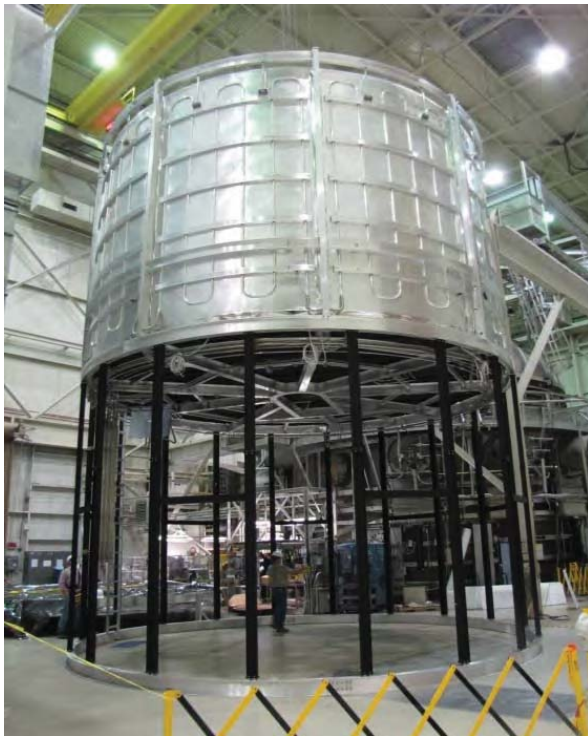
# Helium Volume Test Configuration

*SIF & STMS  
Frame*

*HR Shroud  
(HR)*

*IEC Shroud  
(IEC LN<sub>2</sub> Panel)*

*SIF = SES Integration Frame  
STMS = Surrogate Thermal Management System  
IEC = Instruments Electronics Module*

*HR = Harness Radiator  
DSR = Deep Space Radiator*

- Dimensions 26' dia x 15' tall
- Provide 1000 W cooling capacity
- Cooling between 80K (-193°C) and 20K (-253°C)
- Five independently controlled shroud zones
- The other five helium zones are allocated to various parts of ISIM structure

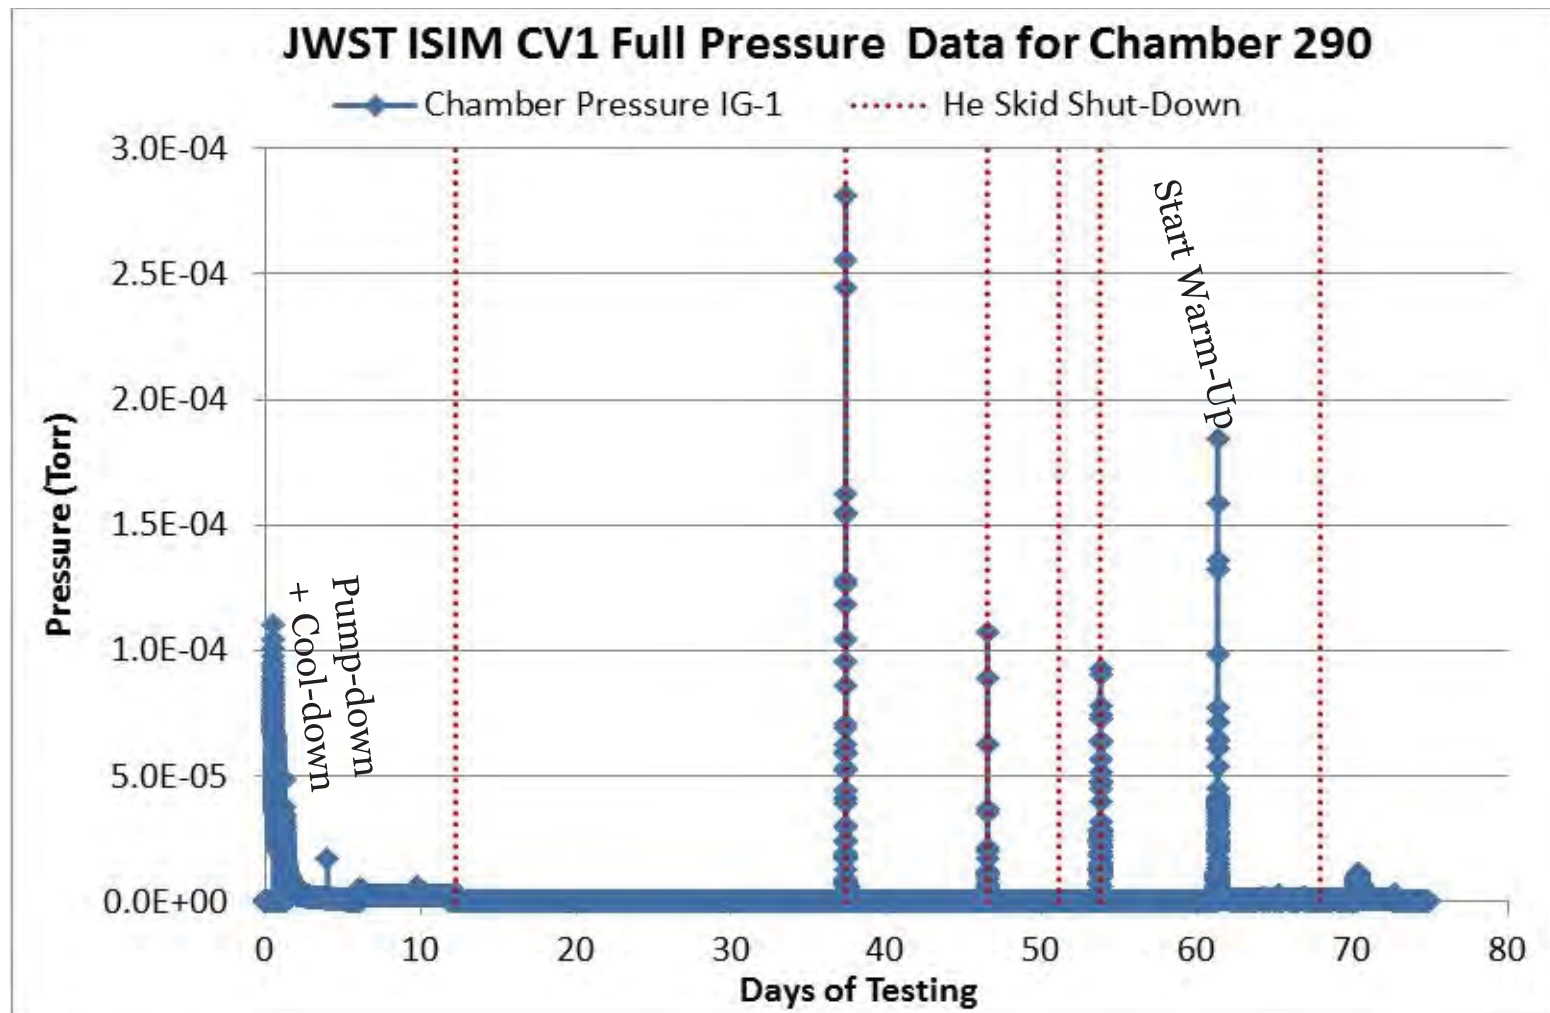
# Chamber Vacuum Performance

Chamber pressure from pump-down to back-fill

- High vacuum was achieved using:
  - (qty 6) 65000 liter/sec cryopumps
  - (qty 1) 5000 liter/sec turbopump
- 1 (of 6) cryopumps left in reserve at all times

Pressure (Torr)	Time since start
$5.0 \times 10^{-5}$	29 hrs (1.2 days)
$1.0 \times 10^{-5}$	35 hrs (1.5 days)
$5.0 \times 10^{-6}$	46 hrs (1.9 days)
$1.0 \times 10^{-6}$	108 hrs (4.5 days)
$5.0 \times 10^{-7}$	128 hrs (5.3 days)

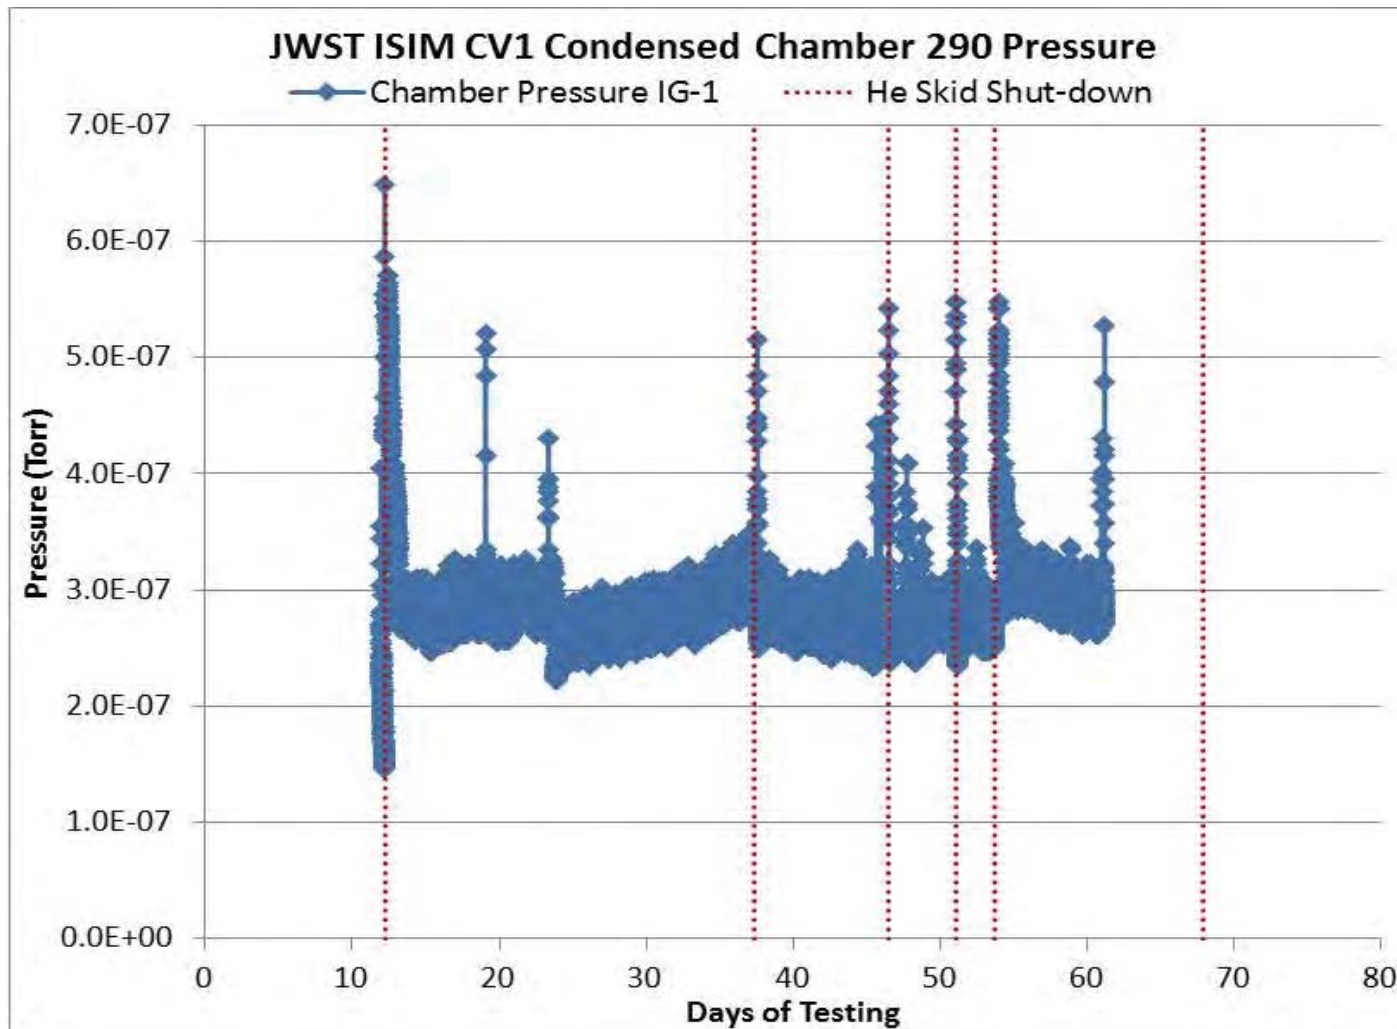
# Chamber Vacuum Performance

With cool-down, warm-up, & He skid shut-down pressure spikes omitted, normally  $3 \times 10^{-7}$  Torr

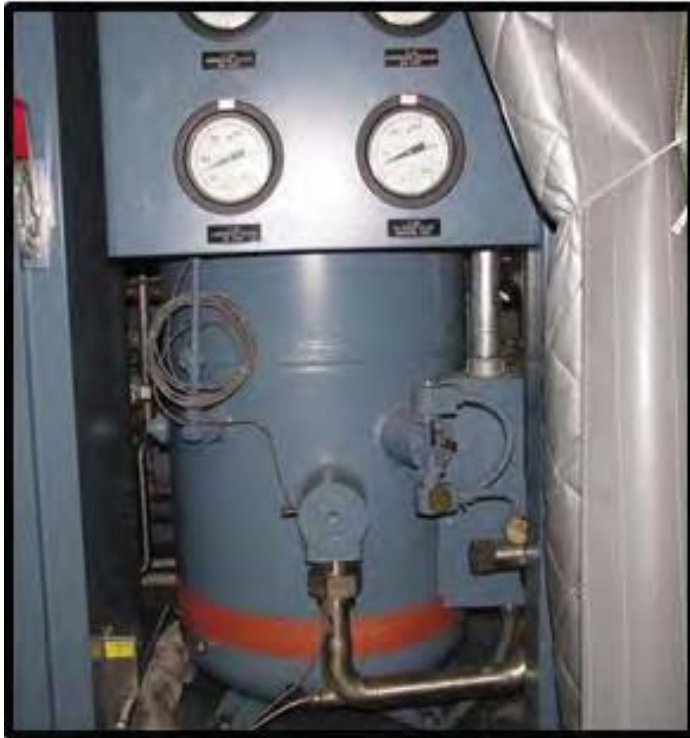
Old

Replace Dunham Busch Compressor  
6 to 10 week delivery  
Successfully installed & checked out May 2014

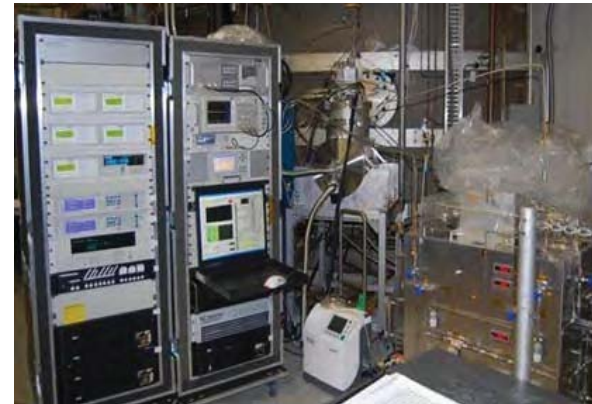
## Helium Leak Detection Improvement

- MIRI requirement: 6.2 K (-266.8°C) at the instrument
  - 2-stage cooler system
  - Accurate heat map required during environmental testing
- Issues encountered during CV1
  - Measured heat loads to cooler from MIRI higher than expected
  - Presumed cause is higher levels of helium in chamber
- Actions
  - Add RGA in STMS volume a
  - Implement more stringent leak checking requirements

The chamber RGA detected helium levels of  $5.0 \times 10^{-7}$  Torr

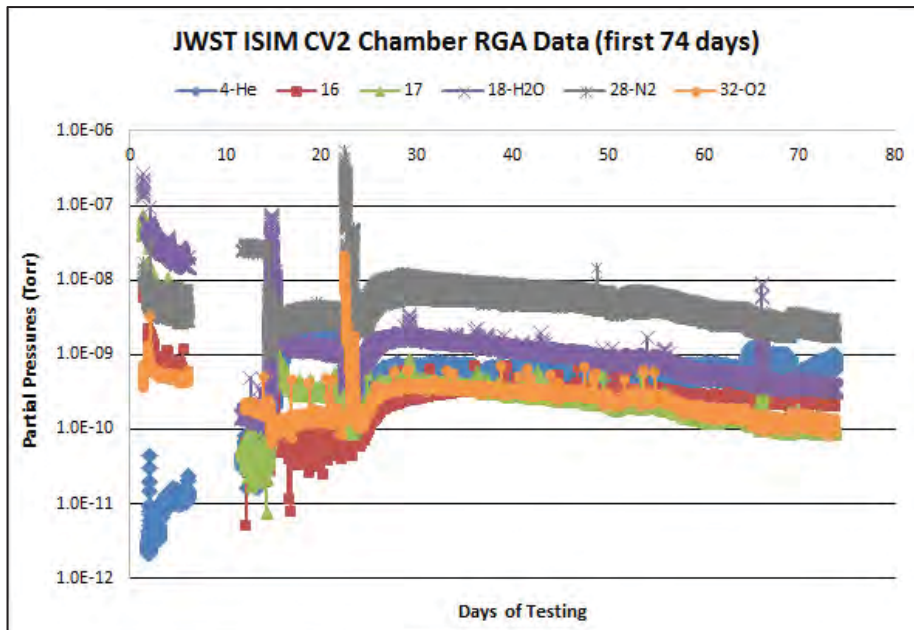
# JWST ISIM CV2 RGA Data Preview

Helium levels consistently detectable to levels of  $1.0 \times 10^{-9}$  Torr (as opposed to  $5.0 \times 10^{-7}$  in CV1)

Helium levels in ISIM volume slightly higher than in the N<sub>2</sub> chamber volume: consistently  $<1.0 \times 10^{-8}$  Torr

The MIRI predicted thermal loads matched the measured within the prediction and measurement uncertainties

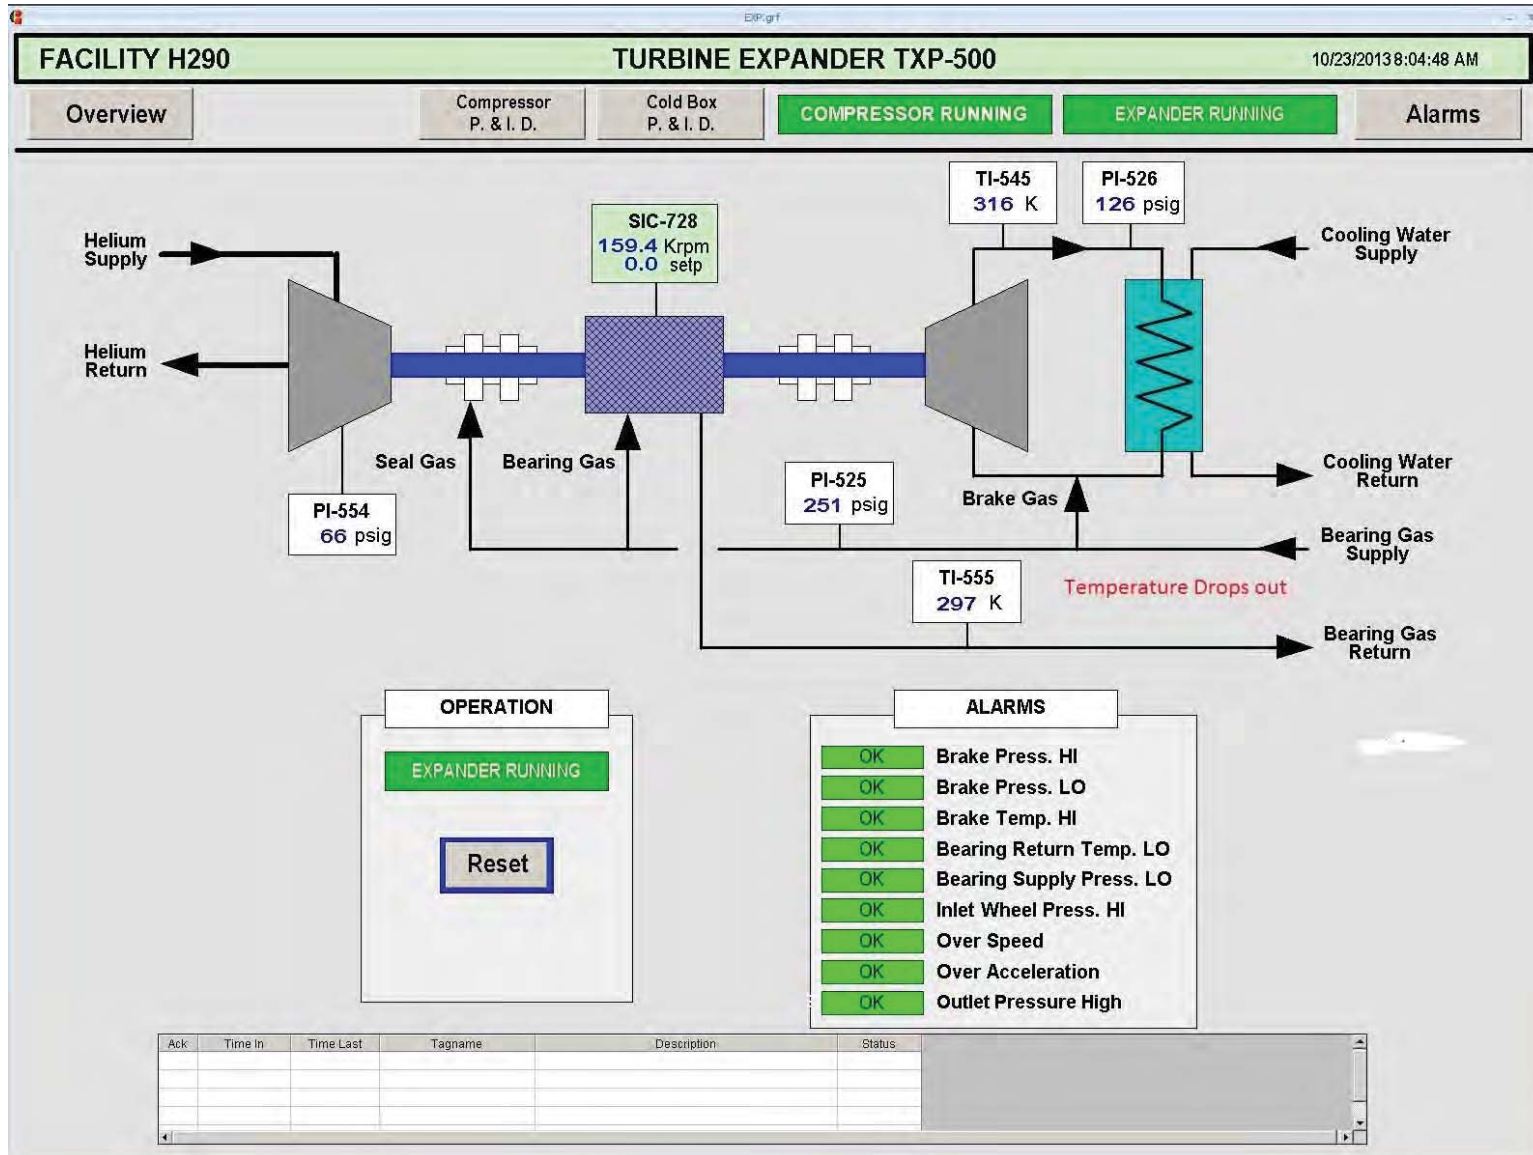
# Helium Skid Shutdown Cause #2: Low turbine bearing return temperatures

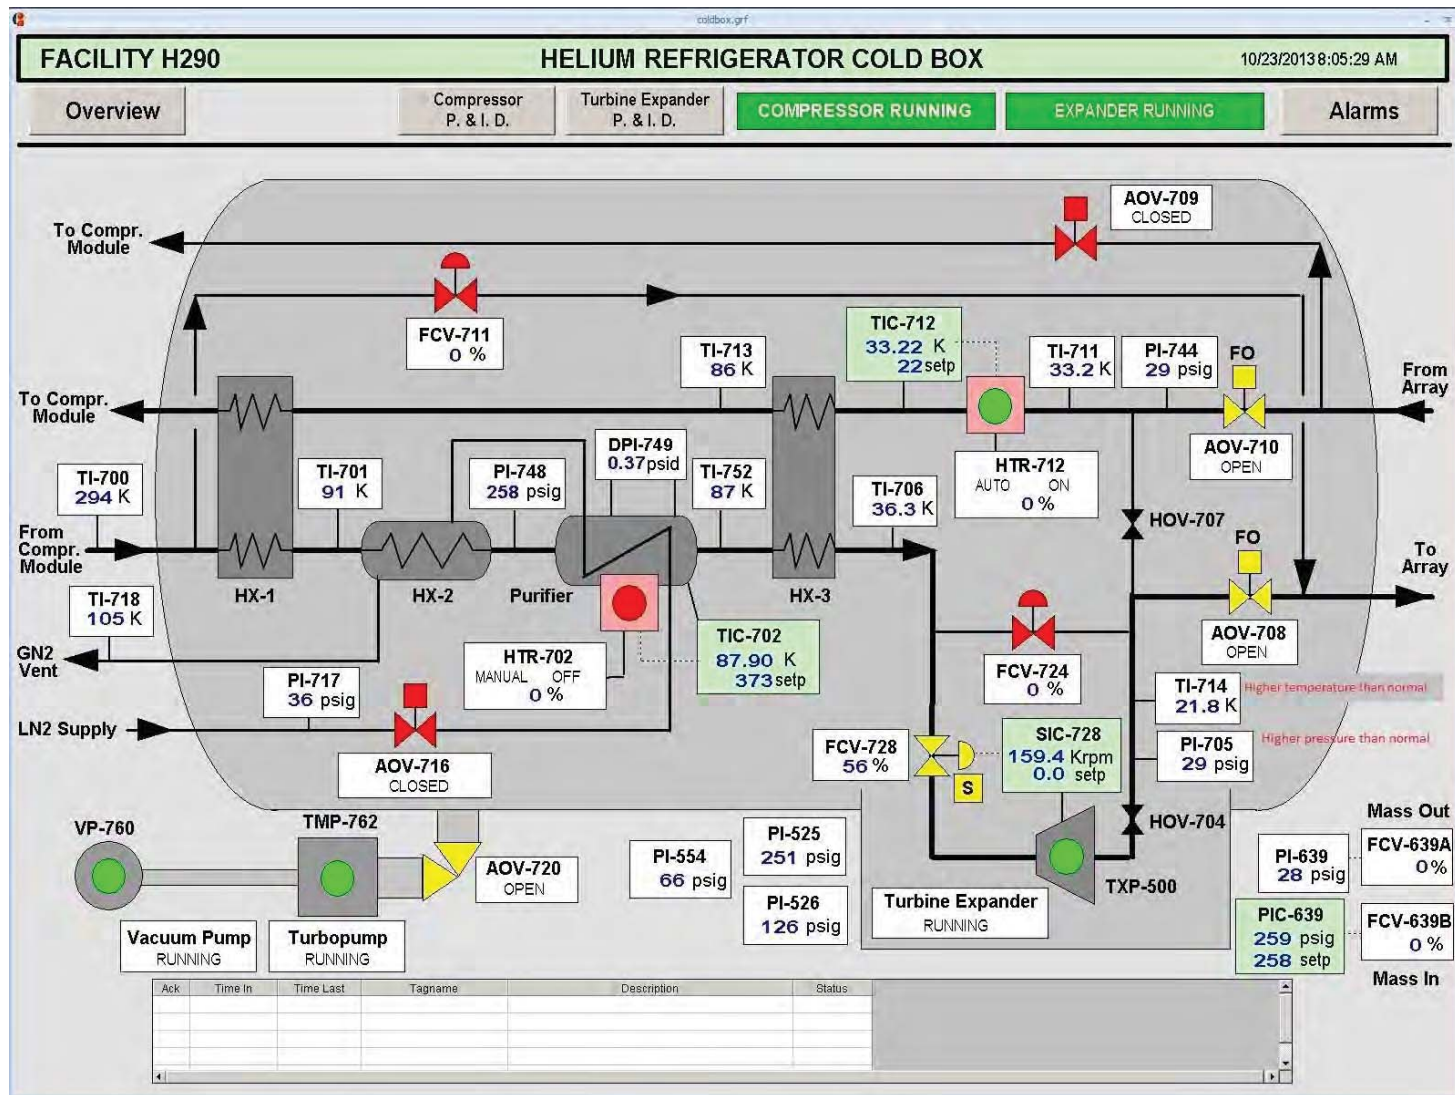
# Helium Skid Issues #3: Unable to achieve 20K on refrigerator due to compressor loading mechanism malfunction
