# Buckling of a Longitudinally Jointed Curved Composite Panel Arc Segment for Next Generation of Composite Heavy Lift Launch Vehicles: Verification Testing and Analysis

Babak Farrokh\*, Aerospace Engineer – NASA Goddard Space Flight Center

# Overview

The objective of this work was to exercise an out-of-autoclave all-bonded joint design concept for a Space Launch System (SLS) fairing during the Composites for Exploration (CoEx) effort

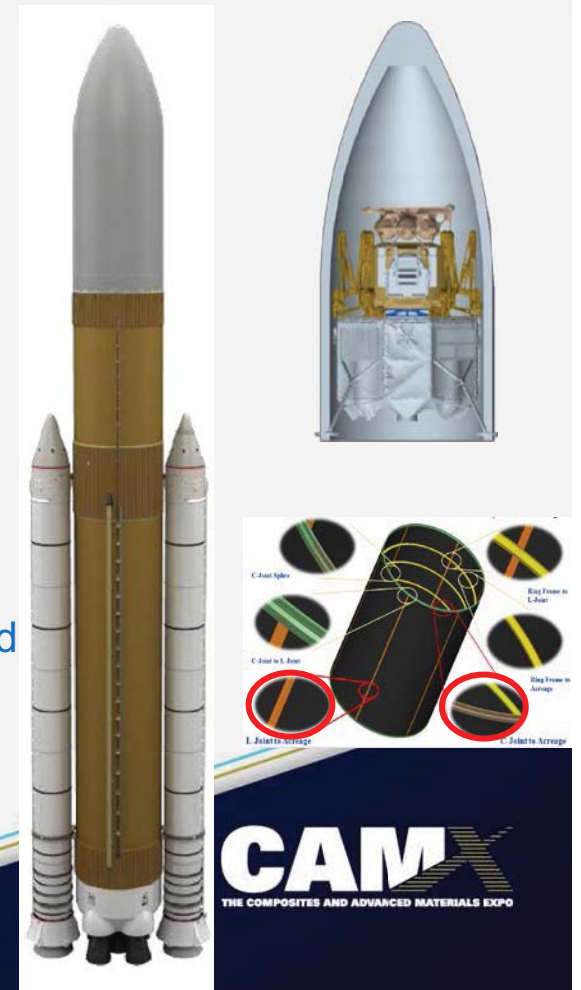
- Report the buckling test and analysis correlation results for the 54" x 29" CoEx IM7/977-3 jointed panel. The analyses include:
  - Pre-test analyses to obtain a baseline buckling load and the stress state
  - A trade study to look at design changes to lower the panel ends/corners stresses
  - Correlating the buckling test data:
    - Using linear vs. non-linear analysis
    - Investigating surface (shape) imperfections on the jointed panel buckling behavior
- Present a summary results of the damaged jointed panel buckling and edge-supported compression tests, and to discuss the next steps to correlate the observed behaviors

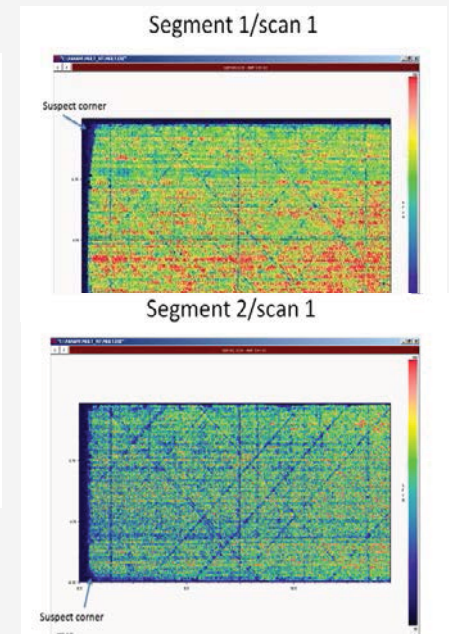
- The parent material:
  - The Hitco demonstration HC sandwich panel, 1/16<sup>th</sup> arc segment of 33-ft diameter cylinder, made under the CoEx program
    - 8-ply  $[45^\circ/90^\circ/-45^\circ/0^\circ]_s$  face-sheets (IM7/977-3) with 1 in thick 3.1 pcf Al honeycomb core

Note: The final trimming reduced the overall size of the “jointed panel” to 52 in. x 27.8 in. (The panel still to be referred to as 54 in x 29 in)

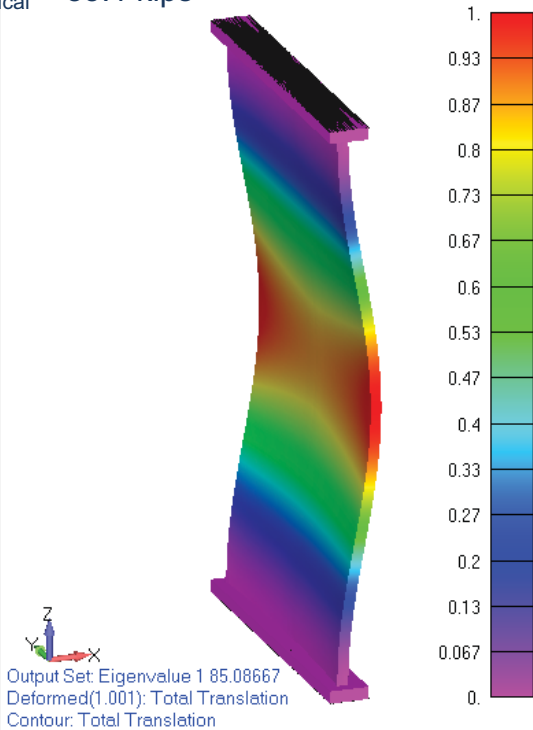
Euler eigenvector buckling contour

$P_{critical} = 85.1$  kips

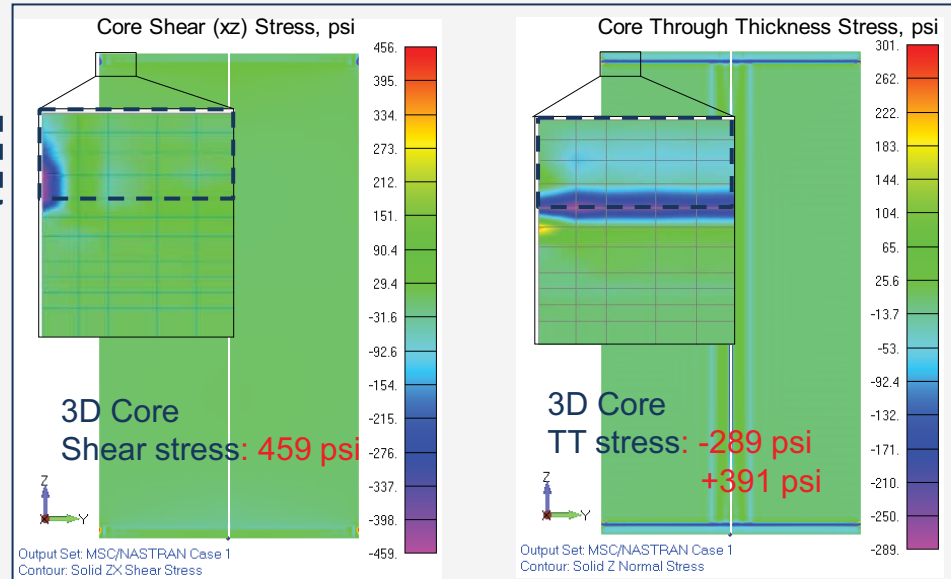
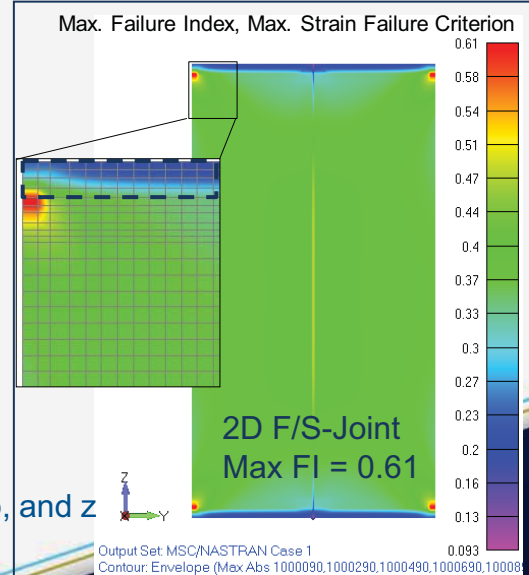
- Stress concentration in F/S and core at ends/corners
- FI = 1 indicates failure

## Hexcel Core Stress Allowables:

Shear (xz): ~145 psi

Compressive stabilized strength:

215 (min) - 300 (typ) psi

Crush strength: 130 psi

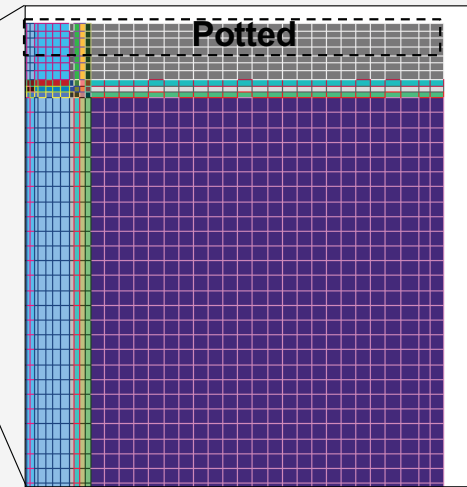
- Plain weave
- A 4-ply laminate
- Co-bonded to panel at same time as joints

2.5 in Wide Doubler

End frame is not shown

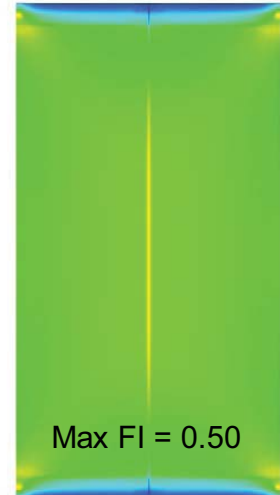
with Stress Relief Features (only)

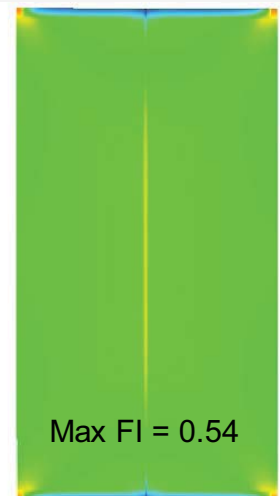
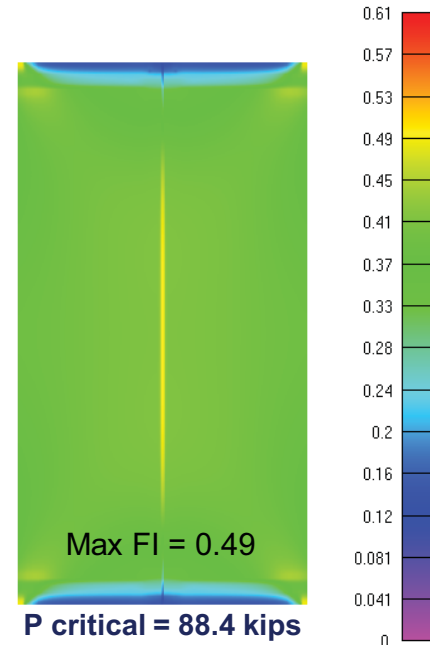
Failure Index Contour, Max. Strain Failure Criterion  
with End-doublers and Stress Relief Features

**Selected Design**

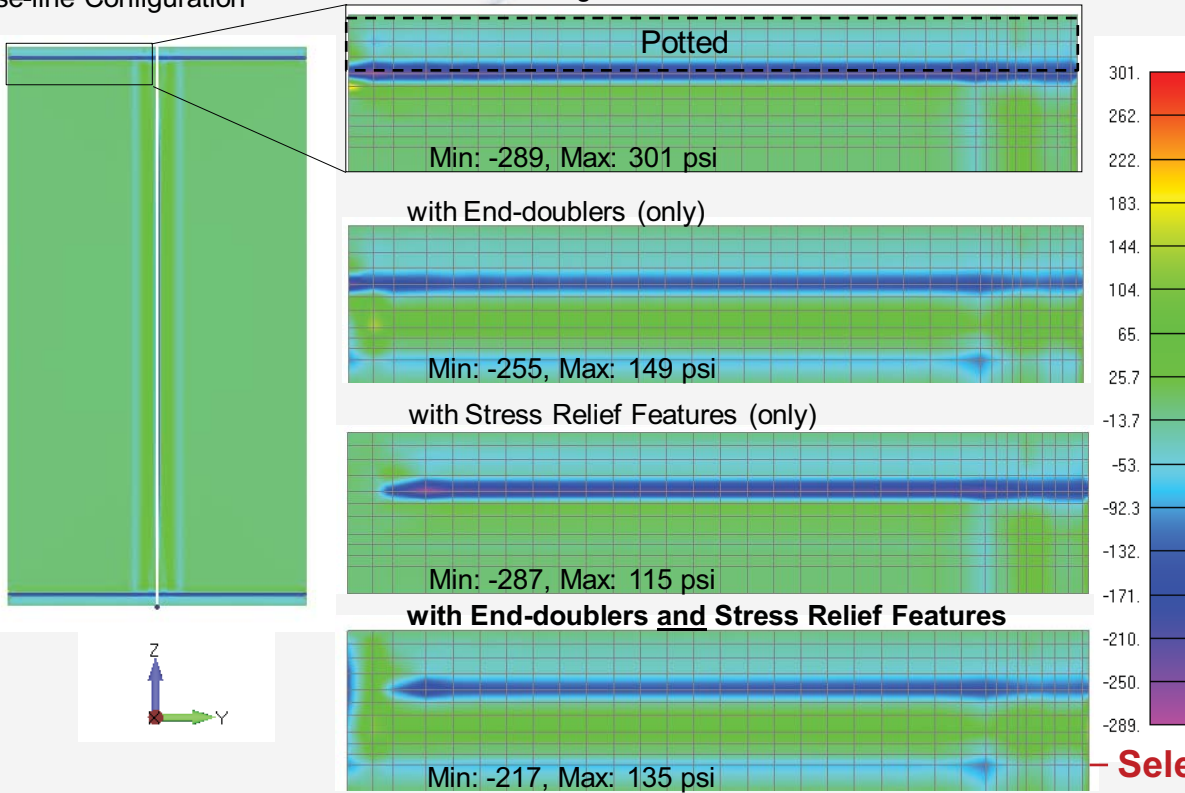
Core Through Thickness Stress at Panel Ends, psi  
Base-line Configuration

← P critical = 85.1 kips

← P critical = 88.7 kips

← P critical = 84.9 kips

← P critical = 88.4 kips

← Selected configuration

Configuration	SOL 105 Buckling Critical Load (kips)	Face-Sheet and Joint Honeycomb Out-of-Plane Stresses, psi			
		Max. FI	Min $\sigma_z$	Max $\sigma_z$	$ \tau_{zx} $
Base-line	85.1	0.61	-289	301	459
with End-doublers	88.7	0.50	-255	149	478
with Stress Relief Features	84.9	0.54	-287	115	101
<b>with End-doublers and Stress Relief Features</b>	<b>88.4</b>	<b>0.49</b>	<b>-217</b>	<b>135</b>	<b>75</b>

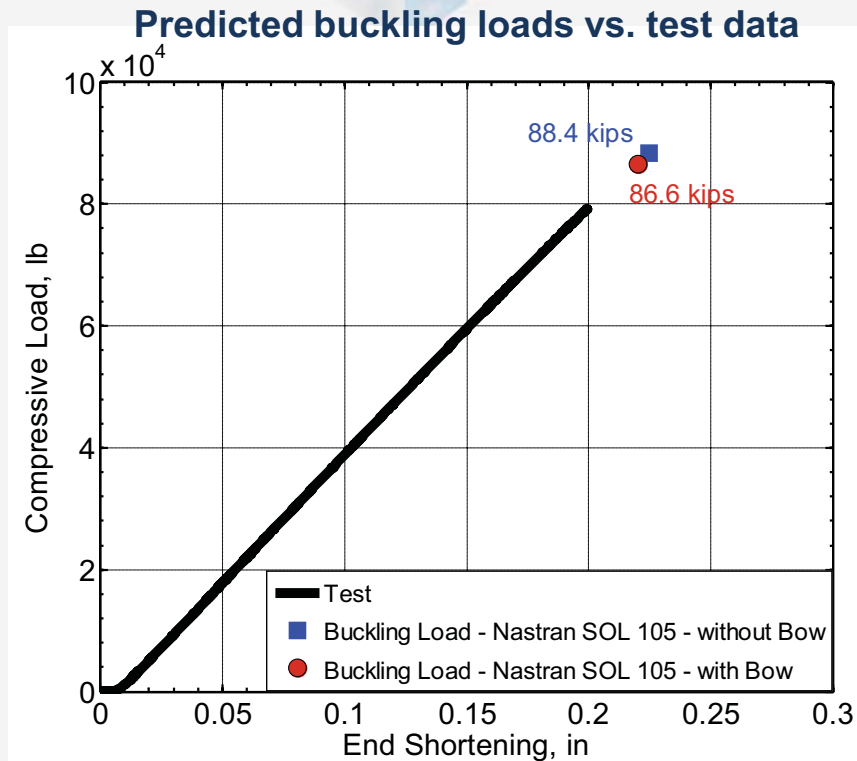
NASTRAN linear SOL 105 Euler eigenvector buckling contour

- ~11% over predicting the buckling load when surface imperfections are not included
- ~8% over predicting when the surface imperfections are included
- ~4% difference in stiffness between test and analysis

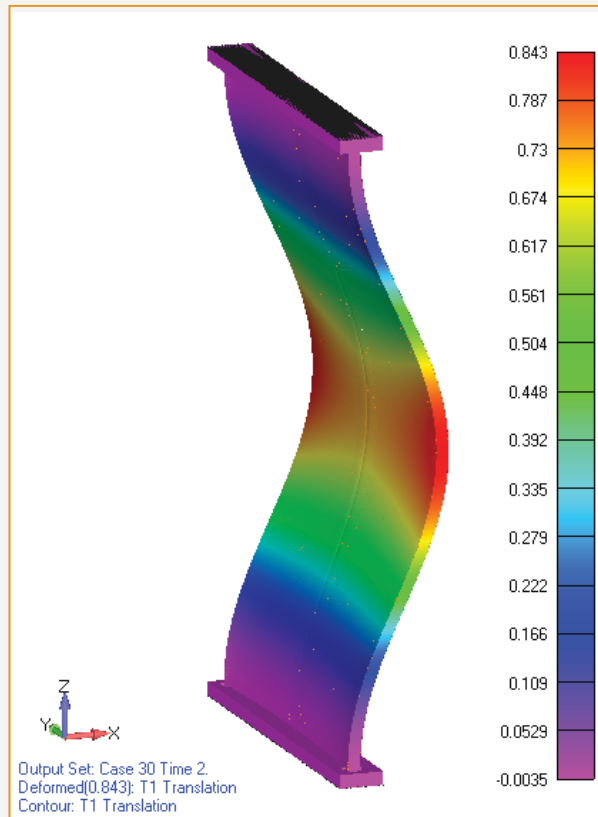
Surface imperfection NOT included in FEM

Panel buckles towards OML

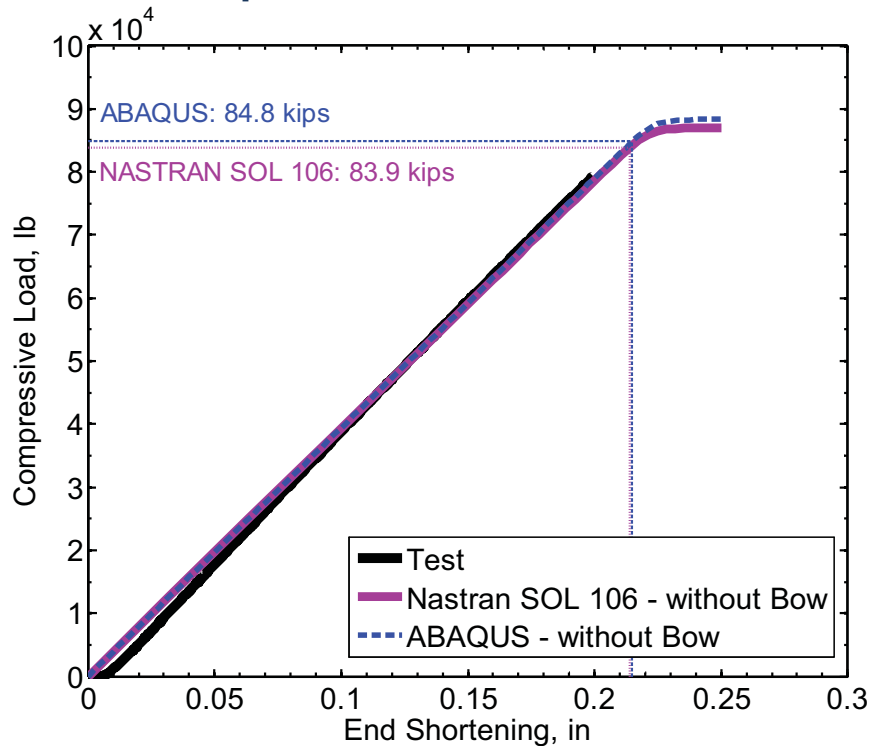
Surface imperfection **NOT** included in FEM

- Critical buckling load decreases as a result of including the surface Imperfections
  - From within 5% the test value to about 2%

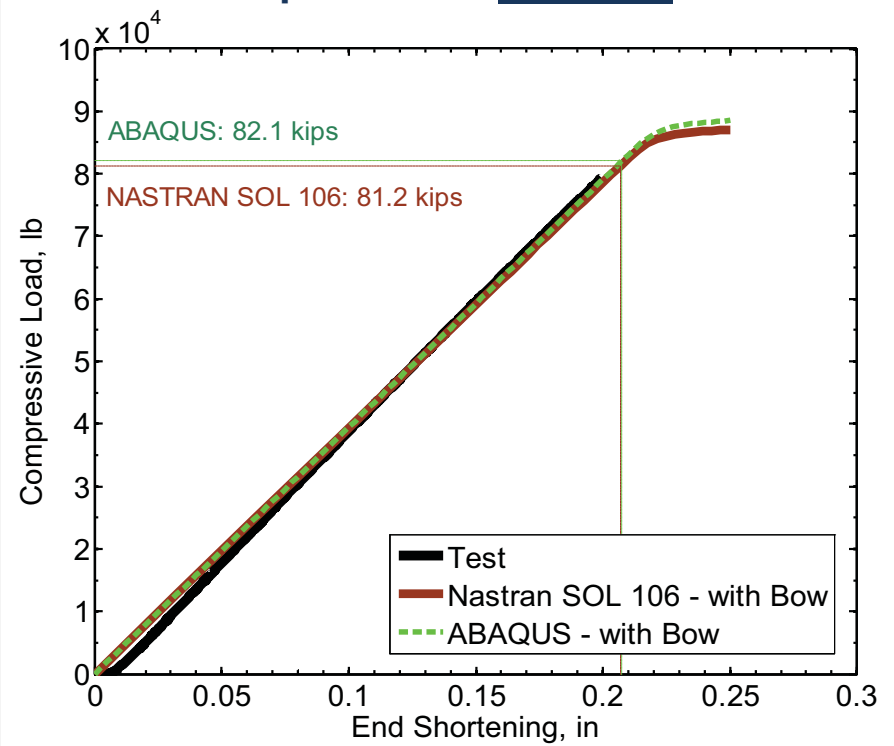
Surface imperfection included in FEM

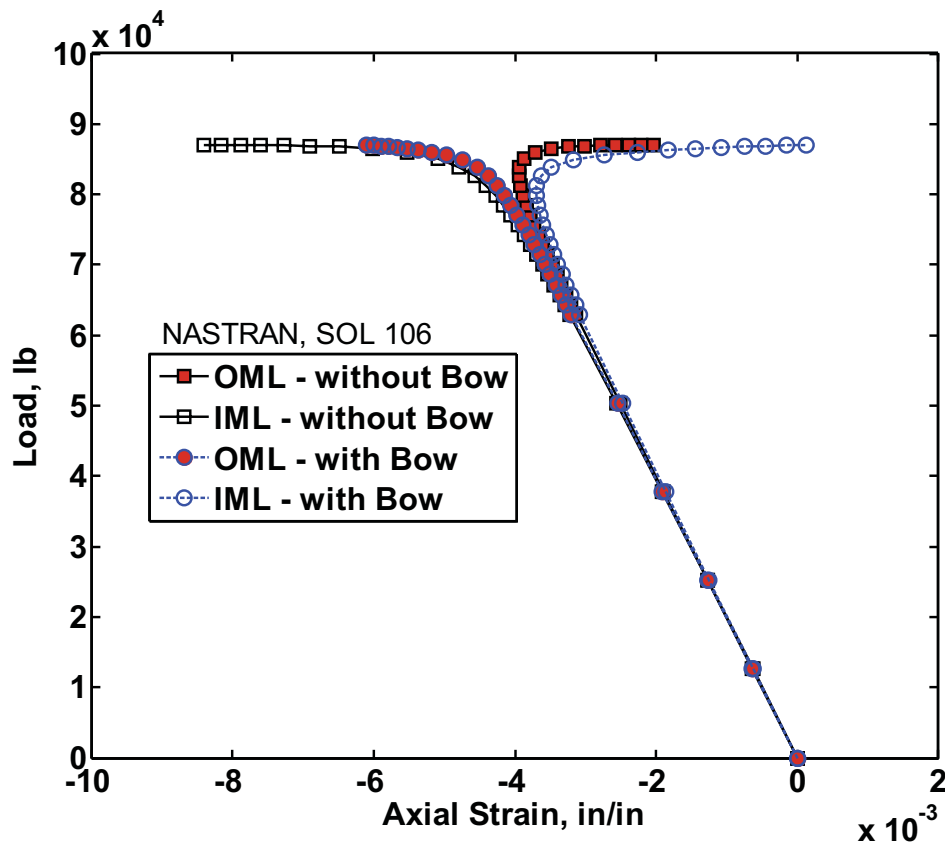
Back-to-back  
2D elements

Monitoring back to back elements' axial strains, in the panel's middle edge to determine the onset of buckling analytically – Analogous to what determines when the buckling event has occurred during the experiment, prior to unloading the panel, without cartographically failing the specimen.

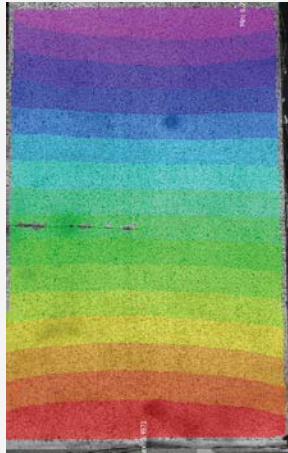
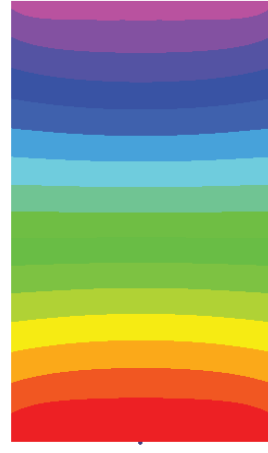
Test correlation at buckling load of ~79.3 kips

OML VIC Results

OML FEA Results

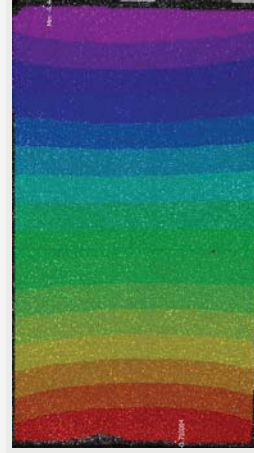
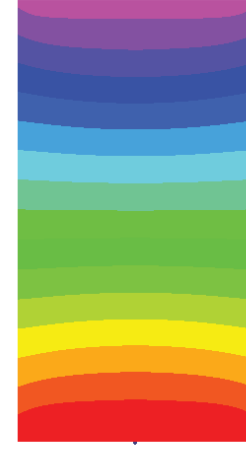
Test correlation at buckling load of ~79.3 kips

IML VIC Results

IML FEA Results

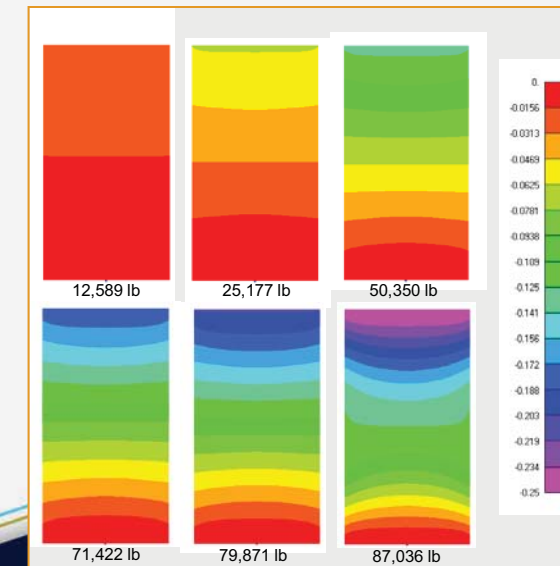
Buckling/ post buckling analysis results

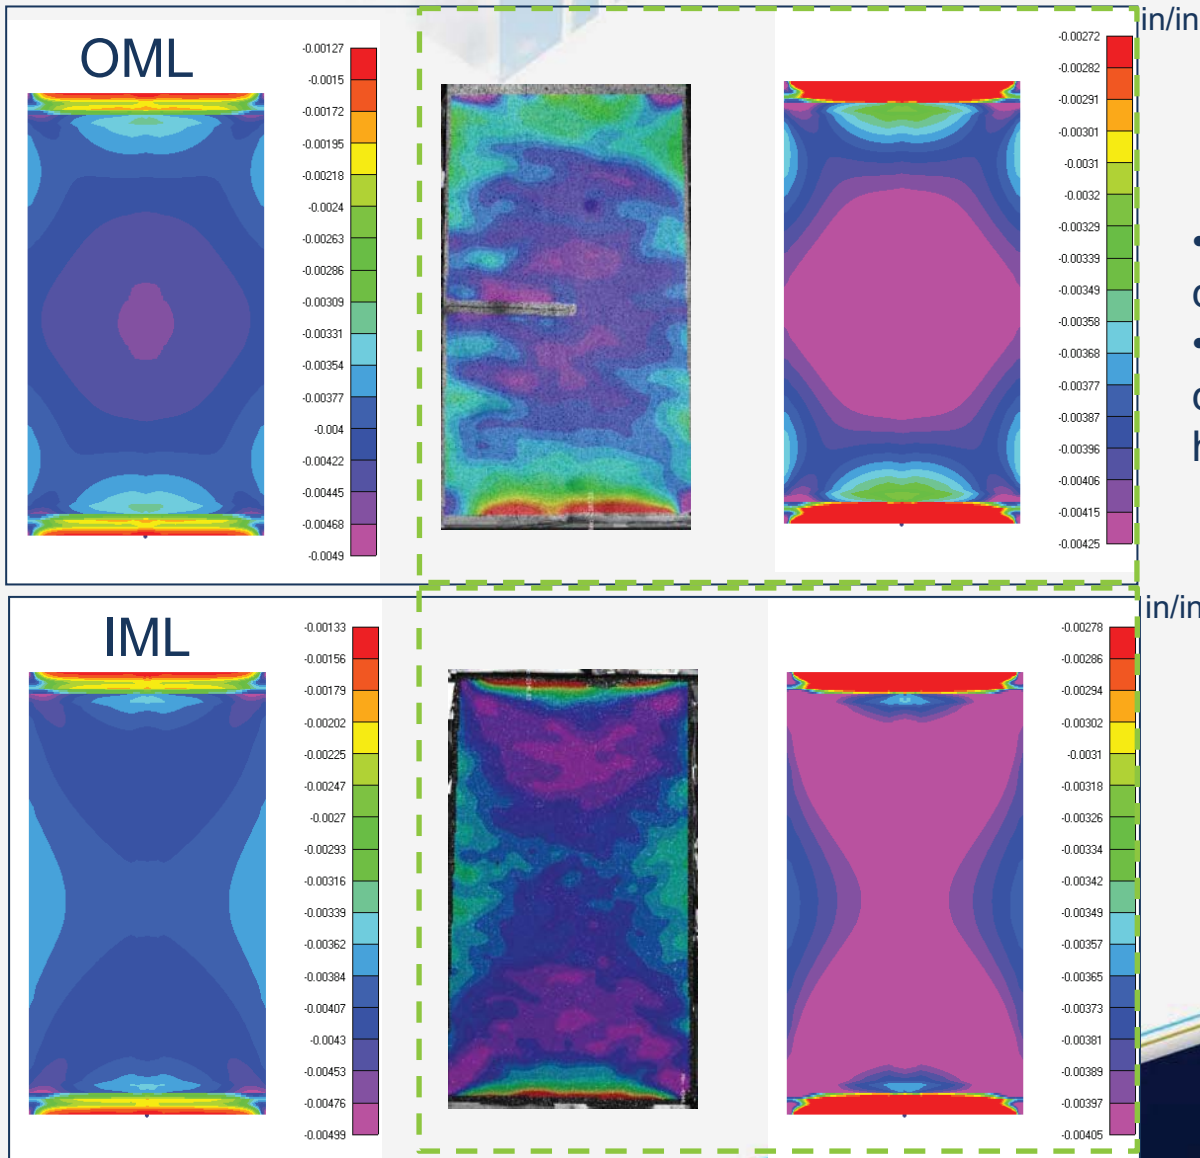
Test correlation at buckling load of ~79.3 kips

- Qualitative and qualitative comparison
- The ~4% stiffness difference causes the FEA to show slightly higher axial strains

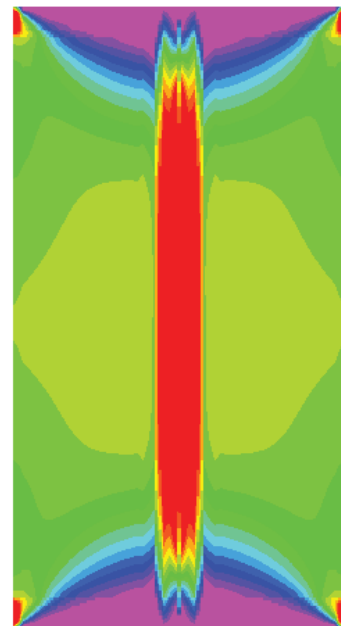
Test correlation at buckling load of ~79.3 kips

OML VIC Results

OML FEA Results

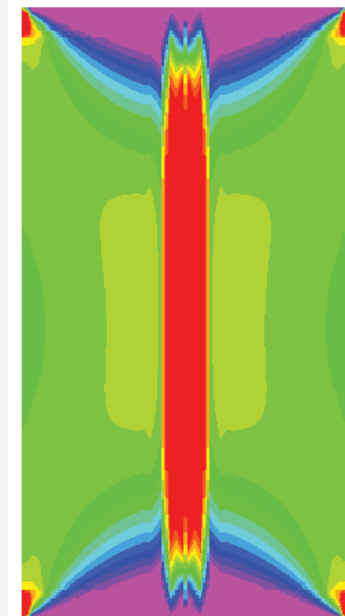
Test correlation at buckling load of ~79.3 kips

IML VIC Results

IML FEA Results

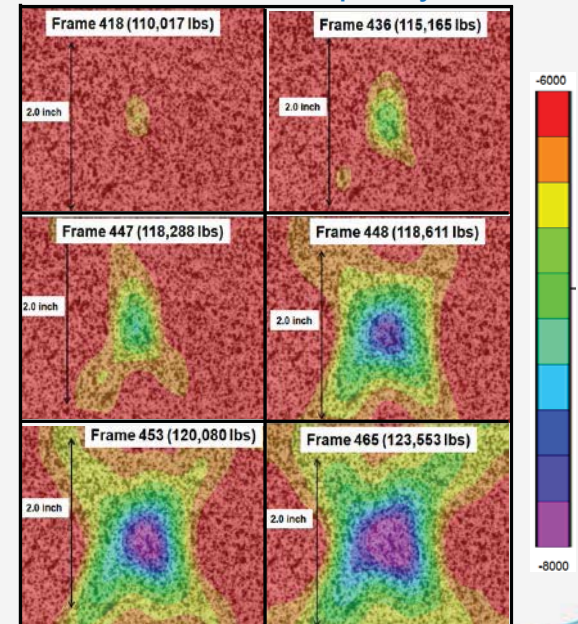
The evolution of impacted damage with compressive load; the axial VIC strain at different loads/frames
