NASA/TM—2014-216615

# Burst Testing of Triaxial Braided Composite Tubes

Applications using triaxial braided composites are limited by the materials transverse strength which is determined by the delamination capacity of unconstrained, free-edge tows. However, structural applications such as cylindrical tubes can be designed to minimize free edge effects and thus the strength with and without edge stresses is relevant to the design process. The transverse strength of triaxial braided composites without edge effects was determined by internally pressurizing tubes. In the absence of edge effects, the axial and transverse strength were comparable. In addition, notched specimens, which minimize the effect of unconstrained tow ends, were tested in a variety of geometries. Although the commonly tested notch geometries exhibited similar axial and transverse net section failure strength, significant dependence on notch configuration was observed. In the absence of unconstrained tows, failure ensues as a result of bias tow rotation, splitting, and fracture at cross-over regions.

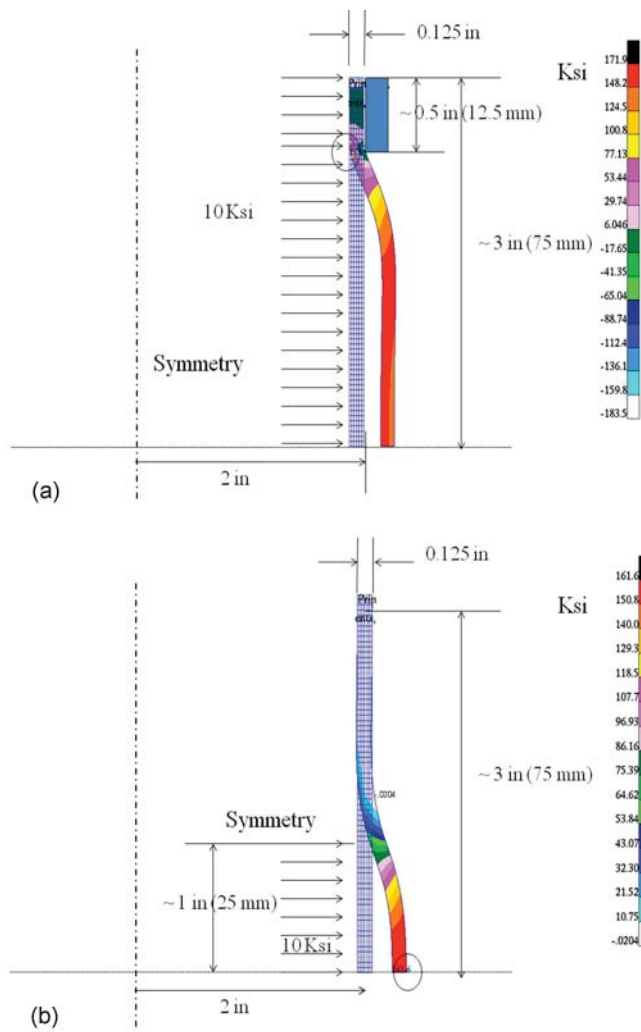
Figure 1.—Maximum principal stresses for (a) constrained edge and (b) free edge conditions.

Because of the large displacements associated with high strength, low stiffness materials such as polymer composites ( $S_f = 120$  ksi,  $E = 7 \times 10^6$  psi), containment of the polymer plug was of concern. Thus tube pressurization in combination with and without edge constraint was considered. Finite element analysis (FEA) results are shown in Figures 1 and 2. Edge constraint proved difficult due to the sharp transition between constrained and unconstrained regions. Thus simple pressurization over a short region ( $\sim 1/3^{\text{rd}}$ ) via a low durometer insert was pursued. For this case, a peak hoop stress occurs about the centerline and is accompanied by a small axial stress. For practical purposes, all stresses at the free edges are zero, as shown in Figure 2.

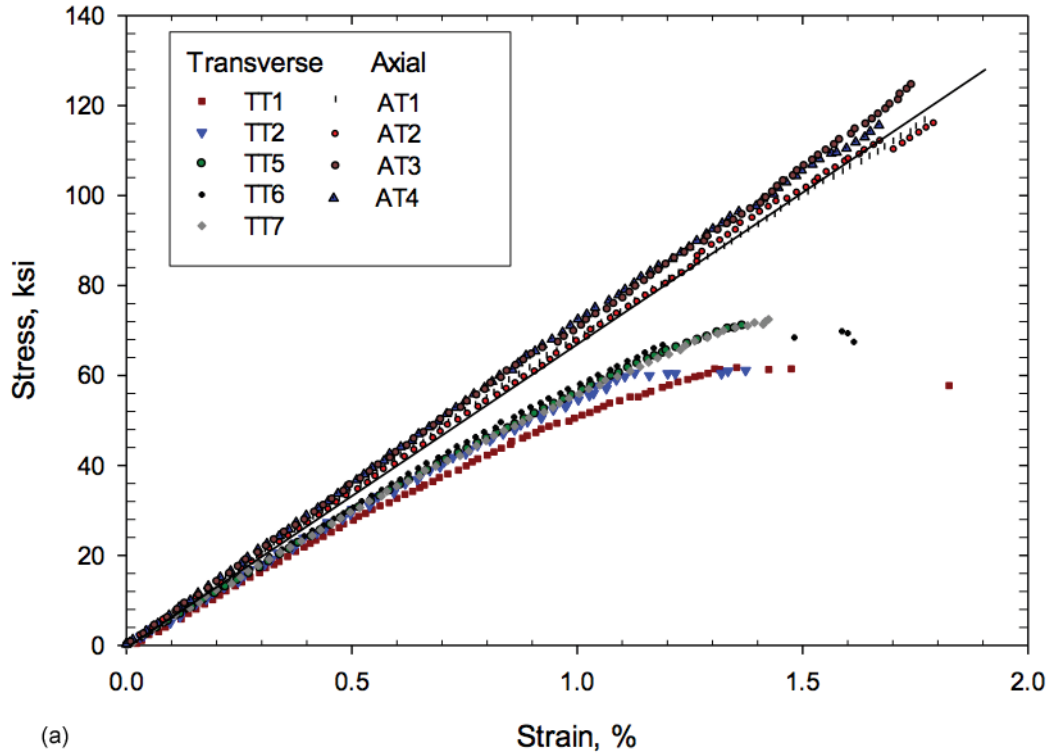
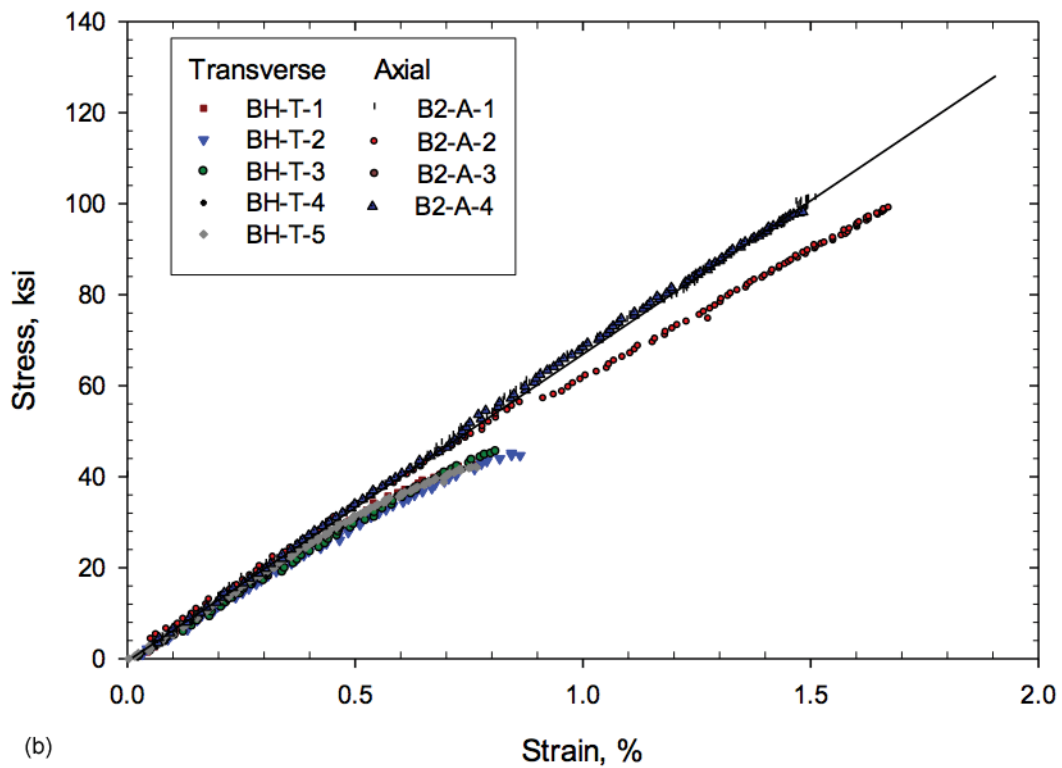
Figure 8.—ASTM D3039 axial and transverse global stress-strain curves for (a) T700S/E862 and (b) T700S/5208.

Axial and transverse, macro-level stress-strain curves are shown in Figure 8 for T700S/E862 and / 5208. For transverse loading, nonlinear extension occurs at  $\sim 0.5$  percent strain and  $\sim 25$  percent of the ultimate axial strength. A linear regression fit range of  $0.5$  percent, which was larger than that used previously ( $0.2$  percent, (Ref. 1)), provided more consistency in Poisson's ratio and met reciprocity requirements ( $\nu_{12}/E_{11} = \nu_{21}/E_{22}$ ) with  $E_{11} = 6.95 \times 10^3$  ksi,  $\nu_{12} = 0.34$ ,  $E_{22} = 6.03 \times 10^3$  ksi, and  $\nu_{21} = 0.30$ , as shown in Table 2.

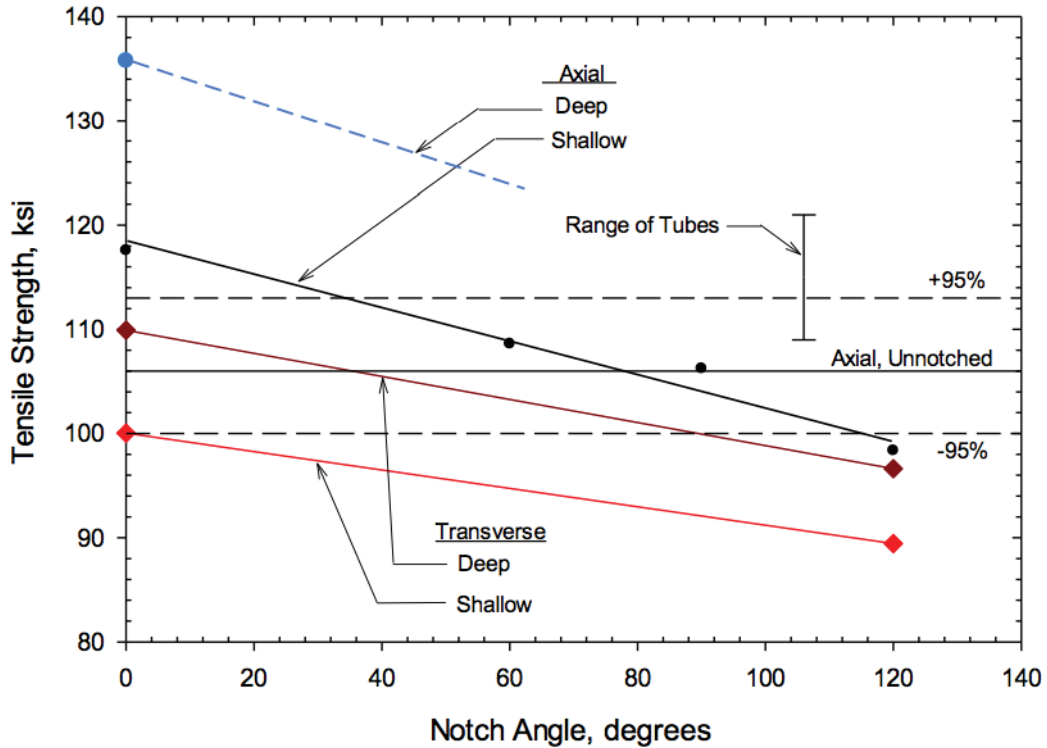
Figure 9.—Uniaxial net section strength as function of notch angle and depth for T700S/5208.

T700S/5208 exhibited less nonlinear extension prior to failure and lower fracture strength. The effects of notch angle and depth are shown in Figure 9, and imply that net section strength decreases with increasing notch angle for transverse and axial orientations. For transverse orientation, large angles cut bias tows thereby resulting in less length of bias tows through which load can be transmitted, and less shielding, via surrounding material, of tows that do carry load through the ligament. Interestingly, shallow notches exhibit lower strength than deep notches again implying that additional material to the side of a tow shields the loaded tow: unsupported tows running along a free edge (e.g., 60 notch) are weaker.

Tube data for T700S/5208 is summarized in Table 4. Figure 9 implies that deep notches ( $2a/W = 0.8$  with  $\theta = 0^\circ$  to  $60^\circ$ ) give the most comparable results to tubes for the current architecture. Clearly, notched specimens show systematic dependence on notch depth and angle for both transverse and axial orientations. It is noteworthy that both the strongest notched specimens and the tubes that presented testing difficulty due to plug extrusion exhibited nominal stresses of 140 ksi, implying that tube strength can be improved. More study of notched geometry effects is needed with various epoxies to give specific recommendations.

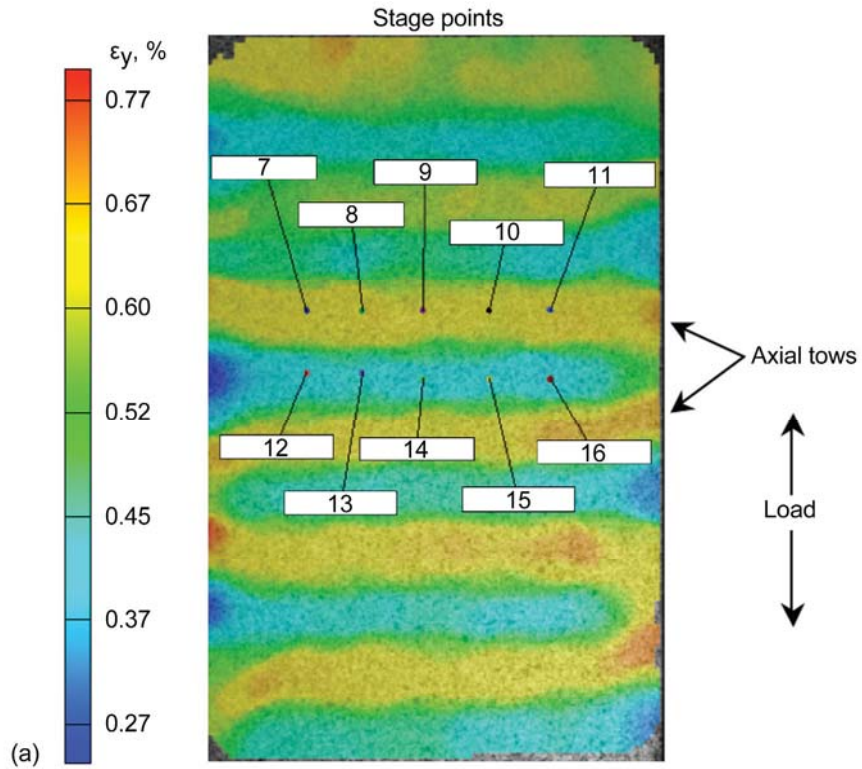
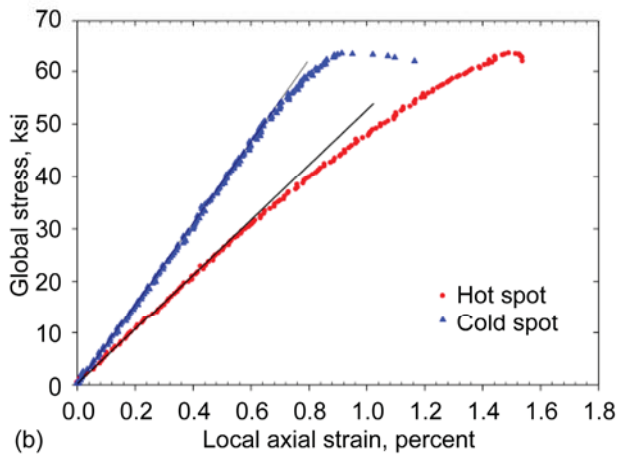
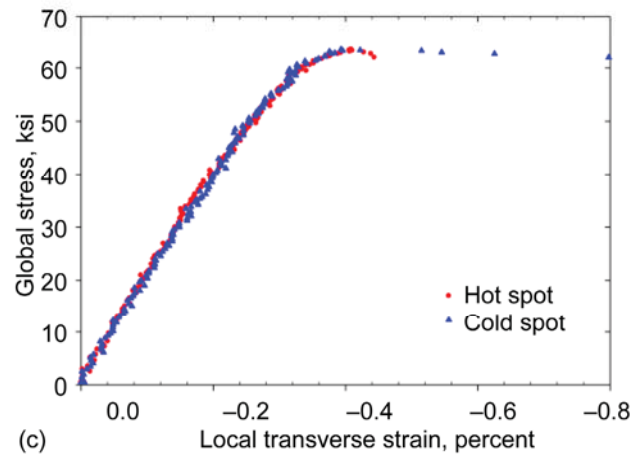
Figure 11.—Strain banding at 32 ksi (a) and correspond axial (b) and transverse (c) stress-strain curves for the high and low strain regions of a T700/5208 transverse tensile test.

Noteworthy for unnotched transverse specimens is the strain banding shown in Figure 11. These local strain concentrations and the applied stress were used to estimate local, effective elastic Young's modulus and Poisson's ratio. These *in situ* measurements gave  $E = 7.74 \times 10^3$  ksi and  $\nu = 0.41$  for the low strain regions between 0° tows and  $E = 5.11 \times 10^3$  ksi with  $\nu = 0.25$  in the high strain regions corresponding to tows. This is  $\sim \pm 10$  percent from the macro-level modulus values. Non-linear strains are exhibited in high strain regions at about two-thirds the applied stress required to create non-linearity in the low strain regions, and the equality of transverse strains implies good compatibility between regions, Figure 11(c). For the axial tests, banding is less apparent and the macro values are representative.

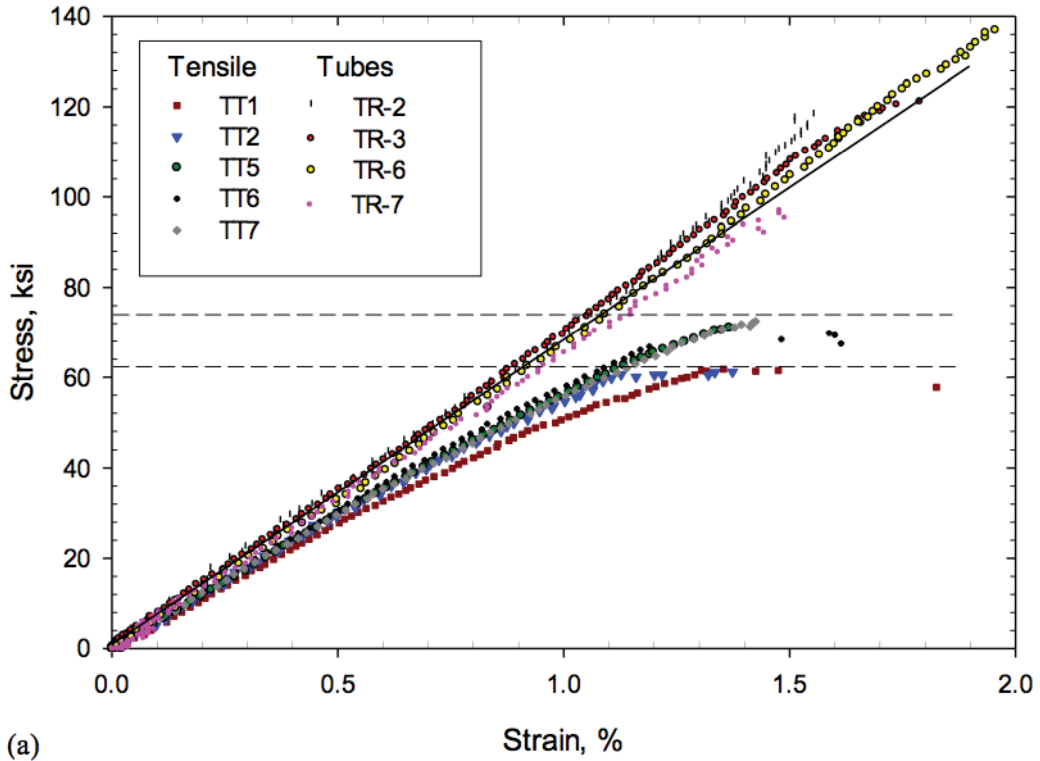
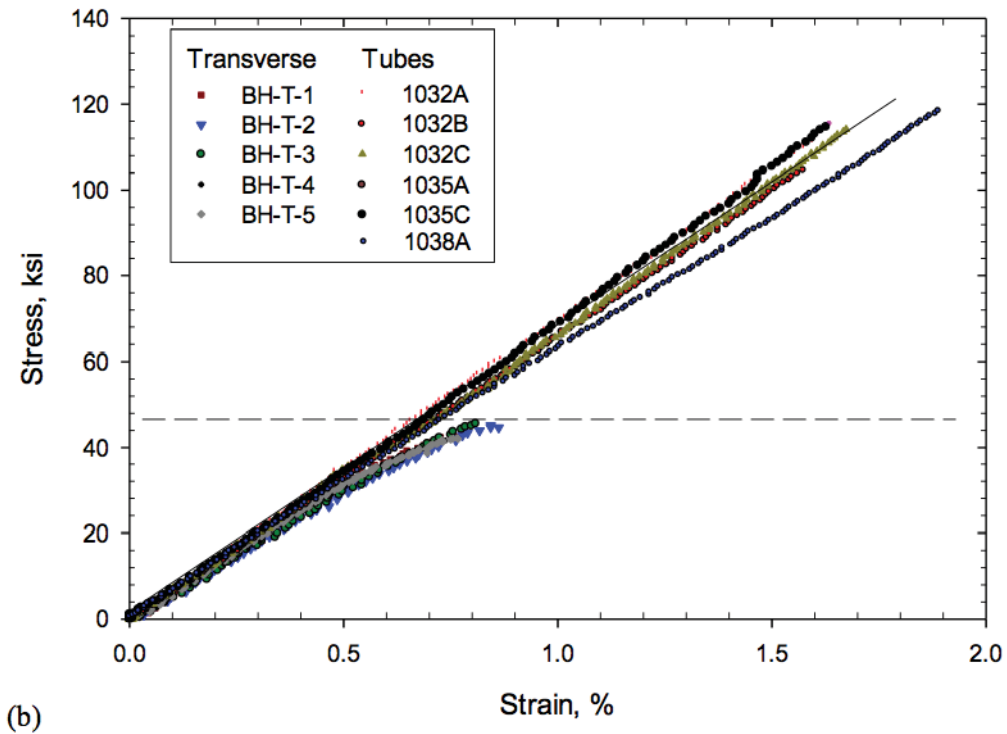
Figure 13.—Strength-of-materials stress for (a) T700S/E862 and (b) T700S/5208 as a function of strain for pressurized axially-woven tubes and ASTM D3039 transverse tensile specimens.

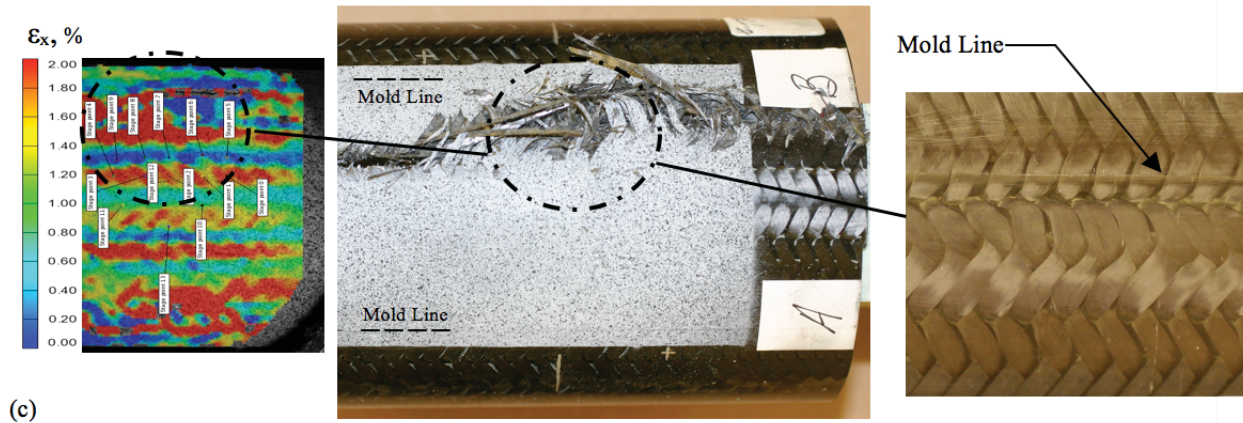
Figure 14.—(a) Stress-strain curves for T700S/E862 tubes with (b) damaged (TR-5 at 34 ksi) and (c) distorted fibers at mold lines (TR-9 at 89 ksi).

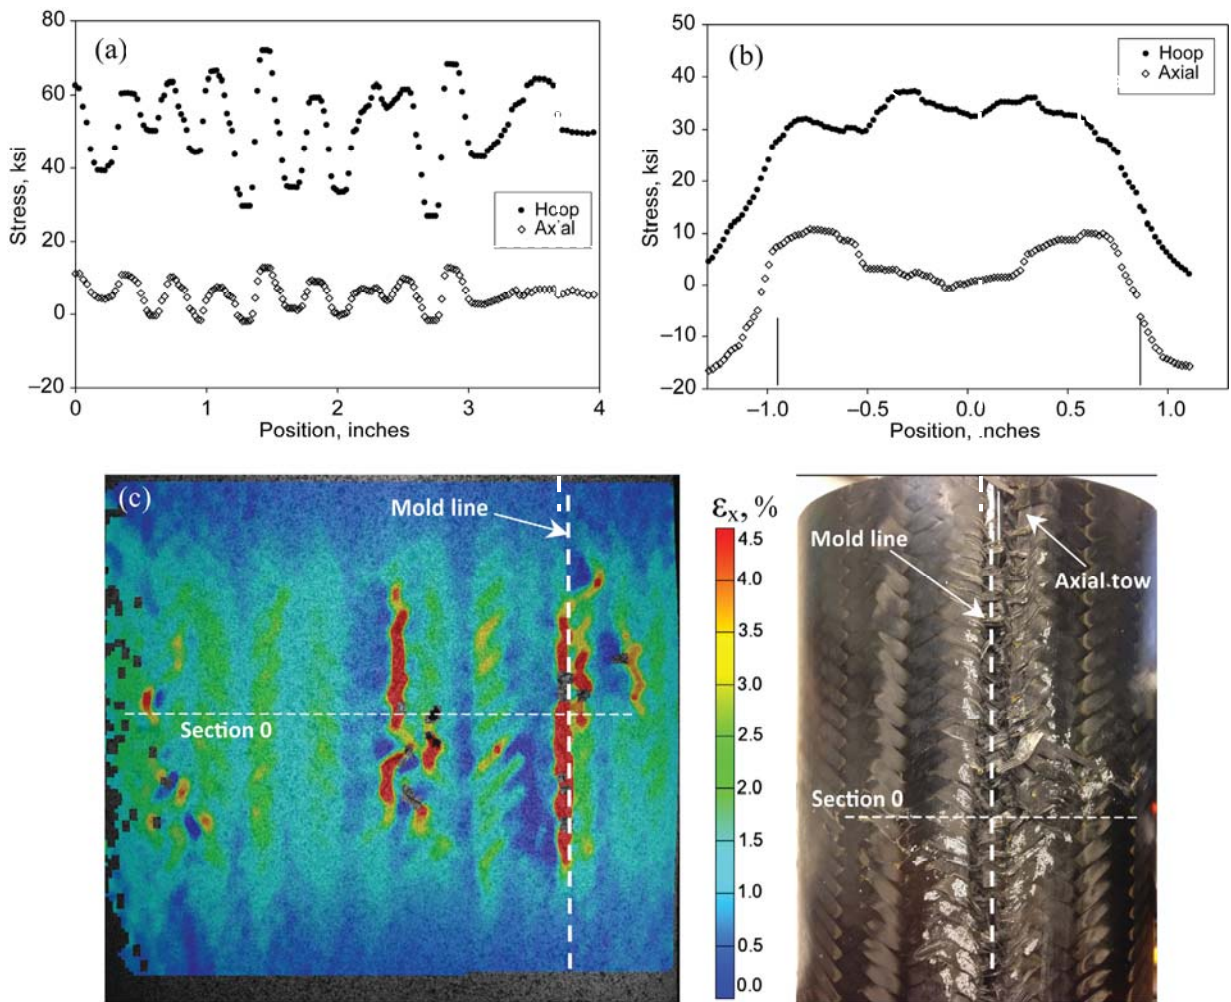
Figure 16.—Strength-of-materials stress variation in a T700S/E862 pressurized tube (TR-3) along (a) tube circumference, (b) tube longitudinal axis at a SOM stress of 52 ksi, (c) strain variation at 104 ksi, and (d) burst tube.

Due to the coarse architecture and associated stiffness variations, the axial overbraided tubes exhibit substantial strain variation in the hoop direction for any axial position, as shown in Figure 16, with high strains corresponding to axial tows, and overall agreement with Figure 3. As pressure increases, specific axial tows exhibit large surface strains (~5 percent) that persist until failure. At relatively high pressures, regions initially exhibiting low hoop strain in axial tows develop significant hoop strain (~4 percent) in the pattern of the bias tows. Thus the choice of location and size of the strain gage can affect interpretation of results. In order to estimate the stress and strain distributions and variations during the failure process, strain measurements were averaged for multiple “hot” and “cold” regions.

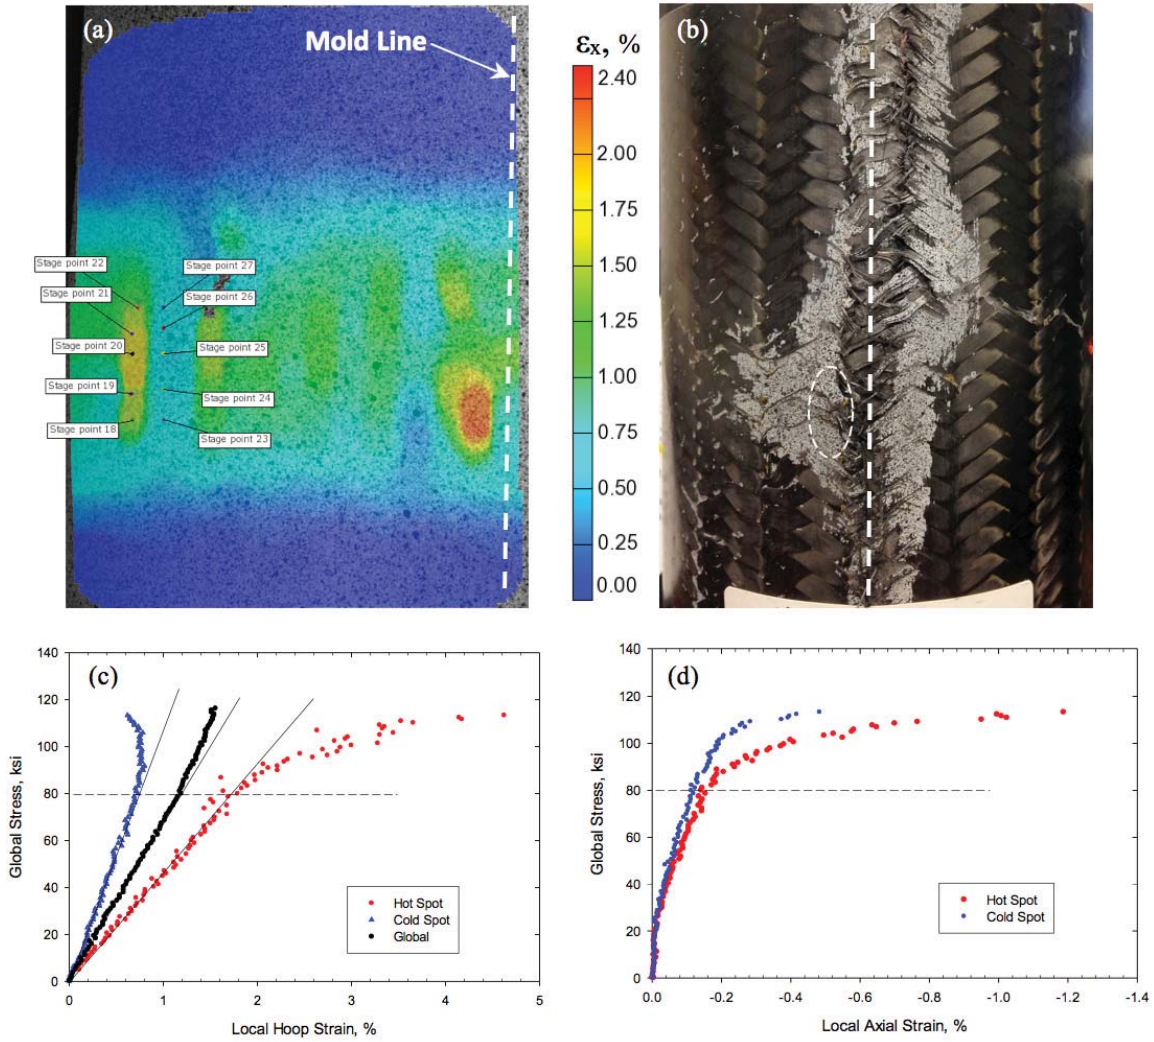
Figure 17.—Stress as a function of strain for high and low strain regions of a T700S/E862 pressurized tube (TR-2): (a) local strain gages and high strain region near mold line at 72 ksi, (b) failed tube, (c) hoop ( $\epsilon_x$ ) strain, and (d) axial ( $\epsilon_y$ ) strain).

As shown in Figure 17, substantial nonlinear extension occurs prior to failure in some regions, and the strains at axial tows are more than double those between tows, Figure 17(a). Once the axial tows exhibit non-linear strain, which occurs simultaneously in hoop and longitudinal directions at ~2 percent hoop strain, the bias tows shed hoop strain while increasing longitudinal strain, Figure 17(b). Thus the axial tows shed load to the bias tows as failure ensues and the system globally stiffens. The bias tows in a tube can take extra load because they are contiguous. Figures 8 and 17 imply that the ultimate strength and the onset of damage are significantly improved relative to transverse uniaxial loading, with the onset of nonlinear behavior occurring at ~75 percent of ultimate for T700S/E862. The global stiffening might be used as an indicator of localized damage.
