42nd Aerospace Mechanisms Symposium

Development Testing and Subsequent Failure of a Spring Strut Mechanism

Jared Dervan (NASA MSFC)
Brandan Robertson (NASA JSC)
Lucas Staab (NASA GRC)
Michael Culberson (LMSSC)
Joseph Pellicciotti (NASA GSFC)

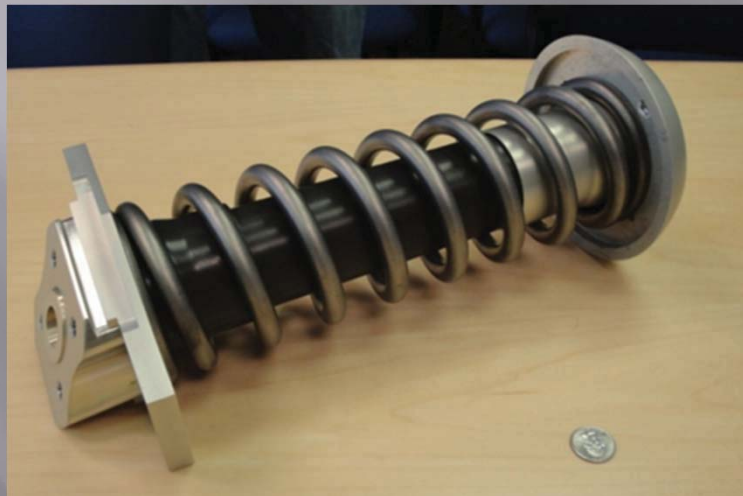
SAFJS Assembly

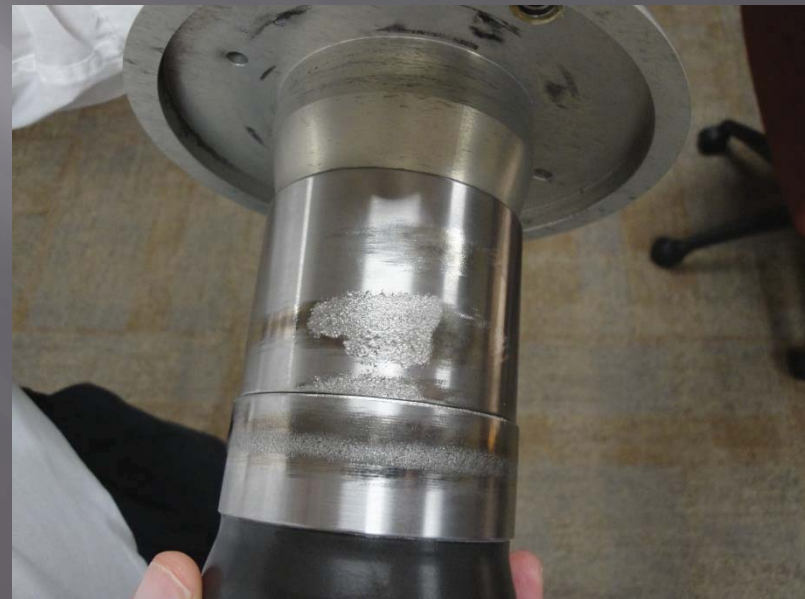
- **Background (contd.)**
 - Problems discovered on other Orion spring assemblies during vibration testing (e.g. Spacecraft Adapter Fairing Jettison Spring (SAFJS) Assembly)

SAFJS Assembly Wear Post Vibration Testing

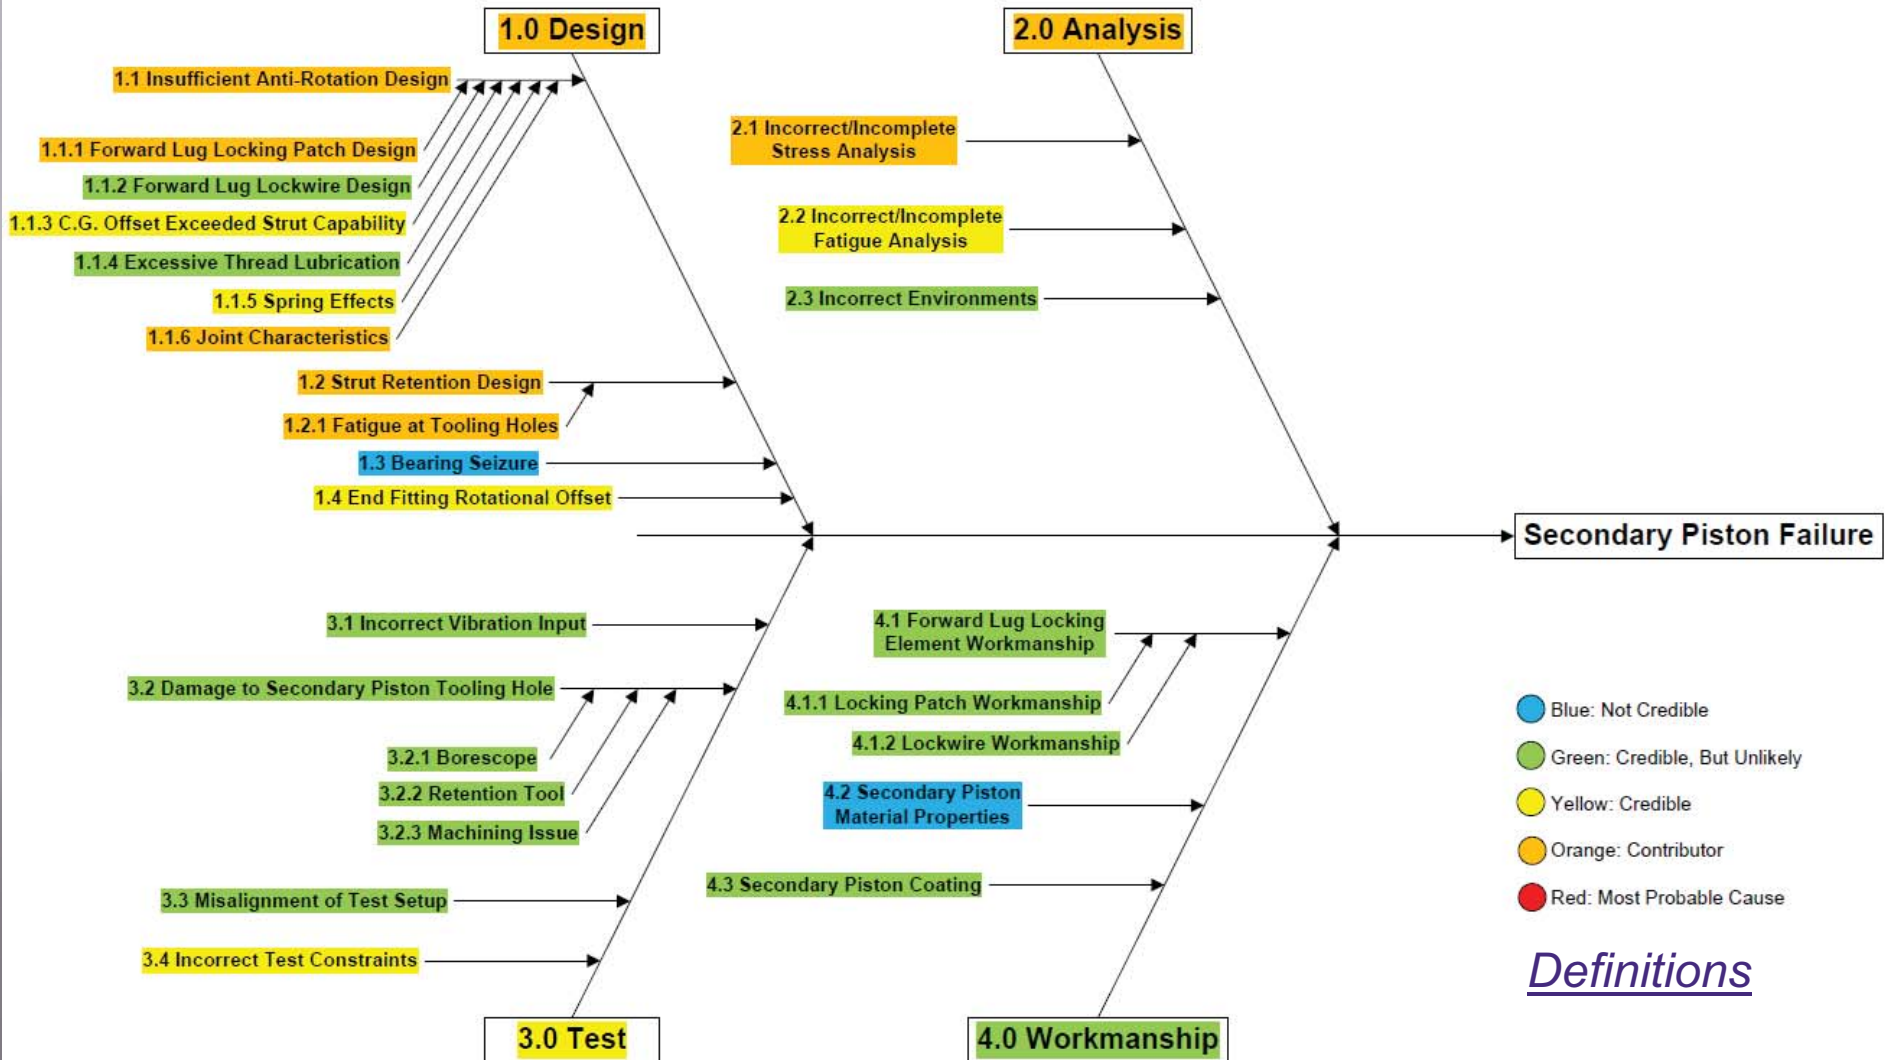
Fishbone

- 1.1.1 Forward Lug locking patch design
- 1.1.6 Joint characteristics
- 1.2.1 Fatigue at tooling holes
- 2.1 Incorrect/incomplete stress analysis

- 1.1.3 C.G. offset exceeded strut capability
- 1.1.5 Spring effects
- 1.4 End fitting rotational offset
- 2.2 Incorrect/Incomplete fatigue analysis
- 3.4 Incorrect test constraints

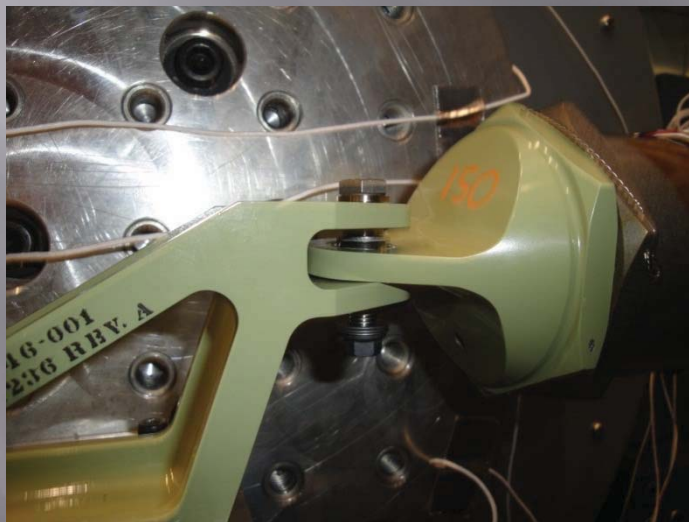
1. Rotational misalignment cause contact at end fittings
2. Inertial forces due to strut C.G. offset result in off-axis contact force
3. Induced force results in loosening torque
4. Torque exceeds resistive capability of joint
5. Lockwire breaks; rotation until C.G. offset aligns with applied force vector
6. Secondary piston tooling holes placed in maximum bending
7. Fatigue failure at secondary piston tooling hole

Rotational Misalignment (Aft Cap)

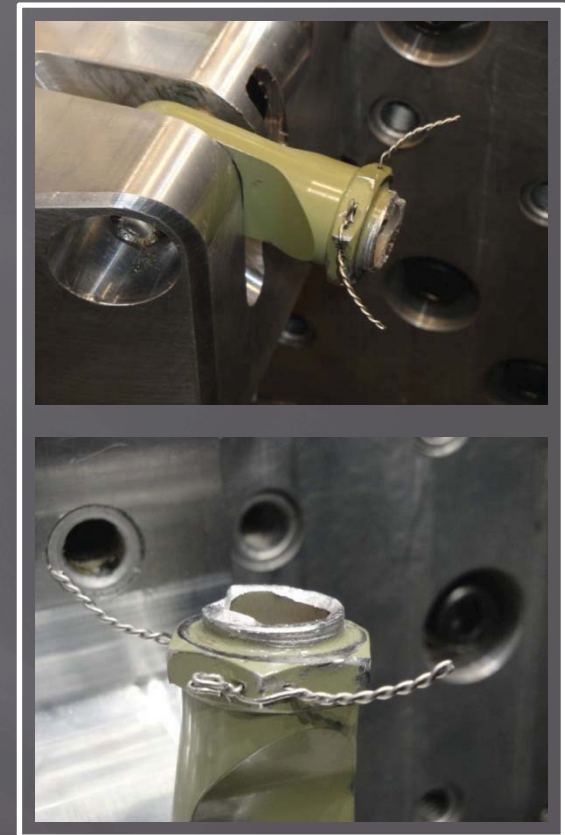
2nd Development Test: Forward Lug
Fatigue Failure

- Due to resource constraints, LM implemented corrective actions addressing proximate cause
- NESC continued root cause investigation
- LM 2nd Development Test
 - Corrective Actions: larger locking patches; larger diameter lockwire and quantity; increase in joint preload
 - Select parts reused from previous test
 - Fatigue failure due to life exceedance on Forward Lug
- LM 3rd Development Test
 - Corrective Actions: integral forward end fitting; aft assembly locking patch removed and joint adhesively bonded
 - Select parts reused from previous test with supporting fatigue life analysis
 - Y-axis qualification test completed successfully

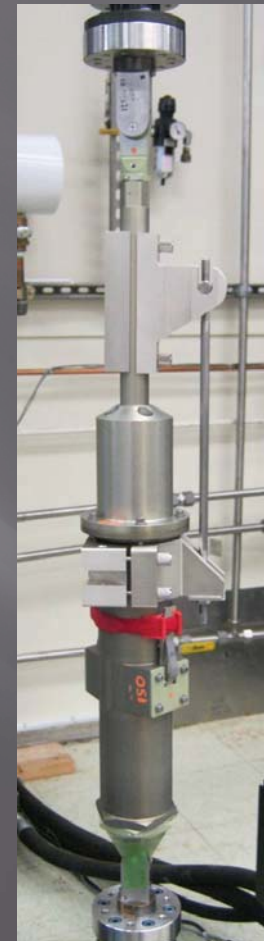
- Ensures adequate force margin exists after being subjected to qualification levels
- Pre-random vibration
 - Both ends of strut attached to Instron through clevis
 - 'Slow' performance test measuring force vs. displacement; data compared to analytical prediction
 - Wear-in testing performed at deployment velocity; 15 cycles
- Post-random vibration
 - Secondary piston truncated aft of 1st development test failure location
 - Cupping interface to Instron at secondary piston
 - Performance test conducted at two speeds (slow and deployment)
 - Pre- and post-vibration data compared

Pre-RV

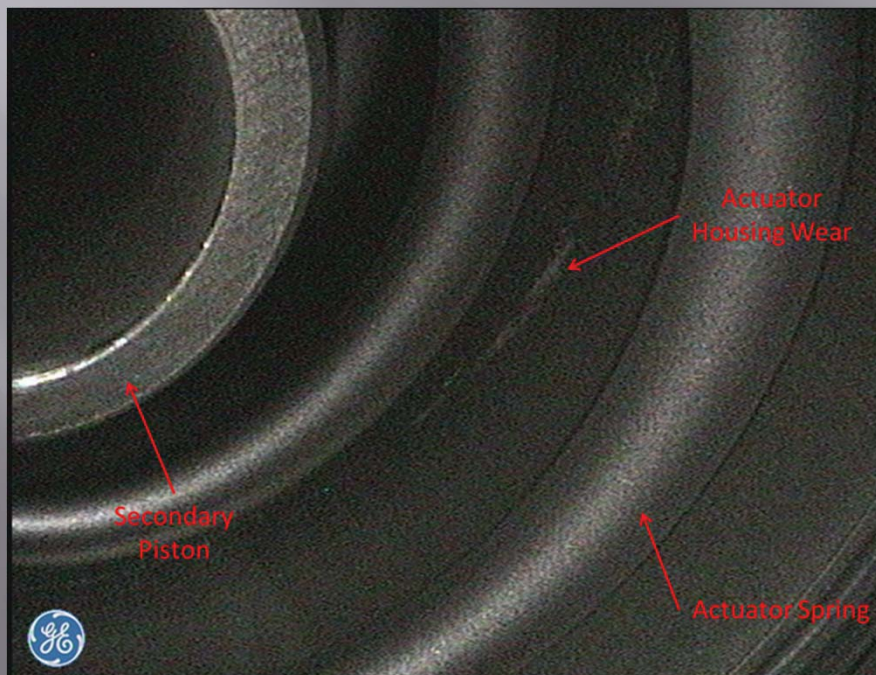
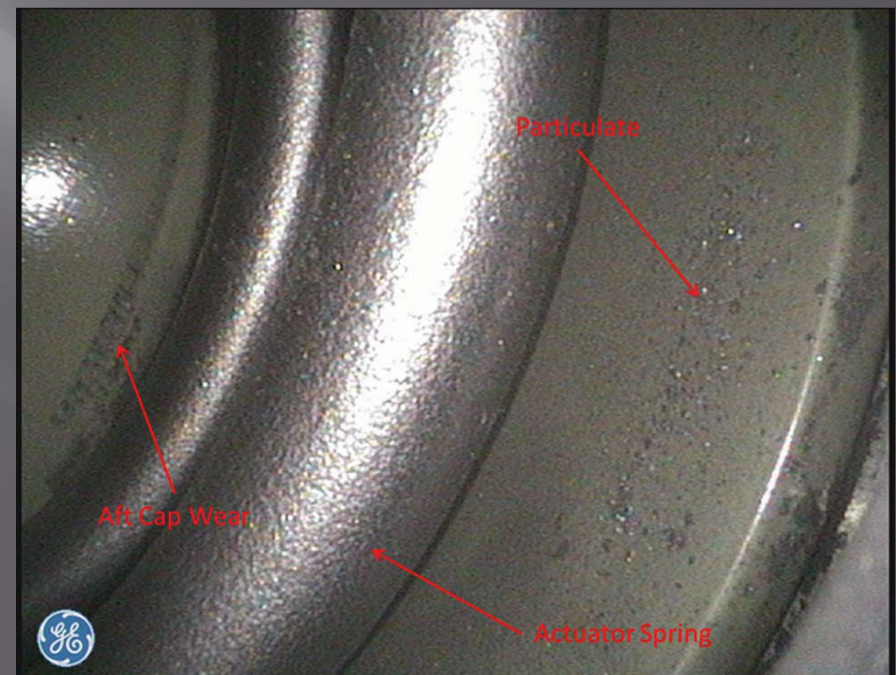
- **Internal Wear & Particulate Formation**
 - Borescope inspection between random vibration test axes (insertion through tooling hole)
 - Larger particulate accumulated at Aft Cap; powder observed throughout
 - Observed existing tooling holes, latch holes, and Forward Cap-to-Secondary Piston interface during testing
 - Powder most noticeable internal to Secondary Piston
