NASA/CR-2014-218157

# Multilayer Pressure Vessel Materials Testing and Analysis

## *Phase 1*

*Joseph W. Cardinal, Carl F. Popelar, and Richard A. Page  
Southwest Research Institute, San Antonio, Texas*

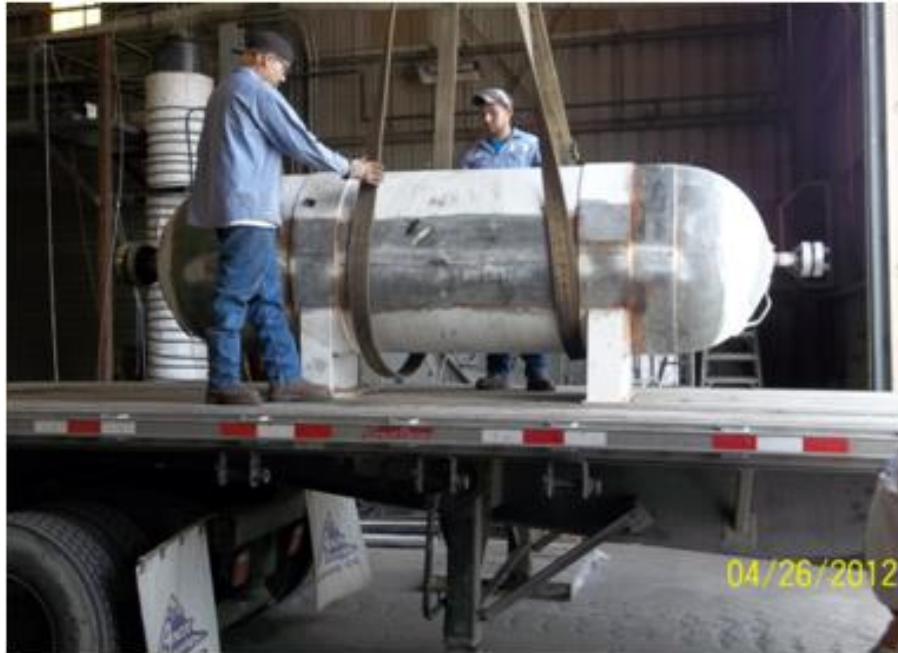
Figure 2-1. Vessel Arrival at SwRI's Fabrication Shop

The multi-layer AO Smith pressure vessel was shipped to SwRI in late April 2012 and was unloaded at the Structural Engineering Department's Fabrication Shop (see Figure 2-1). As a precautionary measure, it was assumed that the paint on the vessel contained lead and the vessel was stripped of all paint by an outside vendor capable of safely containing and disposing of the paint before any sectioning was performed.

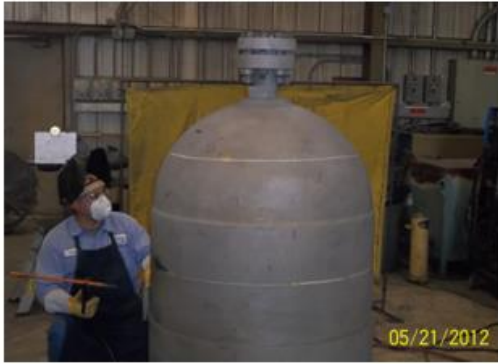
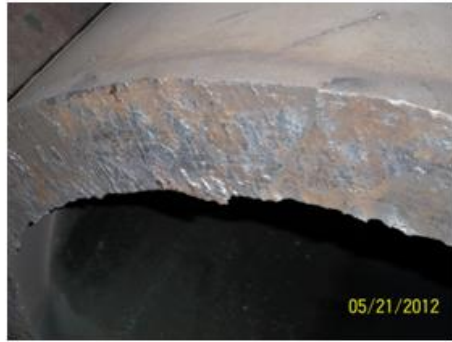
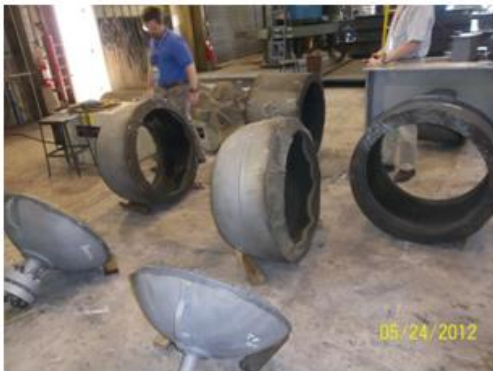
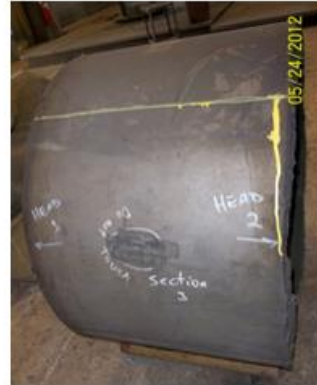
**Figure 2-3. Photos of Sectioned Pressure Vessel**

One of the most notable observations from the vessel sectioning process was how tight the layers of the shell were in contact with each other; see the photo in the upper right hand corner of Figure 2-3 and Figure 2-5. However, once the shell ring was cut axially, the layers sprung apart loosely as shown in Figure 2-4. In flipping through one of the stacks of shell layers, a Carilloy Steel logo was found on layer number nine (assuming the inside layer is layer number one) as shown in Figure 2-4. This was indeed a surprise to see and indicates that the source of the steel that AO Smith used for the layers of the shell was Carilloy Steel, which at the time, was a subsidiary of US Steel.

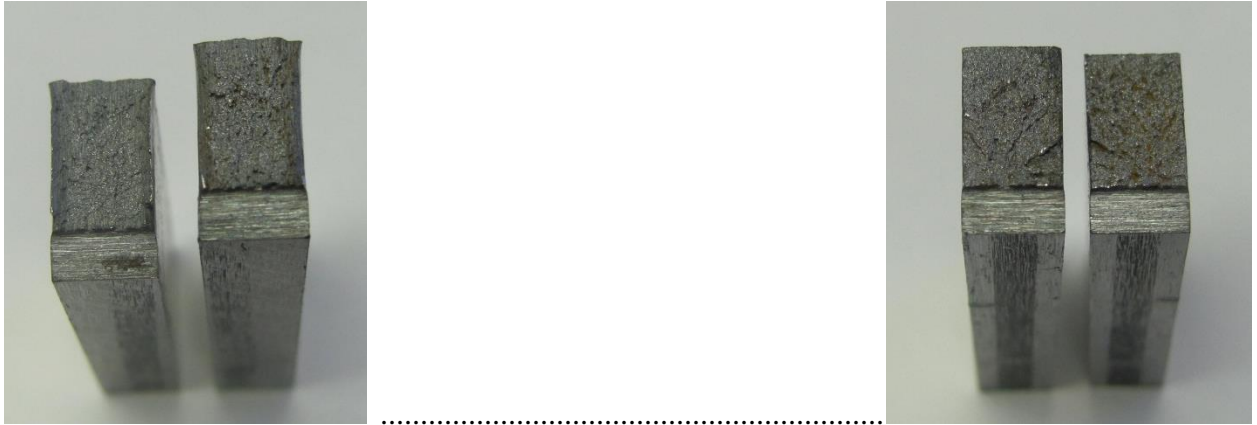
**Figure 5-1. AO Smith 1146a Shell CVN Specimens**

The scaled data is compared to data available in a NASA Tech Memo [2] in Table 5-2. The CVN energies are well below reported values [2]. Representative CVN specimens of the shell and head materials are shown in Figures 5-1 and 5-2, respectively. The fracture surface for both materials at room temperature and -20 °F is indicative of brittle failure. Some shear deformation associated with the formation of shear lips is evident at room temperature while negligible shear was noted at -20 °F. These fracture surfaces are indicative of the measured CVN energies. The source of the discrepancy with the reported values is currently unknown. It is unknown if these differences are attributable to the chemistry differences noted in Section 3.0.

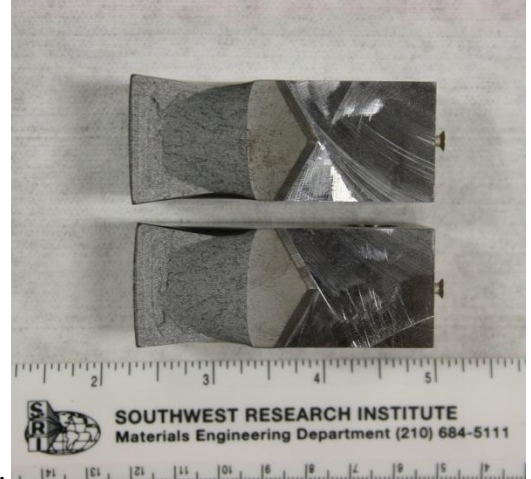
**Figure 5-5. Typical A-225 Specimen After Toughness Testing**

specimen following testing is shown in Figure 5-5 that indicates the extreme plasticity at the crack tip and considerable lateral contraction through the thickness. The results so grossly violate the conditions of ASTM E399 for plane strain toughness that subsequent data analysis was not performed.

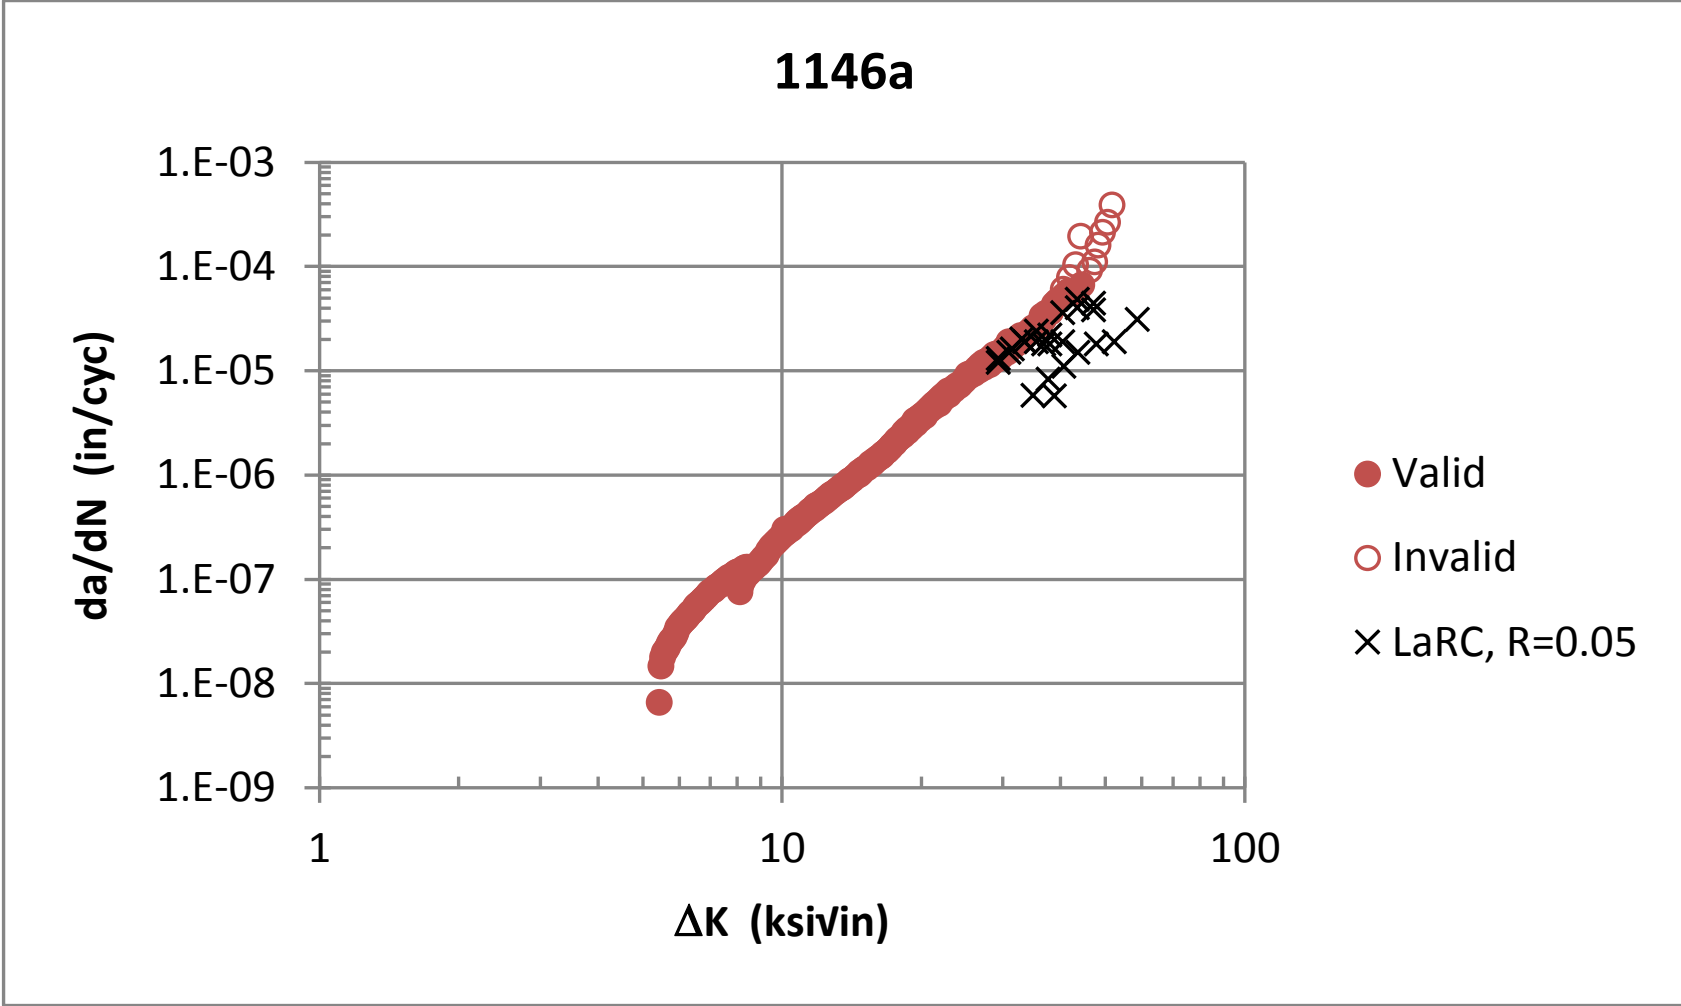
Also included in Figures 5-11 and 5-12 are FCG data generated by NASA Langley (LaRC) [2]. The Langley data were generated with  $R = 0.05$  (recall that data generated in this SwRI effort were at  $R = 0.15$ ). While the Langley data certainly has considerable scatter, there appears to be reasonable consistency given the difference in  $R$  between these data sets since one would expect the  $R = 0.15$  data to be only slightly higher than the  $R = 0.05$  data. The new data obtained herein lie above the Langley data for both materials.

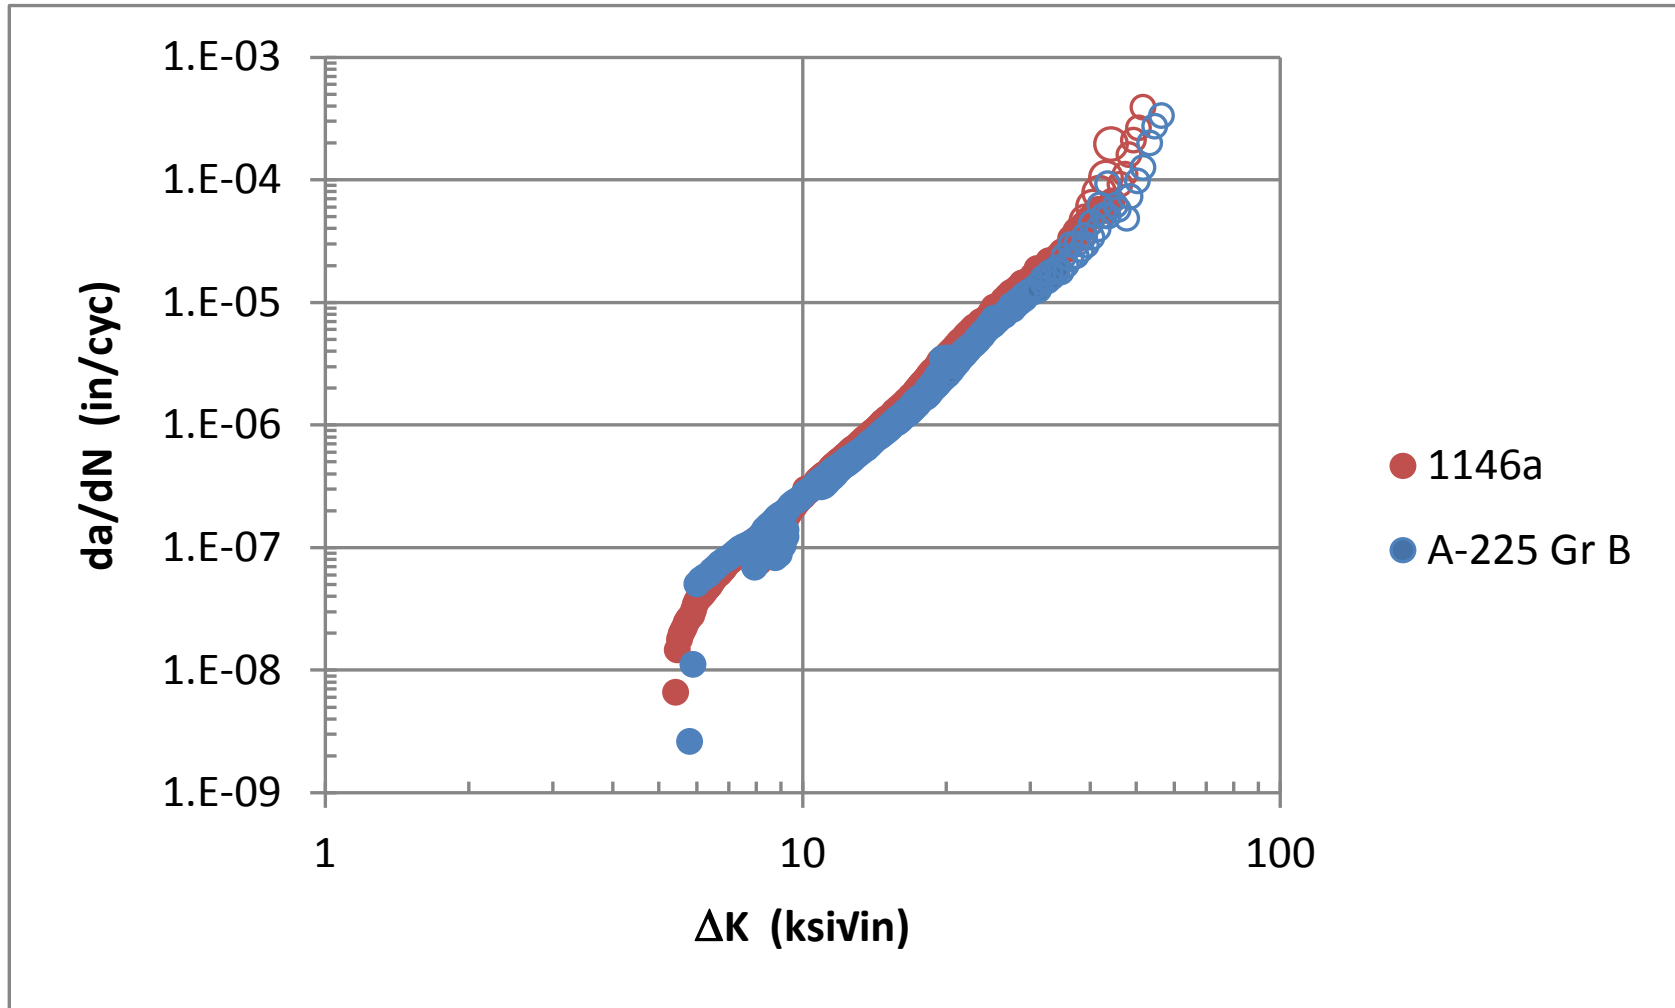
Figure 5-13. Comparison of 1146a and A-225 FCG Behavior at R = 0.15

A comparison of the 1146a and A-225 FCG behavior is shown in Figure 5-13. The behavior of the two materials is extremely consistent, including the near threshold region.
