NASA/TM—2014-216635

Engineered Polymer Composites Through Electrospun Nanofiber Coating of Fiber Tows

Abstract

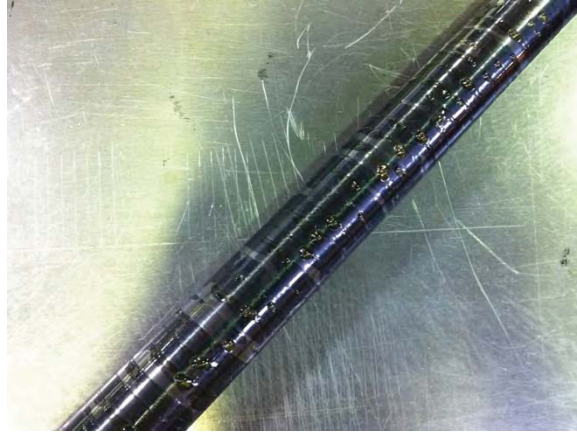
Figure 10.—Photograph of cured hoop-wound tube wrapped in shrink tape.

In order to achieve a wall thickness near 2.5 mm (0.1 in.), hoop-wound tubes were made with nine coverages with a circumferential pattern (each stroke is a coverage with a circumferential pattern). Likewise, the ±45° tubes were made with four helical pattern coverages (each coverage is a ±0 layer in a helical pattern). A helical pattern of five was used in ±45° tubes—meaning there are five rhombic patterns around the circumference of the tube. After the layers were wound, Dunstone 220R brand shrink-tape (Charlotte, NC) was circumferentially wound onto the parts with a 50 percent overlap. Following the application of shrink-tape, the parts were placed stationary in an oven and cured at 143 °C (290 °F) for 2 hr. A photograph of a cured part, prior to removing the shrink tape, is shown in Figure 10.

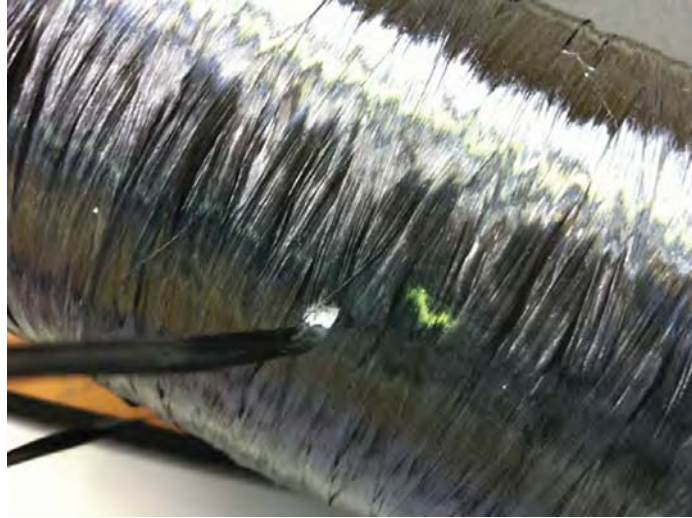
Figure 14.—Fibers crossing over the outermost tow.

This section summarizes the winding characteristics of a preliminary batch of coated carbon/epoxy towpreg received on June 13, 2013. The outermost tow was marked clearly and seemed to unspool without any problem at the beginning of the winding process. But after a few passes, it was realized that the tow was not unspooling freely. When the process was stopped and the spool was taken out of the winder, it was seen that the outermost fiber could not unspool freely due to the restriction of the fibers that are crossing over it, as shown in Figure 14. As the outermost tow was pulled during winding, it cut the fibers that are crossing over it causing the occurrence of open-ended fibers as seen in Figure 15. This problem became more severe as the tow was allowed to cut more fibers and the number of the open-ended fibers accumulated. The problem was solved by manually cutting all the fibers that were crossing over the outermost tow, and by removing all of the open-ended fibers. This same behavior was also observed during unwinding of the spool during deposition of the nanofiber and was likely more severe in the modified tow due to rewinding. Performing the nanofiber deposition in line with the resin impregnation process would reduce or eliminate this problem.

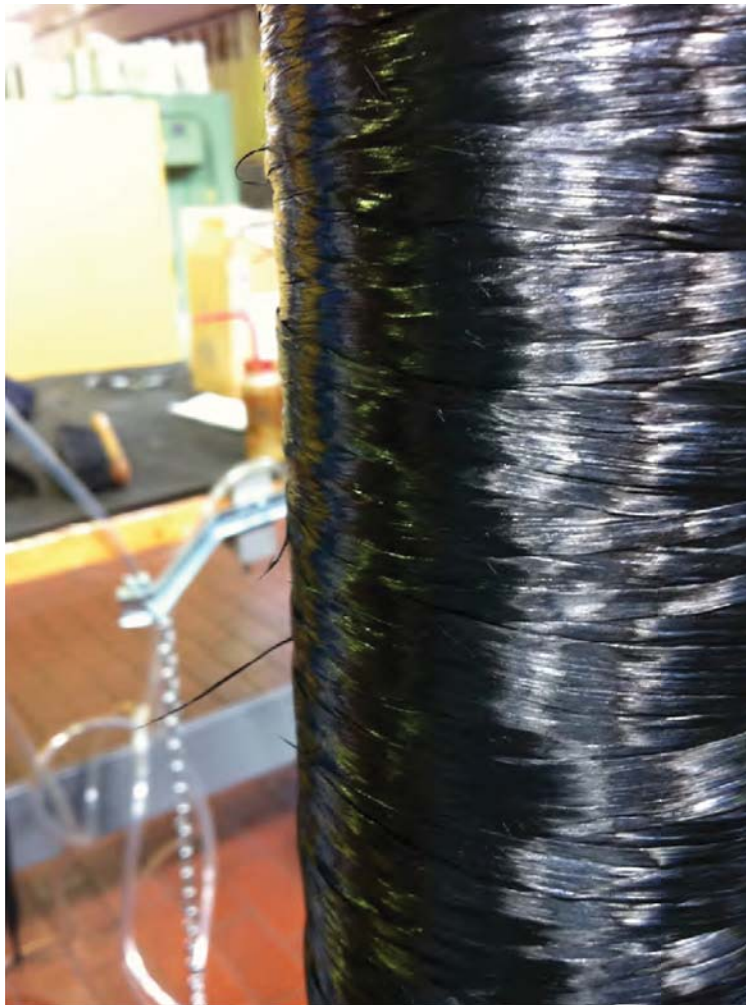
Figure 15.—Open ended fibers.

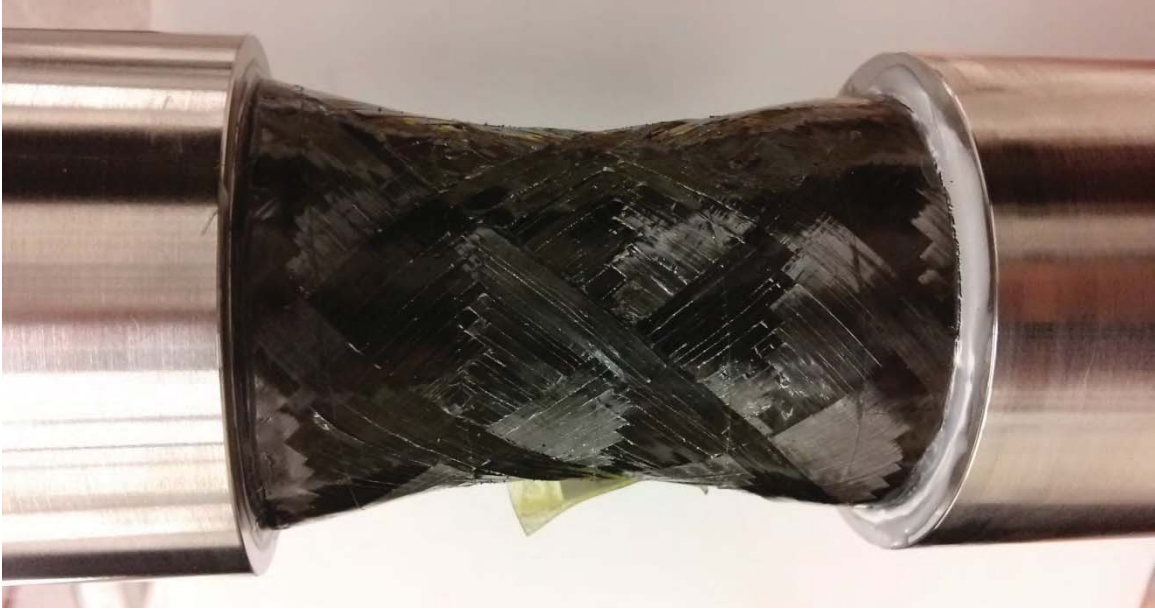
Figure 23.—Failed ± 45 tension specimen still mounted in test machine.

The $\pm 45^\circ$ tensile specimens deformed significantly (radial contraction) following the onset of nonlinearity above 8000 lb (35.6 kN) load (Appendix C). Ultimate failure was characterized by a peak in load followed by an extended unloading (negative load/displacement curve slope) resulting from progressive delamination of the tows. The 90° tensile specimens failed at the end cap bond line at relatively low load with no nonlinear deformation as anticipated. Figure 23 shows a $\pm 45^\circ$ tensile specimen after failure, still mounted in the load frame.

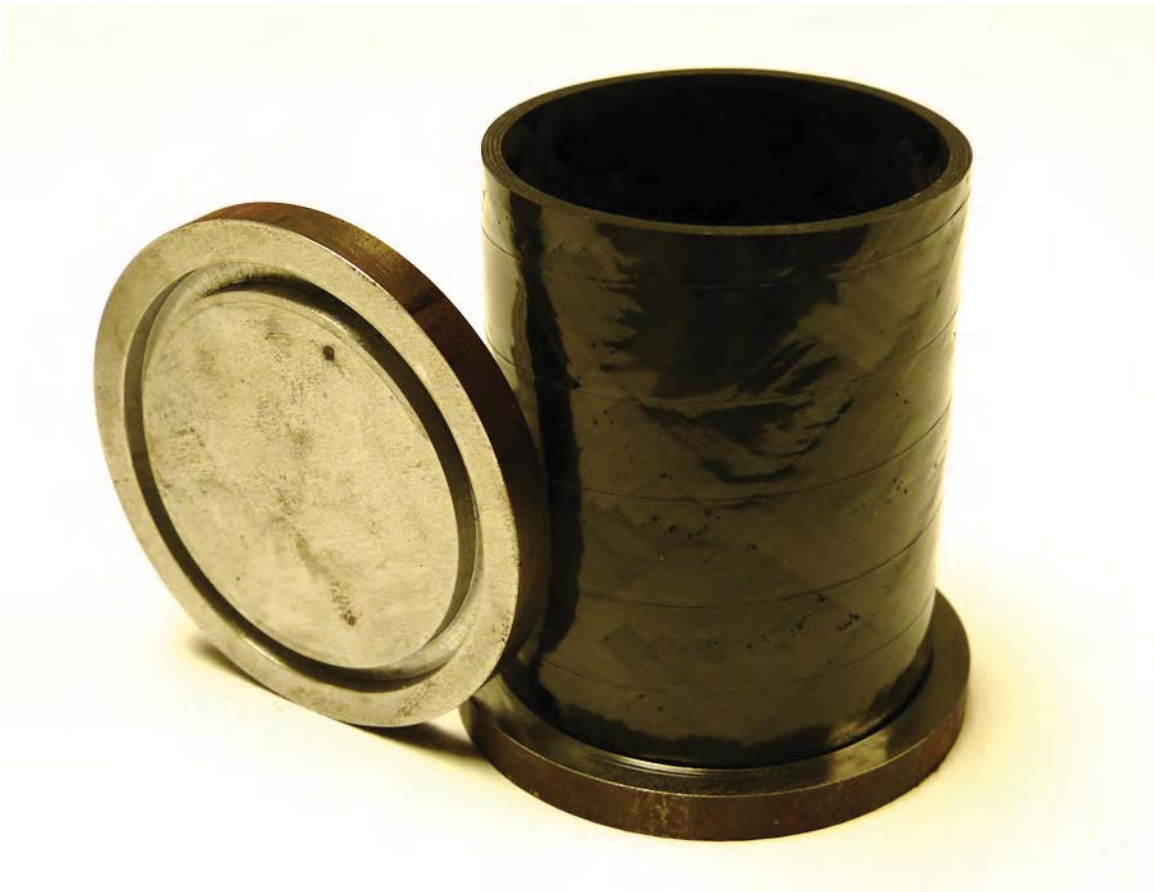
Figure 24.—Compression test end plates and ± 45 specimen.

The ends of the compression coupons were cut flat and parallel using a precision diamond saw. Steel end plates with a shallow channel (0.125 in. deep by 0.125 in. wide with a mean diameter of 1.985 in. or 3.175 mm deep by 3.175 mm wide with a mean diameter of 50.419 mm) were used on the ends of the coupons. The end plates were not bonded to the specimens. The coupon with loose fitting end plates was placed in the test machine between flat compression platens. Figure 24 shows the compression test end plates and a ± 45 specimen.

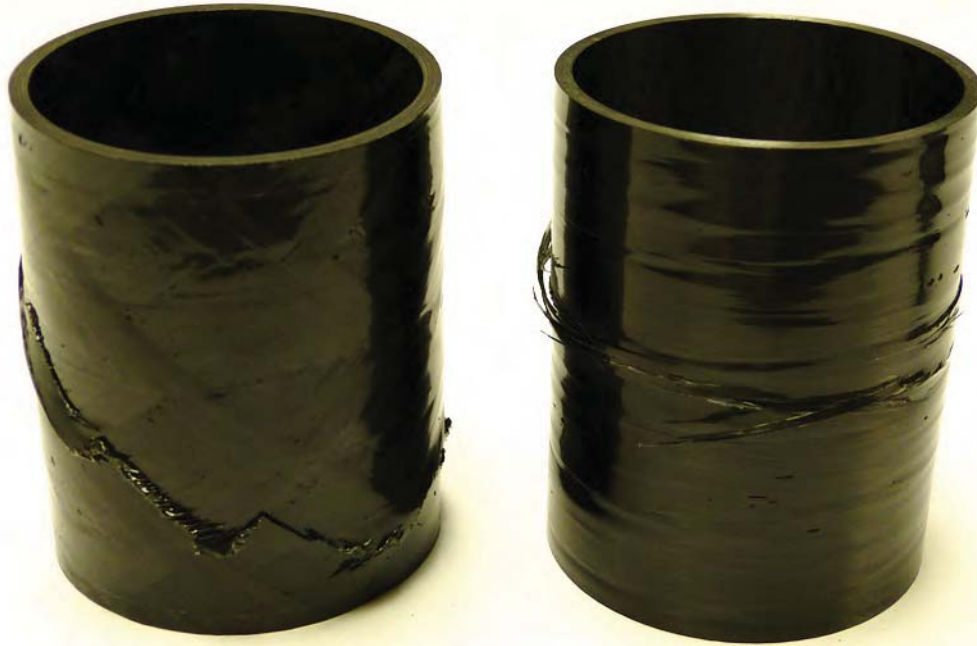
Figure 25.—Examples of compression specimen failures, ± 45 (left) and 90 (right).

The $\pm 45^\circ$ compression specimens show a significant change in stiffness (softening) at higher load that was associated with severe barreling of the tube. The final failure resulted in fractures running along the 45° directions of the fibers, often near one of the end plates. The 90° tubes showed significantly less non-linearity. The compression specimens typically failed toward the middle of the specimen and resulted in broken hoop direction fibers and a local ring of compression damage. Examples of the failure of ± 45 and 90 compression test specimens are shown in Figure 25.

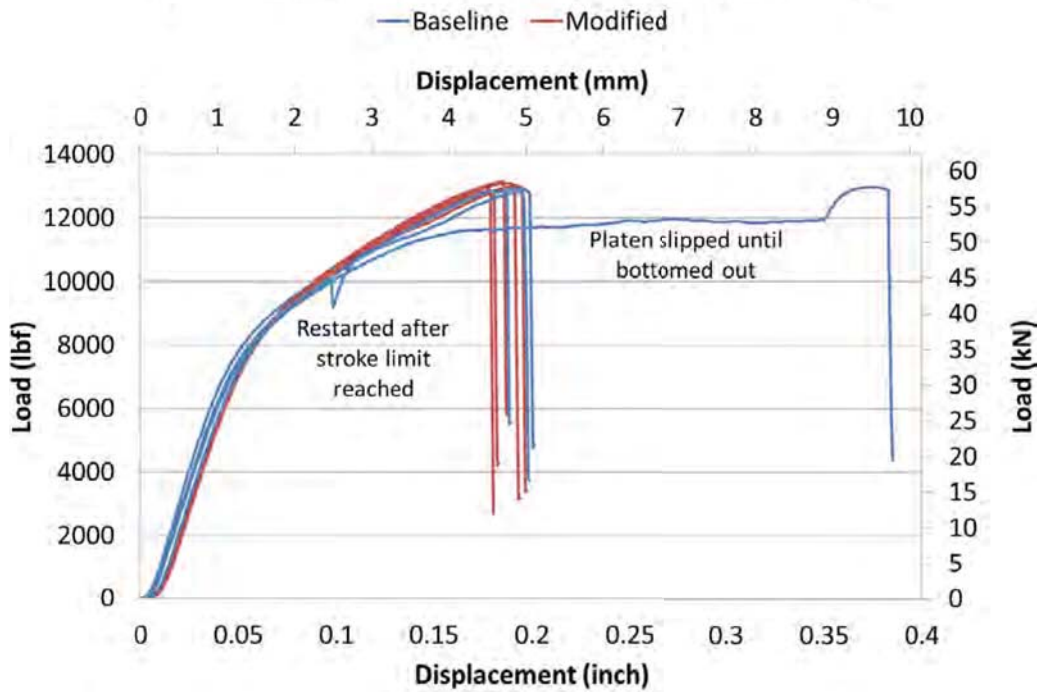
+/-45 Tube Compression Load vs. Displacement

Figure 30.—Load vs. displacement curves for all tubes with the $\pm 45^\circ$ wind angle loaded in compression.
