NASA/CR-2014-218149

PRSEUS Panel Fabrication Final Report

*Kim A. Linton, Alexander Velicki, Krishna Hoffman, Patrick Thrash,
Robert Pickell, and Robert Turley
The Boeing Company, Huntington Beach, California*

January 2014

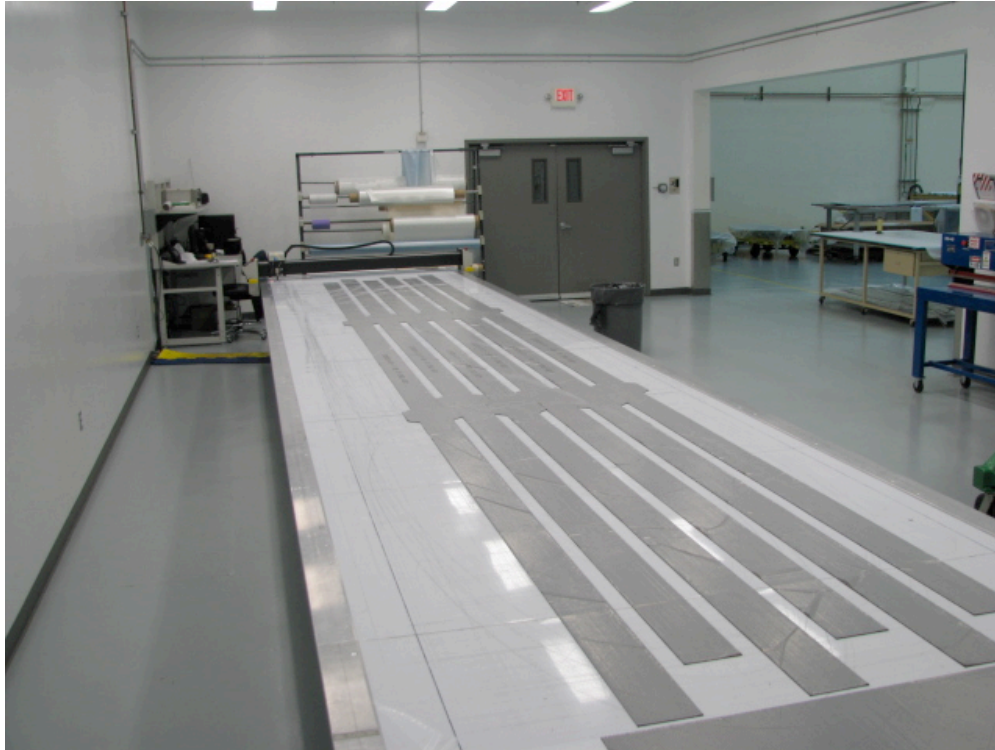
Figure 3. Nested Flat Patterns for Stringer Preforms CNC Cut from Multi-Axial Carbon Fiber Fabric

Stringer preforms were fabricated for the eight PRSEUS panels of the MBB test article. Nested flat patterns were cut from 55-inch wide DMS2436, Type 1, Class 72 warp/knit multi-axial carbon fiber fabric using a Gerber CNC ply cutting table. The individual flat patterns were subsequently folded over a steel leader wire and placed inside a large assembly fixture to stitch. A CNC gantry style lock stitch sewing machine was used to insert two seams of stitching into the

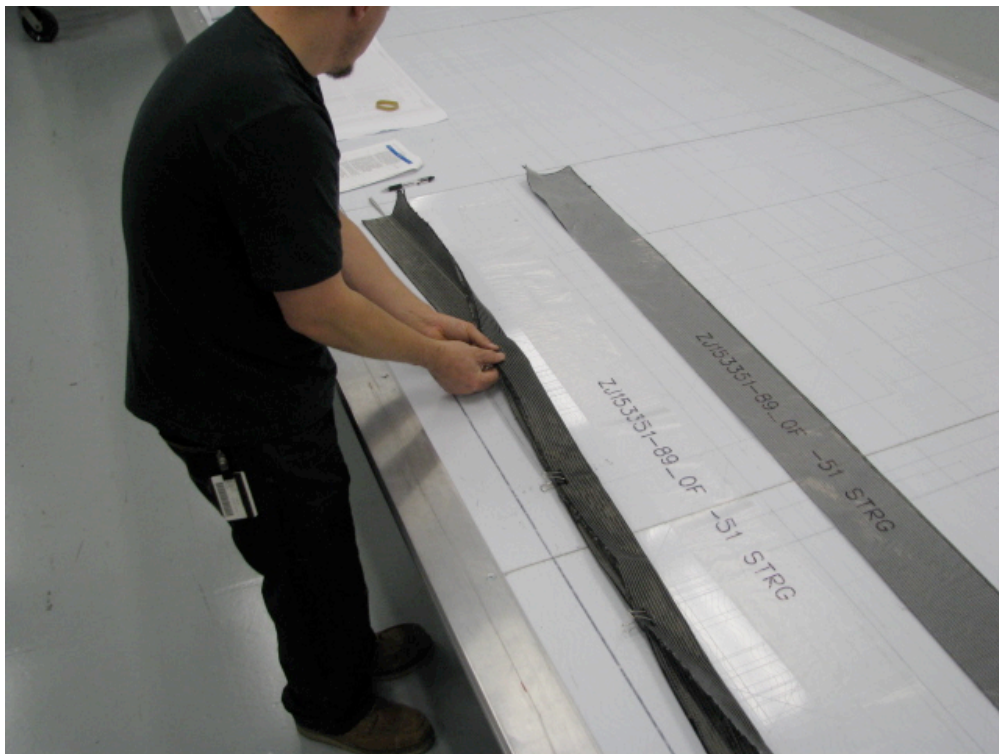
Figure 5. Stringer Flat Pattern Folded Over Leader Wire

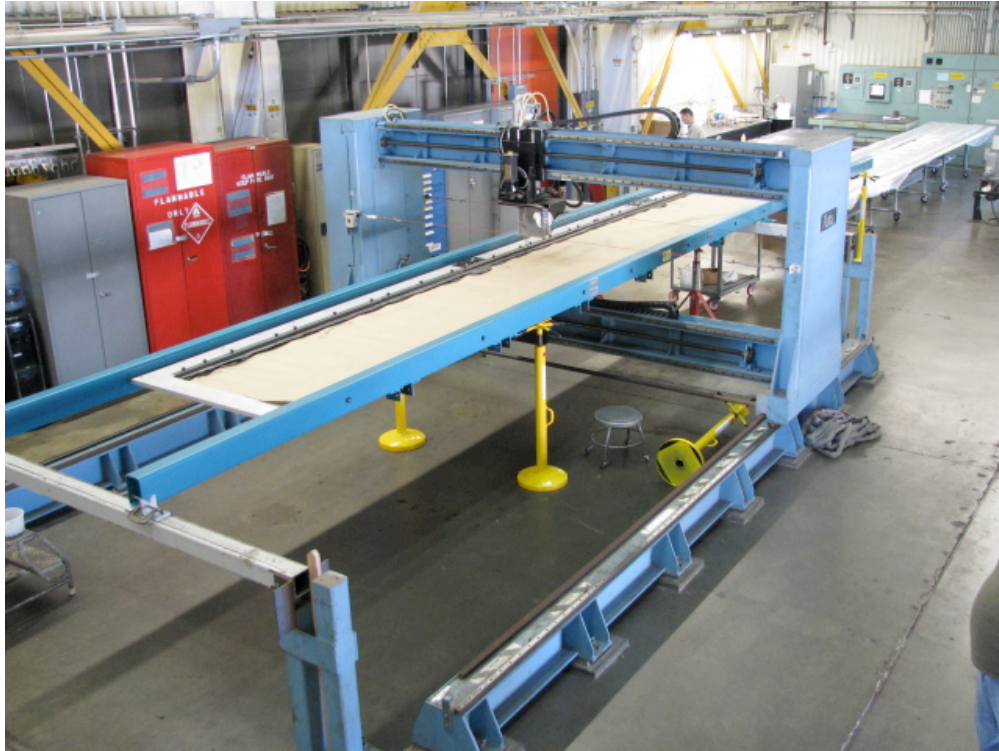
Figure 6. Stringer Preform on Gantry Style Sewing Machine

stringer web using Vectran 1200d thread. The first stitching seam was positioned at the apex of the fillet at the base of the stringer bulb feature. The second stitch seam was located at the apex of the fillet for the web-to-flange radius. With the flanges still laid out flat and the bulb feature collapsed the stringer preform was placed inside a polyethylene bag. Pictures in Figure 3 through Figure 8 show the stringer subassembly process.

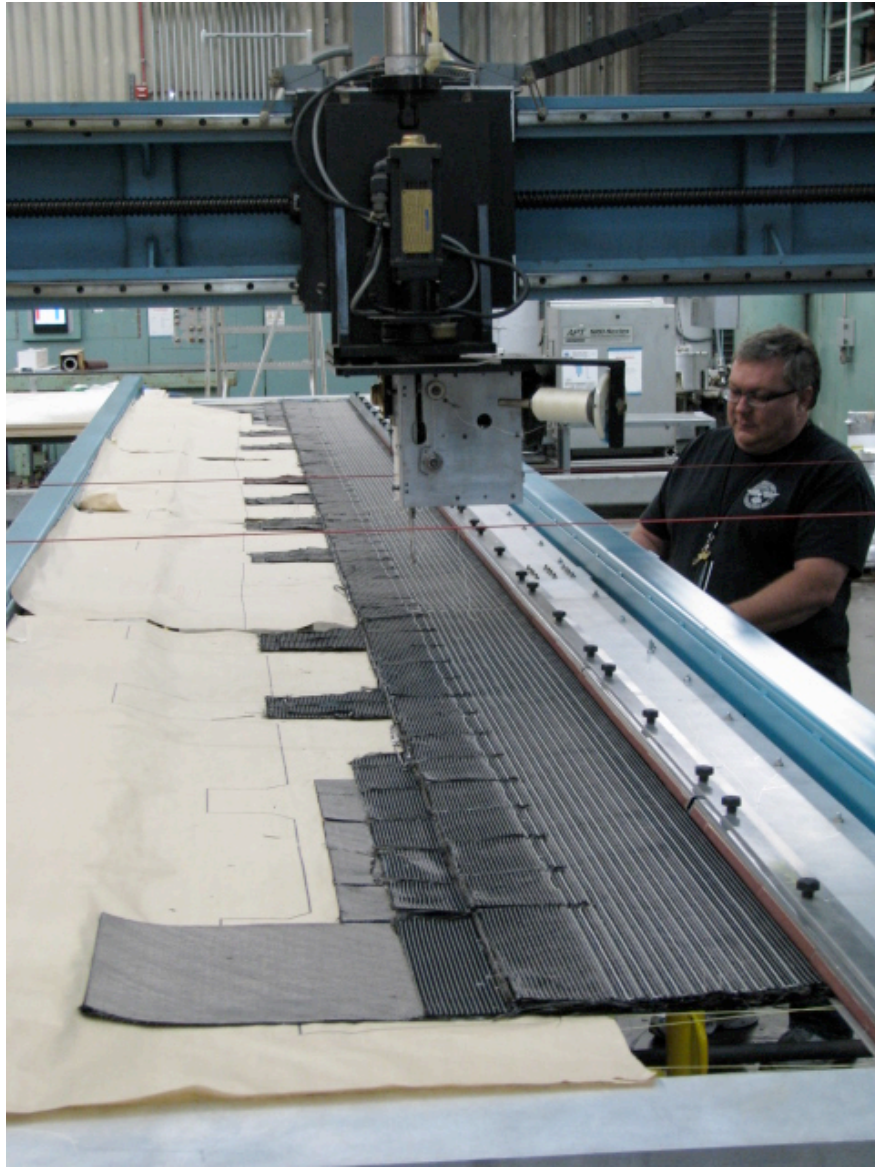
Figure 10. Stitching of Crown Panel Cap Web on the Gantry Sewing Machine

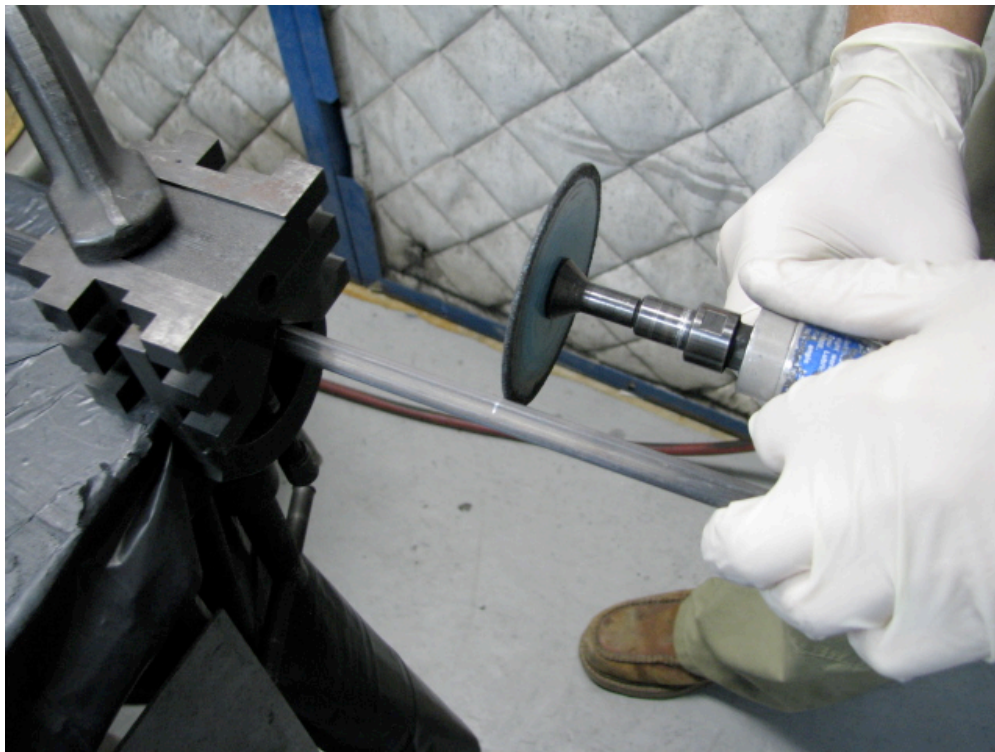
Figure 11. Rough Cutting of a Pultruded Carbon Fiber Epoxy Rod to Length

The PRSEUS panels of the MBB test article utilized a pultruded carbon fiber epoxy rod in the top of the bulb shaped stringers. The rod is pre-cured and subsequently bonded to the carbon fabric of the stringer surrounding it in-situ with resin infusion processing of the panel dry fiber preform. The pultruded rods were manufactured by Lawrie Technologies in Girard, PA. using Applied Poleramic Inc. PUL6 epoxy resin system and standard modulus GRAFIL 34-700WD carbon fibers. Preparation of the rod began with a post-cure cycle in an oven at 350°F for two hours. The rods were then cut to length using an abrasive cut-off wheel mounted on a portable power tool. The fillet feature was then abrasively removed from approximately 0.5 inches at the end of the rod to enable insertion of the rod into pockets created at the top of the stringer preform. A hole was drilled axially in one end of the rod and a nylon set screw installed for subsequent attachment of an adapter to connect the rod to the metal wire leader inside the stringer preform. The outer surface of the rod was prepared via grit blasting and rinsed with deionized water. A water break test was then performed to verify the surface was properly prepared for bonding. The rods were dried inside an oven and subsequently wrapped in craft paper to minimize moisture absorption. The prepared rods were ultimately packaged inside a heat sealed poly bag and forwarded to the panel preform assembly jig for installation into the stringer preforms. Pictures in Figure 11 through Figure 15 depict the key steps in the process.

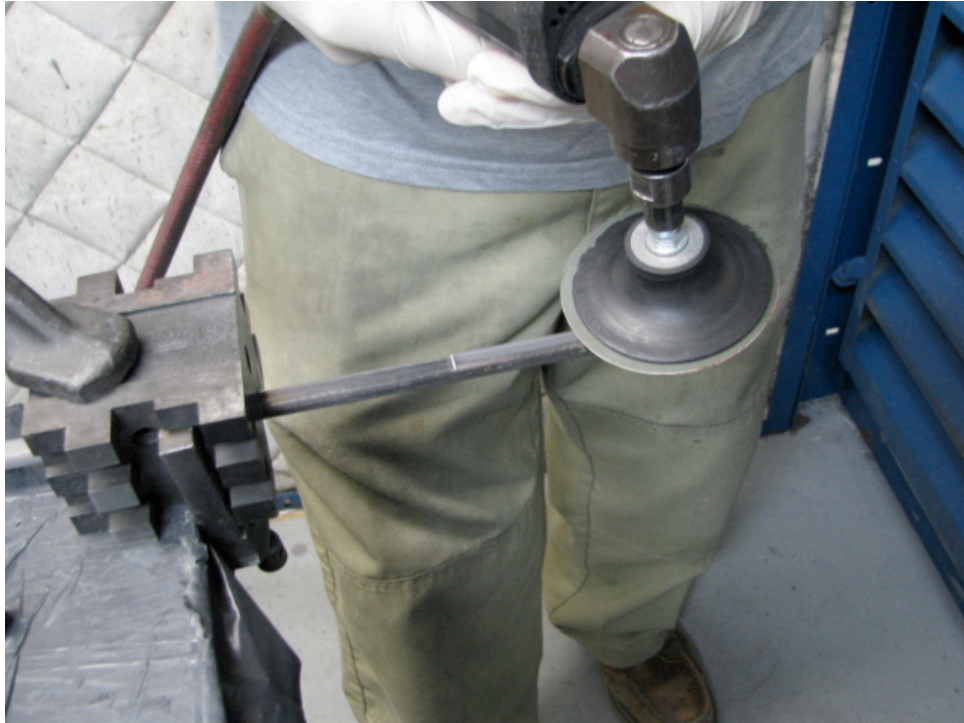
Figure 12. Removal of Fillet Feature from End of Rod Using Abrasive Sanding Disk

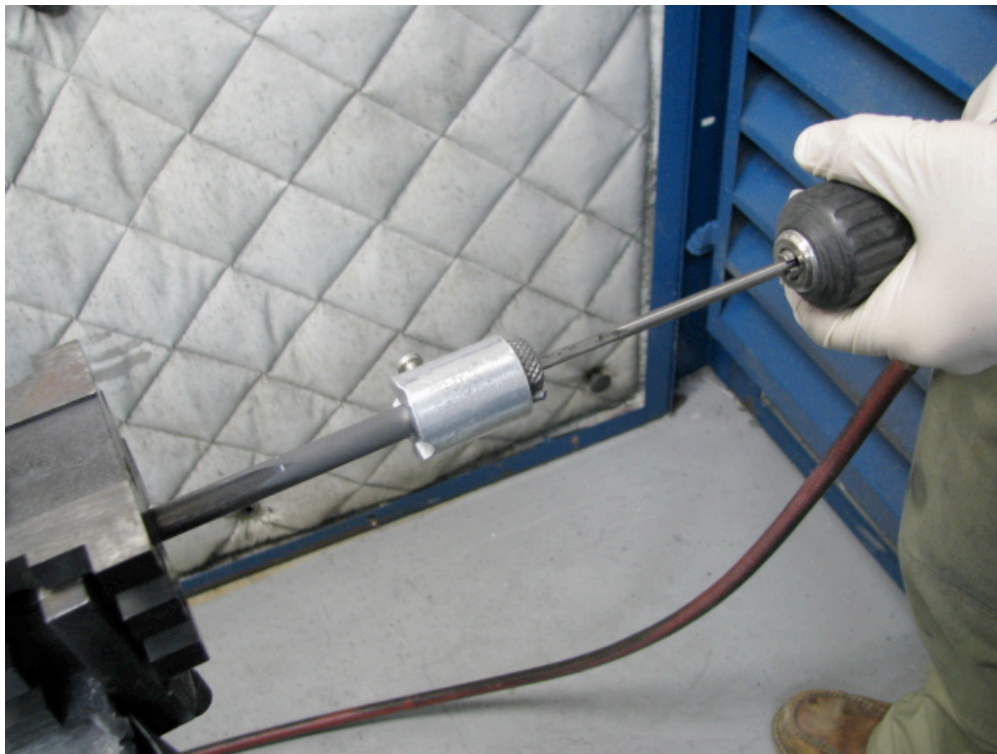
Figure 13. Drilling of Rod End to Accept Nylon Set Screw for Mounting of Leader Wire Adapter

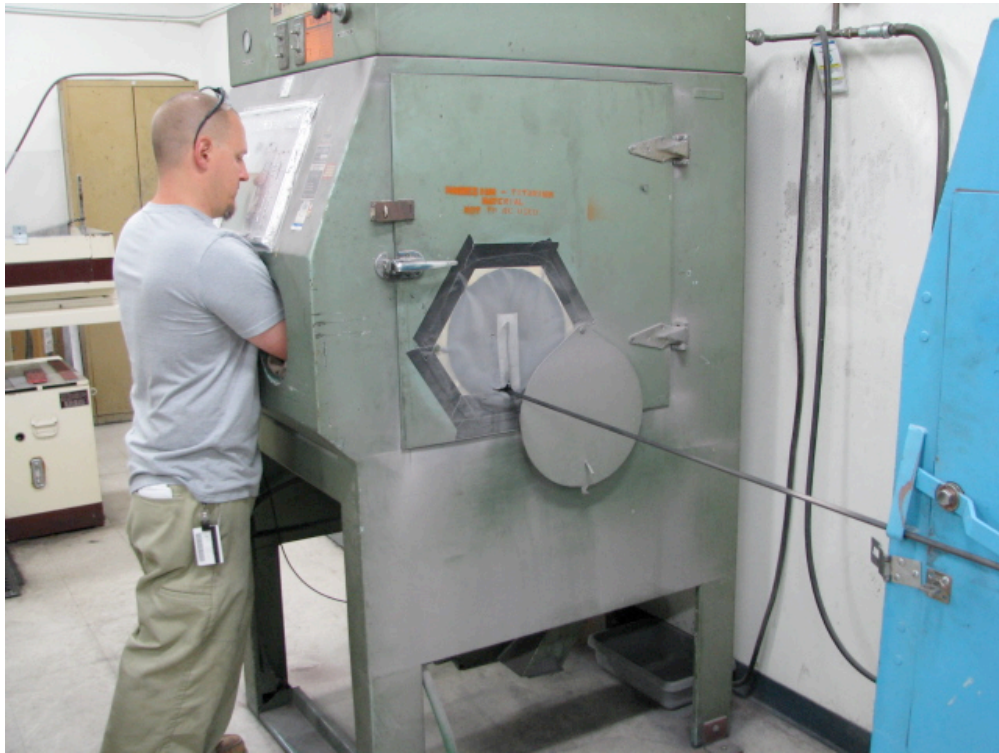
Figure 14. Grit Blasting of Rod to Prepare Outer Surface for Bonding

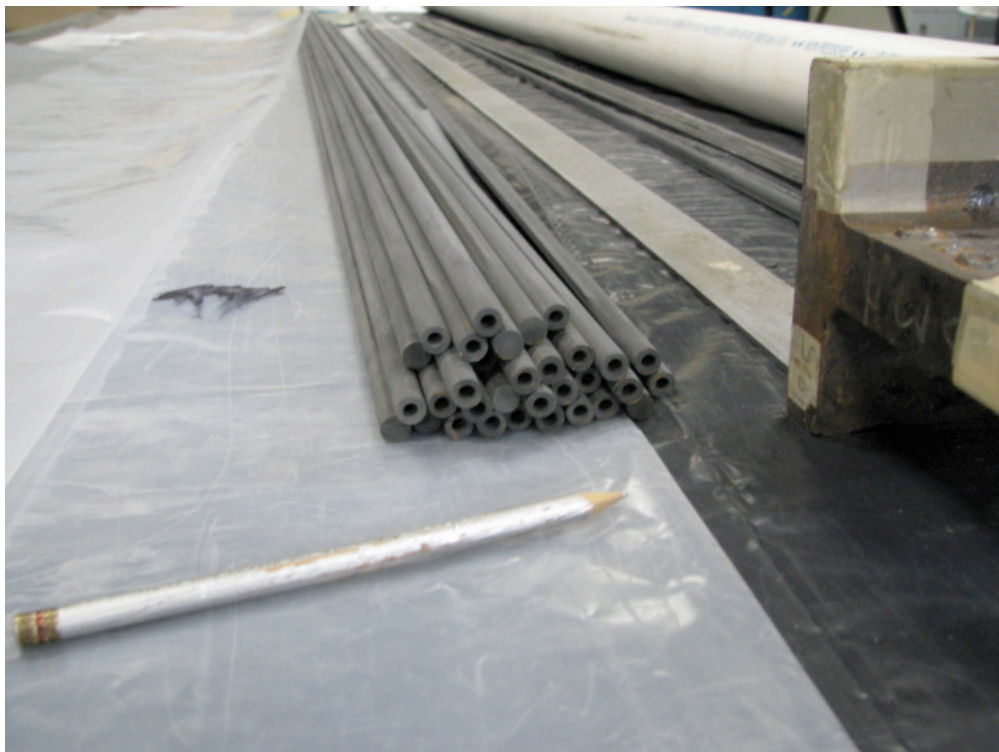
Figure 15. Prepared Rods Ready for Deionized Water Rinse and Water Break Test

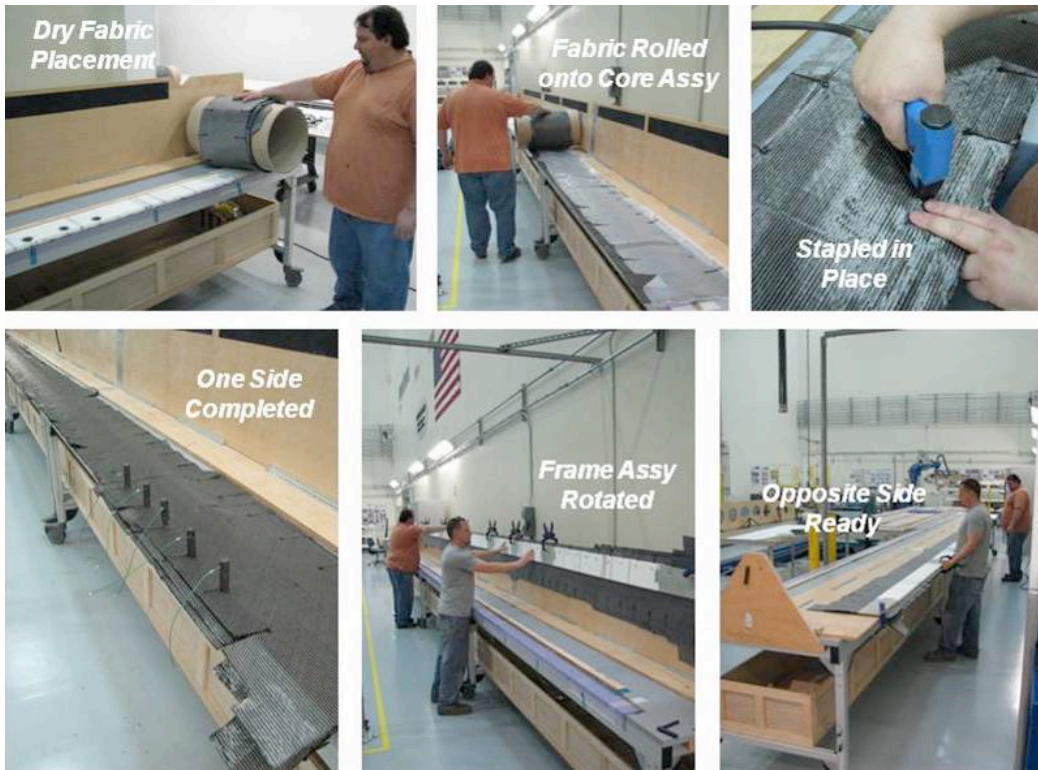
Figure 20. Wooden Assembly Tool Used to Attach Fabric to Foam Core

Next, the pre-cut warp-knit fabric was rolled out onto bonded core subassembly and then stapled into place (Figure 20). A wooden frame assembly tool was used to locate the fabric relative to the core, and then used to flip the frame over to attach the fabric on the other face.

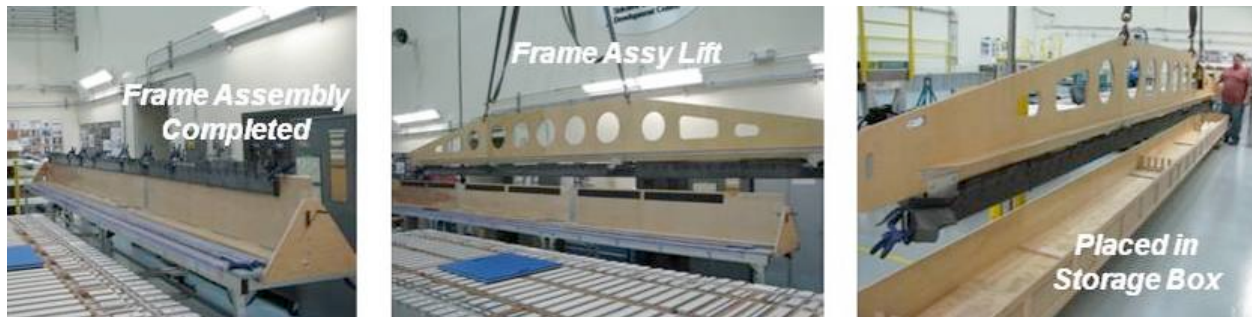
Figure 21. Completed Frame Lifted from the Frame Assembly Tool

When the final face was stapled in place, the tool was rotated into the vertical position and then the completed frame assembly was lifted from the tool and placed in a storage box (Figure 21) until it would be needed for the preform assembly operation.

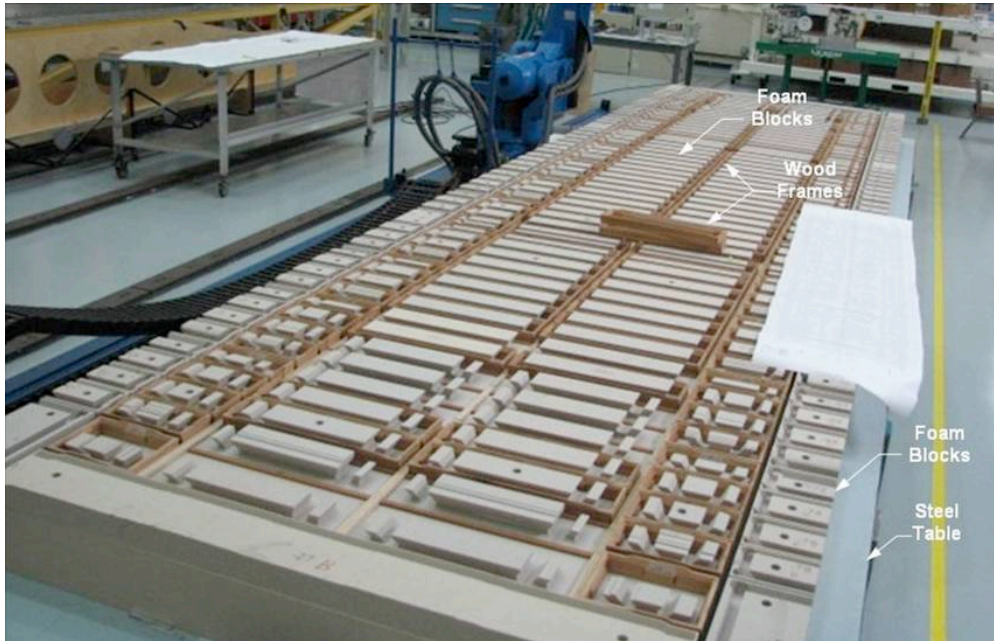
Figure 23. Crown Panel Stitch Tool Preparation and Checkout

The preform assembly takes place in the stitching tool. The tool is a collection of wooden frame elements and foam blocks that is used to hold the dry fabric details in position when the preform was stitched together. The tooling elements were accurately N/C machined details that were indexed to a common steel base. The details were designed to fall away from the base when the tool is rotated to place the preform onto the cure tool. Each panel configuration requires a specific block set to accommodate the differences in panel design features. The initial set up for the crown panel configuration is shown in Figure 23 as it nears completion and checkout.

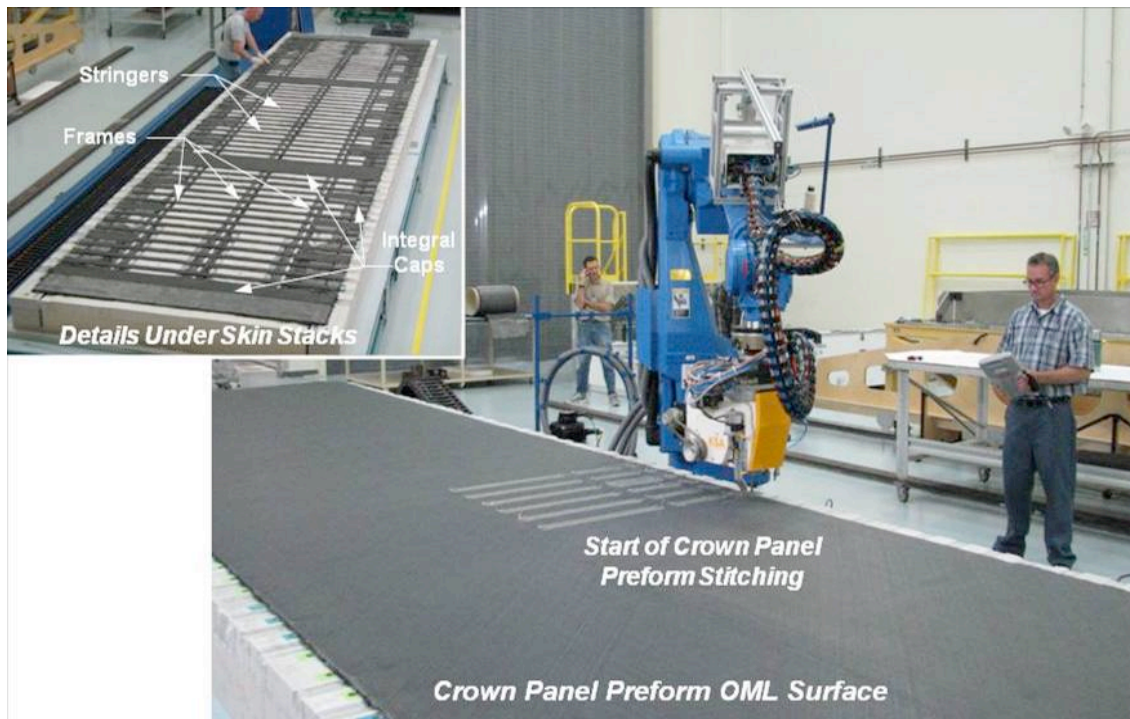
Figure 25. Single-Sided Stitching of Crown Panel Preform Started

Finally, using one-sided stitching technology, the two needle system was used to form a modified chain stitch. The industrial robot arm gives the end effector six degrees of freedom for stitching in 3-D space. The initial seams were inserted into the preform to attach the frame and stringer flanges to the skin (Figure 25).

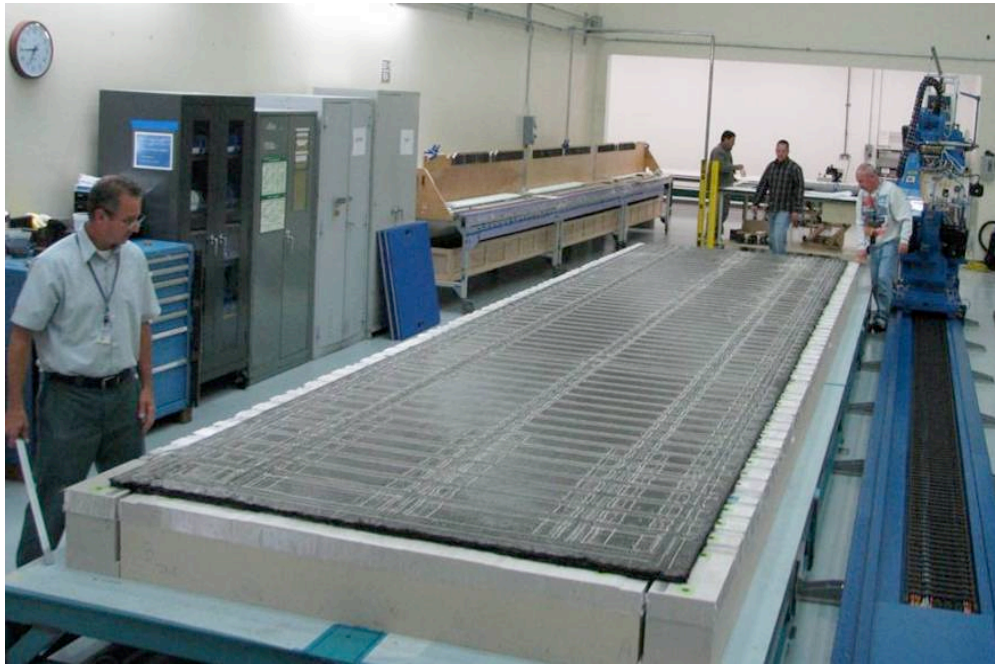
Figure 26. Completed Crown Panel Preform Stitching

After stitching of the preform was completed (Figure 26), it was transferred to an outer mold line (OML) cure tool for resin infusion processing. This was accomplished by strapping the dry preform to the preform assembly tool so it could be inverted without dropping the preform. Once the preform was flipped (Figure 27) and positioned over the cure tool (Figure 28), the straps were removed and the steel base was lifted off.

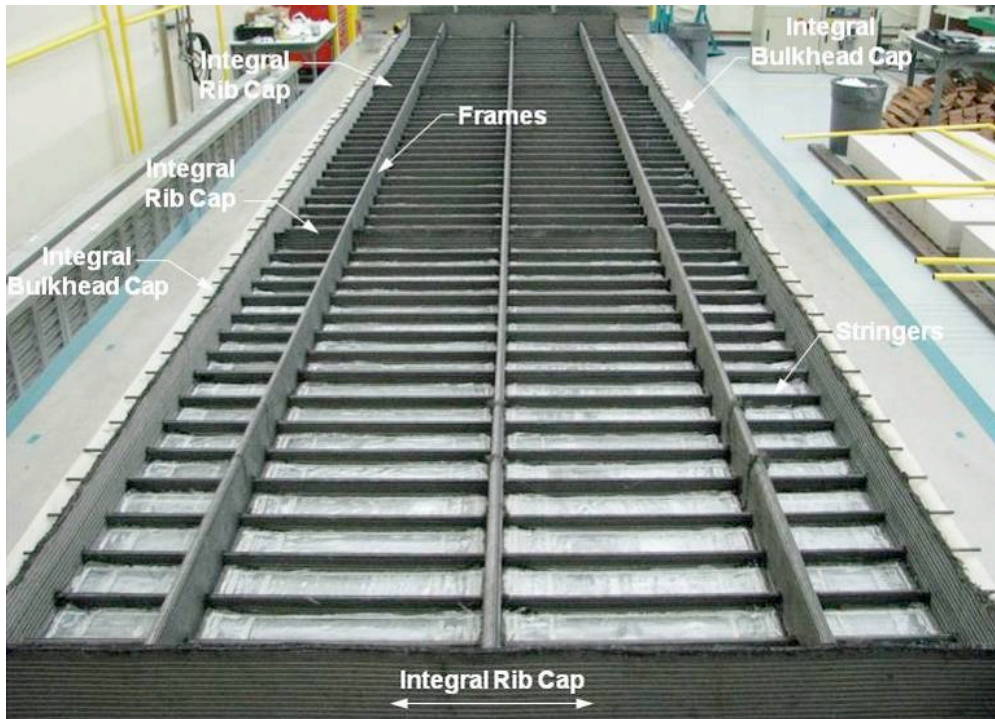
Figure 30. Self-Supporting Crown Panel Preform Placed on the Cure Tool

With the steel base detached, access to the foam blocks and wood picture frame details was now possible. All of the foam blocks and wood frames were easily removed and concerns that the one-piece wood frames might be locked into the preform were not realized. The relative flexibility of the stitched preform was adequate to release the wood frame details without having to pull the rods out. Once these tooling details were removed (Figure 29), only the self-supporting preform remained on the cure tool (Figure 30).

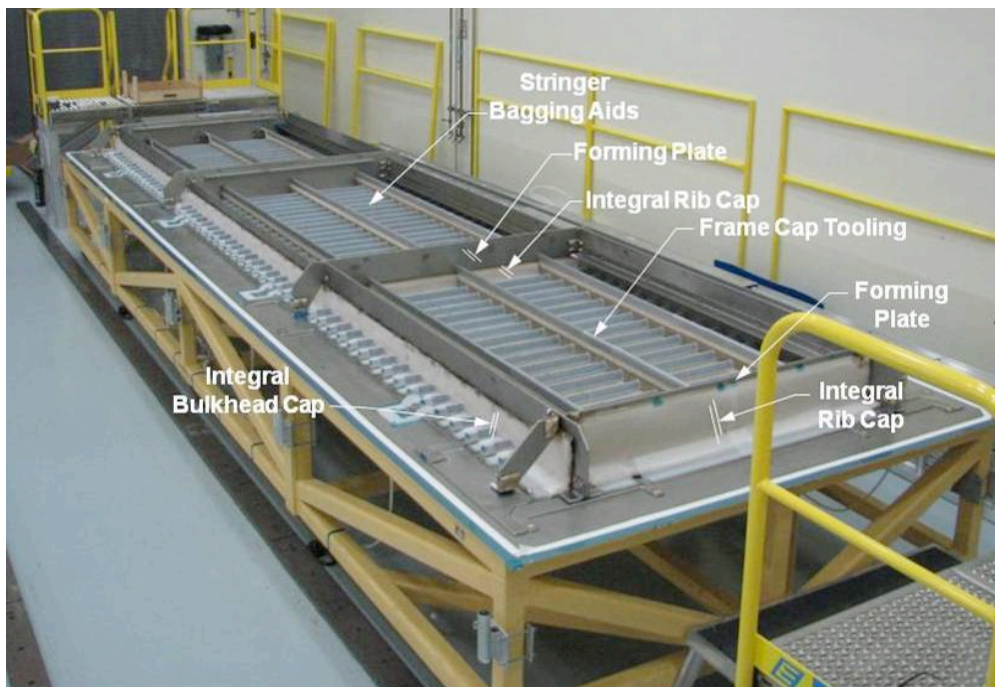
Figure 32. Under Bag IML Tool Details Located

The preform was then prepared for resin infusion and cure cycle processing. The first step was to install all of the IML cure tool details onto the preform (Figure 31). Then peel ply (beige colored material in the photos) layers were added to eliminate resin ridges caused by the pleated vacuum bagging system. Location paddles and forming plates were used to accurately position frame and integral cap feature stations. Frame cap covers were used to maintain frame straightness. Silicone bagging aids were added to the stringers to reduce vacuum bag elongation in the sharp corners. The rigged cure tool with all of these IML cure tool details is shown in Figure 32 for the crown panel.

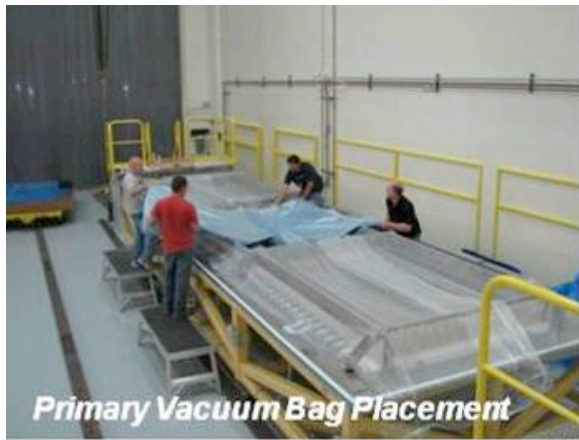
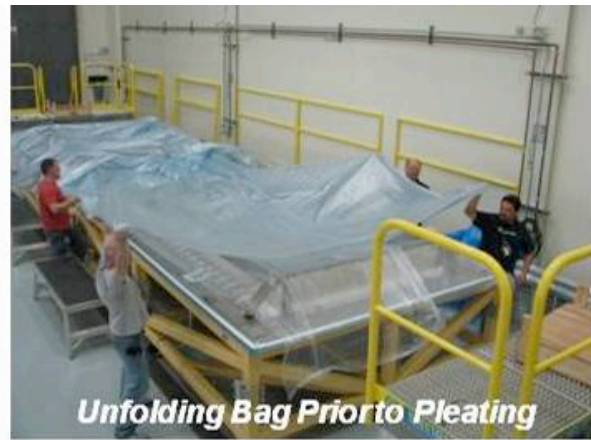
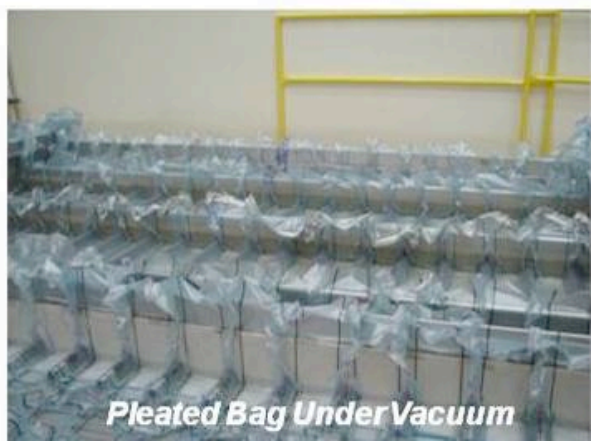
Figure 33. Pleating Operation for Primary Bag Installation

A two bag system is used to seal vacuum the part against the tool. First the primary pleated nylon vacuum bag is draped over the preform, pleated and then sealed down against the OML tool (Figure 33). A secondary textured vacuum bag (green bag in Figure 34) was also added to provide a level of safety should any leaks develop in the primary bag.

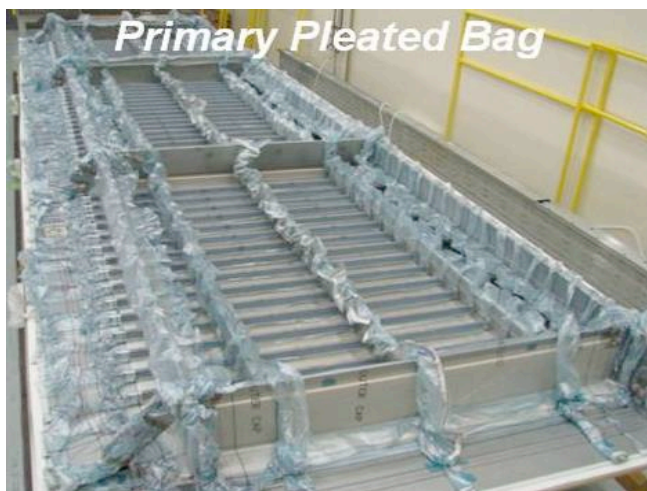
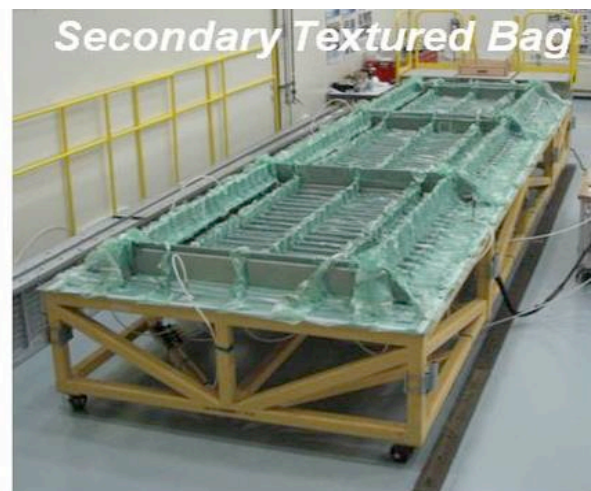
Figure 34. Secondary Bag is added to Maintain Vacuum Integrity during Infusion and Cure

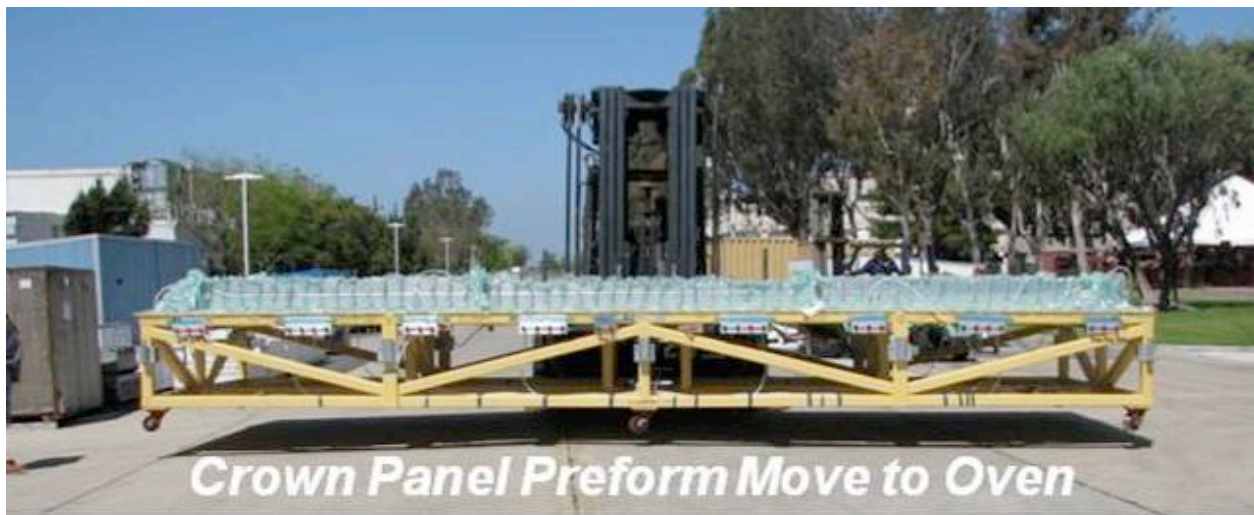
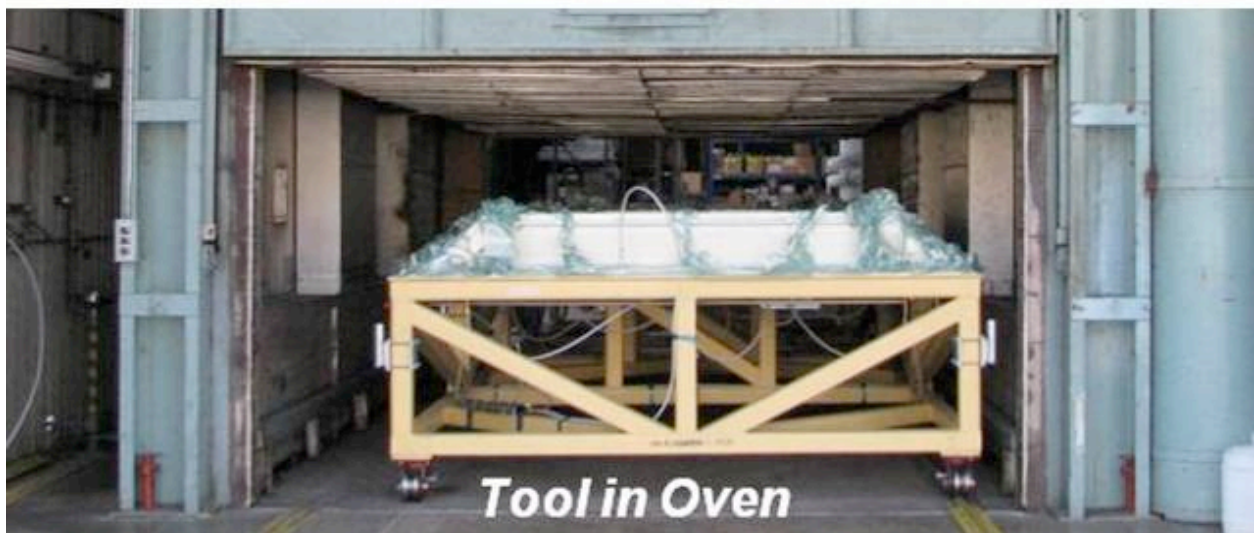
Figure 35. Part is Transferred and Loaded into Oven

After successfully passing a vacuum check, the bagged part was then transported from the Stitching Center to the oven. (Figure 35)

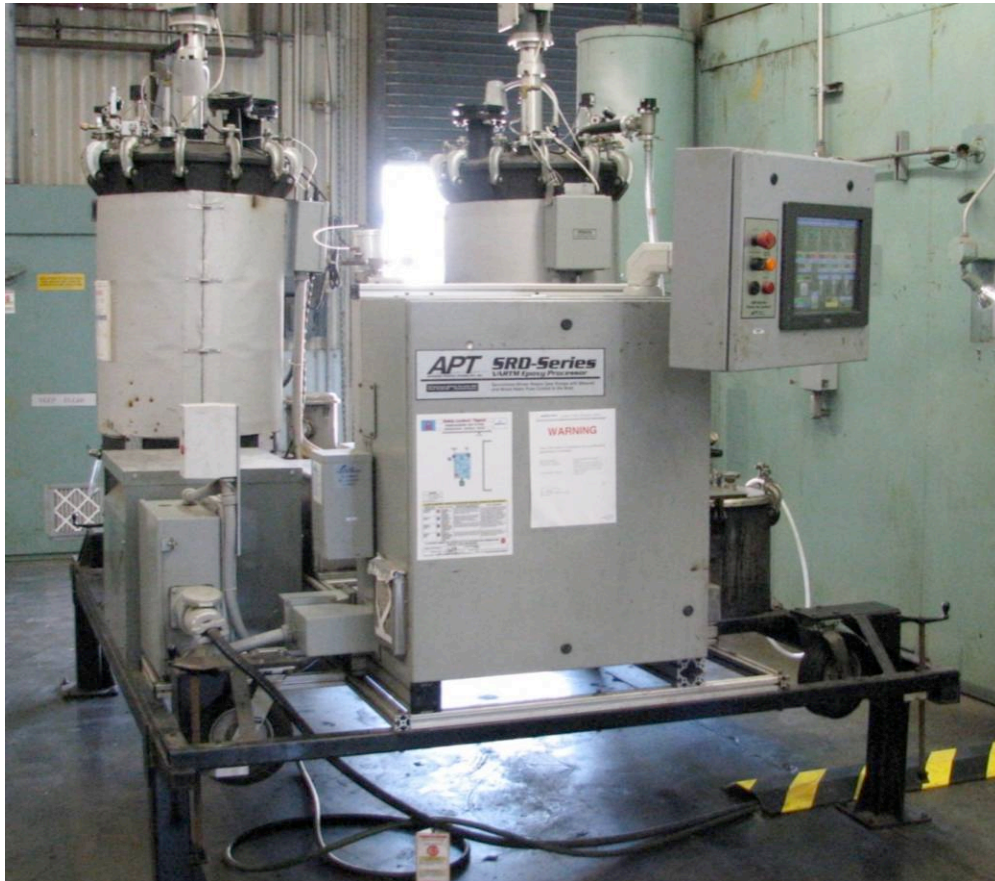
Figure 36. Automated Infusion Equipment Used for Resin Infusion

The 3-D preform was infused using CAPRI process. The resin was a Hexcel two-component amine cured epoxy system known as HEXFLOW VRM34. Resin infusion processing took place with the preform held in a cure tool, which was the only hard tooling required. The preform was infused and cured out. An automated machine was used to prepare and handle the resin (Figure 36). With this machine, the resin and hardener components were kept separated until just prior to entering the part mold fill line. The two components, resin and hardener, were automatically degassed, metered, mixed, and delivered on demand to the mold at the predefined temperature and pressure. The time that the mixed material was at elevated temperature within the machine was reduced to mere seconds, and more importantly, the volume of mixed material is minimized to reduce the chance of an adverse exothermic reaction and clean up time.

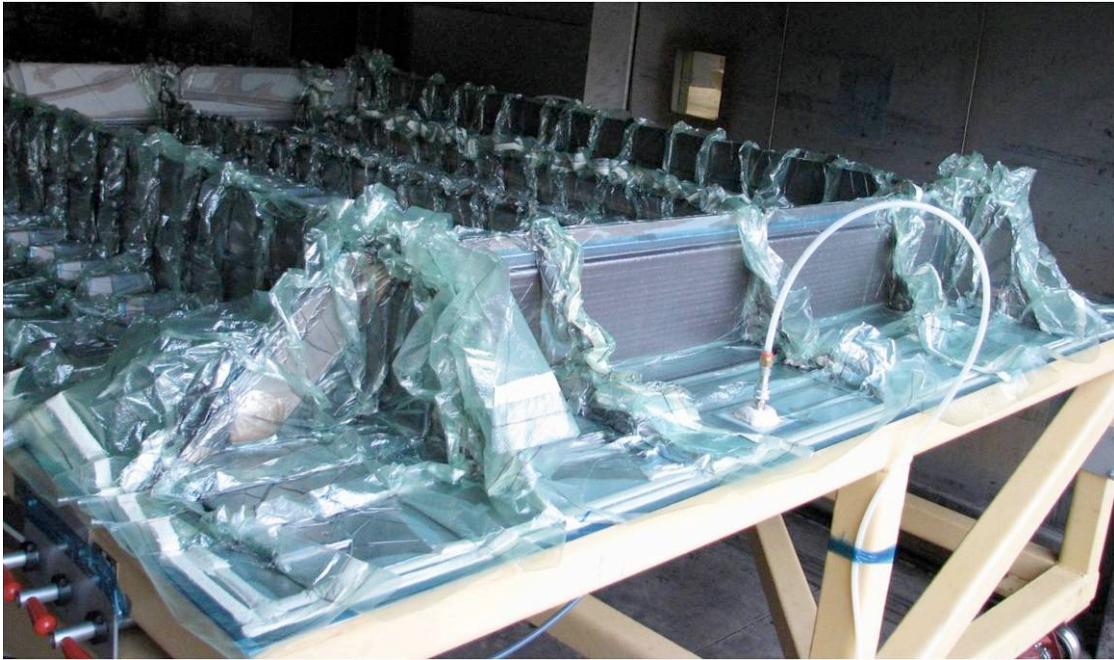
Figure 37. Infusion and Initial Cure Completed

Upon completion of the initial cure, the infused part was removed from the oven (Figure 37) where the bagging materials and resin lines could easily be removed to expose the IML surface of the part and the IML cure tool details (Figure 38). The vertical standing IML tooling plates were then broken away to expose the final cured interior surface of the part. The cured part was then placed back in the oven for the final 350°F free-standing post-cure cycle.

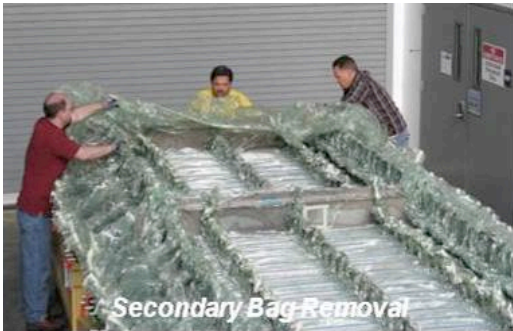
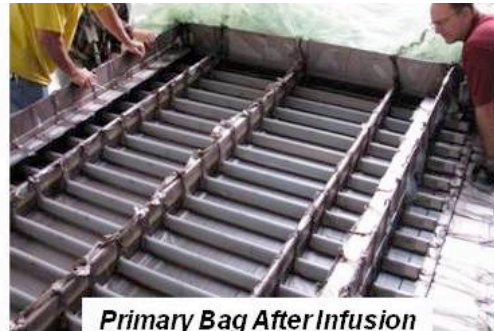
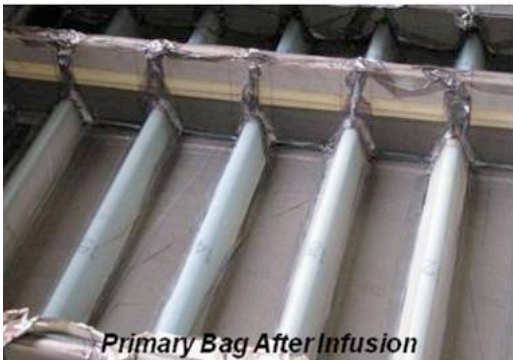
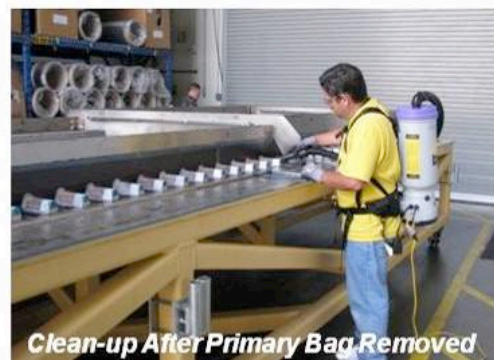
Secondary Bag Removal

Primary Bag After Infusion

Clean-up After Primary Bag Removed

Figure 38. Bag and Tool Removal Prior to Post Cure

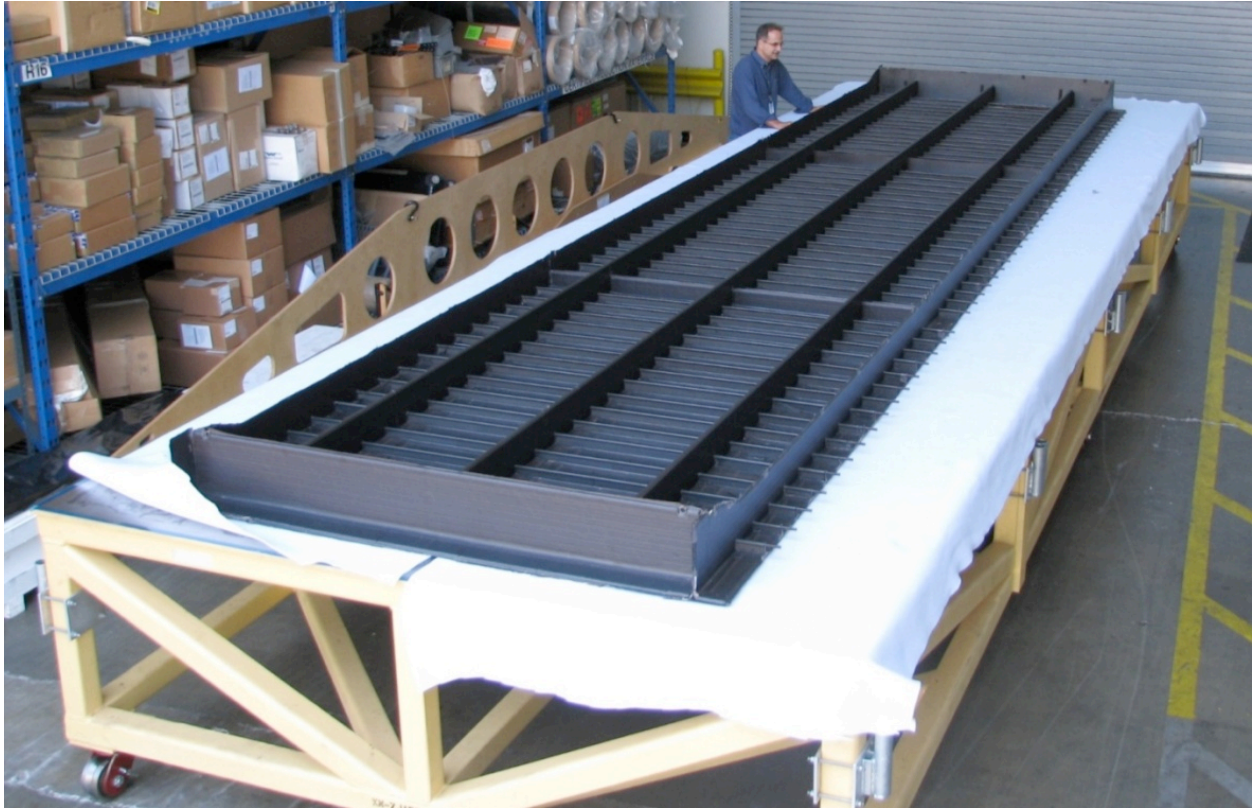
Figure 39. Final Cured Crown Panel Read for Edge Machining

The final cured crown panel is shown in Figure 39. Generally, all aspects of the design approach, tooling concepts, and processing elements worked as expected to produce a useable panel for the test article. Considering the panel size and complexity, along with the simultaneous introduction of new concepts for the IML cure tools, it was encouraging that the first panel off the tool was successfully infused and cured without major complications that would preclude its use, or lead to major tool modifications or process changes on subsequent panels.

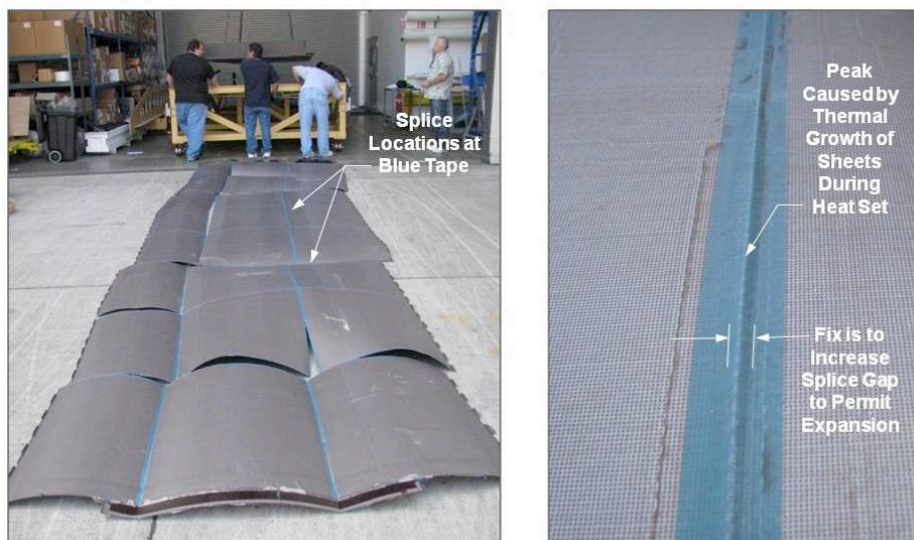
Figure 42. Perforated Caul Sheets from Crown Panel Infusion (Revised for Subsequent Panels)

Since the resulting pattern matched the edges of the individual caul sheets, it was quickly determined that the difference in thermal expansion between the low-carbon steel perforated sheets and the Invar cure tool caused the interference. In addition to the mark-off, permanently buckled regions occurred in the caul sheets themselves along the spliced edges indicating that the sheets had grown during the cure cycle and caused permanent deformations in the regions with the smallest gaps between the sheets (Figure 42). On subsequent panel infusions, this problem was resolved by increasing the spacing between the caul sheets which eliminated the interference condition that led to the grooves in the first panel (Figure 66).

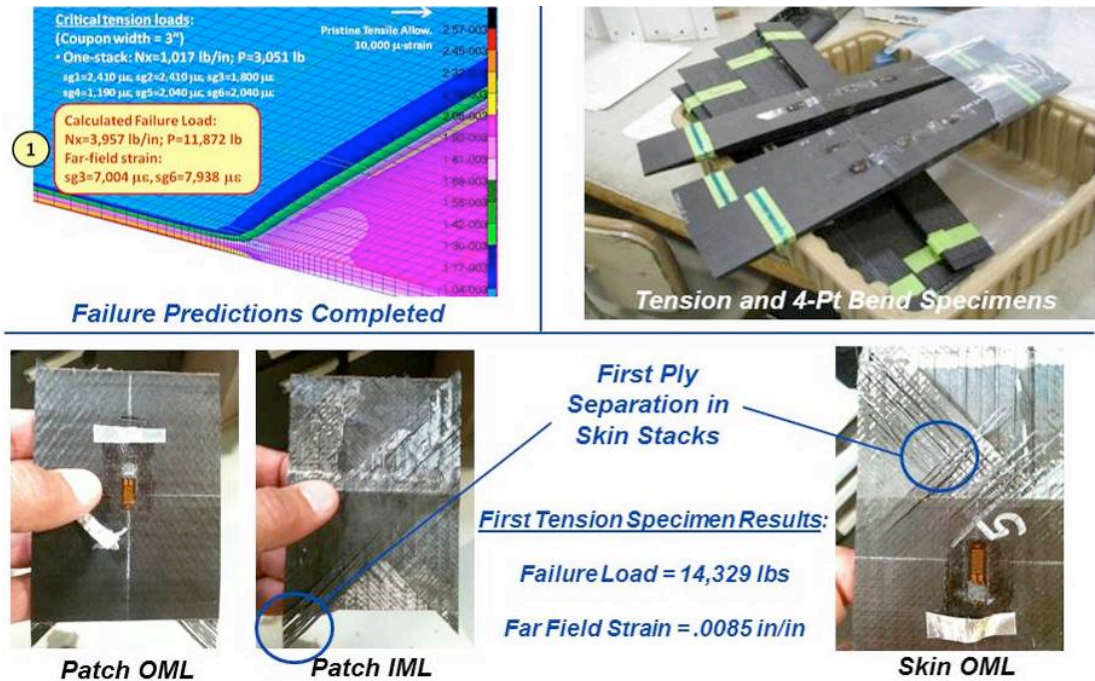
Figure 46. Coupon Testing Used to Validate Repair Design and Processes

The coupon specimens were fabricated and tested under tension and 4-point bending loads to simulate the critical conditions for the crown panel (Figure 46). In both cases, as expected, a classic first-ply failure separation occurred between the outer +/- 45-deg layers of the skin stack at a far-field strain averaging 0.0085 in/in, which exceeded the notched tension design allowable used to design the crown panel.

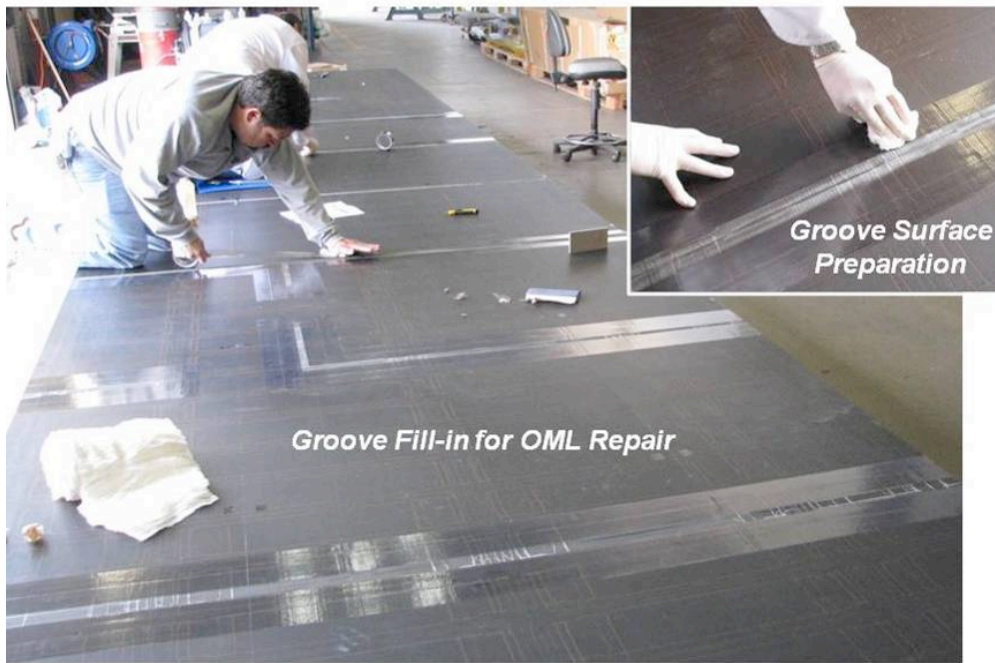
Figure 49. Crown Panel OML Surface Prepared for Repair

Simultaneously, the crown panel OML surface was prepared by filling in the grooves, sanding them flush, grit blasting the bonding regions, and then conducting water-break tests to verify the prepared surface condition. (Figure 49 & Figure 50)
