NASA/CR-2014-218149

PRSEUS Panel Fabrication Final Report

*Kim A. Linton, Alexander Velicki, Krishna Hoffman, Patrick Thrash,
Robert Pickell, and Robert Turley
The Boeing Company, Huntington Beach, California*

January 2014

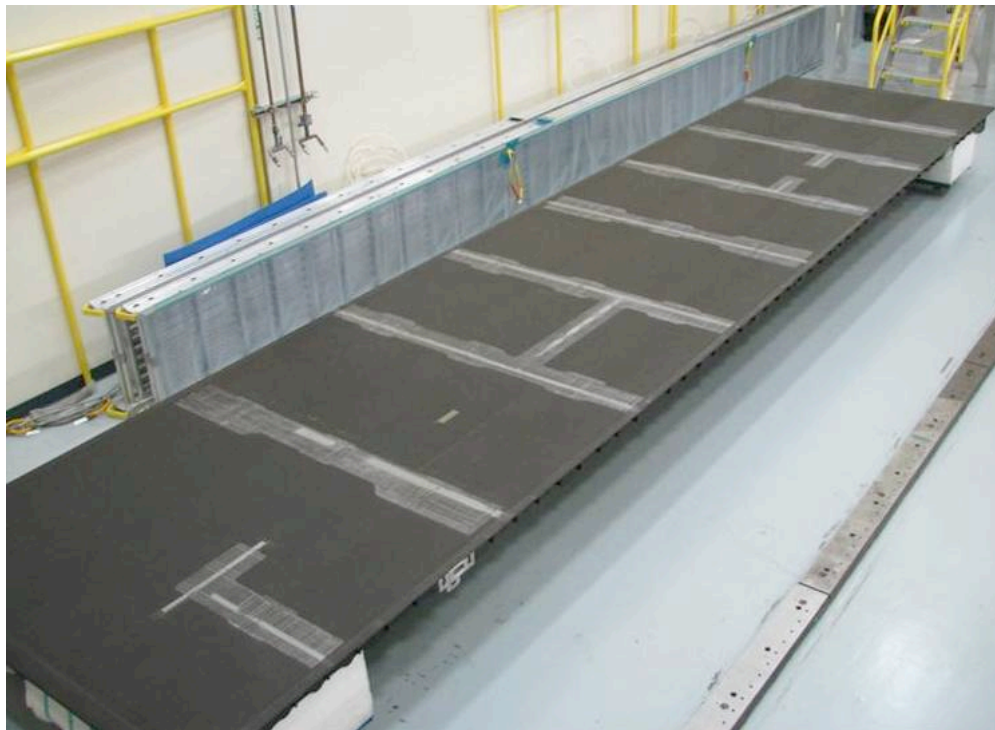
Figure 50. Bonding Surfaces were Readied for Repair Patches

Simultaneously, the crown panel OML surface was prepared by filling in the grooves, sanding them flush, grit blasting the bonding regions, and then conducting water-break tests to verify the prepared surface condition. (Figure 49 & Figure 50)

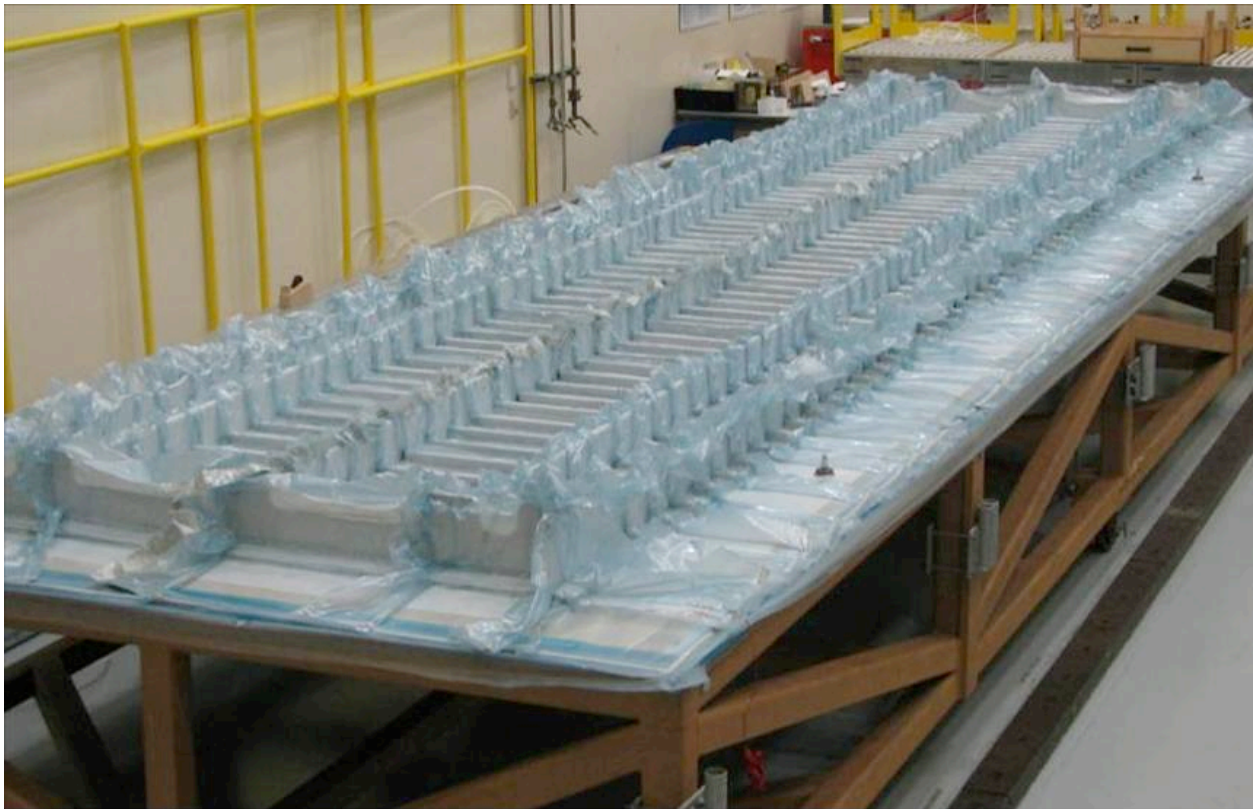
Figure 52. Bagged Crown Panel with IML-side Up and Repair Patches Taped to the OML

The prepared patches were then located into position, taped along the edges to secure them, and marked to aid in finding the bleed holes after the bonding cycle (Figure 51). The panel was then flipped over onto the cure tool and vacuum bagged (Figure 52).

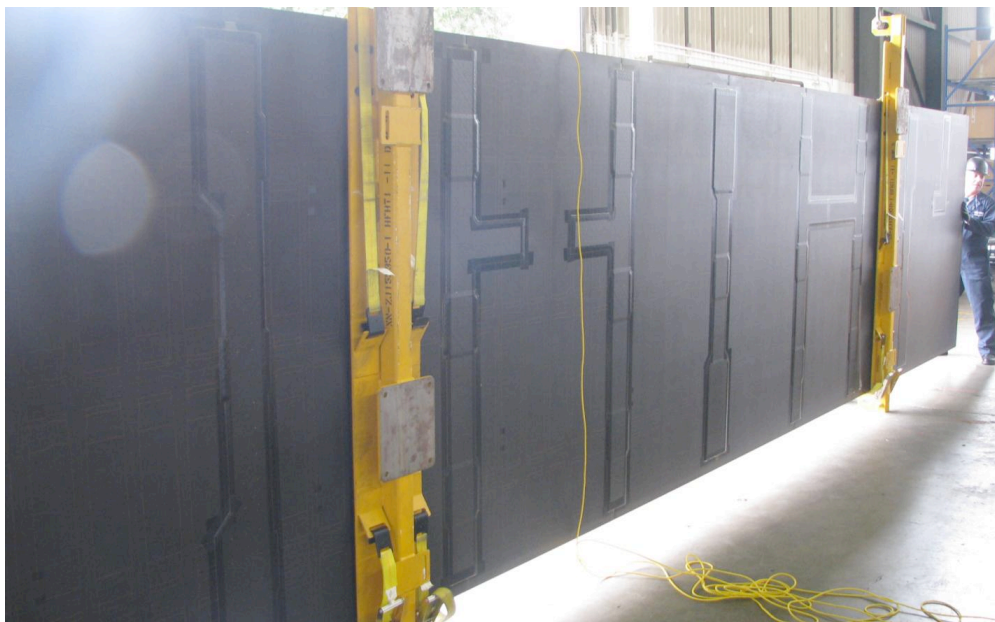
Figure 54. Completed Bonded Repair Patches on Crown Panel OML

Due to the large variation in geometric complexity of the internal structure covered by the patches, the use of common inspection techniques via pre-sampled reference standards was not practical, therefore no ultrasonic non destructive inspection was performed. The repair was bought-off based on using the same process control standards as the test coupons, visual inspection of the adhesive wet-out, tap testing of the completed repair, and ultimately the favorable results of the coupon test effort. The repaired panel was then delivered to the assembly site (Figure 54).

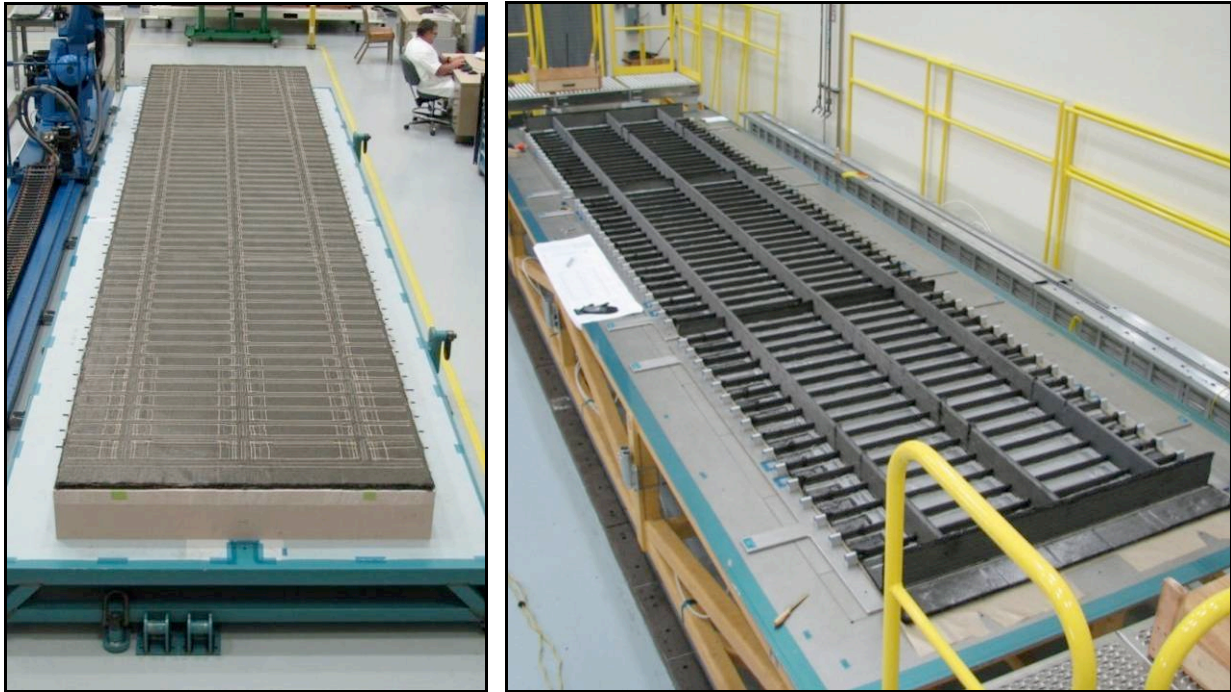
Figure 55. Completed Floor Panel Stitched Preform

The floor panel design is similar to the crown panel except that it does not have the integral cap features at the forward and aft edges. As such, the preform was built on the common stitching table, but required some new foam blocks and wooden frames for the edges that were specifically developed for the floor panel configuration. The preform details were loaded into the tool and stitched in the same manner as the crown panel described earlier before being flipped onto the cure tool, where the internal foam blocks and wooden frames could be removed to reveal the self-supporting dry carbon fabric preform (Figure 55).

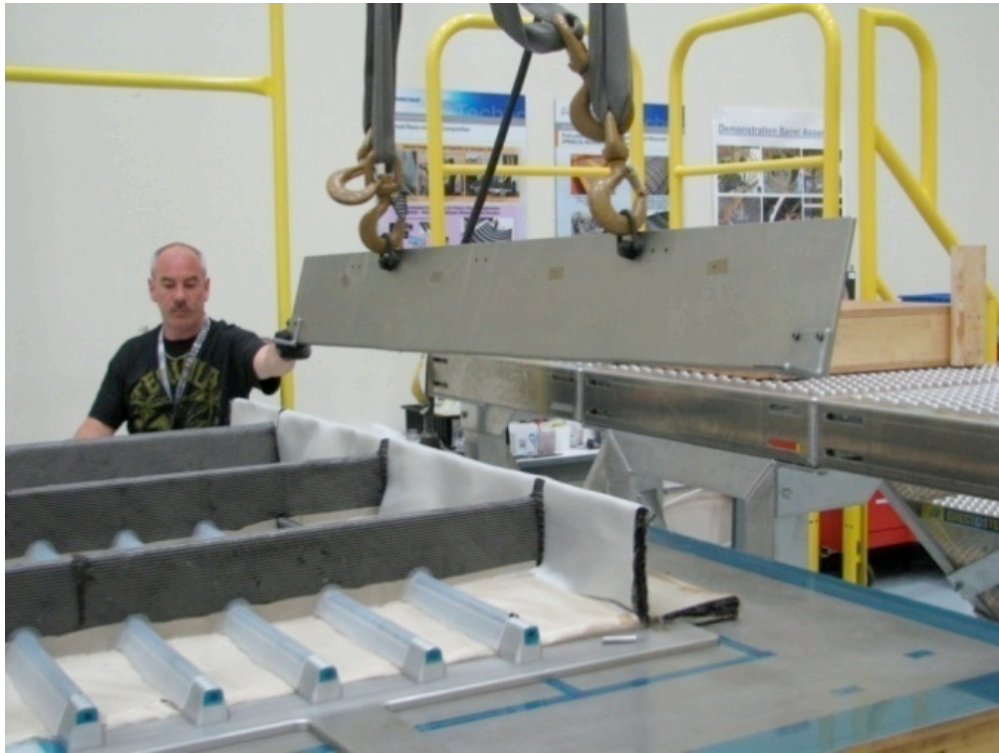
Figure 56. Integral Cap Tooling Plate Installation

The preform was then positioned onto the cure tool and located by the IML tooling details around the perimeter. The vertically positioned IML cure plates were placed underneath the bag to form the smooth tooled surfaces on the integral cap features (Figure 56). The remaining IML cure tool details, silicon rubber bagging aids and aluminum channels on frame caps were also added (Figure 57).

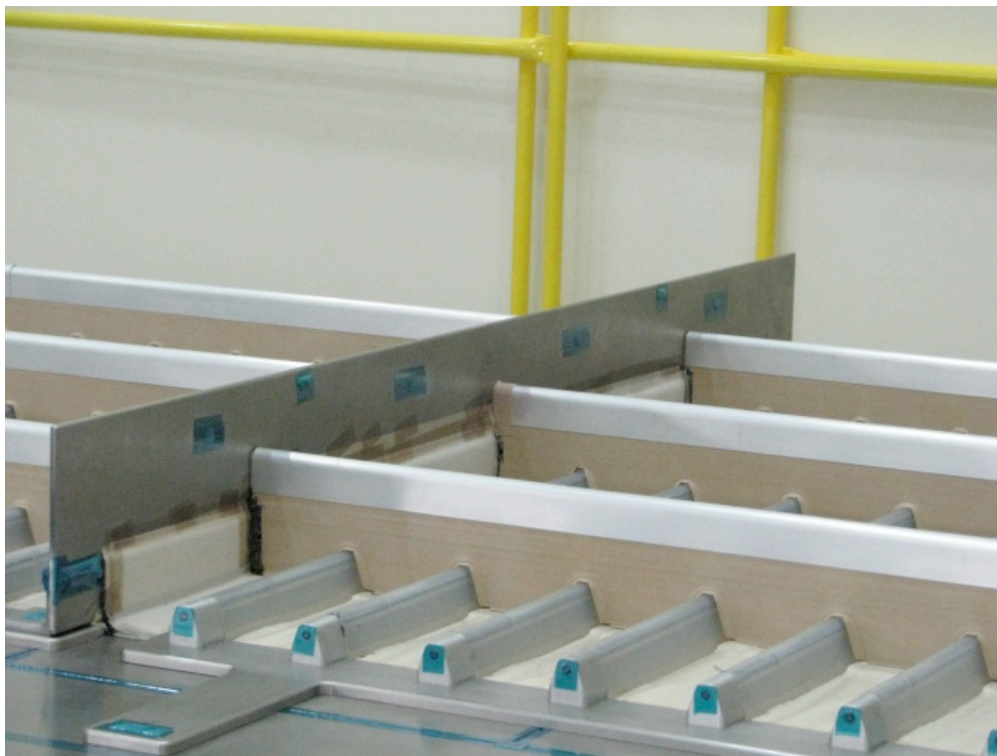
Figure 57. Bagging Aids on Frames and Stringers

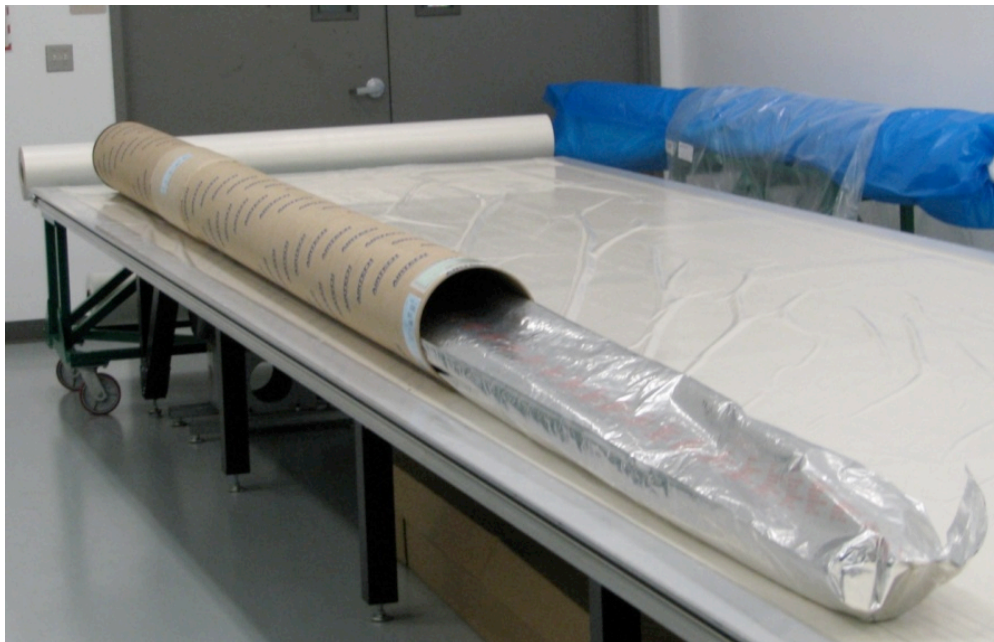
Figure 58. New Pre-Conditioned Vacuum Bag Delivery Packaging

The first step in the new process was to receive the bagging film from the supplier in a rolled and fully moisture-saturated condition, rather than the loosely controlled folded state where high stress concentrations at the double-folded corners were becoming initiation sites for bag cracking. In addition to having the vendor initially steam treat the bags, tighter control of the bag moisture content was also maintained during transport, storage, and the pleating operation on the shop floor. The first new precondition bag and packaging packing system received is shown on the cutting table in Figure 58 prior to use.

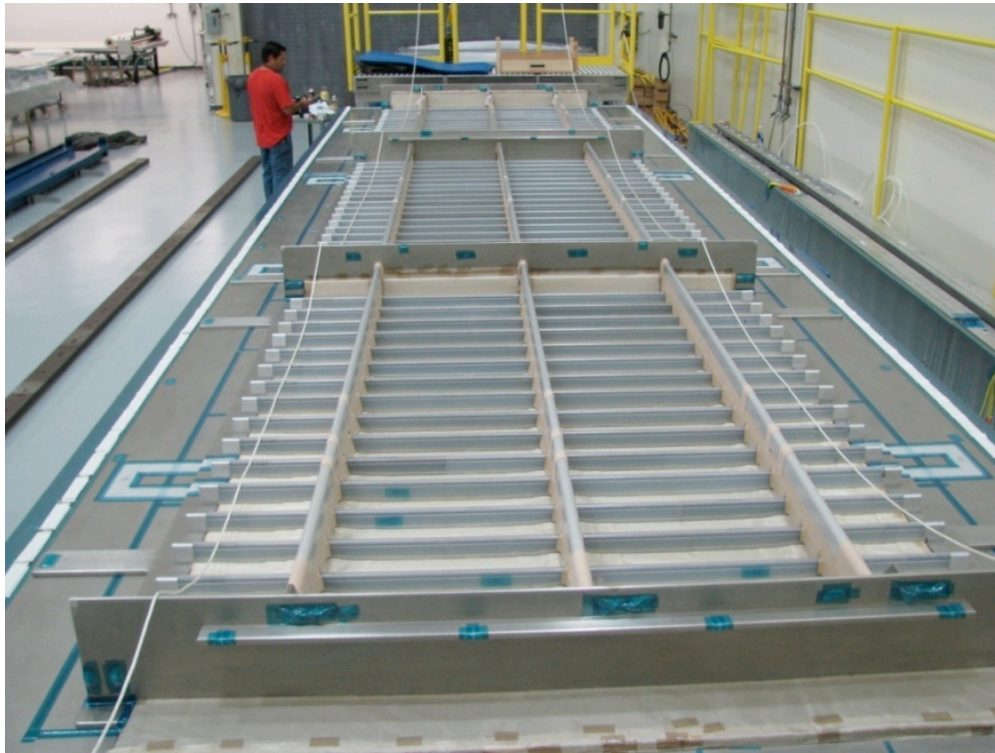
Figure 59. Added Lanyards to Support Bag During Unrolling Operation

Next, two lanyards were added at the edges of the tool to help the bag clear the IML tooling plates as it was unfurled onto the cure tool (Figure 59). Both changes were helpful in reducing the trauma inflicted on the bagging film by the previous method of unfolding, dragging, and pleating the bag across the part and tooling surfaces. Ideally in a production scenario, the vacuum bags should arrive in a pre-pleated, rolled-up state, and packaged in an environmentally-controlled bag media that maintains the high moisture content needed to maximize the workability of the bagging film.

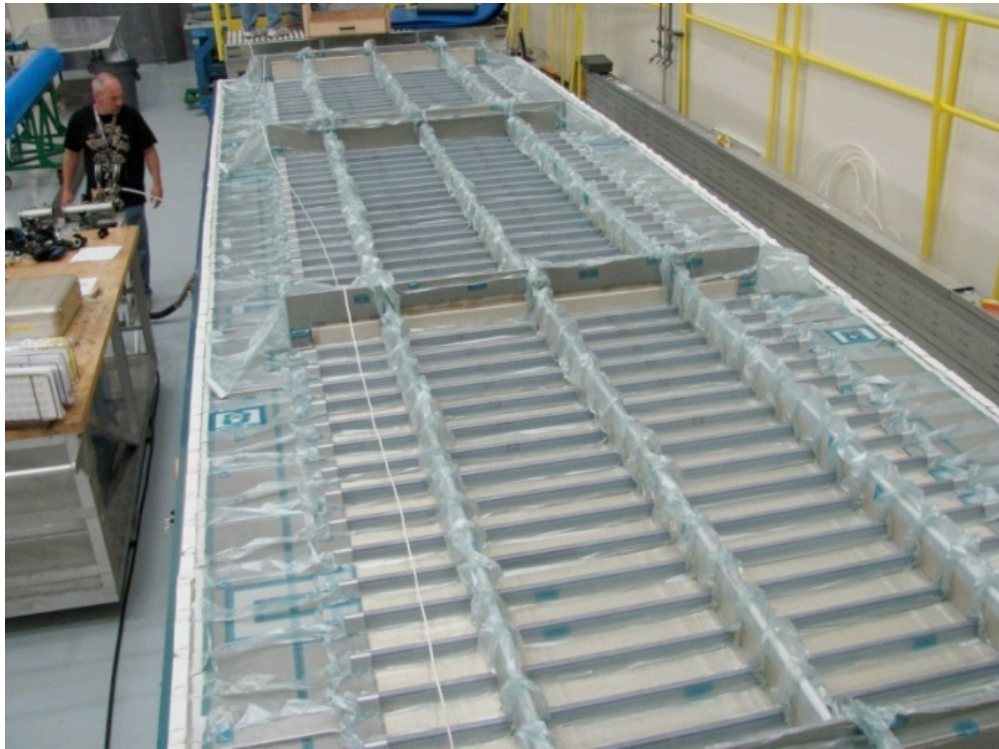
Figure 61. Primary Bag Installed and Leak Checked

Once the tool benching was completed and the preform was re-bagged with new primary and secondary vacuum bags, it easily passed the vacuum checks without further leaks (Figure 61 and Figure 62). The floor panel was then placed back in the oven and cured without incident (Figure 63 and Figure 64).

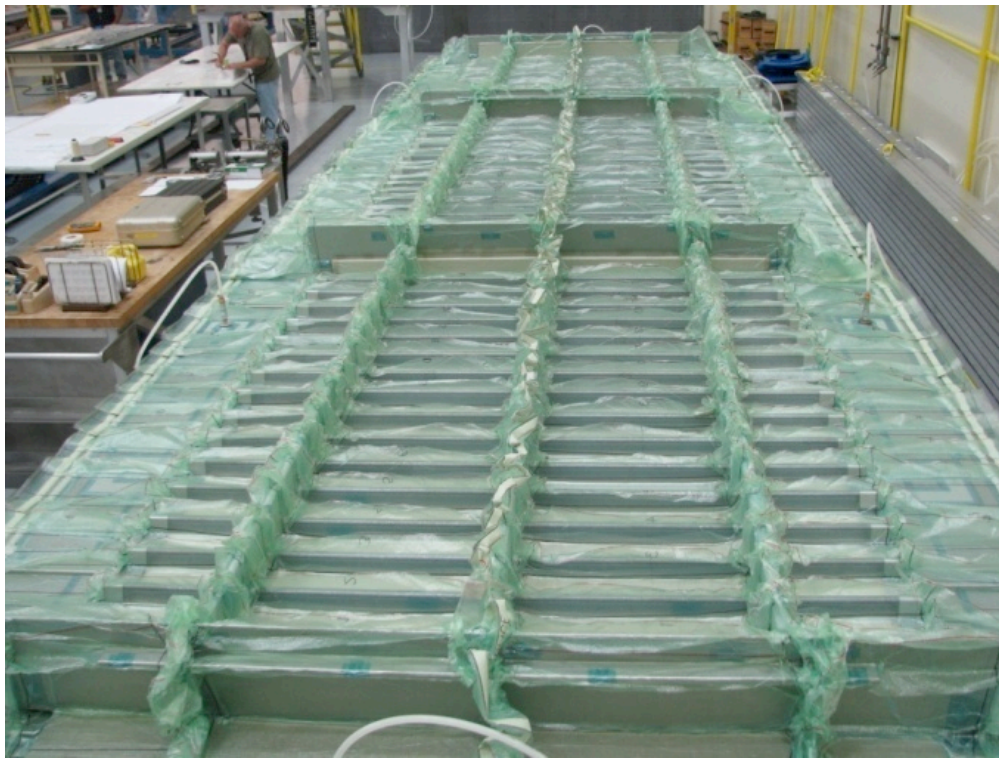
Figure 62. Secondary Bag Installed and Leak Checked

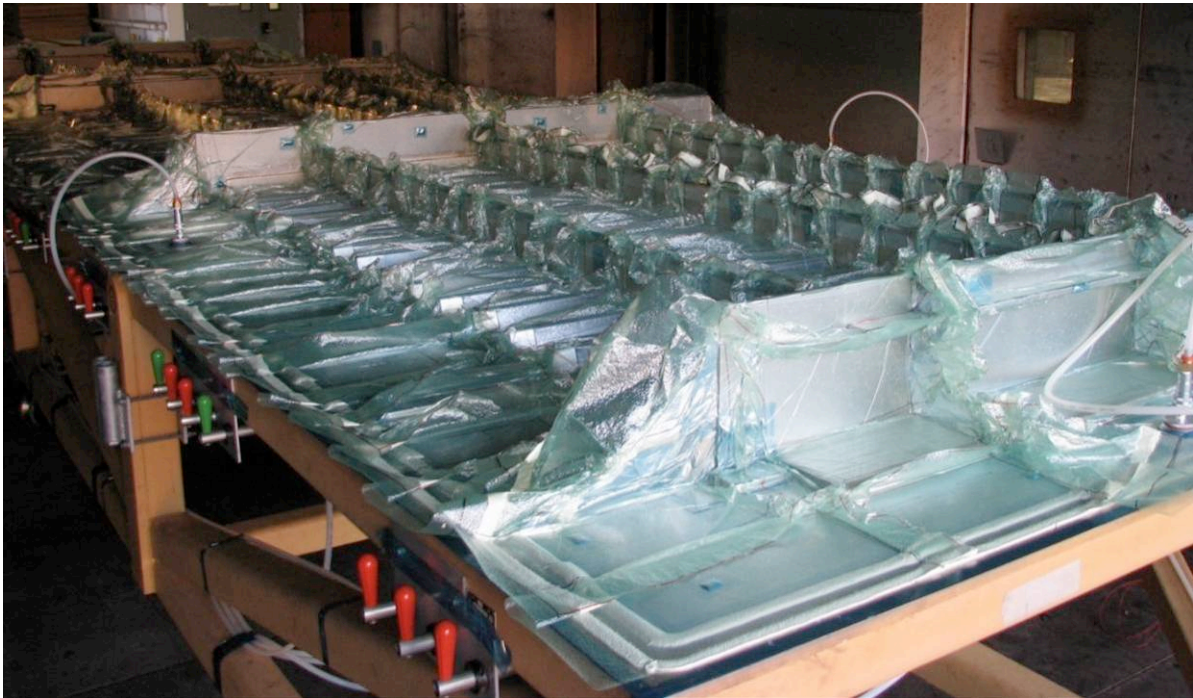
Figure 63. Floor Panel Preform Placed in Oven Ready for Heat-up, Infusion, and Cure

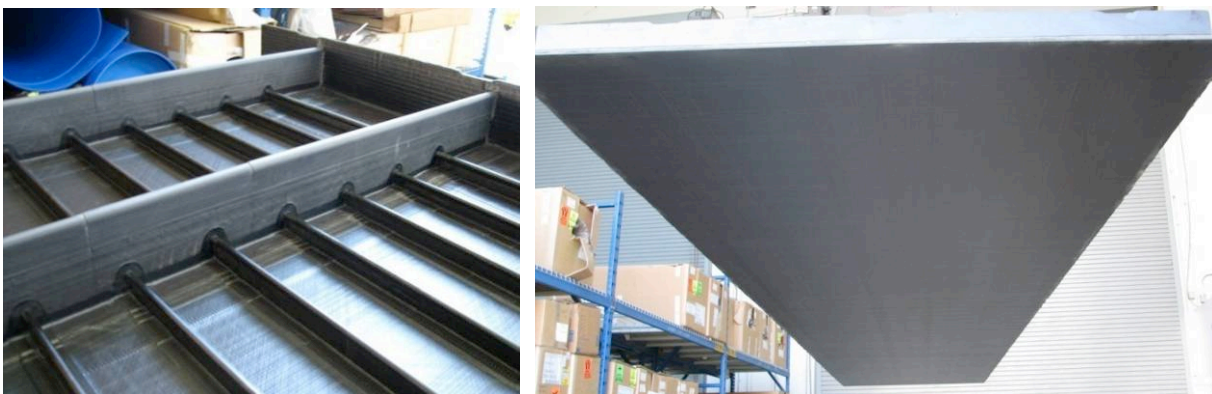
Figure 66. Floor Panel IML and OML Cured Part Surfaces

The resulting floor panel (Figure 65) had high quality IML features and did not have any of the grooves or excessive mark-off (Figure 66) that was prevalent on the crown panel. The cured floor panel was inspected and then placed in storage until the edge trim operation could be scheduled at the machining vendor.

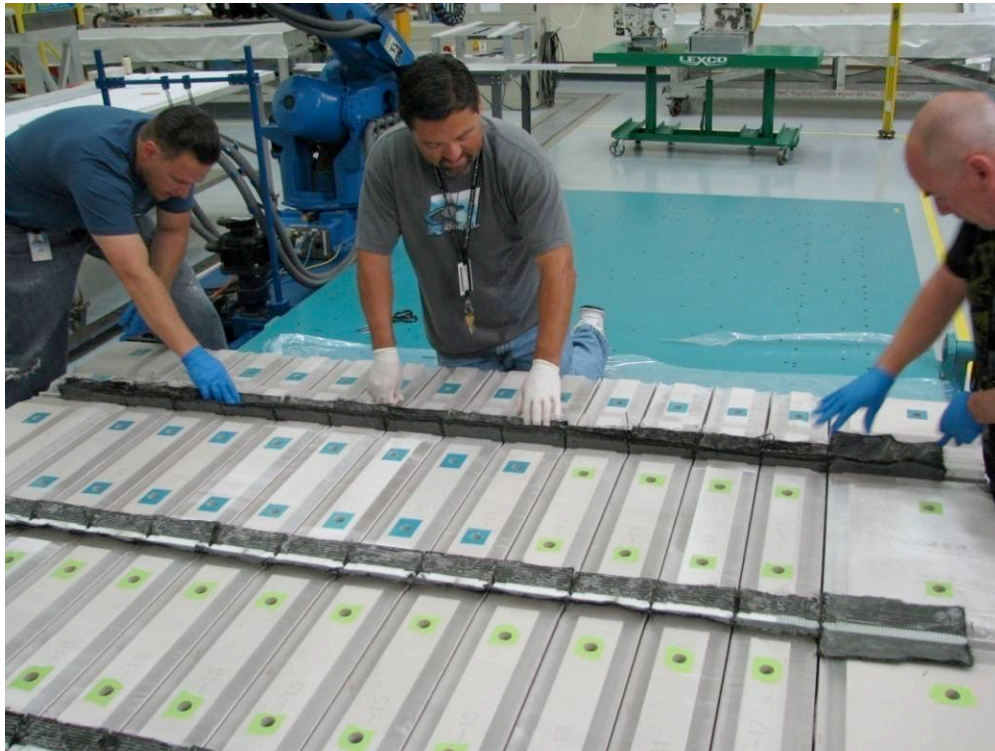
Figure 67. Outer Rib Preform Assembly – Frame Installation

Due to their smaller size and reduced complexity, the two outer rib panels provided an excellent opportunity to demonstrate the process improvements based on the lessons learned with the crown and floor panels. Once the reworked frame elements were loaded in the stitching tool (Figure 67), the remaining details came together quickly (Figure 68), and the stitching (Figure 69) was completed ahead of schedule.

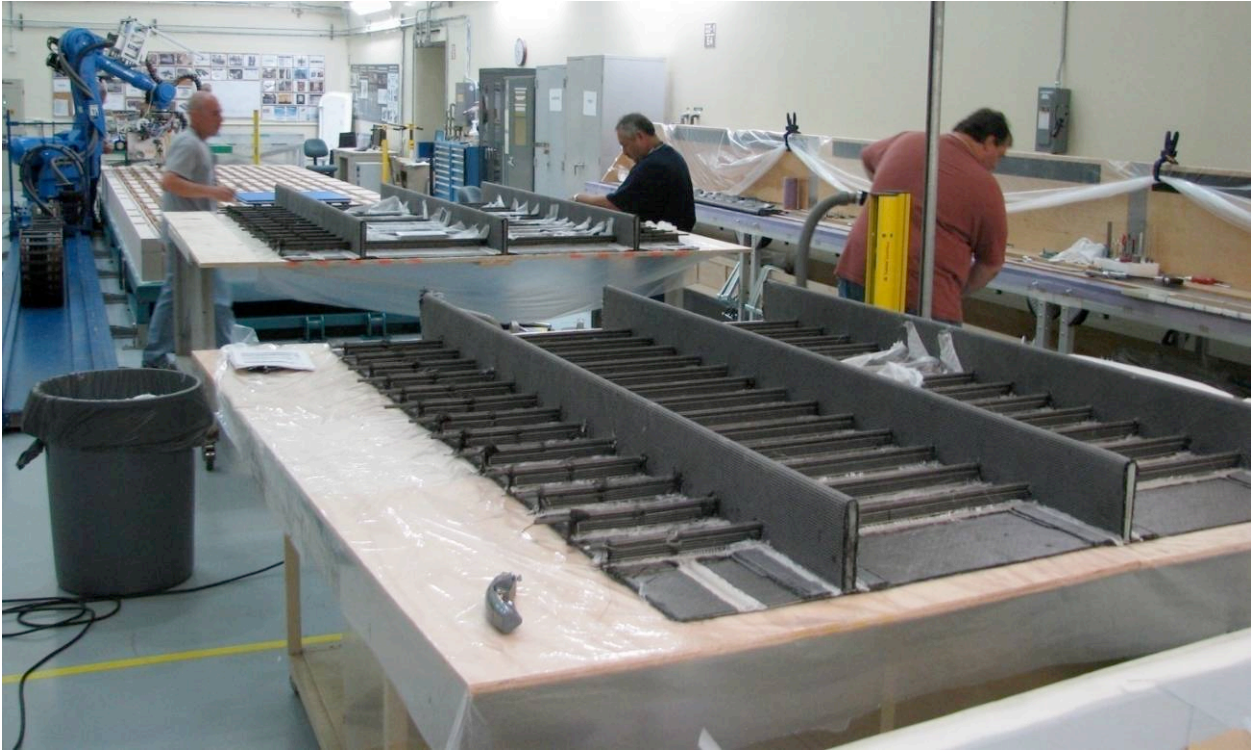
Figure 70. Two Outer Rib Preforms were Fabricated Simultaneously

The first stitched preform was then set aside until the cure tool could be cleaned and rigged with the IML tooling details. Meanwhile, the stitching tool details for the second outer rib panel were quickly reassembled and the second preform was brought together and stitched. The two completed dry preforms are shown together in Figure 70.

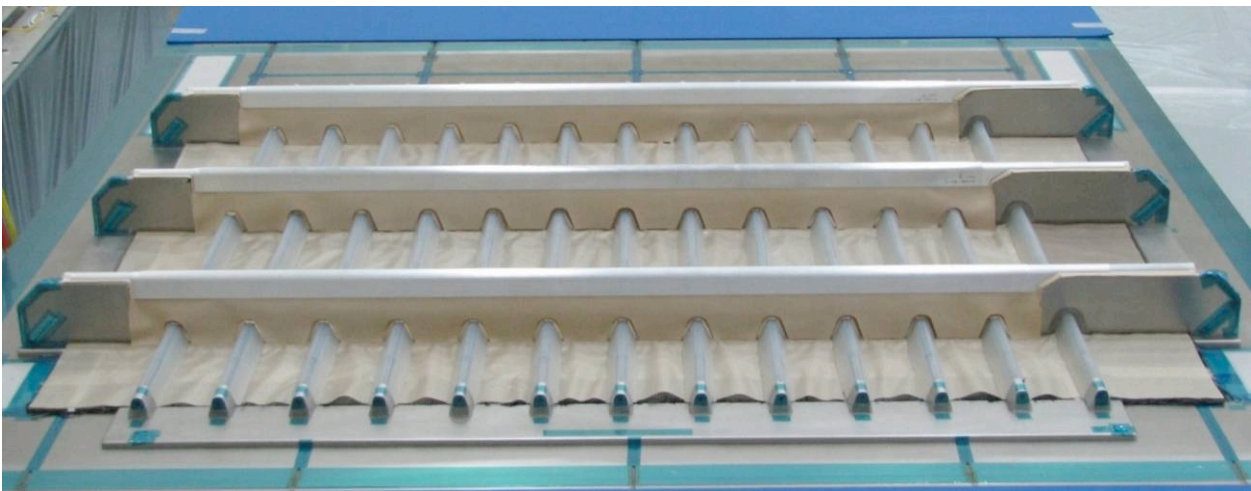
Figure 71. IML Tooling Placed on Preform

Once the cure tool was ready, the first preform was loaded into position so the IML cure tool details could be positioned (Figure 71). It was then covered with the primary and secondary bags using the newly developed bagging procedures, and then vacuum checked (Figure 72).

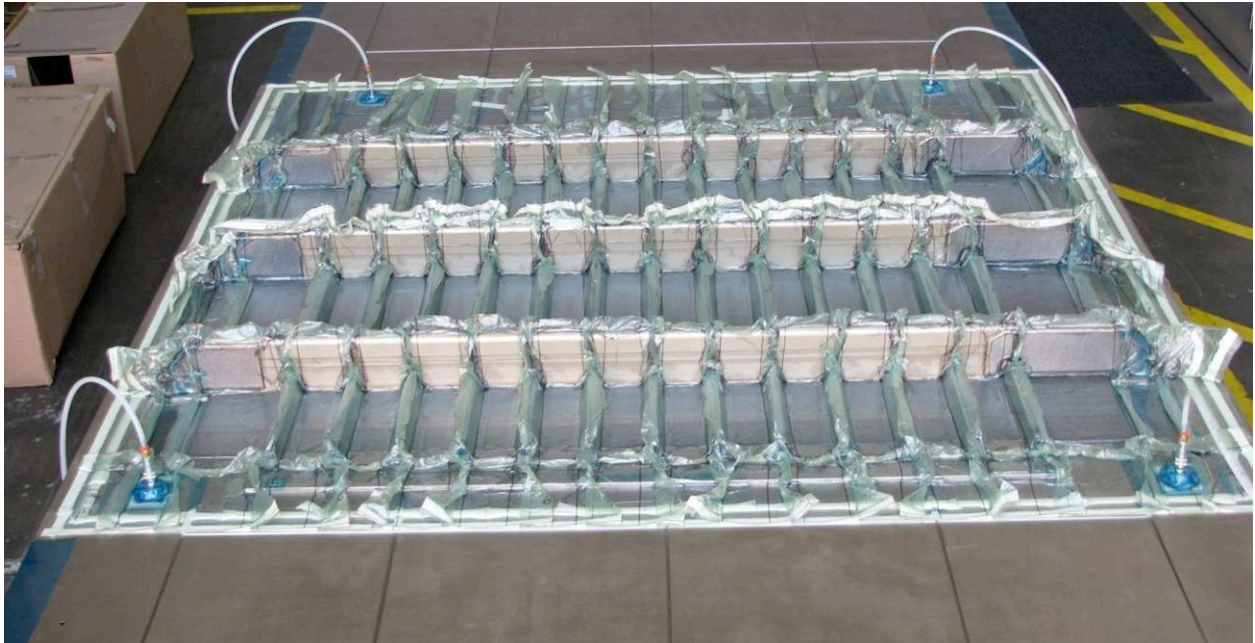
Figure 72. Bagged Outer Rib Panel During Vacuum Check

The bagging improvements were immediately apparent and repeated on both panels. Neither panel leaked during any of the vacuum checks. This single improvement had a substantial impact on reducing the processing schedule for the outer rib panels, shaving 2-3 weeks off the span time. Both panels were infused and cured in a two week period without any defects. The IML and OML surfaces for outer rib panel #1 are shown in Figure 73, and outer rib panel #2 in Figure 74. The cured panels were trimmed to their final shape (Figure 75). A completed outer rib is shown in Figure 76 and Figure 77.

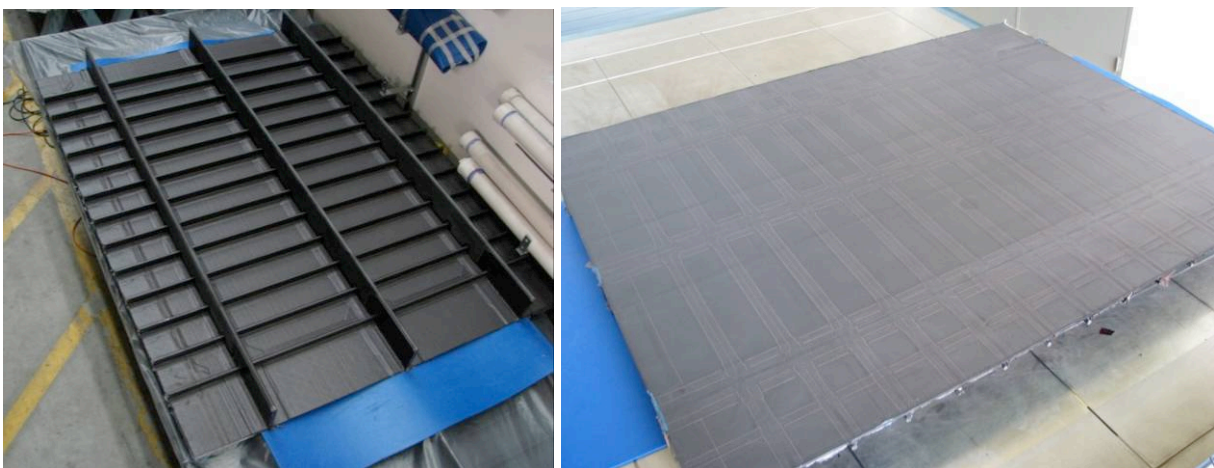
Figure 73. First Untrimmed Cured Outer Rib Panel - IML and OML Surfaces

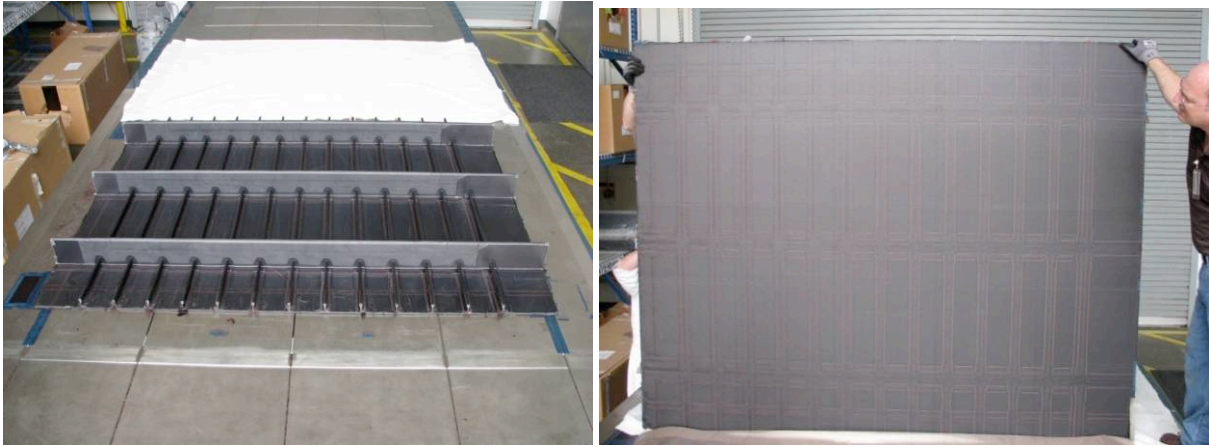
Figure 74. Second Untrimmed Cured Outer Rib Panel - IML and OML Surface

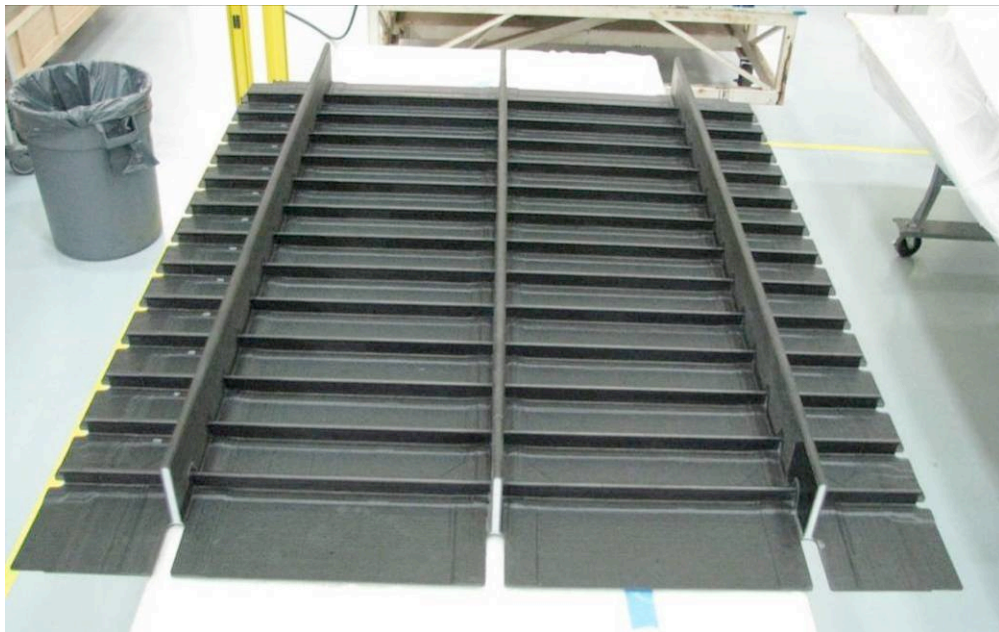
Figure 77. Finished Outer Rib Panel – IML Surfaces

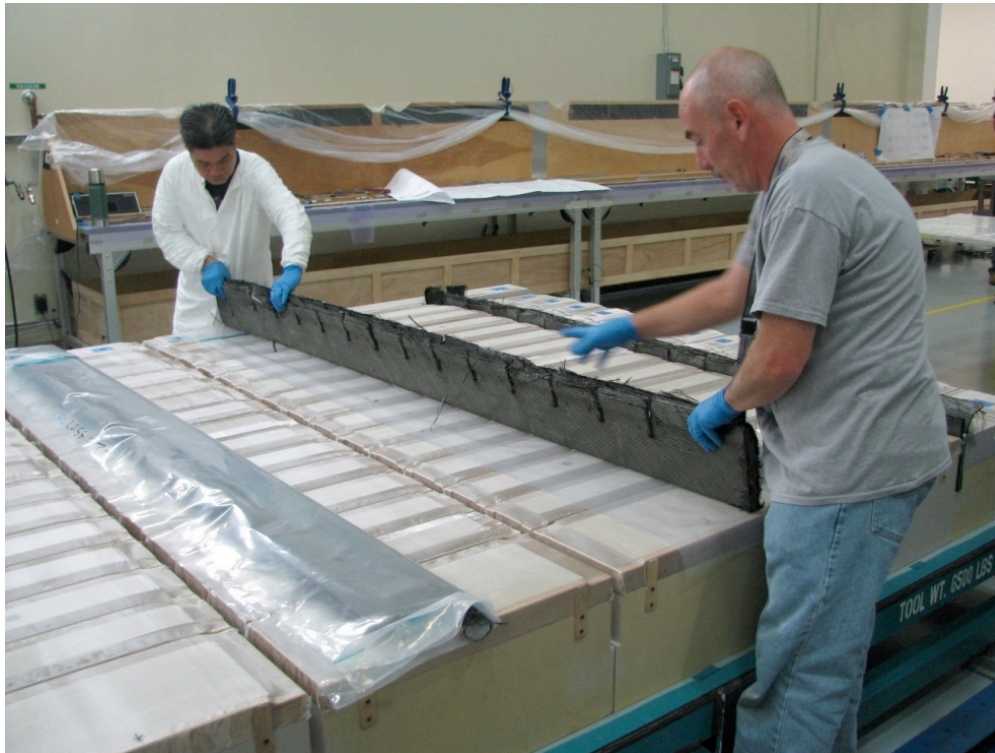
Figure 79. Frame Installation on First Upper Bulkhead Panel

Due to the shorter length, the frame installation went quickly (Figure 79); as did the installation of the integral cap stacks around the edges (Figure 80).

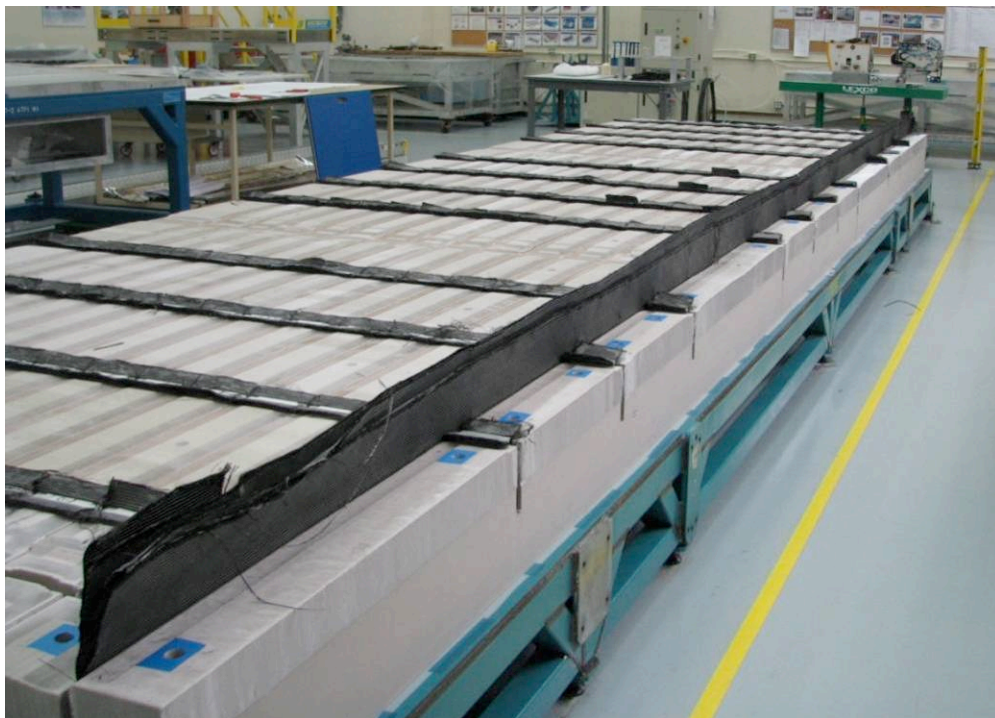
Figure 80. Integral Cap Stacks at Panel Floor Line Installed

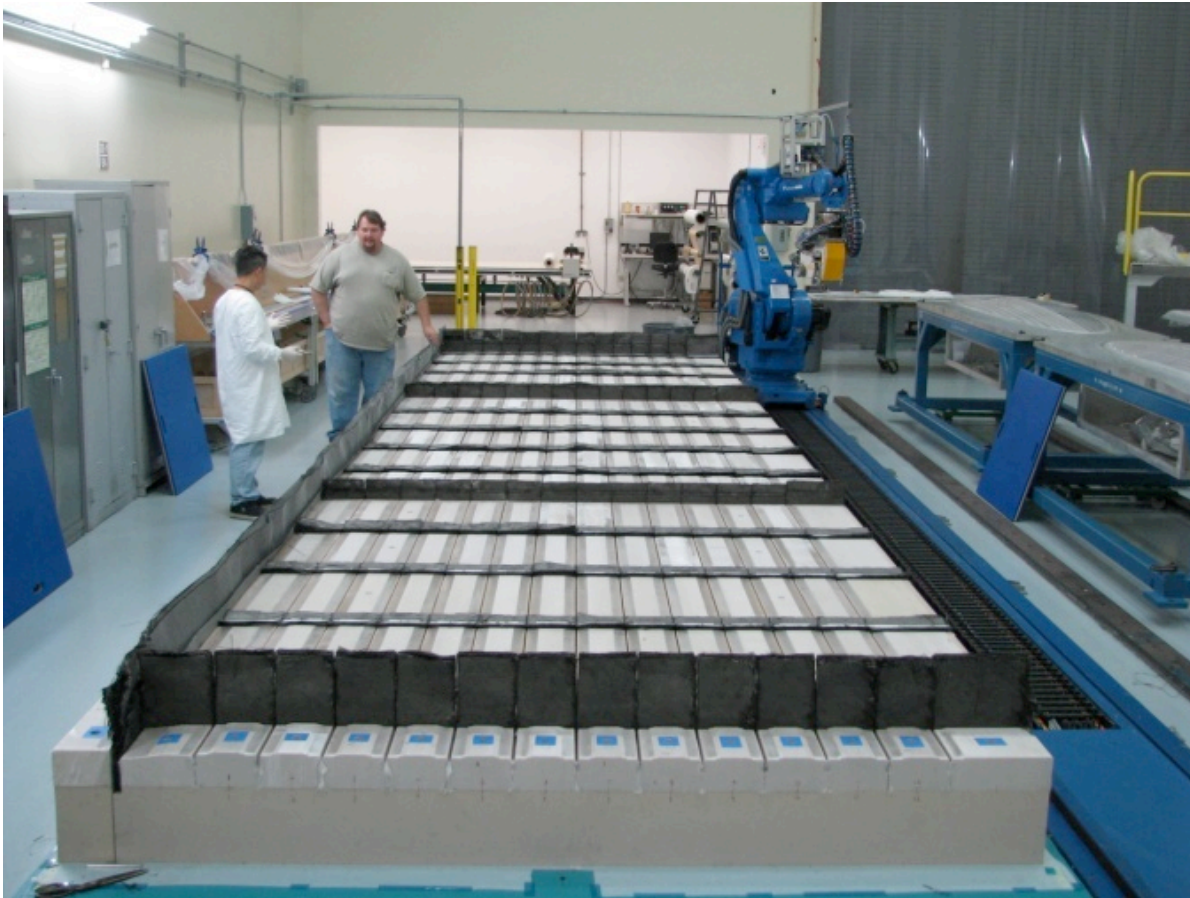
Figure 81. Integral Cap Features Installed

Once all of the integral caps were installed, the flange edges were folded down (Figure 81 and Figure 82). The stringer subassemblies were then loaded into their respective slots. (Figure 83).

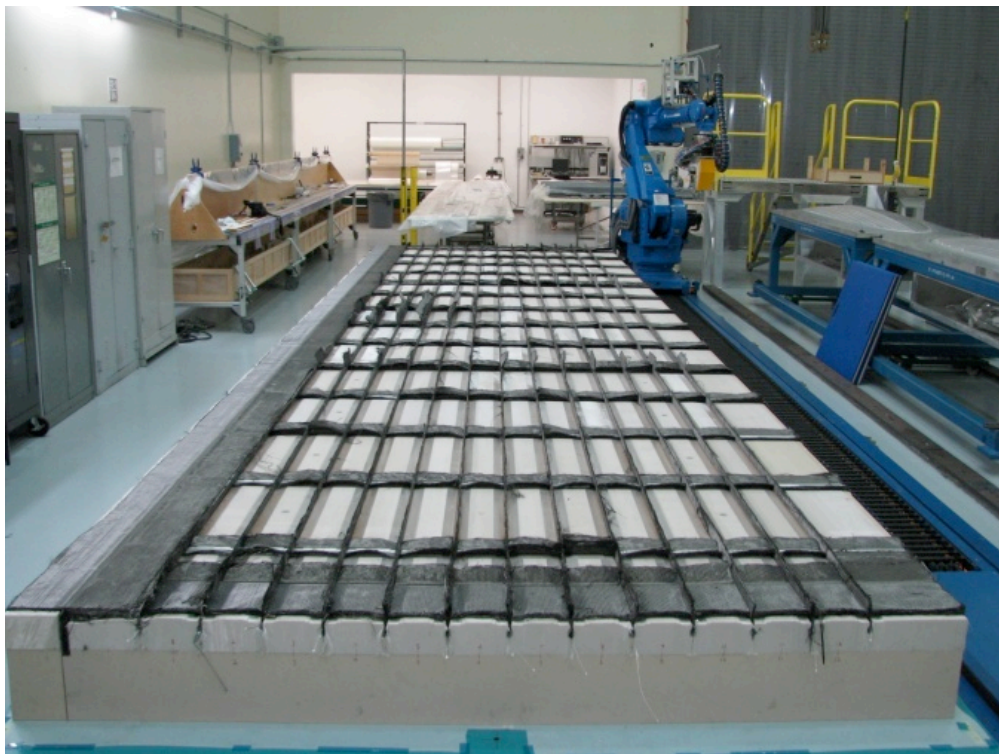
Figure 83. Upper Bulkhead Stringer Stacks Inserted into the Stitching Tool

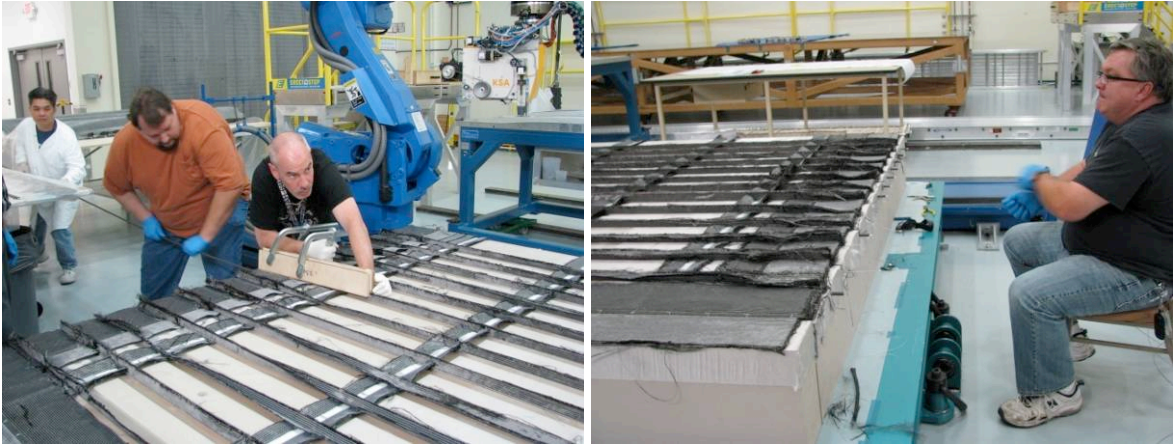
Figure 84. 30-ft Rods were Inserted into the Preform

The next step was to pull the rods through the 30-ft length of the tool. The frictional forces build up as the rod moves through the preform and were primarily driven by the key hole size (diameter) in the frame core and the relative key hole alignment from frame to frame. In this case, the technicians applied hand forces to pull and simultaneously push the rods through the cavities without the use of any specialized tooling (Figure 84 and Figure 85). Once the rods were inserted, the tear straps were added, followed by the skin stacks (Figure 86). The completed stitched preform shown in Figure 87 was ready for infusion.

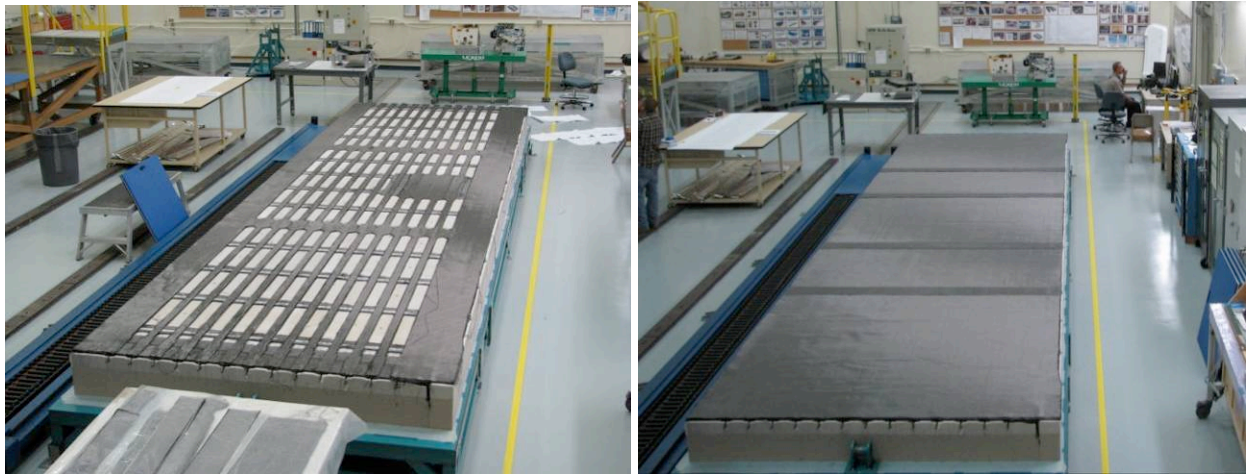
Figure 86. Tear Straps Placed First, Followed by Skins and Skin Stack Splices

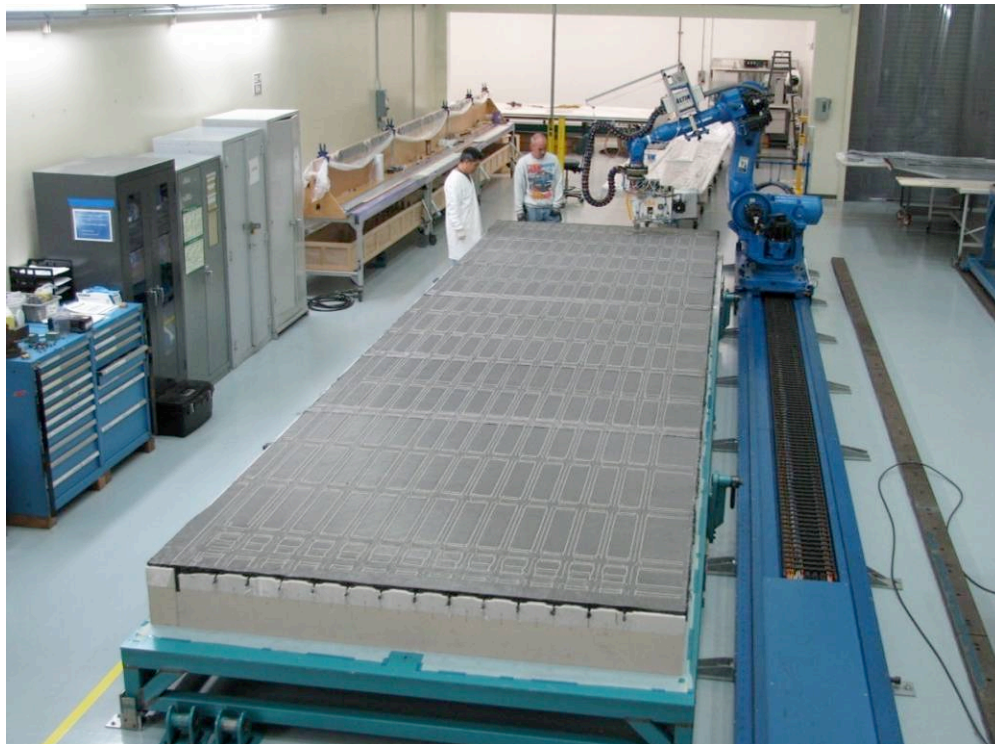
Figure 87. First Upper Bulkhead Panel Stitching Completed

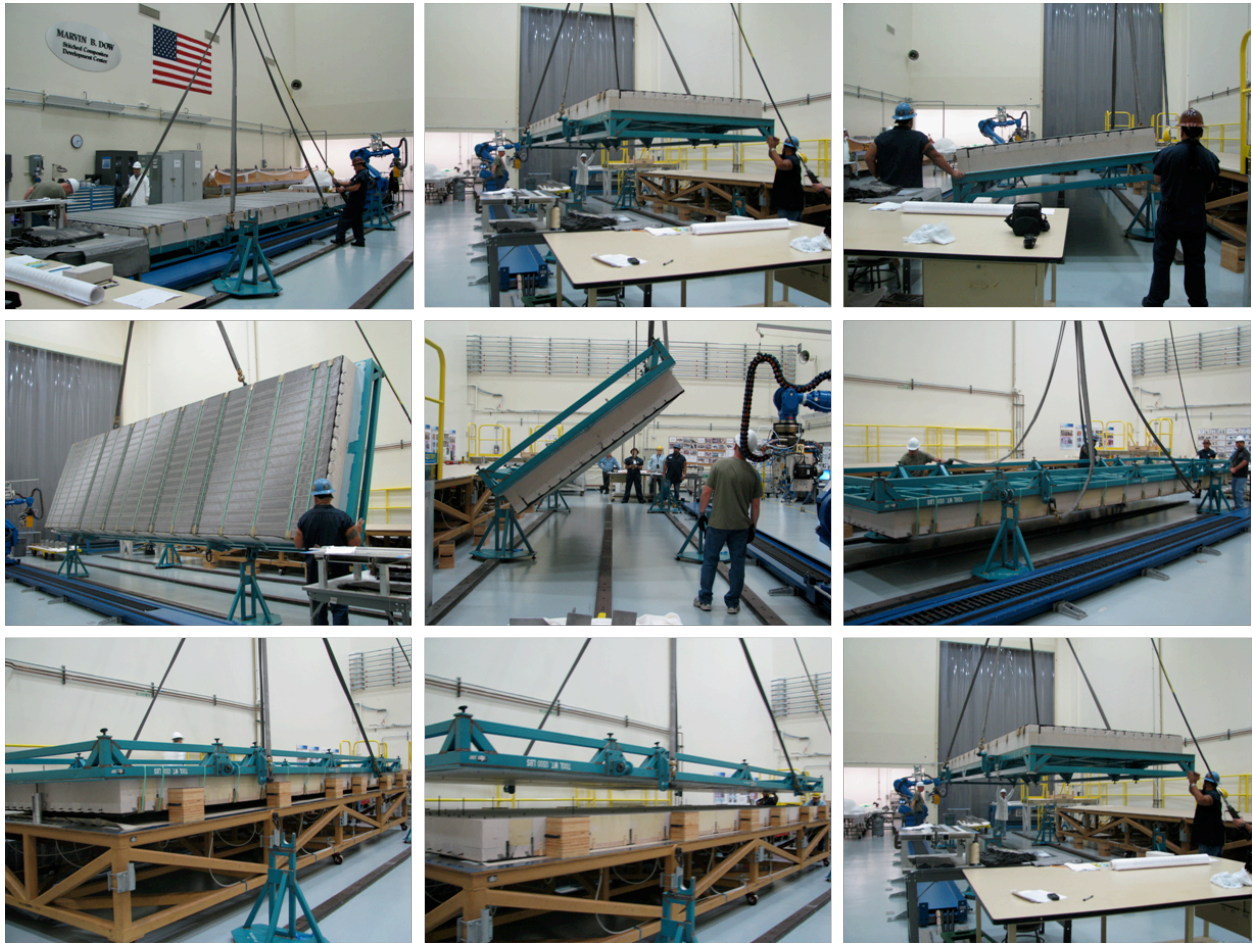
Figure 88. Transferring the Upper Bulkhead Panel Preform onto the Cure Tool

The completed preform was transferred onto the cure tool by rotating the preform assembly tool and releasing the preform from the assembly tool (Figure 88). Hard tooling points were used to precisely index the preform on the cure tool. IML cure details were then pinned into position to accurately locate the key features of the panel (Figure 89). The primary and secondary vacuum bags were installed. The completed preform is then ready to be moved into the oven as shown in Figure 90. The untrimmed cure panel is shown in Figure 91. A special shipping cart (Figure 92) was designed and built to transfer these large panels to and from the vendors for panel trimming. This shipping cart fits into a standard Sea Van container to protect the panel from damage during shipment. The panel was trimmed on a machine that was large enough to trim the entire panel in a single set-up to maintain the tight tolerance of the Determinate Assembly (DA) holes used during assembly of the MBB (Figure 93).
