NASA/CR-2014-218149

PRSEUS Panel Fabrication Final Report

*Kim A. Linton, Alexander Velicki, Krishna Hoffman, Patrick Thrash,
Robert Pickell, and Robert Turley
The Boeing Company, Huntington Beach, California*

January 2014

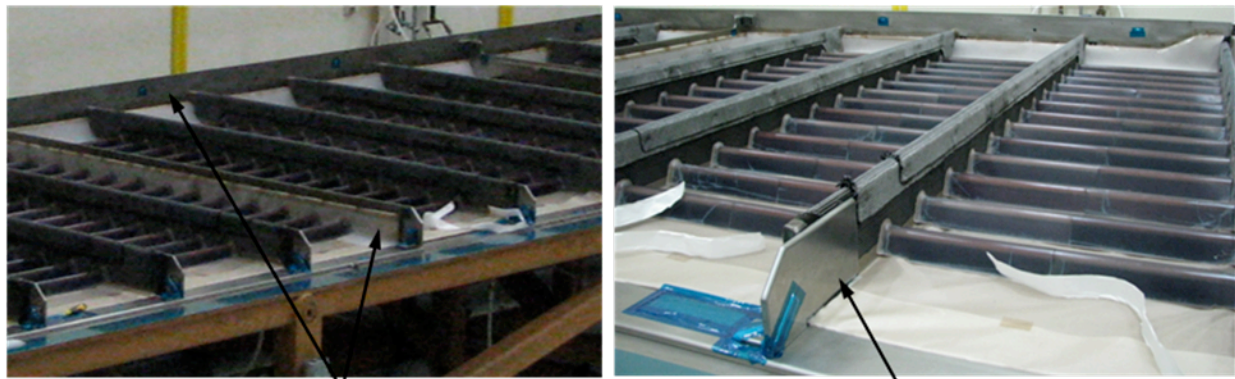
The center rib tee and floor cap are supported by IML Invar tooling

IML frame support tools are located at the ends of each frame to accurately position the attachment point of the self-supporting frame

Figure 89. IML Cure Tooling Located on the Upper Bulkhead Panel

The completed preform was transferred onto the cure tool by rotating the preform assembly tool and releasing the preform from the assembly tool (Figure 88). Hard tooling points were used to precisely index the preform on the cure tool. IML cure details were then pinned into position to accurately locate the key features of the panel (Figure 89). The primary and secondary vacuum bags were installed. The completed preform is then ready to be moved into the oven as shown in Figure 90. The untrimmed cure panel is shown in Figure 91. A special shipping cart (Figure 92) was designed and built to transfer these large panels to and from the vendors for panel trimming. This shipping cart fits into a standard Sea Van container to protect the panel from damage during shipment. The panel was trimmed on a machine that was large enough to trim the entire panel in a single set-up to maintain the tight tolerance of the Determinate Assembly (DA) holes used during assembly of the MBB (Figure 93).

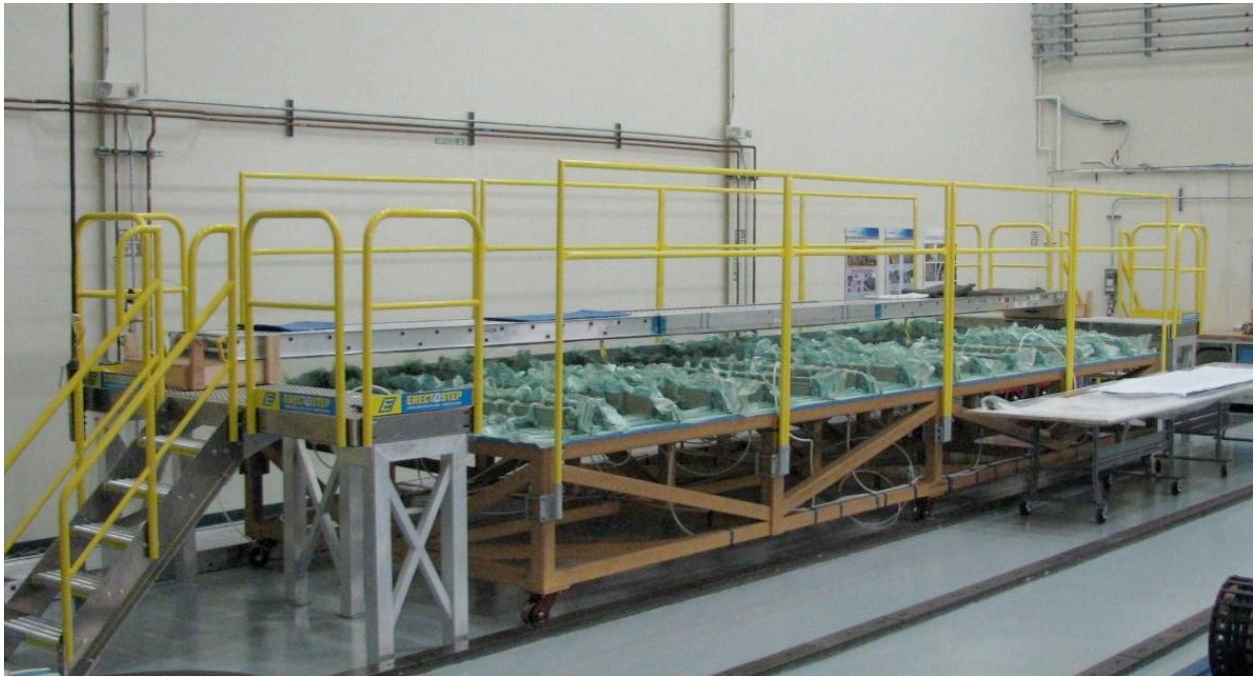
Figure 90. Upper Bulkhead Panel Preform Fully Bagged and Ready for Infusion

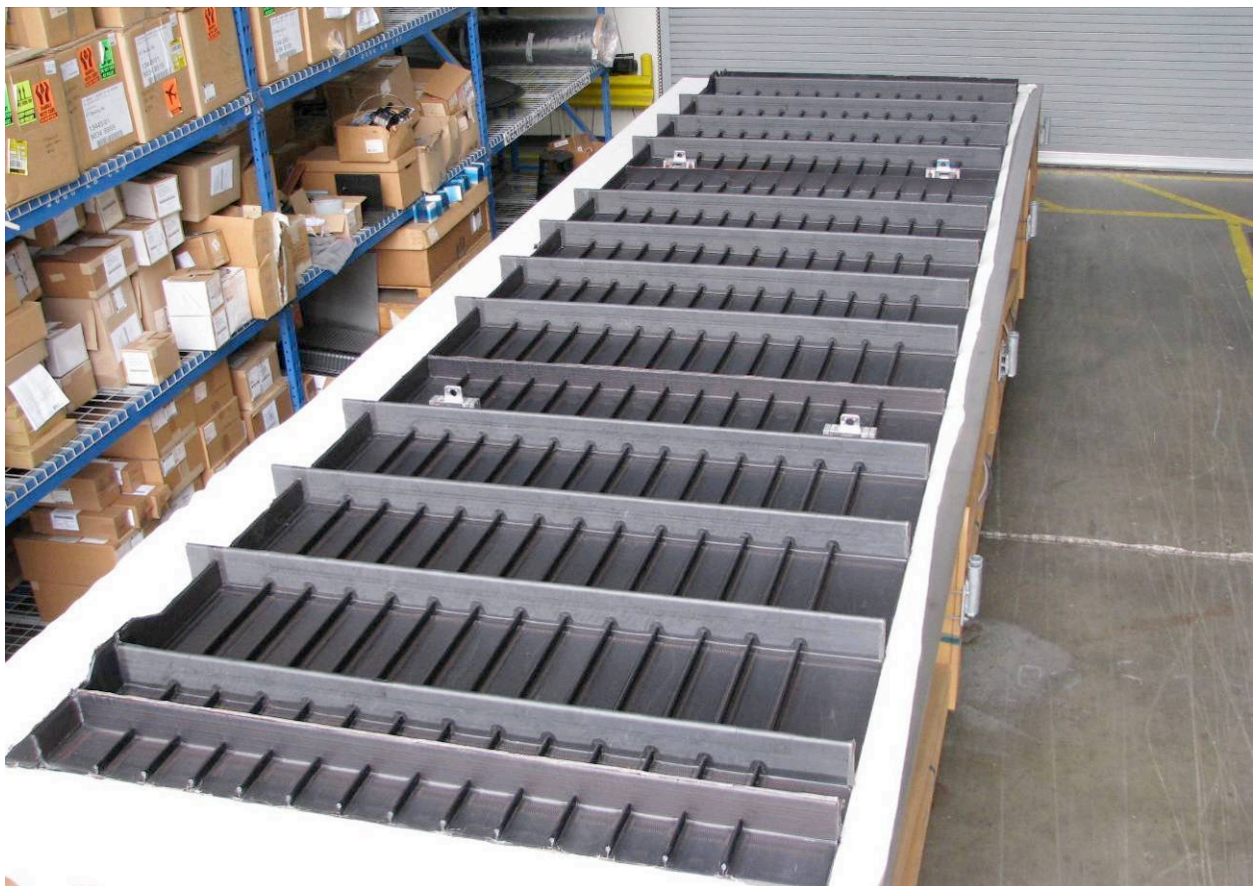
Figure 91. Cured Upper Bulkhead Panel Ready for Trim

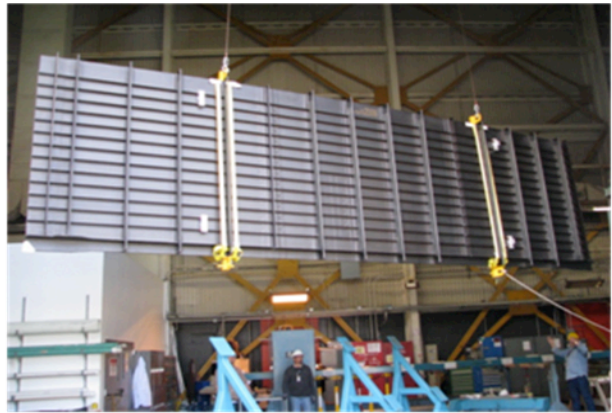
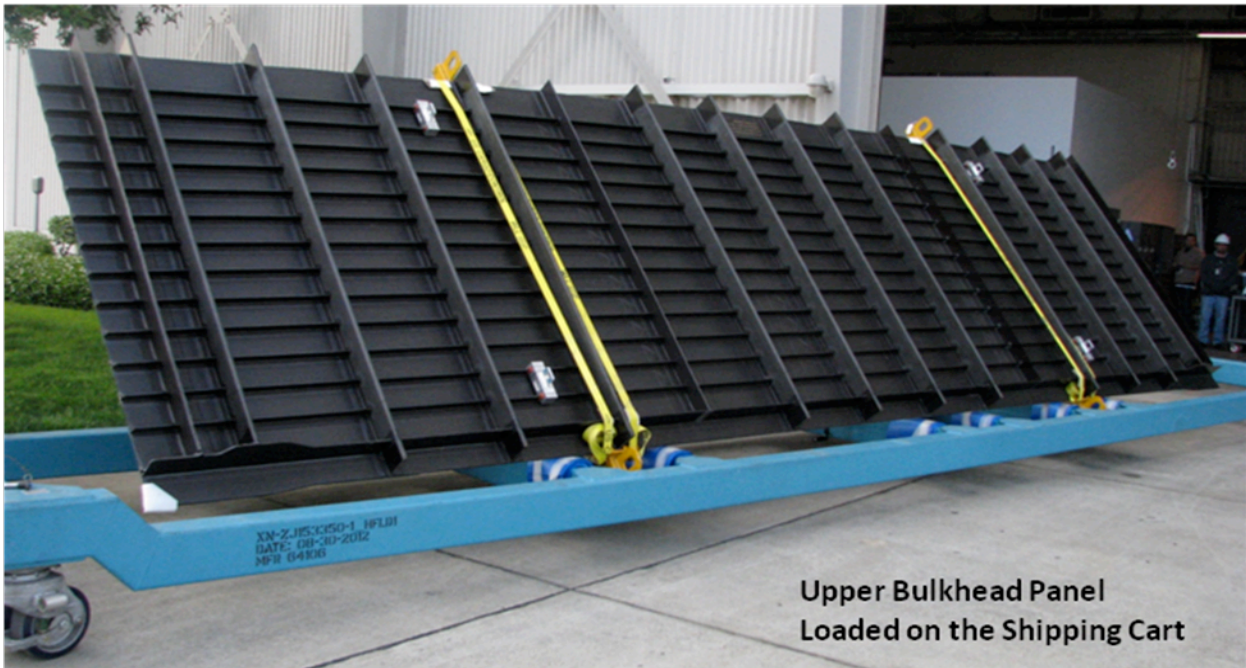
Figure 92. Upper Bulkhead Loaded on the Shipping Cart

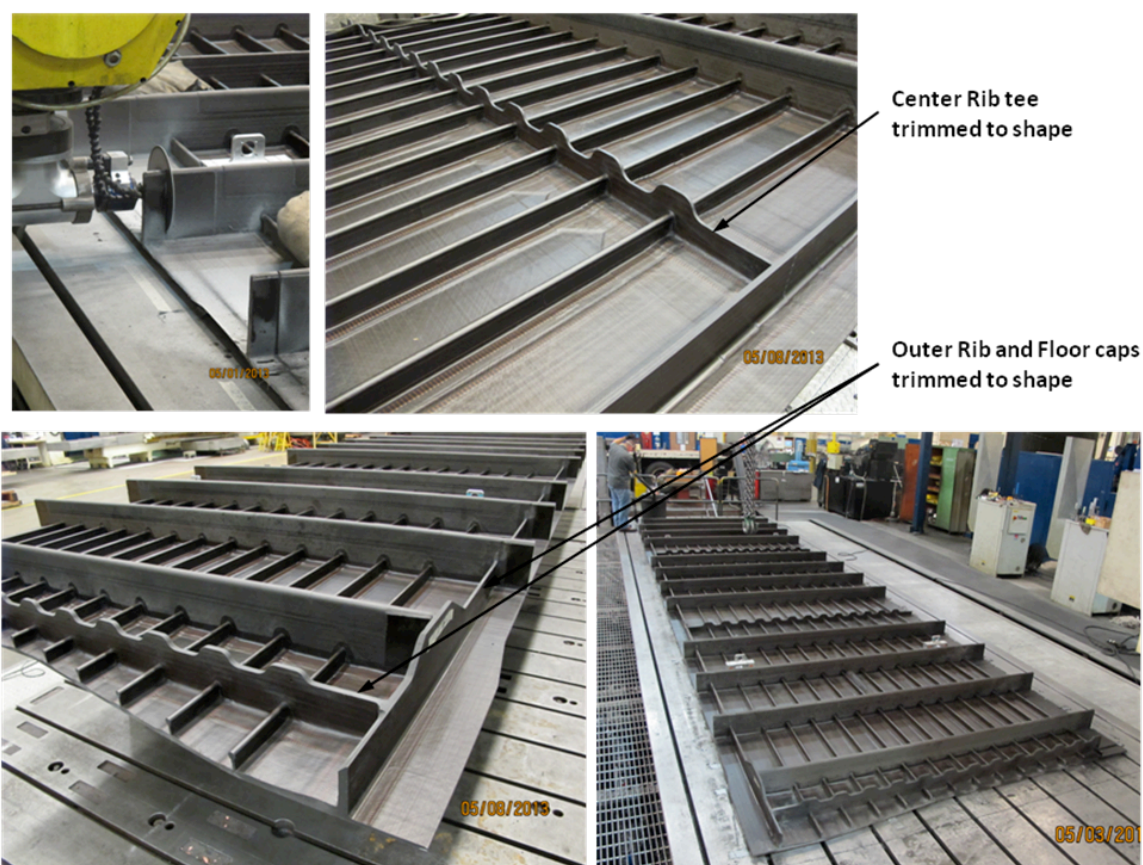
Figure 93. Upper Bulkhead Panel Trimming

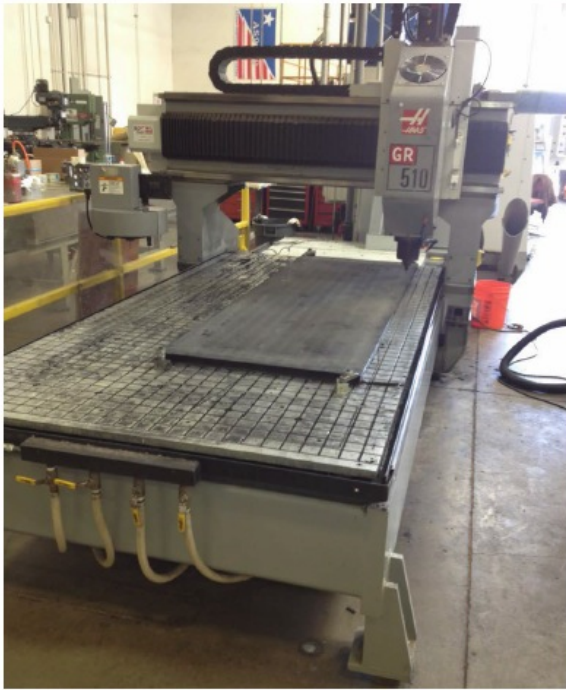
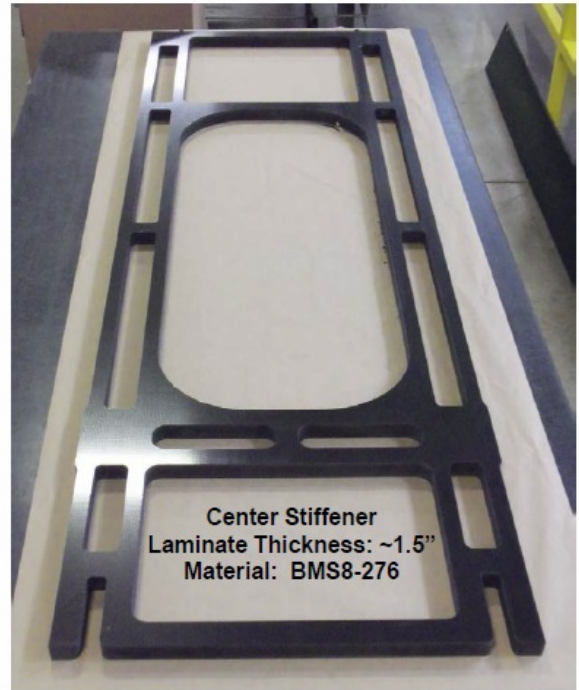
Figure 94. Trimming Solid Laminate Core Details

The core design is a combination honeycomb core and full-depth solid laminate. The entire perimeter of the center rib panel was solid laminate to support the fasteners clamp-up loads. Straight beams in the panel tied the frames of the crown and floor or floor and side keel panels together. The edge of the large cutout was also reinforced with the solid laminate. The solid laminate details were machined from a large panel. This was the thickest solid laminate that had been fabricated using this material system and a special cure cycle was developed to prevent an exothermal reaction from occurring during the cure cycle. The cure went as planned and a void free laminate was fabricated (Figure 73).

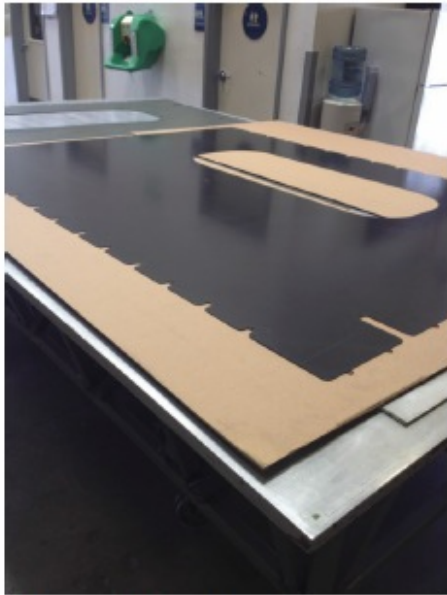
Trimmed facesheets

All details were trimmed with 0.060" TOA with will be machined away after panel bonding

Figure 95. Precured Facesheets Trimmed Net Plus 0.060-inch for Final Trimming

The face sheets were also pre-cured and trimmed to shape leaving an excess of 0.060-inch to trim after the panel was bonded together (Figure 95). Prior to bonding, all of the details were dry fitted together to check for gaps and any mismatch between the core and laminate heights (Figure 96). Then the parts were prepared for bonding. The secondary bond operation for the solid laminate and core to the face sheet was cured at 250° F using FM73 film adhesive per DMS 2169, Type 2. The honeycomb core was simultaneously bonded to the solid laminate using FM410 foaming adhesive to make the shear tie connection. Tooling pins were used to keep the details in position during the bonding cycle (Figure 97). Separate drill templates were developed for drilling the DA holes in the panel to maintain the positional and perpendicularity tolerance of the holes (Figure 98). Once the holes were checked and bought-off by Boeing personal in the template, the DA holes were drilled in the ribs. The completed sandwich panel assembly is shown in Figure 99.

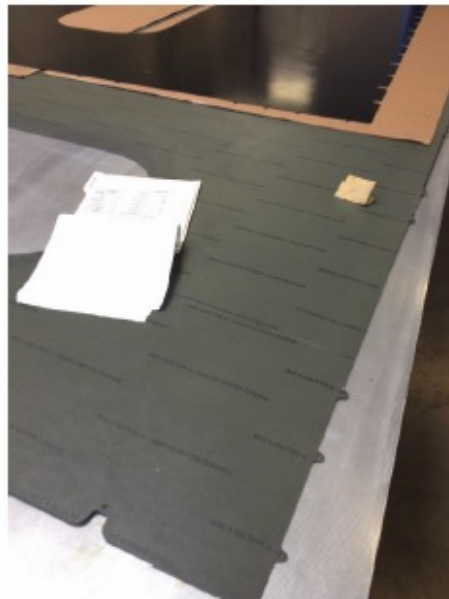
Facesheets fabricated with a peel ply on the surface that will be bonded

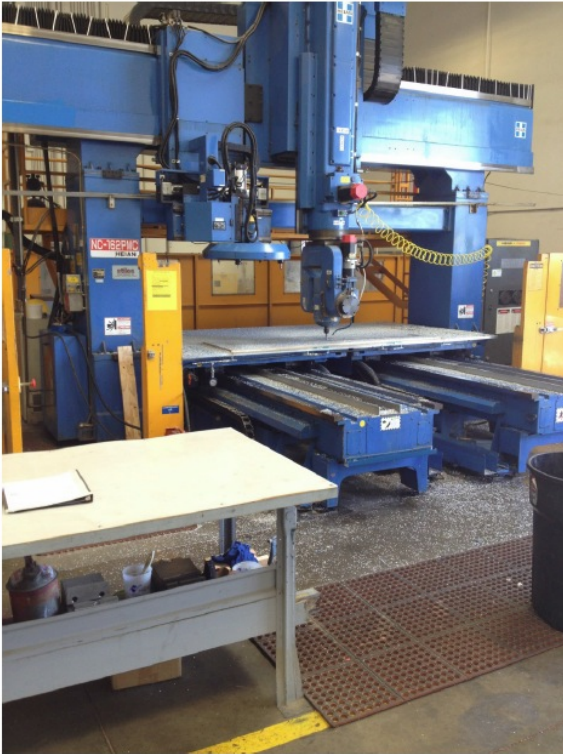
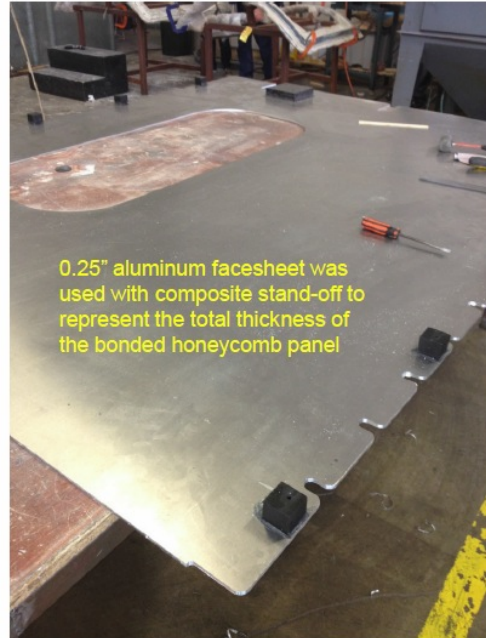
Figure 98. Drill Template was Fabricated to Drill DA Holes on the Panels

A mock panel was used to determine the accuracy of the calibrated machine locating the tight tolerance determinate assembly (DA) holes
