NASA/TM-2013-218050

# Material Property Characterization of AS4/VRM-34 Textile Laminates

*Ray W. Grenoble*  
*Langley Research Center, Hampton, Virginia*

## Abstract

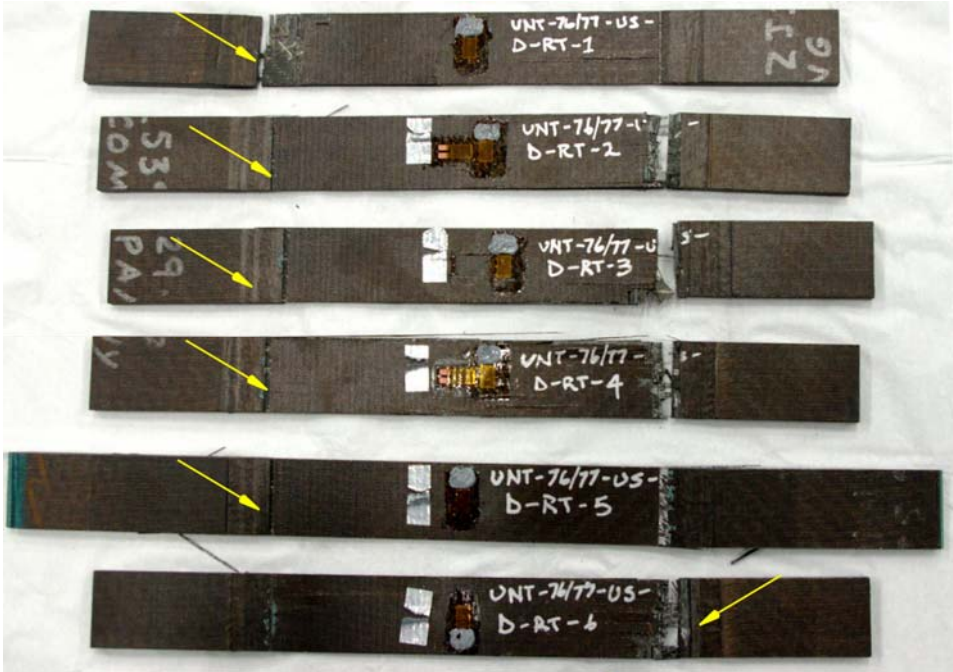
Figure 6. Tensile specimens with final failure location marked, no stitching, tested at 72°F.

Post-test photographs of the tensile specimens are provided in Figure 6 - 10. Yellow arrows indicate the location of the ultimate tensile failure for each specimen. The figures clearly show that 22 of 24 tensile specimens failed directly under the tabs. Other damage visible in the specimens is primarily attributable to spring-back of the specimen after final fracture.

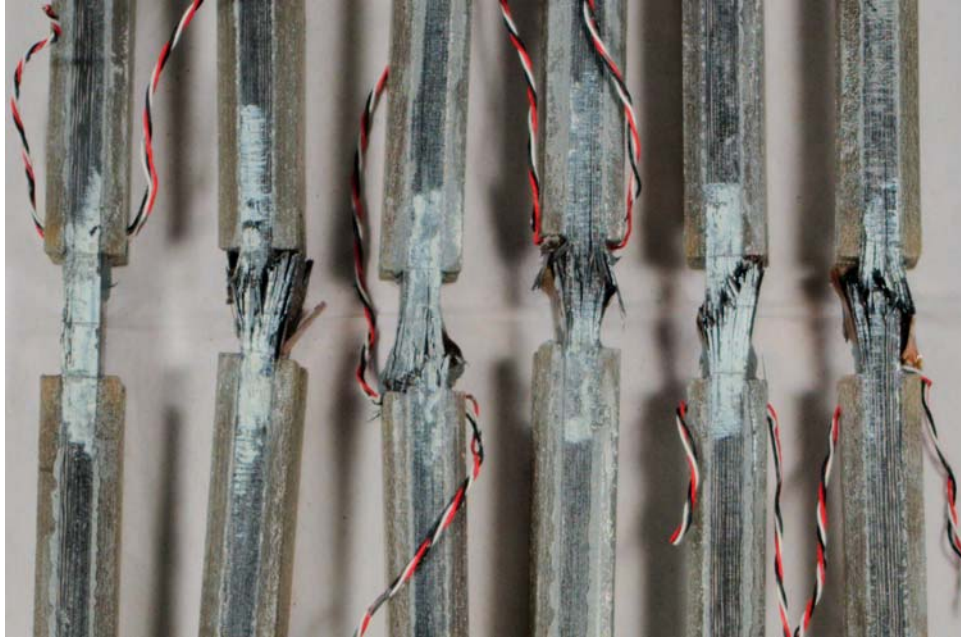
**Figure 10. Edge-on view of unnotched compression specimens tested at 72°F**

All of the compression specimens exhibited acceptable failure modes, generally near the center of the gage section. The specimen set tested at 72°F displayed brooming failures in four of six specimens. The specimens tested at 180°F all exhibited a buckling failure at an angle to the specimen loading direction. The compression test data are compiled in Table 3. The test specimens are shown in Figure 10 and 12. The increase in test temperature from 72°F to 180°F decreased compressive strength and compressive modulus by 7.5% and 4.2%, respectively, and increased the scatter in those properties.

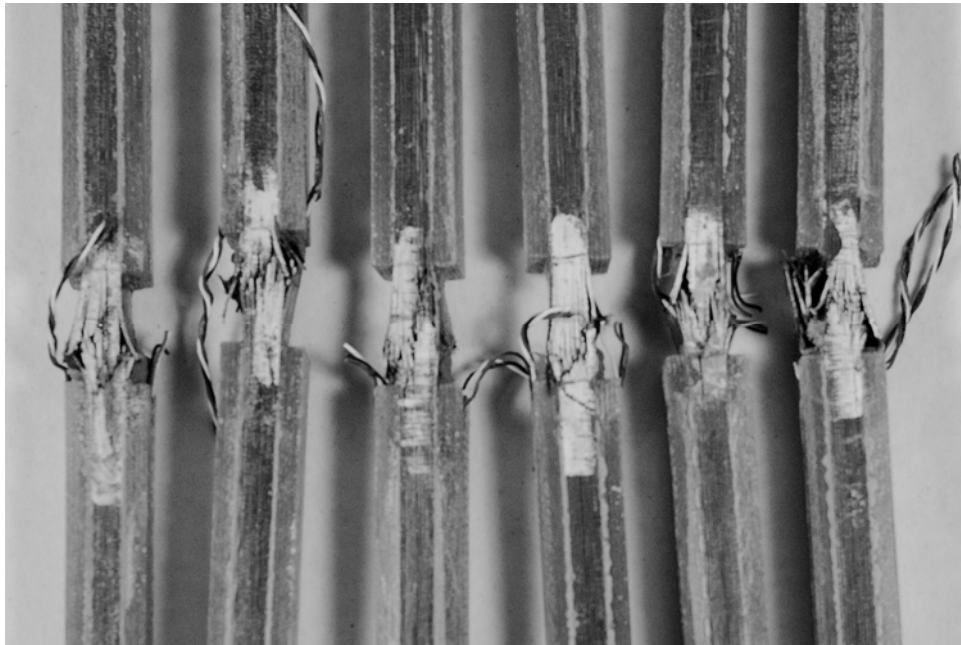
**Figure 11. Edge-on view of unnotched compression specimens tested at 180°F**
