# Optical Strain and Crack-Detection Measurements on a Rotating Disk

Prepared for the  
Smart Structures and Materials and Nondestructive Evaluation and Health Monitoring 2013  
sponsored by the International Society for Optical Engineering (SPIE)  
San Diego, California, March 10–14, 2013

National Aeronautics and  
Space Administration

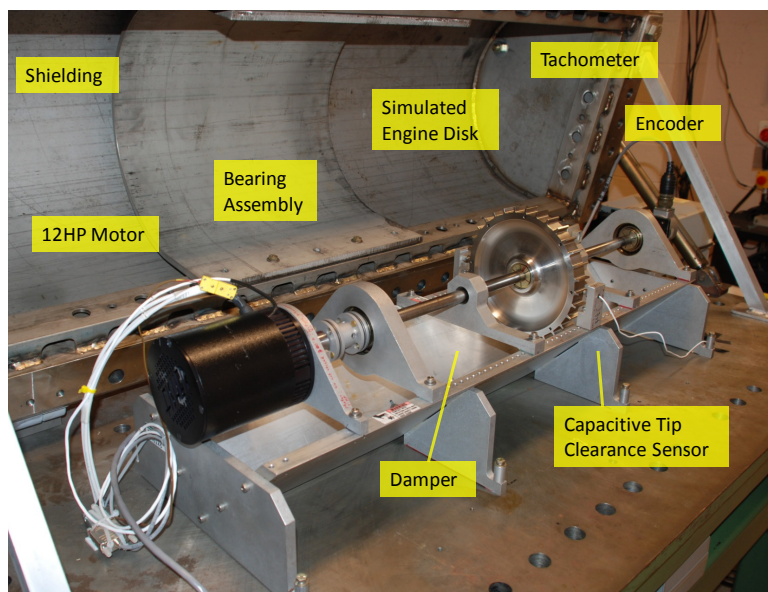
Figure 1 shows the Rotordynamics Laboratory's High Precision Spin Rig, which can accommodate simulated engine rotor disks of up to 235 mm (9.25 in.) in diameter. It has a stainless steel shaft with a length of 781 mm (30.75 in.) and diameter of 20 mm (0.79 in.). The shaft is supported by precision contact ball bearings on each end and has adjustable dampers that were positioned along the length of the shaft for these experiments. An encoder mounted on the end of the shaft was used by the control system to provide closed-loop control of rig speed. A secondary optical tachometer was used to record the speed into the data system and to synchronize the data to the rig's rotation. A 12-hp custom-built, brushless direct-current (dc) motor was used to rotate the spin rig and the simulated engine disks at speeds up to 12 000 rpm.

Figure 1.—High precision spin rig.

As was done for the vibration based crack detection experiment, the NASA Glenn Research Center's High Precision Spin Rig was used to operate the disk for this investigation. The setup for the experiment is shown in Figure 10. A five (5) Megapixel miniature machine vision digital camera with a 12 mm and 25 lens was used to acquire images of the disk statically and when it was being operated at 12 000 rpm. To capture the image of the disk as it was being spun a 10 W white light emitting diode (LED) with pulsed power supply was used as a strobe. A laser 1/rev was used to precisely drive the strobe as a function of rotor location and speed. In-house designed and fabricated pulse delay and pulse width control circuitry was used to condition the 1/rev signal for control of the strobe. The pulse delay was varied in order to image different regions of the disk while it was spinning. The pulse width was adjusted to obtain the crispest image of the disk while it was on test condition. In addition to the optical instrumentation listed above, microwave and capacitive blade tip clearance (BTC) sensors were used to acquire blade tip clearance data. These sensors, shown in Figure 10, were located 180° across from each other on the disk. The purpose of using this additional instrumentation was to compare any radial growth observed optically using the Moiré principle with the radial growth measured by these external sensors.

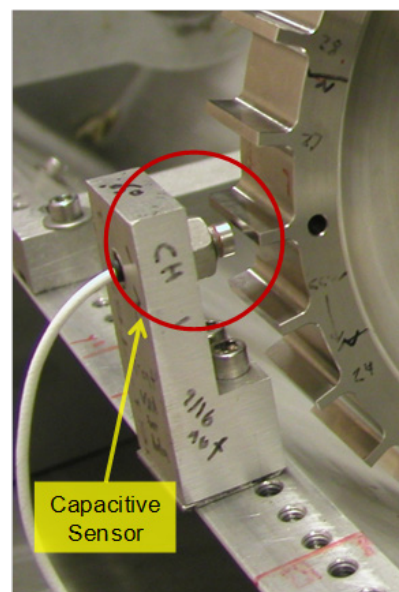
Figure 2.—Capacitive blade tip clearance probe.

The rig was set up to acquire two channels of radial blade-tip-clearance data from the simulated engine disk using capacitive displacement sensors (Fig. 2). These sensors were developed as part of a NASA Small Business Innovation Research (SBIR) contract and were different from traditional capacitive sensors in that their operation was based on a dc offset technique instead of the typical modulation technique (Ref. 8). A National Instruments System was used to acquire data from the capacitive displacement probes at a fixed sampling rate of 1 MHz. This system and its application software were delivered as part of the SBIR contract for the capacitive blade-tip-clearance sensors. The system used custom data acquisition and processing applications that were tailored for acquiring and processing data from the capacitive sensors.

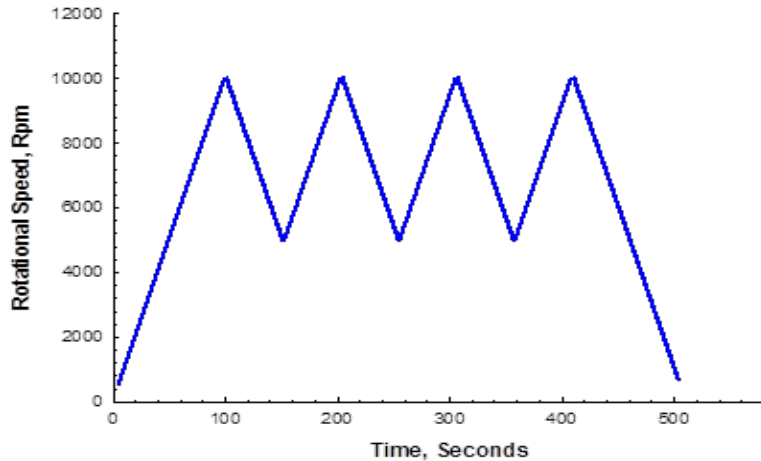
Figure 4.—Simulated mission profile.

The run profile presented in this paper is shown in Figure 4. It is typical of the profiles that were used in the investigation. For this test case, the speed of the disk was increased from 0 to 10 000 rpm at a ramp rate of 100 rpm/s, cycled between 10 000 and 5000 rpm for three cycles, then ramped down from 10 000 to 0 rpm. This was done to simulate a mission profile from cruise to full power and to observe the effects of cyclical loading on the disks.

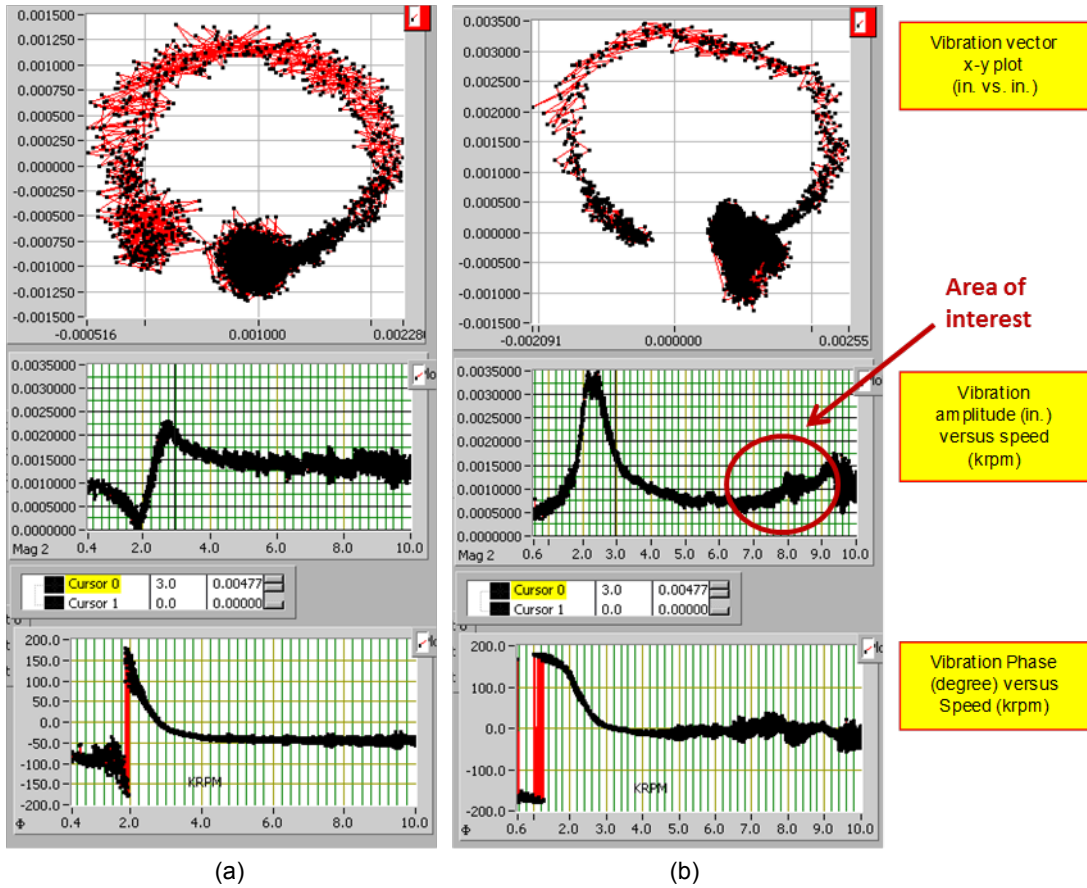
Figure 5 shows the results from this multiple-cycle test run for both the baseline and notched disks. The figure shows the analysis for the last cycle, starting at 10 000 rpm and ending at 0 rpm. As previously discussed, the presence of a crack is indicated if a second-order speed-dependent variation can be observed in the vibration amplitude as it is operated in the post critical speed regime. In this test case, a speed-dependent rise was observed in the amplitude data for the notched disk. The area of interest showing the speed-dependent rise is highlighted within the circle of Figure 5(b). A curve-fit analysis, shown in Figure 6, was conducted on the vibration data in this region and it was found to closely follow a second-order polynomial fit. Thus, possibly indicating the presence of the notch or simulated crack. Even though the vibration data looked promising in this region, it was also observed that the second-order speed-dependent variation was not consistent over the entire range and that it appeared to reset itself at a speed of ~9500 rpm. Moreover, this amplitude variation was not consistently observed in other test runs, which cast some doubt on whether the effect was entirely due to the notch or to some other factor that is yet to be determined. However, this case yielded the best data so far and showed positive indications of being able to detect a defect such as a crack by analyzing the disk's vibration response, specifically the vibration amplitude as a function of disk speed. It is theorized that what made this case different, and more promising than the other test runs, is that this test was conducted towards the end of a test series and that many cycles had been placed on the disk prior to this run. In addition, the disk experienced more loading because of the cyclical nature of the test profile. Overall, the results were promising and plans are in place to further investigate and develop this crack-detection technique as part of future studies.

Figure 5.—10 000-rpm multiple-cycle run comparison. (a) Baseline disk. (b) Notched disk.

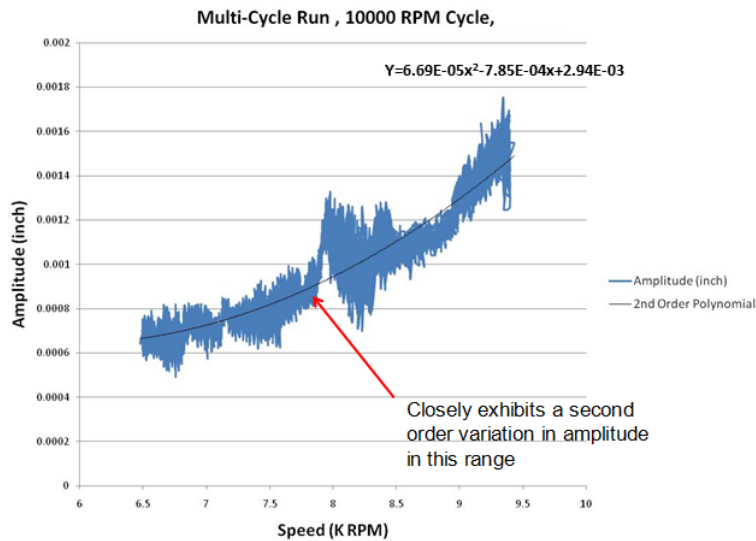
Figure 6.—Detailed vibration amplitude plot for 10 000-rpm multiple-cycle run.

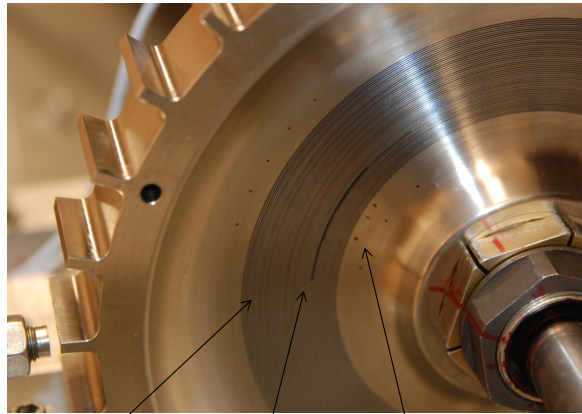
*Circular Patterns*    *2" Long Notch*    *Registration Marks*

Figure 9.—Subscale engine disk with notch and pattern applied.

(0.010 in.) wide and uniformly spaced 0.508 mm (0.020 in.) apart. The pattern was machined on to the disk using a precision lathe. The circles were made just deep enough, ~0.08 mm (~3 mils), so that a material could be applied to the grooves to provide contrast when imaging. A blue dye used in machining applications was applied to the disk then lightly sanded off, leaving the dye in the grooves to provide the needed contrast for viewing the circular pattern. Registration marks were also added to the disk to facilitate the alignment of the images acquired statically and on-condition.

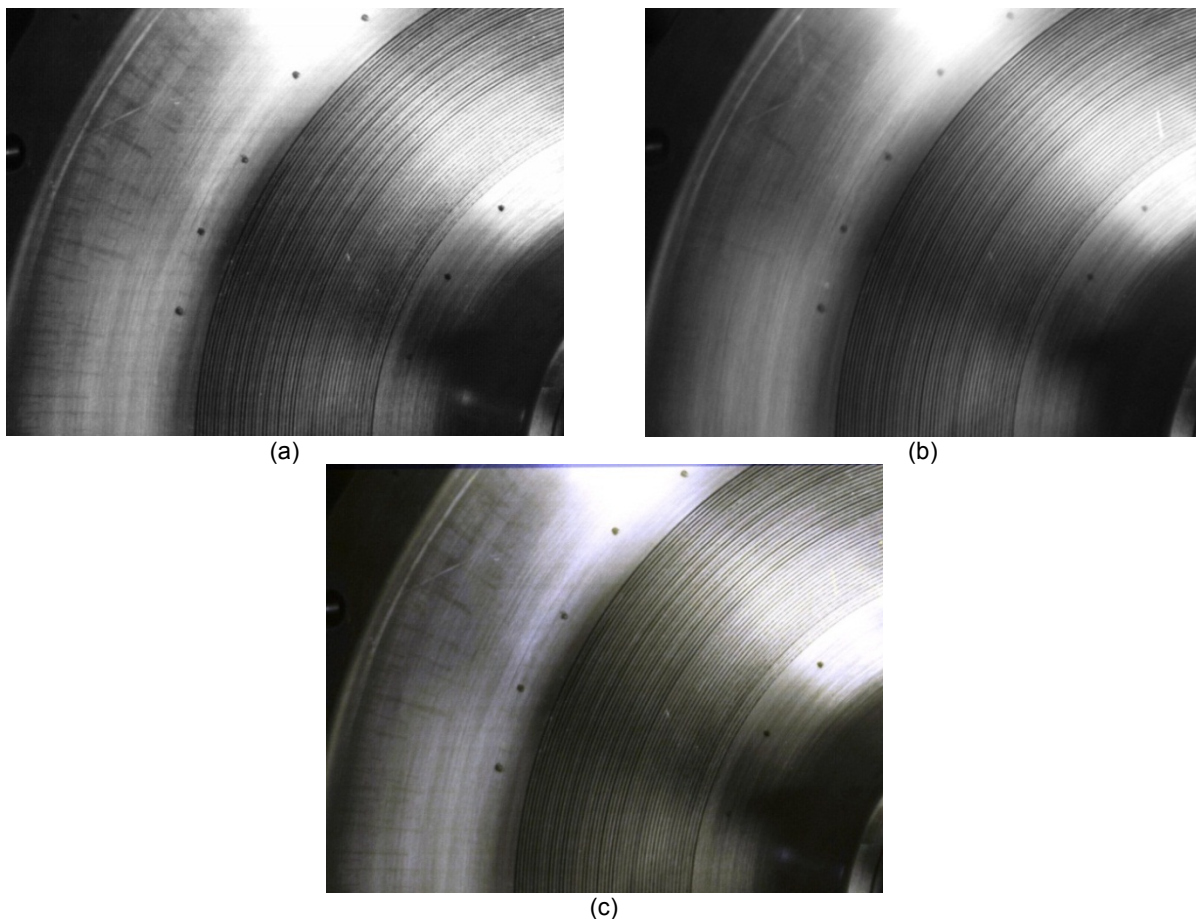
Figure 11 shows the images that were acquired for the clean, or baseline region, of the disk using a 12 mm lens. Figure 11(a) shows the reference image acquired at static conditions, Figure 11(b) shows the on-condition image acquired at 12 000 rpm and Figure 11(c) shows the resulting composite image obtained by overlaying the two images. For the baseline region of the disk the two images lined up exactly on top of each other and the light and dark zones due to the Moiré shift were not observed. Thus, indicating that very little radial growth was observed during high speed operation, which was expected for this side of the disk.

Figure 11.—Baseline region. (a) Static reference image. (b) On-condition image acquired at 12 000 rpm. (c) Composite image.

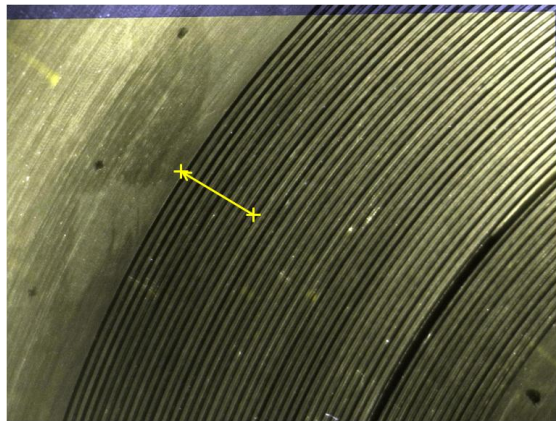
Figure 12 shows the resulting composite image obtained by overlaying the on-condition and reference images that were acquired for the region of the disk where the notched was located. A 25 mm lens was used to magnify the region of interest. Again, as previously observed, the anticipated light and dark zones due to the Moiré shift were not observed. The static reference image patterns lined up almost perfectly on the patterns of the image taken at 12 000 rpm. Thus, further verifying that the disk was experiencing very little if any growth due to the notch and the loads induced on it during operation. It should be noted that the same results were also observed when using the 12 mm lens on this area of the disk. This was unexpected, as finite element analysis showed that up to a  $\sim 0.075$  mm ( $\sim 0.003$  in.) localized radial growth of the disk could be observed in the region of the notch under these loading conditions. The expectation was that at least the initiation of a pattern shift would be observable, especially in the rings beginning at the notch region and heading towards the outside edge of the disk. To further verify the lack of radial growth a line intensity profile analysis was conducted over the last 10 rings on the composite image to determine if there was a shift due to radial growth of the disk as this would represent the best region to detect any growth.

Figure 12.—Composite image of notch region at 12 000 rpm using 25 mm lens.

The region that was used for the intensity profile is indicated by the yellow line in Figure 12. The intensity profile is shown in Figure 13. The green line indicates the intensity for the image that was acquired at 12 000 rpm and the blue line indicates the intensity of the static reference image. The valleys on the chart indicate the location of the grooves or dark lines of the pattern. The peaks indicate the space between the grooves or the light lines of the pattern. From visually analyzing the profile it is evident that the peaks and valleys of the intensity profiles match each other in the x-axis or radial direction on the disk. Again, this verifies that the disk experienced very little if any radial growth during operation, or that the growth is under the detection limits using this optical technique.

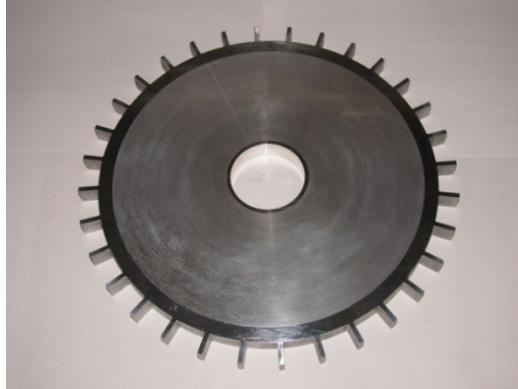
Figure 15.—Aluminum rotor disk with laser etched circular pattern.

was attempted was to apply the circular pattern to the disk using a laser etching process. This process yielded concentric circles that were 0.127 mm (0.005 in.) wide and uniformly spaced 0.254 mm (0.010 in.) apart. This was one half of the previous width and spacing achieved using the precision lathe application technique, thus doubling the pattern's measurement sensitivity. The pattern was able to be nearly applied nearly over the entire surface of the disk, starting at a radius of 24.9 mm (0.98 in.) and ending at a radius of 95.5 mm (3.76 in.). Registration marks were also added to the disk to facilitate the alignment of the images acquired statically and on-condition. The test setup in the High Precision Spin Rig was nearly identical to the setup discussed previously. The only difference this time was the use of a different light source controller which would allow for pulse width as low as 1  $\mu$ s, in order to capture crisper images of the disk while it was rotating.
