COMMON PRACTICE LIGHTNING STRIKE PROTECTION CHARACTERIZATION TECHNIQUE TO QUANTIFY DAMAGE MECHANISMS ON COMPOSITE SUBSTRATES

George N. Szatkowski, Kenneth L. Dudley, Sandra V Koppen, Jay J. Ely and Truong X. Nguyen
NASA Langley Research Center
Hampton, VA 23681 U.S.A.
George.n.szatkowski@nasa.gov

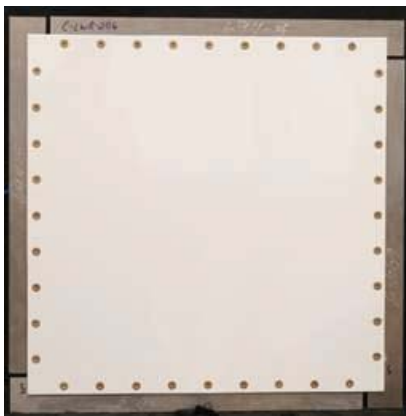
The panels have countersunk fastening with 2 inch spacing. Each panel is fastened to four independent aluminum ground bars. Common steel or CRES fasteners are used to provide a conductive path from the panel to the frame and eventually into the test equipment ground. Figure 1 shows a test panel with ground bars attached.

Figure 1. Photograph of CFRP Test Panel

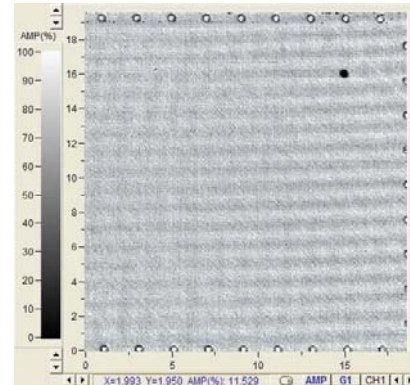
the attenuation of the adjacent areas without flaws or defects. An ultrasonic “defect” is an indication greater than 0.50 inch in diameter. Multiple indications are allowed, up to three (3) per panel, as long as they are at least 1.00 inch apart. Any deviations are noted in the test data report. Figure 2 shows a typical TTU image of a CFRP test panel.

Figure 2. Typical TTU Image of CFRP Test Panel

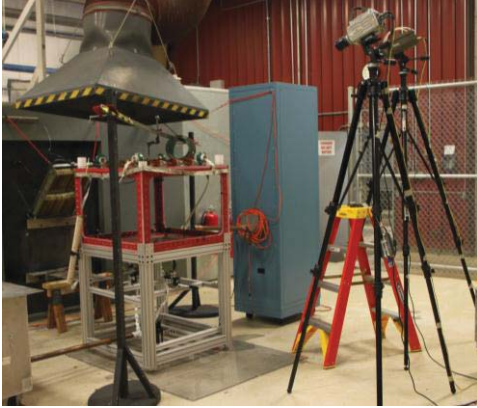
The test bed fixture design allows leeway in construction provided the resulting structure has comparable rigidity and capability. The test panel is secured in position by toggle clamps which apply pressure to the panel's ground bars and ensures solid contact to the 4 grounding straps. Four Pearson 4418 Current Probes are used to monitor the electrical current on the 4 grounding straps. The test bed design allows all four edges of the test panel to be independently sensed and provides a means to study current propagation for asymmetric LSP designs. Figure 5 shows a picture of the test bed assembly at Lightning Technologies Incorporated (LTI).

Figure 5. Test Bed installed at LTI.

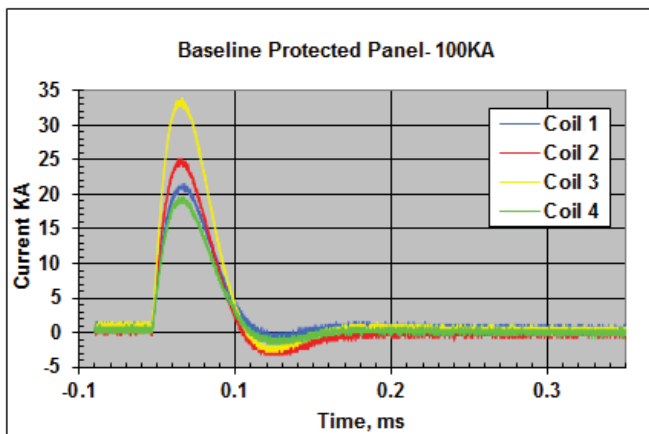
The test data show the electrical current on each of the 4 ground straps is within about 5% of being equally distributed at peak current. Further investigation is needed to determine if adjustments to the length of individual ground straps could reduce the level of bias from the measurement or replacing the used braided copper ground strap with new straps would eliminate the bias. The Pearson probes were within calibration specifications. The CFRP test panel data show similar bias as the Aluminum calibration plate with coil 3 typically measuring higher and coils 1 and 4 typically measuring lower. These results are believed to have not impacted this study, but future evaluations of asymmetrical LSP concepts would require improved measurement fidelity. Figure 6 presents the electrical current measured at the 4 sides of a baseline protected CFRP panel at 100KA.

Figure 6. Current waveform at 100KA measured on the 4 edges of the protected baseline CFRP panel.

The electrical current on the 4 edges of the test panel were independently monitored during the lightning test. 4 Pearson 4418 Current Probes were used to monitor the electrical ground current off the edges of the CFRP panel. The 4 ground straps were installed with equal length and kept as short as possible. A quarter inch thick Aluminum calibration test plate was struck repeatedly as a test case to measure current at the 4 edges to ensure no significant bias was observed. For this isotropic calibration test panel it is expected each ground strap would receive approximately 25% of the total current. Table 1 presents the peak current data measured on the 4 Pearson probes identified as Coil 1 thru Coil 4 for the July 2013 lightning test for 3 repeated strikes to the Aluminum calibration test plate and 3 protected and 3 unprotected CFRP panels struck at around 100KA.

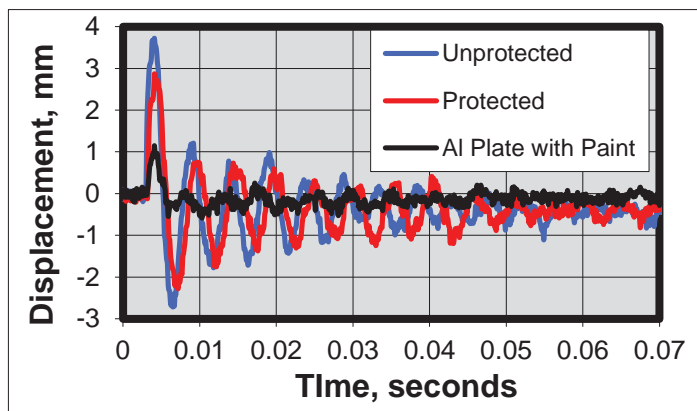
A time profile of mechanical displacement versus time is presented in Figure 7 for an Aluminum plate with paint, unprotected and protected CFRP test panels at 100 KA. The data shows a typical damped sinusoidal response from the lightning impact on the test panel.

Figure 7. Displacement versus Time Plot of Aluminum Plate with Paint, Unprotected and Protected CFRP Test Panels at 100 KA.
