# MLI/BAC Shield Thermal and Acoustic Test

Cryogenic Propellant Storage and Transfer (CPST) Technology Maturation Plan Objectives: Assess the structural performance of a Multilayer Insulation (MLI) and Broad Area Cooling (BAC) shield assembly subjected to launch acoustic loads.

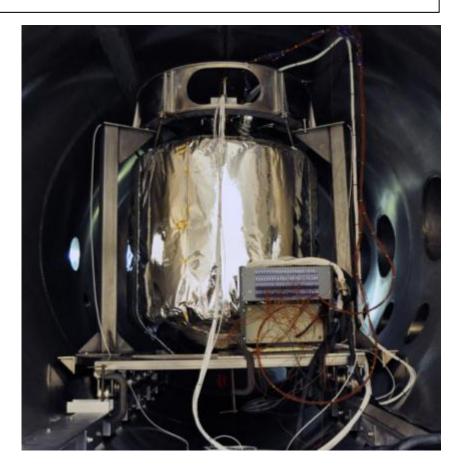
- Design, fabricate, and assemble a structurally and thermally acceptable MLI/BAC shield test article
- Install MLI/BAC shield on tank
- Expose tank-applied MLI/BAC shield assembly to simulated launch acoustic loads
- Compare data from thermal tests conducted before and after the acoustic test to assess possible degradation to the MLI/BAC shield system

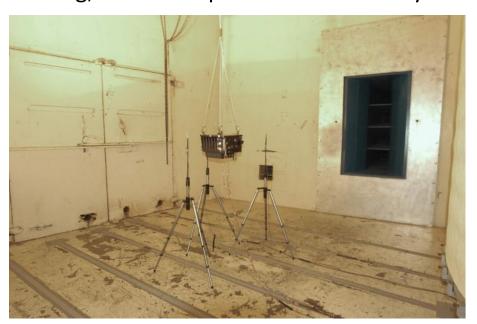
### **MSFC 4619 Acoustic Chamber**

- The Acoustic Test Facility consists of a Reverberation Chamber, which is constructed of reinforced concrete.
  - Encloses 5000 ft<sup>3</sup>.
  - Shape is approximately cubic with 17 feet per side.
  - No parallel surfaces in the room to promote a diffuse acoustic environment.
- The acoustic input is generated by four WAS 3000 Modulators with a combined acoustic power of 120 kW.
  - Maximum acoustic level is approximately 160 dB in the room's center.
- Data acquisition will consist of a Precision Filters 28000 for signal conditioning, a TEAC GX for recording, and an m+p vibration control system for analysis.

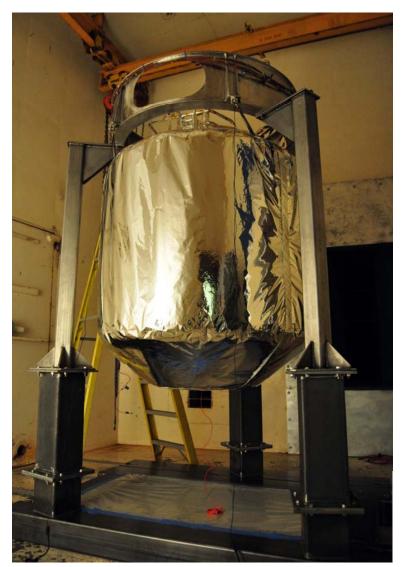
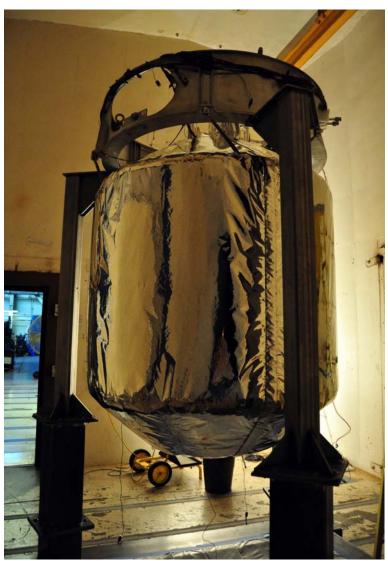
## **VATA1a Acoustic Test Configuration**

VATA was transported from 4205 to 4619 for acoustic testing. A plastic cover was used to keep VATA MLI clean and protected.

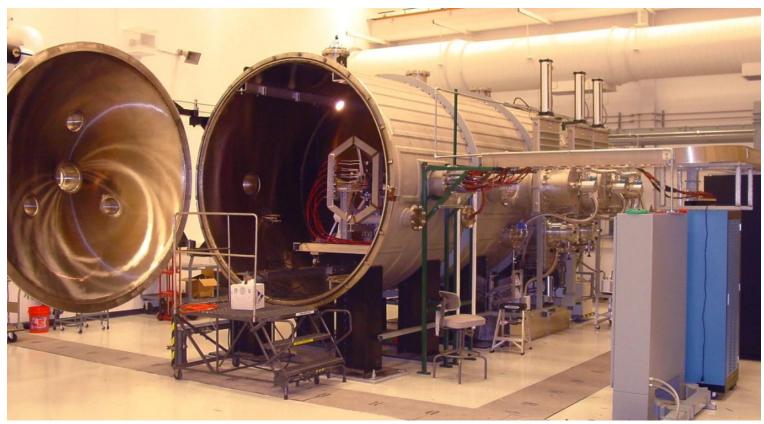
# **MSFC PRDL Exploration Systems Test Facility**

- NASA MSFC Propulsion Research and Development Laboratory (Bld. 4205/Rm. 108)
- 9 ft diameter by 20 ft long vacuum chamber (10-8 torr)
- Pumps: 1 roughing (Kinny-CB7230), 2 turbos (TMG2400), 2 cryos (ADPSHD22)
- 240 kW DC power (16 supplies @ 150 V, 100 Amps)
- Control, Data Acquisition via LabVIEW, NI, and lotech
- Liquid nitrogen (150 psig) / gaseous nitrogen (4500 psig) / Missile grade air (3500 psig)

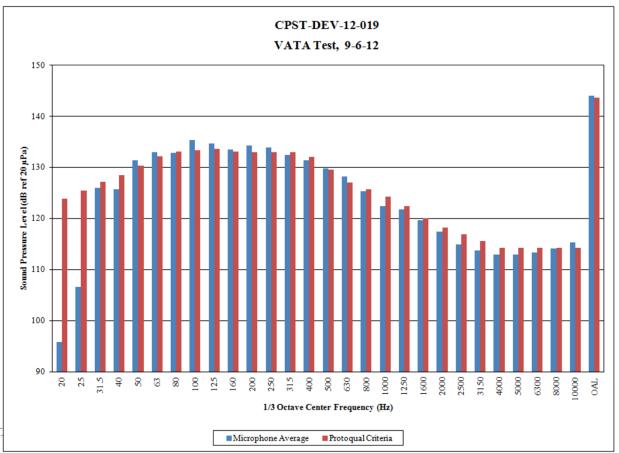
### Results Summary: VATA1a Acoustic Test Data

- Desired acoustic environment was successfully produced for test.
  - Based on NASA-STD-7001A and MLI-STD-1540
- Out-of-plane responses occurred between 1.28 and 4.81 root mean square acceleration (GRMS).
- Overall highest response occurred on Accelerometer #05, positioned on the BAC shield standoff at the VATA tank equator.
- Acceleration levels and overall profiles recorded during testing were appropriate for the applied acoustic environment.

Accelerometer	GRMS		
R1R	1.941		
R1L	1.82		
R1T	0.904		
R2R	2.695		
R2L	0.772		
R2T	0.48		
R3R	1.278		
R3L	3.55		
R3T	1.178		
R4R	3.359		
R5R	4.806		
R7L	0.911		
R8L	1.648		
R9R	1.928		
R9L	1.774		
R9T	0.847		
R10R	2.142		
R10L	0.49		
R10T	0.477

- Test Sound Pressure Level (SPL) consistent with test requirements
- Accelerometer data reasonable for test
