NASA/TM—2013-216612

Application of Advanced Nondestructive Evaluation Techniques for Cylindrical Composite Test Samples

Richard E. Martin
Cleveland State University, Cleveland, Ohio

Donald J. Roth and Jonathan A. Salem
Glenn Research Center, Cleveland, Ohio

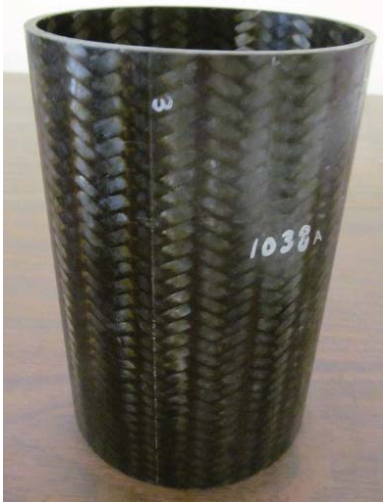
Figure 1.—Representative cylindrical composite test sample.

Three 6 in. (152.4 mm) long carbon-epoxy composite tube samples were used in this experiment. A representative sample is shown in Figure 1. Samples were fabricated using a preform of overbraided layers of triaxial braid carbon fiber with the axial tows of the braid running in the axial direction of the tube. The finished composite was formed by resin transfer molding using a 3502 epoxy resin. Final dimensions were an inner diameter of 4 in. (102 mm) and a wall thickness of 0.140 in. (3.6 mm). Visual examination of the samples indicated discontinuities on the outer surface of the cylinder at the locations where the outer mold sections joined together as well as some visible fiber misalignment on the sample exterior surfaces.

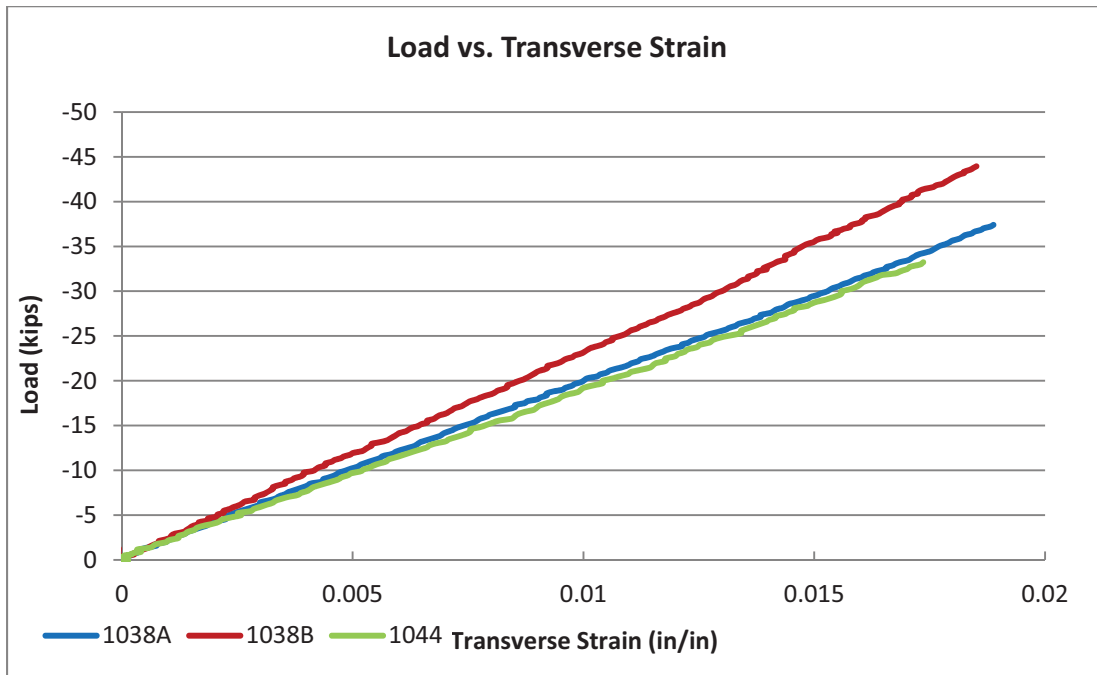
Figure 8.—Load-strain response for samples tested to failure.

Mechanical response for the three composite tube samples is shown in Figure 8 with a photo of a failed sample shown in Figure 9. Strain response data in the transverse direction indicates a nearly linear response to failure with failure strains in the range of 1.7 to 1.9 percent based on DIC data. One of the samples, 1038B, did show a stiffer response and a higher failure load than the other samples. Full field DIC results near failure show non-uniformity in the strain field. An example of this behavior is shown in Figure 10.

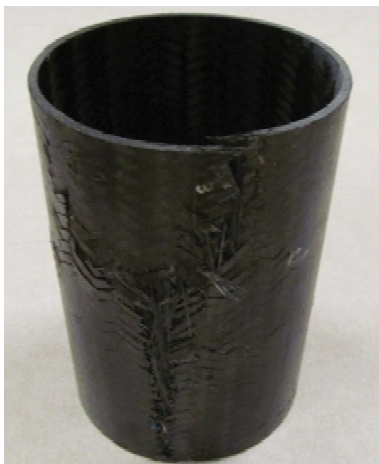
Figure 9.—Photograph of failed sample 1038A.

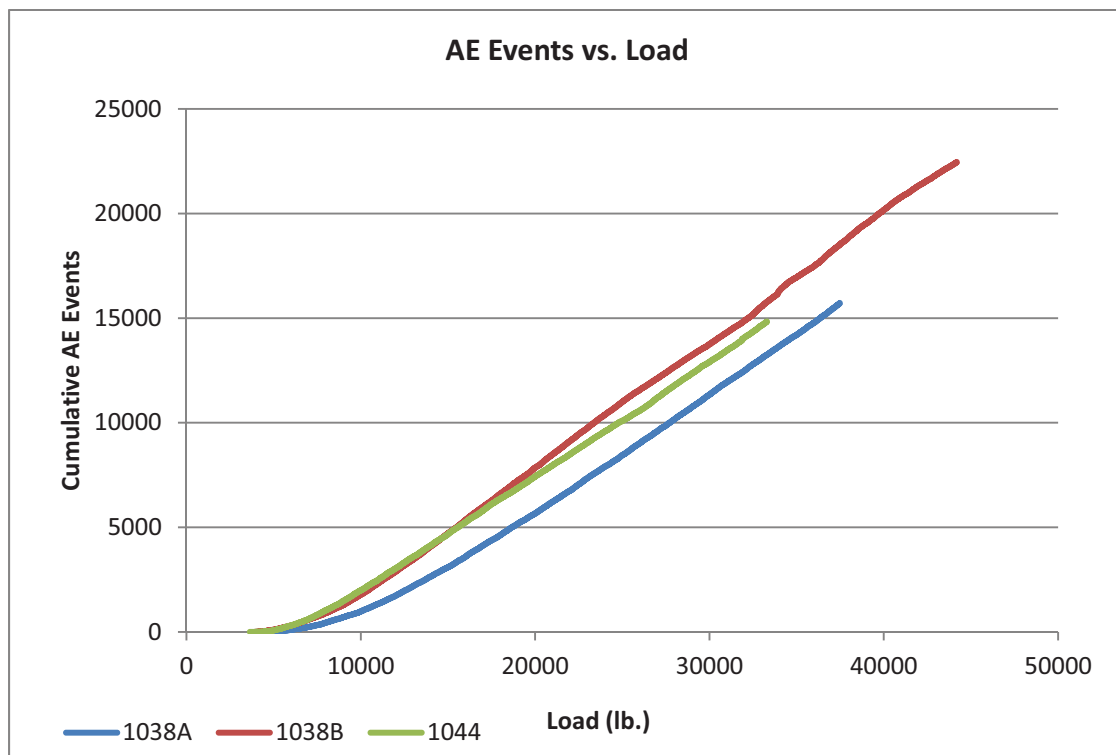
Figure 11.—Cumulative acoustic emission activity as a function of load.

A summary of the cumulative acoustic emission response for the three samples is shown in Figure 11. All three of the samples exhibited a similar response with an initiation of AE activity around 4,000 lb followed by a nearly linear increase of activity starting at 10,000 lb and continuing until failure much like the load-strain response shown previously. As expected, the sample with the higher failure load, 1038B, resulted in a higher amount of total AE activity.

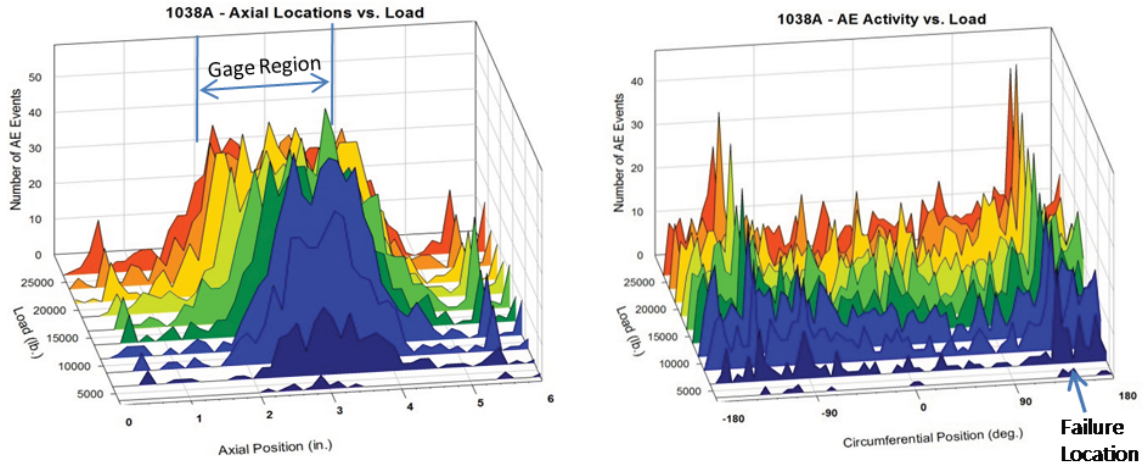
Figure 12.—Axial and circumferential location data for sample 1038A.

Results from post-processing of the AE data in terms of location are shown in Figures 12 to 14. Location of the individual events in both the axial and circumferential directions over the load history were calculated and plotted. All of the samples appear to show the same trends in terms of location. In the axial direction, AE activity initially begins in a narrow region within the gage region of the sample. As the load increases, the distribution of AE activity begins to widen and extend slightly beyond the edges of the gage region where it remains until reaching failure load. All three samples also contained a small amount of activity near the ends of the sample which is most likely due to noise from the load frame and fixturing.

AE event activity in the circumferential direction also displays a noticeable trend. During the loading history of each of the samples, there is a background level of AE activity detected over the entire circumference of the sample starting at the initiation load. Coupled with this background activity, there are one or two locations on each sample where AE events are concentrated. These peaks begin to form at the earliest stages of activity and continue until failure. In all three cases, the location with the highest peaks can be associated with the eventual failure location suggesting that the location of damage leading to failure occurs early in the loading process. Other significant peaks in the data correlate well with the locations of the mold lines of the cylinder.

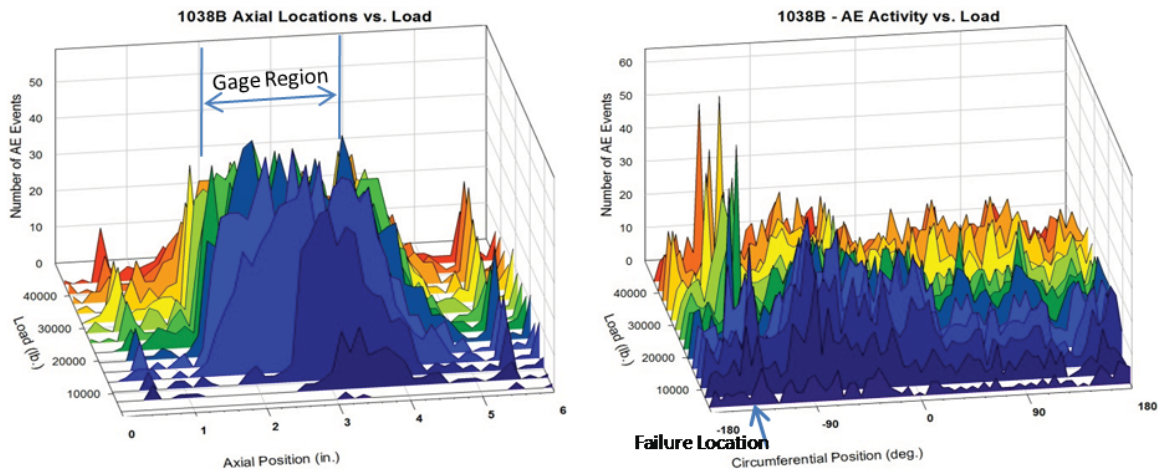
Figure 13.—Axial and circumferential location data for sample 1038B.
