Arcjet Testing of Micro-Meteoroid Impacted Thermal Protection Materials

Parul Agrawal¹

Michelle M. Munk², Louis A. Glaab³

There are several harsh space environments that could affect thermal protection systems and in turn pose risks to the atmospheric entry vehicles. These environments include micrometeoroid impact, extreme cold temperatures, and ionizing radiation during deep space cruise, all followed by atmospheric entry heating. To mitigate these risks, different thermal protection material samples were subjected to multiple tests, including hyper velocity impact, cold soak, irradiation, and arcjet testing, at various NASA facilities that simulated these environments. The materials included a variety of honeycomb packed ablative materials as well as carbon-based non-ablative thermal protection systems. The present paper describes the results of the multiple test campaign with a focus on arcjet testing of thermal protection materials. The tests showed promising results for ablative materials. However, the carbon-based non-ablative system presented some concerns regarding the potential risks to an entry vehicle. This study provides valuable information regarding the capability

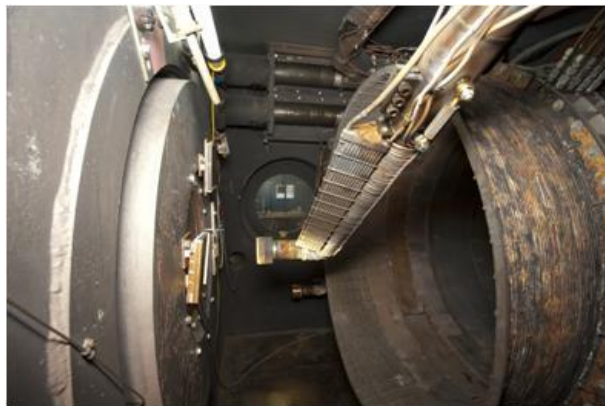
Figure 9. Articles inside the arcjets for thermal testing. (a) 60 MW IHF (b) 20 MW AHF.

The last leg of the test campaign consisted of arcjet testing at NASA Ames Research Center to simulate the atmospheric entry. All the forebody candidates were tested in the 60 MW Interaction Heating Facility (IHF), and the aftbody candidates were tested at the 20 MW Aerodynamic Heating Facility (AHF). The pictures of samples mounted on both the facilities are shown in Figure 9. The details of both the facilities at NASA Ames are provided in References 10 and 11.

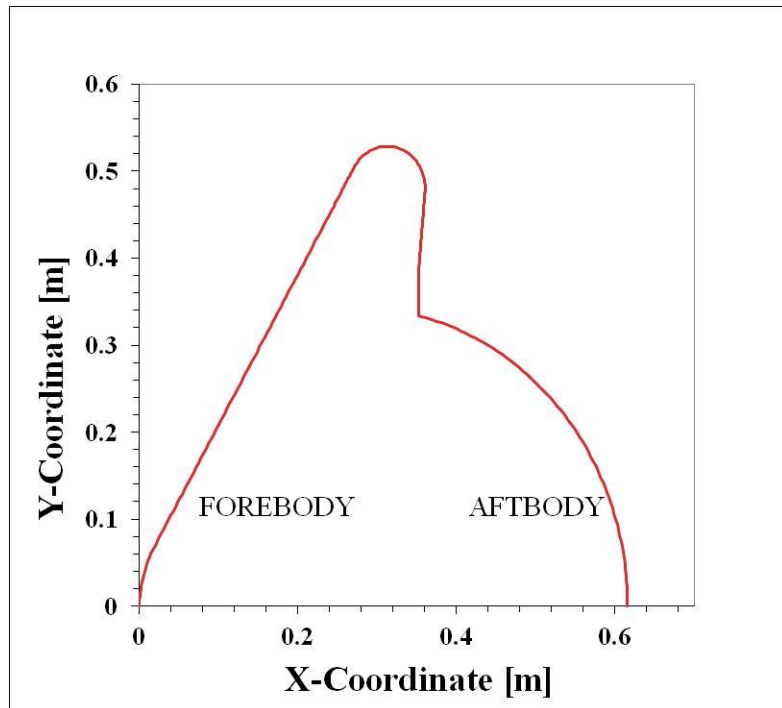
Figure 10: Entry vehicle contour for CFD analysis.

The present test campaign is not tied to a specific NASA mission. Therefore, the environments for arcjet testing were determined by referencing an aerothermal environment from computational fluid dynamics (CFD) analysis for a nominal trajectory of an Earth entry vehicle.¹² Figure 10 shows the simplified geometry of an Earth entry vehicle. Figure 11 shows the peak heat flux and corresponding pressure profile for this geometry for a given Mars Sample Return (MSR) mission type trajectory. The peak stagnation heat flux at the nose is about 1000W/cm². Near the shoulder area, where the likelihood of occurrence of MMOD type damage is greatest, the heat flux reduces by 50%. The pressure at the fore body is between 30-40 kPa. Therefore, for the forebody materials, 500W/cm² heat flux and 30 kPa pressure were chosen as the nominal test condition in the IHF. Based on the CFD analysis the heat flux magnitude prediction at the backshell is below 50 W/cm², and pressure is lower than 300 Pa. As it was not possible to achieve such low pressure inside the arcjet facility, we decided to use 60 W/cm² heat flux and 3 kPa pressure as the nominal condition for the aftbody TPS material candidates. Table 2 provides the details for each of the test environments. The plasma exposure times for all the materials were estimated based on their capability to withstand heating (without raising the bondline temperature above the limit) and the calculated heat loads from the trajectory near the shoulder and backshell area. The heat load varied between 5.0 kJ/cm² to 40.0 kJ/cm². Based on this, the estimates for exposure time for forebody materials could vary from 10 seconds to 80 seconds. All the carbon-carbon samples, except one, were exposed for 30 seconds. One of the samples was exposed for 40 seconds to investigate the effects of longer exposure on the cavity growth. For the backshell candidates, the exposure times in the AHF were determined based on material capability. The test matrix for both forebody and backshell candidates is provided in Table 3.

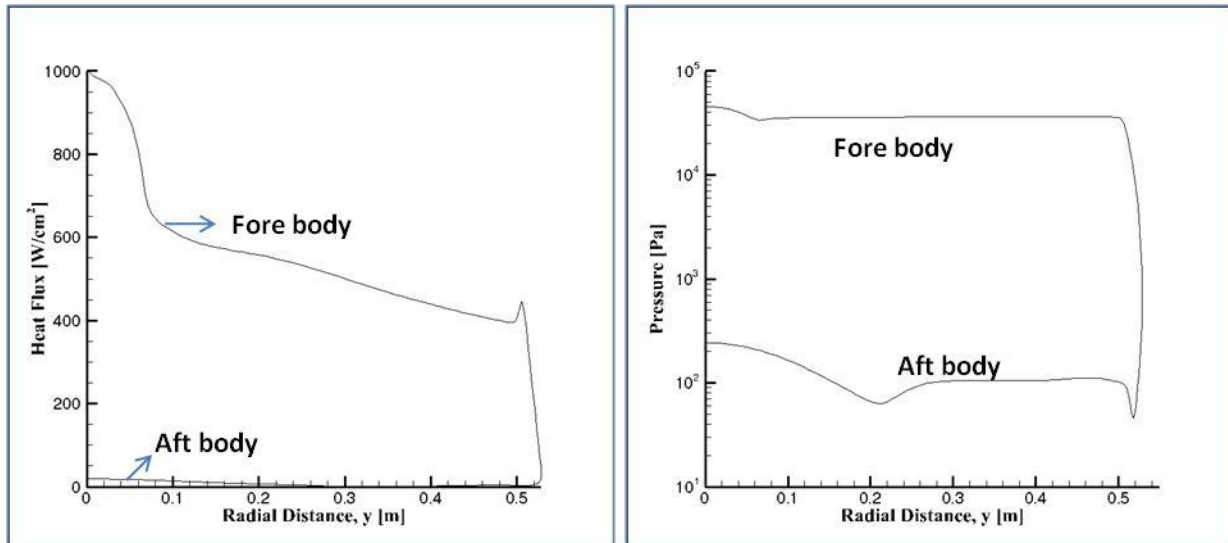
Figure 11: Environments from a nominal MSR trajectory. (a) Heat flux distribution (b) Pressure distribution

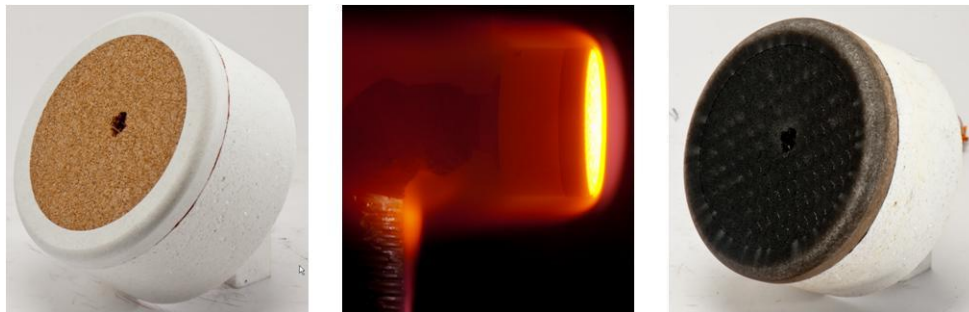
Figure 21: SLA sample before, during, and after the arcjet test.

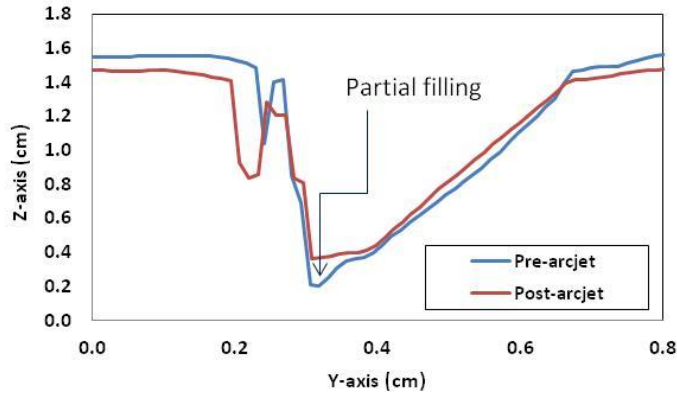
Figure 23: Laser scan of pre- and post-arcjet SLA-561V sample.

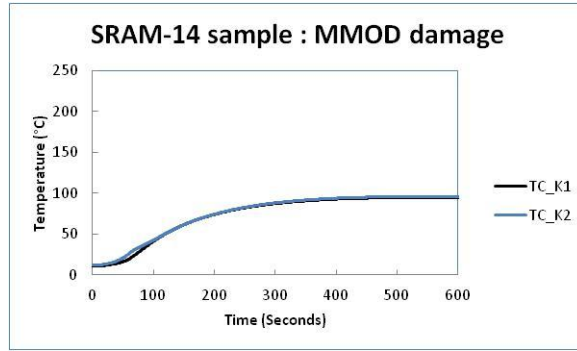
Figure 27: Temperature history at the bondline.

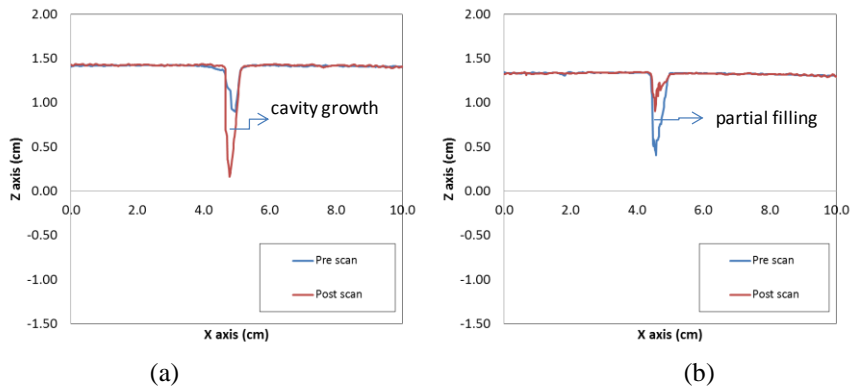
Figure 28: Laser scan profile of SRAM samples. (a) Cavity growth (b) Partial filling.

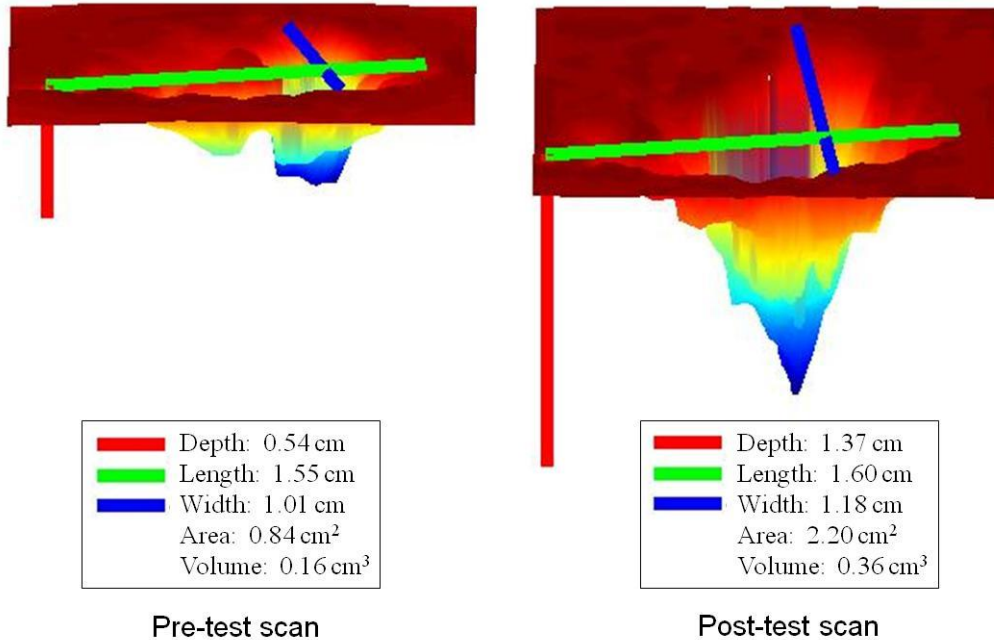
Figure 29: Contour plots of cavities showing growth in one of the SRAM sample after arcjet test.
