# FABRICATION AND TESTING OF DURABLE REDUNDANT AND FLUTED-CORE JOINTS FOR COMPOSITE SANDWICH STRUCTURES

Shih-Yung Lin, Scott C. Splinter, Chris Tarkenton, David A. Paddock, and Stanley S. Smeltzer  
NASA Langley Research Center, Hampton, VA 23681-2199

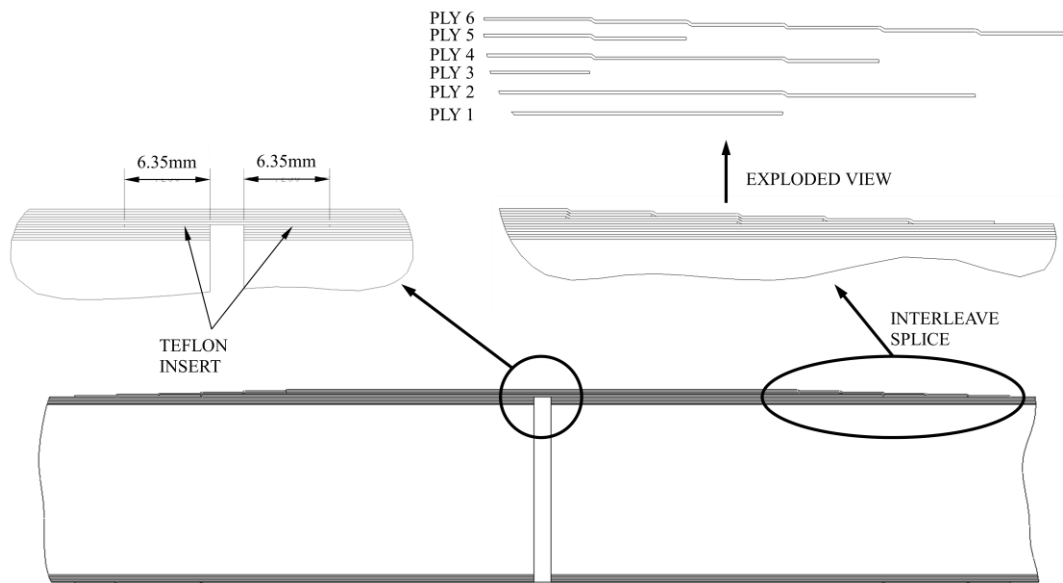
Figure 2 SJ with Teflon® edge relief strip and interleaved ply-drop scheme

The interleaved ply-drop configuration with 6.35mm between ply-drops was selected for the splices (Figure 2). Another design feature added to the SJ and DRJ was a 6.35mm wide Teflon® strip running the length of the joint, located at the edge of each panel. This feature was integrated based on previous related work [4] to characterize the effects of the Teflon® (PTFE) strip on the joint through a PDA study. The intended function of this strip was to shift stress concentrations associated with edge effects of the joined panels, to a less critical location.

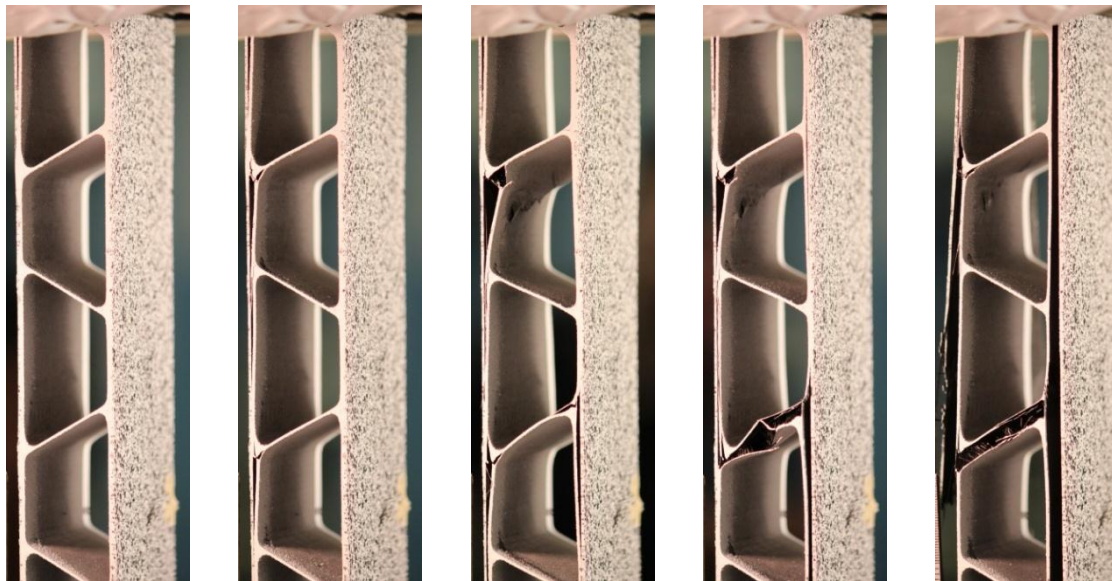
**Figure 10.** Fluted core tension test, damage propagation.

Second, due to the geometry of the web, the load transferred between the front and back sides quite easily. Delamination at the webs, as shown in Figure 10, also complicated the load distribution.

Third, because damage propagation at one side caused that side to lengthen, the other side had to carry more load and eventually developed more damage and lengthened too. This process happened multiple times, and a large delamination area was developed before final failure with the facesheet on one side totally broken. As shown in Figure 10 : (a) shows delamination started at the left side, (b) shows extensive delamination and most of the load should be carried by the right side facesheet, (c) shows delamination developed on the right side and some web area separation, (d) shows extensive delamination on both sides, and then finally (e) shows final failure.

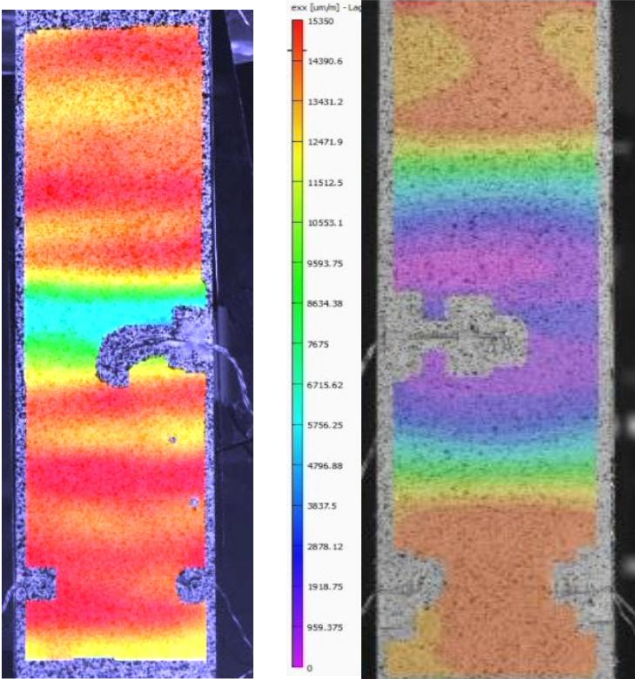
**Figure 11. VIC 3D strain pattern in loading (vertical) direction. Left shows FCJ influenced by the core and right shows SJ having a more consistent pattern**

Fourth, the alignment gages never worked in this design due to core geometry. Gage readings from all the fluted core tests scattered significantly more than other joint types. As shown in Figure 11, the VIC 3D strain pattern of FCJ is quite inconsistent compared to that of the SJ.

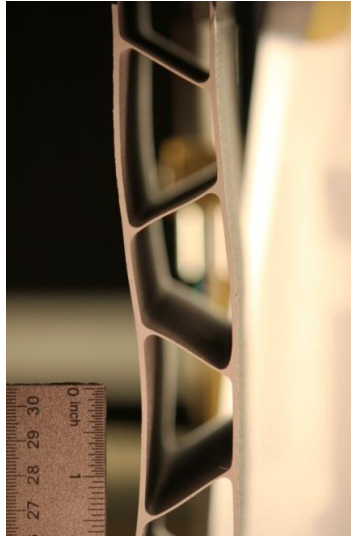
Figure 15. Buckling of a fluted core sample.

Tests conducted perpendicular to the joint direction, with and without a joint, had low buckling resistance due to its design. These samples came with some waviness due to their fabrication process, up to 0.9 mm between peak and valley according to surface profile measurements conducted separately. The samples were loaded to 56238 N/M (321 lbf/inch) when excessive lateral deflection was observed. Figure 15 shows the mode shape of a buckled sample.
