Natural Resource Assessments in Afghanistan Supported by High Resolution Digital Elevation Modeling and Multi-spectral Image Analysis

USGS/USAID Natural Resource Assessments

Kajakai Dam and Spillway Level Increase: Location and Plan

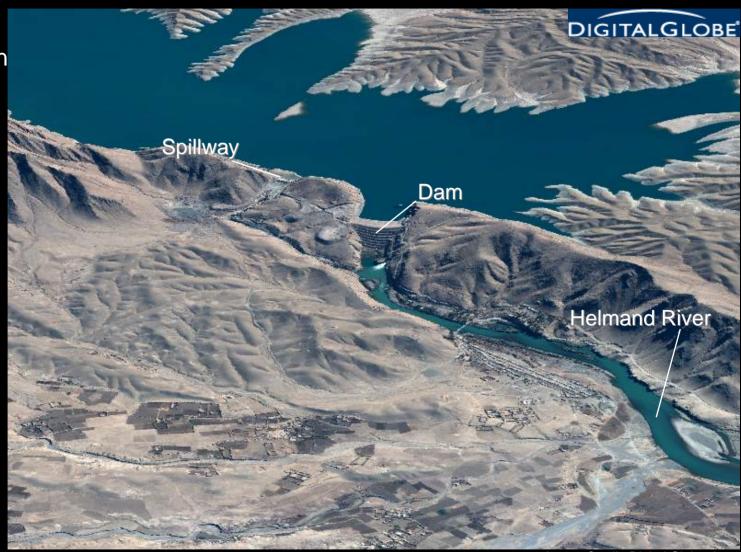
TerrainVisualizationof KajakaiDam

Kajakai Dam and Spillway Level Increase
