# Teflon FEP Analyzed After Retrieval From the Hubble Space Telescope

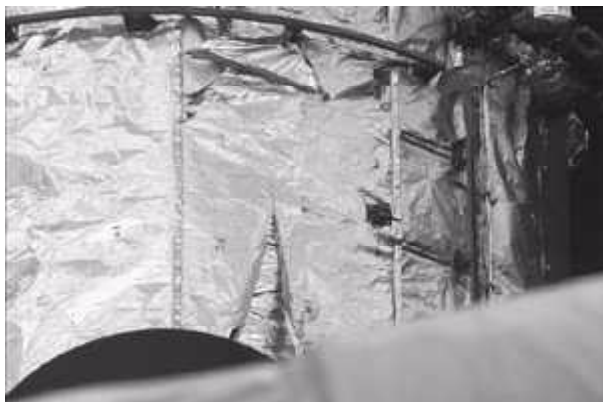
*Hubble Space Telescope light shield sample retrieved during the second servicing mission; shown prior to removal.*

During the Hubble Space Telescope (HST) Second Servicing Mission, 6.8 years after the telescope was deployed in low Earth orbit, degradation of unsupported Teflon FEP (DuPont; fluorinated ethylene propylene), used as the outer layer of the multilayer insulation (MLI) blankets, was evident as large cracks on the telescope light shield. A sample of the degraded outer layer (see the photograph) was retrieved during the second servicing mission and returned to Earth for ground testing and evaluation. Also retrieved was a Teflon FEP radiator surface from a cryogen vent cover that was exposed to the space environment on the aft bulkhead of the HST. NASA Goddard Space Flight Center directed the efforts of the Hubble Space Telescope MLI Failure Review Board, whose goals included determining the FEP degradation mechanisms. As part of the investigations into the degradation mechanisms, specimens retrieved from the first and second HST servicing missions, 3.6 and 6.8 years after launch, respectively, were characterized through exhaustive mechanical, optical, and chemical testing. Testing led by Goddard included scanning electron microscopy, optical microscopy, tensile testing, solar absorptance measurements, time-of-flight secondary ion mass spectroscopy (TOF-SIMS), Fourier transform infrared microscopy ( $\mu$ -FTIR), attenuated total reflectance infrared microscopy (ATR/FTIR), and x-ray diffraction (XRD). The NASA Lewis Research Center contributed significantly to the analysis of the retrieved HST materials by leading efforts and providing results of bend testing, surface microhardness measurements, x-ray photoelectron spectroscopy, solid-state nuclear magnetic resonance spectroscopy, and density measurements. Other testing was conducted by Nano Instruments, Inc., and the University of Akron.

Results of mechanical properties testing of FEP specimens retrieved after 3.6 and 6.8 years of HST exposure indicated significant decrease in tensile test elongation at break and reduced tolerance to strain upon bending. Space-exposed samples also showed increased

surface hardness that decreased with depth. Solar absorptance of the space-exposed FEP was slightly increased. In general, analyses showed that all of the retrieved specimens underwent chain scission. Evidence of increased crystallinity was found only in the light shield specimen from the second servicing mission, which had curled on orbit and thus experienced a significantly higher temperature than is typical for the HST light shield. Heating specimens from the first servicing mission also generated increased crystallinity. The conclusions of the Hubble Space Telescope MLI Failure Review Board were based on the combined evidence of HST damage and data uncovered in ground-based experiments. The review board concluded the following:

"The observations of HST MLI and ground testing of pristine samples indicate that thermal cycling with deep-layer damage from electron and proton radiation are necessary to cause the observed Teflon FEP embrittlement and the propagation of cracks along stress concentrations. Ground testing and analysis of retrieved MLI indicate that damage increases with the combined total dose of electrons, protons, UV, and x-rays along with thermal cycling."
