NASA/CP-1999-208982/PART1

The Second Joint NASA/FAA/DoD Conference on Aging Aircraft

Proceedings of a conference sponsored by the
National Aeronautics and Space Administration,
Federal Aviation Administration, U.S. Air Force
Materiel Command, U.S. Naval Air Warfare
Center, and U.S. Army Research Laboratory, and
held in Williamsburg, Virginia
August 31 - September 3, 1998

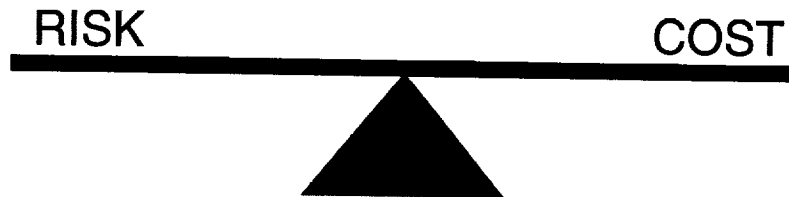
Figure 1. Balancing risk vs. cost

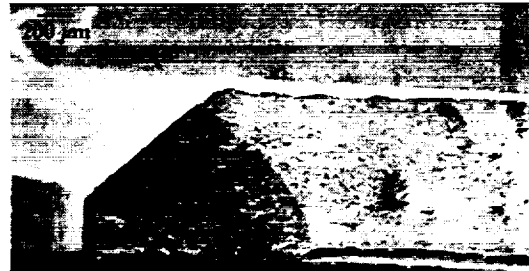
Figure 5. SEM micrograph of the fracture surface of a specimen which was fatigued at a maximum stress of 154 MPa. The crack initiation sites are at the corner where the knife edge intersects the hidden surface.

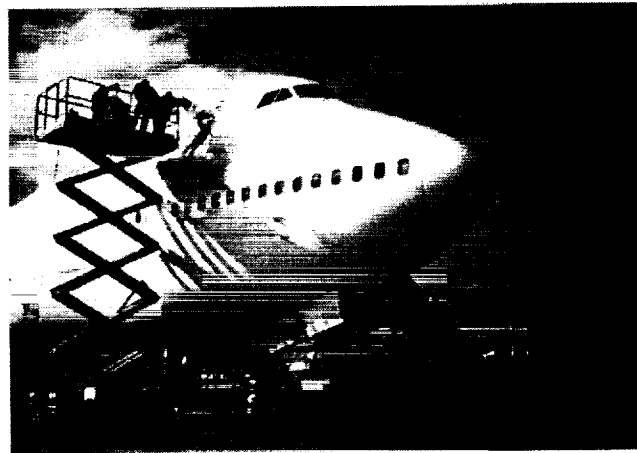
Fig. 2 Photograph of the pulse echo thermal wave imaging system in operation to inspect a B747 aircraft for the presence disbonded internal doubler structures. Two of the authors are shown operating the system from an extendable lift platform, from which they are using the hand-held imager.
