NASA/CR—97-206227

OMC Compressor Case

W. Donald Humphrey
Lincoln Composites, Lincoln, Nebraska

November 1997

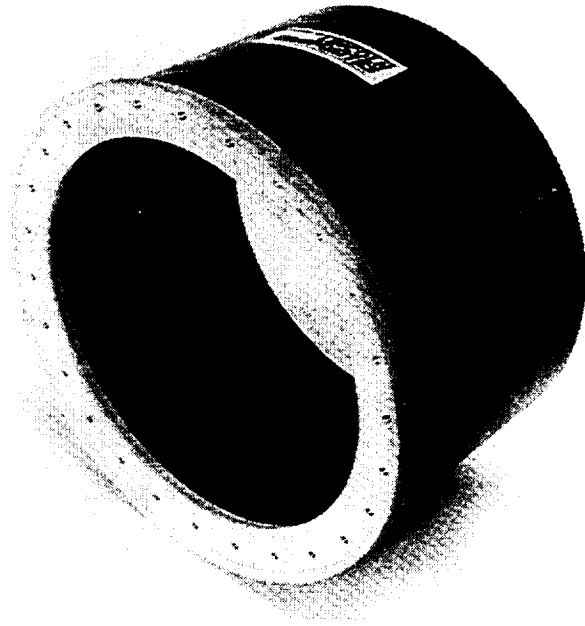
Figure 4-8. Completed Compressor Case

The last manufacturing operation consisted of machining the outboard edges of the end closures to meet the requirements of drawing TE-39917. Holes were drilled in the molded closures and helicoils installed to complete the assembly (see Figure 4-8).

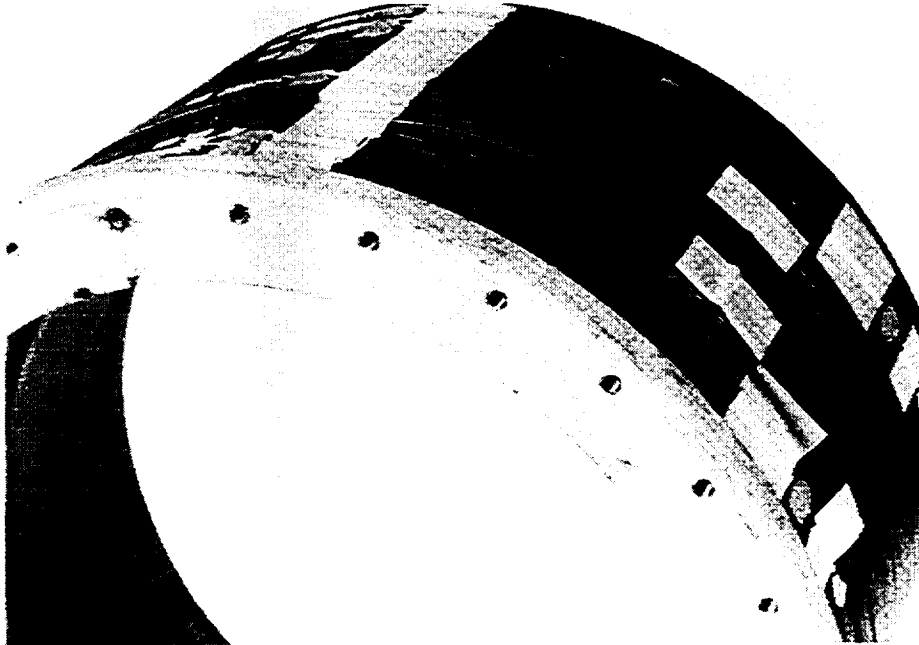
Figure 6.2-2. AFR-700B Unit, Outer Skin Secondary Failure at Eight times Limit Load

Post test inspection indicated that the failure initiated as a compressive bearing failure of the inner skin at the edge interface between the aft end fitting and the inner skin (see Figure 6.2-1). Secondary to this initial failure of the inner skin, the wall became unstable and the outer skin also fractured near the aft fitting (see Figure 6.2-2).

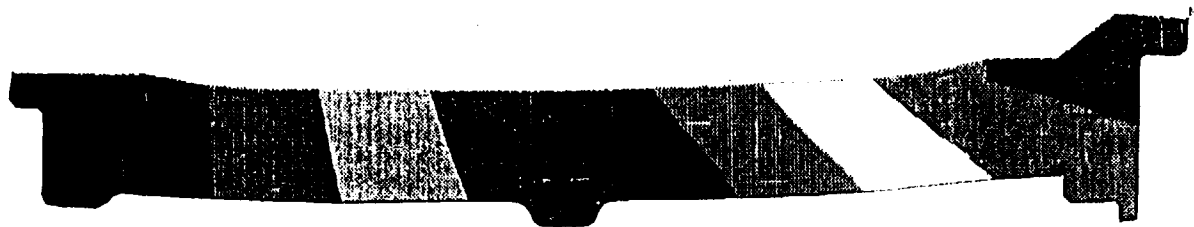
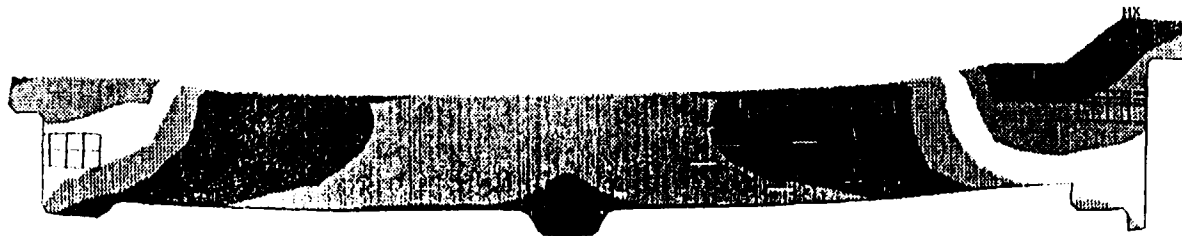
Figure 8-2. Combined Limit Loads, Deformations [in.]

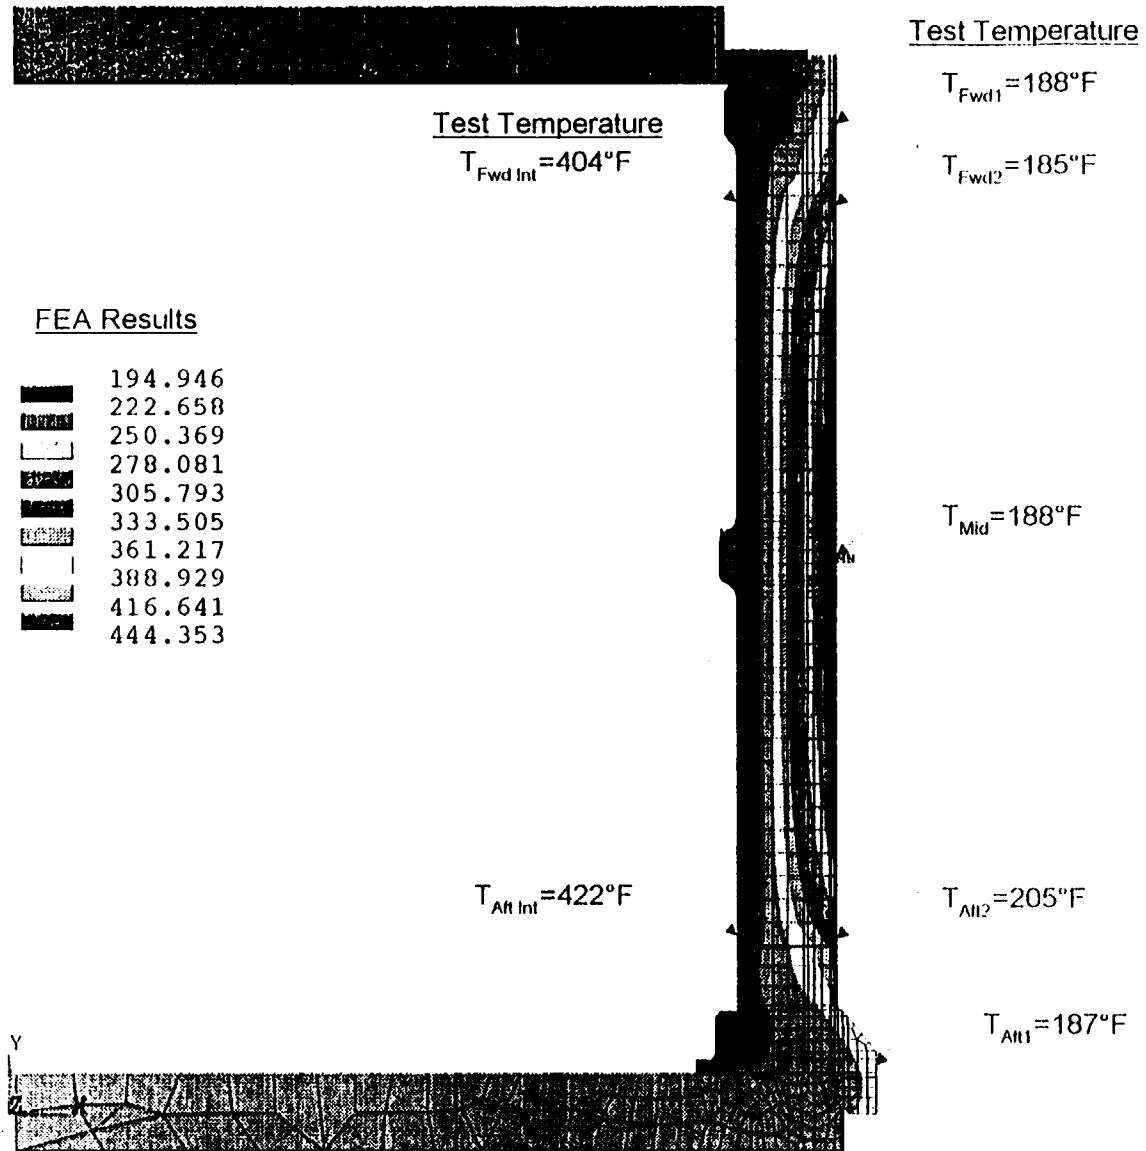
Figure 8-4. Temperature Distribution, [$^{\circ}F$]

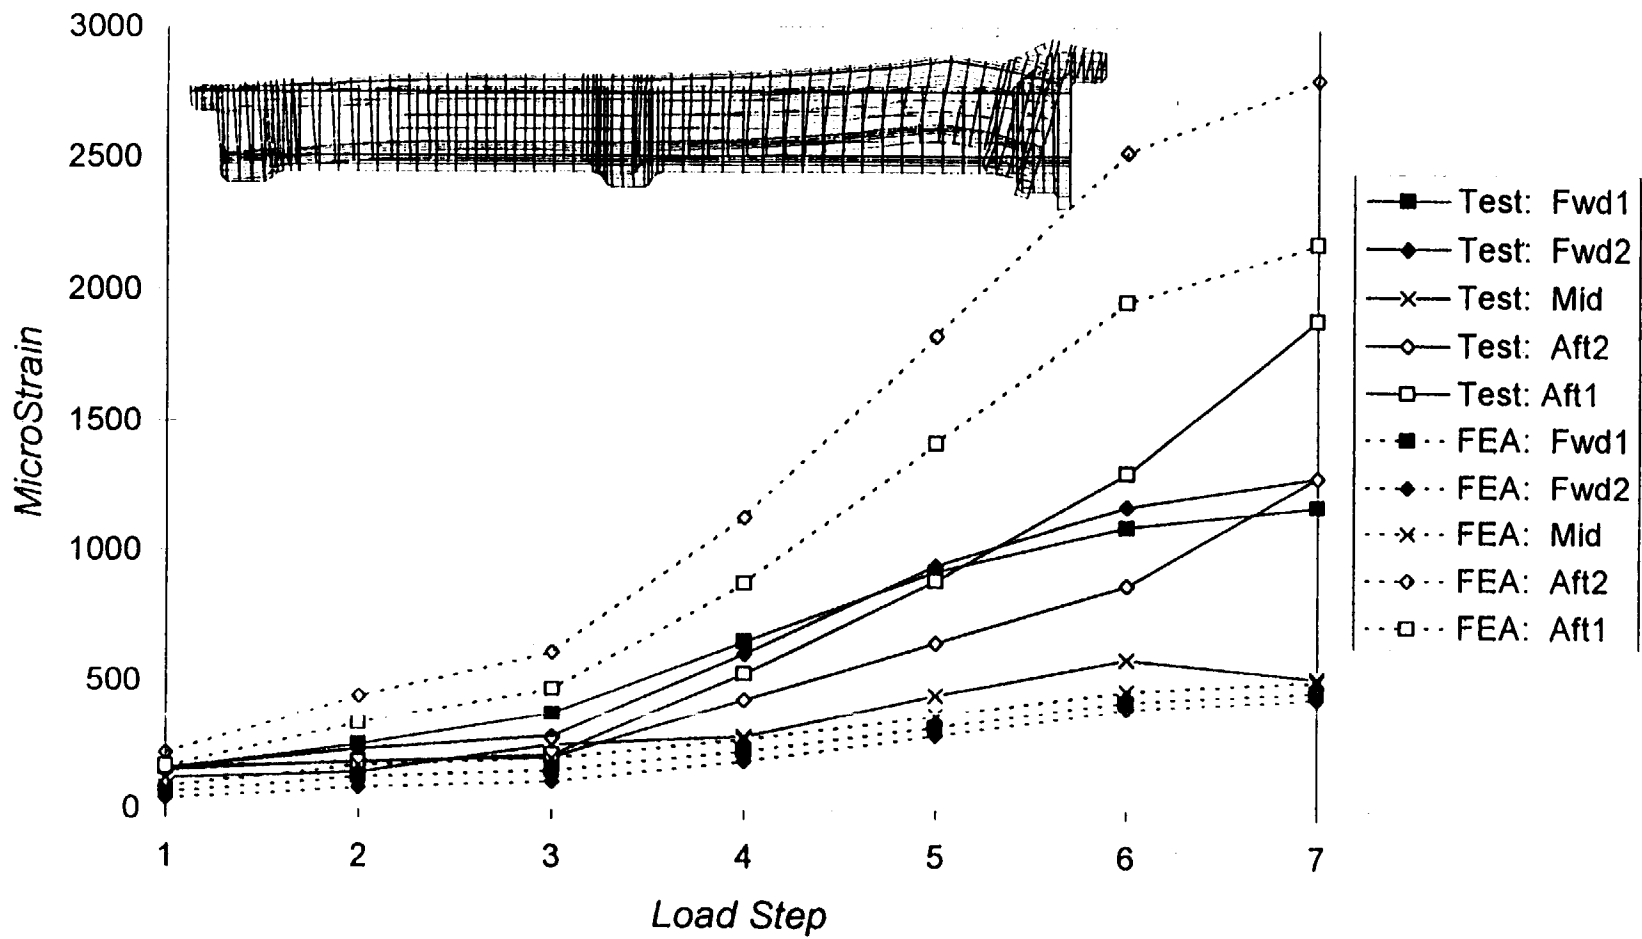
Figure 9-4. Circumferential Strain Comparison
