NASA/CR-1998-207669

Development of a Flexible Seal for a 60 psi Cryogenic Pressure Box

David E. Glass
Analytical Services & Materials, Inc., Hampton, VA

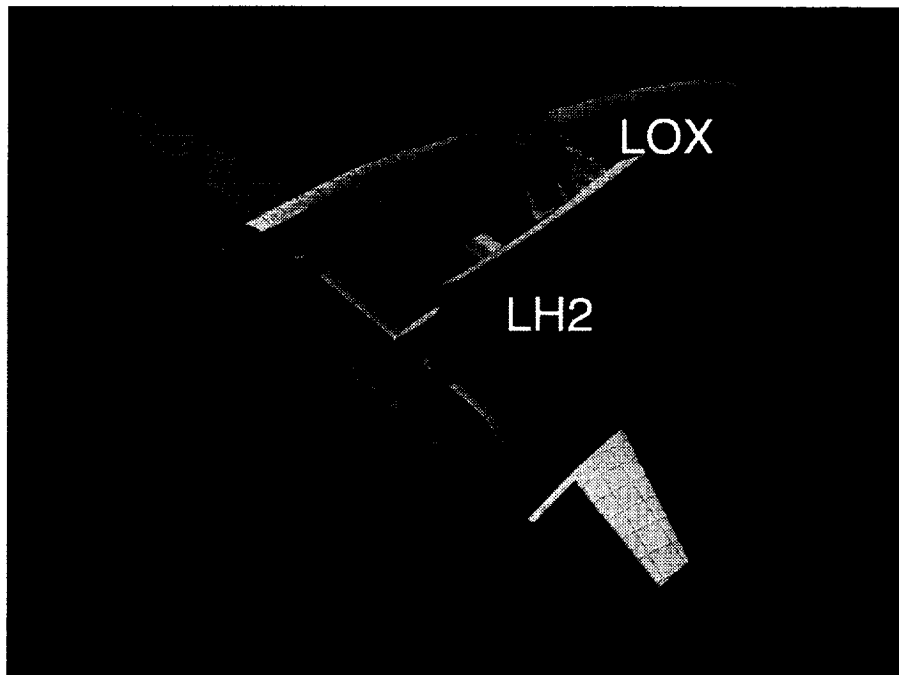
Figure 1: Conceptual drawing of the Lockheed Martin reusable launch vehicle showing the liquid hydrogen (LH2) and liquid oxygen (LOX) tanks.

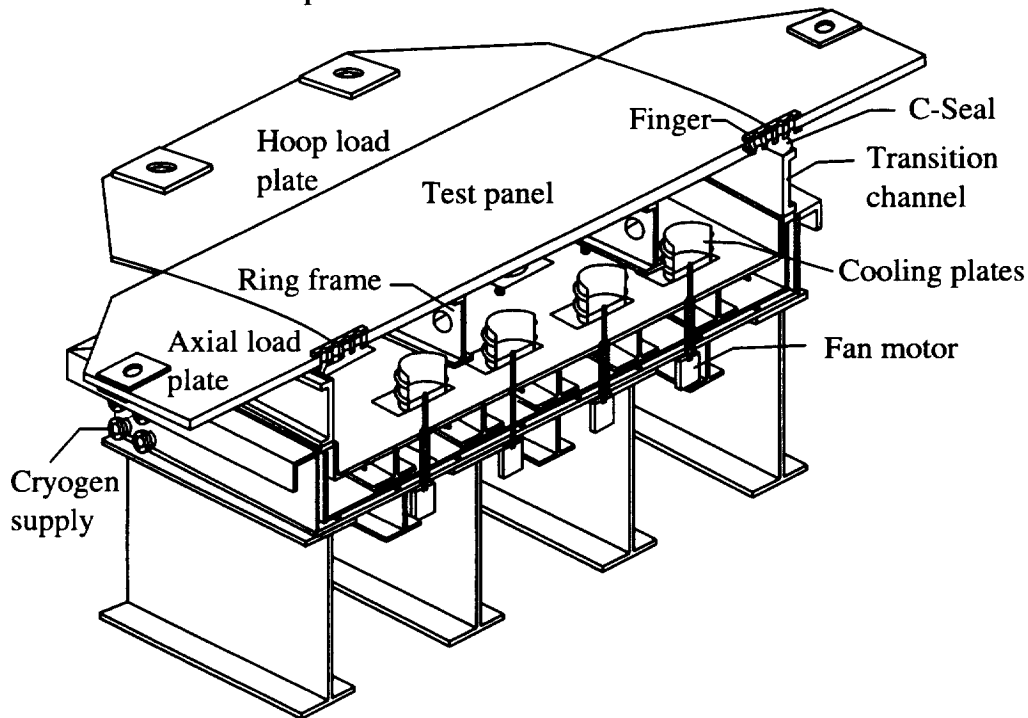
A schematic of the pressure box is shown in Figure 2. The test panel covers the top of the pressure box. Fingers, not all of which are shown in the figure, transfer

mechanical loads from the hoop and axial load plates to the test panel. The C-seal is connected to fingers below the test panel and seals the region between the test panel and the transition channel. The transition channel is the top portion of the pressure box. Several other components shown in the figure are the cryogen supply lines, the cooling plates, and the fan motors.

Figure 2: Schematic drawing of the cryogenic pressure box showing the location of the C-seals.

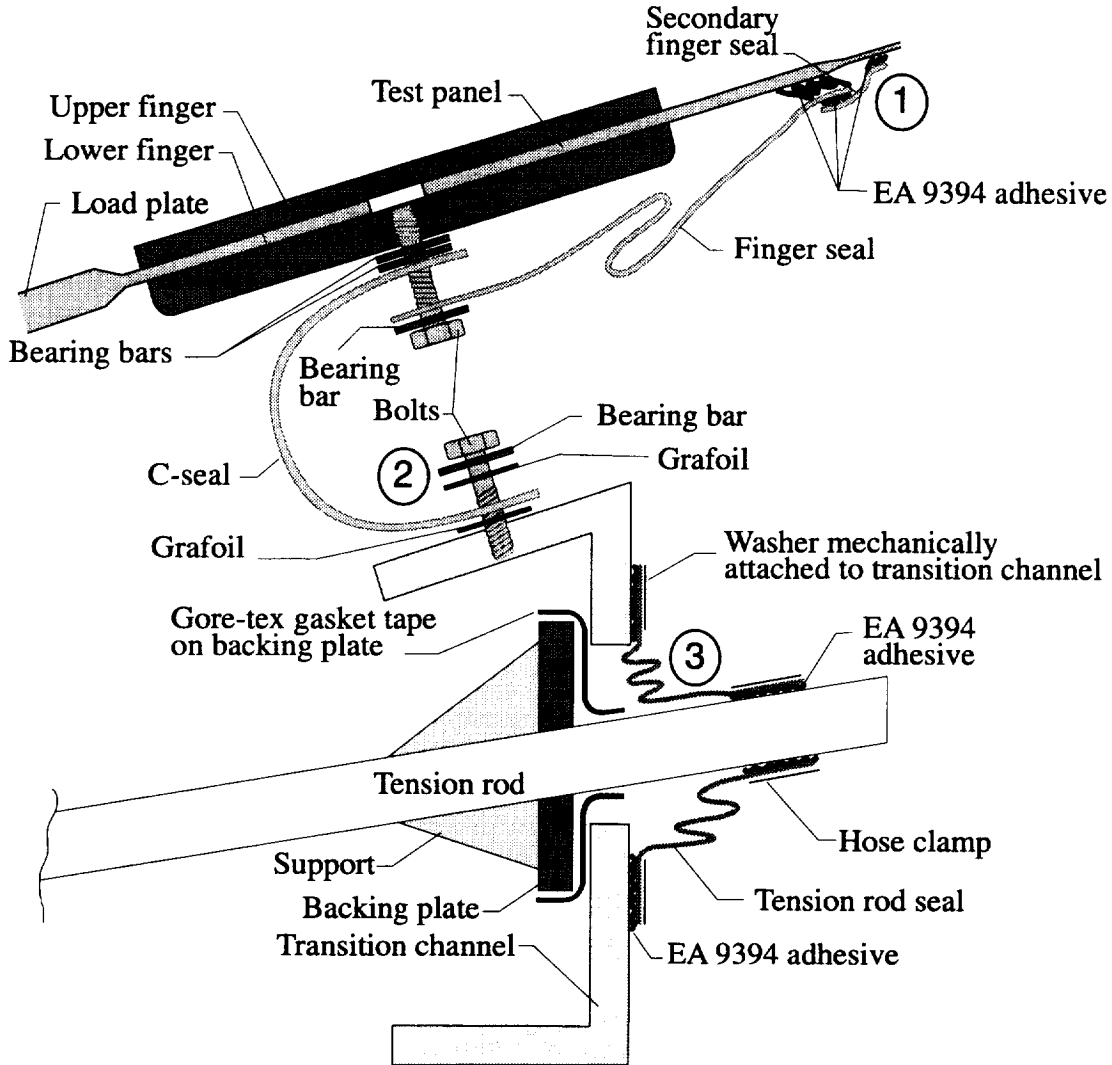
Three seals were required to seal the pressure box, assuming the test panel has ring frames. Each of these seals are illustrated in Figure 3. One is a finger seal which seals the leak paths between the fingers and the C-seal. The second seal is the C-seal, which connects the panel to the transition channel, and the third seal is a tension rod seal that seals the penetration for the tension rod. Each of the different seals uses the same Gore-tex[®] material and is discussed in detail below.

Due to the space between the fingers and the space between the load plate and the panel, a leak path exists that is sealed by the finger seal. The finger seal, indicated by number 1 in Figure 3, carries minimal tensile loads since the seal rests against the panel and fingers. The finger seal is bonded to the panel forward of the fingers with EA 9394 ambient temperature cure adhesive. A secondary finger seal, 2-in. wide, is bonded over the edge of the finger seal where it is bonded to the panel as a safety measure. The opposite end of the finger seal is bolted between bearing bars with the C-seal under the fingers.

The C-seal seals the region between the fingers and the transition channel. The C-seal must remain flexible at -423°F, carry the tensile loads generated by the 60 psi internal box pressure, and maintain minimal pressurization gas leakage. Due to the fact that the test panel must be allowed to move relative to the fingers (resulting from the biaxial loading), the fingers cannot be tightened against the test panel. Thus, the C-seal attachment to the fingers is through three bearing bars, the top one which is bolted to the finger with freedom to allow motion. The middle bearing bar is then bolted tightly to the upper bearing bar. The lower bearing bar, with the C-seal and finger seal sandwiched between the lower and middle bearing bars, is tightly attached to the middle bearing bar. The bottom of the C-seal is bolted down to the transition channel with another bearing bar.

A 1 7/8 in. diameter stainless steel tension rod will penetrate the transition channel, as shown in Figure 3, and attach to the ring frame of one panel planned for testing. Due

to the possibility of the test panel lifting up to 2 in. upon box pressurization, the hole where the tension rod penetrates must be able to allow for that vertical motion. A stainless steel bellows seal was initially considered. However, due to the magnitude of the required length (~36 in.) and diameter (~ 6 in.) of the bellows seal, a more compact sealing mechanism was required. It is anticipated that the tension rod seal will use the same seal material used for the C-seal and finger seal. However, the seal design has not been finalized and is thus not included in the figure.

Figure 3: Schematic drawing of the cross-sectional view of the seals and the transition channel.

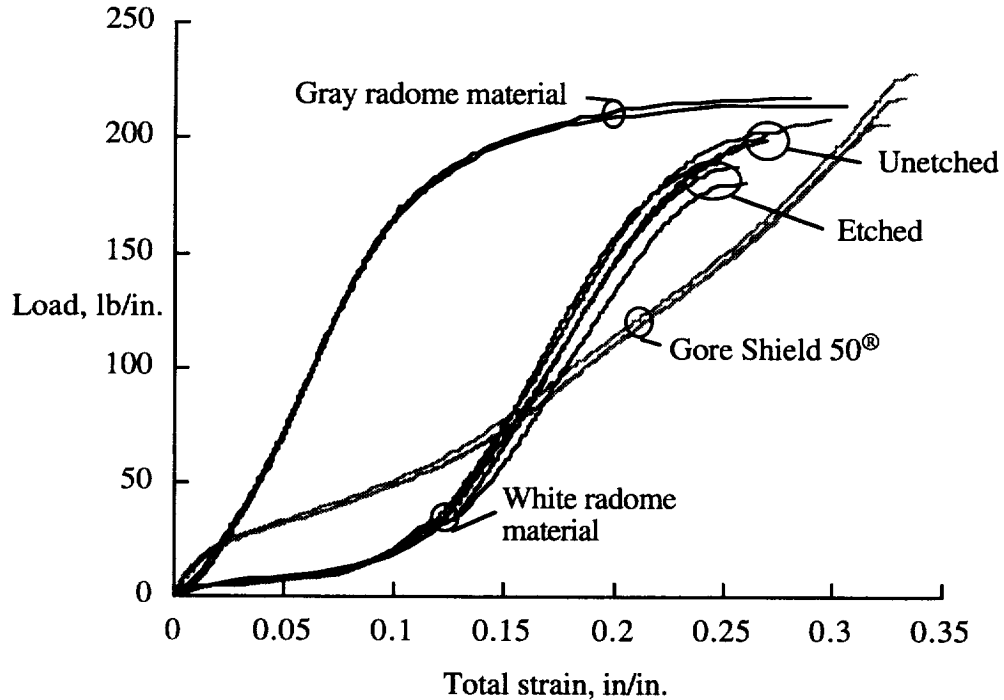
Figure 4: Load versus strain for the seal material under ambient temperature tensile testing.

Three samples of each specimen were tested. The gray radome material was loaded in the white thread direction, perpendicular to the gray threads. The samples were 4-in. wide with a test length of 3 in. Figure 4 shows the load per inch width of material versus the strain. The load per inch was obtained by dividing the total load by the initial 4-in. width of the samples. There was significant necking down of the samples, on the order of 0.5 in., as the load was increased. The test length was initially 3 in. and the strain shown in the figure is the total displacement divided by 3 in. The gray and white radome material and the Gore Shield 50[®] all failed at similar loads. However, the path each material followed to failure was radically different. The white radome material experienced a large initial strain at very low loads. After the initial strain, the white radome material experienced an increase in the strain similar to the gray radome material. The Gore Shield 50[®] material demonstrated a behavior unlike the radome material. Though it initially was thought that the Gore Shield 50[®] would be stronger due to its heavier weight (i. e., greater stiffness and thickness), it experienced significantly more strain with increased load than the gray radome material. Testing was also performed to evaluate the effect of etching on the strength of the white radome material. As can be seen in the figure, the etching decreased the failure load slightly, but had little effect on the properties prior to failure. Though the strain characteristics of the three different materials were very different, failure occurred in each at a strain of approximately 0.3 ± 0.05 in/in.

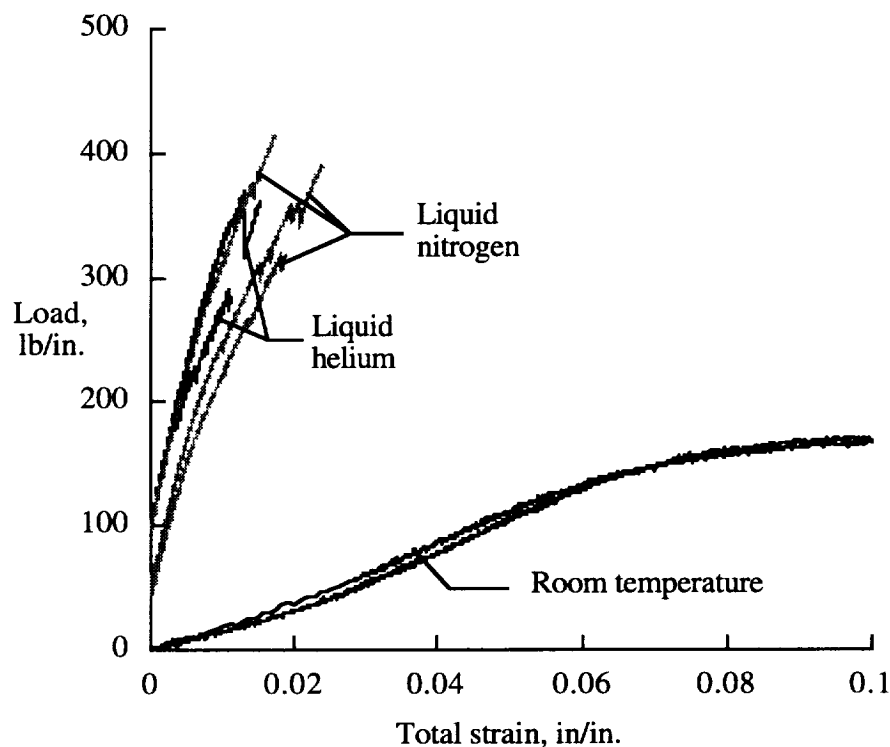
Tests were also performed at liquid nitrogen (LN2) and liquid helium (LHe) temperatures. For these tests, the entire fixture, along with the 1 in. x 7 in. specimen test area, was inserted into a dewar of the cryogen. The results are shown in Figure 5 for each of the LHe and LN2 exposed samples and ambient temperature controls. All specimens were loaded in the gray thread direction (load direction in actual seal) with a load rate of 100 lb/min/in. The ambient temperature controls failed at a strain of approximately 0.1 in/in. One of the specimens failed at the grip, while the other one failed between the grips. As can be seen in the figure, the specimens were much stronger when tested in LHe and LN2. All three of the LN2 tested specimens failed at the grip, while both of the LHe specimens failed between the grips. The LN2 and LHe samples experienced an offset in the load due to the contraction of the fixturing (due to cooling) in the cryogen during the test. The offset increased the load throughout the test, but was only known at the final load position. The offset increased the failure load of the LN2 samples to 398 lb/in. and 458 lb/in., while the LHe failure load was increased to 413 lb/in. and 423 lb/in. When the offset was included in the data, there appeared to be no significant difference between the LN2 and LHe test results. The LHe and LN2 samples also had a preload on them after installation in the fixture prior to testing. The preload was 50 lb/in. for the LN2 samples and 100 lb/in. for the LHe samples. The stroke (strain) was zeroed at the preload value, and thus any strain resulting from the preload was neglected. This may account for the different shape in the ambient temperature and cryogenic temperature tests, i.e., no inflection point at the early load values.

Figure 5: Load versus strain for 1-in-wide samples at ambient temperature, LN2 and LHe temperatures loaded in the gray thread direction with a load rate of 100 lb/min/in.

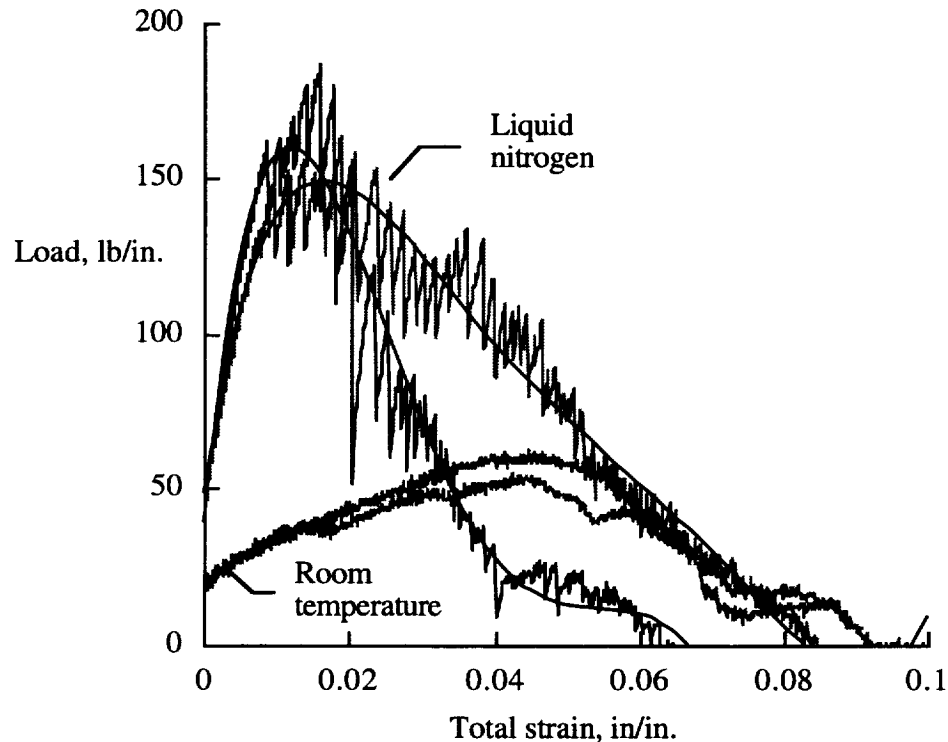
The seal will have several seams joining different pieces of fabric. The strength of the sewn joints was thus investigated. In the actual application, the seams will run parallel to the load, while in the test specimens, the seams were perpendicular to the load. Thus the test was conservative relative to the actual seal conditions. Figure 6 shows the

load versus strain for the 1-in-wide sewn joint samples. In each case, two pieces of the seal material were sewn together with a double seam, the two seams being approximately 0.25 in. apart. The load rate was again 100 lb/min/in., and the preload and offset are not included in the figure. However, unlike the prior tests, these samples were loaded in the white thread direction. The ambient temperature samples had a maximum load of approximately 50 lb/in, while the two LN2 samples had a maximum load of approximately 150 lb/in. The LN2 samples experienced much more oscillating in the data than in prior tests, and thus a curve fit is provided for the LN2 data. The cause of the noise in the data is uncertain. All of the joint tests failed in a similar manner regardless of the test temperature. In each case, the white thread (load carrying thread) broke at one of the seams. However, the gray threads, perpendicular to the load, separated approximately 0.3 in. from the seam. The reason for the gray threads separating away from the seam is unclear.

Figure 6: Load versus strain for 1-in-wide sewn joint samples at ambient temperature, LN2 and LHe temperatures loaded in the white thread direction with a load rate of 100 lb/min/in.

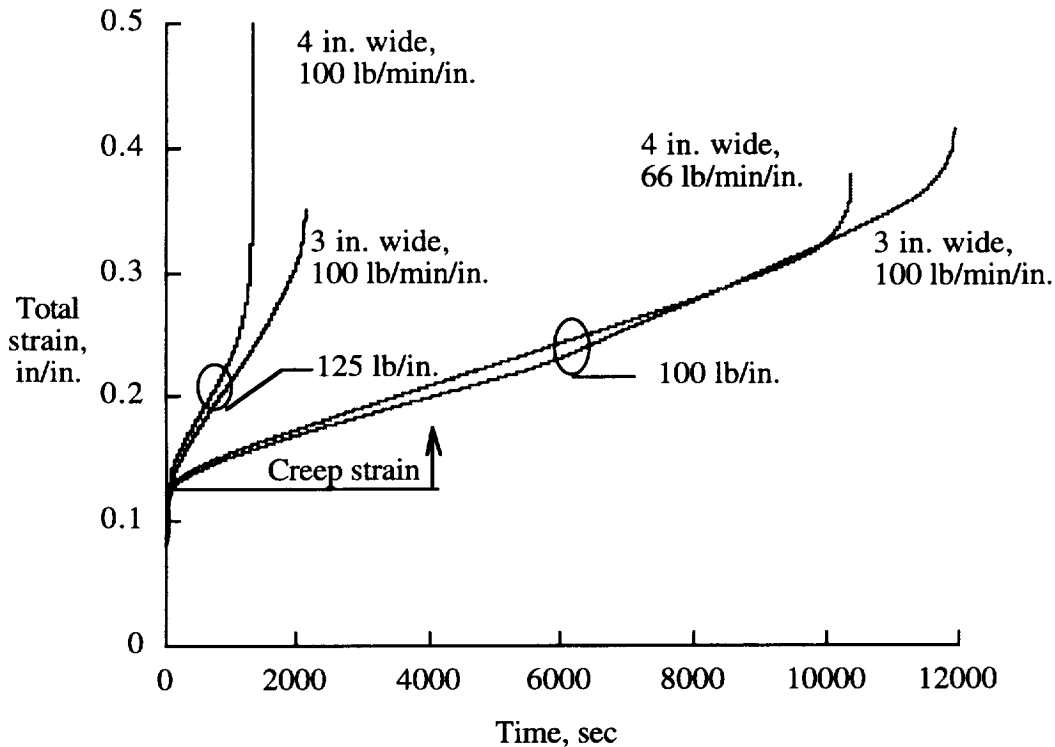
held at that load level and the time varying strain was measured. From the figure, it can be seen that the width had an effect on the creep of the specimen. For both values of the maximum load, the 4-in-wide samples failed sooner and at a slightly lower strain. It should be pointed out that the 4-in-wide specimen at a load of 100 lb/in. was loaded at a slower initial rate than the other specimens. However, as will be seen later, a slower rate results in a longer time to failure and a higher total strain. Thus the 66 lb/min/in. initial loading rate provided a longer time and higher strain than would have been obtained with a 100 lb/min/in. initial loading rate as in the other specimens.

Figure 7: Effect of specimen width on creep for 3-in-wide and 4-in-wide samples loaded at ambient temperature in the gray thread direction with an initial load rate of 100 lb/min/in.

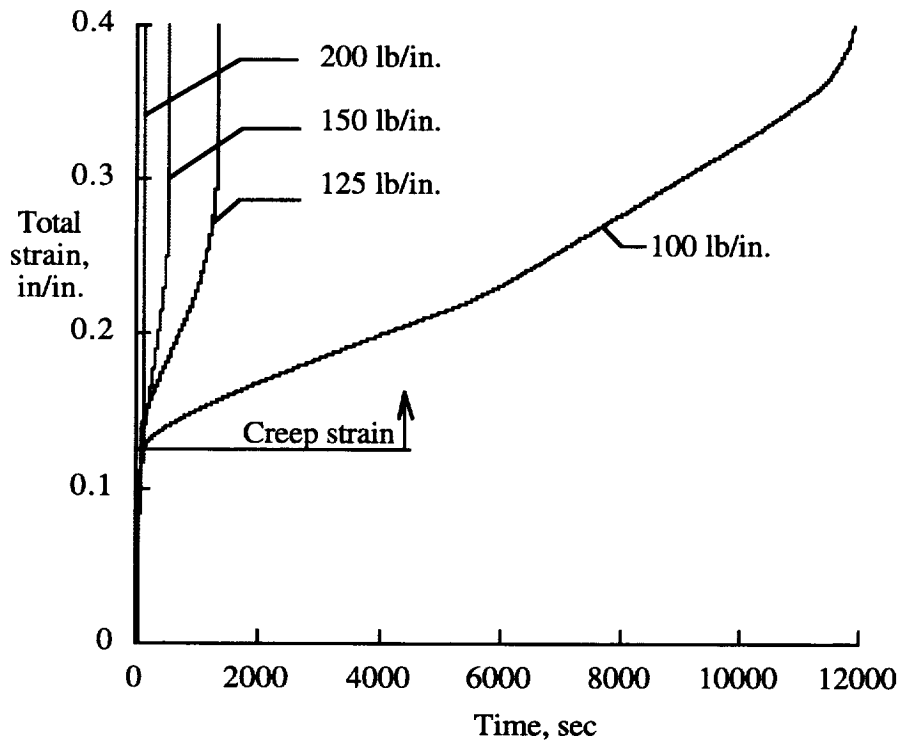
Samples with a width of 4 in. were also tested for creep, with the results shown in Figure 9. As in Figure 8, the time to failure increased non-linearly as the load was decreased. The samples were again loaded in the gray thread direction.

Figure 9: Effect of maximum load on creep of seal material with 4-in-wide samples loaded in the gray thread direction with an initial load rate of 100 lb/min/in.

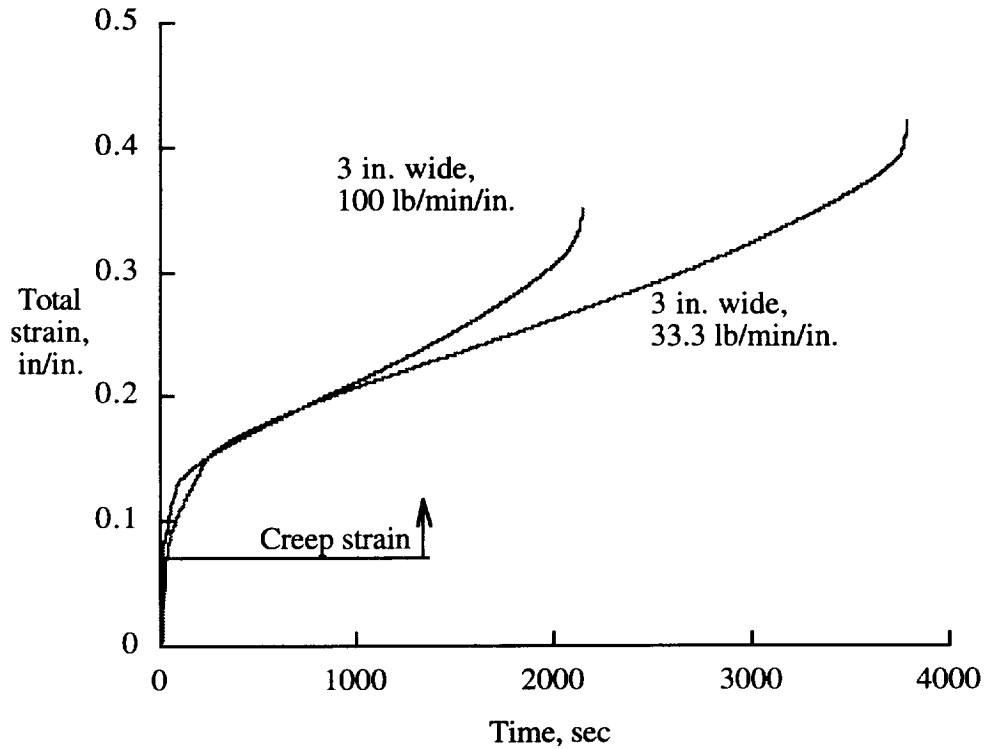
The effect of the initial load rate on the creep was also evaluated. Figure 10 shows the strain as a function of time for 3-in-wide samples with 100 lb/min/in. and 33.3 lb/min/in. initial load rate for a test load of 125 lb/in. Again, the samples were loaded in the gray thread direction and the testing was performed at ambient temperature. The slower initial load rate resulted in a longer time to failure and an increased strain capability.

Figure 10: Effect of initial load rate on the creep of 3-in-wide specimens at 125 lb/in. loaded in the gray thread direction at ambient temperature.

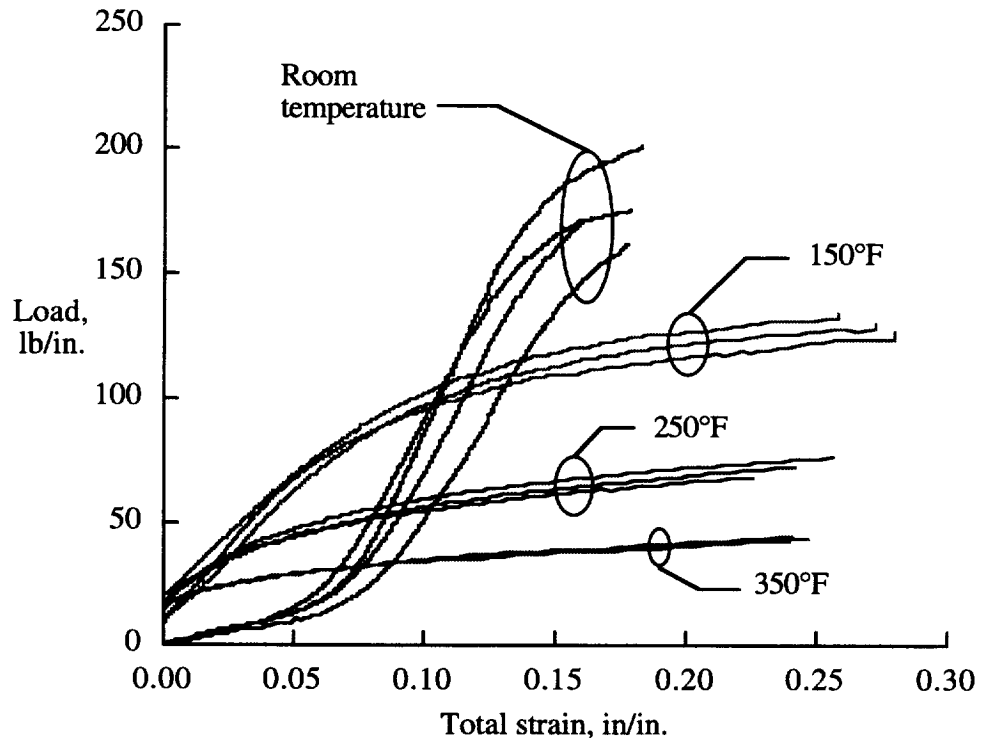
Figure 11: Effect of temperature on the load versus strain for 1-in-wide samples loaded in the gray thread direction with a load rate of 20 lb/min/in.

Figure 11 shows the effect of temperature of the strength of the material, as shown by plotting load versus strain. The specimens for the static testing were 1-in. wide and were loaded in the gray thread direction. In each case, the specimen test length was 4 in. The load rate was 20 lb/min/in. until failure. For all of the heated specimens, the test machine stroke limit was reached prior to failure. As expected, the maximum load decreased with temperature. The ambient temperature data are similar to data shown in previous figures. The ambient temperature specimens did not have a pre-load from which displacement measurements are referenced, and thus appear to initially have a large strain with only a small load. The elevated temperature specimens had a pre-load of 10 lb (150°F) and 15 lb (250°F and 350°F).

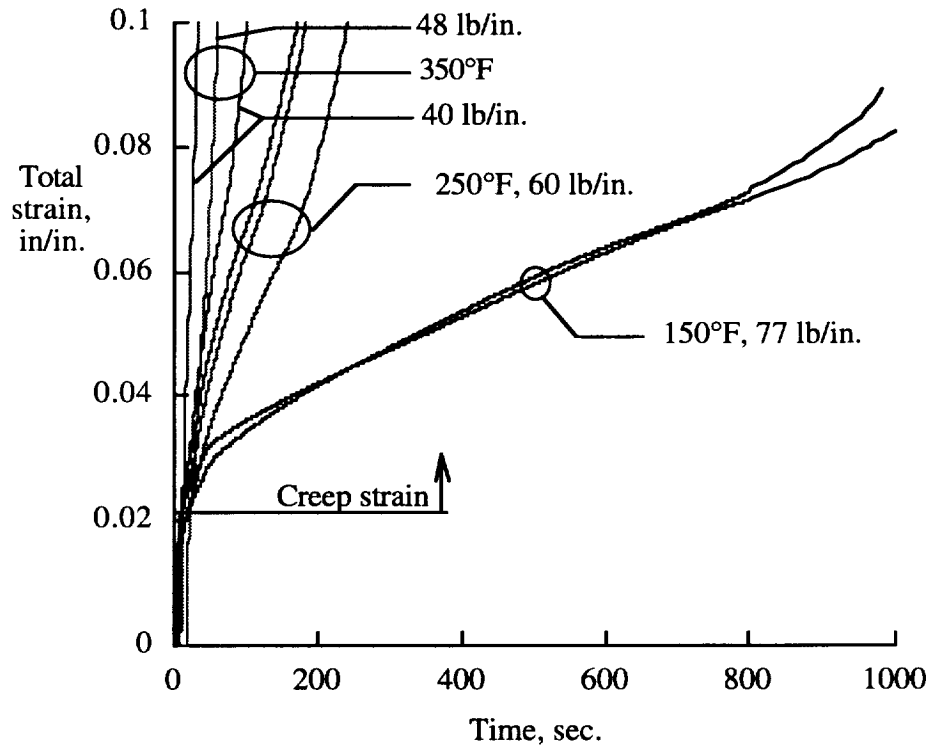
Creep testing was also performed at elevated temperature, and the results are shown in Figure 12. The specimens were 1.5-in. wide and were loaded in the gray thread direction at an initial load rate of 100 lb/min/in. up to the test load. The fact that the test loads chosen decreased with temperature implies the effect of temperature is even more than it appeared in the figure. Thus, if the 250°F and 350°F tests were performed at 77 lb/in, the time to failure would be even less. The tests at 350°F were performed at two different loads, 48 lb/in. and 40 lb/in. However, the different loads does not appear to be

significant as the 48 lb/in. lies between two 40 lb/in. tests. A photograph of a specimen after creep testing is shown in Figure 13. The necking down of the specimen is shown quite well with this specimen. However, most of the specimens did not fail in the manner shown in Figure 13.

Figure 12: Effect of temperature on creep for 1.5-in-wide samples loaded in the gray thread direction with an initial load rate of 100 lb/min/in. up to the test load specified.

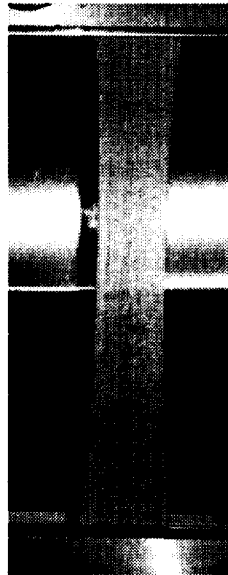
Figure 13: Photograph of seal failure after creep testing at elevated temperature.

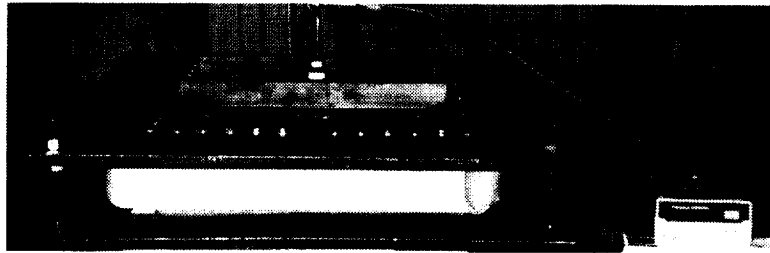
A fixture was fabricated to test the C-seals at ambient temperature to failure. The fixture was designed to withstand an internal pressure of 200 psi over an area 13.5 in. x 13.5 in. The 200 psi was chosen to give enough margin so that the pressure could be increased to a level to fail the seals. A photograph of the test fixture is shown in Figure 14. The seal, pressurized to 6.1 psi, can be seen between the two 0.5-in-thick steel plates in the photograph.

Figure 14: Photograph of the modified fixture for pressure testing the seals to 200 psi.

The final test on the seal was a burst test at ambient temperature. The seal was placed back in the high pressure, ambient temperature test fixture shown in Figure 14. The seal was pressurized at a rate of approximately 5 psi/min with nitrogen gas. The seal failed at an internal pressure of 103 psi, 16 minutes after starting the pressurization, with an applied pressure of 125 psi. From a post-test video examination of the seal failure, it

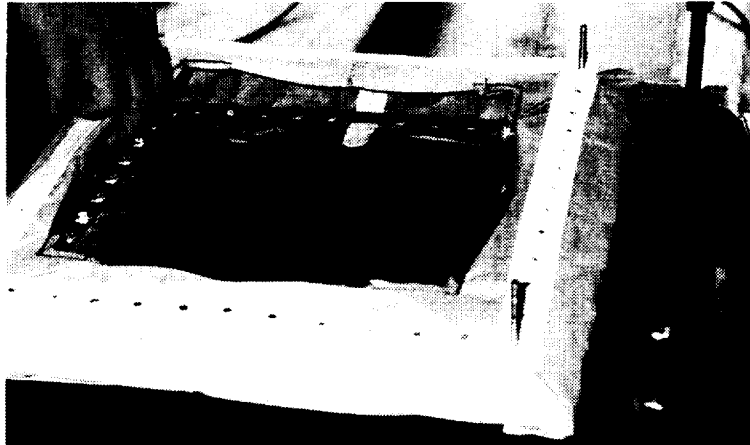
Gore Seal #1: The first seal tested was provided by W. L. Gore & Associates. The corners of the seal were folded multiple times and sewn together to form a pleated corner, as shown in Figure 15. Also shown in Figure 15 is the Gore-tex[®] gasket tape with adhesive backing placed on the outside surfaces of the seal over the bolts holes. On the inside surface of the seal can be seen a strip of seam seal material to reduce leaks at the seam. The bearing bar can also be seen in the photograph. When the C-seal was placed in the fixture, all the bolts were tightened with a torque wrench to 60 in-lb. The seal was then pressurized to 6.1 psi and examined for leaks with a soapy solution for detecting leaks. Small leaks were observed in the corners of the seal where there was a step change in the seal thickness from approximately 6 layers to one layer. The pressure was then gradually increased to 60 psi. The time to 60 psi was approximately 18 minutes. At 60 psi, a large leak was present and 400 psi was required from the high pressure nitrogen bottle to maintain 60 psi in the seal. The 60 psi pressure was maintained for only a few

seconds and the nitrogen supply was shut down. Upon examining the seal, it was observed that the seal material had been forced out of one of the corners at the step change between the multiple layers of the corner and the single layer of seal. The seal material that was forced out had a portion of a bolt hole through the edge of the fold. Thus when it was forced out (and tried to inflate) a 0.3-in-diameter hole was present in the seal. The data implied that this occurred at approximately 48 psi. It was also observed that the seal material had several pinhole leaks. In addition, the bolts on top of the plate leaked much more than the bolts on the bottom plate.

Figure 15: Photograph of Gore seal #1 prior to final assembly in fixture.

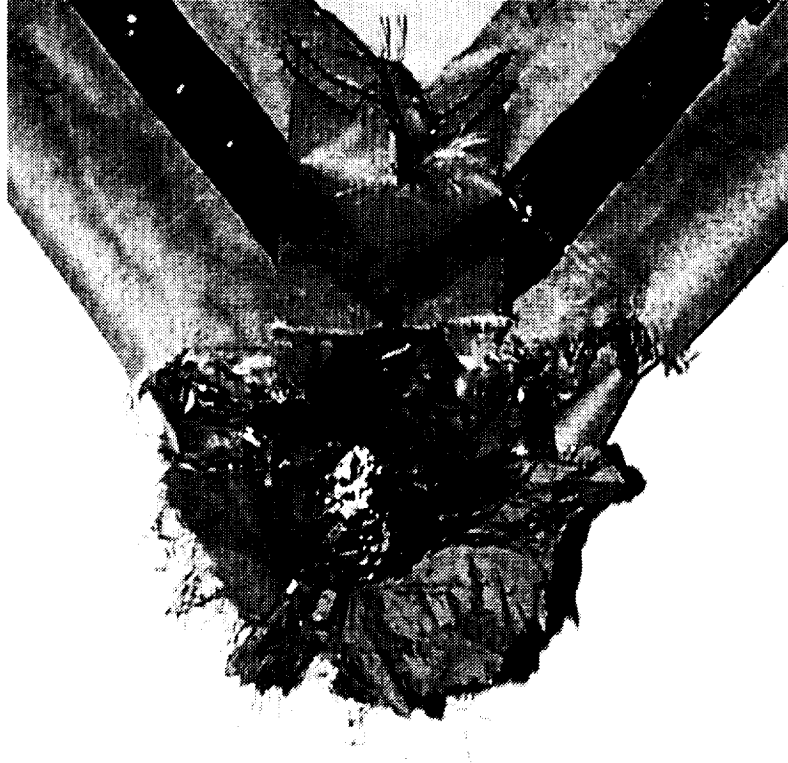
Figure 16: Photograph of the failed corner of LaRC Seal #2.

LaRC Seal #2: A second LaRC seal was fabricated exactly like the first LaRC seal. Grafoil[®] was used between the seal and the fixture instead of the Gore-tex[®] gasket tape in an effort to avoid the relaxation observed with the Gore-tex[®] gasket tape. In addition, an aluminized mylar liner was used on the inside in an attempt to reduce gas leakage through the seal. No attempt was made to seal the seam. Bolts were torqued to 130 in-lb. During an initial observation at several psi, leakage occurred between the seal and the plates at the location of the seams, but the seams did not leak. The seal was pressurized to 20 psi, and only 30 psi was required from the nitrogen bottle. The seal pressure was gradually increased to 60 psi over a period of 5 minutes and held for approximately 30 minutes. At 60 psi, the applied pressure was 70 psi. The Grafoil[®] seemed to do a better job of sealing than the Gore-tex[®] gasket tape. In prior tests, the Gore-tex[®] would be forced out of corners at the higher pressures causing excessive leakage. That kind of failure was not noticed with the Grafoil[®]. After approximately 29 minutes, the seal failed. A photograph of the failed portion of the seal is shown in Figure 16. The failure was symmetric about the top corner. Upon examining other corners, it was noticed that the corner of the inside bearing bar was beginning to tear the corner of the seal. It was determined that modifications to the bearing bar were required. The bearing bars were modified by cutting off the corners and radiusing the edges that were cut. Cutting off the corners eliminated the corner bolt hole.

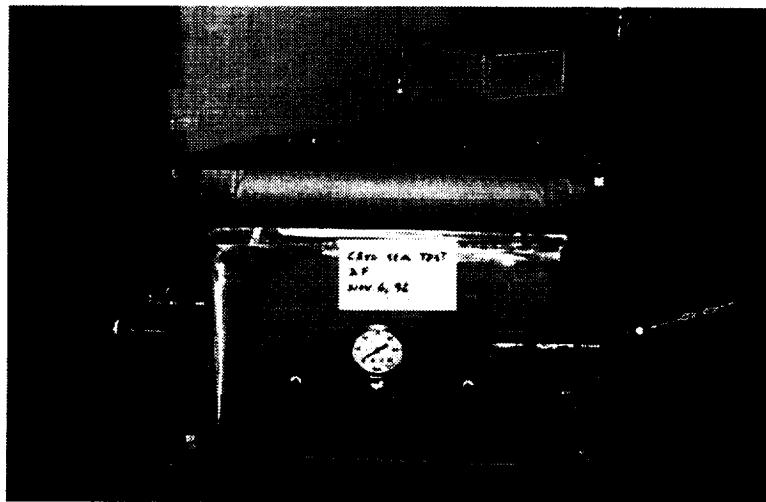
LaRC Seal #5: A fifth LaRC seal was fabricated exactly like the prior LaRC seals. The same bearing bars that were previously rounded off on the corners were used along with the non-adhesive Grafoil[®]. The aluminized mylar was again used on the inside as an impermeable liner. The seal was installed in the small cryogenic test box, shown in Figure 17, to facilitate cryogenic testing if the ambient temperature cycling was successful. The small cryogenic pressure box was fabricated by AET for development of the seals and to assist in the full size cryogenic pressure box design.

Figure 17: Photograph of the small cryogenic test box with LaRC Seal #5 ready for pressure testing.

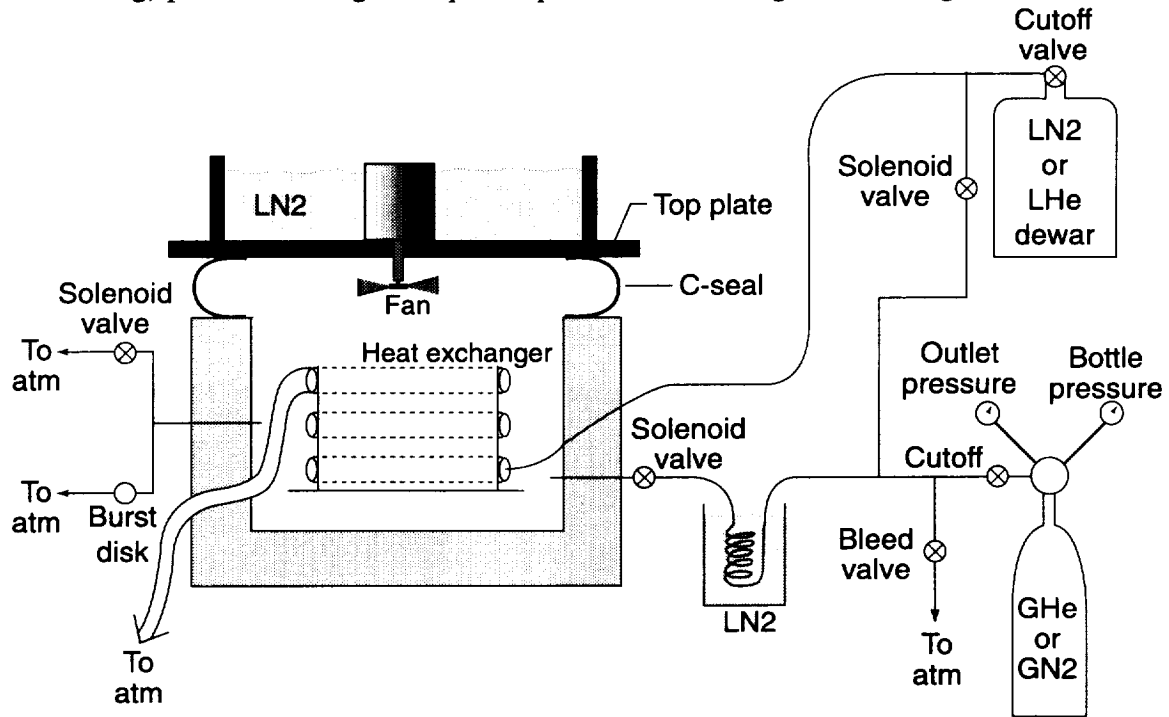
A schematic diagram of the pressurization and cooling systems used for the small cryogenic pressure box is shown in Figure 18. The schematic diagram shows a fan penetrating the top plate and a LN2 bath on the top plate. The fan was initially used without the LN2 bath, but was determined to be a source of leaks and to not cool effectively. The LN2 bath was added and used to supplement cooling the seal. The pressurization gas was supplied from a high pressure nitrogen or helium bottle. The pressurization gas was precooled in a LN2 bath prior to pressurizing the box. A solenoid valve and burst disk were utilized on the box to facilitate releasing pressure in the box. In

addition to the LN2 bath on the top plate, cooling was provided by LN2 or LHe in the heat exchanger in the box. The liquid coolant was provided by a dewar. The coolant lines were purged with gaseous helium (GHe) or gaseous nitrogen (GN2) (same gas as used for cooling) prior to flowing the liquid to prevent condensing and freezing air.

Figure 18: Schematic diagram of pressurization and cooling lines for the small cryogenic pressure box.

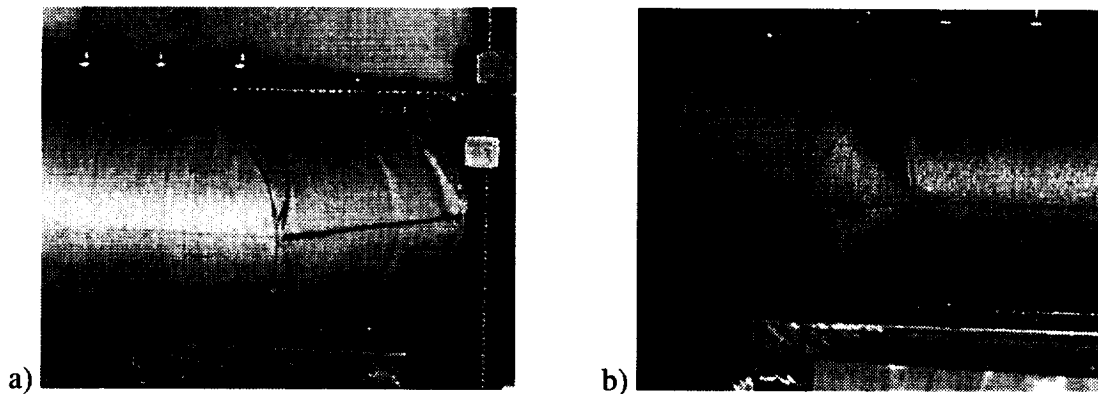
Figure 19: Photograph of the seal a) prior to full pressurization where initial folds can still be seen, and b) after pressurization, where prior folded regions are now “puffed” out.

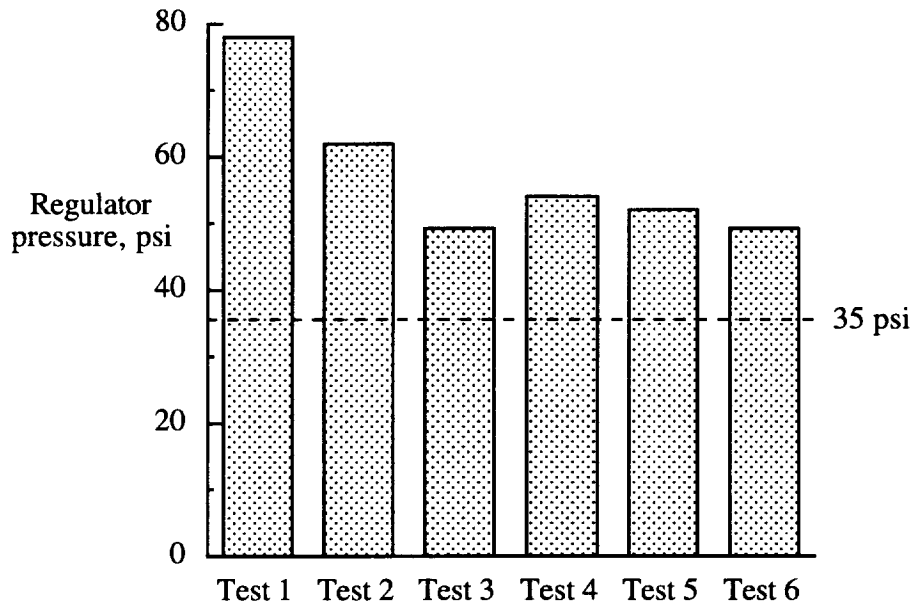
The six tests on LaRC seal #5 were performed over a span of 6 days. After test #5, several bolts through the top plate were broken due to the deflection of the top plate at 35 psi. All but one of these bolts (a bolt that was broken below the surface of the plate) were replaced. The applied pressure seemed to experience a downward trend with increased number of cycles, as shown in Figure 20. Tests #1-5 were all performed the first two days. Test #6 was performed on the sixth day, and after the bolts were replaced. It appeared that the Grafoil[®] set with increased number of cycles, thus decreasing the required regulator pressure.

Figure 20: Regulator pressure for LaRC seal #5 ambient temperature tests when internal pressure was 35 psi.

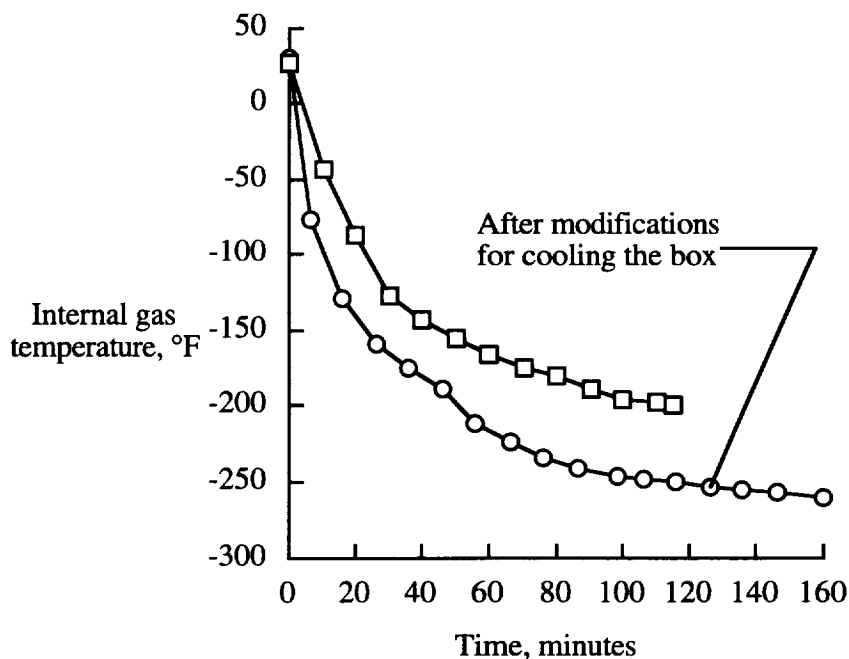
Figure 21: Internal gas temperature as a function of time during cooldown of LaRC seal #5 and test fixture.
