NASA/CR—1998-206593

Isothermal Fatigue, Damage Accumulation, and Life Prediction of a Woven PMC

Andrew L. Gyekenyesi
Cleveland State University, Cleveland, Ohio

ISOTHERMAL FATIGUE, DAMAGE ACCUMULATION,
AND LIFE PREDICTION OF A WOVEN PMC

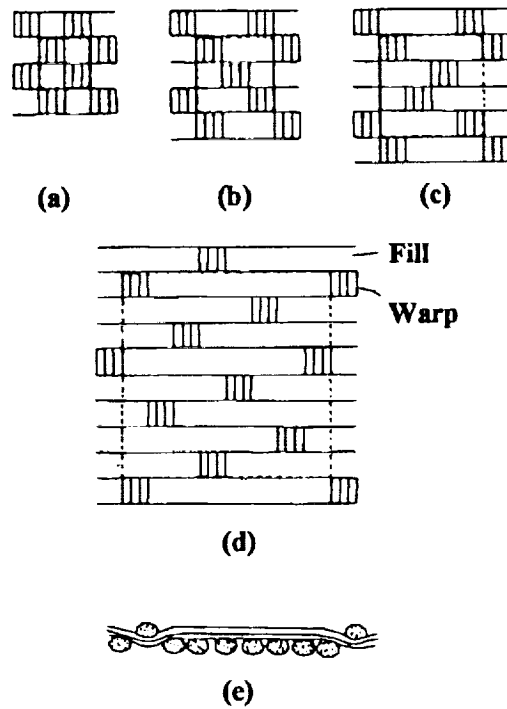
Figure 1.1 Woven 2-D fabrics with various n_g values, (a) $n_g = 2$, plain weave, (b) $n_g = 3$, twill weave, (c) $n_g = 4$, 4-harness (crow foot) satin, (d) $n_g = 8$, 8-harness satin, (e) cross-sectional view (Ishikawa and Chou (1982)).

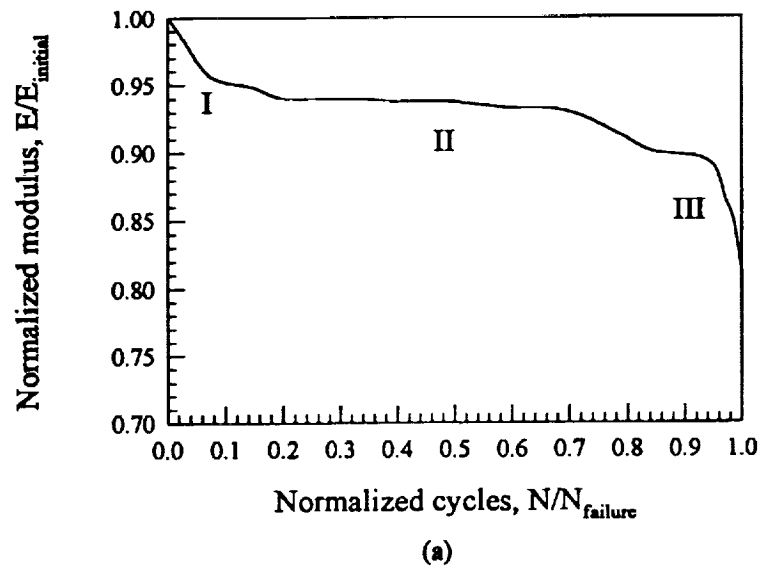
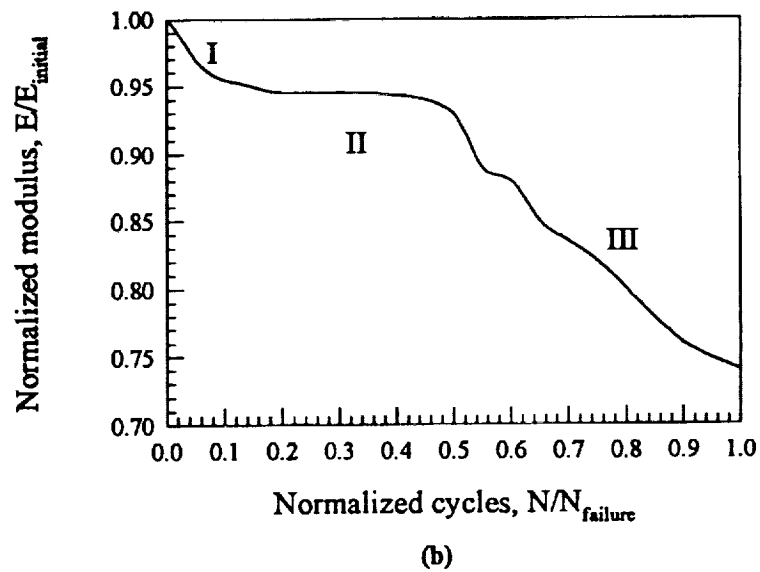
Figure 1.5 (a) Typical three stage stiffness reduction for $(0_2/90_2/0_2/90_2)_s$ carbon/epoxy laminate. (b) Stiffness degradation for a carbon/epoxy 8-harness satin cross-weave (Schulte (1986)).

A three stage stiffness degradation plot of a cross-weave laminate is depicted in Figure 1.5 (b). The experimental conditions for the figure are the same as for the cross-ply appearing in the same figure. As is the case for non-wovens, transverse cracks dominate the

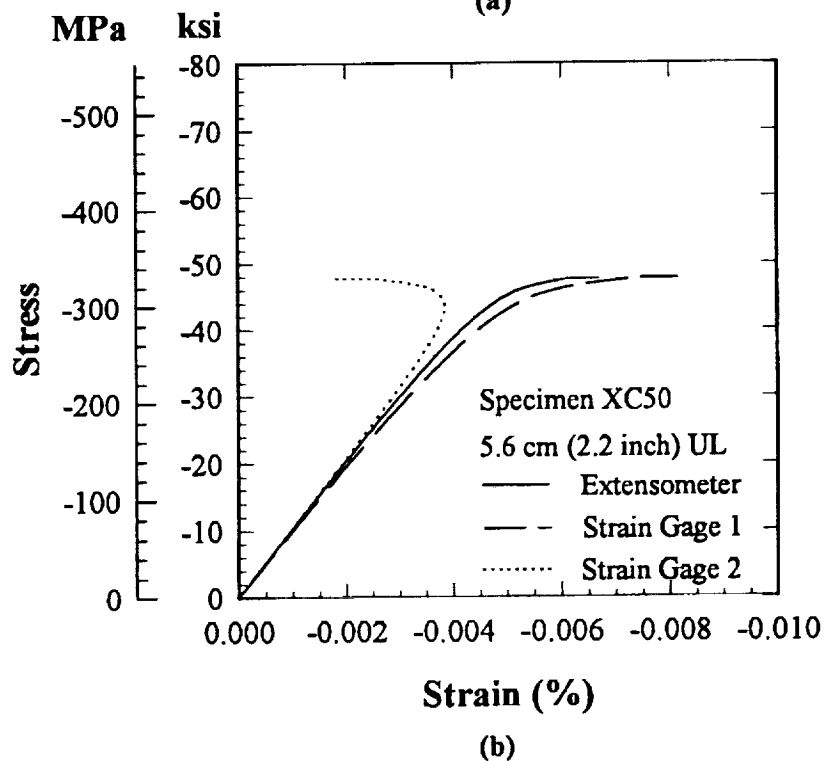
Figure 2.2 Preliminary compressive tests to study buckling as a function of unsupported length (UL). (a) No apparent buckling. (b) Strain gage behavior indicative of buckling.

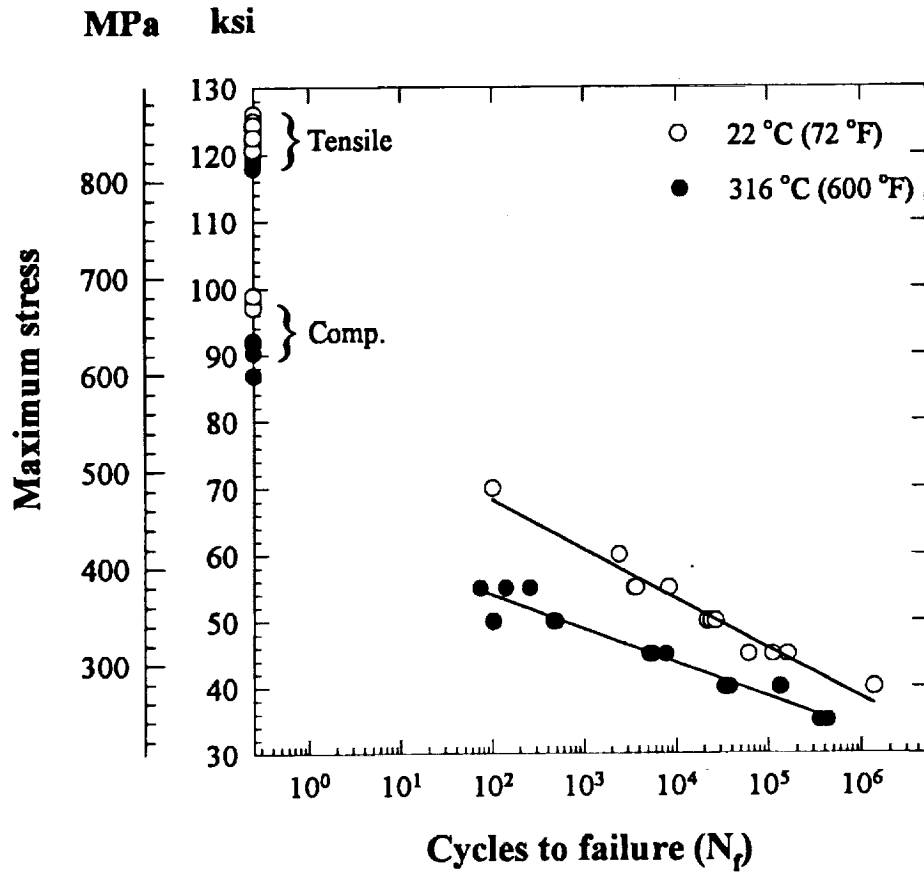
Figure 3.11 Stress based isothermal fatigue life comparison for T650-35/PMR15 (0/90) weaves at 22 and 316 °C (72 and 600 °F). Test conditions were $R_\sigma = -1$ and $Freq. = 2$ Hz.

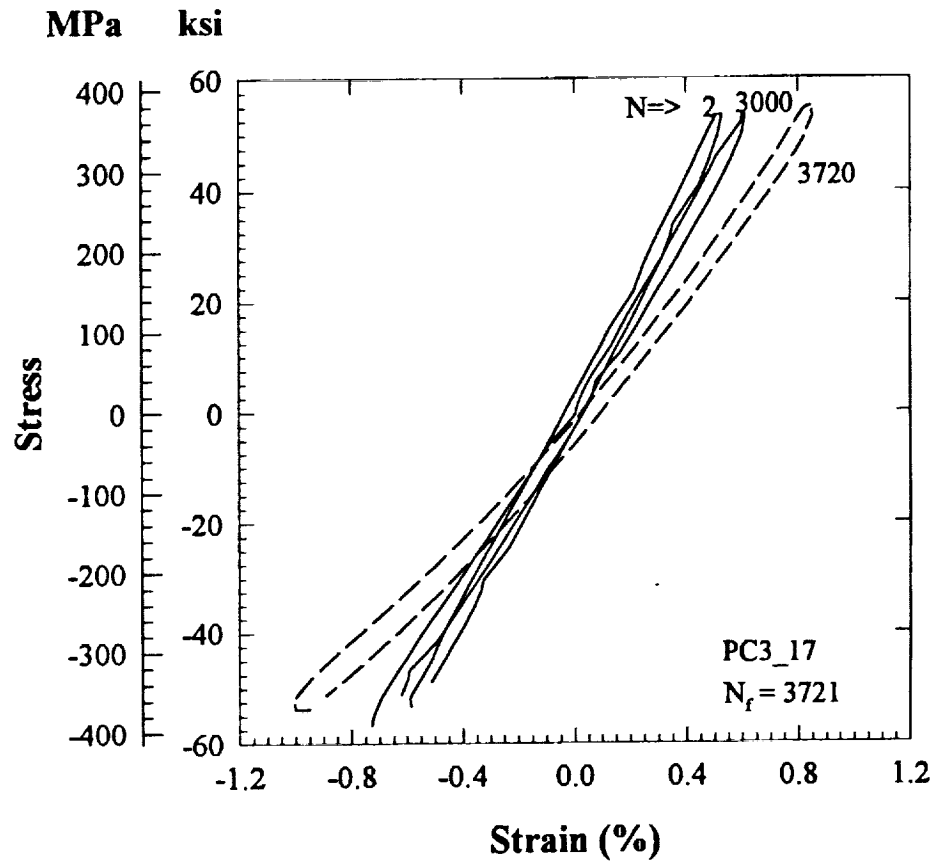
Figure 3.12 Fatigue deformation response of T650-35/PMR15 16-ply (0/90) weave at 22°C (72°F): $\sigma_{max} = 379$ MPa (55 ksi).

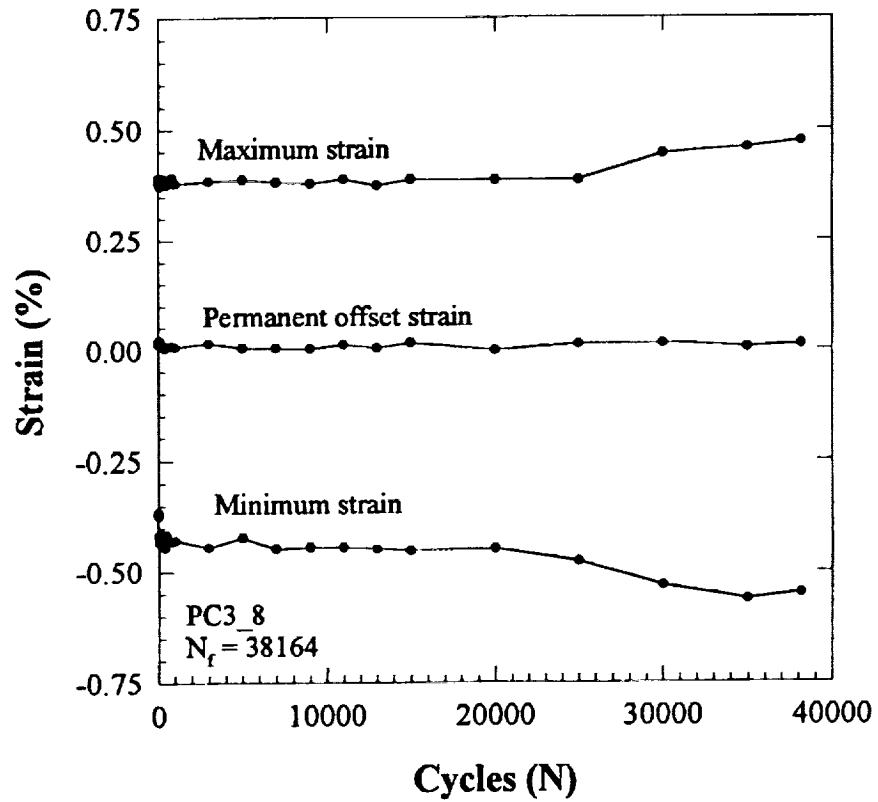
Figure 3.15 Fatigue strain behavior of T650-35/PMR15 (0/90) at 316°C (600°F)
 $\sigma_{max} = 276$ MPa (40 ksi).

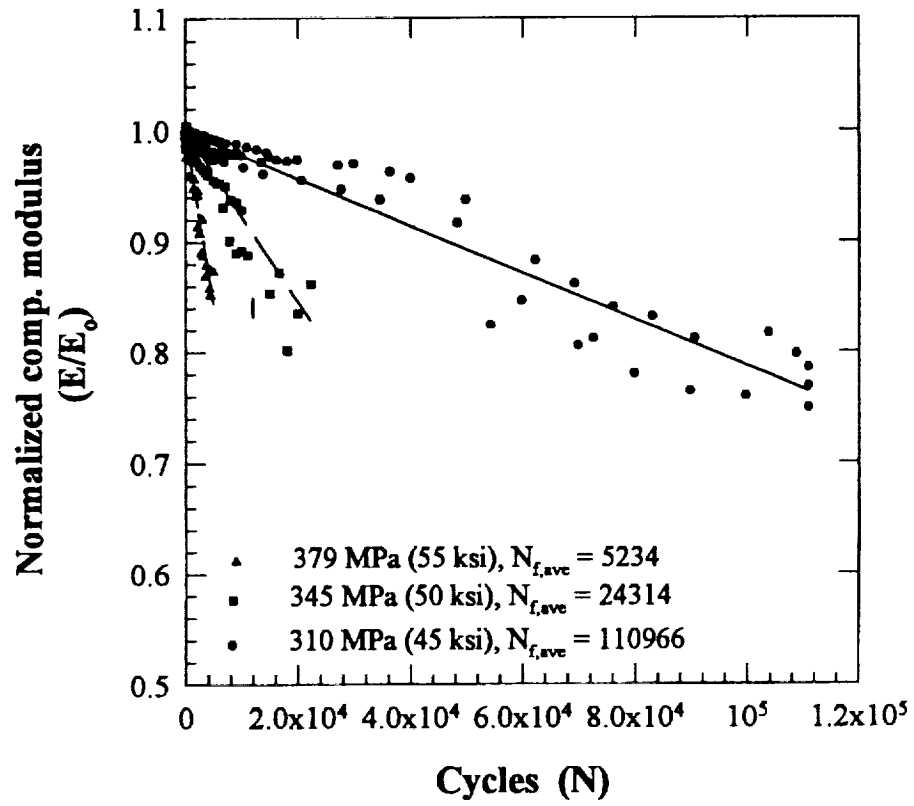
Figure 3.20 Normalized compressive modulus degradation behavior at various cyclic loads for 22°C (72°F) condition. For clarity, Stage III is not shown.
