**DAMAGE CHARACTERISTICS AND RESIDUAL STRENGTH OF  
COMPOSITE SANDWICH PANELS IMPACTED WITH AND WITHOUT  
COMPRESSION LOADING**

David M. McGowan and Damodar R. Ambur  
NASA Langley Research Center  
Hampton, VA 23681-0001

Presented at the 39th AIAA/ASME/ASCE/AHS/ASC Structures,  
Structural Dynamics and Materials Conference  
Session No. 15 - Damage Tolerance

AIAA Paper No. 98-1783

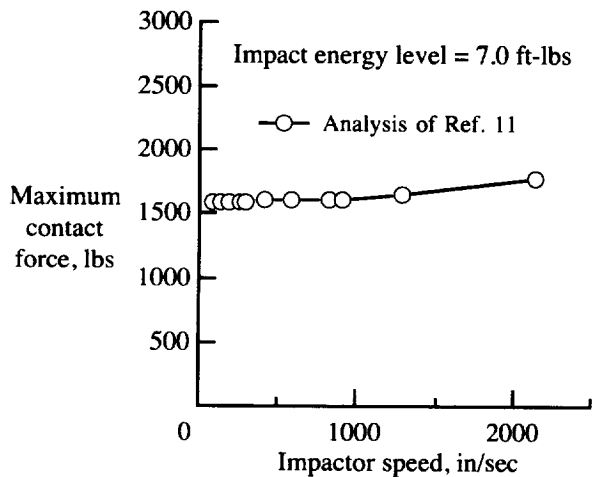
Fig. 3 Maximum contact force as a function of impactor speed for the present sandwich panels.

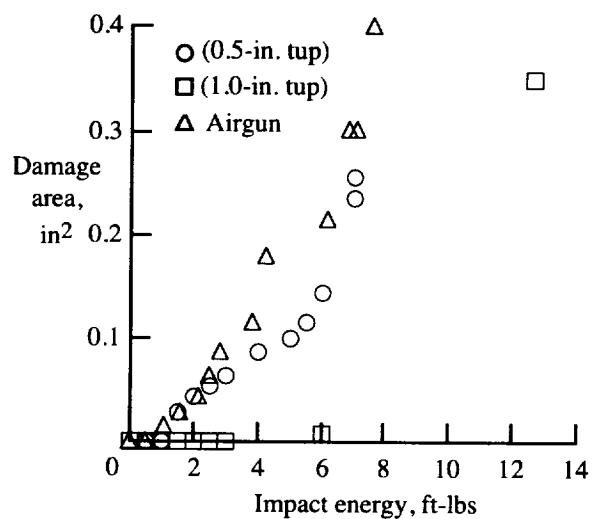
Fig. 6. Damaged area values at each impact site.

Measured values of the residual dent depth and the damaged area at each impact site are plotted as a function of the impact energy in Fig. 5 and Fig. 6, respectively, for dropped-weight impacts using a 0.5-in.- and a 1.0-in.-dia. tup and the airgun impacts. The damaged area measurements are approximated from C-scan inspections of the impacted samples. As seen in Fig. 5, the values of dent depth for all three impact methods are very similar to each other for impact-energy levels of up to approximately 3.0 ft-lbs. The values of the damaged area are also very similar for the

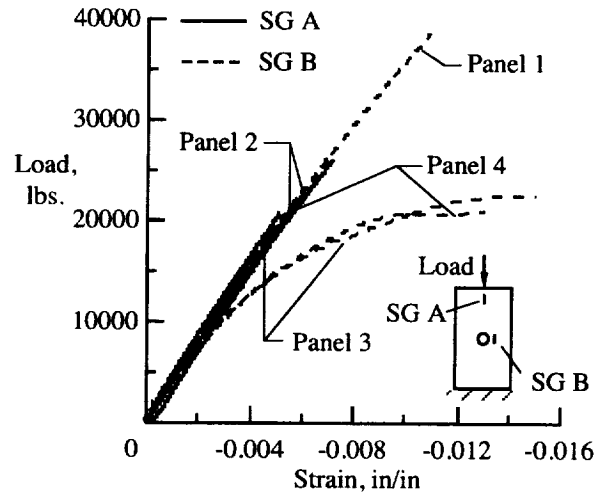
Fig.14. Axial surface strain results for Panels 1 - 4.

Typical axial surface strain results that show the redistribution of load around the impact damage location are shown in Fig. 14 for Panels 1 through 4 and in Fig. 15 for Panels 1 and 5 through 8. In these figures, far-field strains at the location marked SG A are plotted using solid lines, and strains at a location adjacent to the impact site (SG B) are plotted using dashed lines. As shown in Fig. 14, Panels 3 and 4 exhibited local strain concentrations (ratio of SG B to SG A data) near the impact site. Each panel exhibited a maximum measured strain concentration of 2.54. Panel 2 did not exhibit any local strain concentration near the impact site. Panels 5, 7, and 8 exhibited maximum measured strain concentrations of 1.61, 2.83, and 2.62, respectively. The strain concentrations exhibited by the airgun-impacted panels were slightly higher than those for the dropped-weight-impacted panels for a given impact energy level. These results support the observed severity of the damage conditions for airgun impacts as compared to that for dropped-weight impacts.

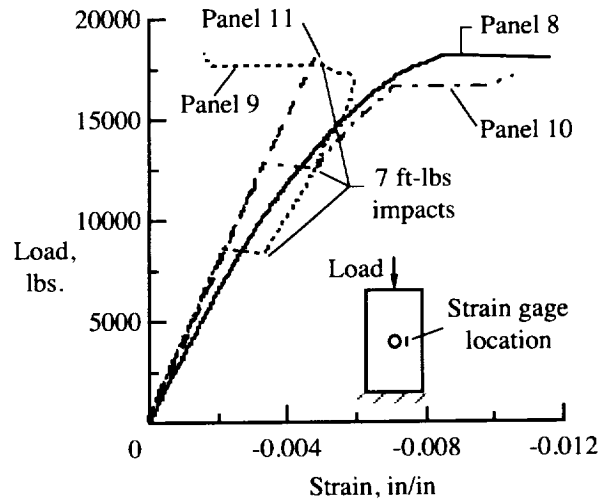
Fig. 20. Axial surface strain results for Panels 8-11.

Axial surface strain results for Panels 8 through 11 measured at locations away from the impact site and adjacent to the impact site are shown in Fig. 19 and Fig. 20, respectively. The results in Fig. 19 indicate that the far-field response of the impacted facesheet is relatively insensitive to the order in which the panel is impacted and loaded. However, the results in Fig. 20 indicate that the local response of the impacted facesheet is sensitive to this order. Upon impact, Panel 9 exhibited a 54 percent increase in the strain adjacent to the impact site (approximately 1,200  $\mu$ -in/in), and Panel 10 exhibited a 43 percent increase (approximately 1,500  $\mu$ -in/in). Panel 11 failed upon impact at a strain level of approximately 4,900  $\mu$ -in/in. The strain at this location in Panel 8 just prior to failure was 11,600  $\mu$ -in/in, which is more than twice as large as that in Panel 11 when it was impacted. This result also supports the conclusion that there is a threshold value of strain in the loaded panels above which impact at an energy level high enough to cause BVID will result in failure. Although this strain threshold is larger than the relatively low design strain for the present sandwich panels, a more aggressive structural design could easily require design strain values that approach this threshold. The existence and value of this threshold must therefore be taken into account when using residual strength results determined from CAI tests to design aircraft structures.
