NASA Technical Memorandum 113153

# Investigation of Teflon FEP Embrittlement on Spacecraft in Low Earth Orbit

Prepared for the  
Seventh International Symposium on Materials in a Space Environment  
cosponsored by ONERA, CERT, CNES, and ESA/ESTEC  
Toulouse, France, June 16–20, 1997

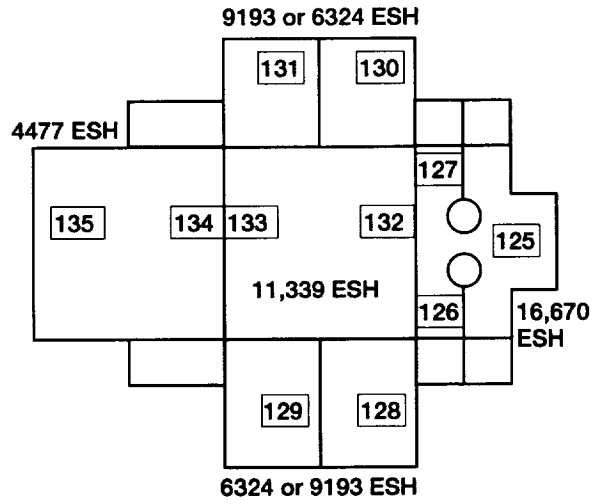
Figure 2. HST MSS MLI solar fluence and sample sectioning diagram.

**HST MSS FEP.** The outer most layer of the retrieved HST MSS MLI is 5 mil FEP with vapor deposited aluminum (VDA) on the backside. Underneath the Al-FEP layer are layers of embossed Kapton with VDA on both sides. The MLI blanket is held together in selective areas with acrylic adhesive and stitching. Figure 1 shows the two retrieved magnetometer MLI cover assemblies. The blankets are approximately 35 x 38 cm in size. The two holes in the blankets are for cable access and are on the side of the blankets which received the highest solar exposure. Figure 1b is a close-up of one of the cable holes. Figure 2 is a sketch of the sample locations along with calculated solar exposures for the 5 “sides” of the blanket.<sup>9</sup> Table 2 summarizes the HST MSS samples and their environmental exposures. The two magnetometers received identical but symmetrical solar exposures. Because the MSS blankets are identical, and unlabeled, it was not known which blanket was on which MSS electronics box. Therefore, it was not known which of the two sides received 6,324 ESH (+V1 direction) or 9,193 ESH (-V1 direction). An atomic oxygen ram fluence of  $4.9 \times 10^{20}$  atoms/cm<sup>2</sup> for the mission duration has been calculated at NASA Goddard Space Flight Center (GSFC) using the Mass Spectrometer Incoherent Scatter Model (MSIS-86). Because of the random positioning of the MSS with respect to the ram direction, the AO fluence was estimated to be  $1/\pi$  of the ram fluence ( $1.56 \times 10^{20}$  atoms/cm<sup>2</sup>) for the side of the MSS blanket facing directly out to space (side D), and  $1/2\pi$  of the ram fluence ( $7.8 \times 10^{19}$  atoms/cm<sup>2</sup>) for the 4 sides of the MSS which have a view of the telescope and are therefore shielded from AO during a portion of the orbit. Scattering contributions have not been included in the atomic oxygen fluences.

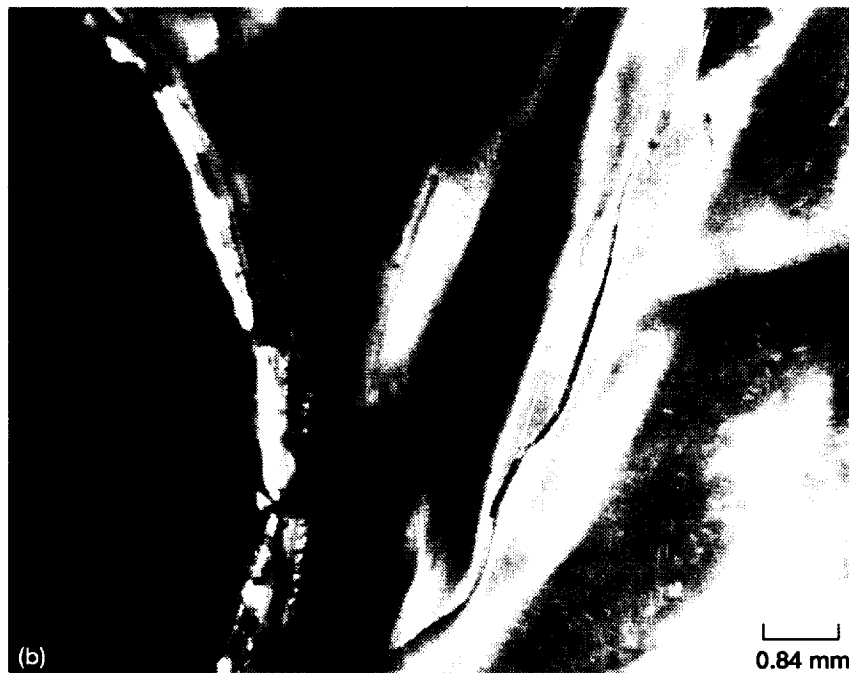
Figure 4. HST MSS MLI near cable holes (16,670 ESH). (a) Extensive cracking of FEP and delamination of FEP from Al (circular area on left). (b) Through thickness crack in 5 mil FEP.

**Visual Examination.** The solar facing HST FEP appeared to be significantly more structurally damaged after 3.6 years in LEO than the LDEF FEP after 5.8 years in LEO. The MSS MLI FEP was obviously embrittled, with cracking of the FEP observed on the higher solar exposure sides of the MLI blanket, as seen in Figure 4a. Solar induced FEP degradation has been attributed to photodissociation of carbon-carbon bonds through chain scission and breaking of carbon-fluorine bonds. Further photodissociation causes double-bond formation, radical formation and cross-linking. A highly cross-linked surface layer results in surface embrittlement.<sup>10,11</sup> Through-thickness cracking of the FEP was observed around the cable holes (see Figure 4b) along with FEP delamination from the aluminized layer. The MSS blankets were attached with Velcro<sup>®</sup>, therefore the astronauts had to manipulate them to remove them. They were then packed into plastic bags for transport. The majority of observed cracks in the MSS MLI were likely to have been introduced during retrieval handling. No visible cracks were observed in the FEP from the side with the lowest solar exposure. The SADA MLI was retrieved and examined in its operational state. The blanket received no on-orbit handling, yet on solar facing surfaces, adjacent to stitched areas or vent holes, through-thickness cracks were observed in the 5 mil FEP (see Figure 5). More details of the condition of the as-retrieved HST materials are available elsewhere.<sup>3</sup>

It is interesting that, although through-thickness surface cracking was observed on the as-retrieved HST samples, bend testing did not produce any through-thickness surface cracking. Because the areas which had through thickness cracks were in stressed areas, there may be a stress-corrosion type failure occurring on-orbit. It is also likely that thermal cycling played a role in the on-orbit cracking. Temperature fluctuations of -100 to +50°C are expected on solar facing Al-FEP surfaces on HST.

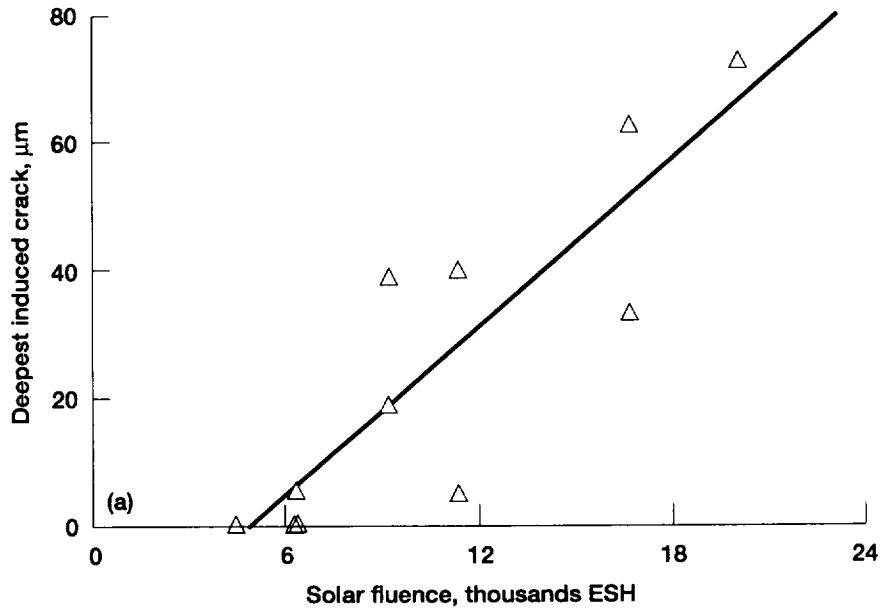
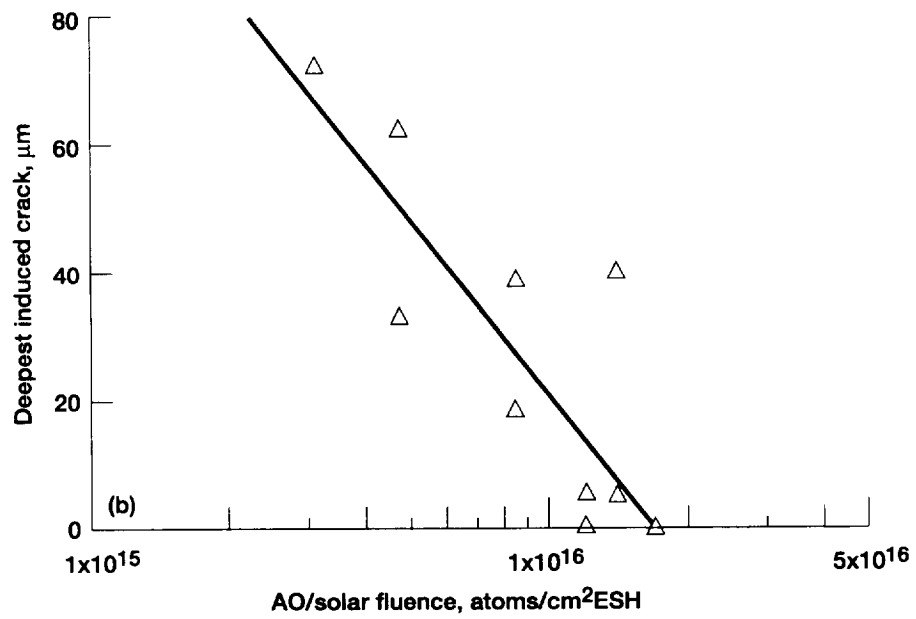
Figure 12. Deepest induced crack for HST samples. (a) Versus solar fluence. (b) Versus AO/solar fluence ratio.

Figure 11 is a typical optical micrograph of a cross-sectioned sample (MSS 130) showing bend test-induced surface cracks. There seems to be a trend for increasing crack depth with decreasing AO/solar fluence for the LDEF samples. The average crack depth for the HST samples both increases with increasing solar fluence, and with decreasing AO/solar fluence ratio, as would be expected because the atomic oxygen fluence is so uniform. This is most obviously displayed if the deepest induced crack is plotted, as seen in Figure 12a and 12b, respectively.

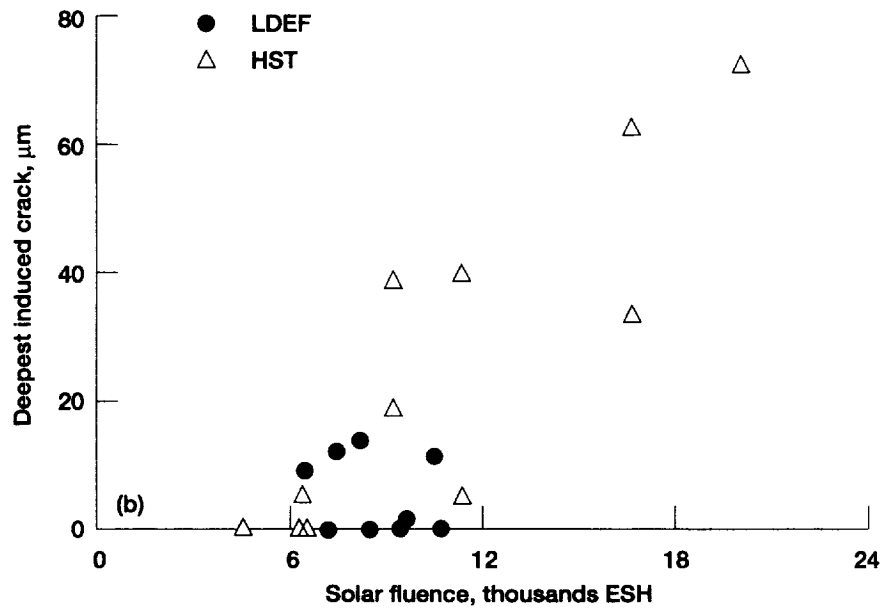
When comparing the LDEF and HST crack depth data, the HST samples appear more damaged if the AO/solar fluence ratios are compared. Figure 13a shows significantly deeper cracks in most of the HST samples than for the LDEF samples. When comparing the deepest induced crack versus solar fluence for the LDEF and HST samples, as seen in Figure 13b, again, the HST samples do appear embrittled deeper than the LDEF samples. In Figure 13b, it also becomes more obvious that the very deep cracks have received a higher solar fluence. The deepest HST crack was 5 times as deep as the deepest LDEF crack, for 2.5 times the solar fluence. It is not currently understood why the hardness data does not indicate an embrittled layer deeper than 500 nm, which does not correspond with the depth of embrittlement based on crack depth data. Hardness versus depth on cross-sectioned samples may provide some insight.

Figure 13. Deepest induced crack for LDEF and HST samples. (a) Versus AO/solar fluence ratio. (b) Versus solar fluence.
