LDEF
MATERIALS/CONTAMINATION

NAS 8 - 40581

GARY PIPPIN
BOEING DEFENSE & SPACE GROUP
JULY 1997

NASA-CR-205361

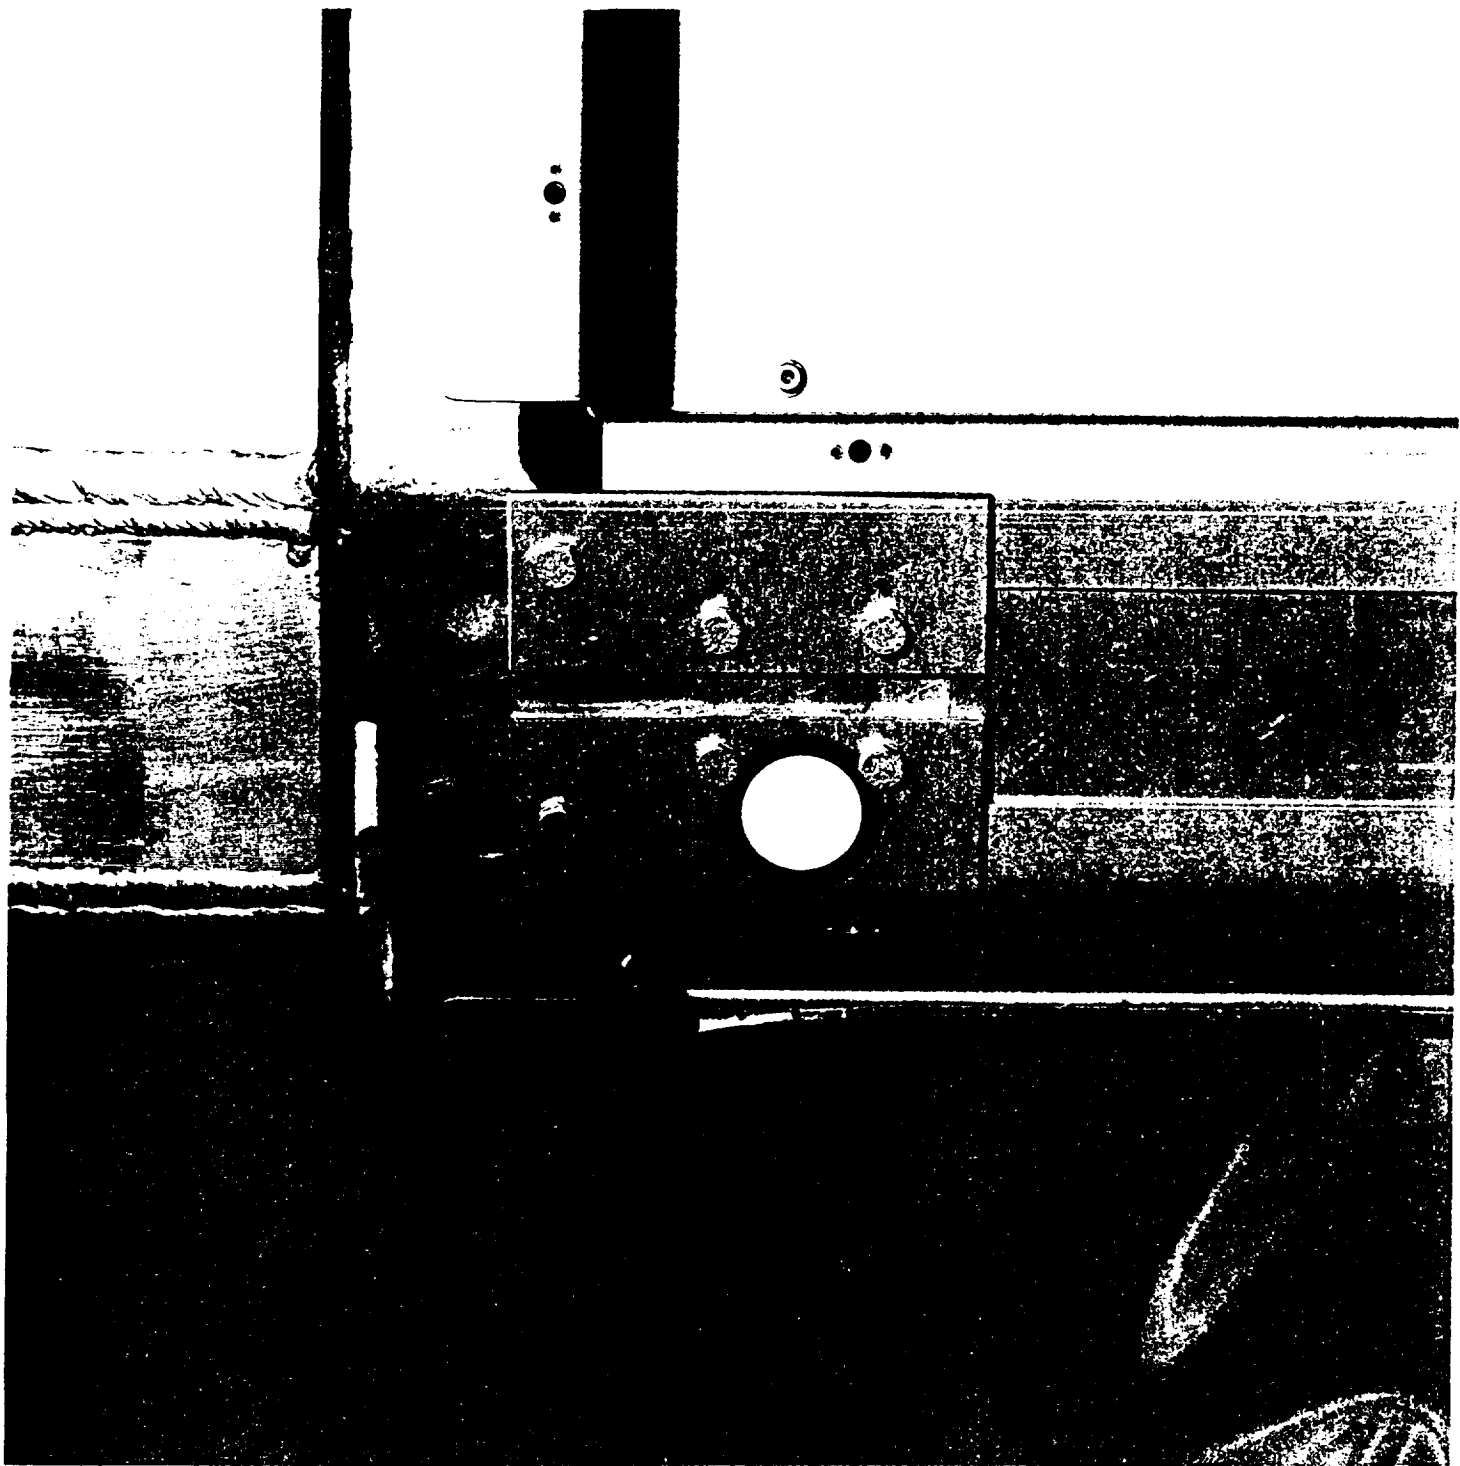
Fig. 1 - 100 X 130 LT

Tray clamp & bolts-this NASA photo shows the tops of some LDEF tray clamp bolts. These surfaces were analyzed post-flight for silicon containing contaminants.

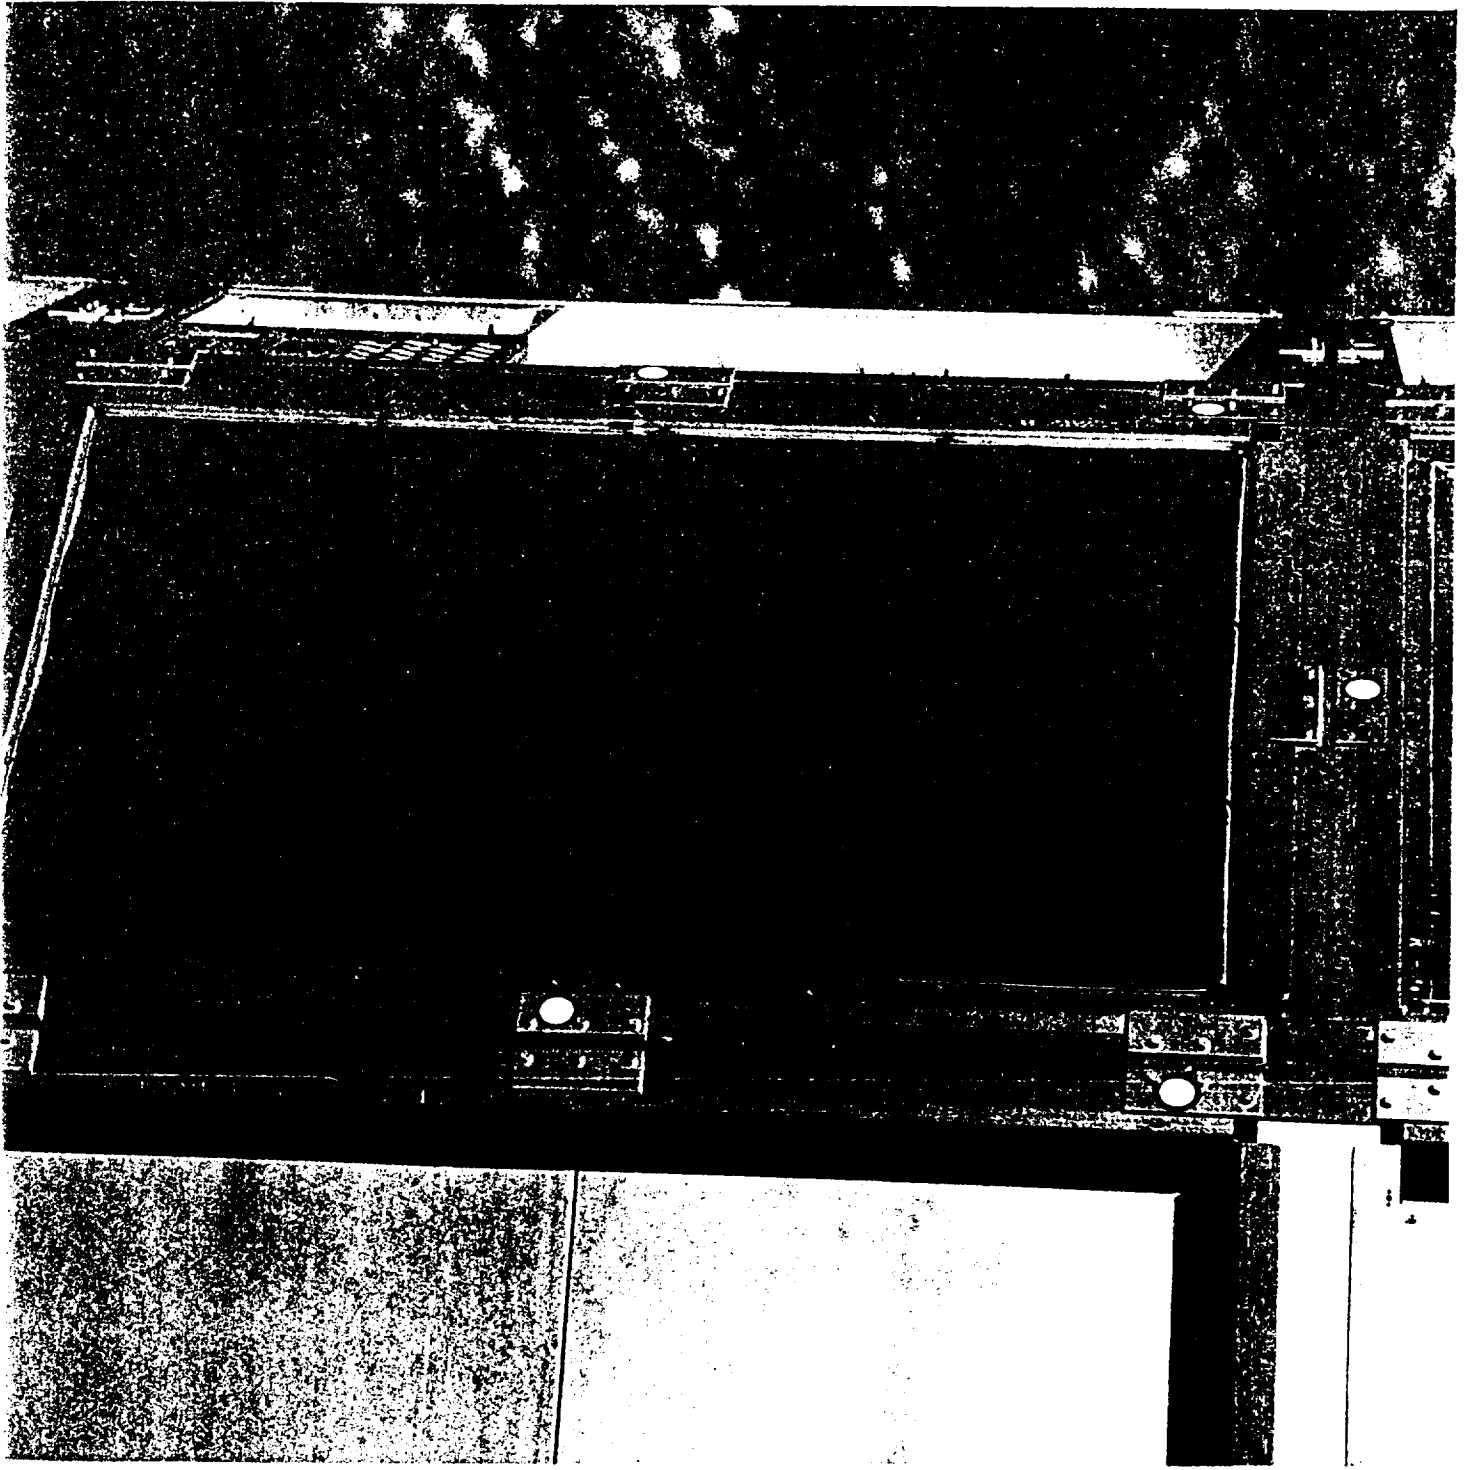
On-orbit view of vent holes in blanket. This NASA photo of the LDEF on-orbit shows the vents at the edge of thermal control blankets on the European Heavy-Cosmic-Ray experiment. Adhesive under the blanket outgassed through these vents and deposited on the tray surfaces. Our current NASA contract is to determine the distribution of this contaminant on selected tray surfaces.

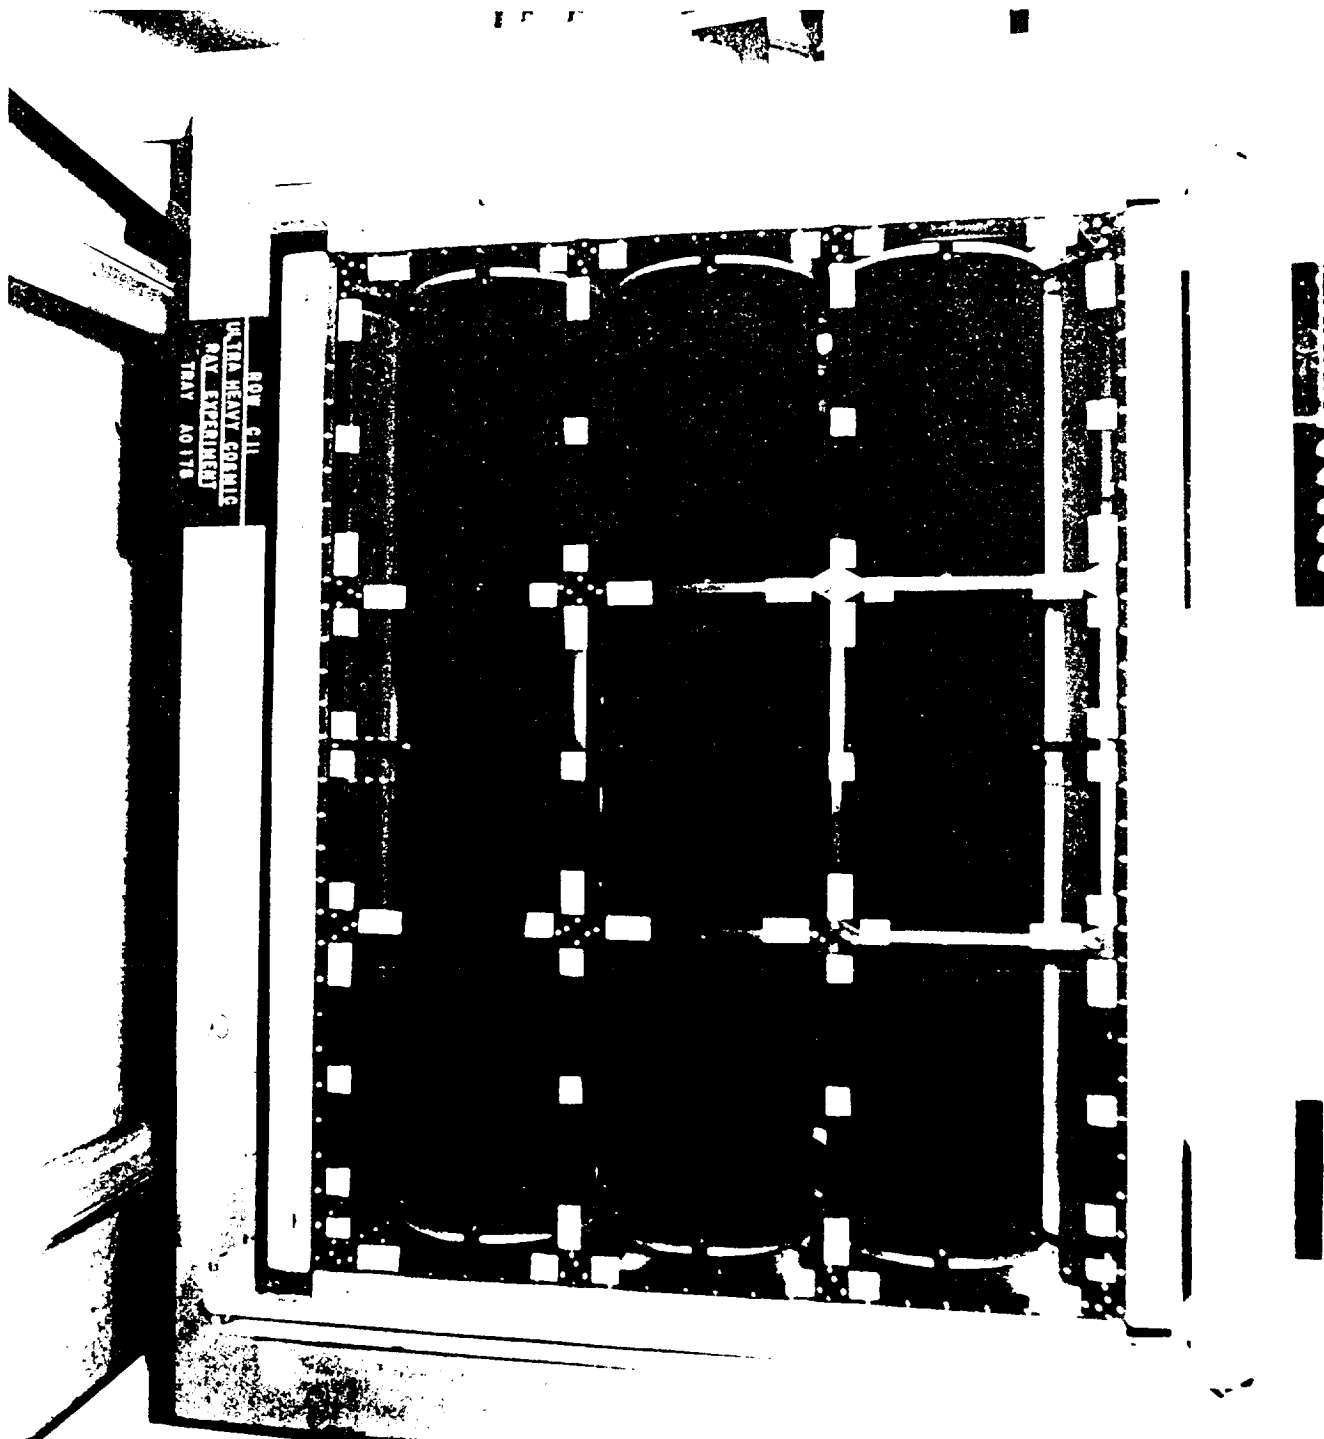
POSITION OF THE CYCLOADHESIVE LOCATIONS

Position of velcro/adhesive locations-This NASA photo shows the locations of the silicone which was the source of the contamination being analyzed on our current contract. This is to show the audience the extent of the material and the geometry of the tray interior.

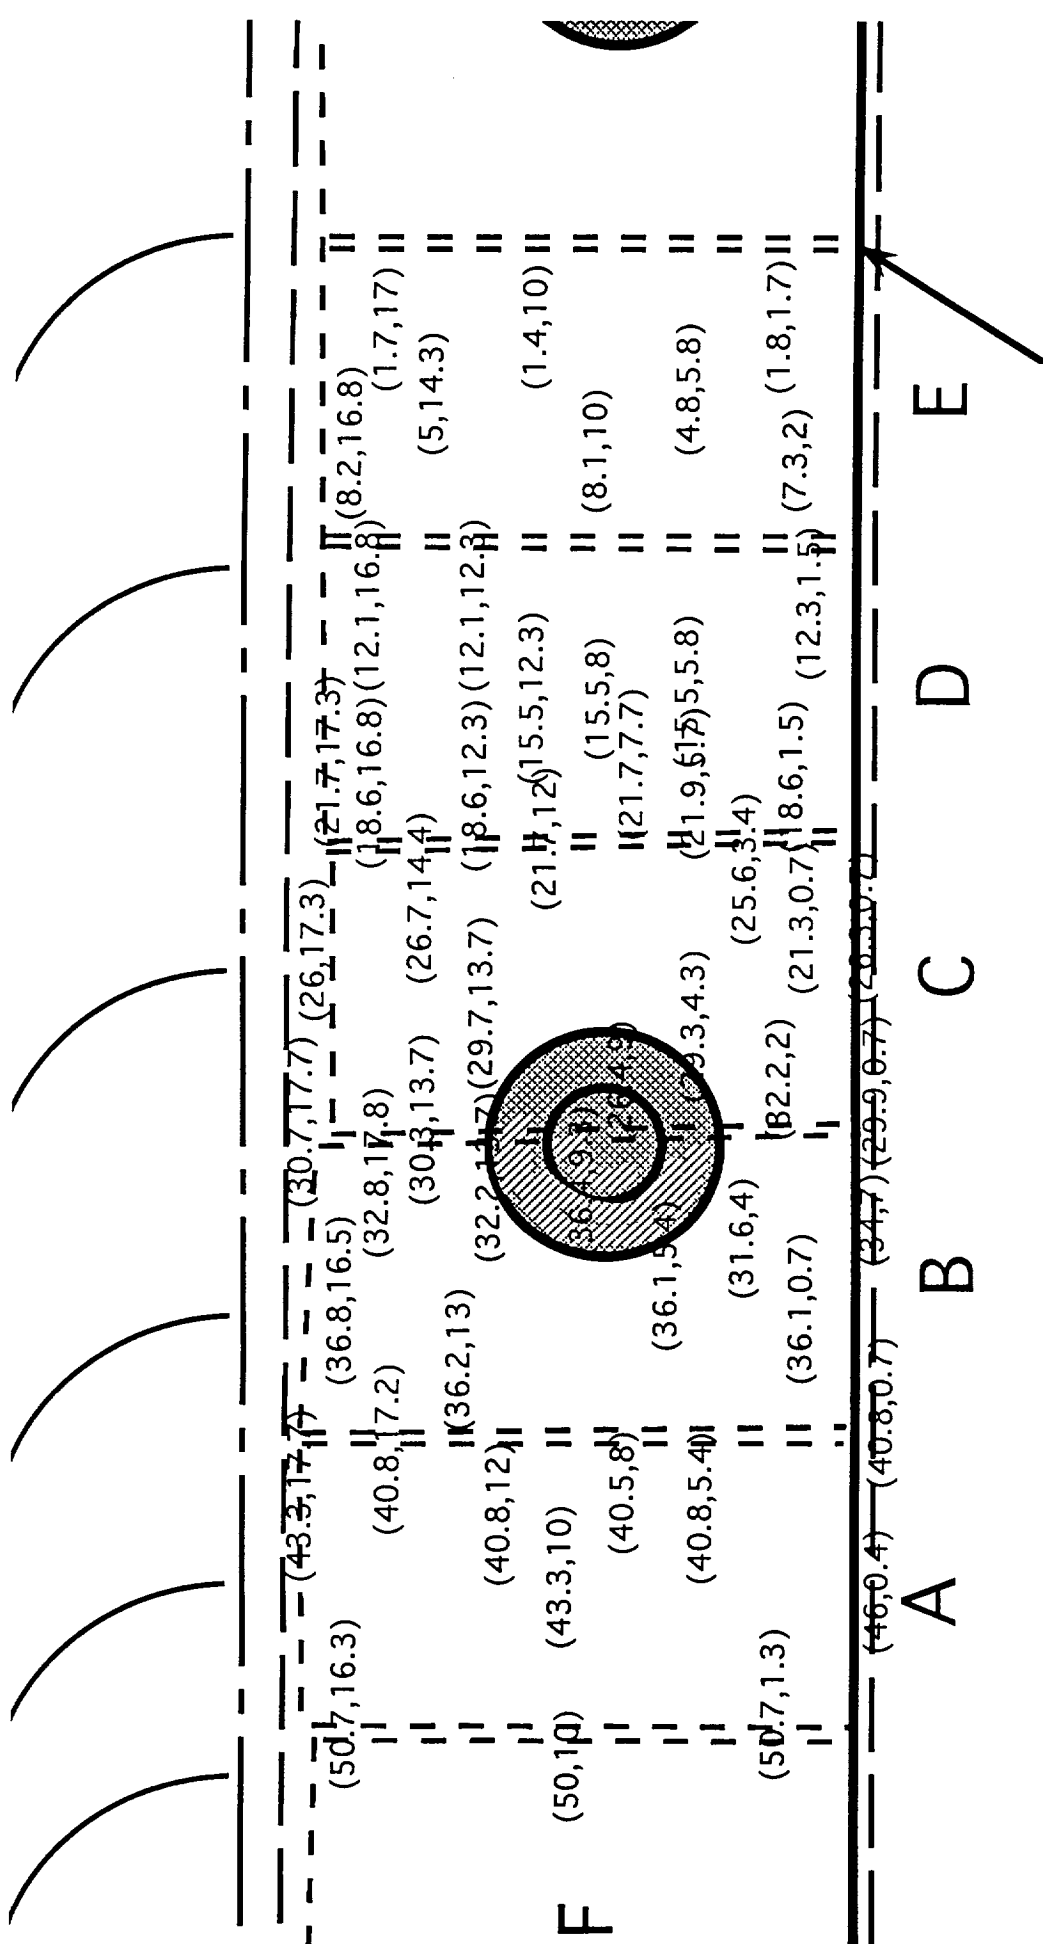
E10-8

Origin for grid names (0,0) is at lower, right corner of piece E

This chart identifies the locations for which a detailed analysis of the amount of silicon present on the surface was determined. E10 is an area with high solar and atomic oxygen exposure, C6 is an area of high solar exposure and moderate amounts of atomic oxygen exposure, and A4 is an area with high solar exposure and no atomic oxygen exposure.

The next several charts detail the results of the measurements made on the selected surfaces from the Long Duration Exposure Facility. These charts show the location of individual measurements and the results (the % silicon detected at each site). Some of the data will be shown and the rest I will have as backup charts in case someone wants to see data from a specific location. One of these charts shows a depth profile of the deposited contaminant, showing the thickness of the deposit.

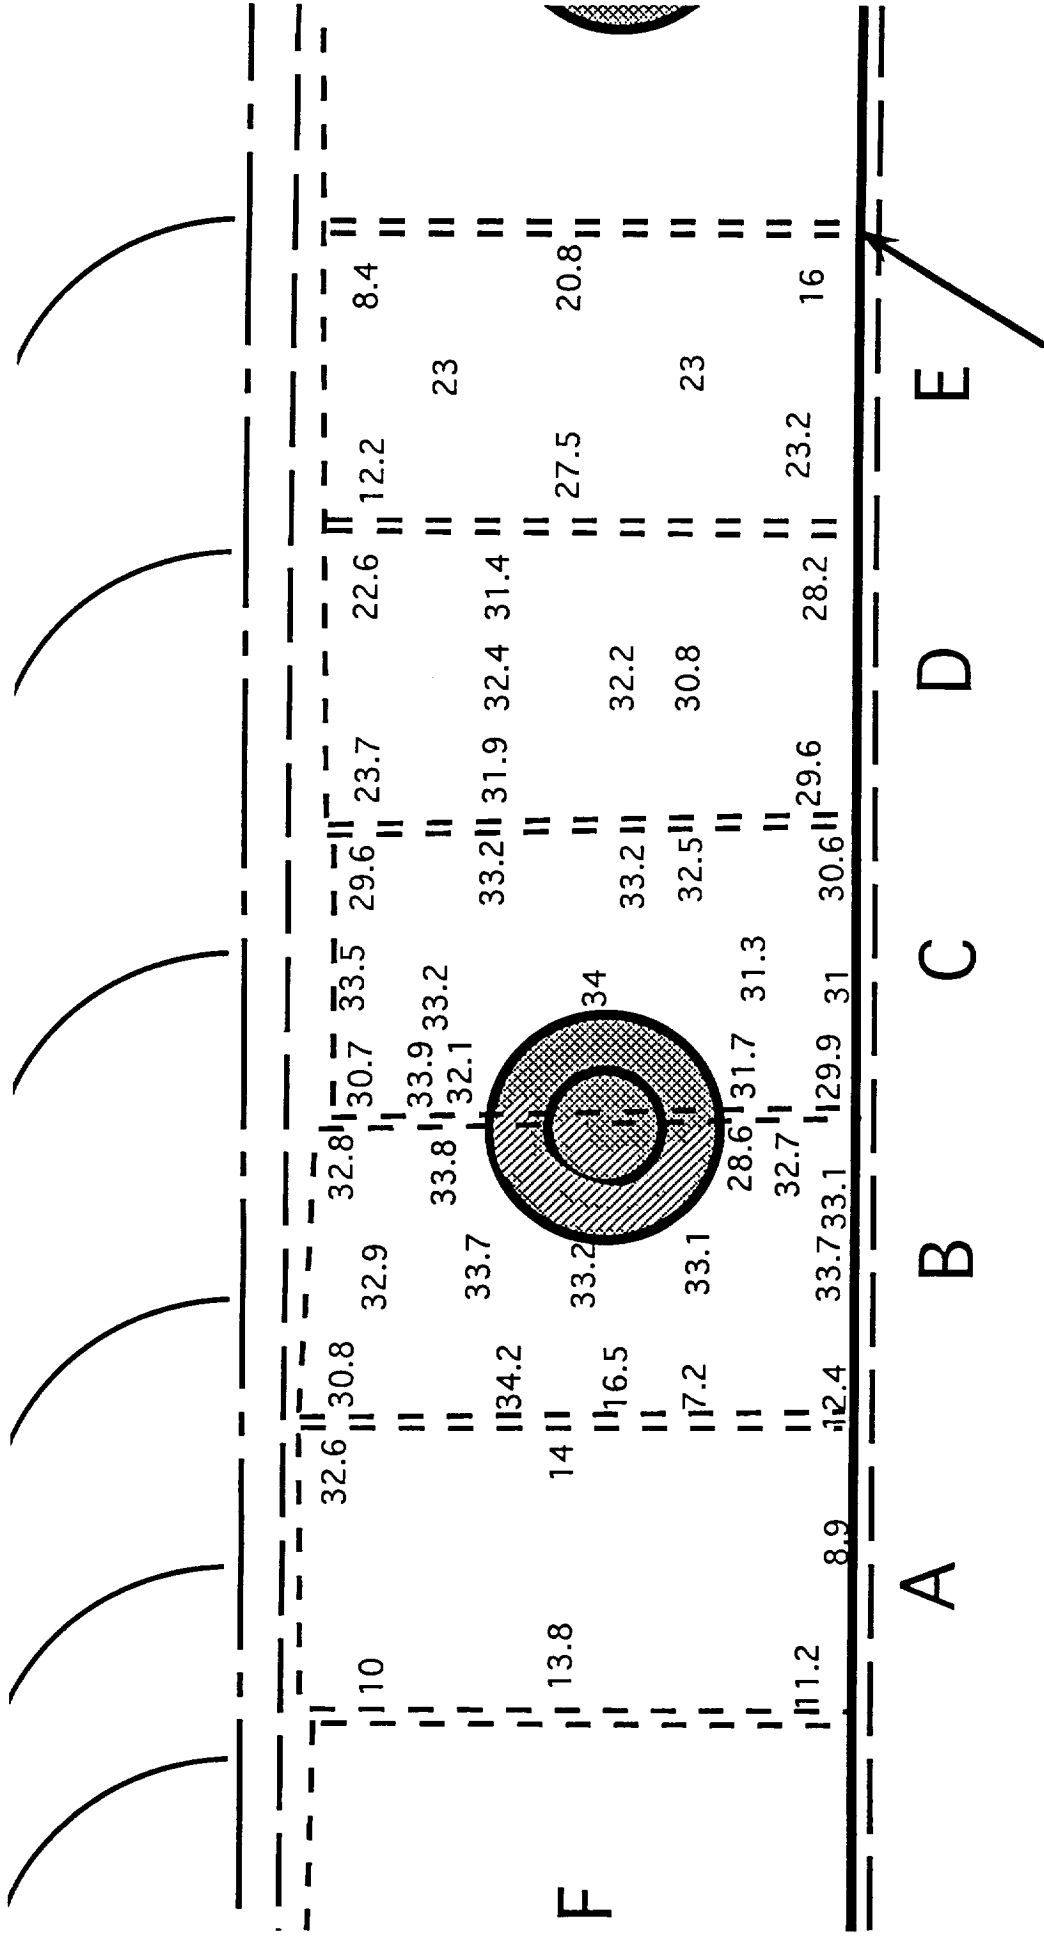
E10-8

Percent Silicon

Origin for grid names (0,0) is at lower, right corner of piece E

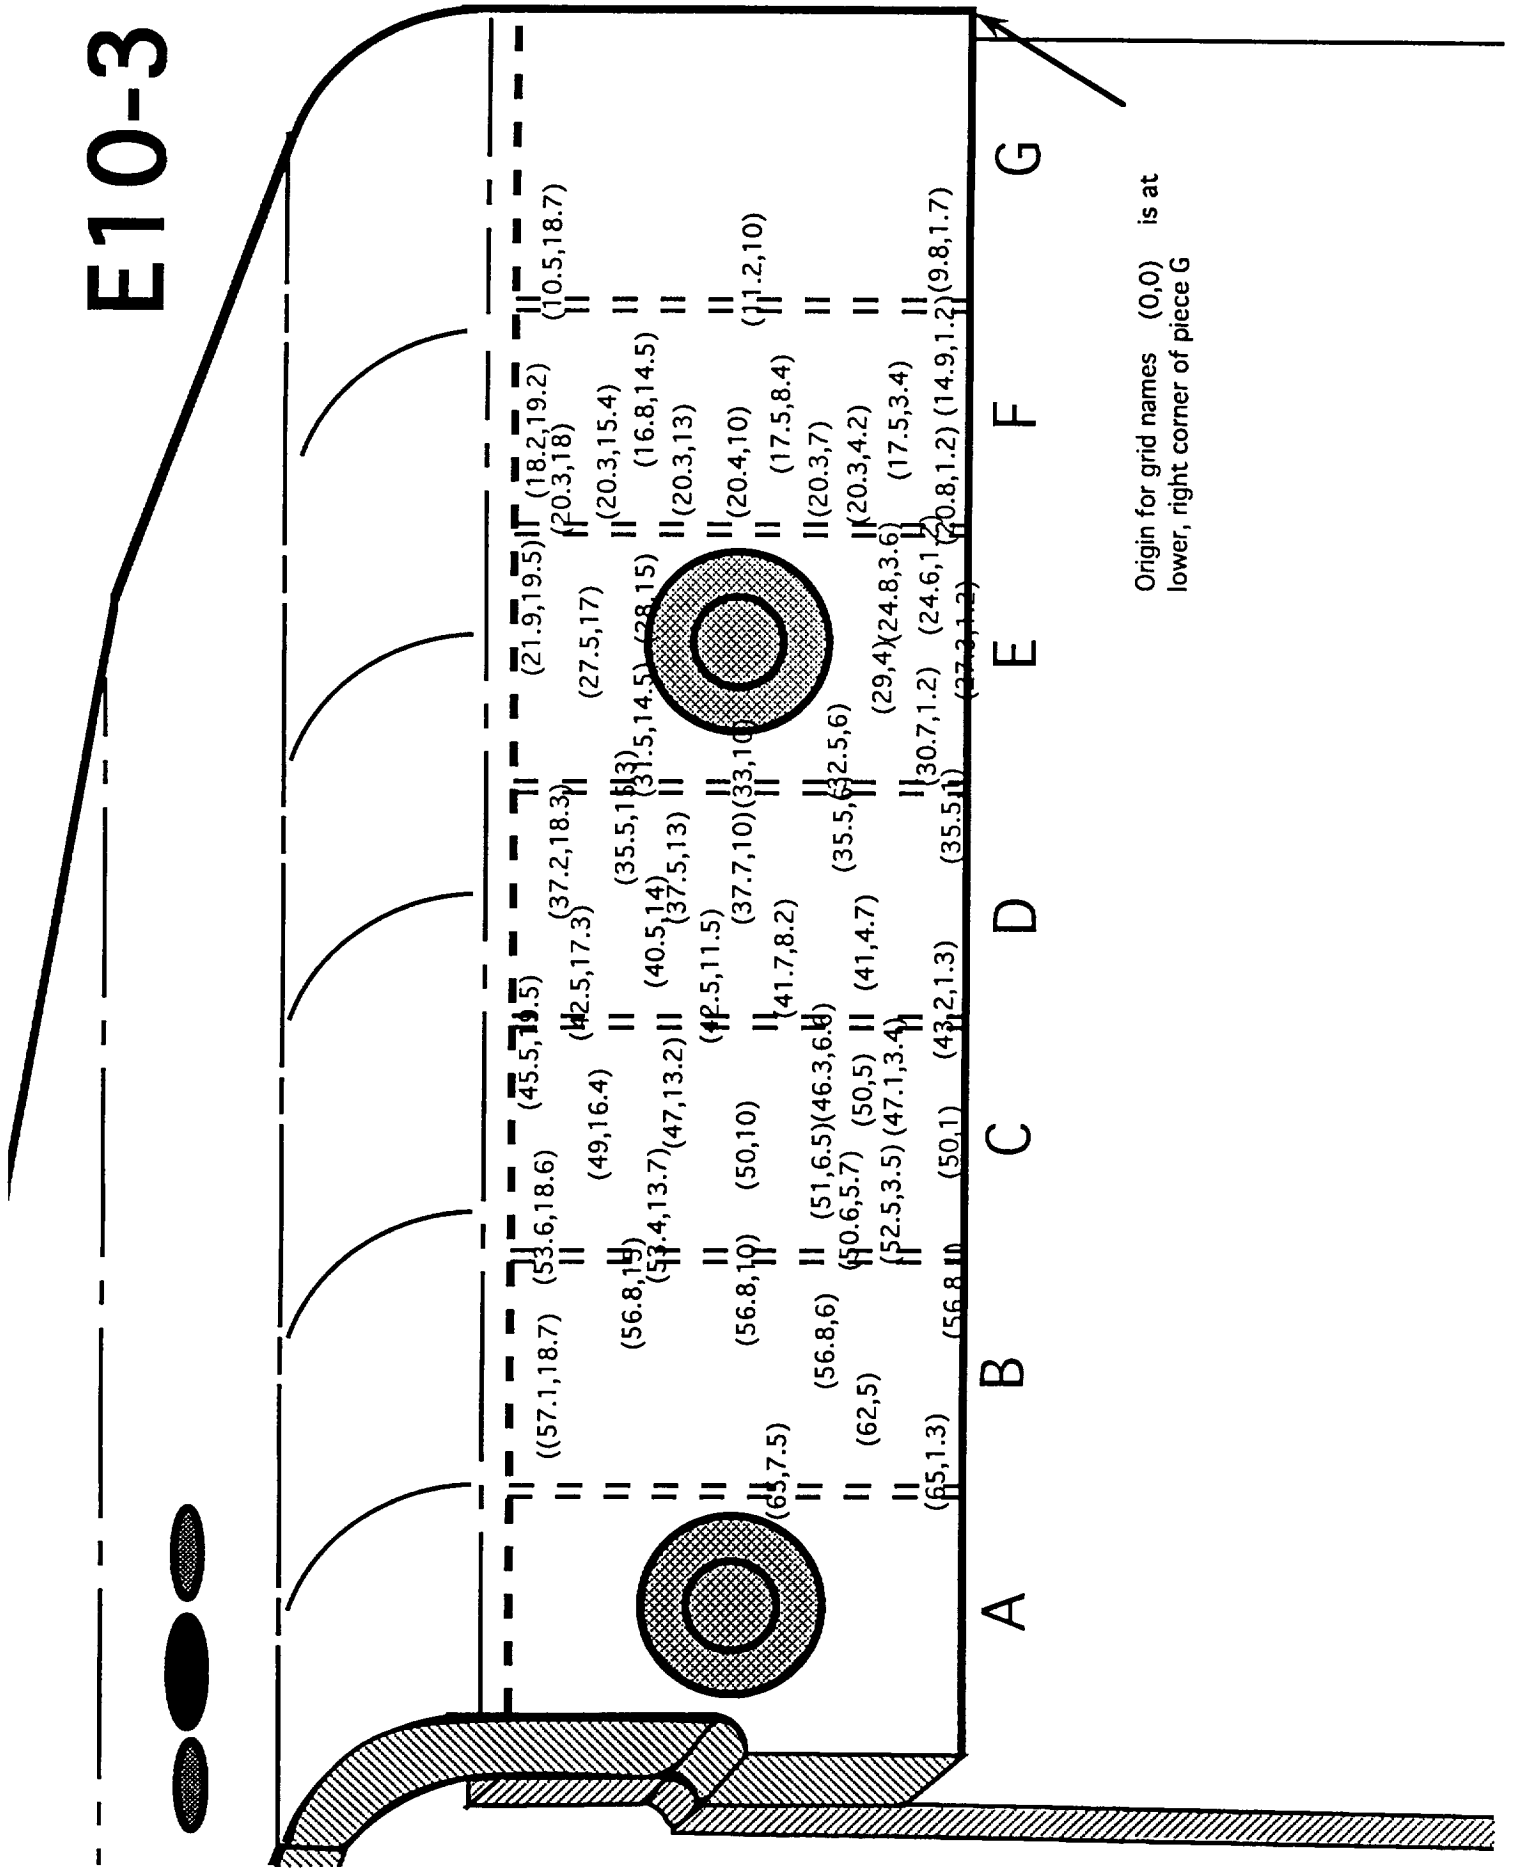
E10-3

Origin for grid names (0,0) is at
lower, right corner of piece G

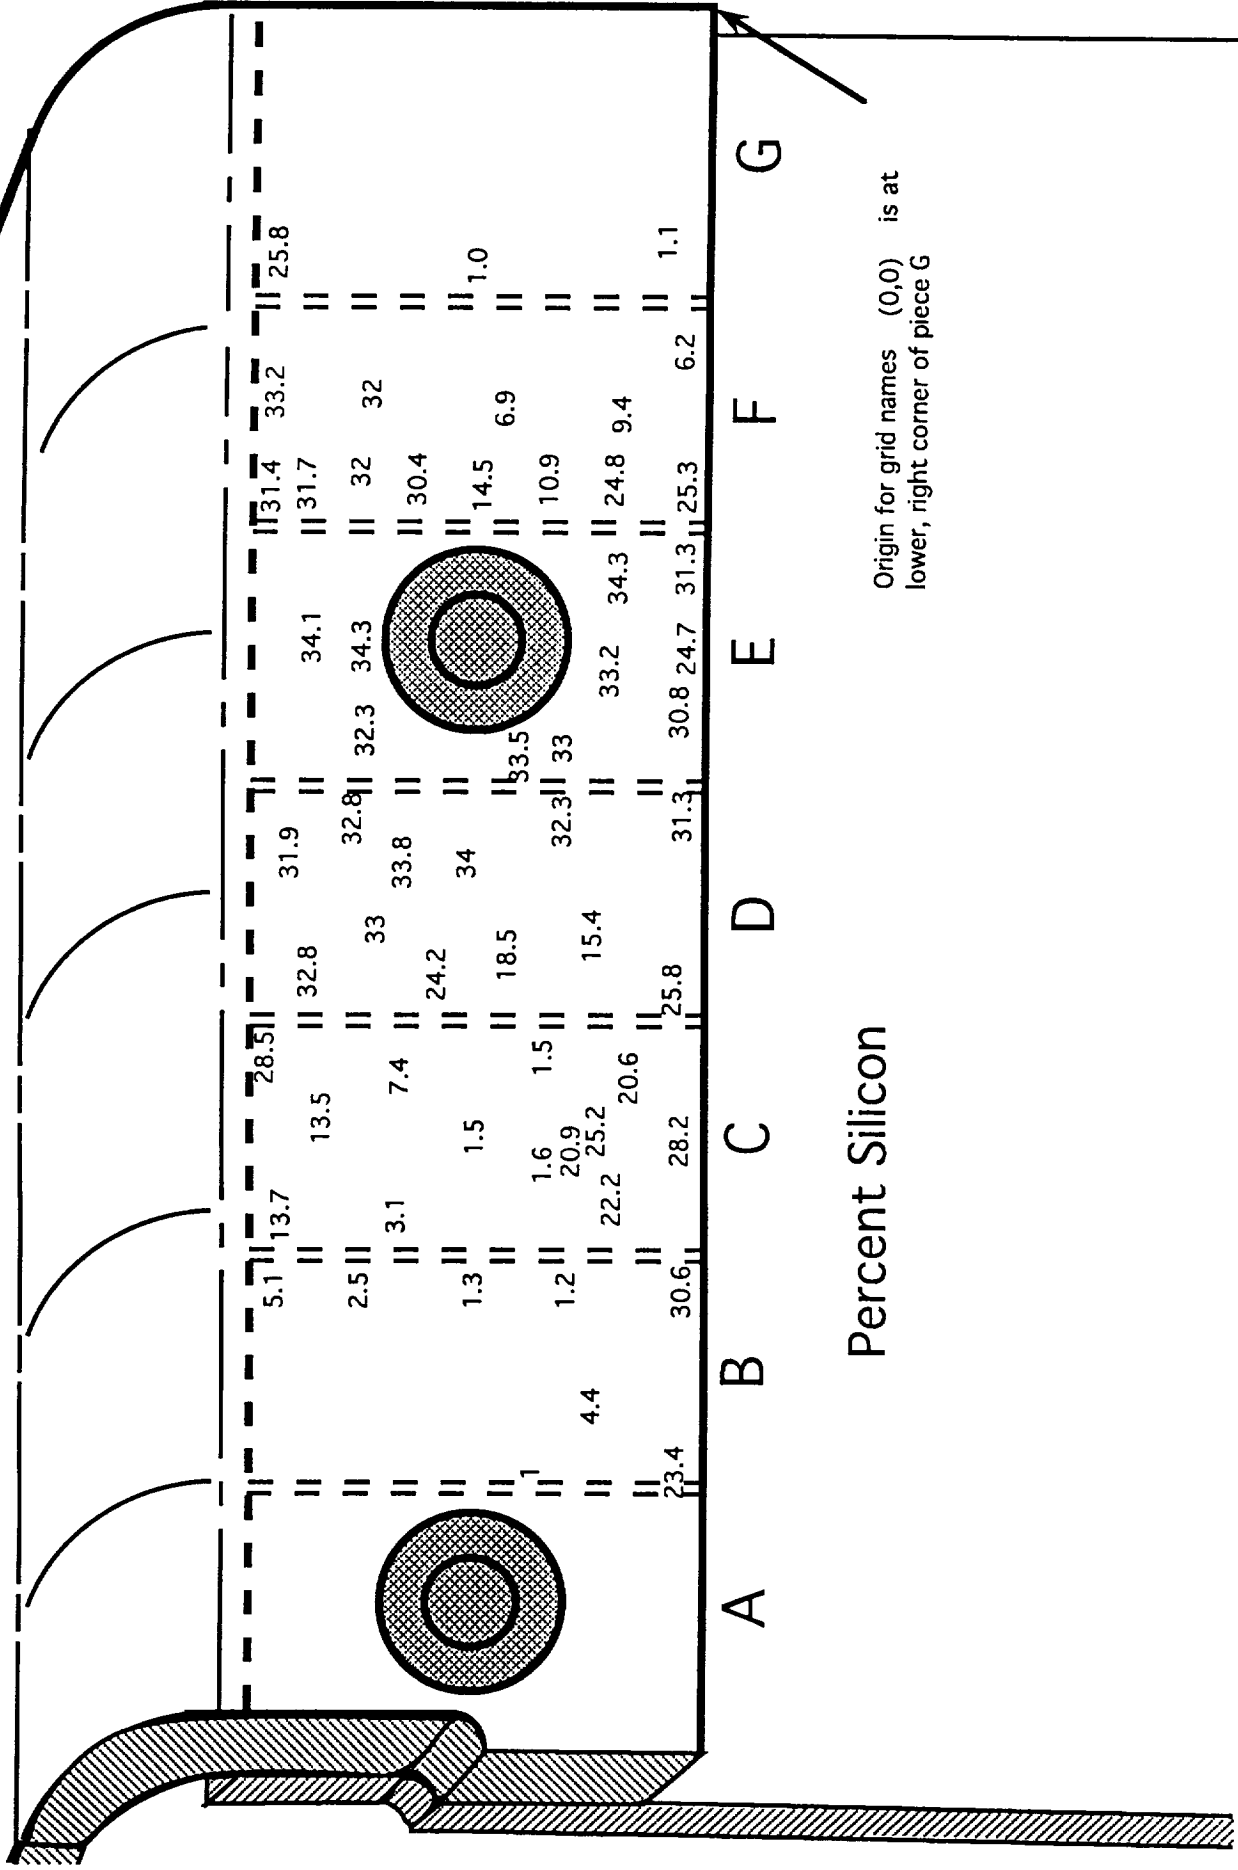
C6

Percent Silicon

Origin for grid names (0,0) is at lower, right corner of piece G

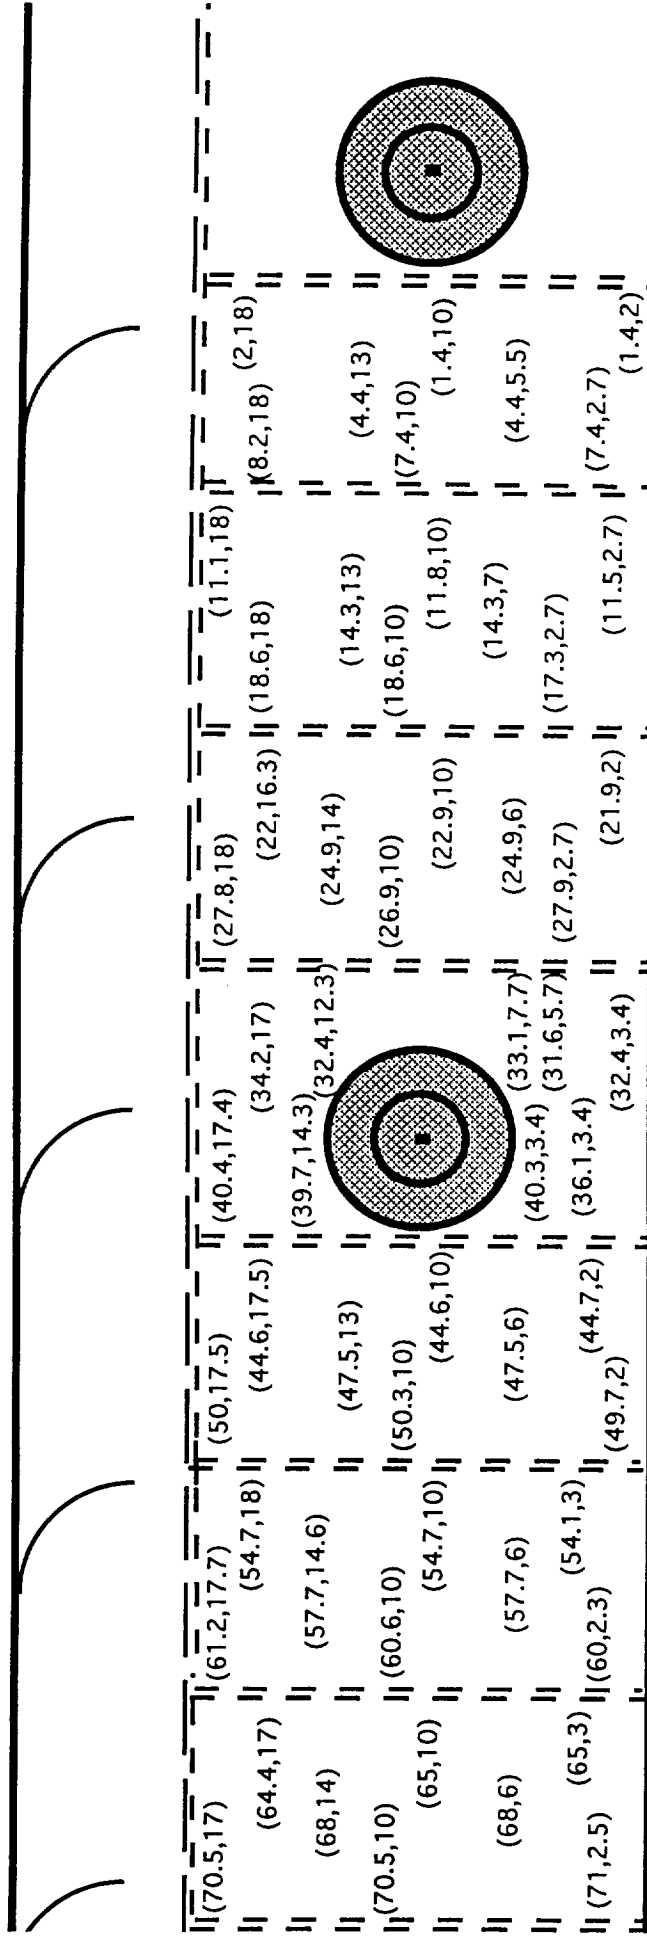
C6

Origin for grid names (0,0) is at lower, right corner of piece A

% Silicon

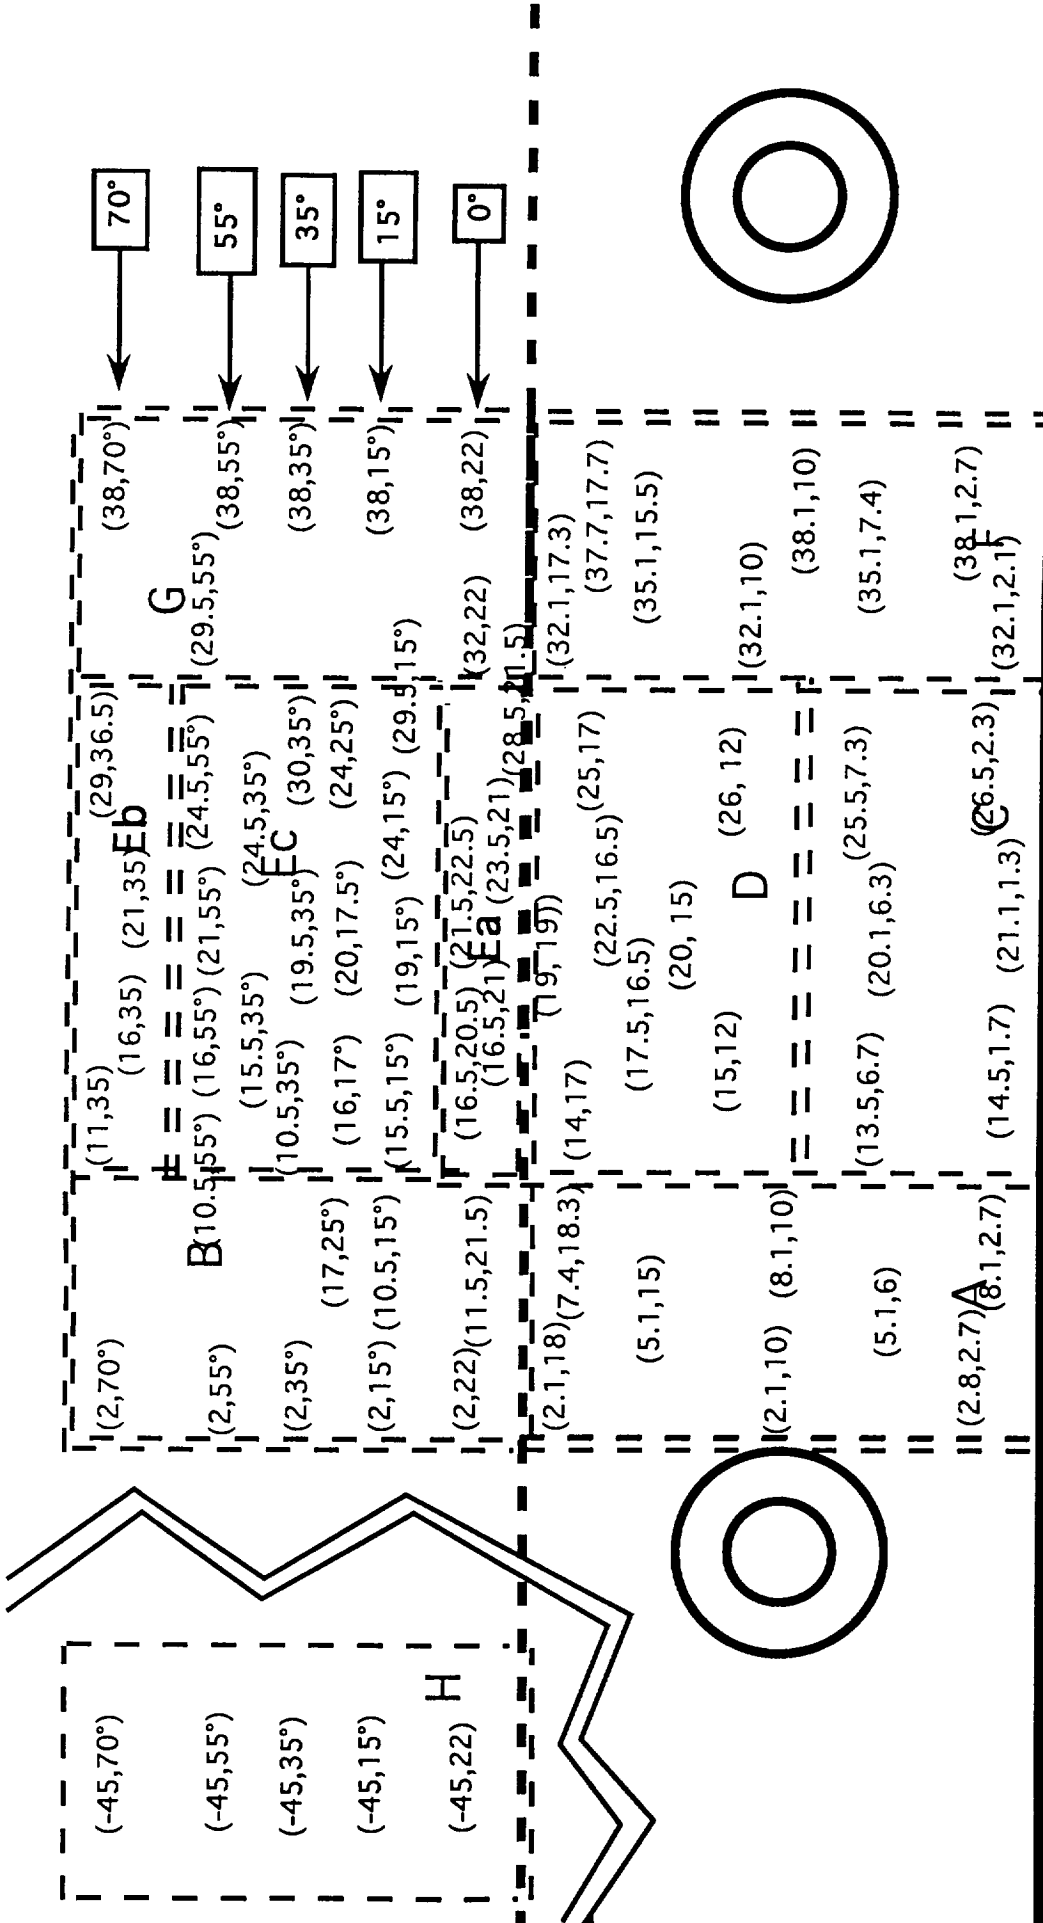
C6-2

Origin for grid names is at lower, left corner of piece A in the keyhole section

Grid names of analysis positions

'Unbent' sample pieces

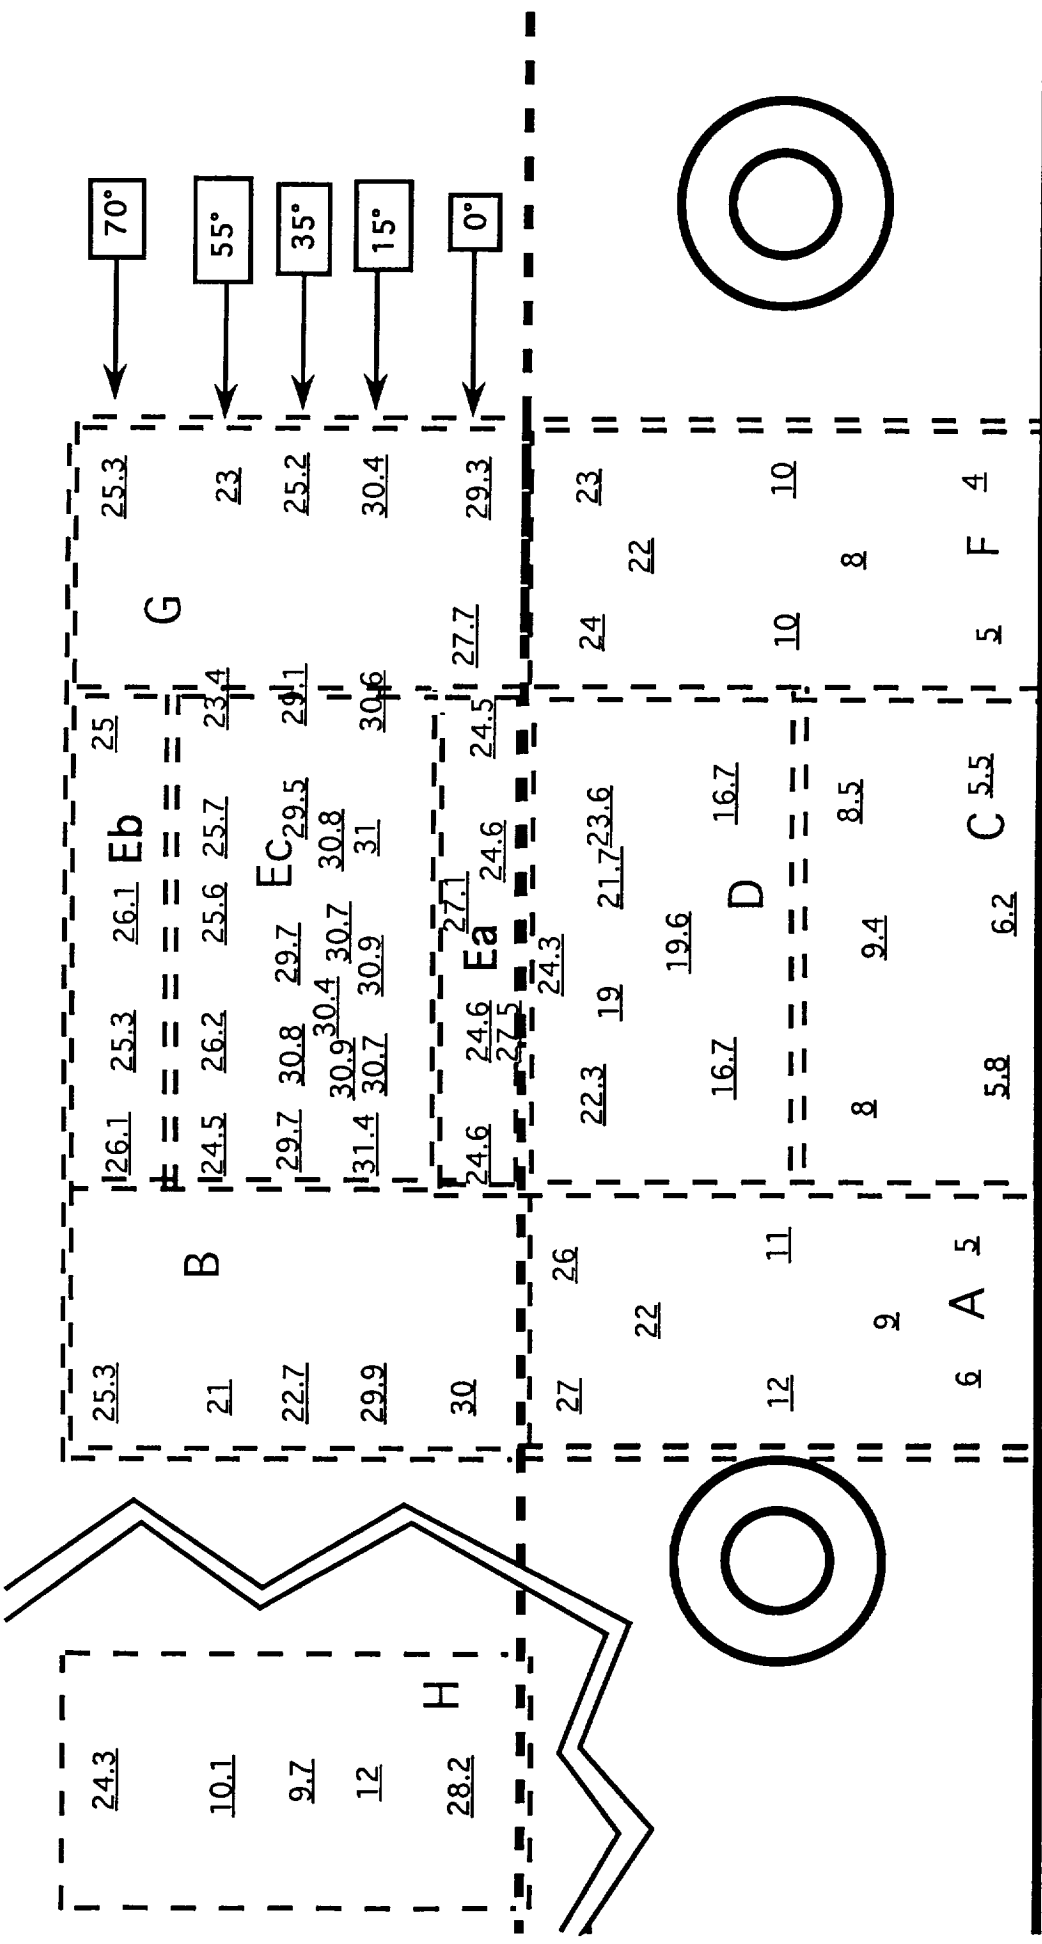
C6-2

Origin for grid names is at lower, left corner of piece A in the keyhole section

Percent Silicon

'Unbent' sample pieces
