LDEF
MATERIALS/CONTAMINATION

NAS 8 - 40581

GARY PIPPIN
BOEING DEFENSE & SPACE GROUP
JULY 1997

NASA-CR-205361

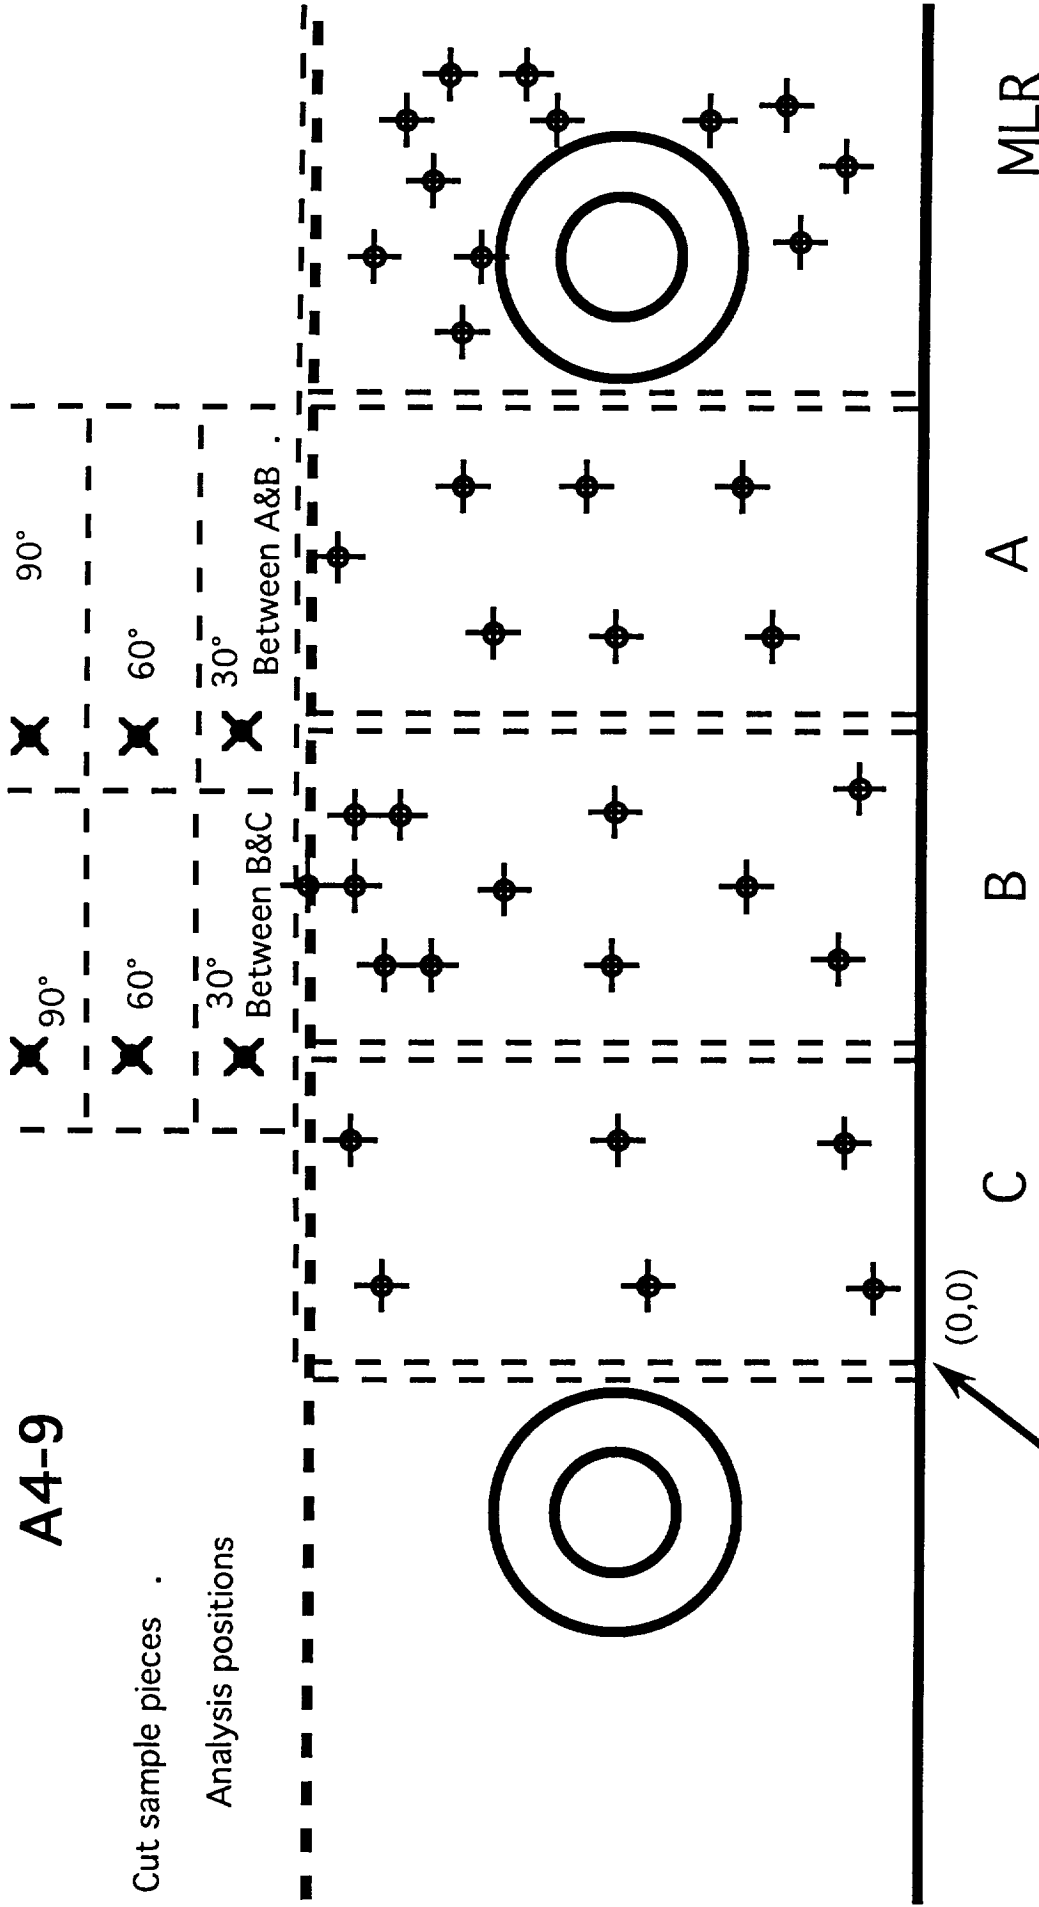
A4-9

Cut sample pieces .

Analysis positions

Origin for grid names is at lower, left corner of piece C in the keyhole section .

Each analysis area is a 0.6mm diameter circle centered on the point described by the grid name .

TRAILING EDGE LOCATIONS(A4) SHOW THIN BUT WIDESPREAD SURFACE SILICON DISTRIBUTION

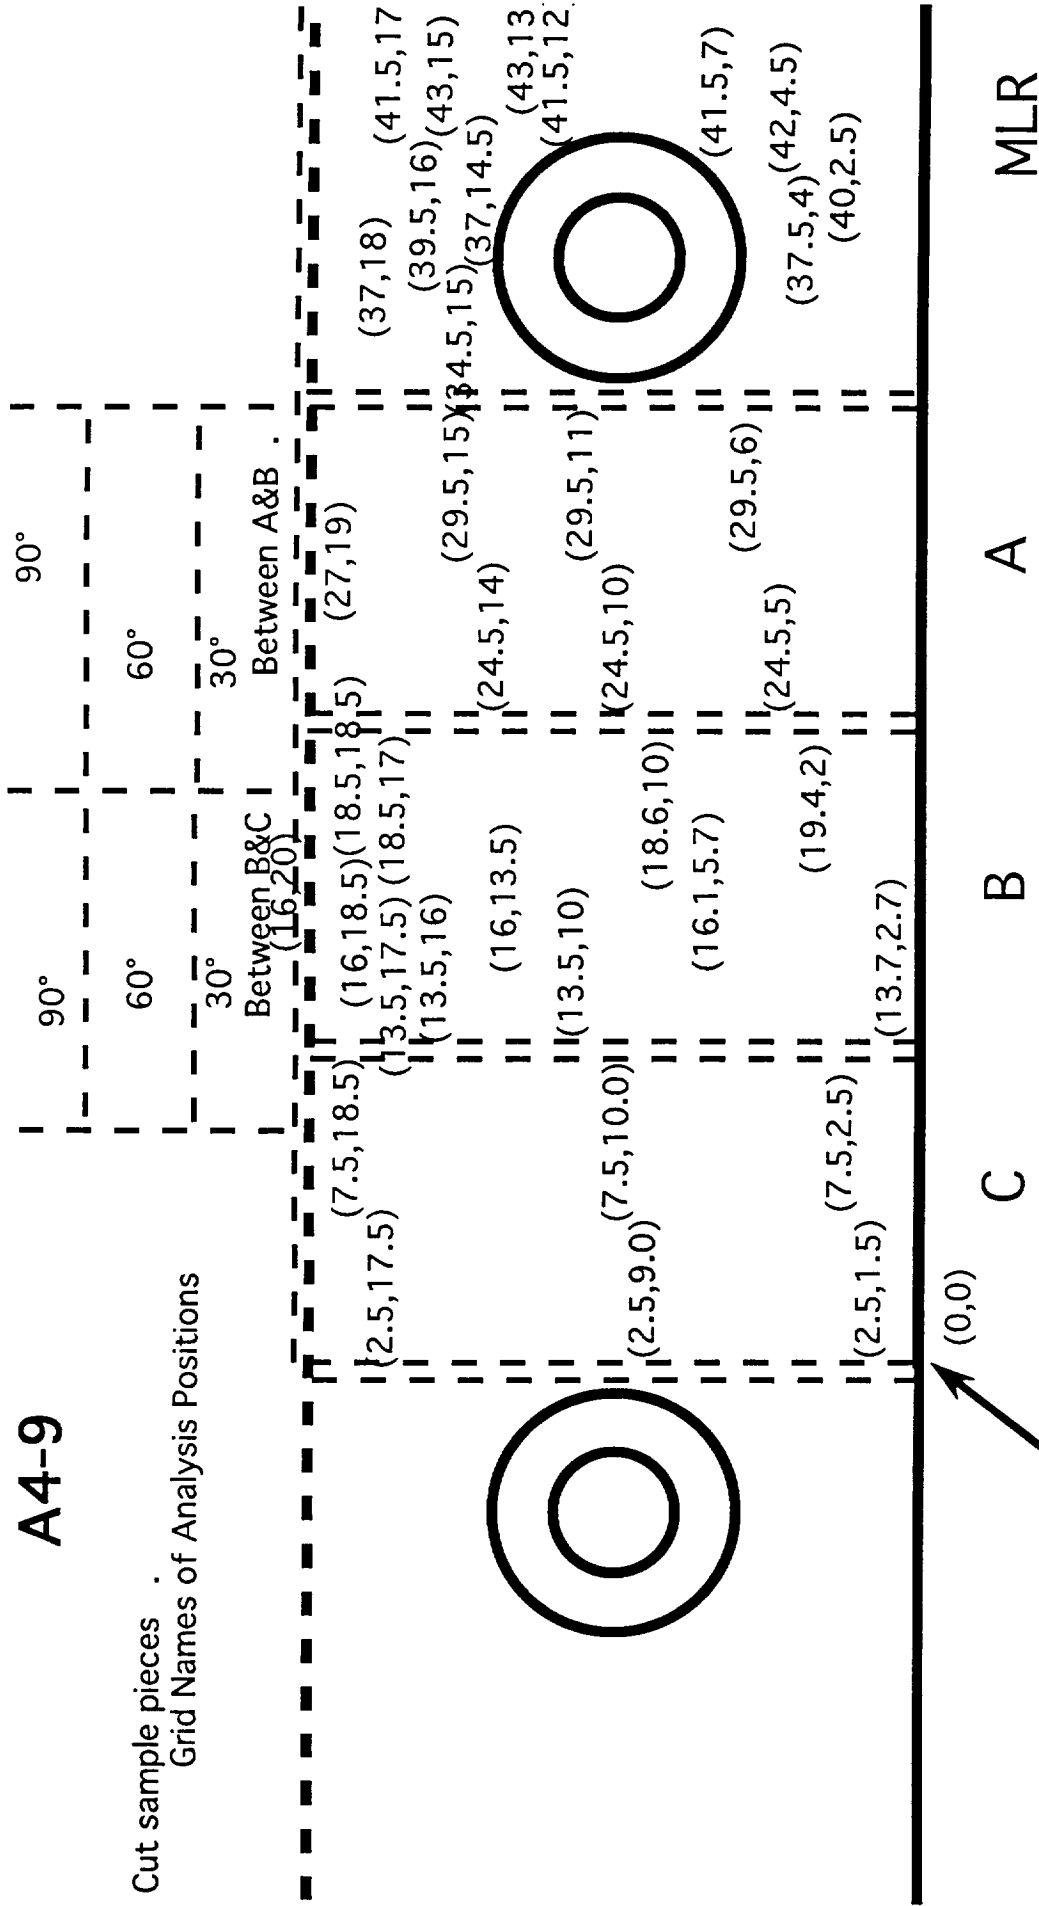
A4-9

Cut sample pieces .
Grid Names of Analysis Positions

Origin for grid names is at lower, left corner of piece C in the keyhole section .

which is 1.0mm to the right of the right edge of the left rivet.

Coordinates are given in (-x-mm, -y-mm) .

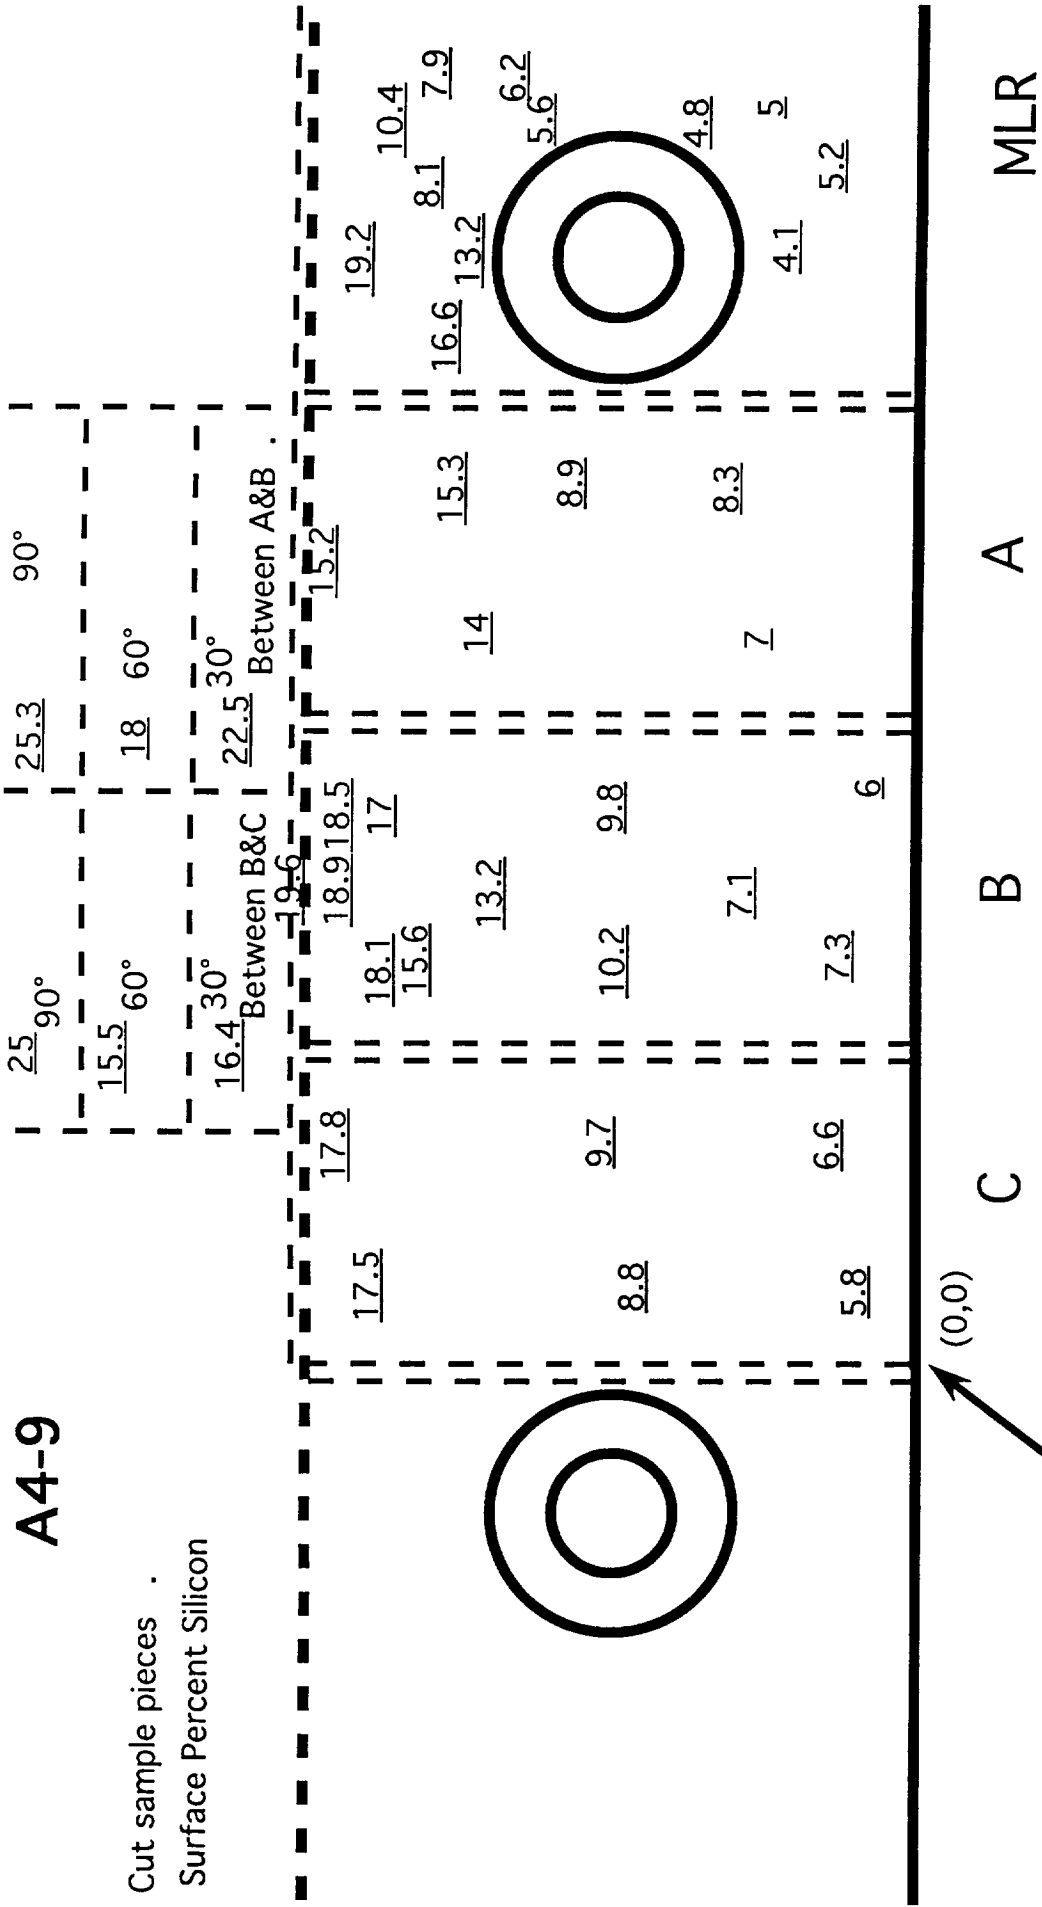
A4-9 (24.5, 5)

Cut sample pieces .
Surface Percent Silicon

Origin for grid names is at lower, left corner of piece C in the keyhole section .

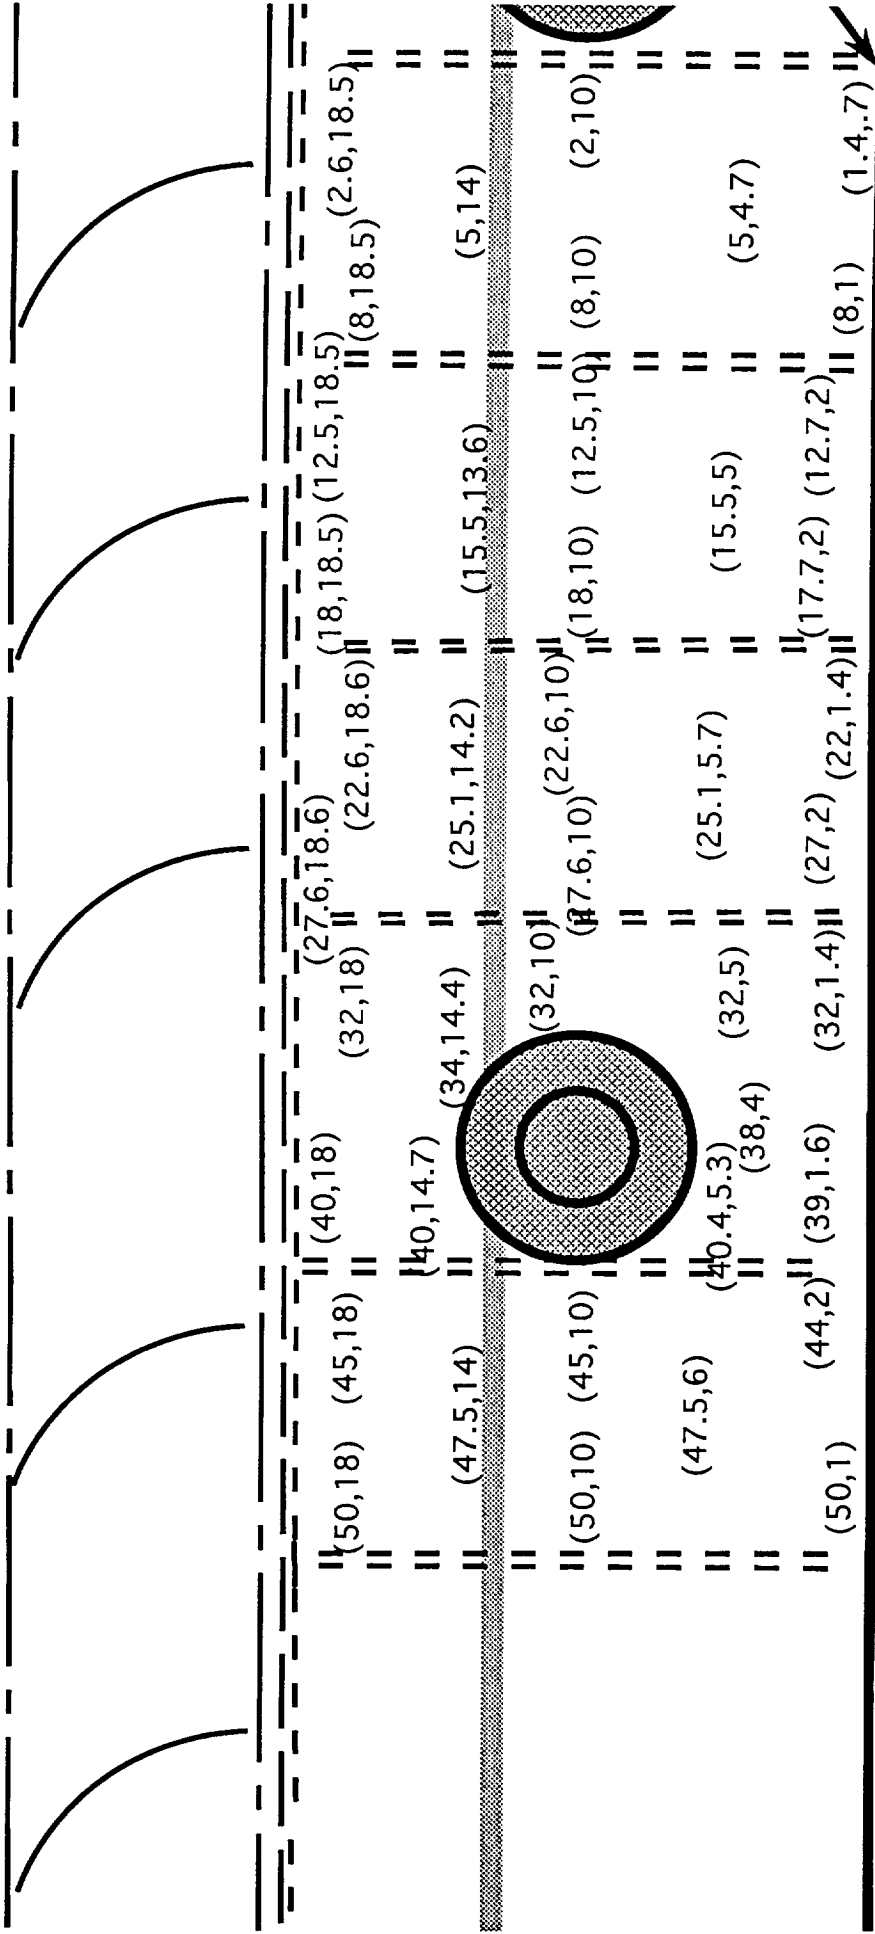
A4-1

Percent Silicon

17.9	19.2	23.4	24.3	24.9	21.3	16.3	14.4	13	12.6
16.1	21.7	22.6	21.1	21.1	13.2	12.5			
12.8	13.1	20.8	21.5	15	10.8	10.7	11.7	13	
13.7	8	16.3	14.3	11.1	13.5				
13.9	11.1	9.3	11.9	9	10.9	11.6	9.6	9.6

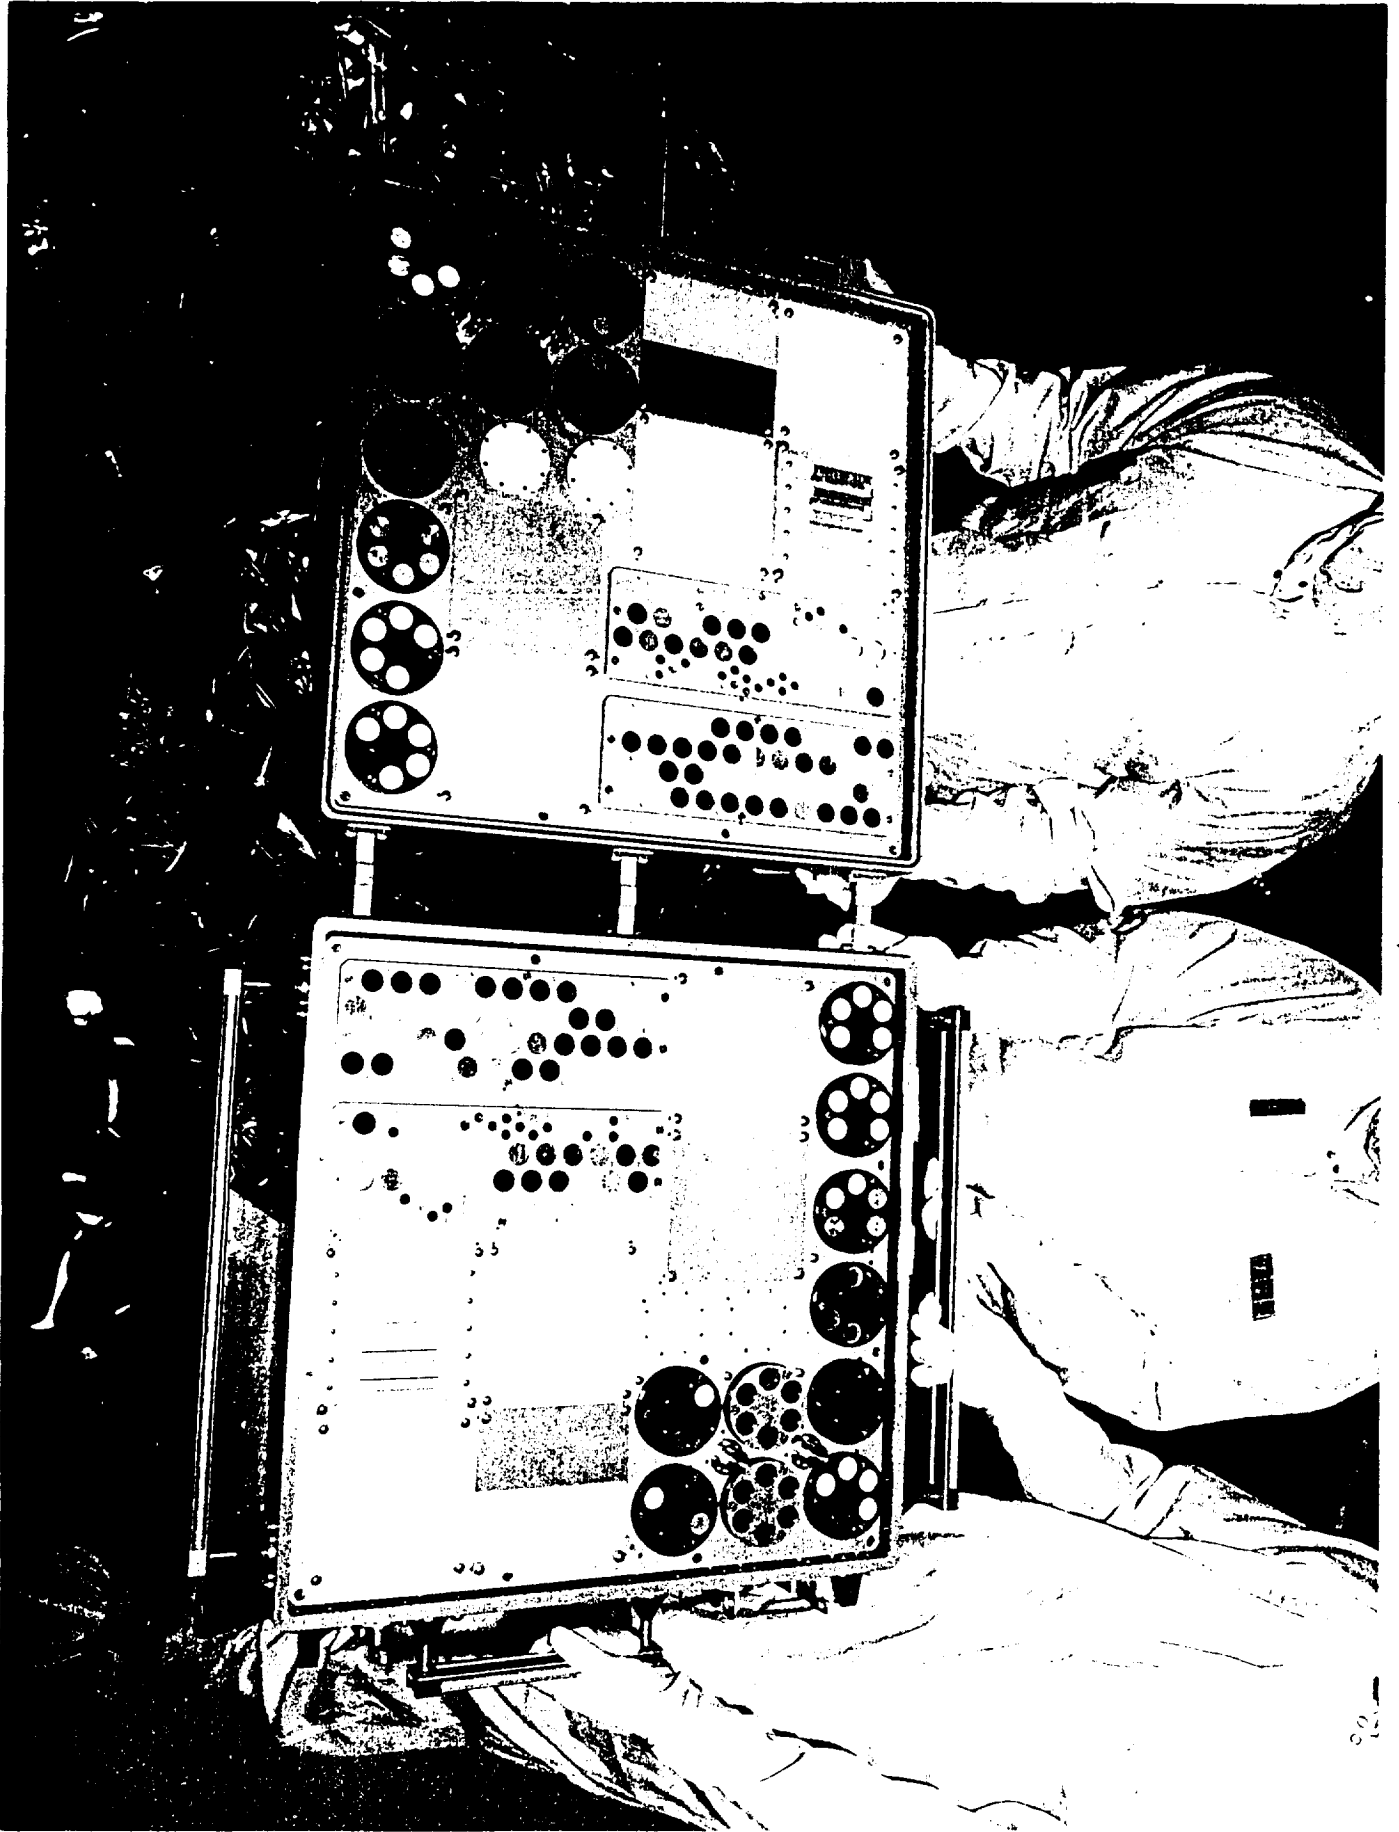
POSA I, pre-flight This NASA photo shows the POSA I experiment with all specimens mounted, prior to flight. I intend to point out some of the Boeing specimens on this experiment.

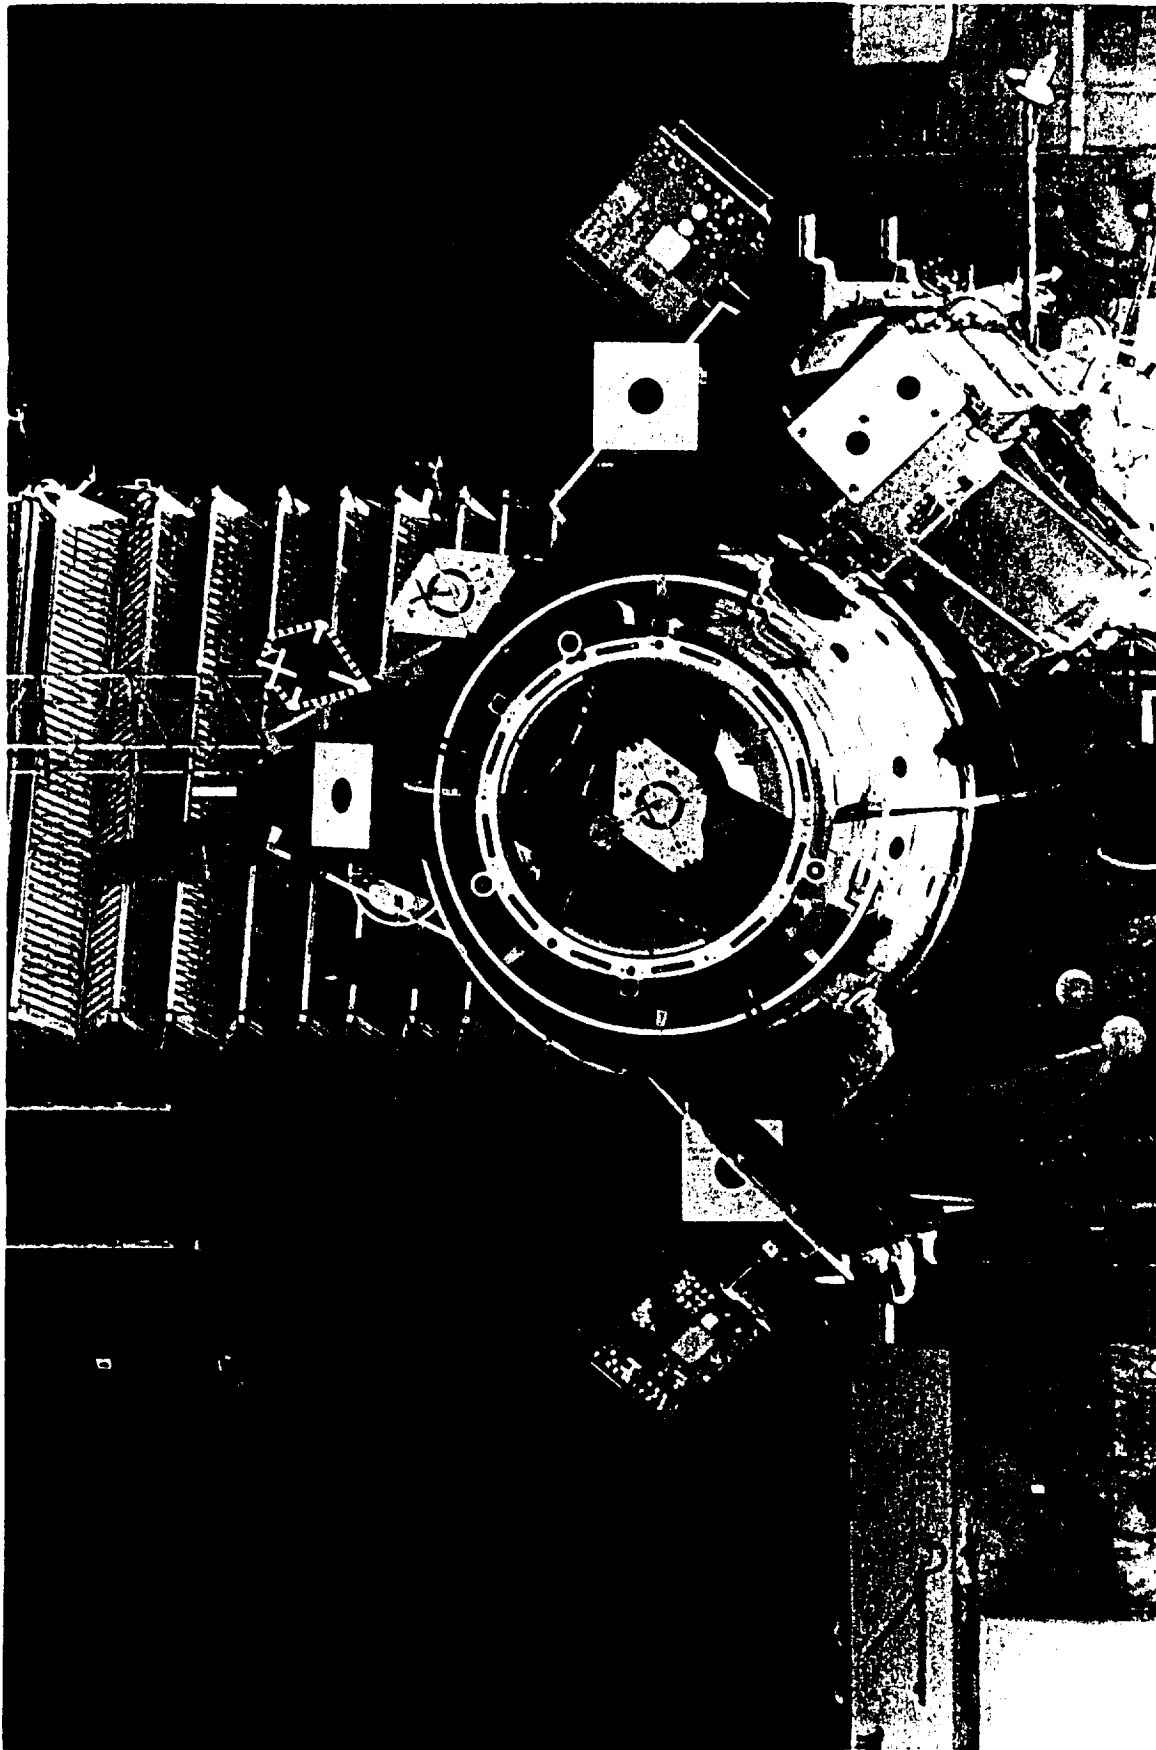
POST I & II ON ORBIT

POSA I & II, on-orbit This NASA photo shows the POSA experiments mounted on the docking module attached to the MIR space station. This is the best view available of these two experiments and was taken from a camera in the payload bay of the Space Shuttle.

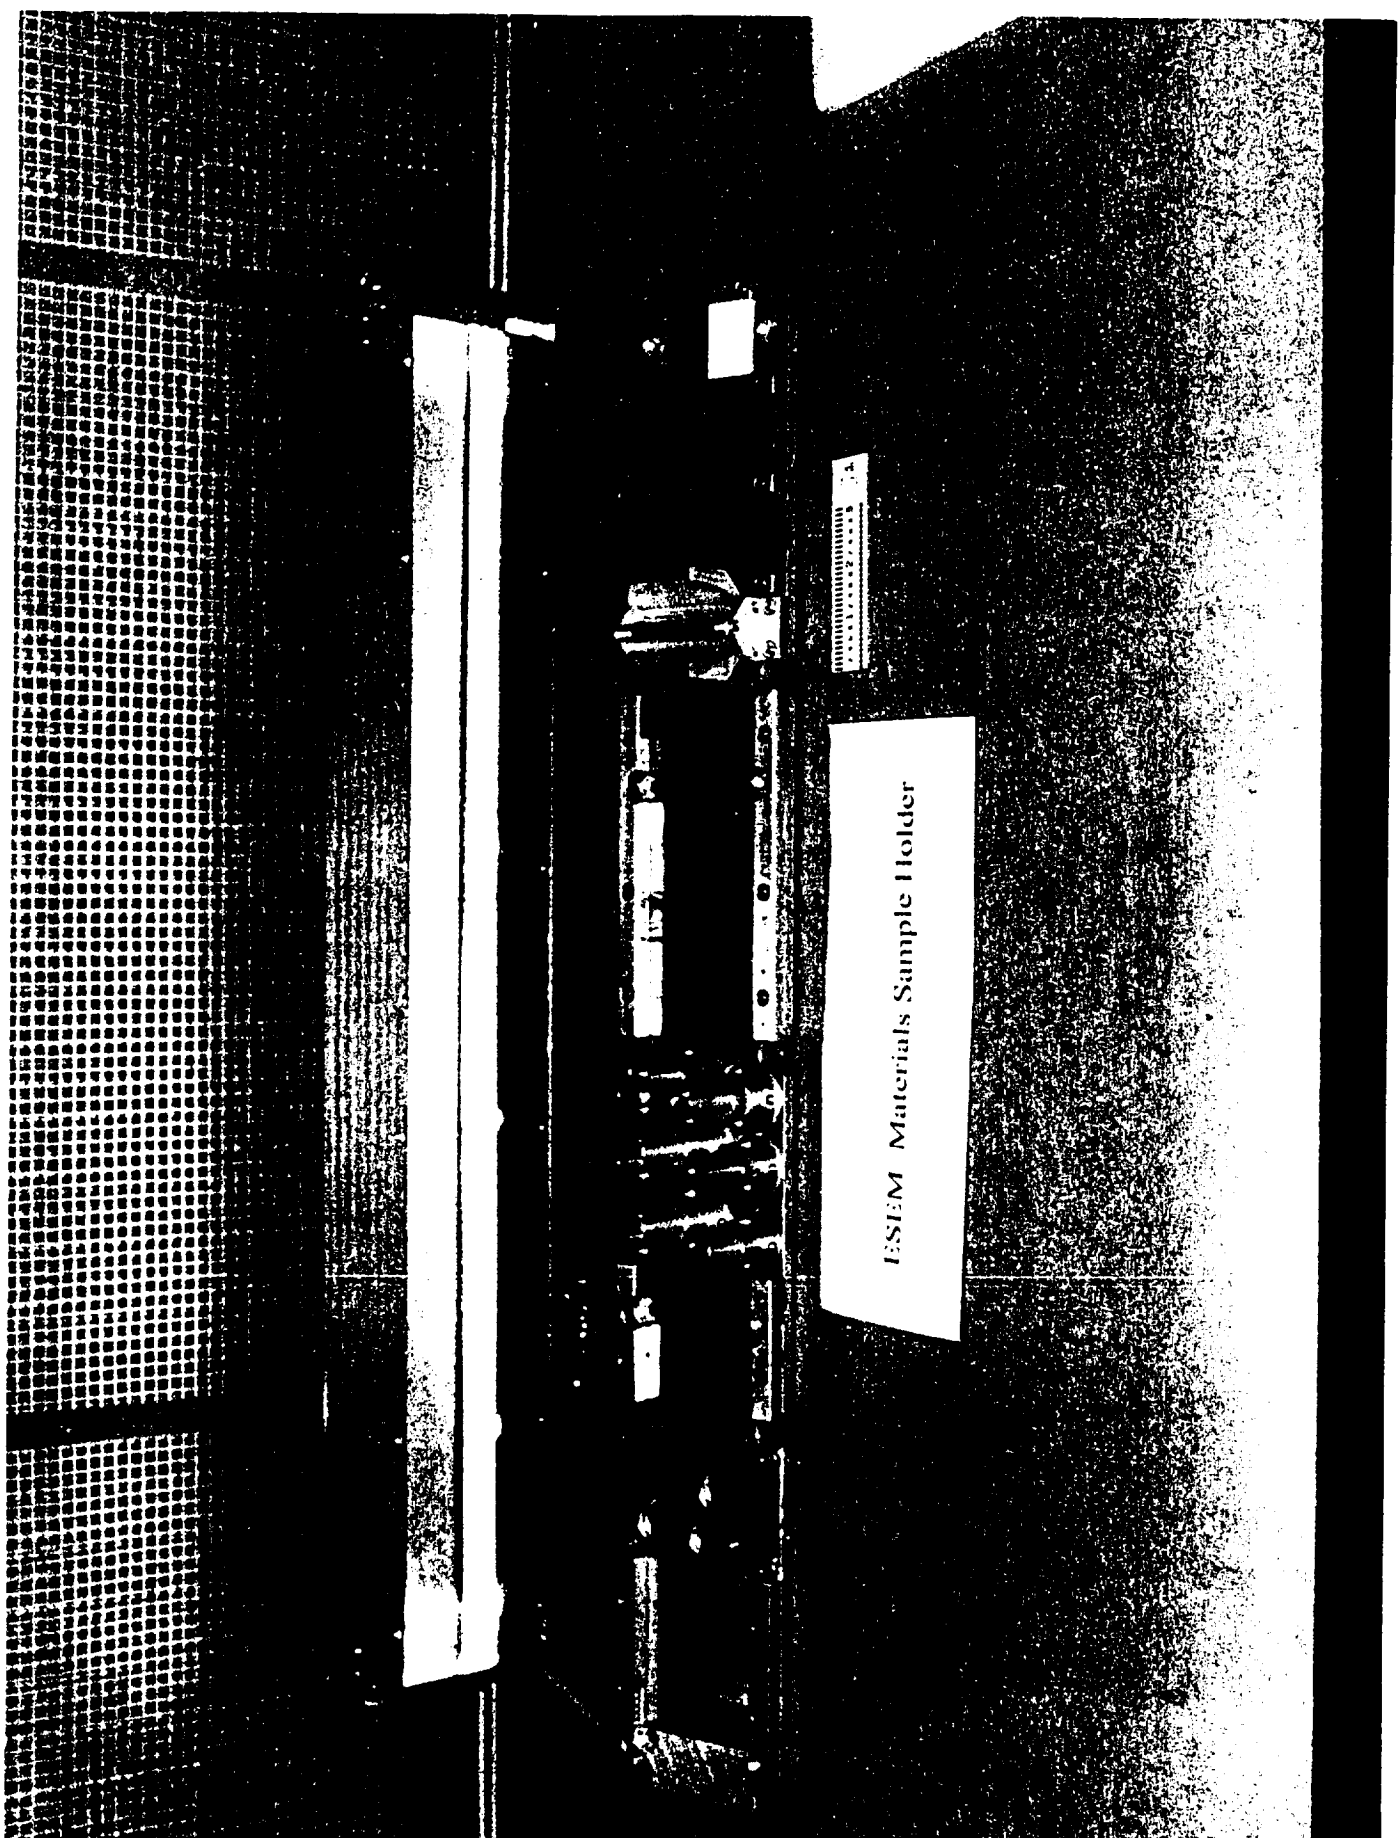
ESSEM Materials Sample Holder

ESEM, pre-flight This NASA photo shows the material sample holder for the ESEM experiment, complete with the specimens mounted in place. This shows the effective use of the area available for this experiment and I will discuss the details of the layout of the samples.

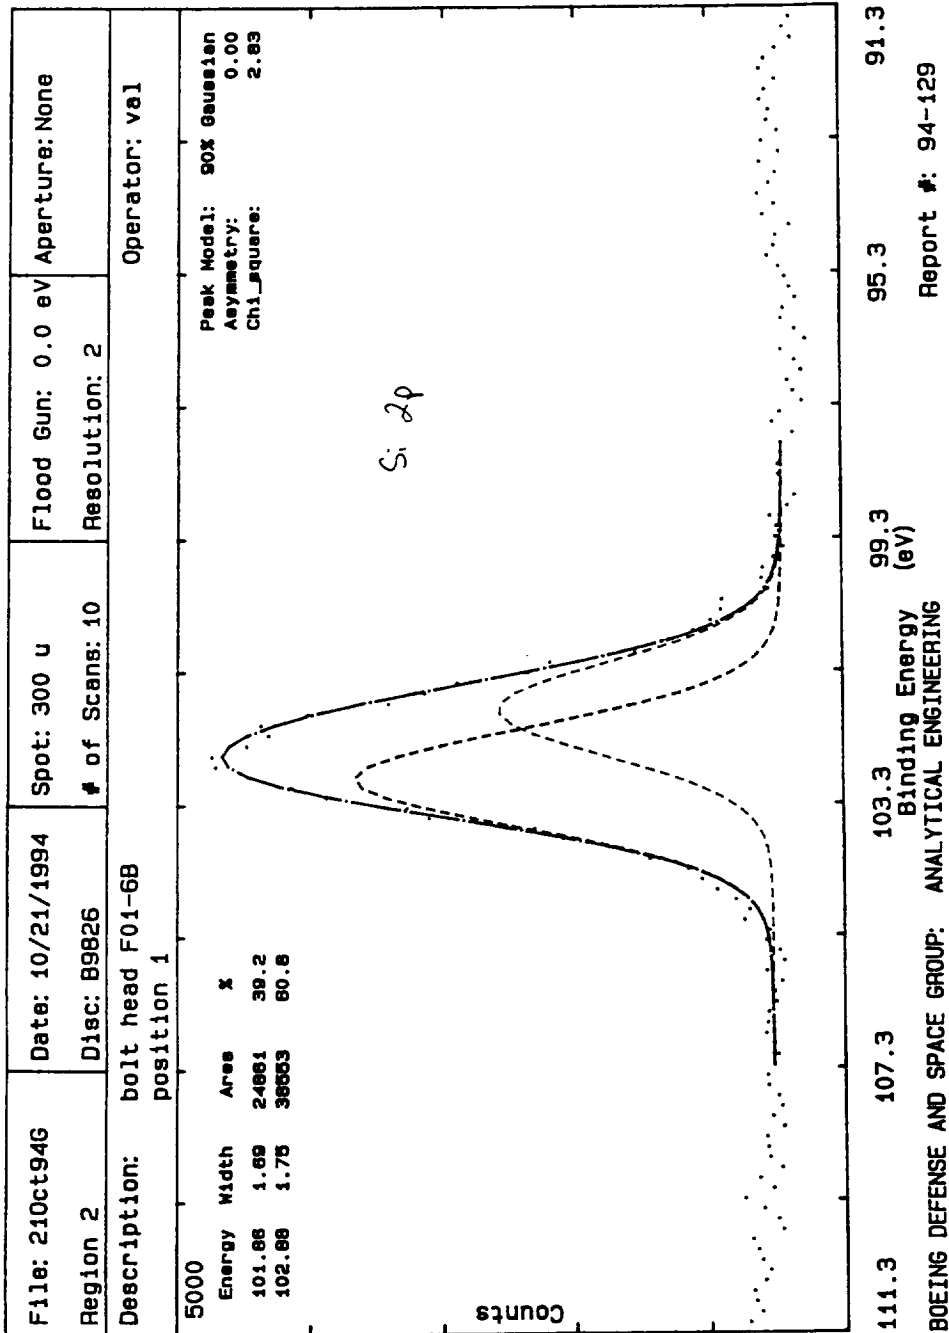
Figure G-27. Silicon 2p spectrum for bolt F1-6b, position 1.

This chart is a detailed energy spectrum obtained using surface X-ray photoelectron spectroscopy(XPS). This spectrum is for silicon and shows the separation of the measured peak into its two components representing inorganic and organic based silicon deposits.

SINGLE BROAD PEAK IN THE ~99-105 eV RANGE IS CURVE FIT TO TWO PEAKS

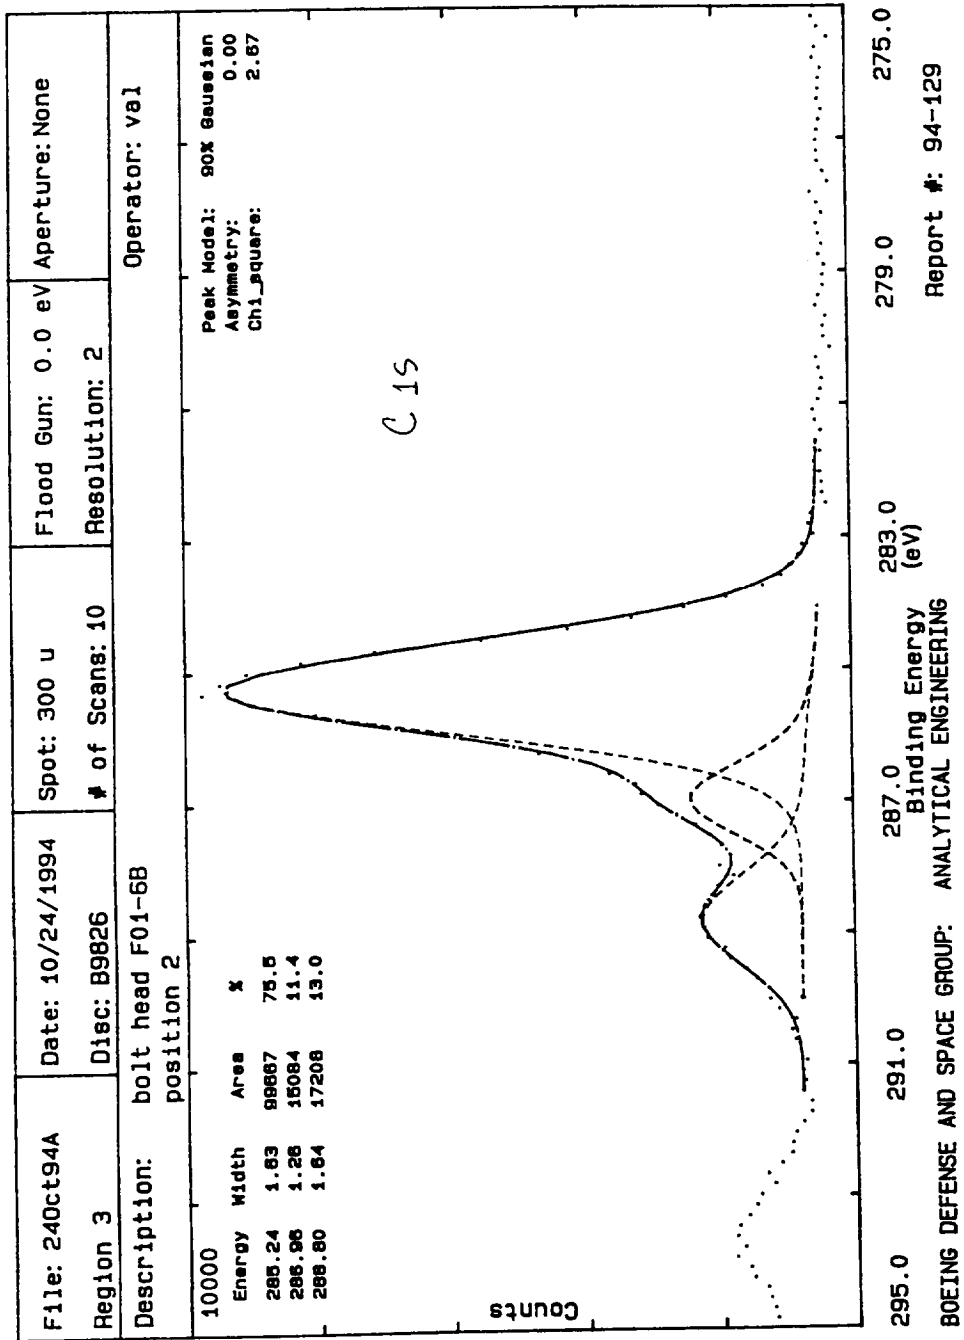
Figure G-28. Carbon 1s spectrum for bolt F1-6b, position 2.

This chart shows a reference carbon 1s spectrum used as a standard to precisely establish the energies of the peaks shown in the previous silicon XPS measurement.

CARBON 1s REFERENCE PEAKS ALSO OBTAINED FOR EACH BOLT HEAD MEASUREMENT

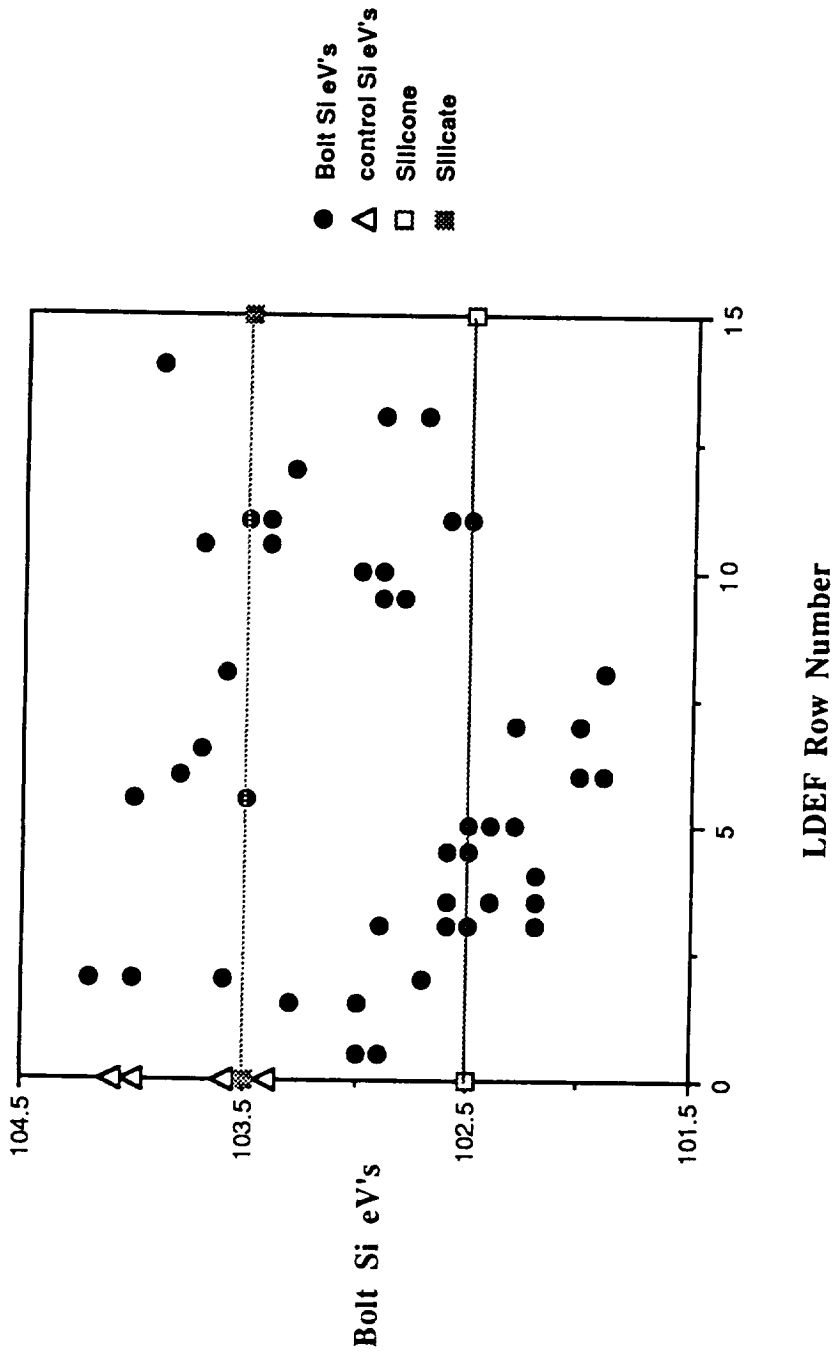
Figure 17. Results of high resolution ESCA measurements on selected stainless steel bolt heads from LDEF.

This chart summarizes the results of the XPS measurements made on selected tray clamp bolt heads from the Long Duration Exposure facility. The results indicate the presence of silicone based material for areas which had considerable atomic Oxygen exposure on-orbit, indicating a source of silicone contamination after the LDEF was captured by the Space Shuttle.
