# **INHIBITED SHAPED CHARGE LAUNCHER TESTING OF SPACECRAFT SHIELD DESIGNS**

**Donald J. Grosch  
Southwest Research Institute**

**FINAL REPORT  
Contract No. NAS8-40634  
SwRI Project No. 06-7698**

**NATIONAL AERONAUTICS and SPACE ADMINISTRATION  
MARSHALL SPACE FLIGHT CENTER  
Huntsville, Alabama**

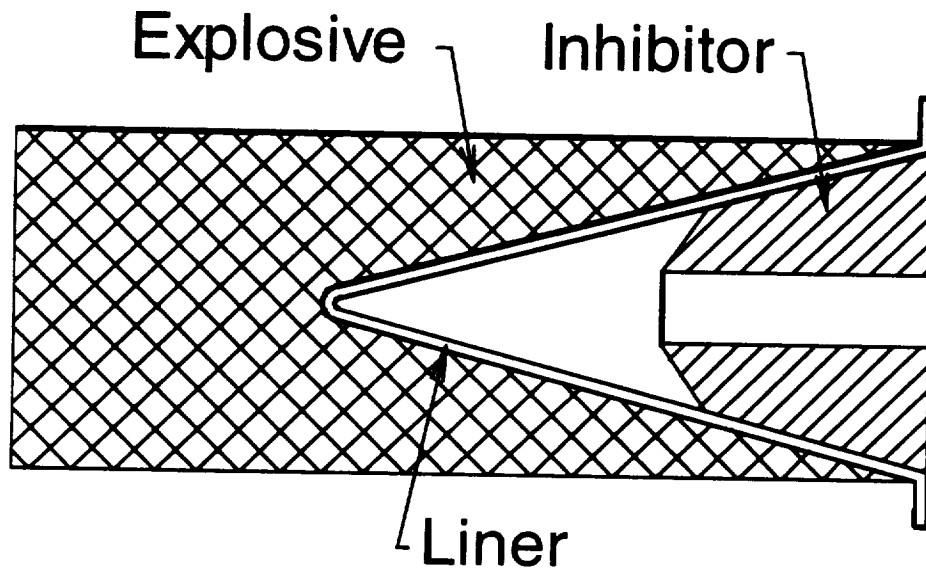
Figure 2. Shaped Charge with Inhibitor.

An aluminum (1100-O) lined shaped charge with a 30° included angle was used for each test. Octol 70/30 was cast upon the aluminum liner to form the charge. The charge was initiated using an explosive bridge-wire detonator (EBW) and a precision initiation coupler (PIC). An OFHC copper inhibitor was used for each test to inhibit the formation of the shaped charge jet. (The reader is referred to Reference 1 for a detailed description of the ISCL concept.) Figure 2 shows a shaped charge with an inhibitor placed inside the aluminum liner.

The ISCL isolates the high-speed jet tip of the shaped charge through the use of an inhibitor. The inhibitor is placed within the cavity of the shaped charge. It allows the jet tip to develop as usual but prevents the remainder of the jet from forming. The isolated jet tip is the projectile used to simulate space debris.

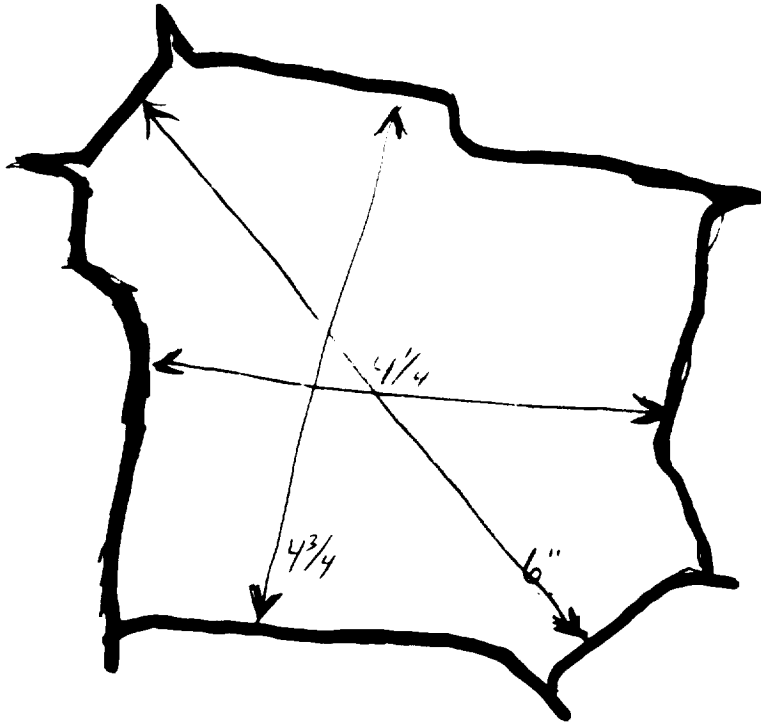
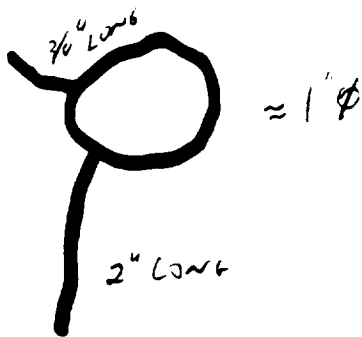
FACE  
Velocity = 11.68 m/s (high est.?)

- # 1 - DESTROYED
- # 2 - HURT BAD
- # 3 - DAMAGED

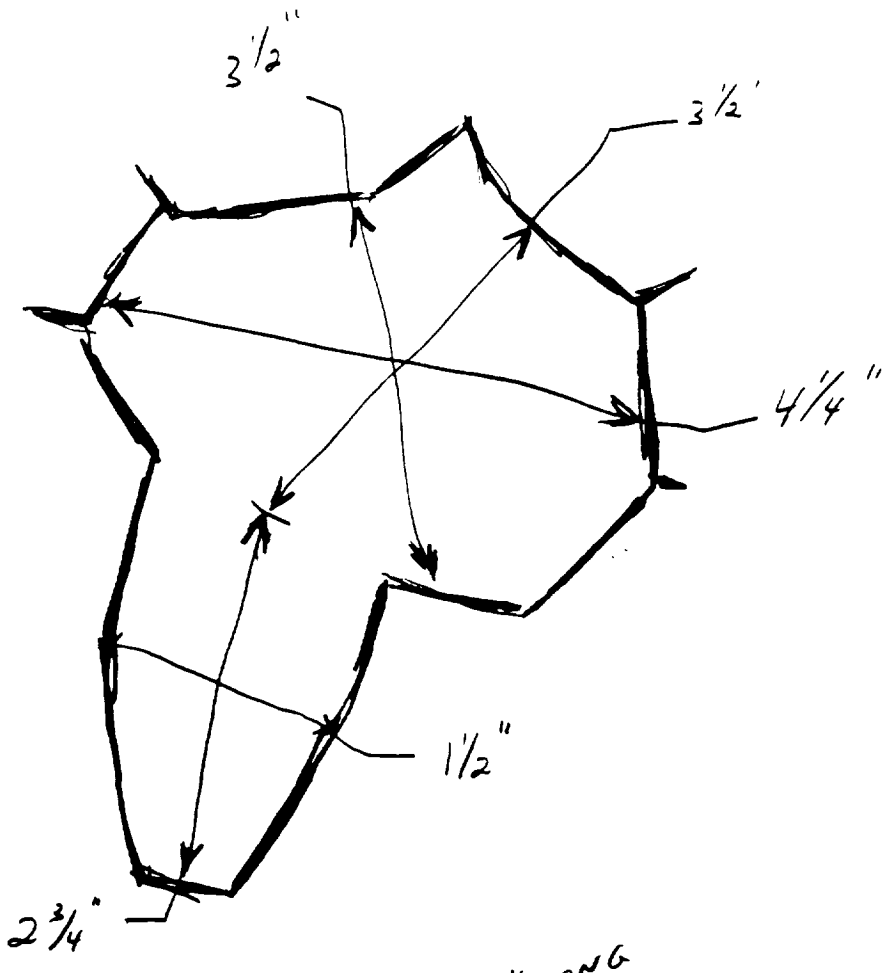
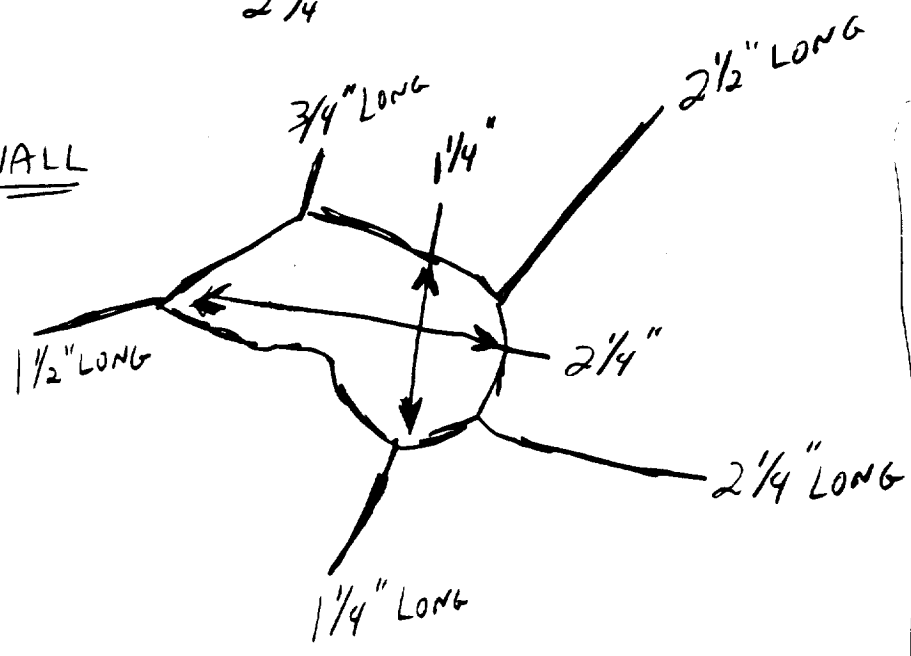
velocity = 11,38 km/s (est)

4"  $\phi$  Hole & A LOT OF TRASH

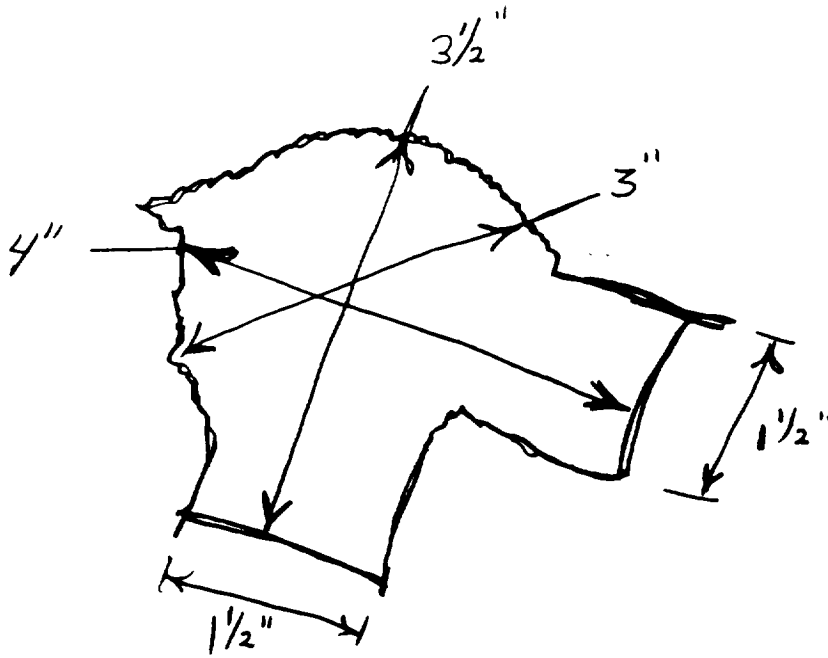
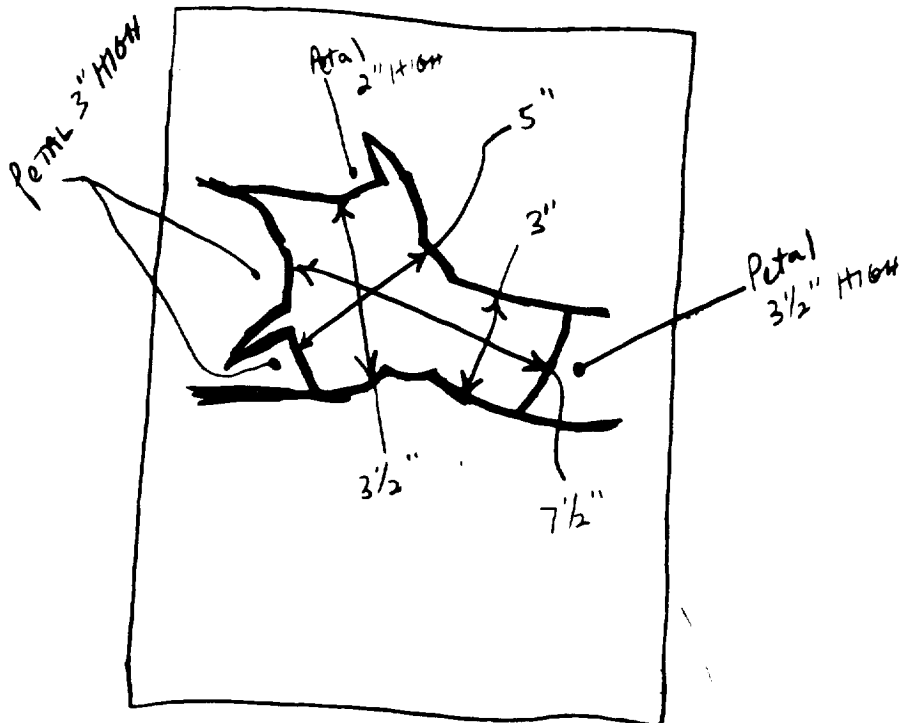
Velocity = 11.64 km/s (est.)

Had MULTIPLE  
 Small to Medium  
 (1/4"  $\phi$  to 1"  $\phi$ )  
 SIZE HOLES.  
 All 3 were  
 Deformed (Bent).

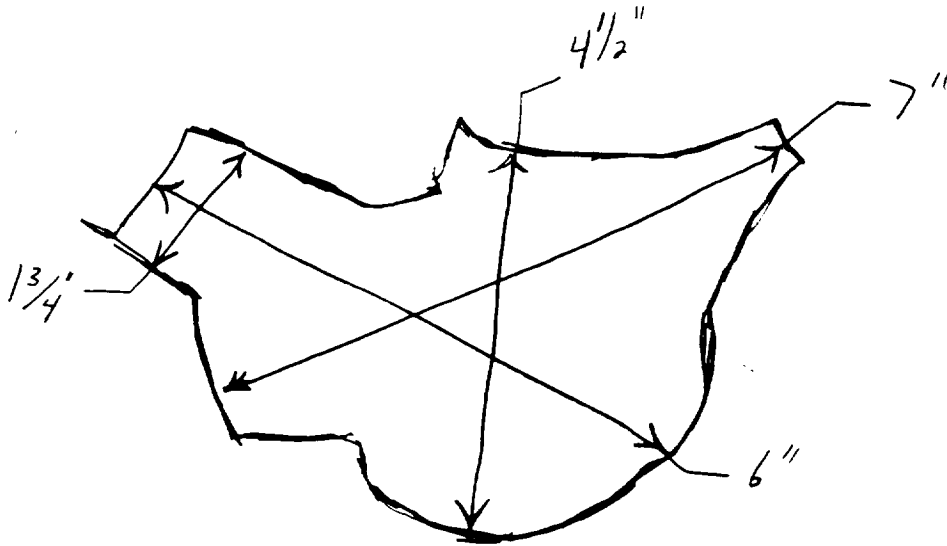
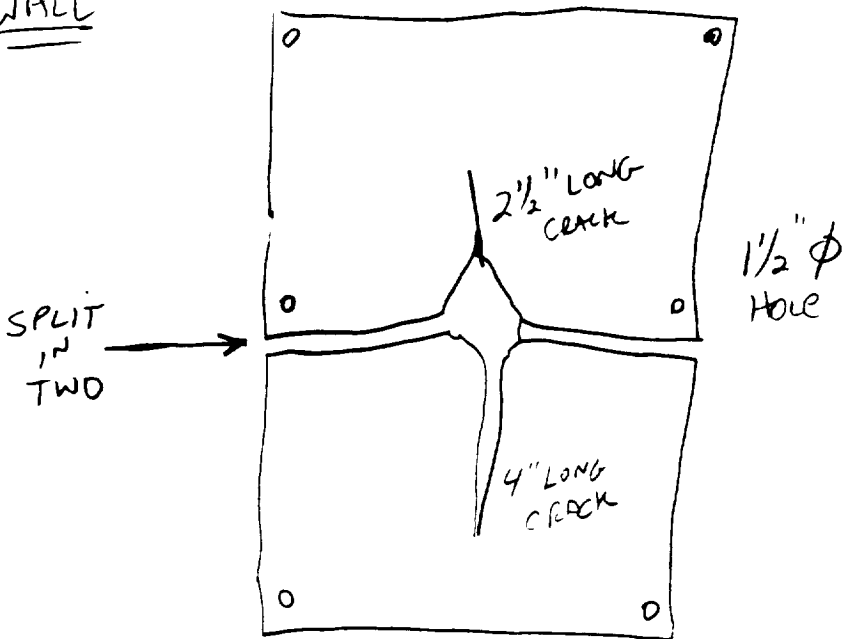
10.11.38

DAMAGE DECREASES FROM  
MANY SMALL ( $\frac{1}{2}$ "  $\phi$ ) HOLES  
ON PLATE #1 TO ONLY  
A FEW SMALL HOLES  
( $< \frac{1}{4}$ "  $\phi$ ) ON PLATE #2

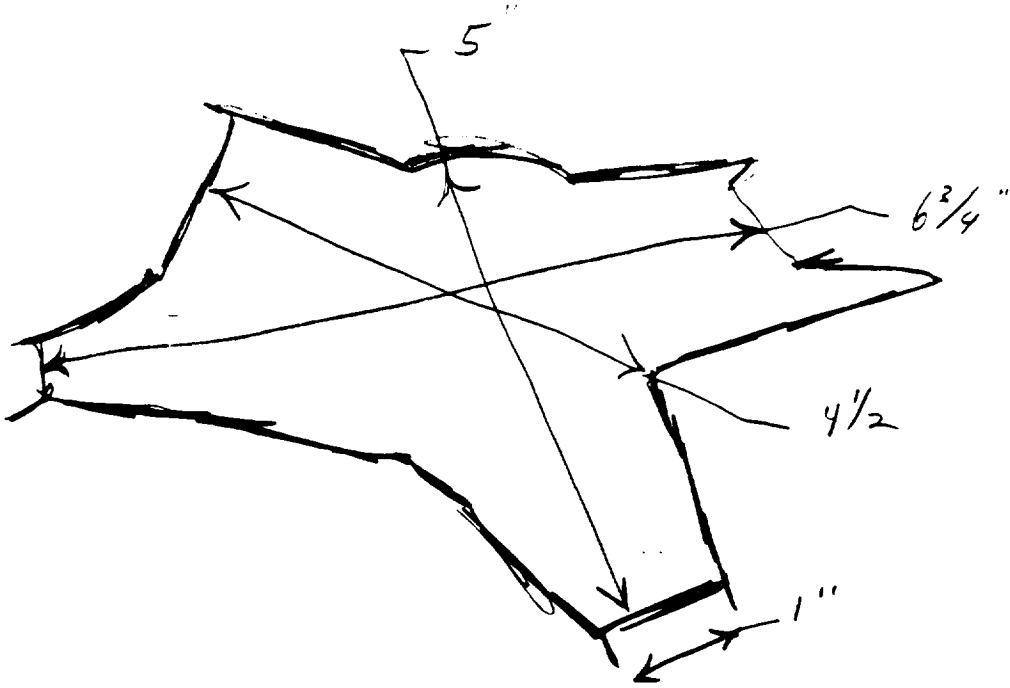
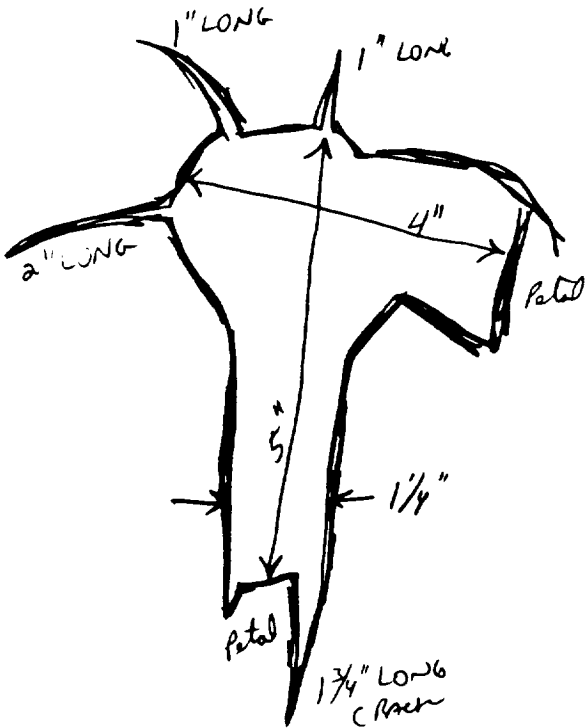
JFM0

- #1 HAS A 8'  $\phi$  HOLE & LARGE CRACK
- #2 IS CUT IN HALF WITH LARGE HOLE & BEND
- #3 HAS SEVERAL TEARS & A LARGE CRACK

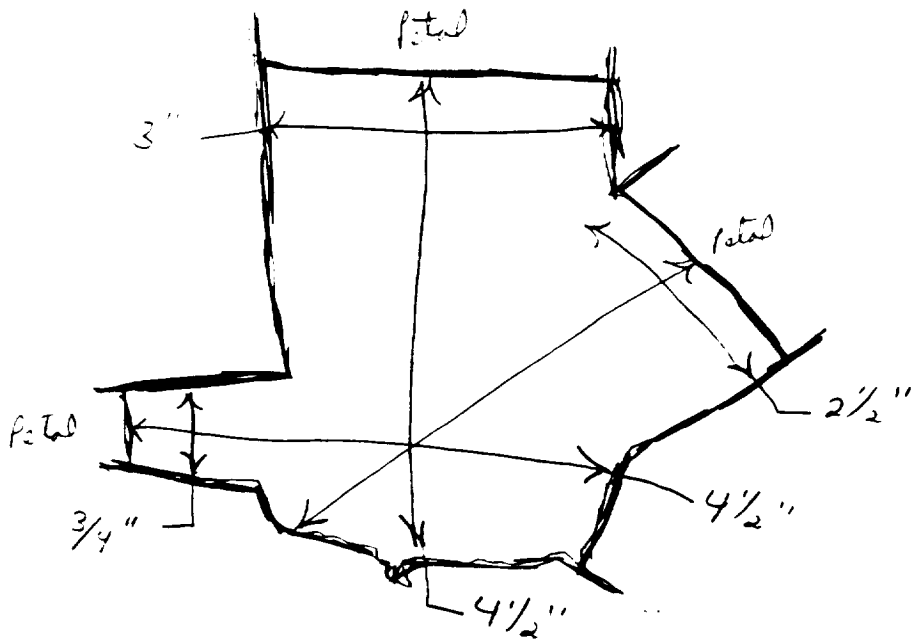
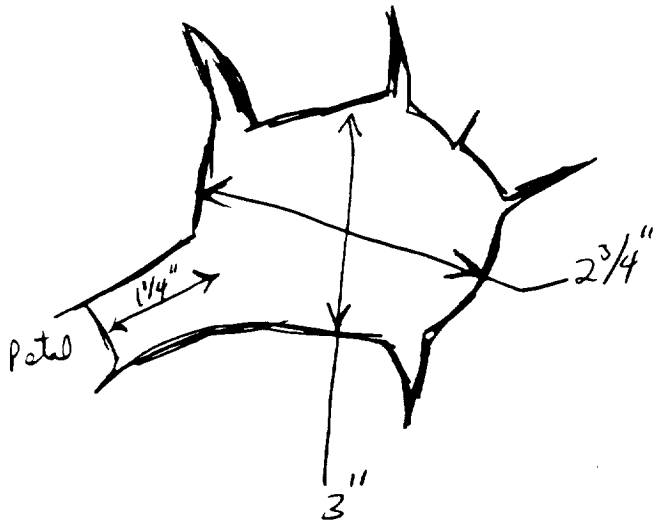
10

WITNESS large cells in #1. Decreasing in #2, several small ones in #3 (may have been ... MAKE SCREEN ...)

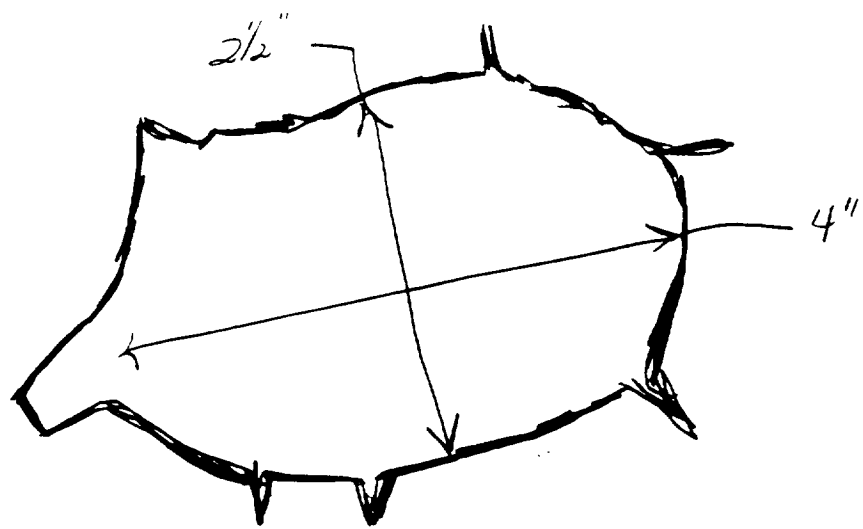
372-?  
LE-15

THROUGH Hole  $\approx$  2"-3" Dia

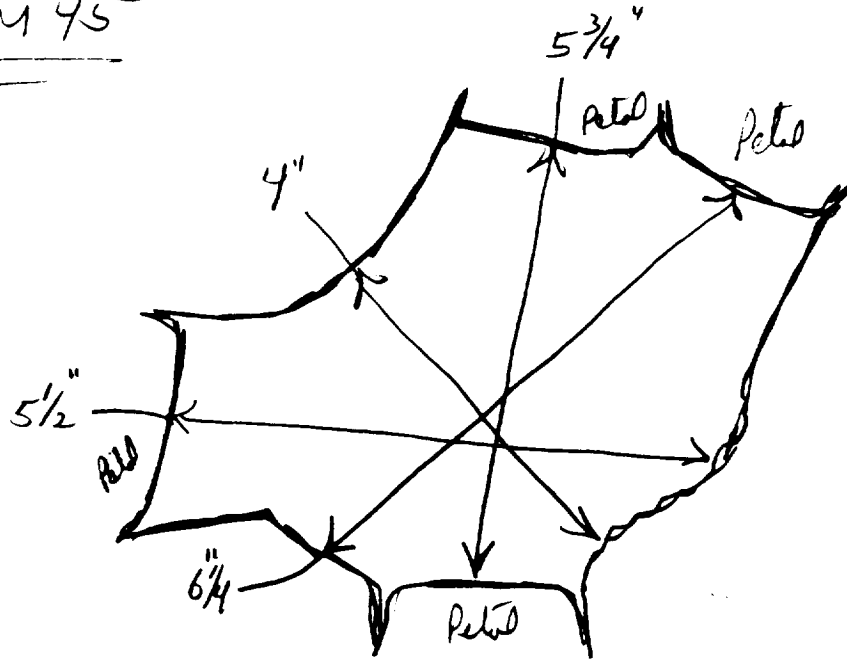
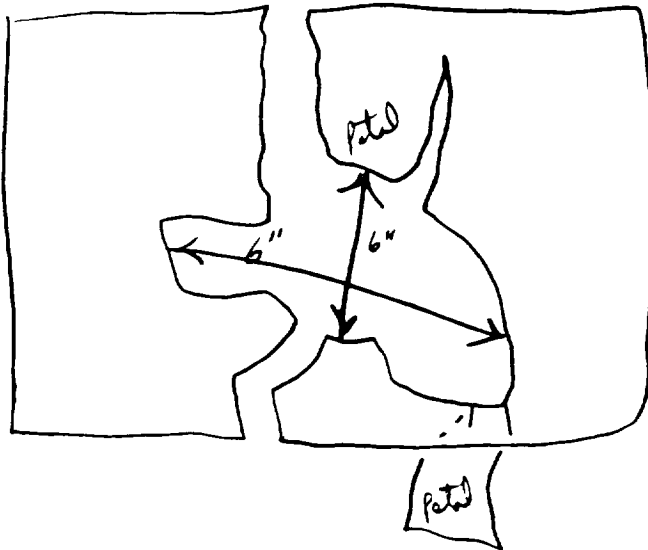
JEM 45

MULTIPLE small, 1 large ( $1\frac{1}{2}'' \times 3\frac{1}{4}''$ ) hole

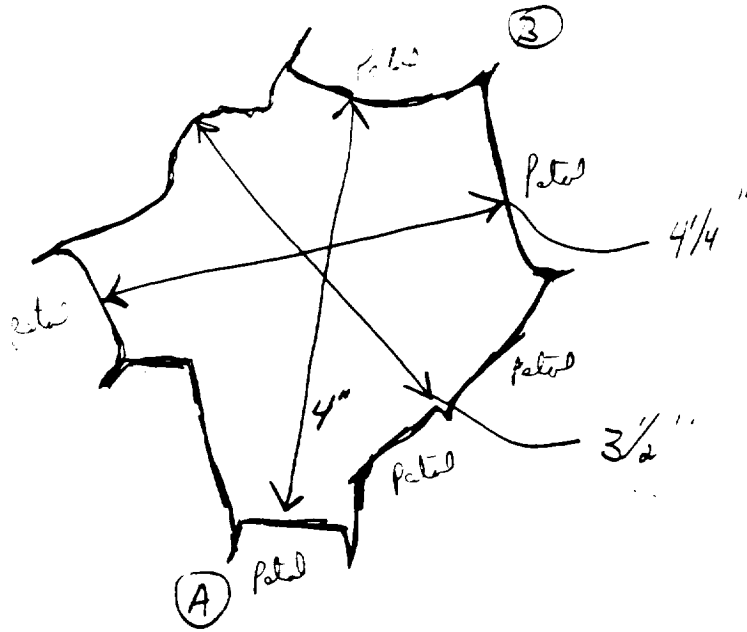
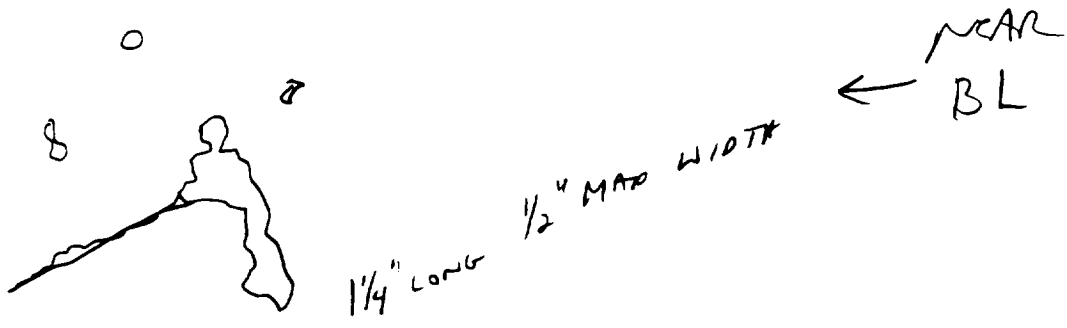
7028-11

TST = 4 3/4"

Very little Deformation  
Several small holes

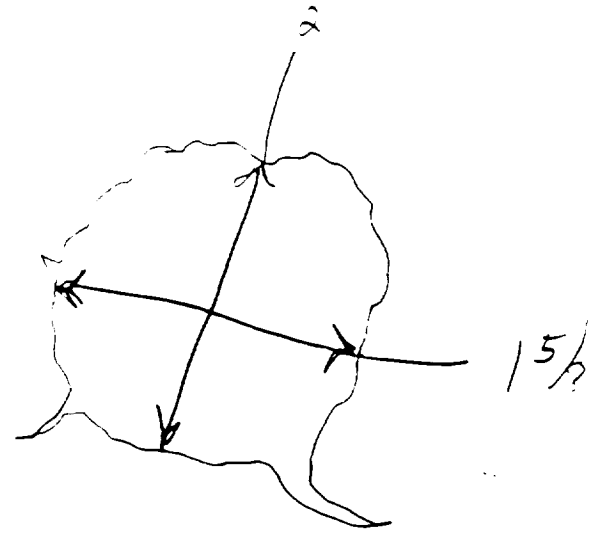
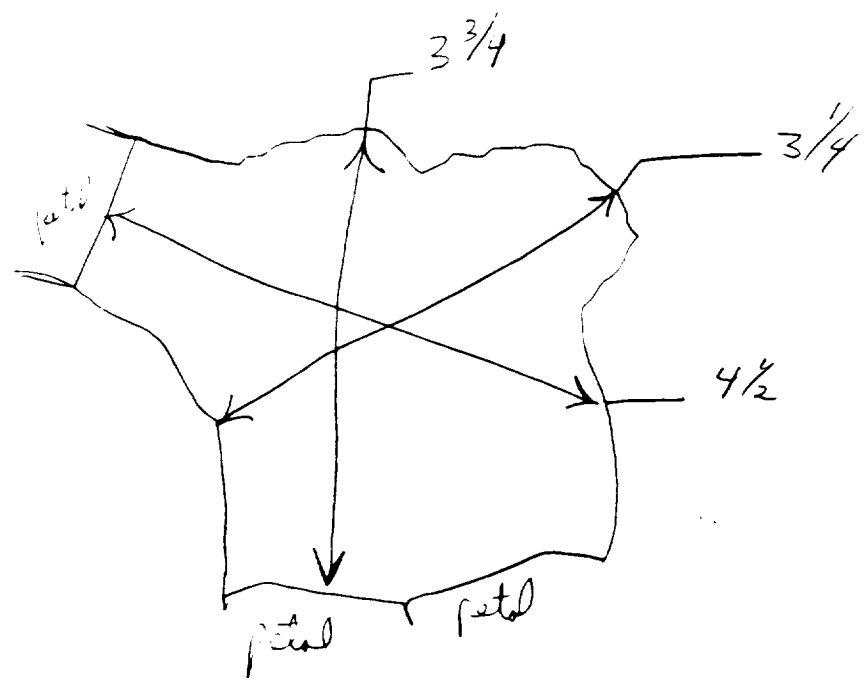
LEO.7

NAIL NO HOLE

1-1/4 BULGE

WITNESS NO DAMAGE

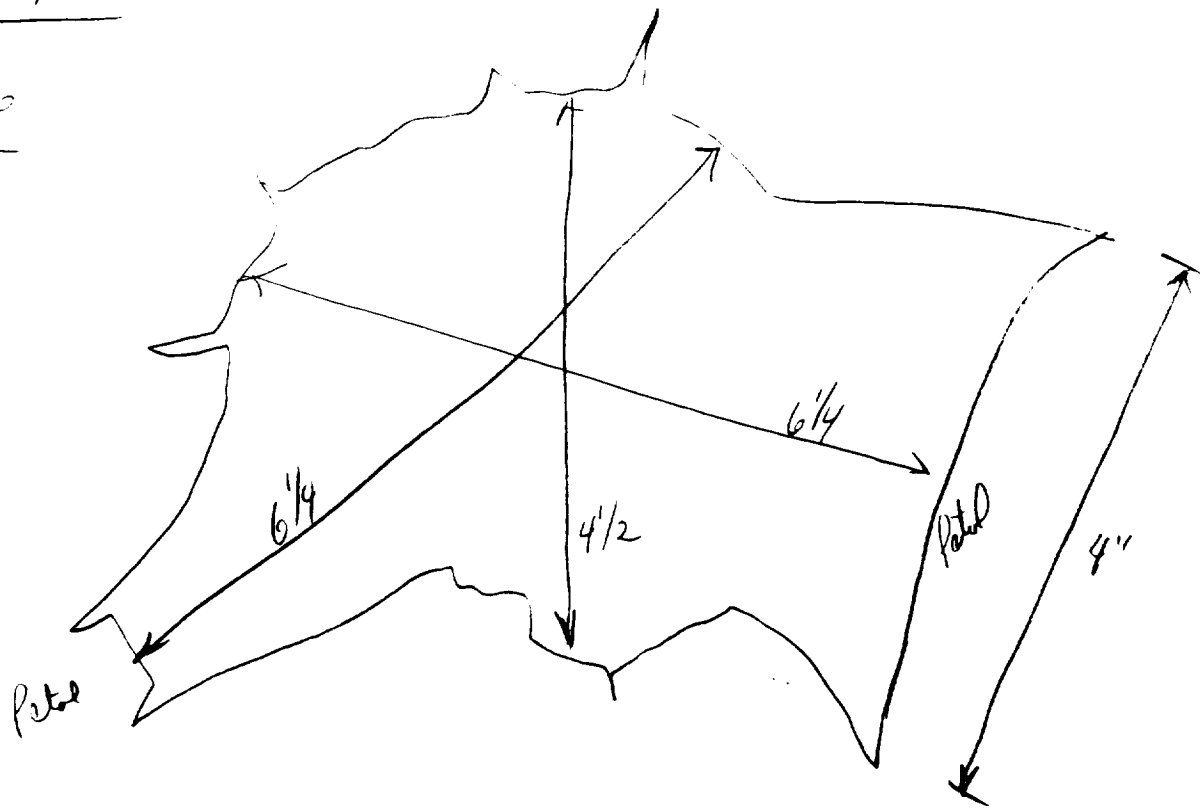
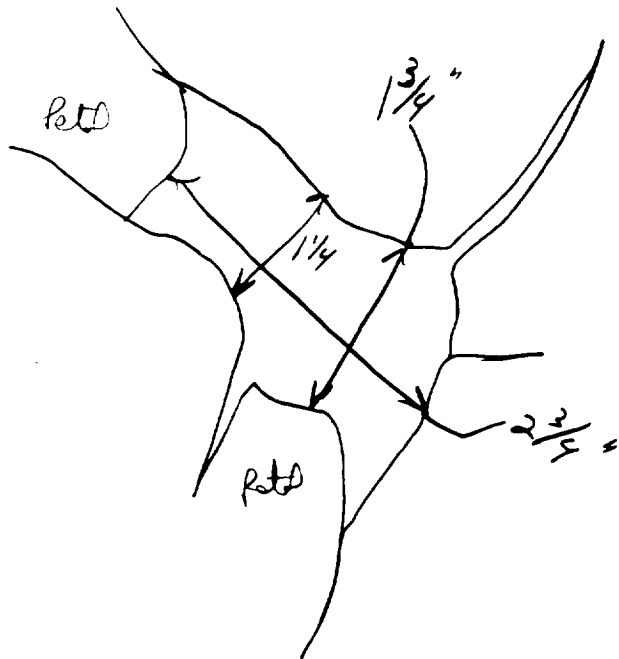
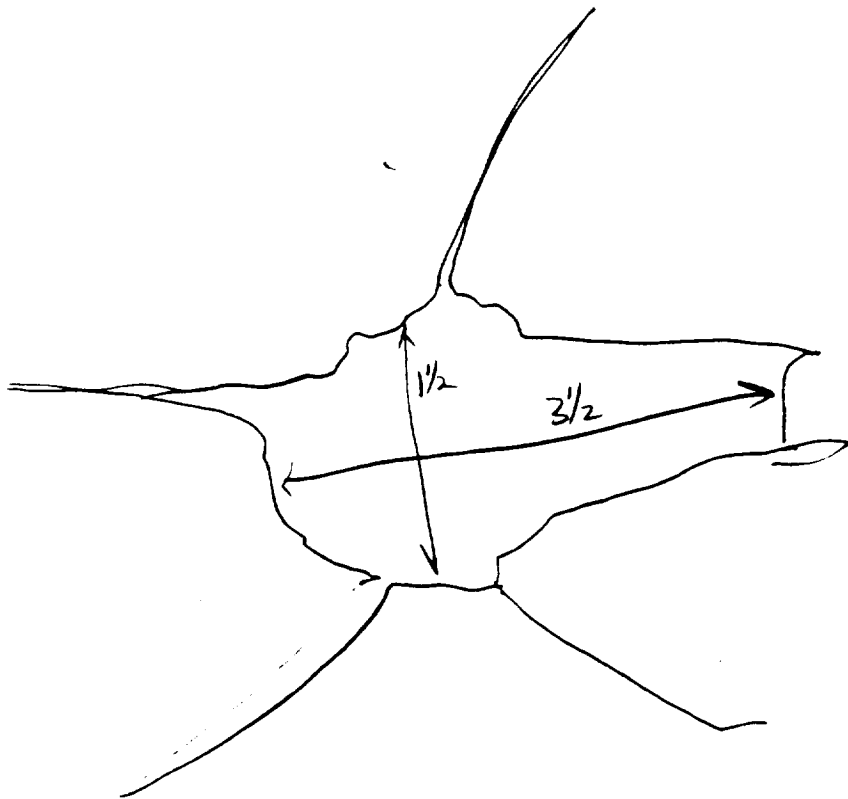
L45

Holes in #1 - (5 1/4 - 40 small - 1 1/2)

all 3 interior plates have numerous small holes
