NASA Technical Paper 3626

# Texture Modification of the Shuttle Landing Facility Runway at Kennedy Space Center

*Robert H. Daugherty and Thomas J. Yager  
Langley Research Center • Hampton, Virginia*

May 1997

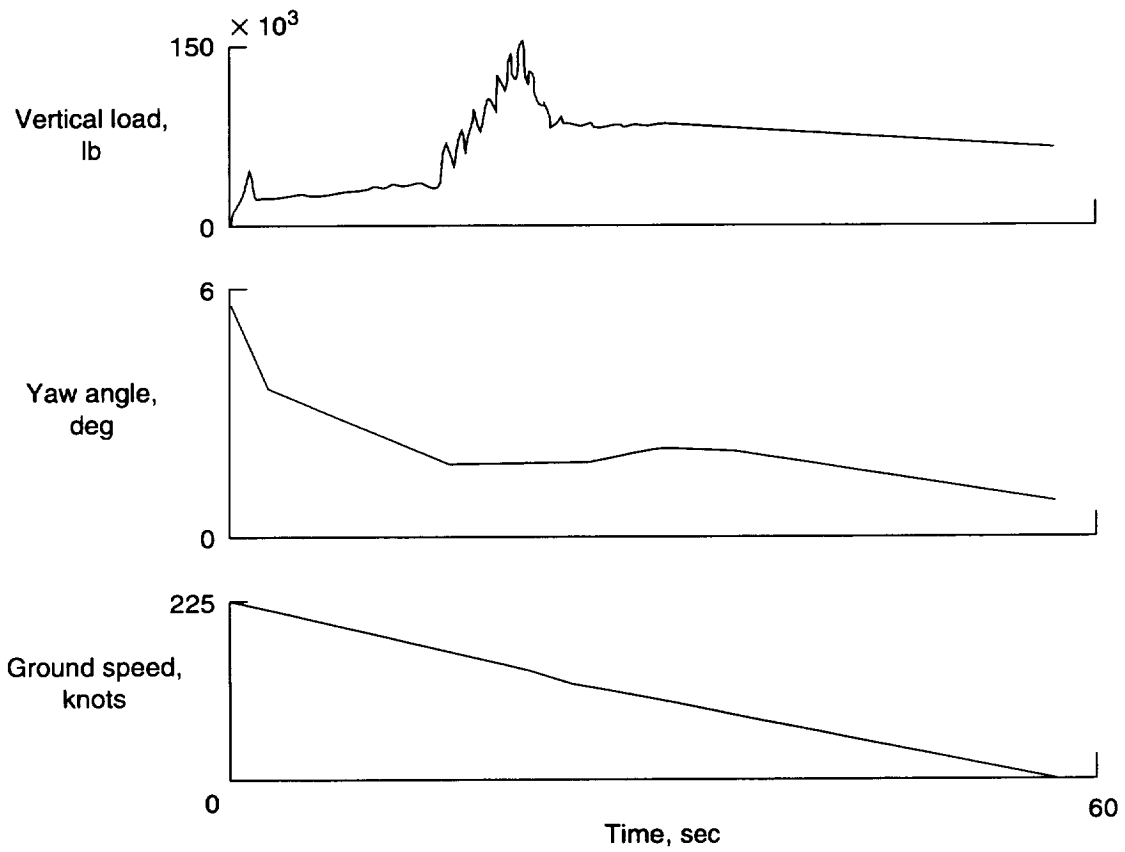
Figure 5. Typical time histories of inputs for LSRA test fixture.

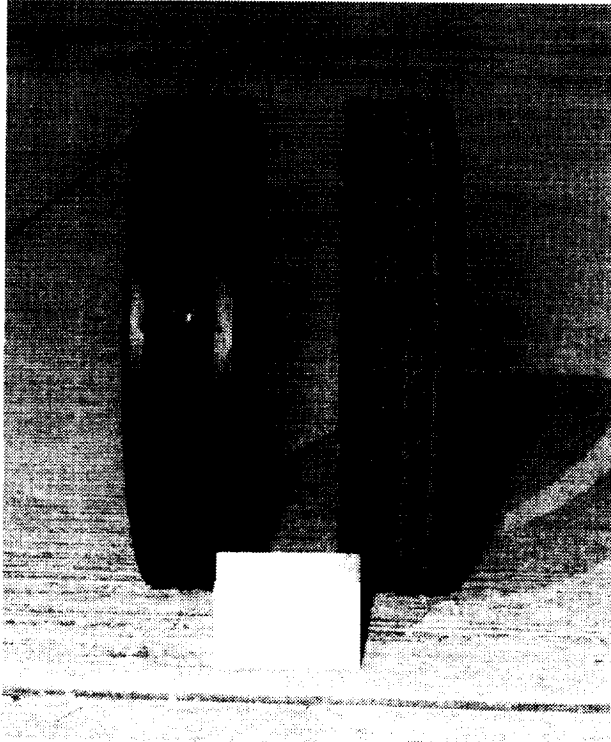
(a) ITTV test tires.

**ITTV tests.** The test tires used on the test fixture of the ITTV were  $20 \times 4.4$  bias-ply Type VII aircraft tires with a ply-rating of 14 and a 3-groove tread design; they are similar to those found on the main gear of a T-38 aircraft. A new and a worn ITTV test tire are shown in figure 6(a). The rated load and pressure of the tire are 6000 lb and 265 psi, respectively. Because it was desirable for wear testing to have the test tire inflated to the actual Orbiter tire pressure, the ITTV test tires were inflated to 350 psi. The tires were mounted on standard aircraft wheels according to accepted buildup procedures. A new tire was used for each surface tested.

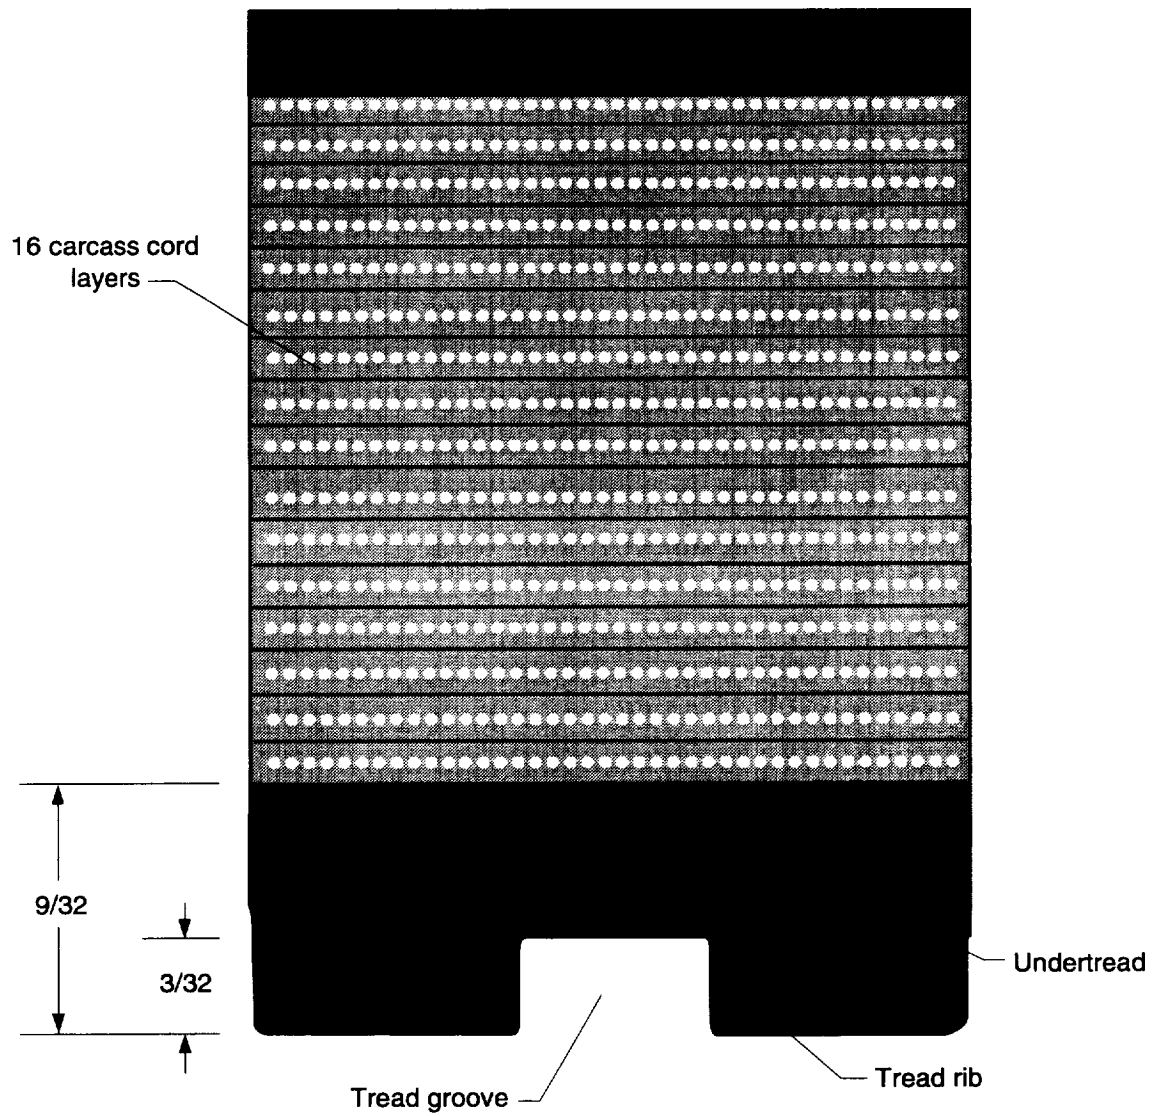
Figure 7. Cross section of modified Orbiter main gear tire. Dimensions are in inches.

main gear flight tires. One of the 44.5 × 16.0 - 21 bias-ply aircraft tires with a 34-ply rating is shown in figure 6(b). The original rated load of the tire and the pressure were 60 900 lb and 315 psi, respectively. These test tires (and the flight tires) are generally inflated to higher values prior to flight because of some small expected leakage and the cold temperature expected during normal landing operations. Therefore, these test tires were inflated to 340 psi at ambient temperature. The peak certified tire load at the time of this writing is 142500 lb. This load limit is intended to prevent excessive tire deflections which could damage the carcass structure during landing operations. The test tire is of the *modified* tire design, in which an additional 0.1 in. of undertread was added to the original design, and the entire tread material was changed from a natural rubber composition to a blend of natural and synthetic rubbers comparable to those used on commercial aircraft. These modified tires provide a much-improved wear behavior as compared to tires of the original design. The tread grooves themselves are 3/32 in. thick. A sketch of the tire cross section is shown in figure 7.

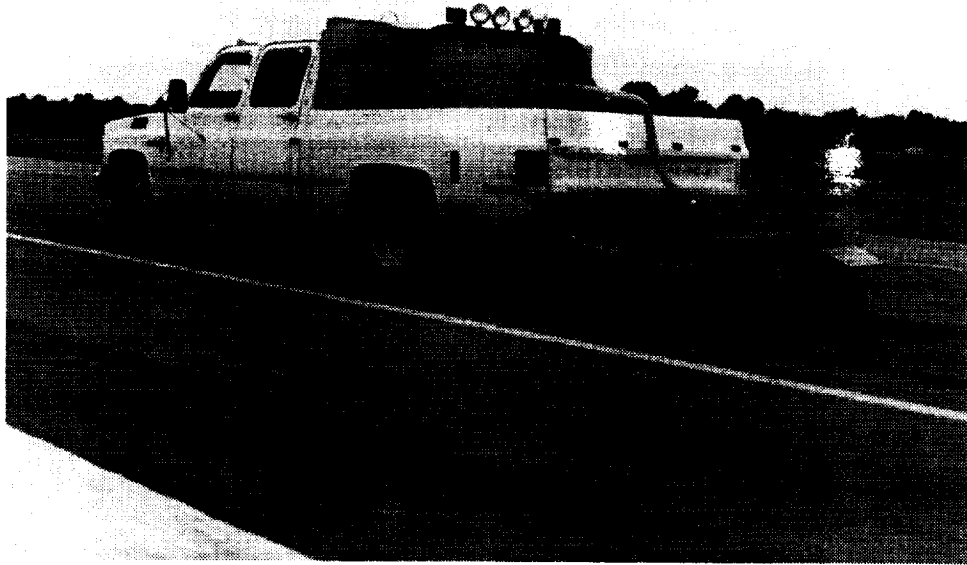
(a) Mu-meter and tow vehicle.

**Mu-Meter.** The Mu-meter (fig. 8(a)) is a friction-measuring device designed to be towed behind a vehicle on a test surface (ref. 9). The device consists of two test tires loaded vertically and *toed* out to include an angle of 15°, thus forcing each tire to operate in a yawed-rolling condition with side forces directed away from and canceling each other. The device measures the tensile force in the axle and gives a measure of the surface friction being developed by the yawed test tires. The device can conduct tests on dry surfaces and is capable of using an onboard water tank to wet the test surface just ahead of the test tires.

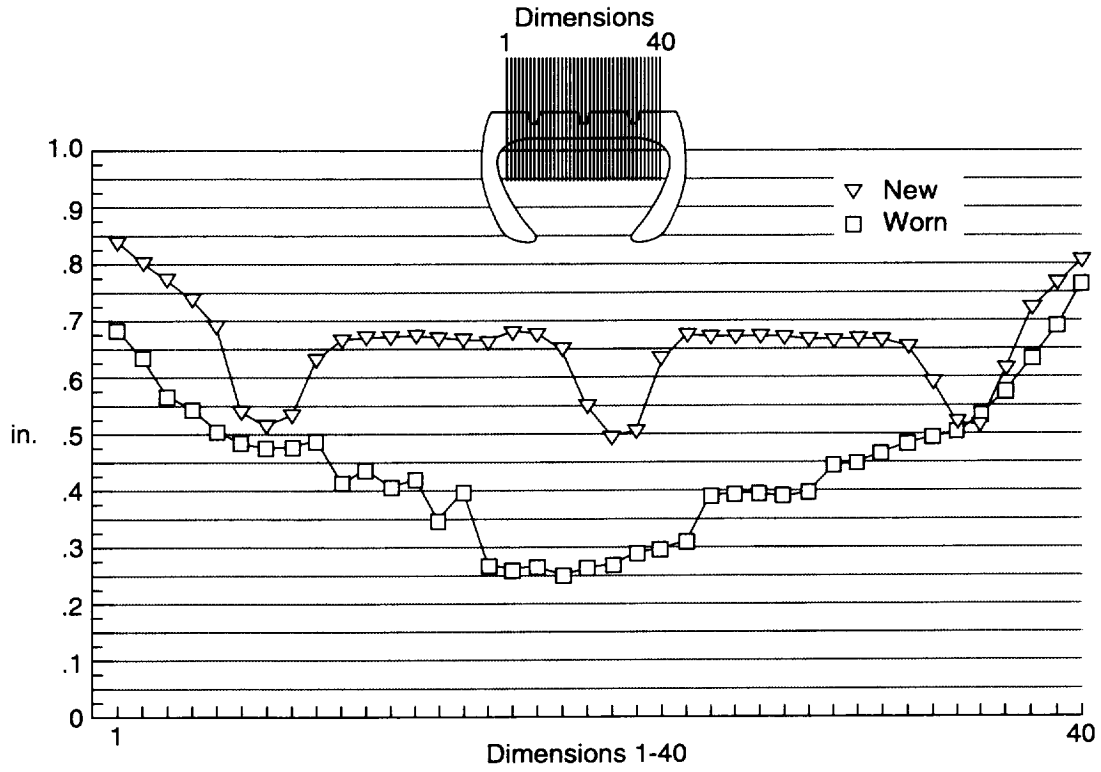
(a) New versus worn tire-profile comparison.

(b) Tire scan images.

Figure 12. Computer tomography examples.

example of the tire-profile dimensions before and after testing is shown in figure 12(a). In the figure, dimensions 1 through 40 represent scans that are parallel to the rotational plane of the tire, thus providing 40 data points from the left towards the right shoulder of the tire to characterize the tire-tread wear. Figure 12(b) provides a representation of the tire cross section before and after testing. The change in thickness can then be correlated with other tire-wear measurements. This kind of examination is advantageous because many more *individual* or discrete measurements can be performed automatically in a nondestructive manner. Reference 13 has more information about this technique.

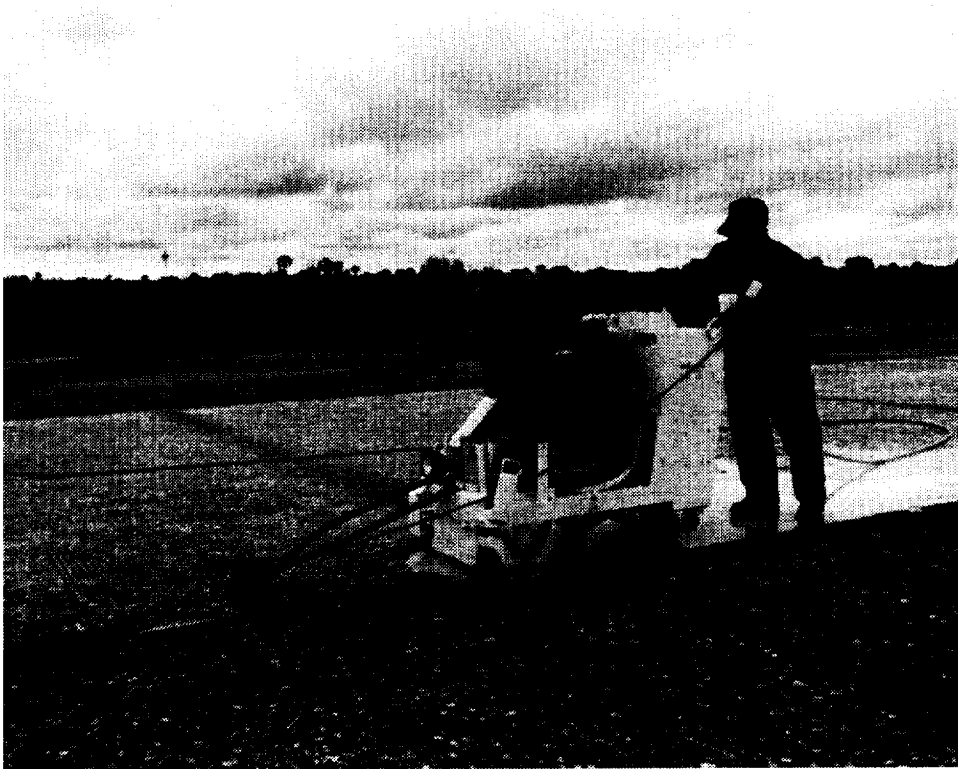
Figure 14. Diamond-blade-grinding machine.

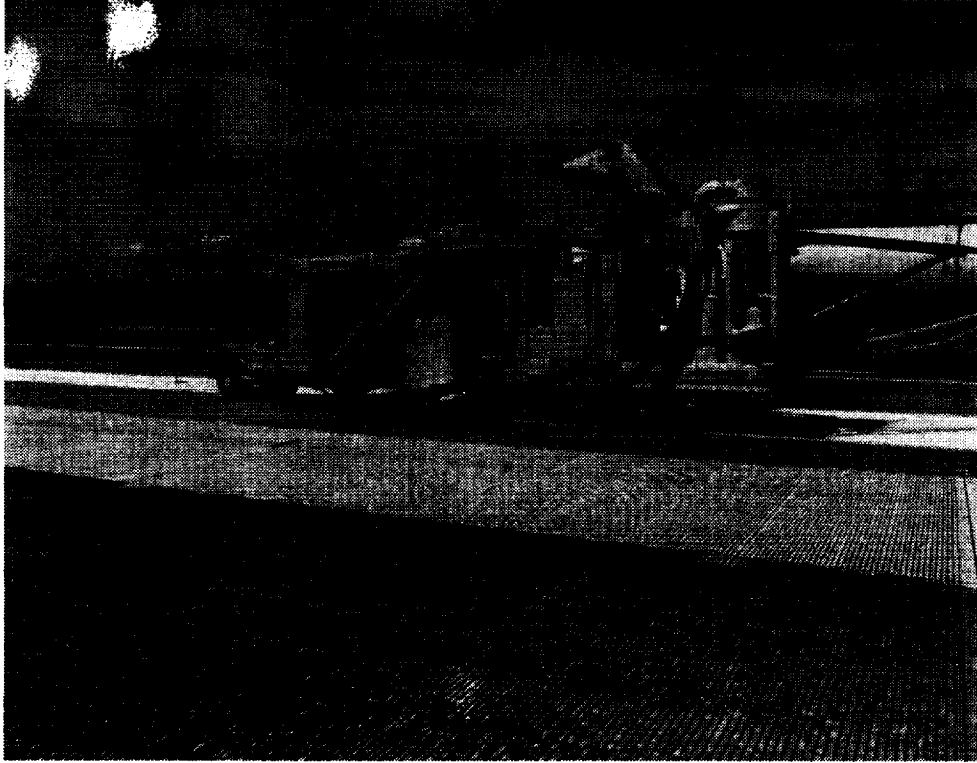
Figure 16. Large diamond-blade-grinding machine.

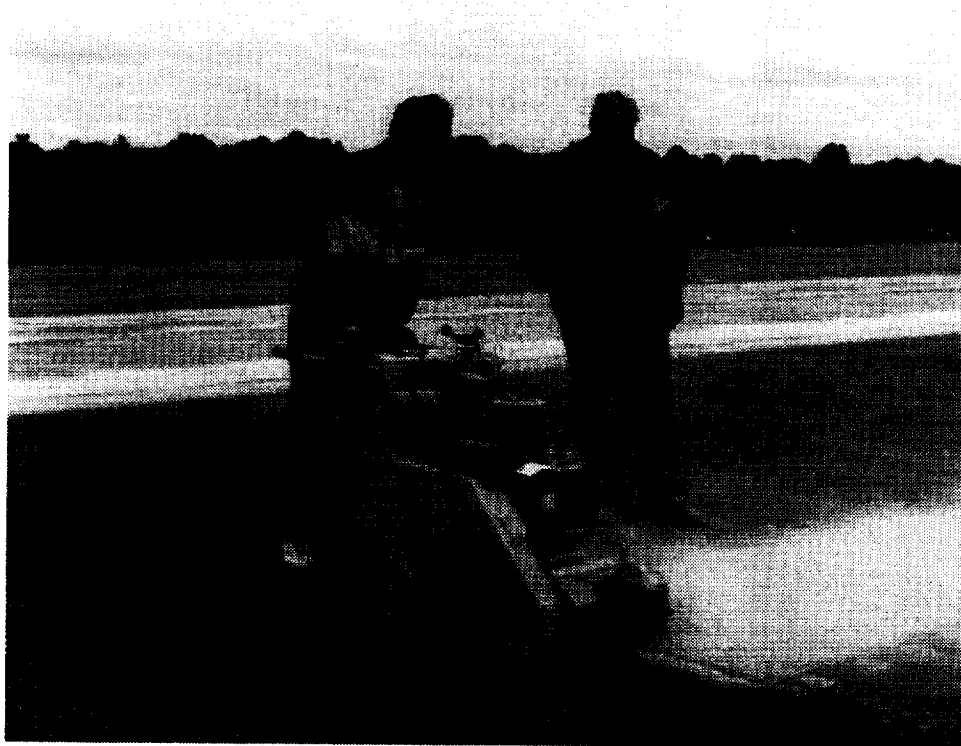
(a) Lateral application.

(b) Surface after rotopeening.

Figure 19. Rotopeener machine.

**Rotopeening.** The rotopeener shown in figure 19(a) is a device with tungsten buttons attached to leather-like belts or straps. A head loaded with these straps of buttons rotates, and as it does, the buttons *slap* the runway surface and cause the tops of the macrotexture peaks to be broken off in much the same way as they are with the Skidabrader™. The buttons were unable to penetrate the texture as deeply as the Skidabrader™ machine; thus, the rotopeener changed the texture on the very top surface of the runway and on the edges of the transverse grooves when applied in the center section of the runway

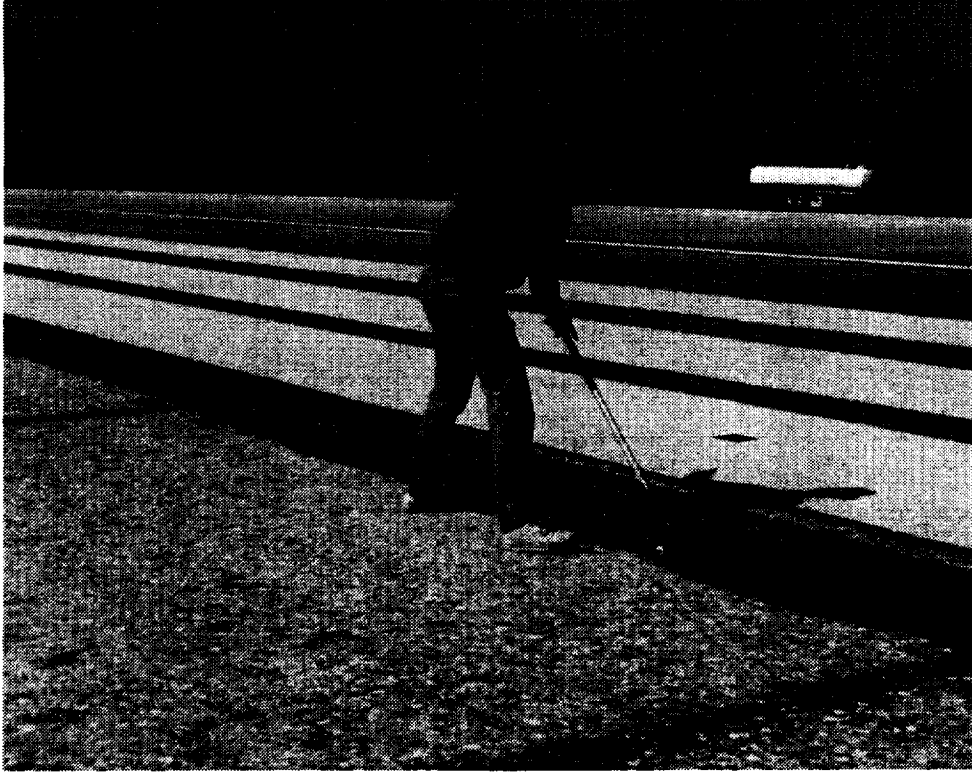
(a) Application to corduroy surface.

(b) Appearance of methacrylate after drying on surface.

Figure 20. Methacrylate coating.

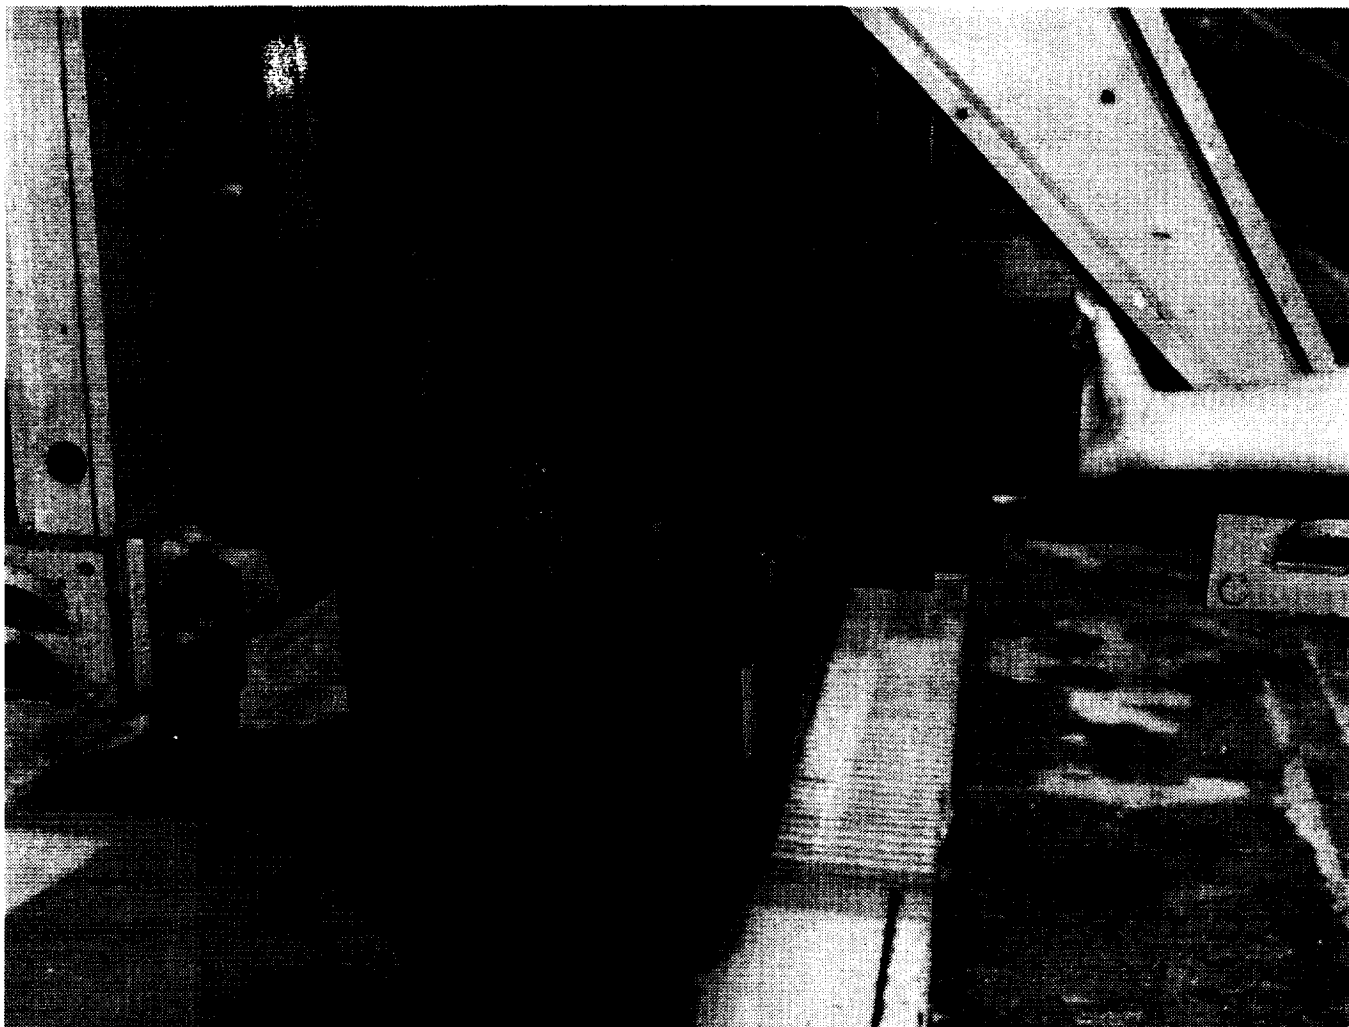
Figure 21. Typical *bull's-eye* appearance of spin-up wear spot after cornering.

Using the LSRA onboard recorded data, time histories of side force, yaw angle, and speed were used according to the above equation to provide a time history of the side energy for the test tire. The videotape of the test as seen from the front of the test tire was reviewed, and the time at which different carcass cord layers became visible was recorded to be correlated later with the side-energy time history. As the first and successive cord layers of the test-tire carcass become visible because of wear, a *bull's-eye* pattern is produced that makes the interpretation of tire wear reasonably easy. Figure 21 shows a photograph of a typical bull's-eye

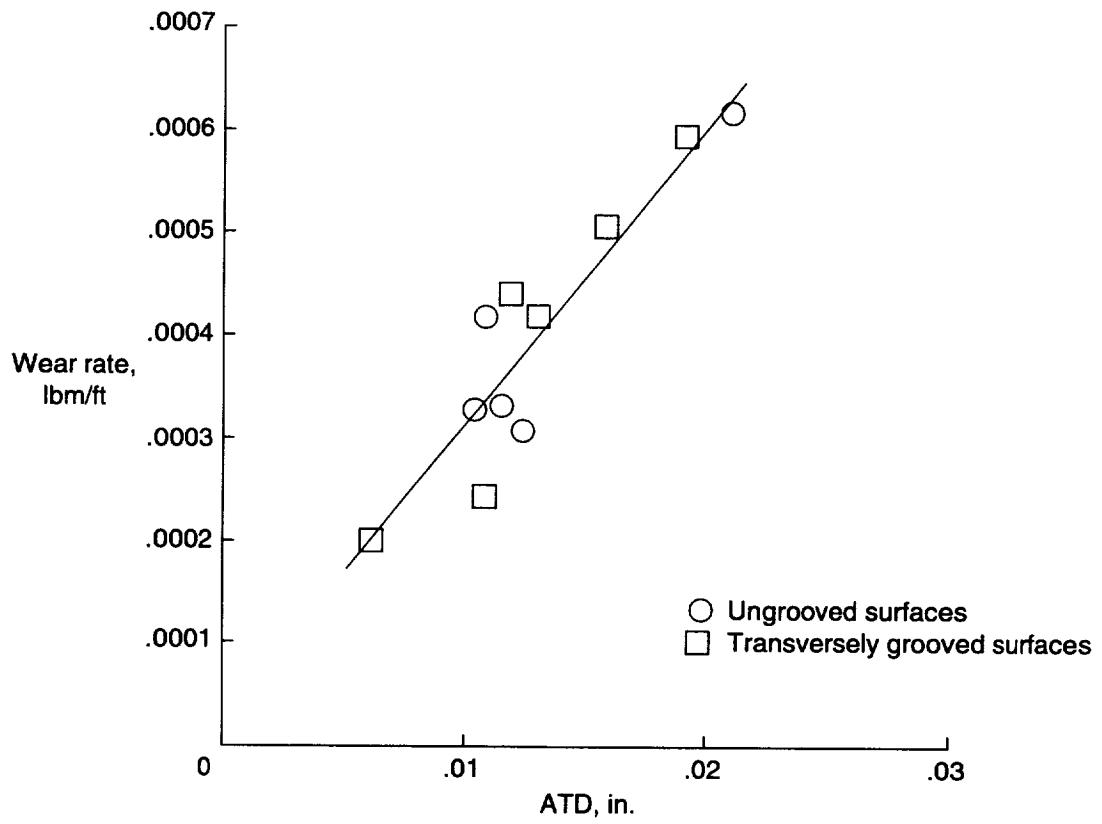
Figure 23. Relationship between wear rate and average texture depth (ATD).

Figure 23 presents a plot that confirms this strong link and shows the wear rate for the test tires on both the transversely grooved center section and the corduroy touchdown zone with their respective modifications plotted as a function of ATD. The figure, however, does not completely explain the wear phenomenon. As seen in table 2, the ATD for the 5 blades/in. diamond grinding that is applied to the corduroy touchdown zone is 0.0108 in. This ATD is virtually identical to the values for the Skidabrader™ and rotopeening techniques, yet the wear on the 5 blades/in. diamond-grinding surface was worse and provides evidence that there must be other parameters such as sharpness qualities that the ATD technique does not measure but that are important nevertheless. The values in table 2 for the BPT of these surfaces also show that the BPT cannot discern a significant difference among these four surfaces. Table 2 shows that the surface with the single coating of methacrylate had an ATD of 0.0123 in. This apparently small change in the ATD, as compared to the Skidabrader™ and rotopeened surfaces (since it reflects an even rougher surface), is further evidence of the existence of other unmeasured parameters. Although equivalent side loads were produced on all these surfaces during tests, one could hear an unusual noise as the test tire traversed the methacrylate test strip. The low-pitched sound gave the impression that the tire was *slipping* on this test surface more than on the other test surfaces.

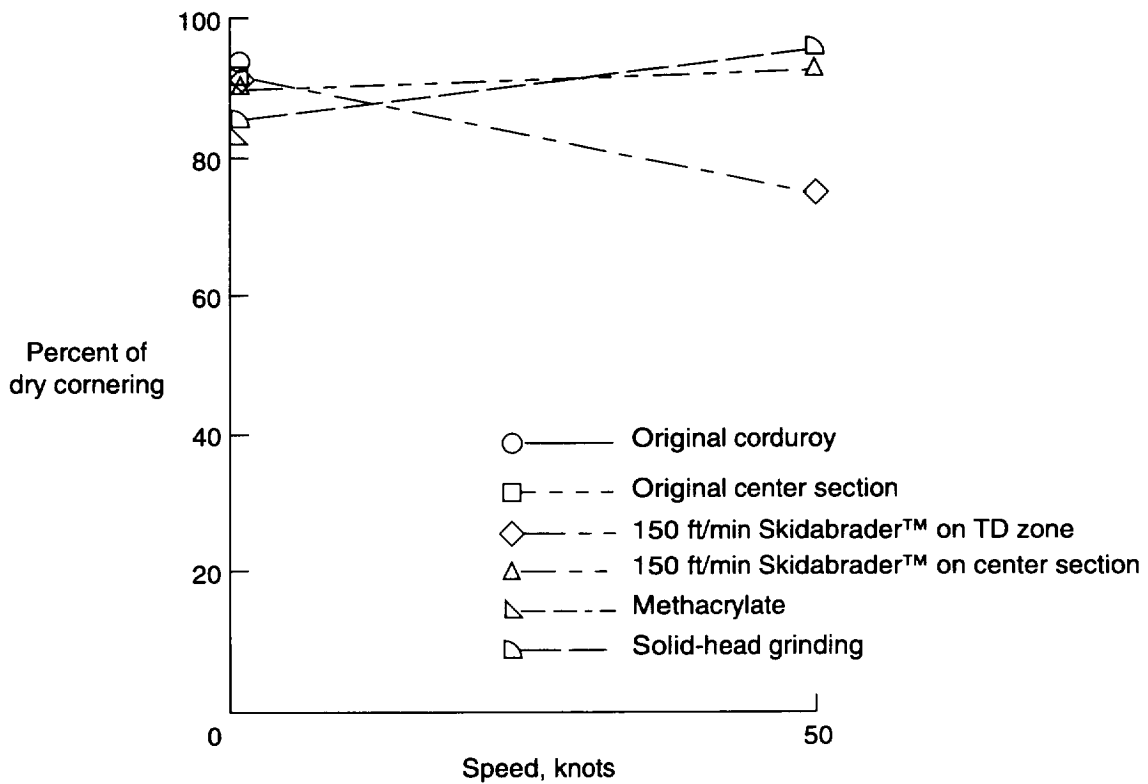
Figure 25. Effect of speed on wet-corning performance for various textures.

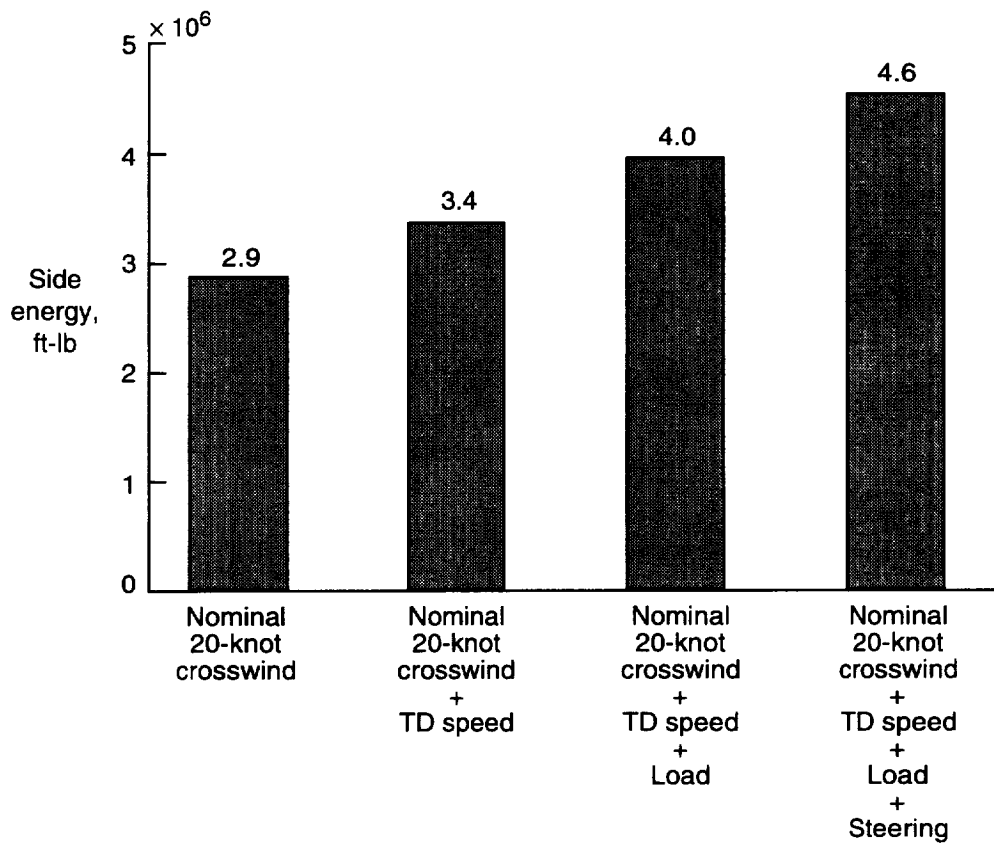
Piloting dispersions: TD speed = 225 knots vs 205 knots  
 Load = 142 000 lb vs 120 000 lb  
 Steering =  $3^\circ$   $\Delta$  triangular pulse

Figure 27. Tire side energy required for nominal 20-knot crosswind landing with and without piloting dispersions.
