NASA Technical Memorandum 110303

# Damage-Tolerance Characteristics of Composite Fuselage Sandwich Structures With Thick Facesheets

February 1997

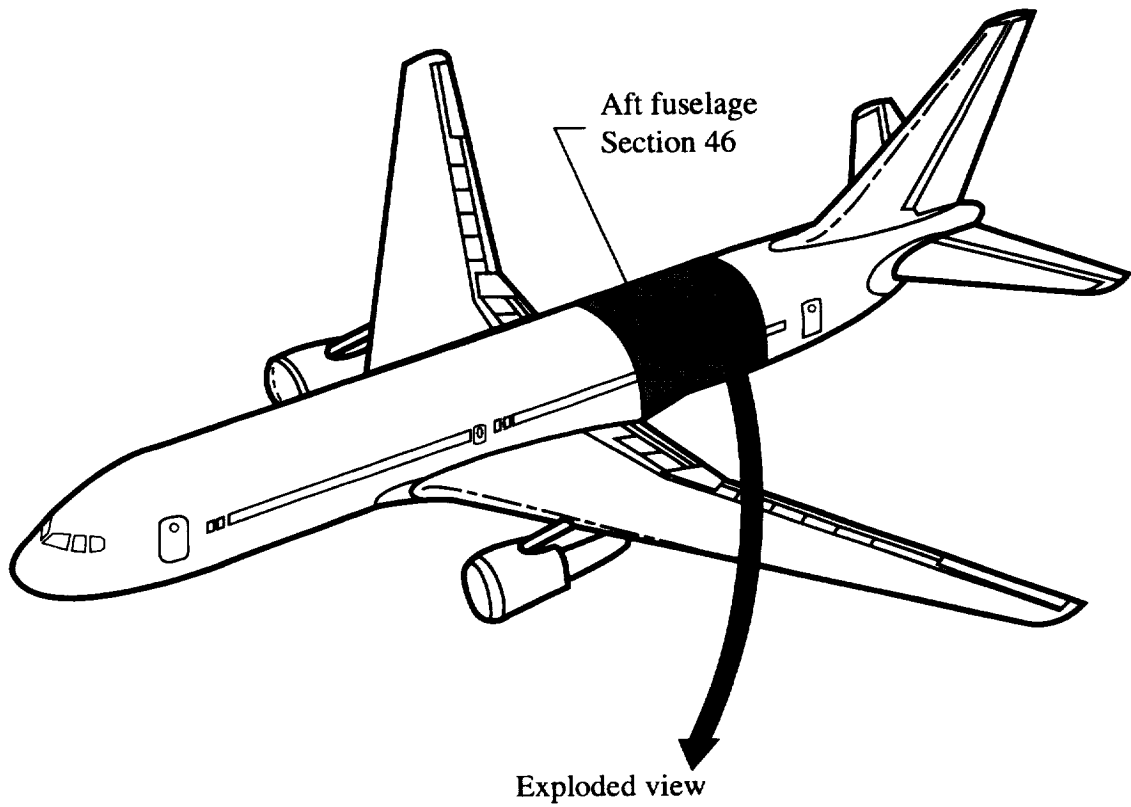
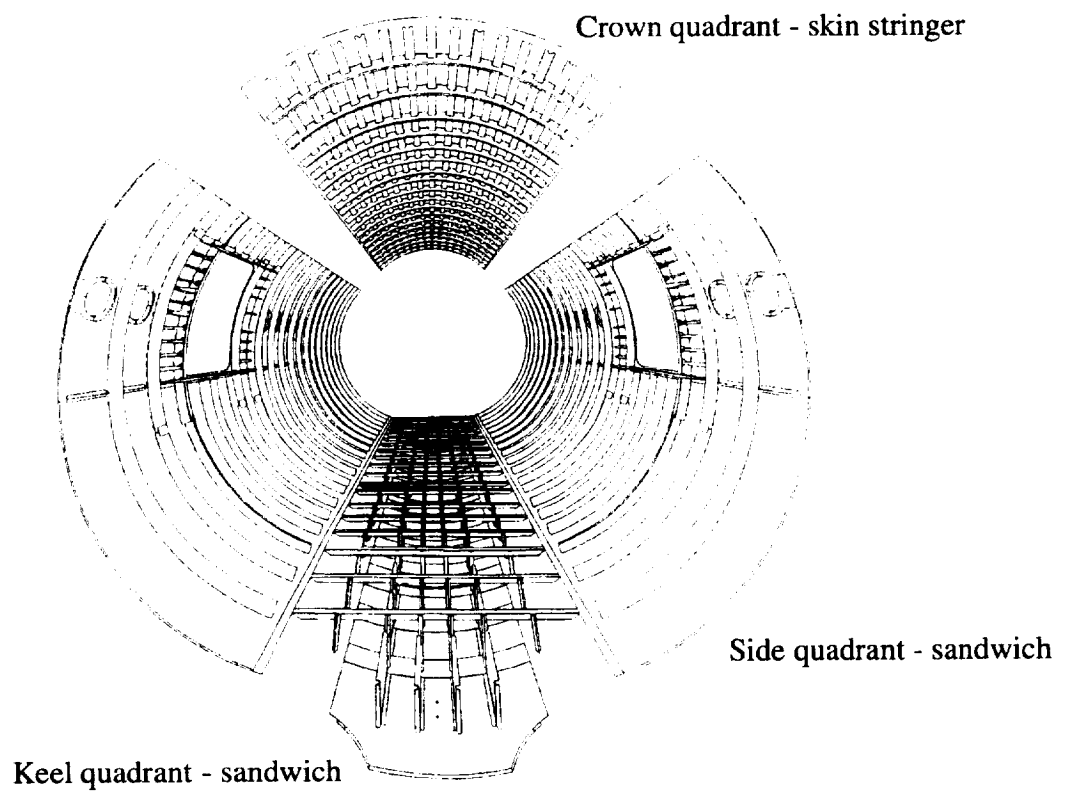
Figure 1. Details of a generic wide-body transport aircraft fuselage structure.

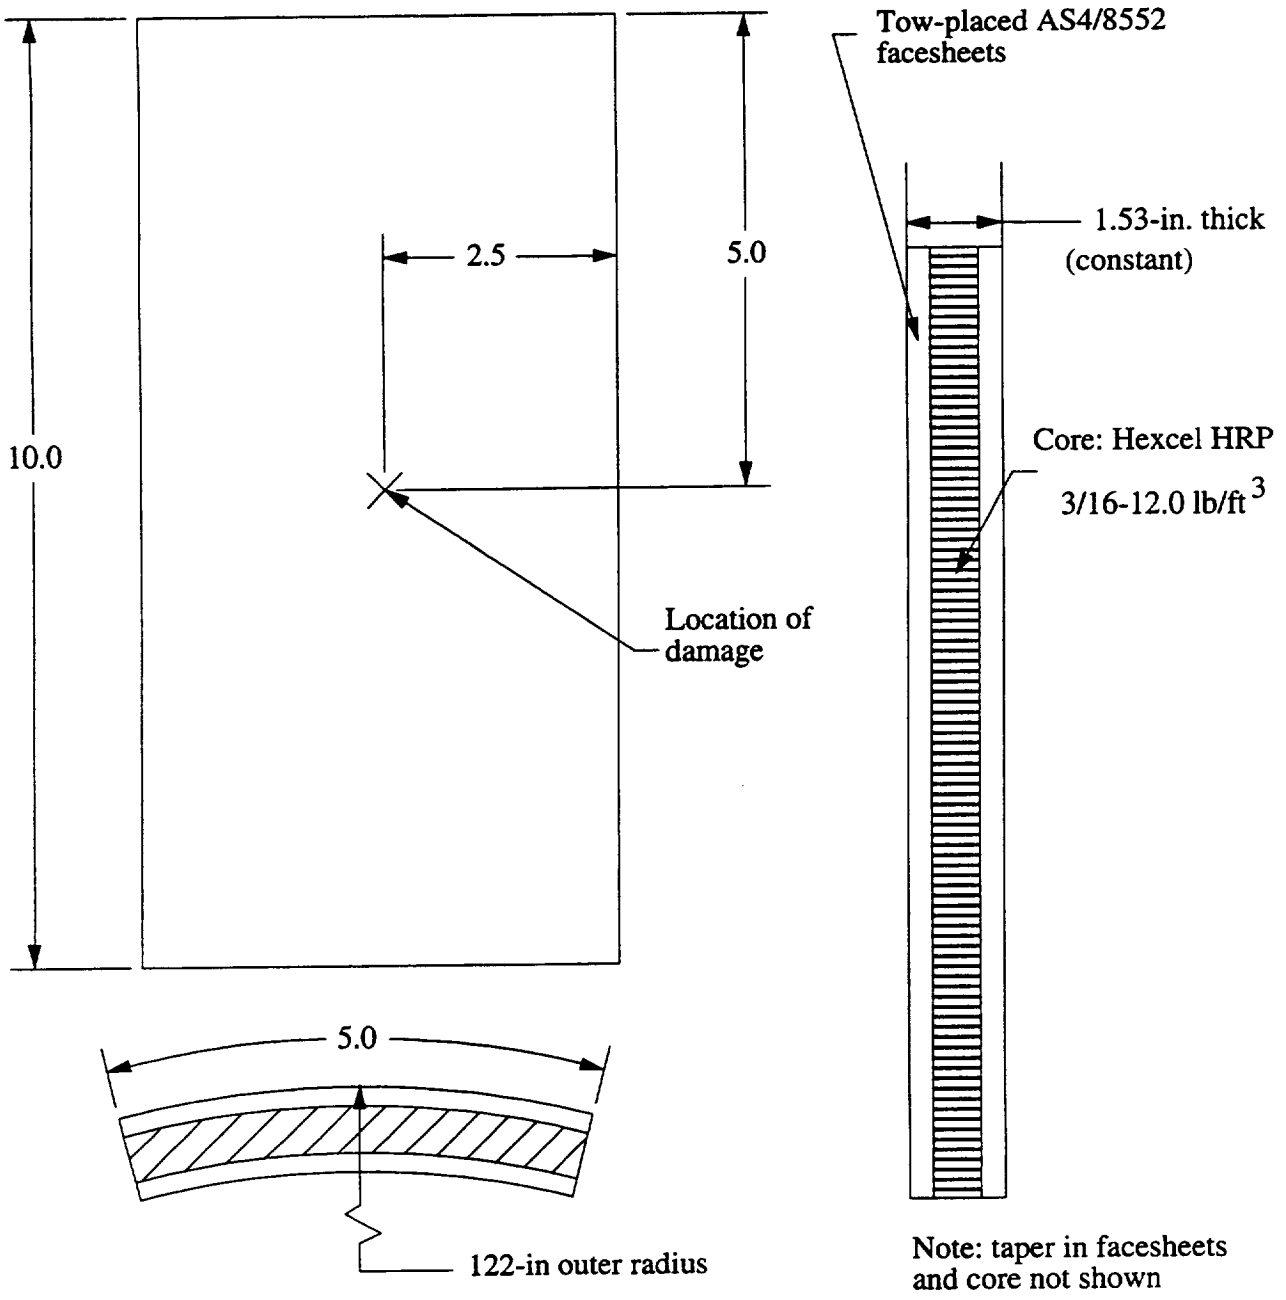
Figure 2. Geometry of test specimens. Dimensions are in inches.

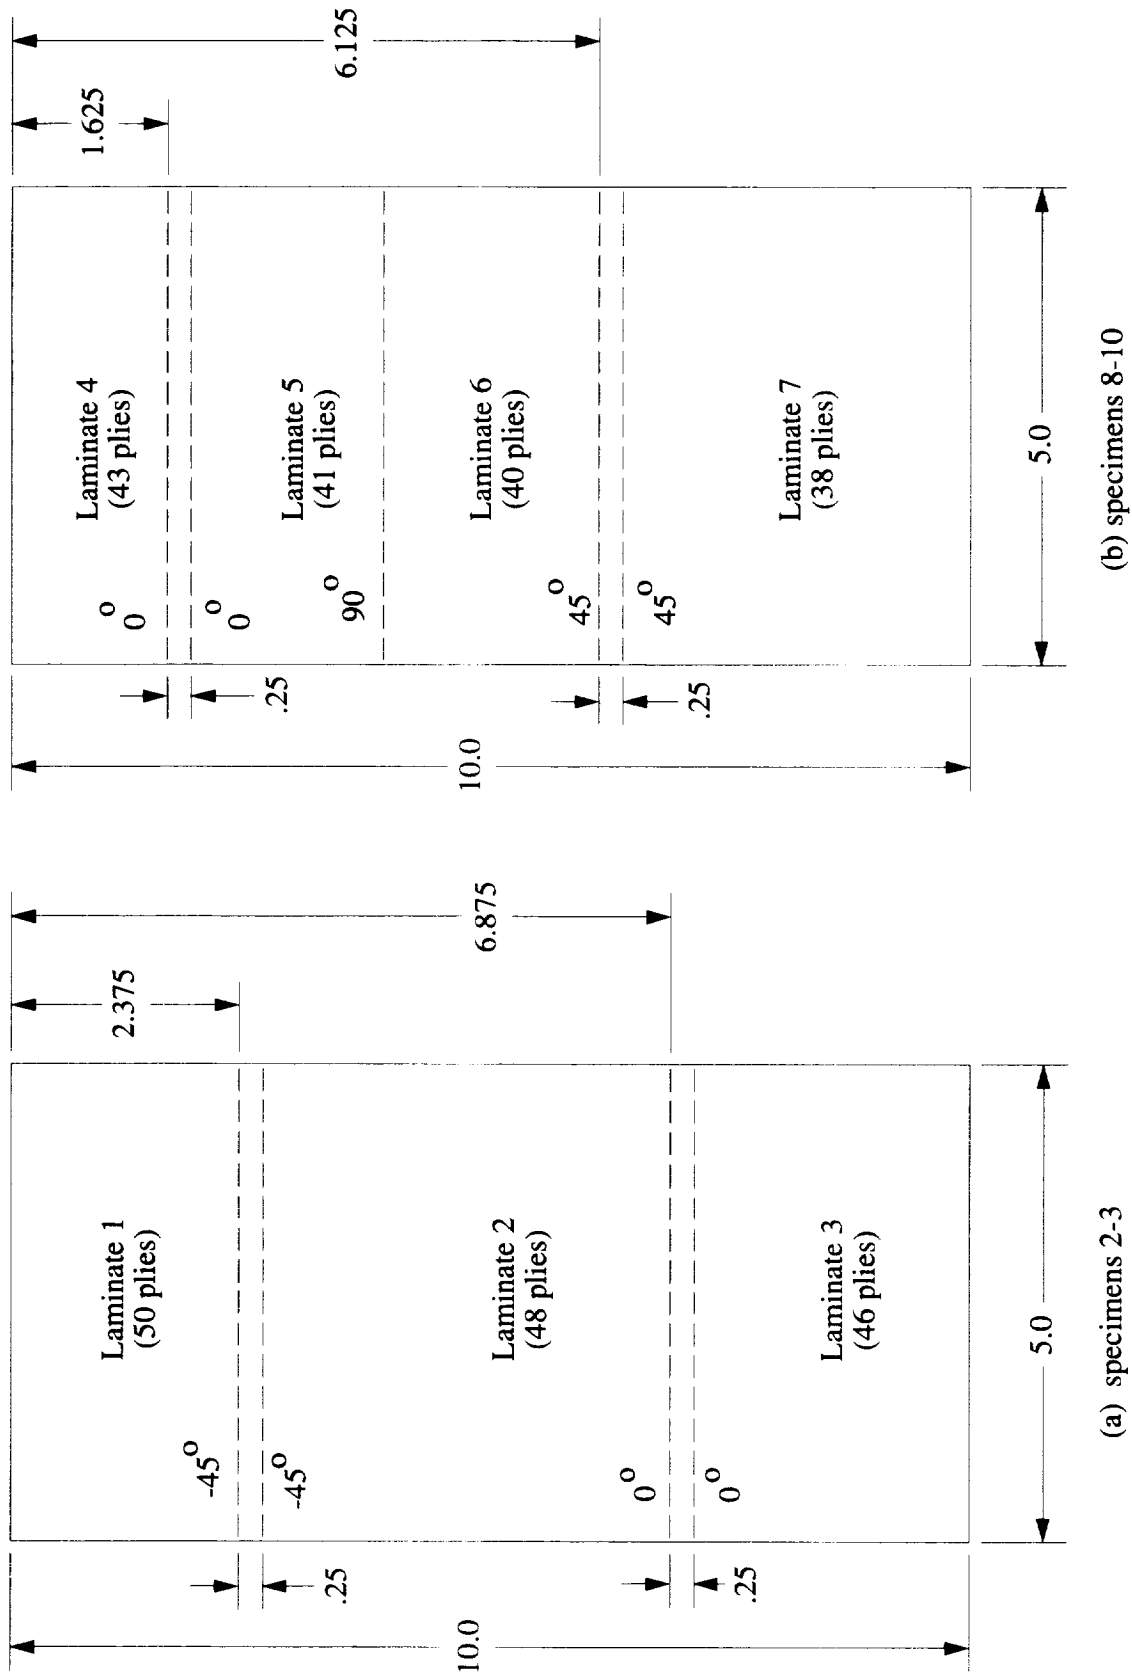
Figure 3. Locations of terminated plies in specimens 2, 3, 8, 9, and 10. Dimensions are in inches.

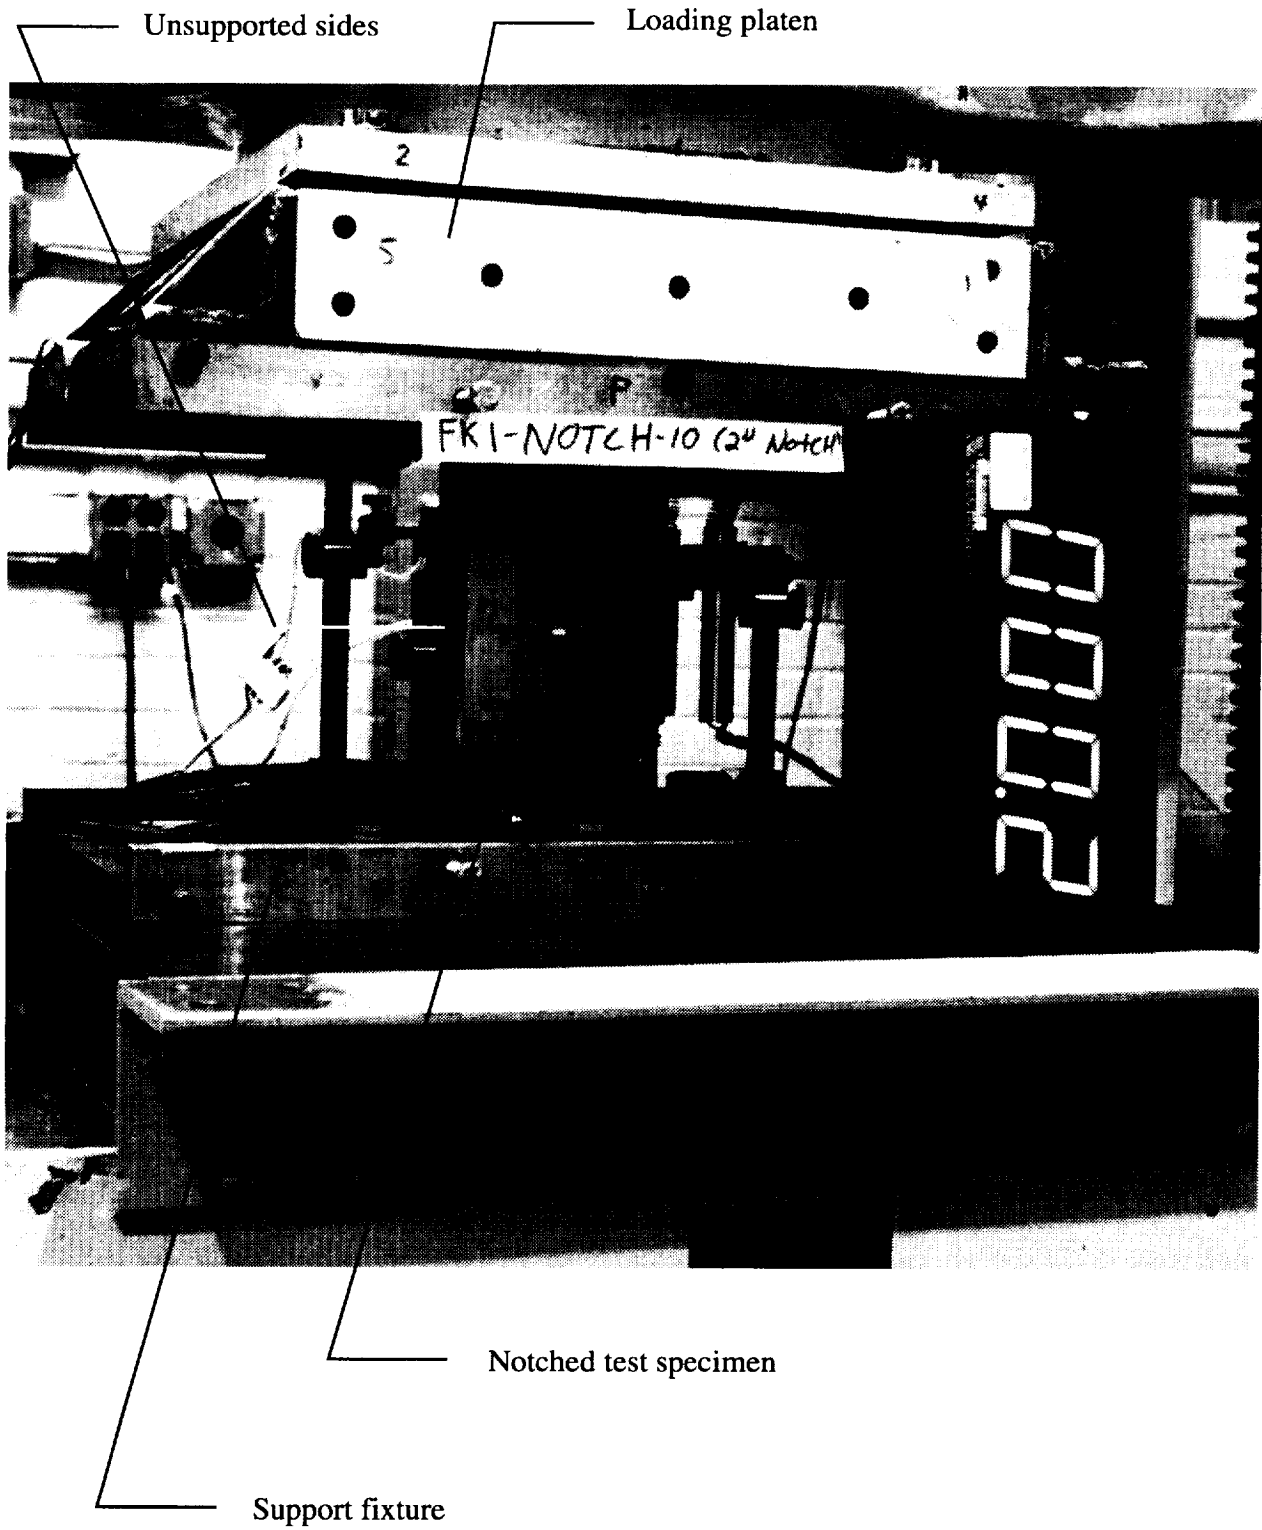
Figure 4. Typical axial compression test setup.

For all tests, the potted ends of the specimens were loaded in uniaxial compression in a 300-kip-capacity hydraulic test machine. The test setup for the test of a notched specimen is shown in Fig. 4. The loaded edges of the specimens were clamped into a curved steel support fixture to provide a clamped boundary condition at those edges. The unloaded edges of the specimens were unsupported. Surface strains were measured using electrical resistance strain gages. Direct-current displacement transducers (DCDT's) were used to measure out-of-plane displacements of the facesheets as well as the stroke of the test machine loading platen. The locations of the strain gages for the undamaged specimens are shown in Fig. 5. The locations of the strain gages for the impacted and notched specimens are shown in Figs. 6 and 7, respectively. The axial load applied to the specimens was measured using the test machine load cell. The strain gage, DCDT, and load data were recorded using a digital data acquisition system. Data were taken at one second intervals while loading the specimens to failure.

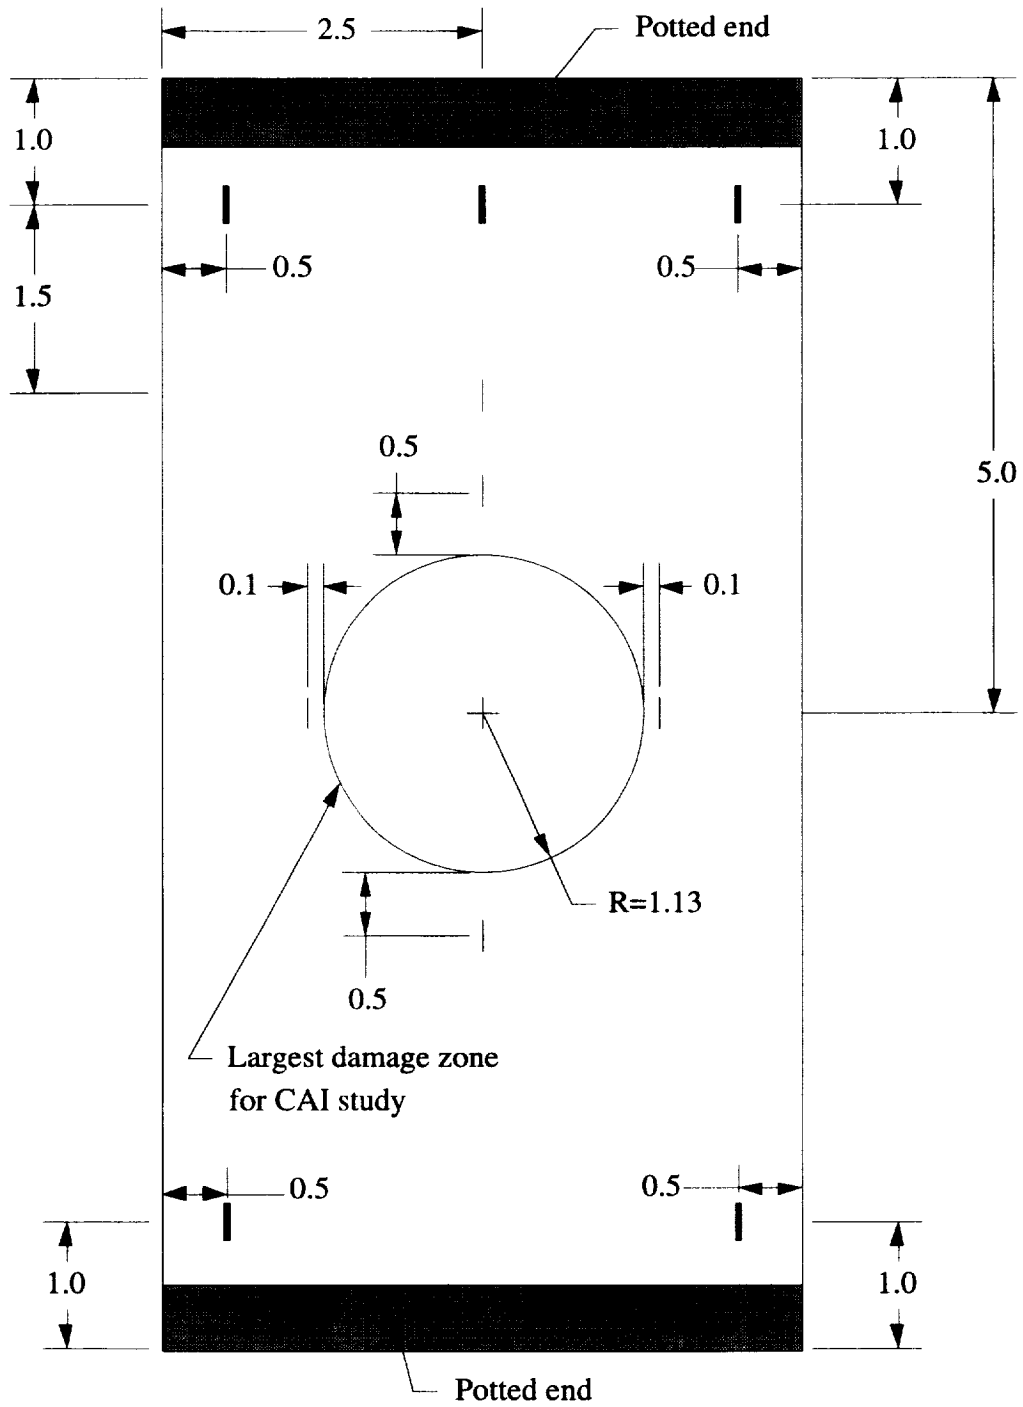
Figure 5. Strain gage layout for undamaged specimens 2 and 7. Dimensions are in inches. View from specimen convex surface. Bold lines indicate back-to-back strain gage pairs, all other gages are mounted on convex surface.

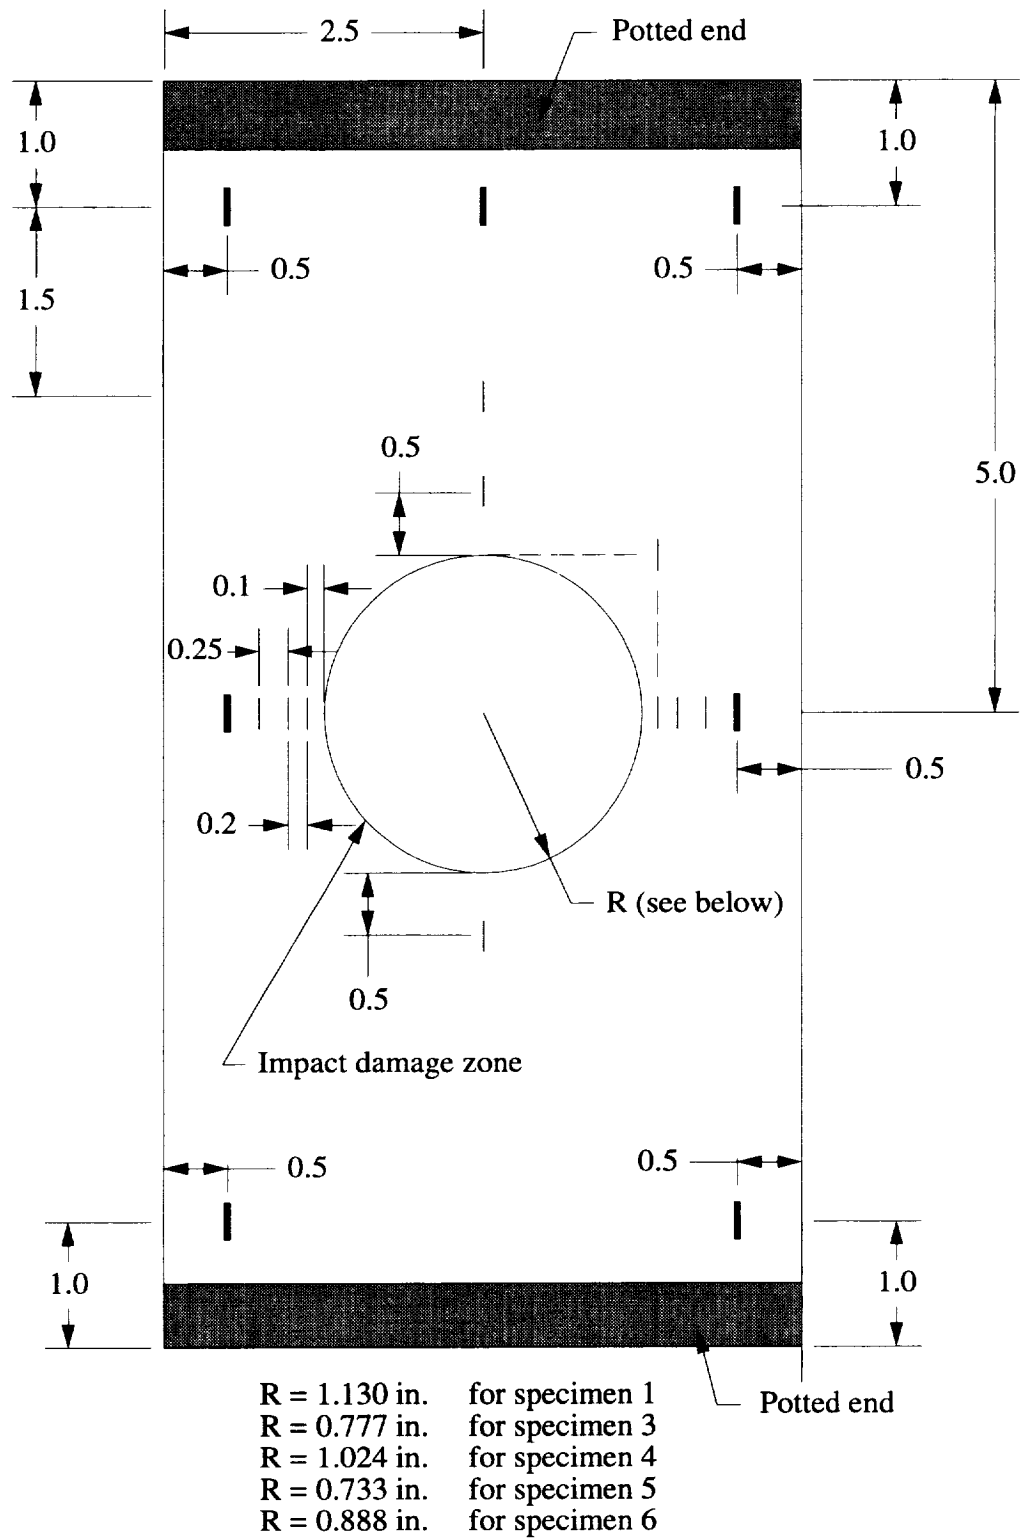
Figure 6. Strain gage layout for CAI specimens 1, 3, 4, 5, and 6. Dimensions are in inches. Viewed from the specimen convex surface. Bold lines indicate back-to-back strain gage pairs, all other gages are mounted on the specimen convex surface.

Both low-speed impact damage and discrete-source damage are simulated in the present study. A summary of the damage state in which each specimen was tested is presented in Table IV. The compression-after-impact (CAI) specimens were impacted using a dropped-weight impact apparatus<sup>5</sup> with an 11.8-lb mass and a 1-inch-diameter hemispherical tup. Impact energies ranging from 40 ft-lbs to 100 ft-lbs were used to impact the specimens. A schematic of the specimen support setup used to impact these specimens is shown in Fig. 8. As shown in the figure, the supports used consist of curved wooden supports and steel I-beams mounted to a rigid table. The specimens were clamped to the support beams to minimize specimen rebound after impact. Other specimen response parameters measured include the residual dent depth at the impact site and the area of the damaged site. The damage area was measured from the ultrasonic C-scan images of the damage site. The damage area in the CAI specimens is represented approximately by the circle of radius  $R$  in Fig. 6. The value of  $R$  for each specimen is indicated in the figure.

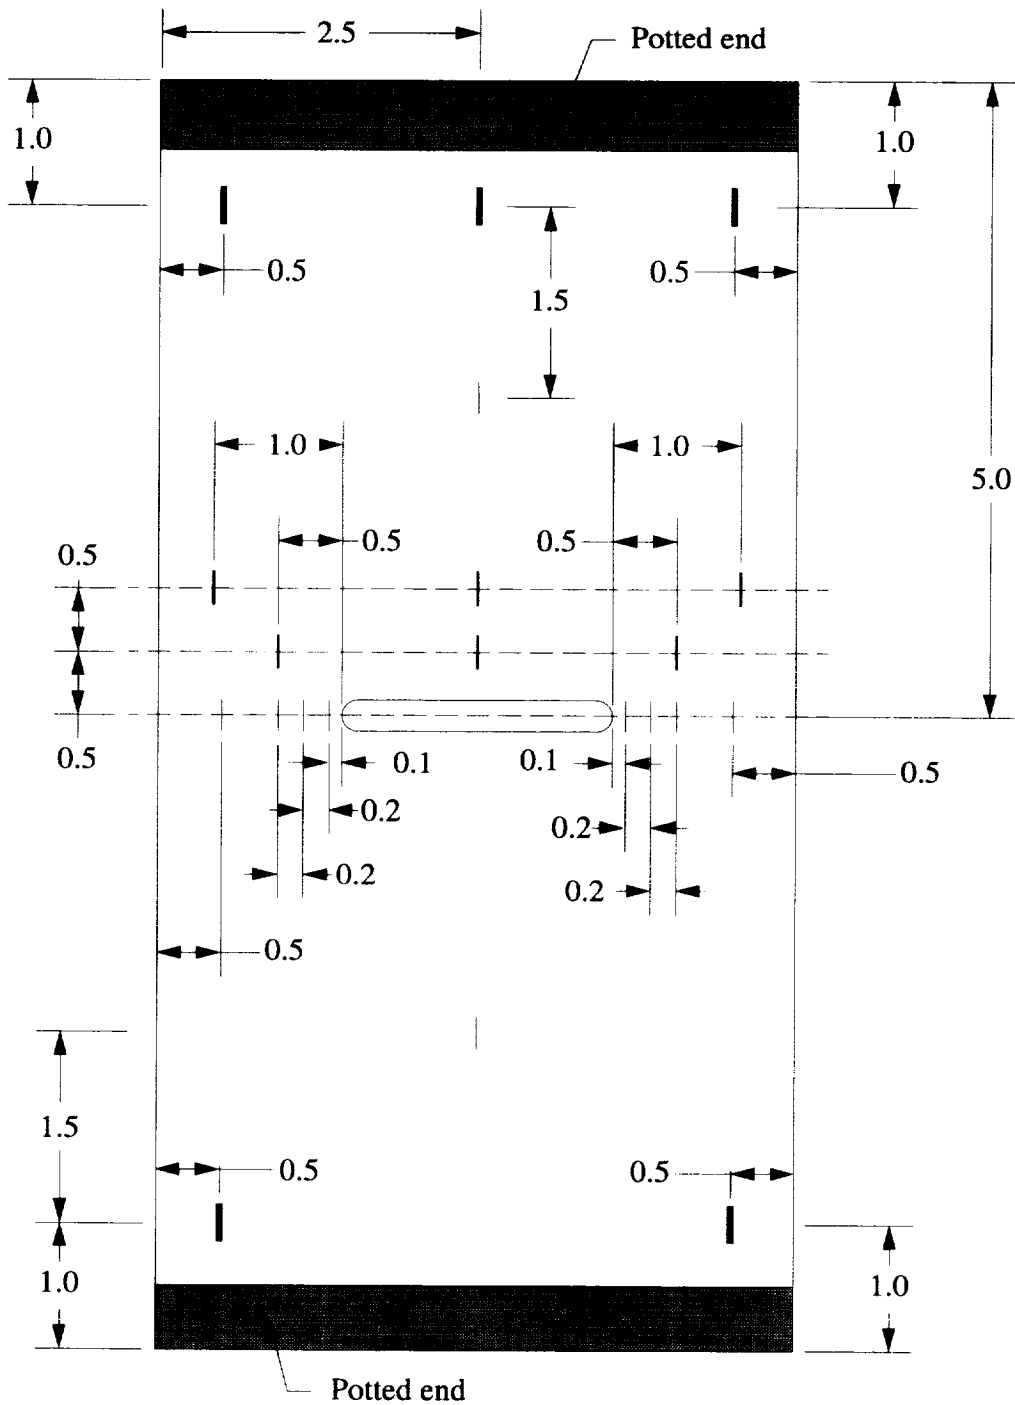
Figure 7. Strain gage layout for notched specimens 8, 9, and 10. Dimensions are in inches. Viewed from the specimen concave surface. Bold lines indicate back-to-back strain gage pairs, all other gages are mounted on the specimen concave surface.

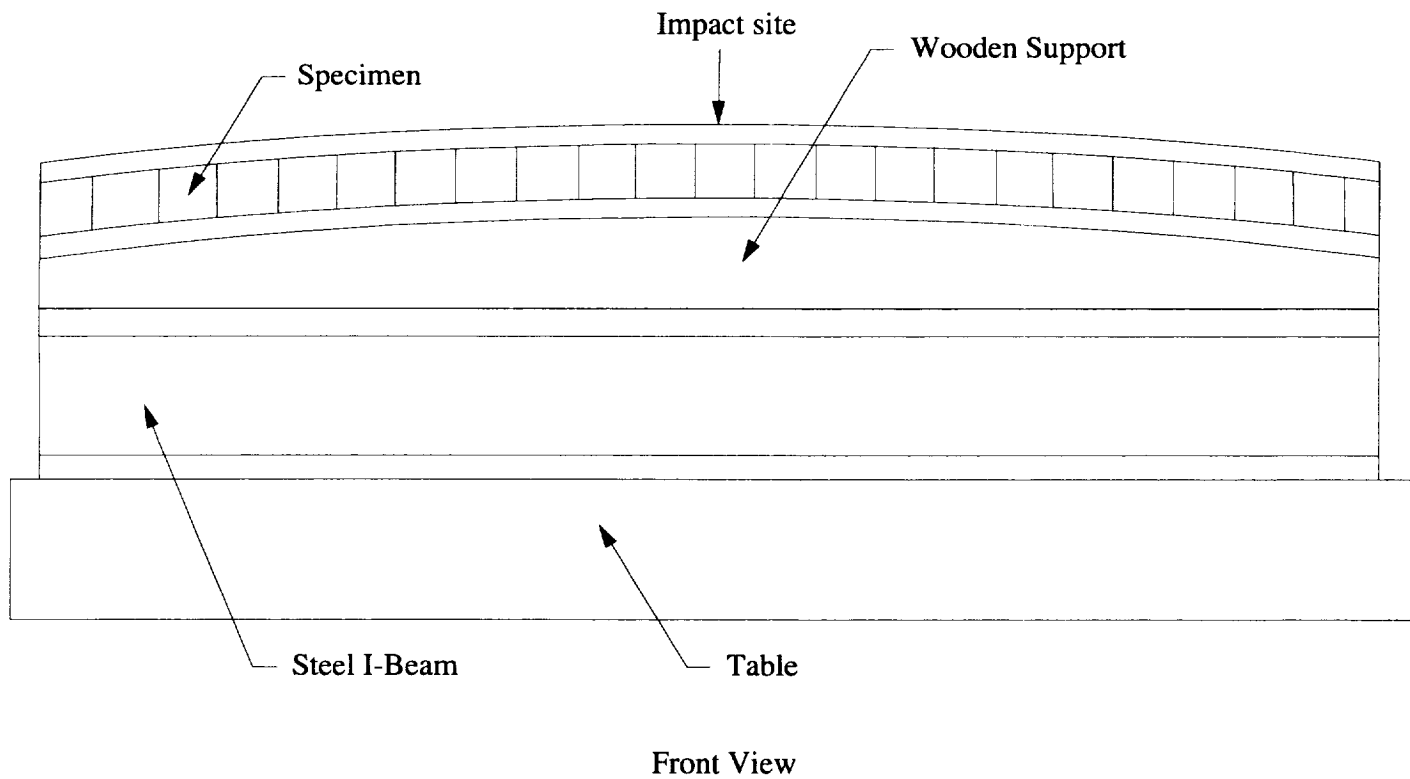
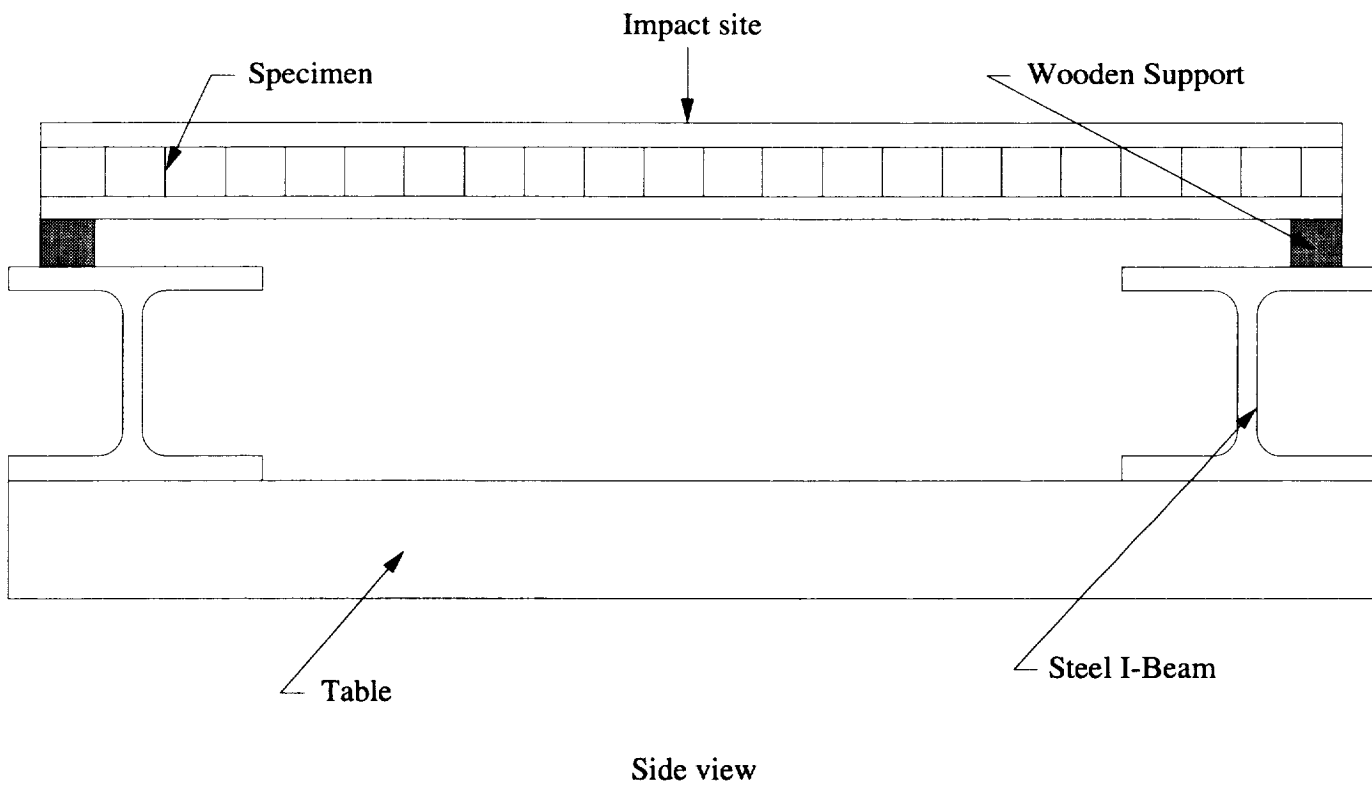
Figure 8. Specimen setup used to impact the specimens.

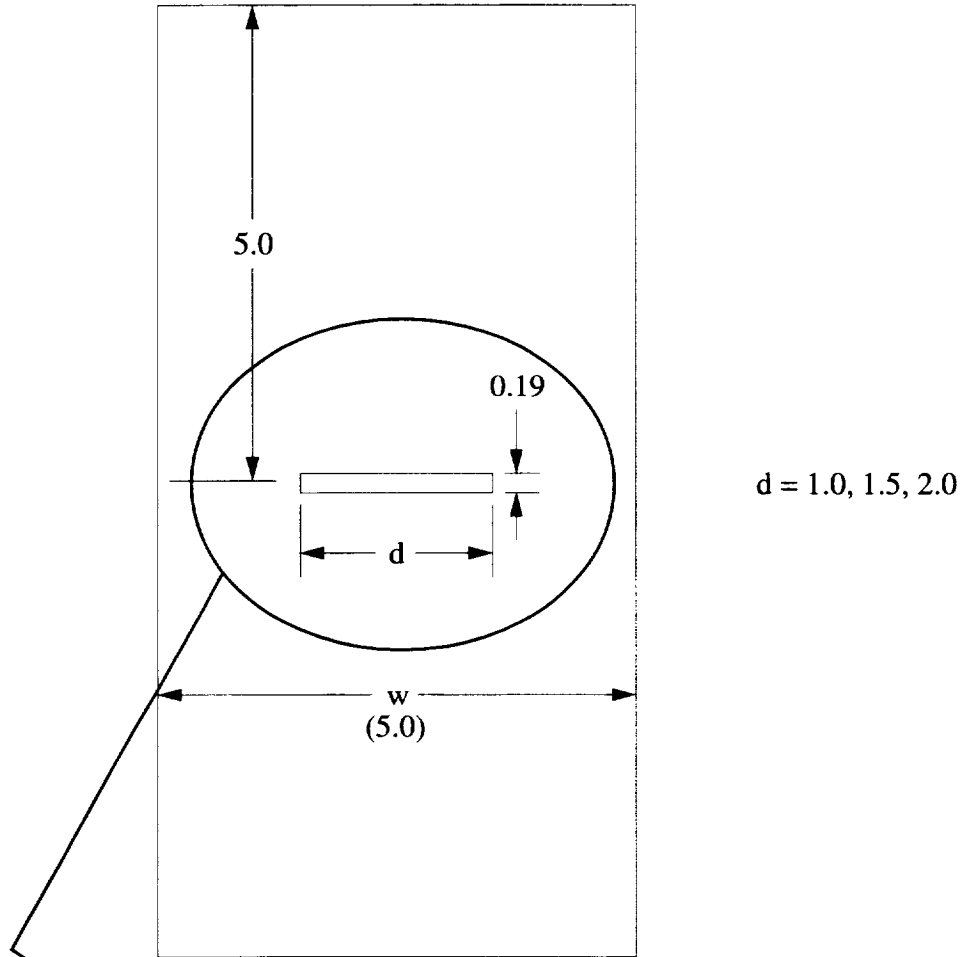
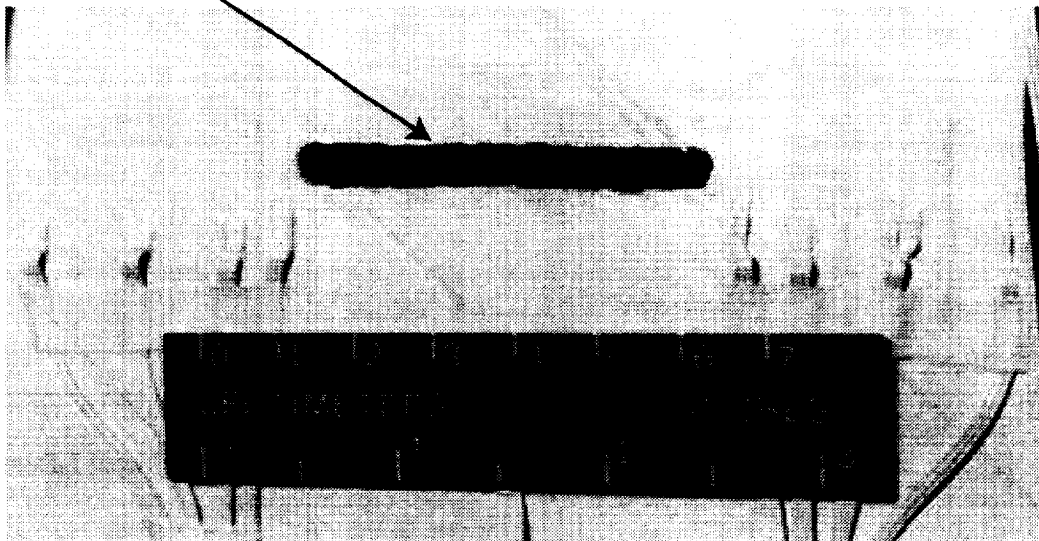
Figure 9. Details of machined notch. Dimensions are in inches.

Discrete-source damage is simulated in the present study by a notch machined through both facesheets at the mid-length of the specimen. The details of a typical notch are shown in Fig. 9. As shown in the figure, the length of the notch is 0.19 inches. Three specimens were tested with notch lengths varying from 1.0 to 2.0 inches. A summary of the notch lengths and different specimen-width-to-notch-length ratios is presented in Table VI. The facesheets for all three notched specimens are identical.

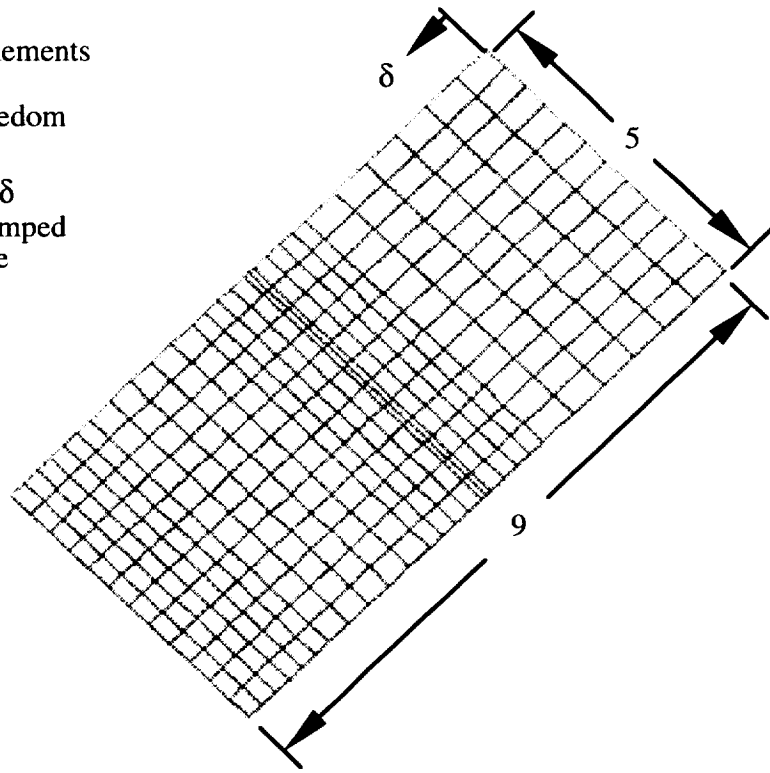
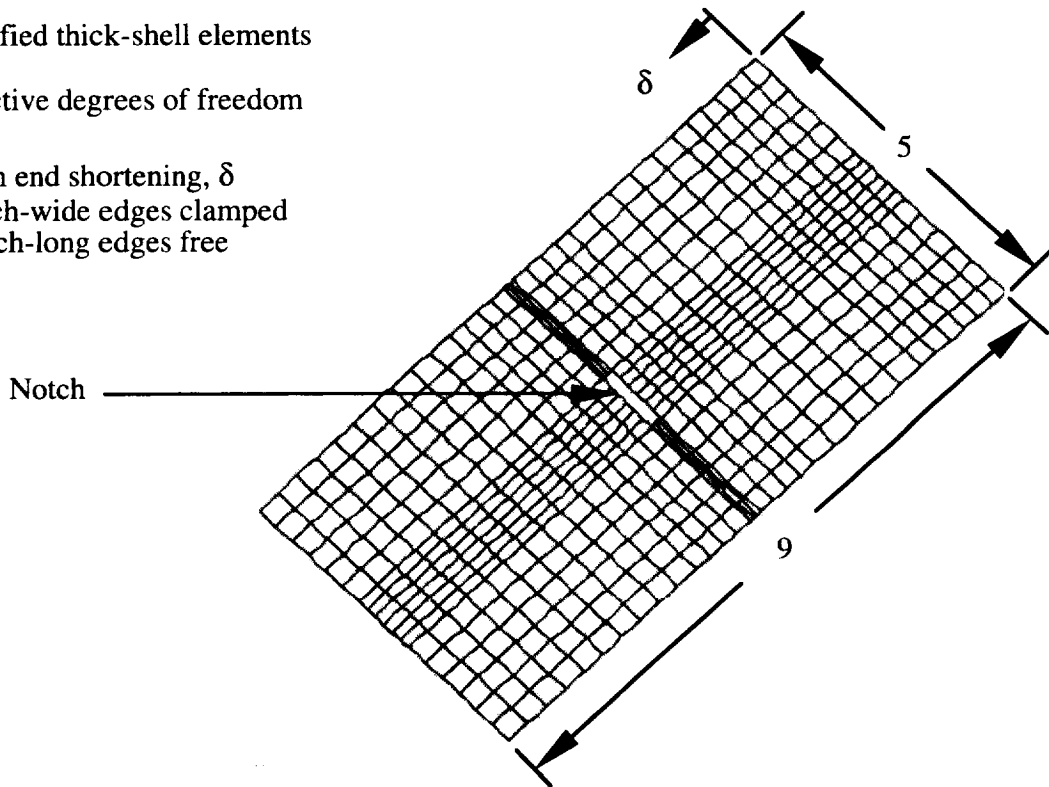
324 modified thick-shell elements

5,080 active degrees of freedom

- Uniform end shortening,  $\delta$
- Five-inch-wide edges clamped
- Nine-inch-long edges free

(a) Model of undamaged specimen

702 modified thick-shell elements

10,941 active degrees of freedom

(b) Model of notched specimen

Figure 10. Finite element models of undamaged and notched specimens. Dimensions are in inches

The undamaged and notched specimens were analyzed using the DIAL finite element code.<sup>11</sup> The specimens were modeled as a combination of several sandwich plates each having a different facesheet stacking sequence and sandwich core thickness. The dropped plies and variations in core thickness in the test panel were therefore accounted for. An eight-node modified thick-shell element was used for modeling the plate. These elements are shear deformable and account for the large shear deformations associated with sandwich construction. The finite element model of an undamaged specimen is shown in Fig. 10(a). This model has a total of 324 elements and a total of 5,080 active degrees of freedom. Load is applied to the model by specifying a uniform end shortening,  $\delta$ , at one of the five-inch-wide edges, as shown in the figure. The potted ends of the panel in the test fixture are not modeled; thus, the total length of the model is 9.0 inches. The effect of the potting is simulated by clamping the loaded edges of the model. The 10-inch-long unloaded edges of the model are free, and the wide-column buckling load is predicted to be 328 kips. The finite element model of a specimen with a 1-in.-long notch is shown in Fig. 10(b). This model has a total of 702 elements and a total of 10,941 active degrees of freedom. As shown in the figure, additional elements are used in the region of the notch to improve the mesh refinement to better represent the stress gradients in that region.

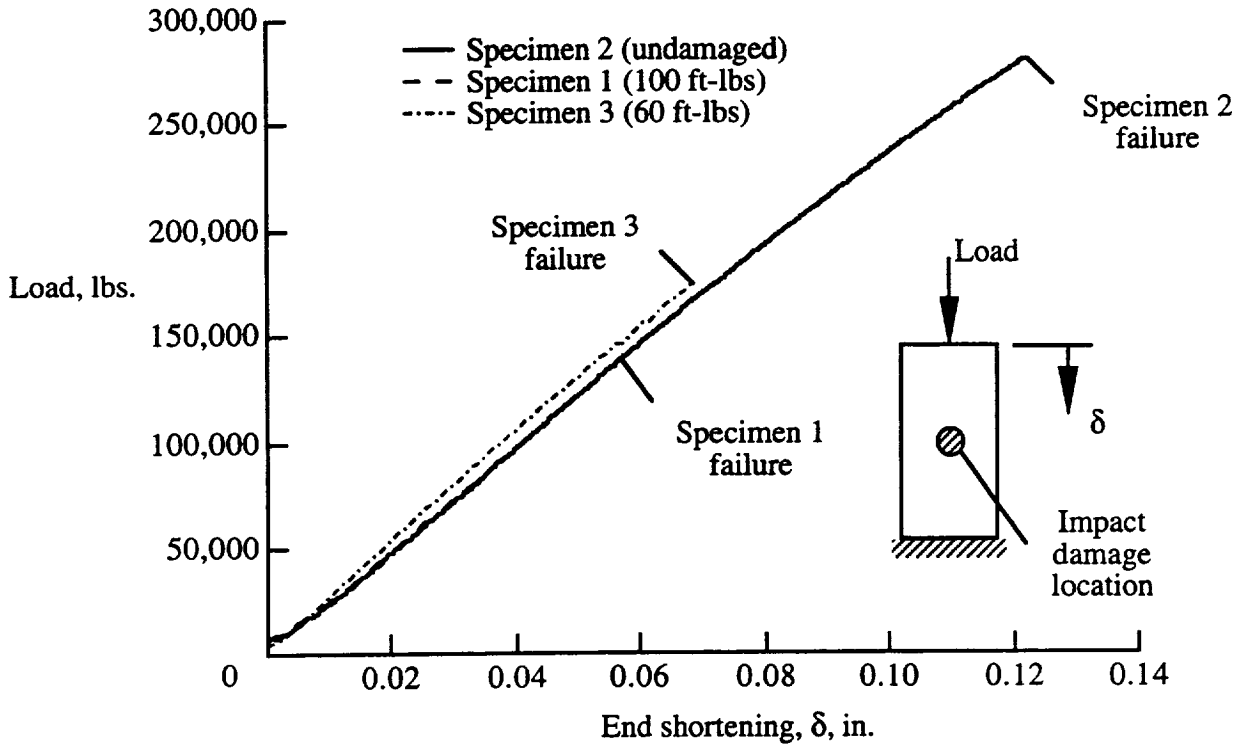
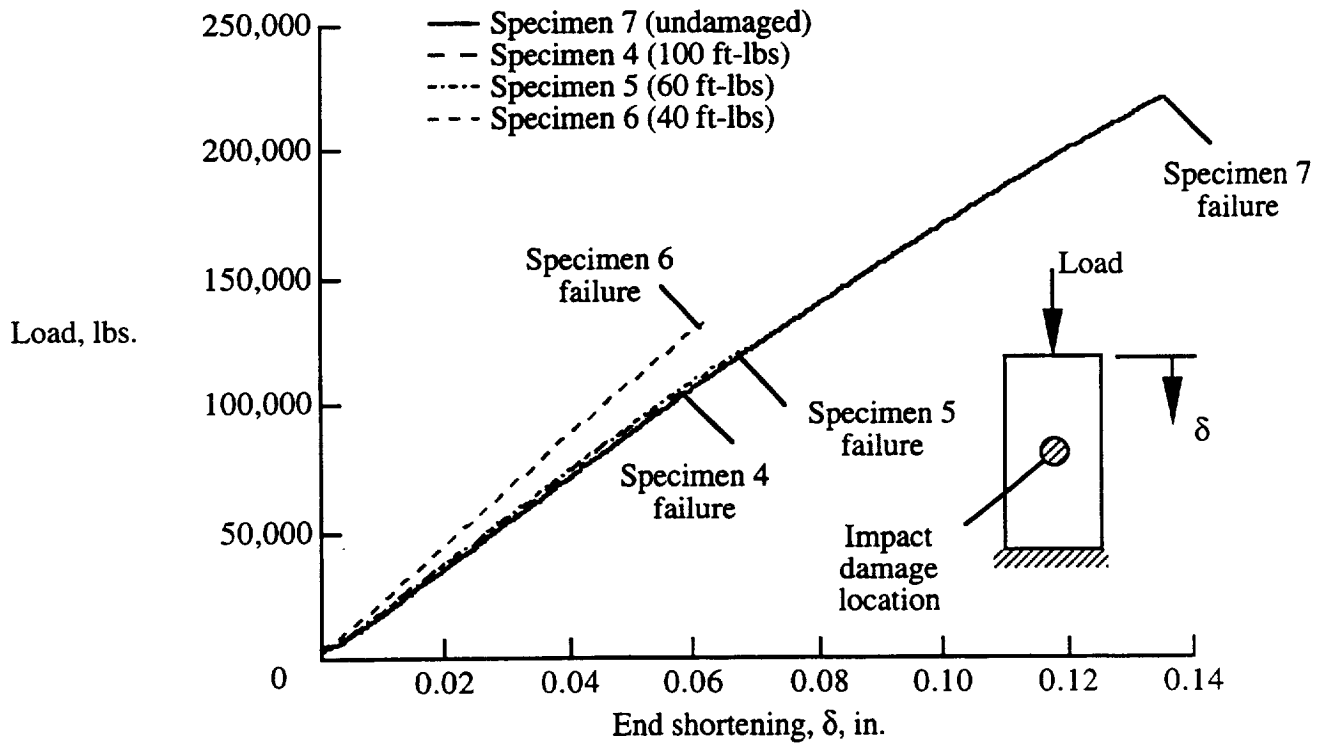
Figure 11. Experimental load-shortening results for the CAI study.

Load-shortening results are presented in Fig. 11(a) for specimens 1-3 and in Fig. 11(b) for specimens 4-7. As seen in Fig. 11(a), the global stiffness of specimens 1-3 is not affected by the presence of the impact damage. This trend is also noted for the thinner facesheet specimens 4-7. Impact damaged specimen 6 exhibited a higher stiffness than the others, which appears to be an anomaly. Experimental axial surface strain results are presented in Fig. 12(a) for specimens 1 - 3 and in Fig. 12(b) for specimens 4-7. The surface strain results presented in these figures are far field results near the loaded edge of the specimens. The strain values presented are averaged values of back-to-back strain gage pairs near the right and left edges of the specimens. As shown in Figs. 12, the far field strain values for all of the CAI specimens are very close to one another indicating that the impact damage has insignificant influence on the global axial stiffness of the specimens. Failure strains for specimens 1 and 4 with 100 ft-lbs of impact energy are approximately 5,000  $\mu\text{in./in.}$  suggesting that the current design practice of using 4,000-5,000  $\mu\text{in./in.}$  for the ultimate load condition is valid.

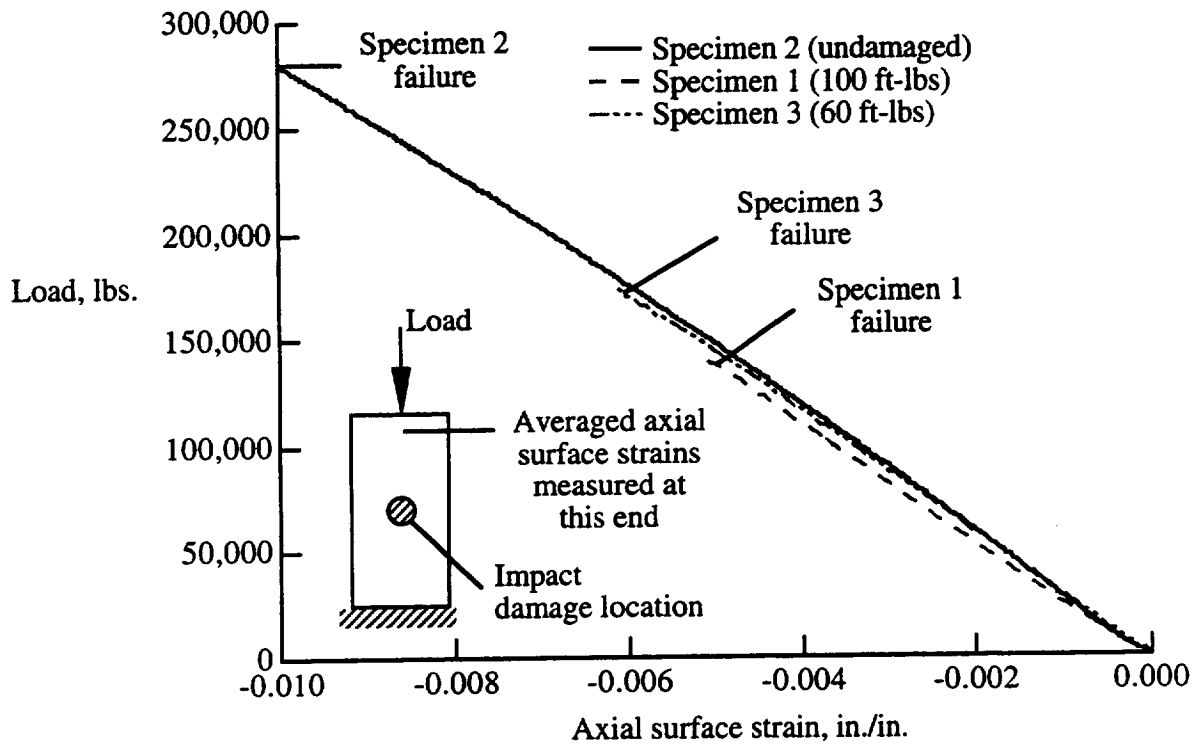
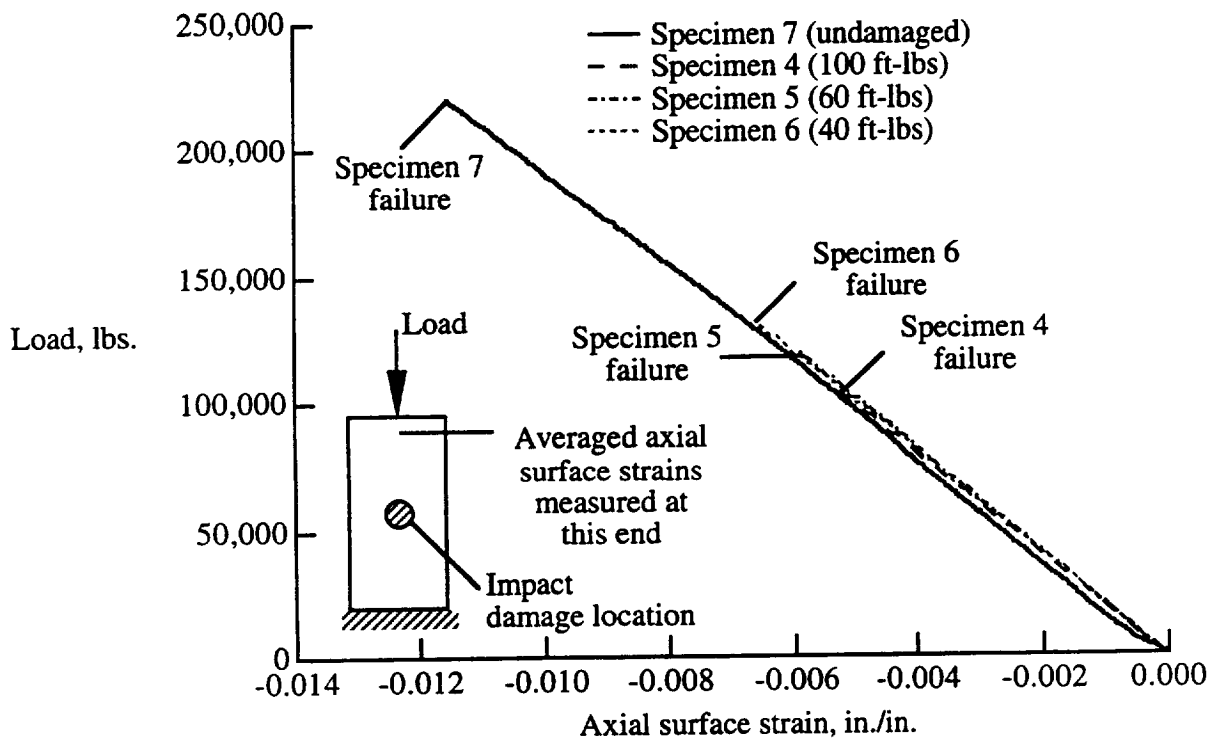
Figure 12. Experimental axial surface strain results for the CAI study.
