NASA Technical Memorandum 110303

# Damage-Tolerance Characteristics of Composite Fuselage Sandwich Structures With Thick Facesheets

February 1997

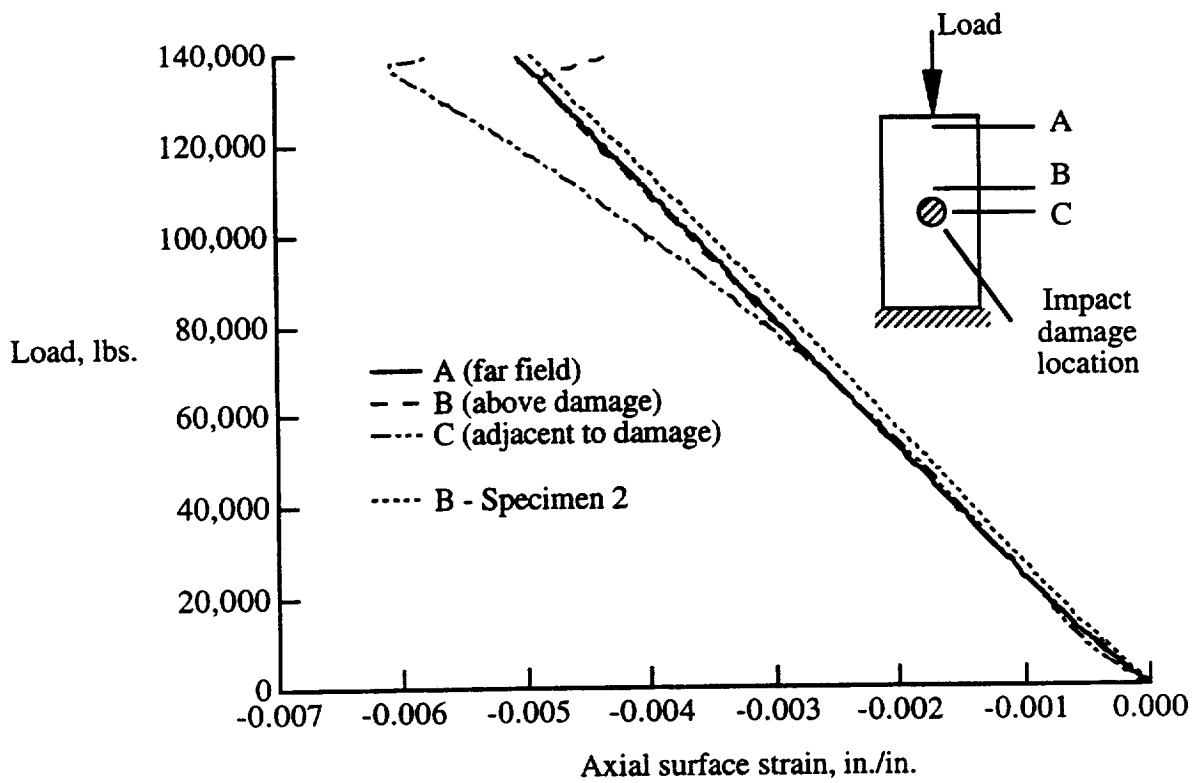
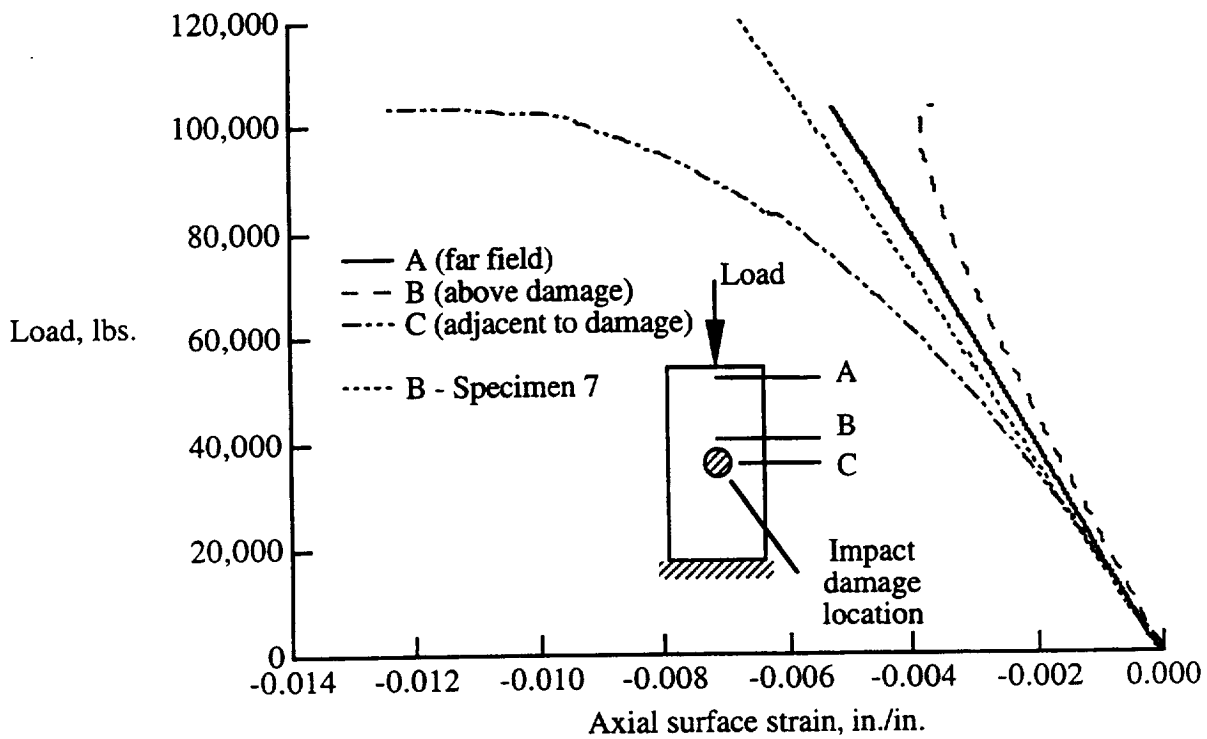
(a) specimen 1 (100 ft-lbs of impact energy)

(b) Specimen 4 (100 ft-lbs of impact energy)

Figure 13. Experimental axial surface strain results from the CAI study.

Experimental axial surface strain results for specimens 1 and 4 are given in Fig. 13(a) and 13(b), respectively. Load is presented in these figures as a function of strain at three locations around each of the impact sites. The strain data at location A are the same far field data presented in Fig. 12. Location B is very near the damage and is located on the axial centerline of the specimen. Location C is adjacent to the damage sites and is located on the horizontal centerline of each site. The strain data recorded for location B during the test of the undamaged specimen are also presented in each figure. The data in Fig. 13(a) indicate that the impact damage in the thicker specimens does not significantly affect the response of the structure in that region since the data for locations A and B are very similar (within 1 percent of each other). Furthermore, the data at location B for the undamaged-panel test are within 3 percent of the data for the impacted specimen at that location. At location C, the strain is approximately 22.5 percent greater than the strain at location A. These results indicate that the damage at this site does introduce a local stress concentration, but does not affect the stress state at a location that is slightly removed from the damage site. The data in Fig. 13(b) indicate that the impact damage in the thinner specimens does have an appreciable affect on the response of the panel in that region. The strains at location A are approximately 34.6 percent greater than the strains at location B. Furthermore,

the strains at location B for the undamaged specimen are 47.4 percent greater than those at location B for the impacted specimen. This difference in strains represents the effect of the impact damage on the response of the specimen since the data from location B for the undamaged specimen is close to that for location A for the impact-damaged specimen. The strains at location C are 2.38 times larger than those at location A at failure. Therefore, although the damaged area in specimen 4 is smaller than that in specimen 1, the stress concentration is much larger, and the load redistribution in the specimen is more extensive.

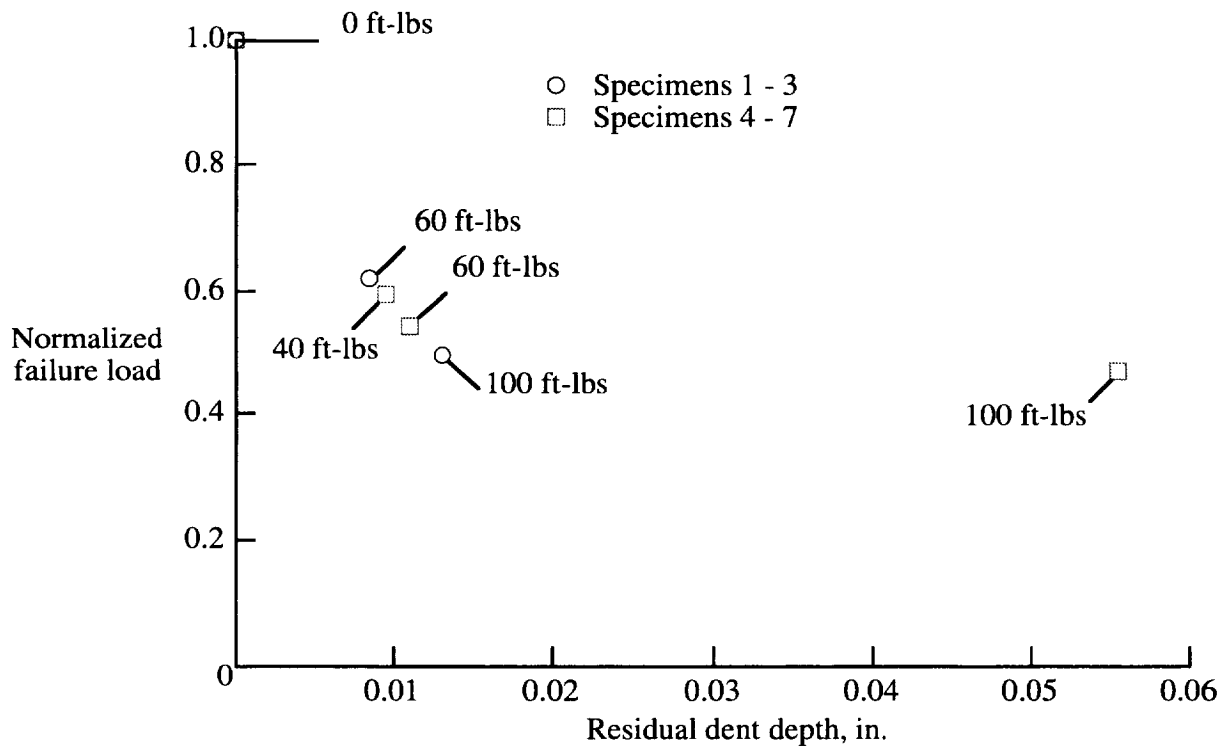
Figure 14. Normalized failure loads as a function of residual dent depth for the CAI specimens. CAI failure loads normalized with respect to undamaged specimen failure loads.

Normalized failure loads are shown as a function of residual dent depth, damaged area, and impact energy in Figs. 14, 15, and 16, respectively. In these figures, the failure loads for specimens 1 - 3 are normalized with respect to the failure load for the undamaged specimen 2. Similarly, the failure loads for specimens 4-7 are normalized with respect to the failure load for the undamaged specimen 7. As shown in Fig. 14, reductions in compression strength of approximately 50 percent result when the residual dent depth value is approximately 0.01 inches. This dent depth value is one-fifth of the threshold value for BVID. The maximum reduction in strength for the thicker specimens is 50.3 percent exhibited by specimen 1 with a residual dent depth of 0.013 inches. The maximum reduction in strength for the thinner specimens is 53.1 percent exhibited by specimen 6 with a residual dent depth of 0.0555 inches. The data in Figs. 15 and 16 exhibit similar trends and appear to be approaching an asymptotic value of the normalized failure load. The important result to note is that appreciable reductions in compression strength occurred in all of the CAI specimens even for conditions in which the impact damage would be considered to be non-visible. For the thinner facesheet sandwich specimens, the BVID criteria of 0.05-in. dent depth or 100 ft-lbs of impact energy appear to be valid. These BVID criteria need further evaluation for thicker facesheet sandwich structures.

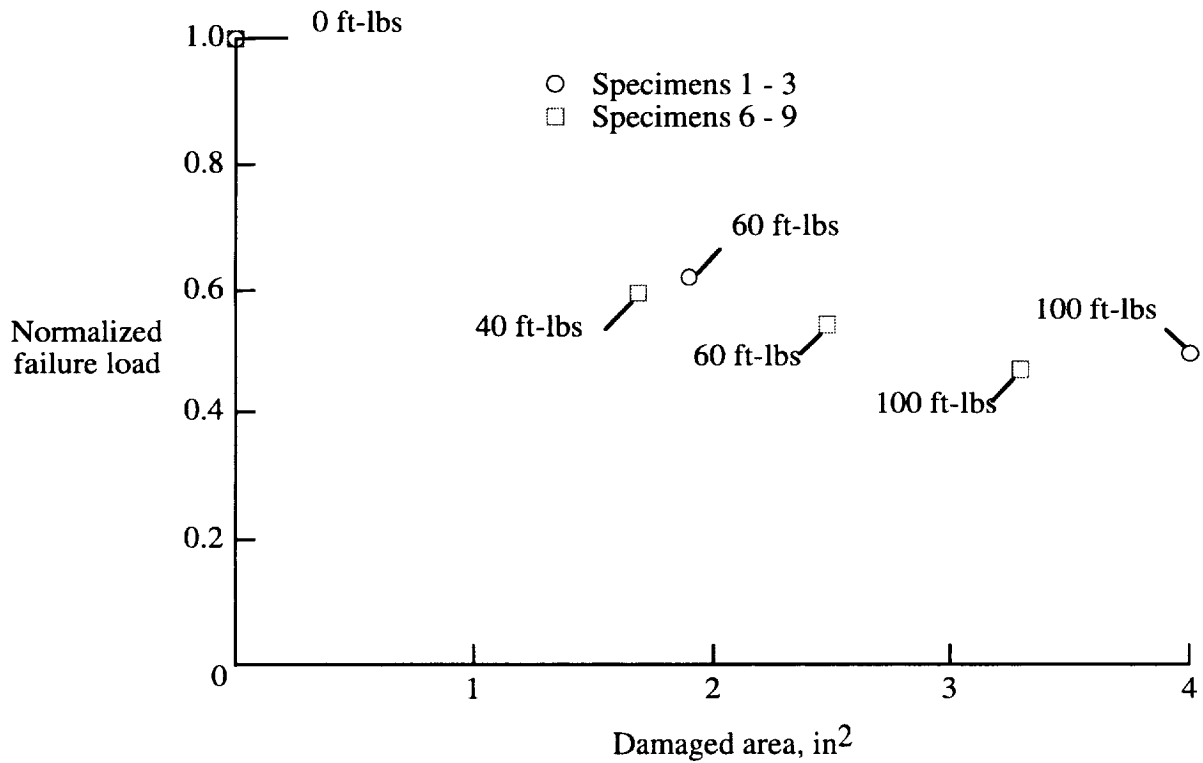
Figure 15. Normalized failure loads as a function of damaged area for the CAI specimens. CAI failure loads normalized with respect to undamaged specimen failure loads.

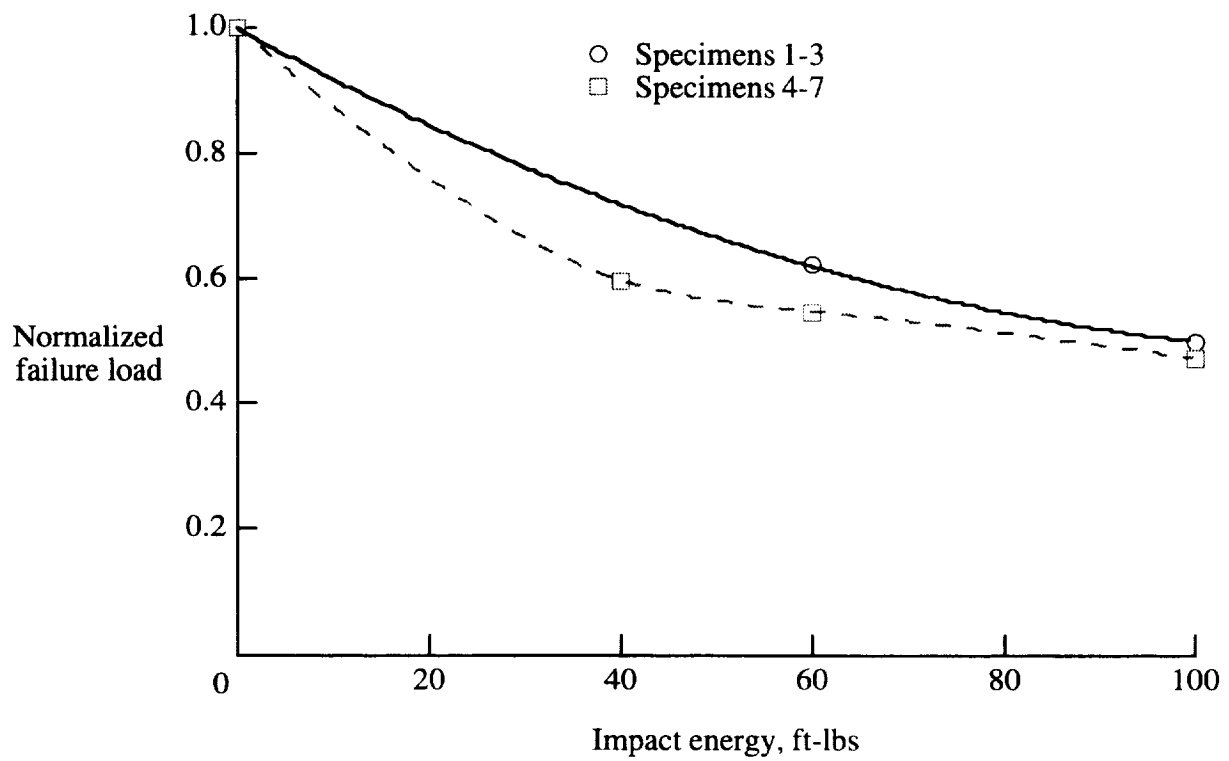
Figure 16. Normalized failure loads as a function of impact energy for the CAI specimens. CAI failure loads normalized with respect to undamaged specimen failure loads.

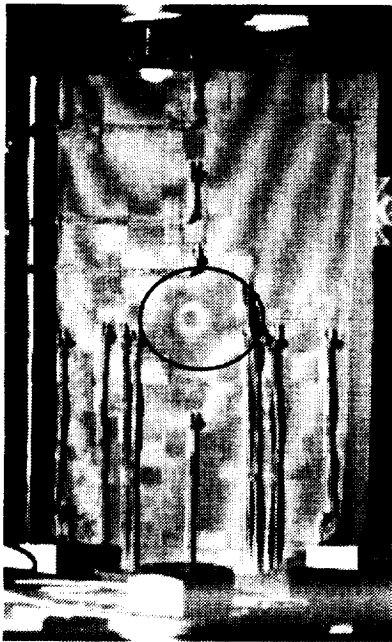
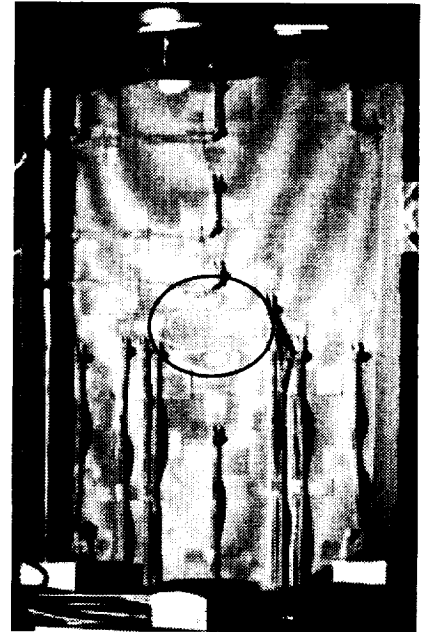
(a) Applied load = 0 lbs

(b) Applied load = 130 kips

Figure 17. Moiré fringe patterns for CAI specimen 8 (40 ft-lbs of impact energy).

Still photographs of the moiré fringe patterns at zero load and just prior to failure of specimen 6 are shown in Fig. 17. As shown in the figure, there was an appreciable amount of damage growth during the test. A typical failure mode is shown in Fig. 18. As shown in the figure, a compression failure occurred in the facesheet that was impact damaged. Following this failure, the sandwich specimen experienced significant bending, and the remaining facesheet failed in bending. The failure initiated in the impacted facesheet at the damage site. A trend noted during the tests is that only the impacted facesheet failed in the tests of specimens 1 and 4 (100 ft-lbs of impact energy). Both facesheets failed for all other specimens. This difference in failure mode is attributed to the fact that specimens 1 and 4 exhibited reductions in failure strength of greater than 50 percent when compared to the undamaged specimens. Therefore, the residual load in the specimen following failure of the damaged facesheet was not large enough to fail the second facesheet. The reductions in strength for the other specimens

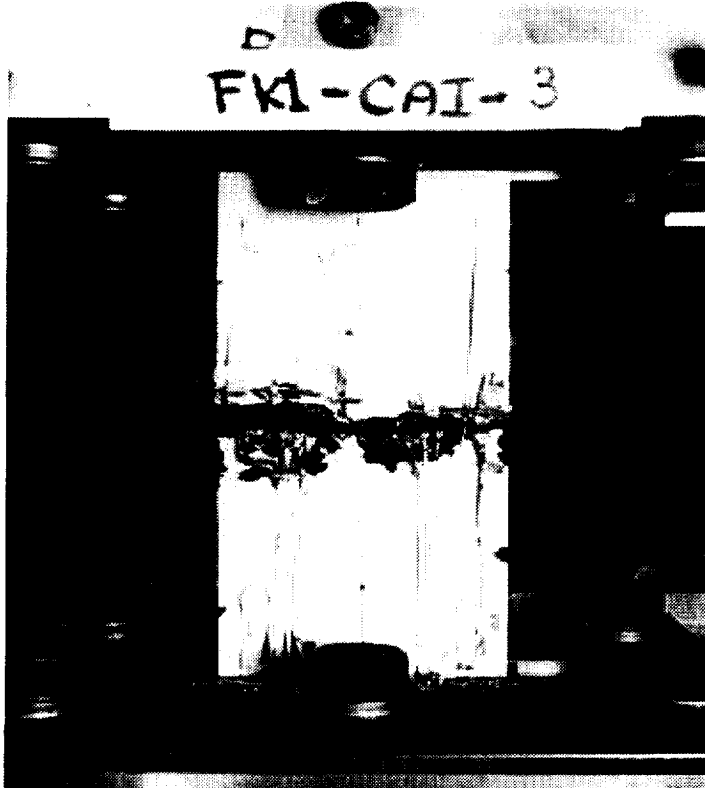
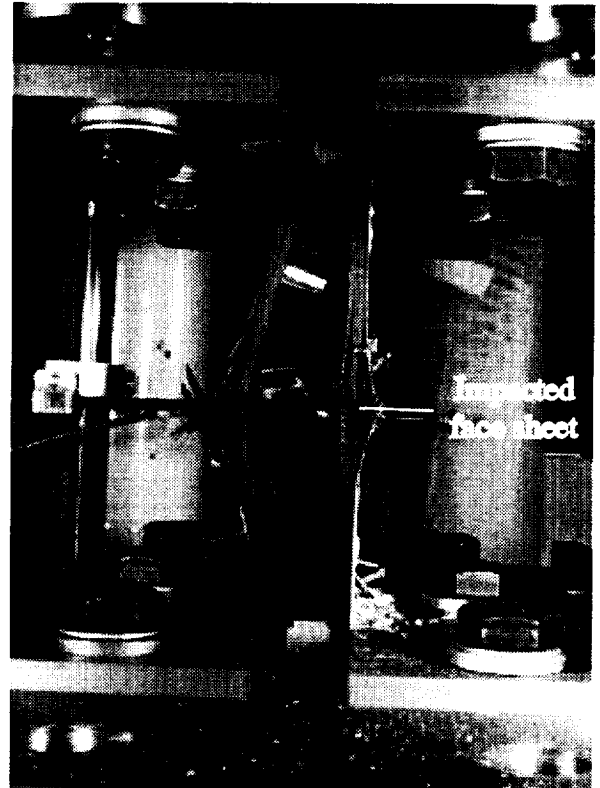
Figure 18. Failure mode for CAI specimen 3 (failure load = 173.5 kips).

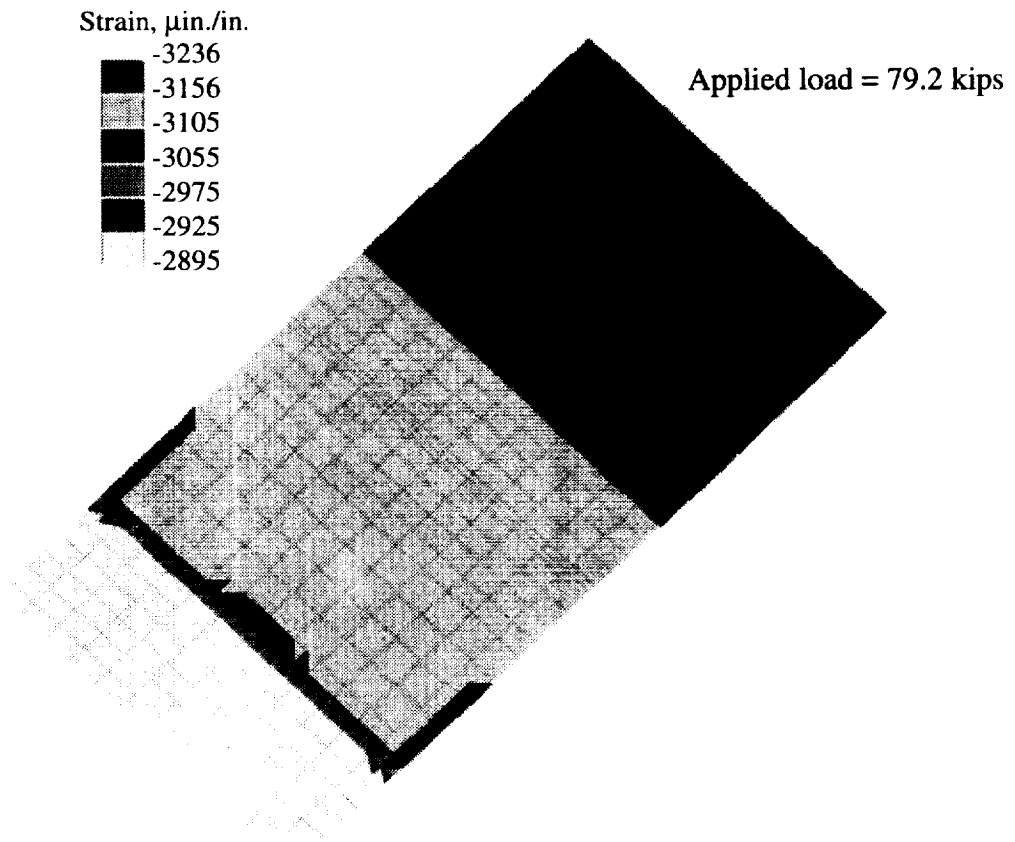
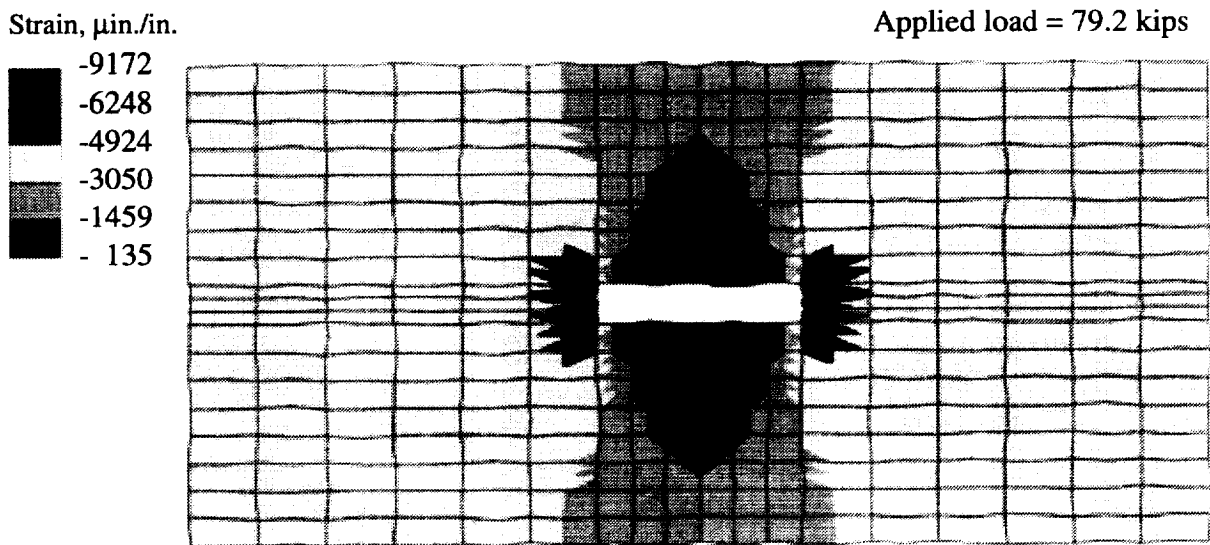
(a) Unnotched specimen 10

(b) Notched specimen 10 (1.0-in.-long notch)

Figure 19. Analytical surface strain contours for specimen 10 without and with a 1.0-in-long notch.

Finite element analysis results for specimen 10 without and with a 1.0-in.-long notch loaded by 79.2 kips of axial compression are presented in Figs. 19(a) and 19(b), respectively. The axial surface strain variations in the unnotched specimen are due to changes in specimen axial stiffness that is a result of terminated plies along the specimen length. The strain gradients in the notched specimen are severe at the edge of the notch and the applied load is redistributed around the notch. Maximum values of strain occur at a location that is very close to the notch tip in the width-direction of the specimen. The analytical surface strain results for specimen 10 with a 1-in.-long notch are compared with the experimental results for that specimen in Fig. 20. The experimental strain contours are those obtained using the optical photoelastic technique. Axial surface strains measured on the concave surface of the specimen are given in Fig. 20(b). The experimental and analytical strain magnitudes compare well with one another.

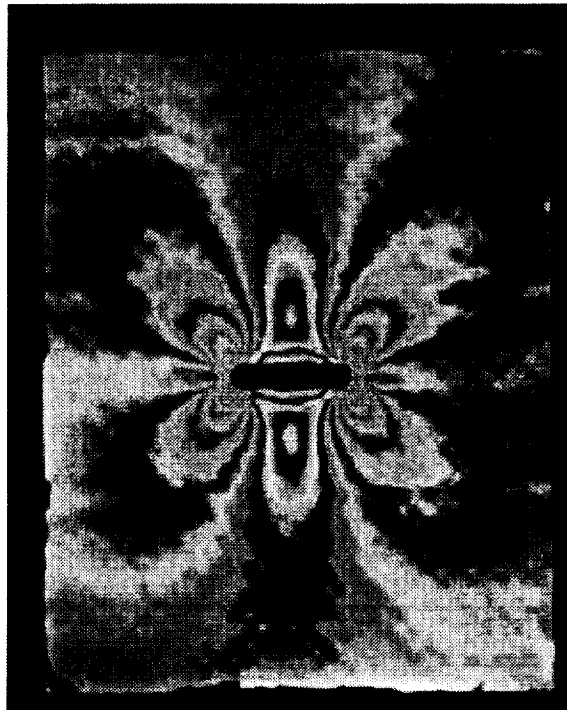
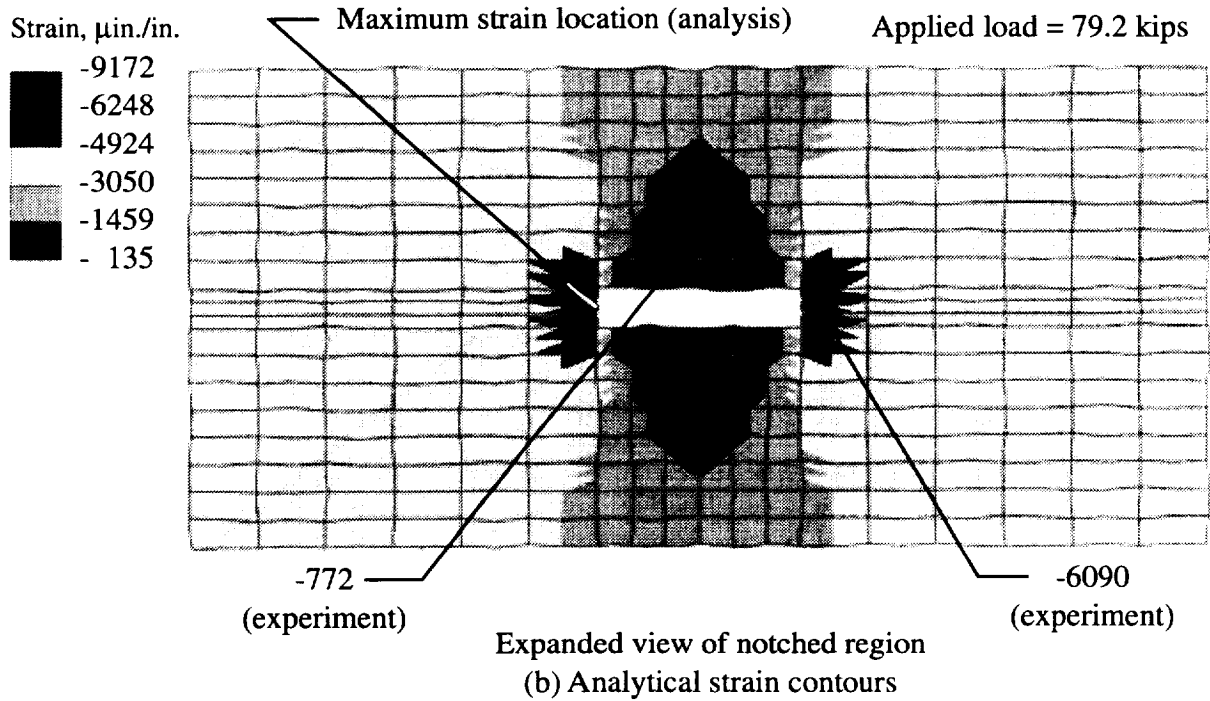
(a) Experimental strain contours

Figure 20. Experimental and analytical strain contours for specimen 10 (1.0-in.-long notch). Strains are in  $\mu\text{in./in.}$

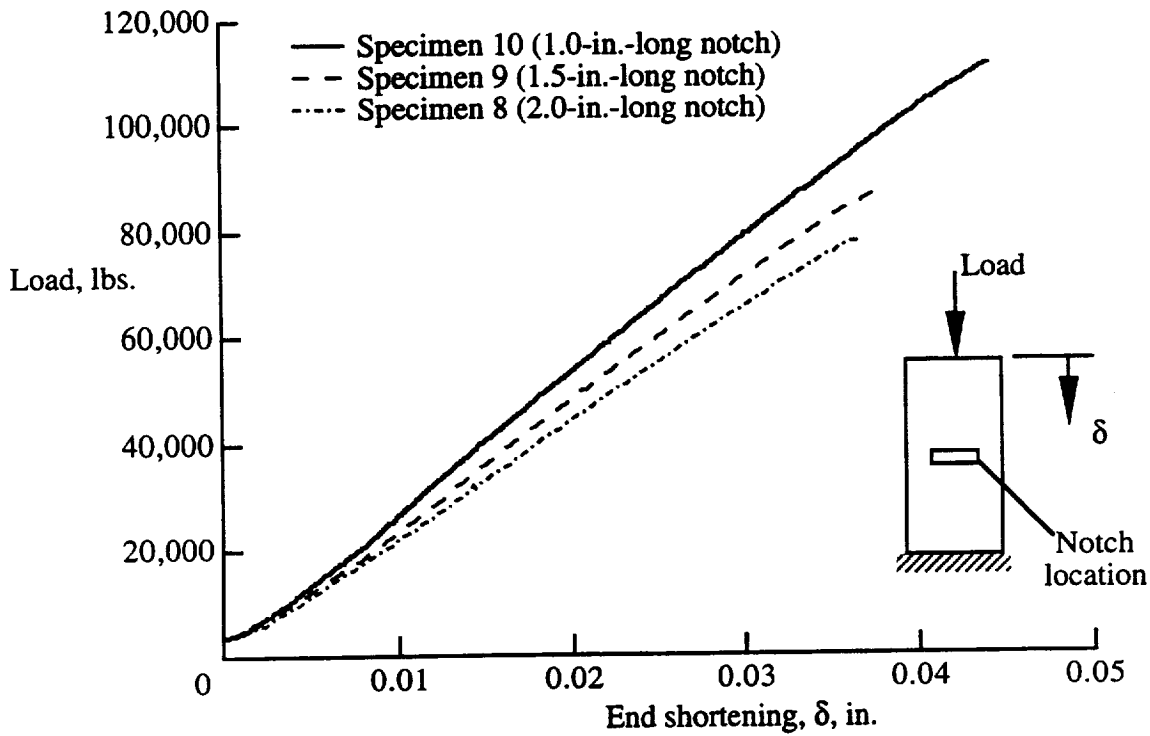
Figure 21. Experimental load-shortening results for the notched specimens (8 - 10).

Load-shortening results are presented in Fig. 21 for notched specimens 8-10. As shown in the figure, there is a small effect of the notch length on the stiffness of the structure. Specimen 10, with the shortest notch, has the highest stiffness, while specimen 8, with the longest notch, has the lowest stiffness. Experimental axial surface strain results are presented in Fig. 22 for specimens 8-10. Once again, the surface strain results presented in these figures are far field results measured near the loaded edge of the specimens. The strain values are averaged values as described in the previous discussion of the CAI study. The effect of the notch length on the far field response of the structure is small. The strain values for specimens 9 and 10 are very close to each other, while the strain values for specimen 8 are higher than those for specimens 9 and 10 for a given load. Experimental axial surface strain results for specimens 10 and 8 are given in Figs. 23 (a) and (b), respectively. Load data are presented in this figure as a function of strain at three locations on the specimen. The strain data at location A are the same far field data presented in Figs. 21 and 22. Location B is very near the damage site and is located on the axial centerline of the specimens. Location C is at the notch tips and is located on the horizontal centerline of the specimen. The data in Fig. 23(a) indicate that the presence of the notch significantly affects the response of the structure in that region. The strain value at location A is approximately 4.02 times larger than that at location B for specimen 10. At location C, the strain value is approximately 2.22 times larger than the strain at location A. Similarly, the strain value at location A is approximately 6.07 times larger than that at location B for specimen 8. At location C, the strain value is approximately 3.17 times larger than the strain at location A. These results indicate that the

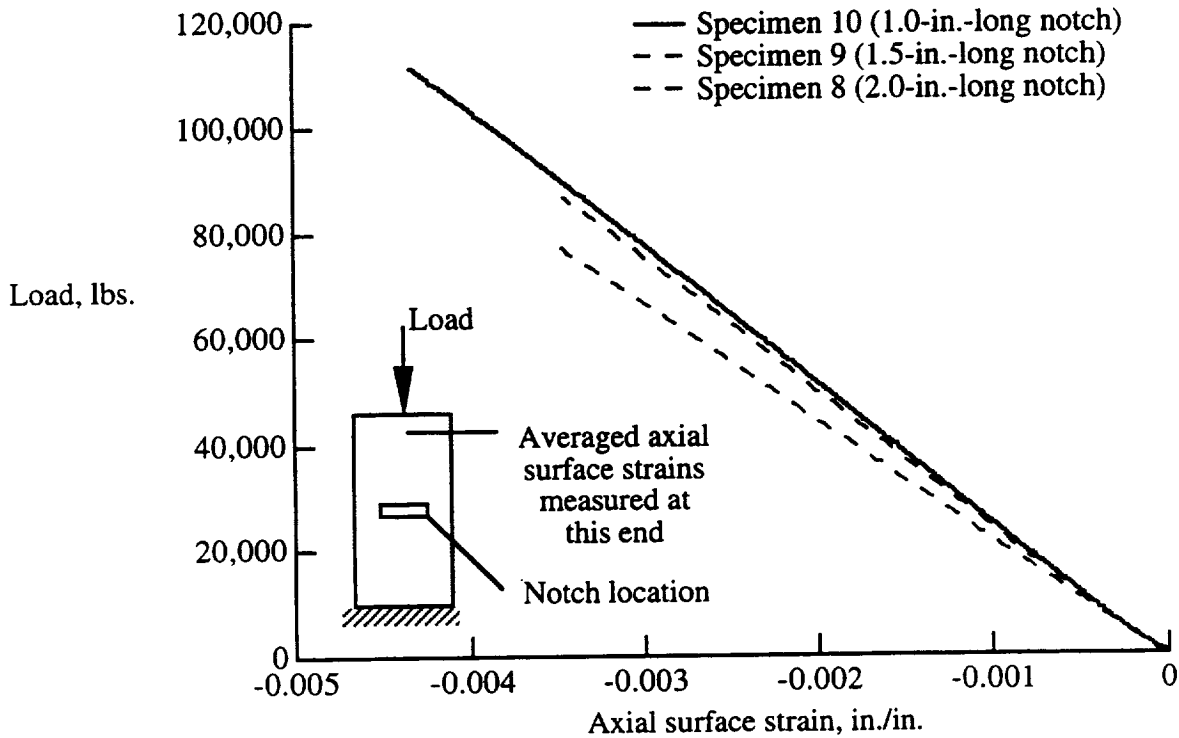
Figure 22. Experimental axial surface strain results for the notched specimens (8 - 10).

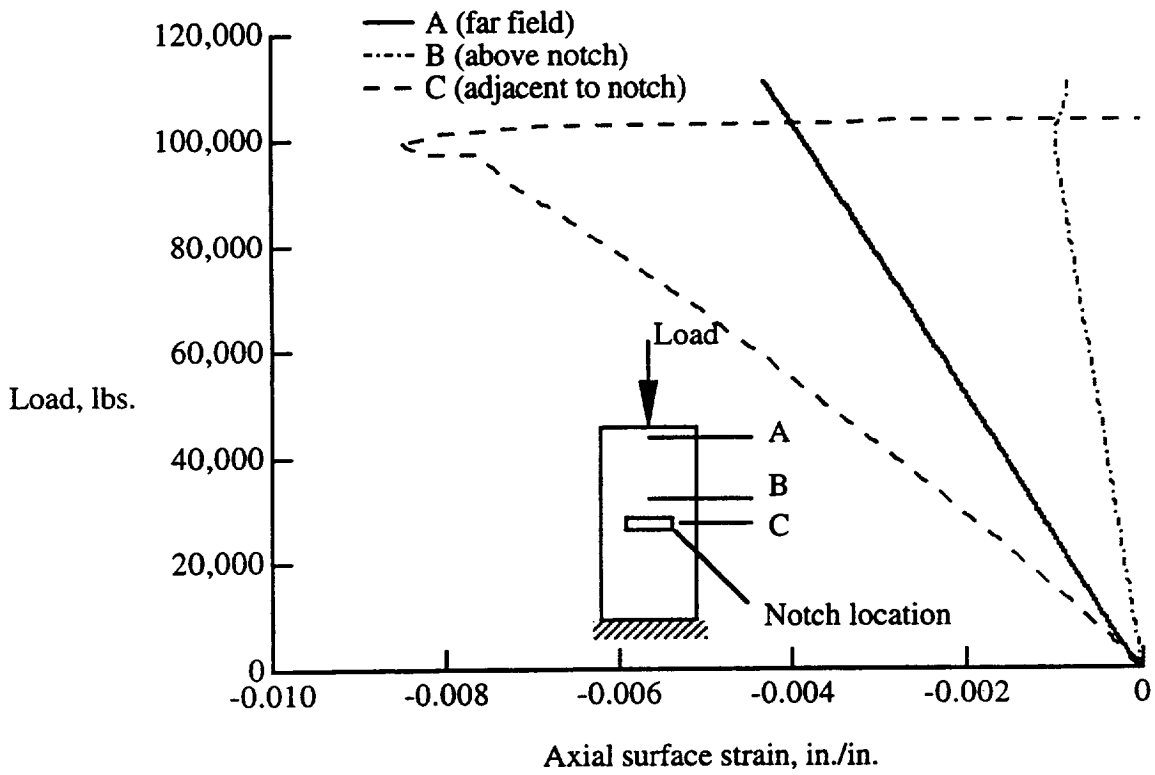
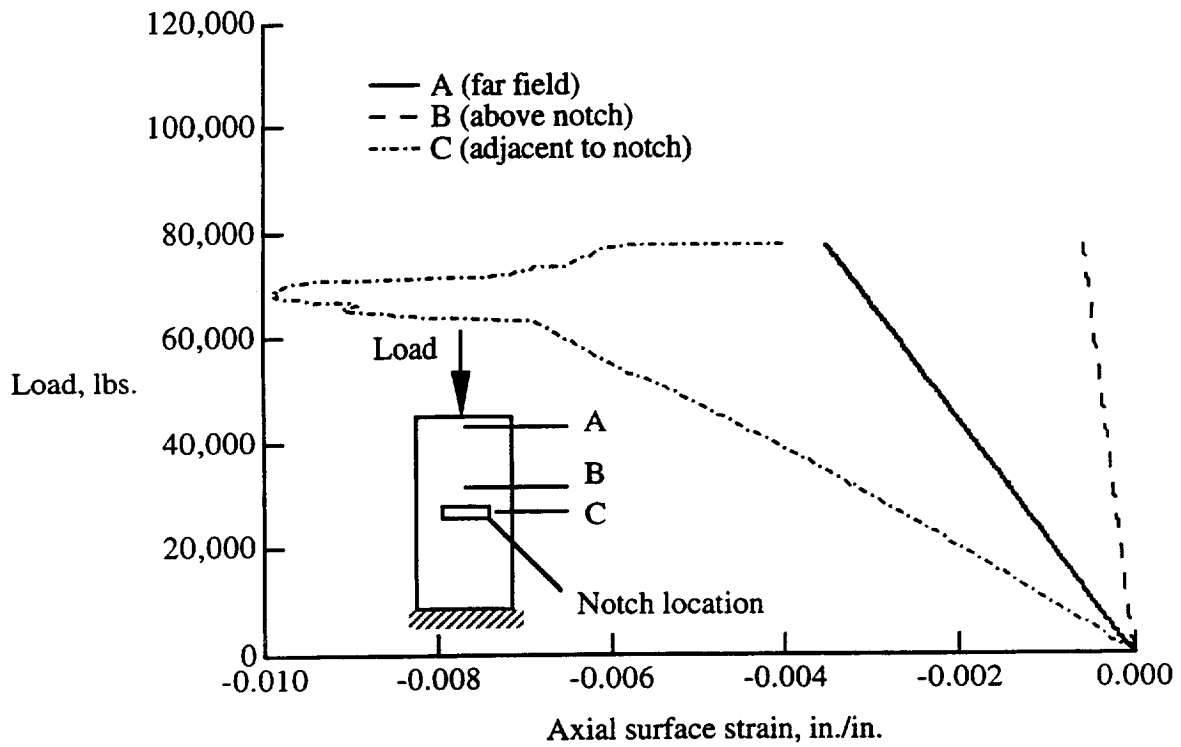
(a) Notched specimen 10 (1.0-in.-long notch).

(b) Notched specimen 8 (2.0-in.-long notch)

Figure 23. Experimental surface strain results for notched specimens 8 and 10.

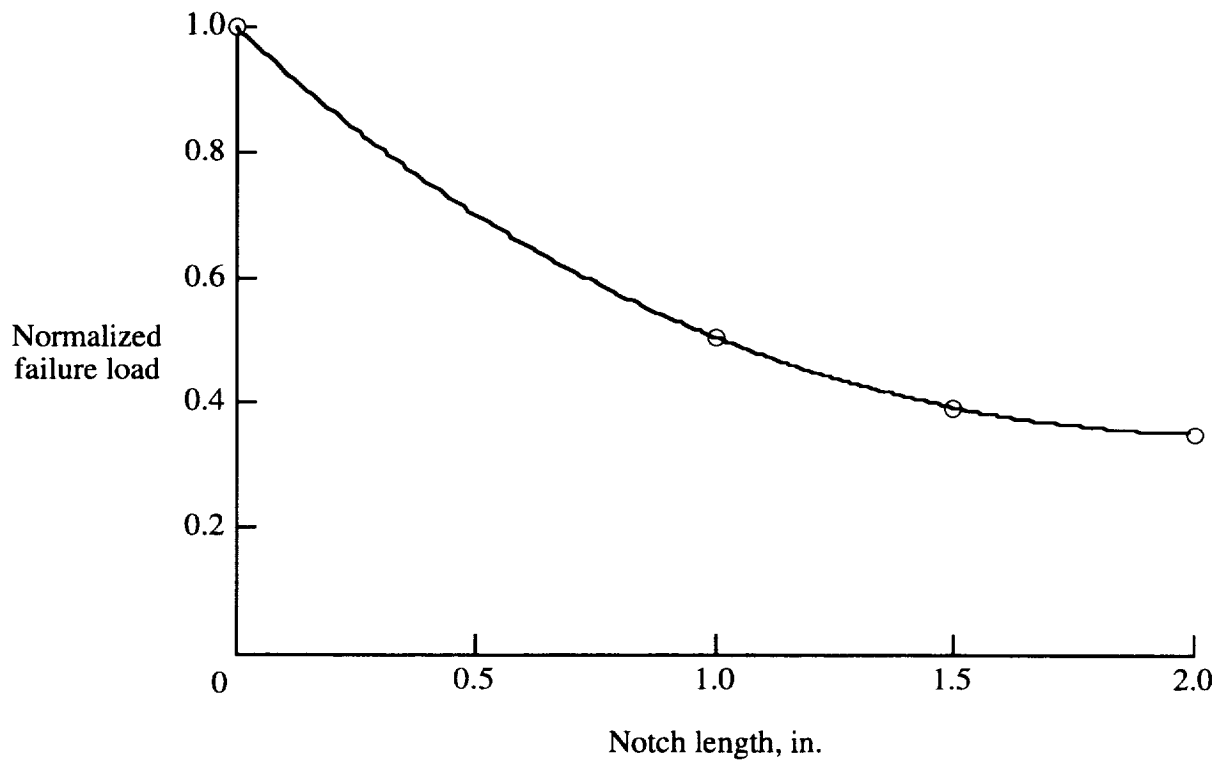
Figure 24. Normalized failure loads as a function of notch length for the notched specimens. Notched specimen failure loads are normalized with respect to the failure load for unnotched specimen 7.

Normalized failure loads are shown as a function of the notch length in Fig. 24 for specimens 8-10. In this figure, the failure loads for these specimens are normalized with respect to the failure load for the undamaged specimen 7. The trend shown in this figure is similar to that shown in Fig. 18 for the CAI specimens. However, the notched specimens exhibit a larger reduction in strength. Specimen 8, which has a 2.0-in-long notch, exhibits a 64.7 percent reduction in strength which corresponds to a normalized failure load of 0.353. The typical failure mode for these specimens is a compression failure of both facesheets that initiates at the notch. A photograph of the failure mode for specimen 10 is shown in Fig. 25.

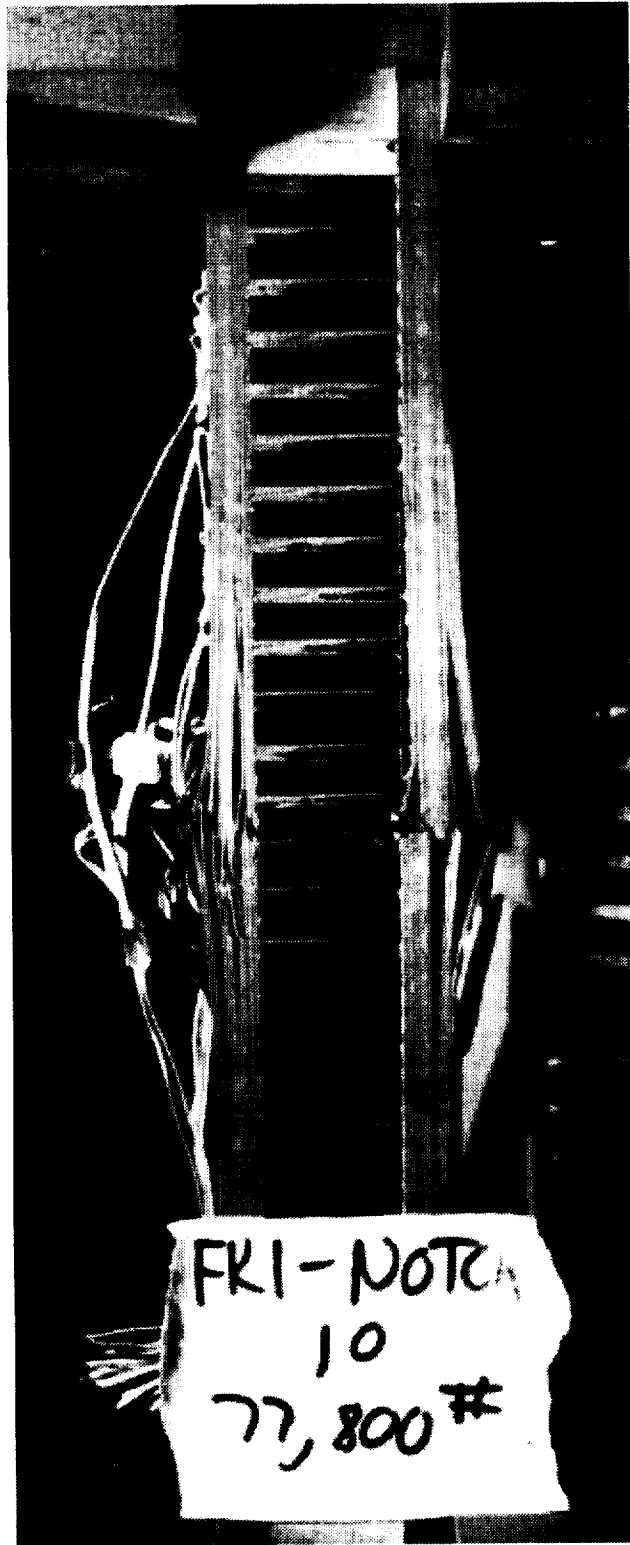
Figure 25. Failure mode for notched specimen 10 with a 2.0-in.-long notch (failure load = 77.8 kips).
