1995-1996

NASA/ASEE SUMMER FACULTY FELLOWSHIP PROGRAM

**ROLE OF THE MICRO/MACRO STRUCTURE OF WELDS IN CRACK
NUCLEATION AND PROPAGATION IN AEROSPACE ALUMINUM-LITHIUM
ALLOY**

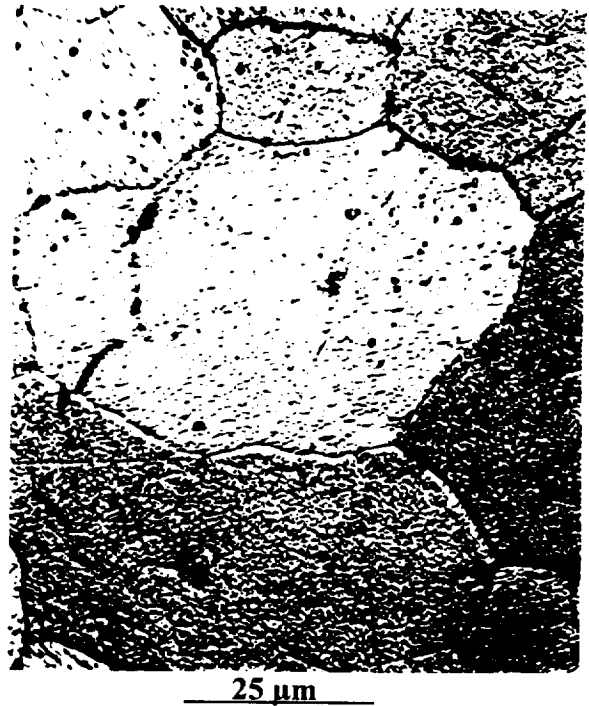
Figure 7.- Micrographs showing the effect of the thermal treatment on the G.B. structure.

The thermally treated 2195 alloy increased in fracture strength from 20 % below to 10 % above that of 2219. Due to the thermal treatment, the G.B. segregation was eliminated (see Figure 7). Apparently, 2195 become much stronger if the interdendritic material is redissolved into the grains.
