INVESTIGATION OF ADVANCED PROCESSED SINGLE-CRYSTAL TURBINE BLADE ALLOYS

**United Technologies Corporation
Pratt & Whitney
Government Engines & Space Propulsion
P.O. Box 109600
West Palm Beach, FL 33410-9600**

December 1995

Under Contract: NAS8-39050

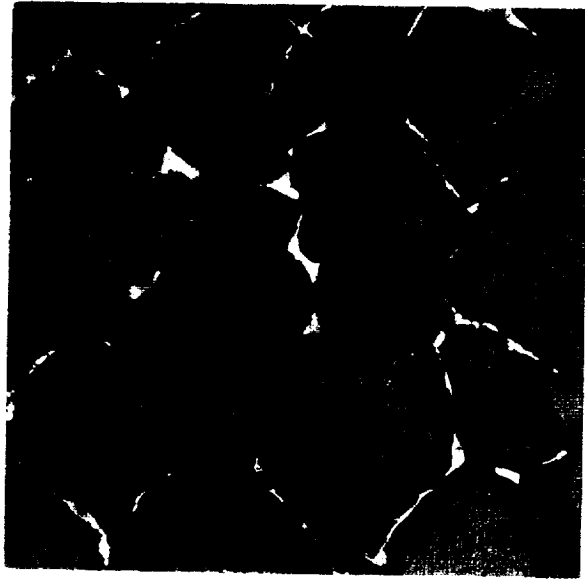
Figure 3. As-Cast Microstructure of PWA 1482 (Top) and PWA 1484 (Bottom)

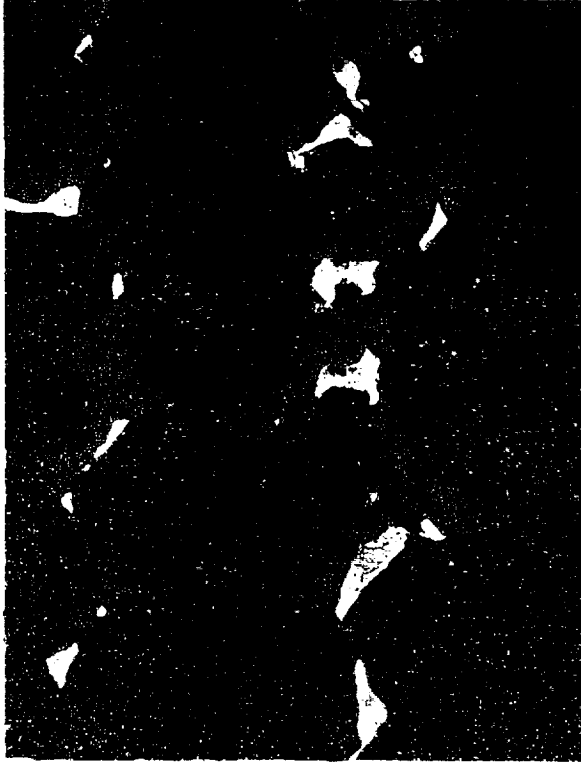
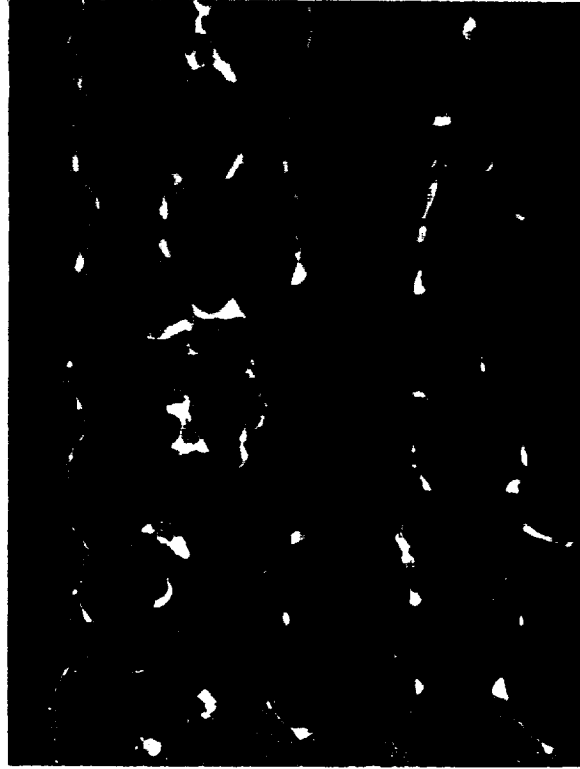
As-Cast

HIP at 1274°C (2325°F)/103 MPa (15 ksi)/4 hr

Figure 8. Typical Microstructure of PWA 1482 Following HIP and Solution Heat Treatment (Etch: AG21)

After studying metallography from samples in the as-polished condition, each sample was etched to document microstructures following HIP processing. Metallography from as-HIP'ed samples of PWA 1482 are shown in Figures 8 through 10. This metallography indicates that minimal eutectic γ/γ' solutioning is observed during HIP at temperatures of 1296°C (2365°F) and below. HIP cycles at temperatures of 1307°C (2385°F) and 1318°C (2405°F) resulted in appreciable eutectic solutioning. Nearly 100 percent of the γ/γ' eutectic phase islands were solutioned at 1318°C (2405°F). No evidence of incipient melting or RX was observed in any PWA 1482 samples.

After coupons were sectioned from each bar for metallography following the HIP cycles, the remaining test bar lengths were solution heat treated to determine whether complete eutectic solutioning was achieved. Post-HIP solution heat treated microstructures of PWA 1482 are shown in Figures 8 through 10. This metallography indicates that complete eutectic solutioning was achieved in all samples irrespective of the level of eutectic solutioning that occurred during the HIP cycles. This metallography also indicates that no additional microporosity or RX was

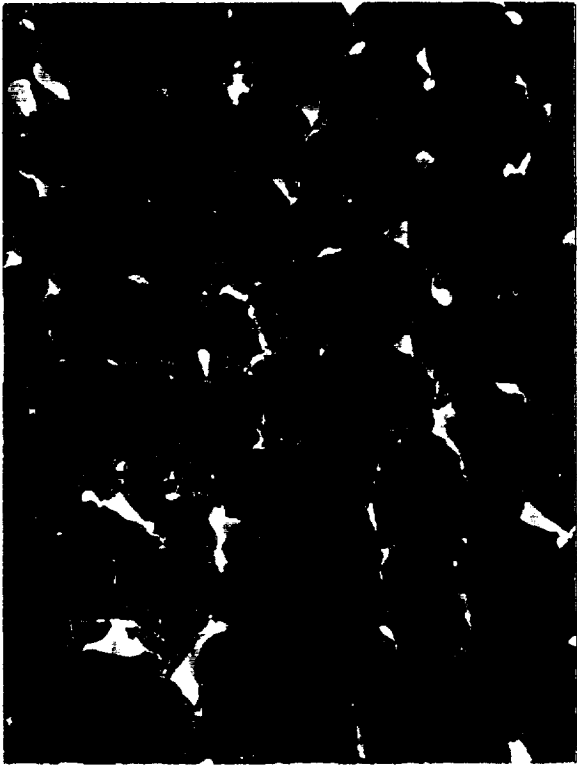
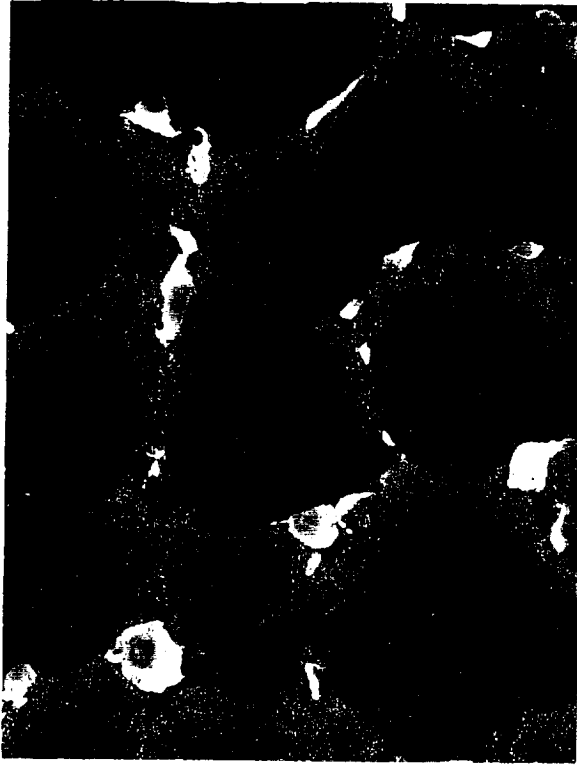
As-cast

HIP at 1285°C (2345°F)/103 MPa (15 ksi)/4 hr

Figure 11. Typical Microstructure of PWA 1484 Following HIP and Solution Heat Treatment (Etch: AG21)

A similar series of metallography was performed on PWA 1484 samples following the HIP cycles and solution heat treatment as shown in Figures 11 through 13. This metallography indicates that minimal eutectic γ/γ' solutioning occurs at HIP temperatures of 1307°C (2385°F) and below. The HIP cycles at temperatures of 1318°C (2405°F) and 1330°C (2425°F) produced appreciable amounts of eutectic solutioning. No evidence of incipient melting or RX was observed in any PWA 1484 samples.

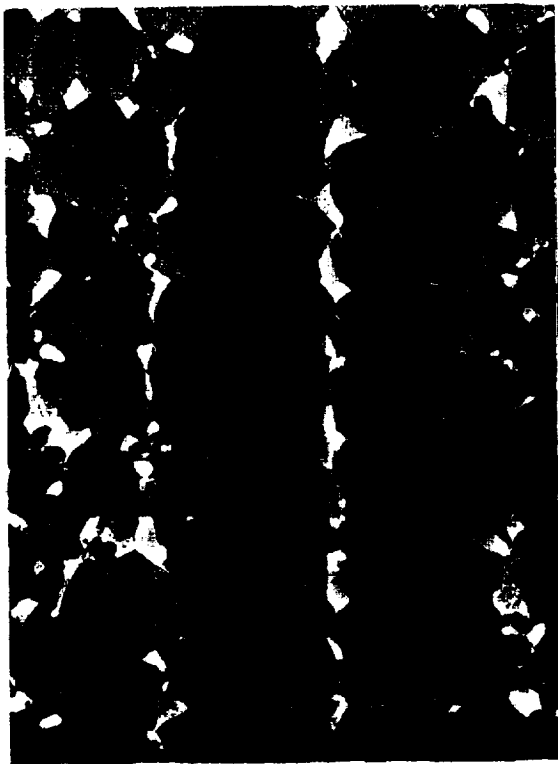
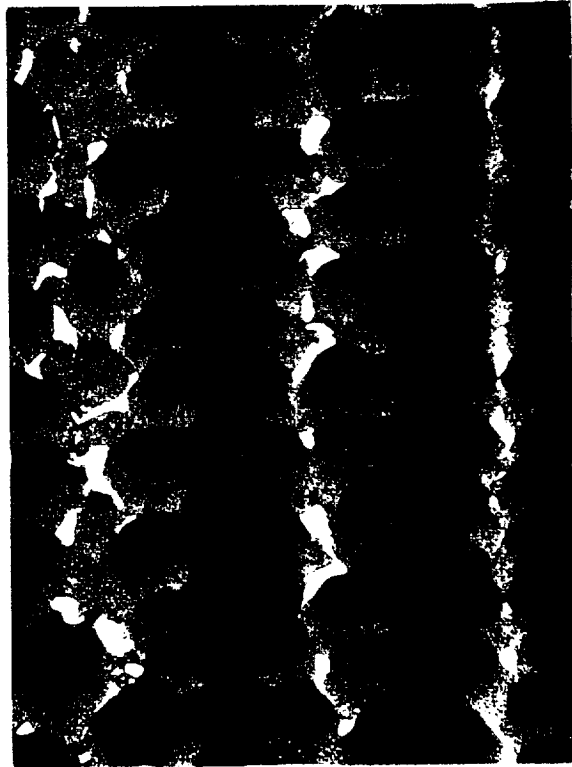
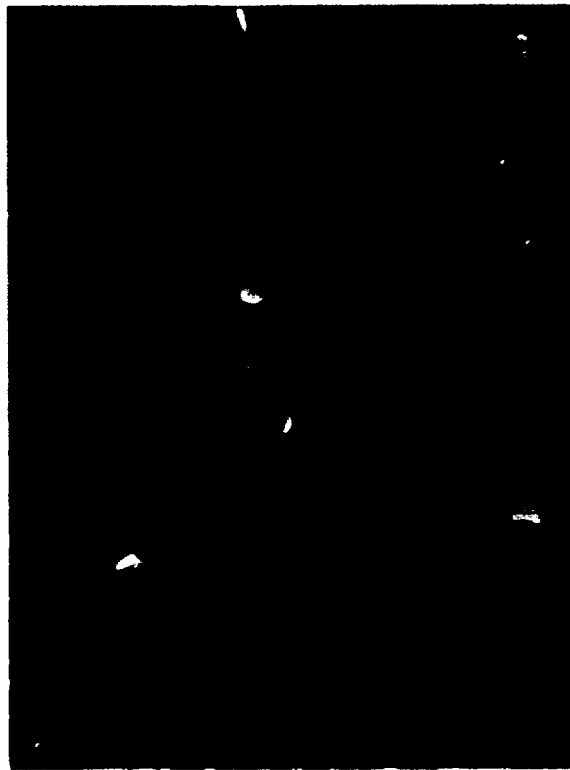
HIP at 1296°C (2365°F)/103 MPa (15 ksi)/4 hr

HIP at 1307°C (2385°F)/103 MPa (15 ksi)/4 hr

HIP at 1330°C (2425°F)/103 MPa (15 ksi)/4 hr

HIP at 1330°C (2425°F)/103 MPa (15 ksi)/4 hr
+
Solution Heat Treat at 1327°C (2420°F)/6 hr

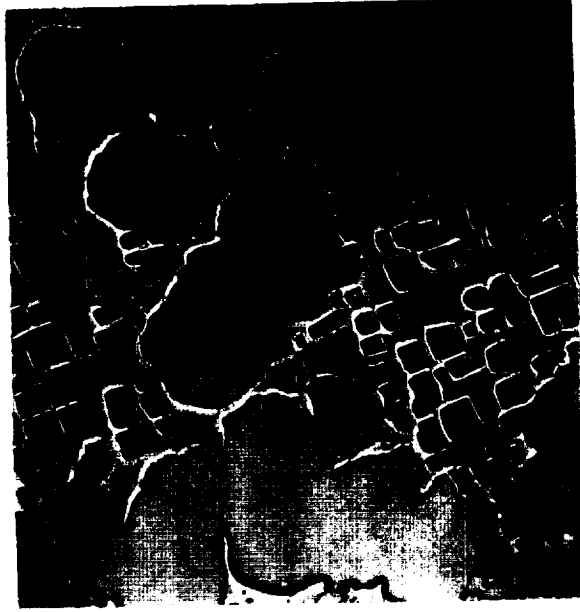
Pore-Free, Eutectic-Free, Bimodal γ

Figure 16. PWA 1484 Alternate HT Microstructures

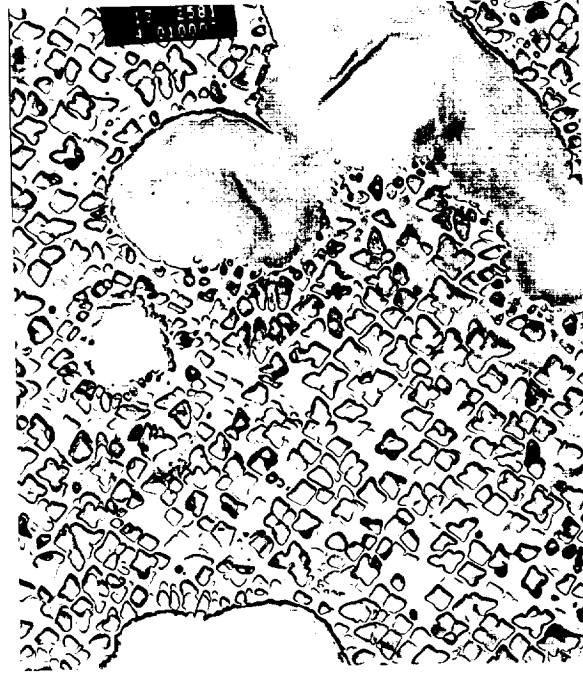
Heat Treat 4

Figure 20. PWA 1484 Microstructure Produced in Thermal Treatment Optimization Studies

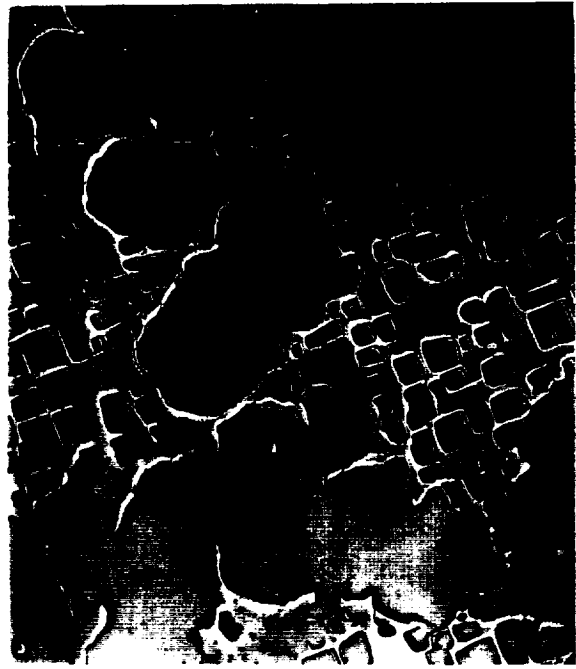
Heat Treat 5
4600X

Figure 21. PWA 1484 Microstructure Produced in Thermal Treatment Optimization Studies

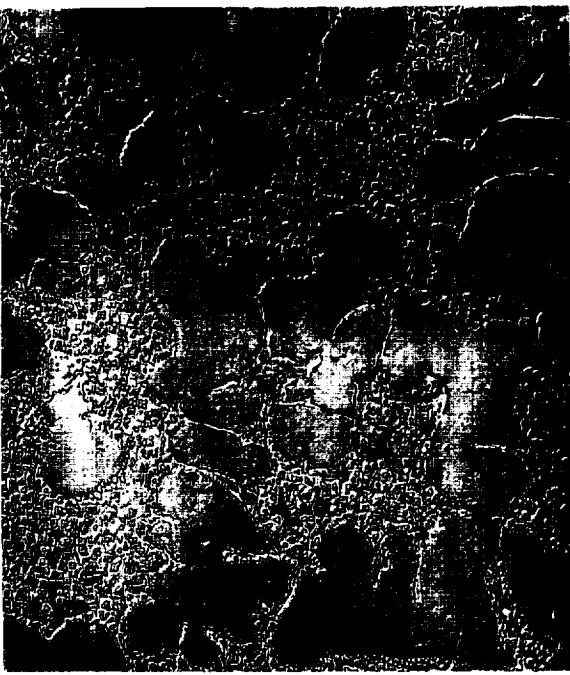
Heat Treat 6
200X

Heat Treat 6
4600X

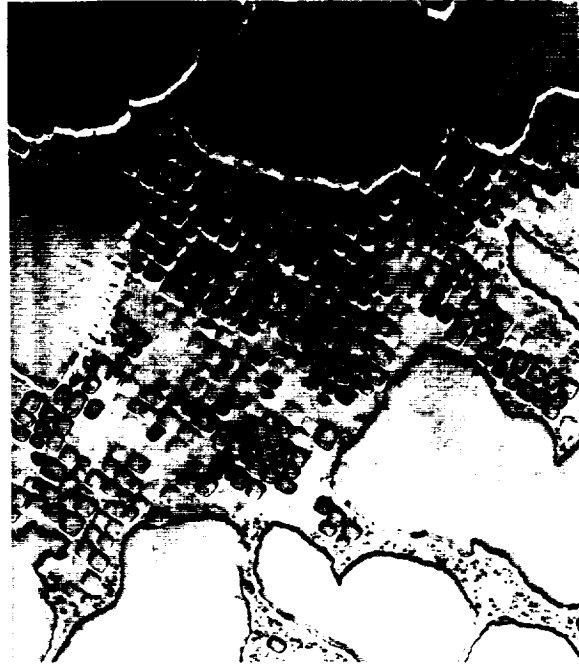
Heat Treat 7

Figure 23. PWA 1484 Microstructure Produced in Thermal Treatment Optimization Studies

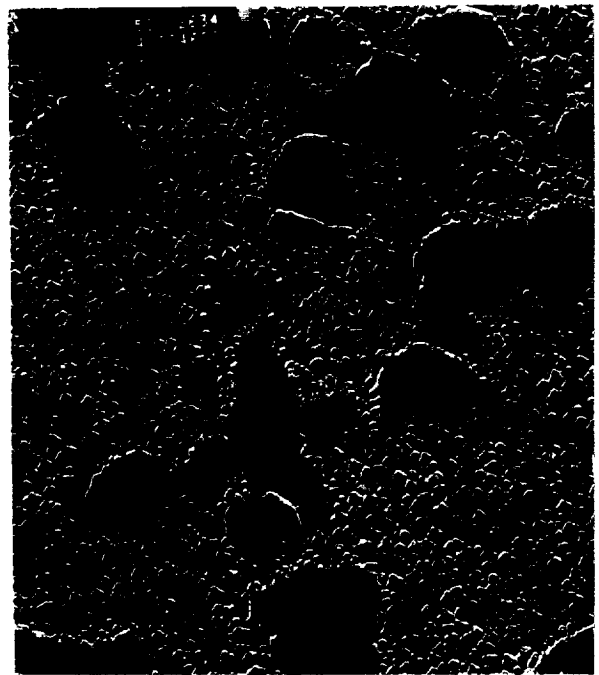
Heat Treat	Hot Isostatic Pressing	Heat Treatment
4	1285°C (2345°F)/103 MPa 15 ksi/4 hr	Solution at 1307°C (2385°F)/6 hr→Slow Cool*+871°C (1600°F)/32 hr
6	1285°C (2345°F)/103 MPa 15 ksi/4 hr	Solution at 1307°C (2385°F)/6 hr→Slow Cool**+871°C (1600°F)/32 hr

* – Slow cool from 1307°C (2385°F) at 0.28°C/min to 1232°C (2250°F). Hold for 2 hr→rapid vacuum cool to RT.
 ** – Slow cool from 1307°C (2385°F) at 0.56°C/min to 1177°C (2150°F)→rapid cool to RT.

Heat Treat 4

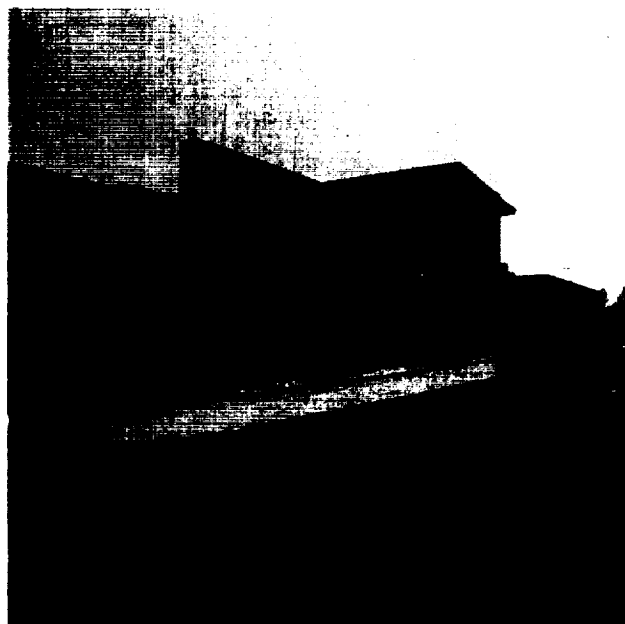
FCD47178-12

Figure 26. Remote Blast Cells Housing High-Pressure Environment Test Machines

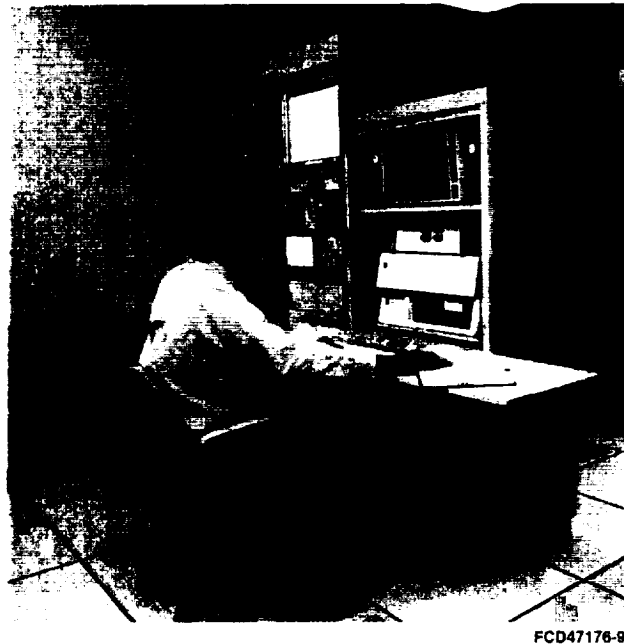
FCD47176-9

Figure 30. Automated Crack Growth Rate Control and Data Acquisition System

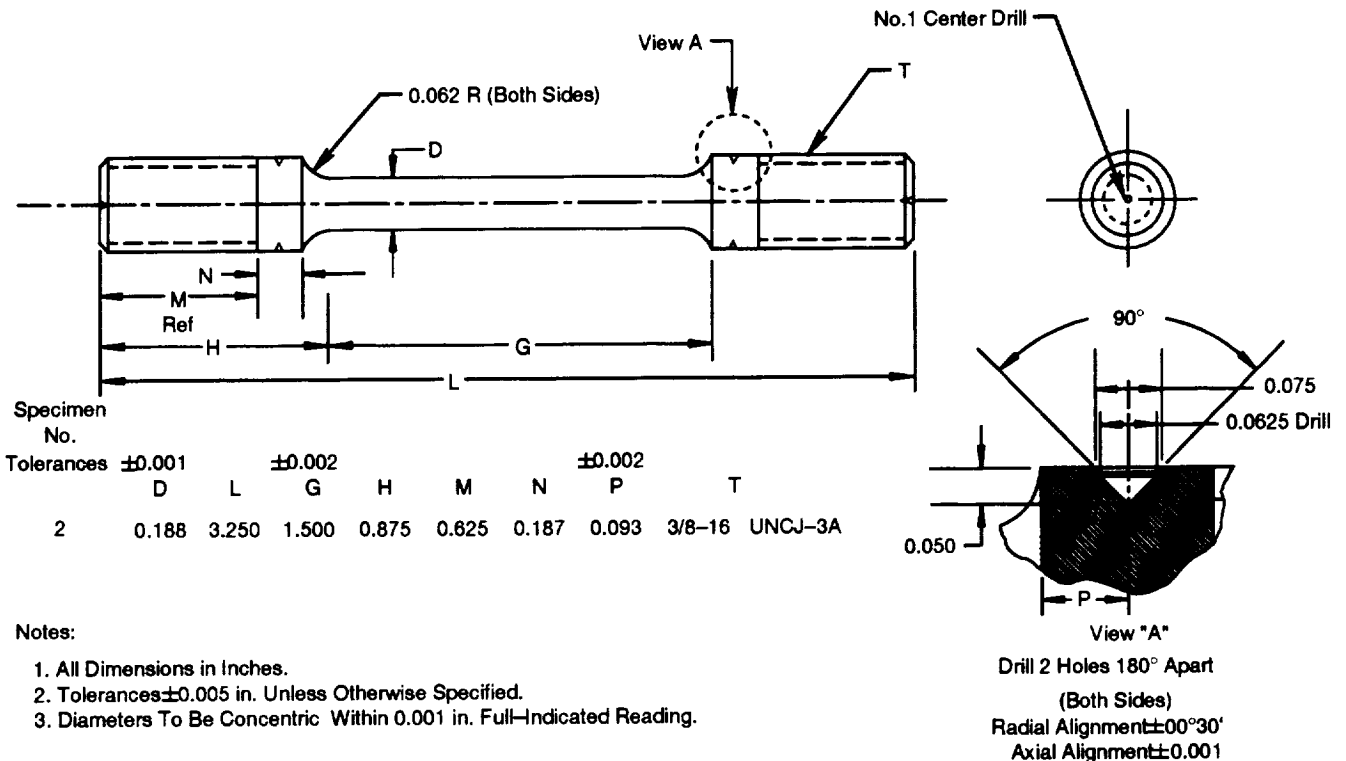
Figure 32. Creep Rupture Specimen

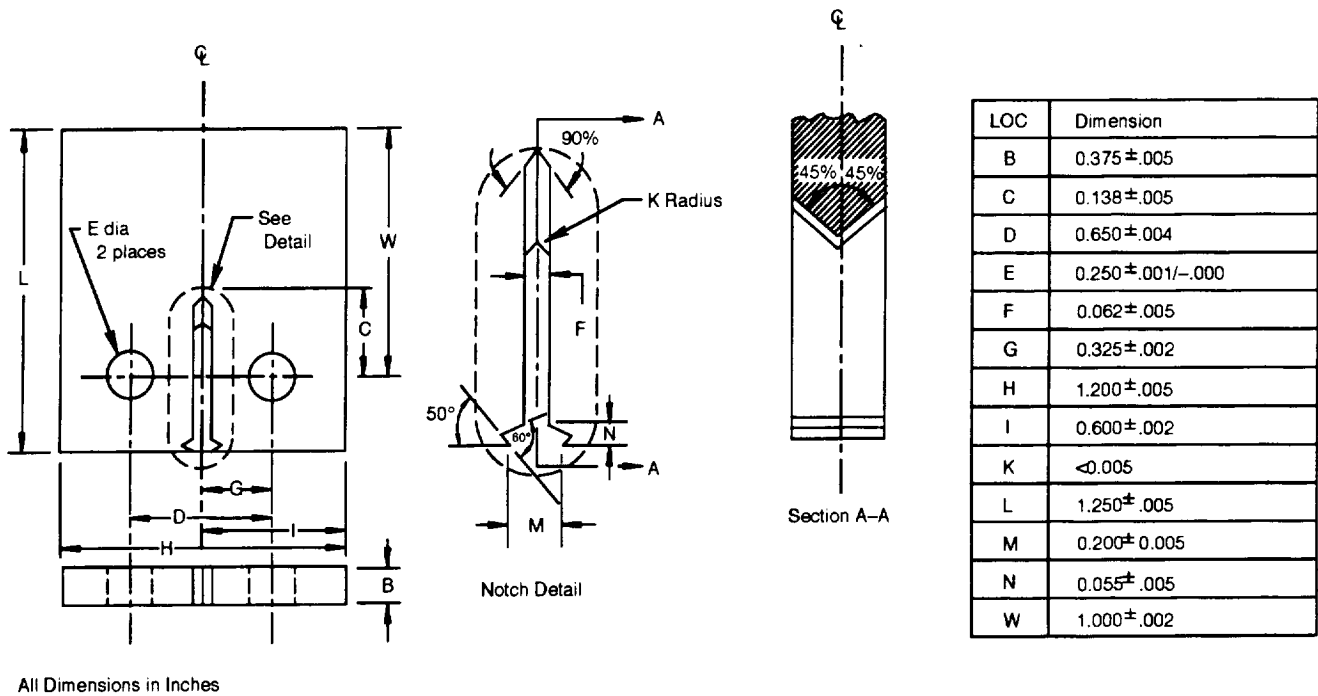
Figure 38. Crack Growth Rate Specimen

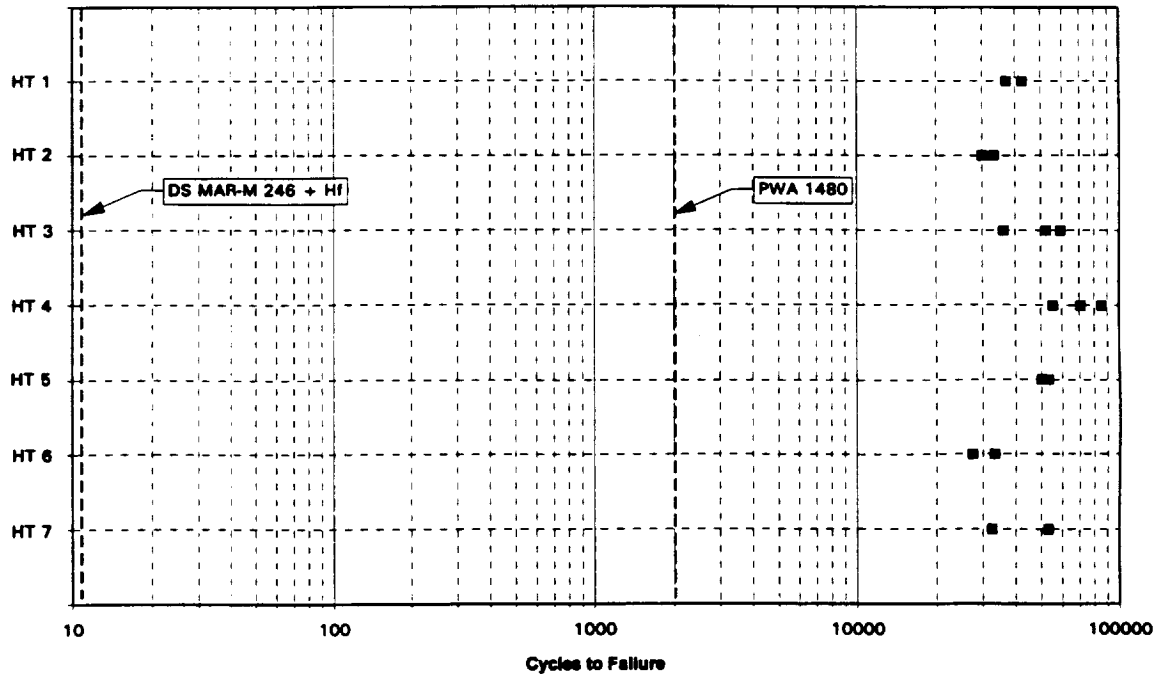
Figure 41. Load Controlled LCF Screening Results for [001] Oriented PWA 1484 Double Notch specimens Tested in 34.5 MPa (5 ksi) Hydrogen at 0.167 Hz, 20°C (68°F), R = 0.05, 620.55 MPa (90 ksi), K_t = 2.18; Comparison to the Means of DS MAR-M-246+Hf and PWA 1480 Tested Under the Same Condition

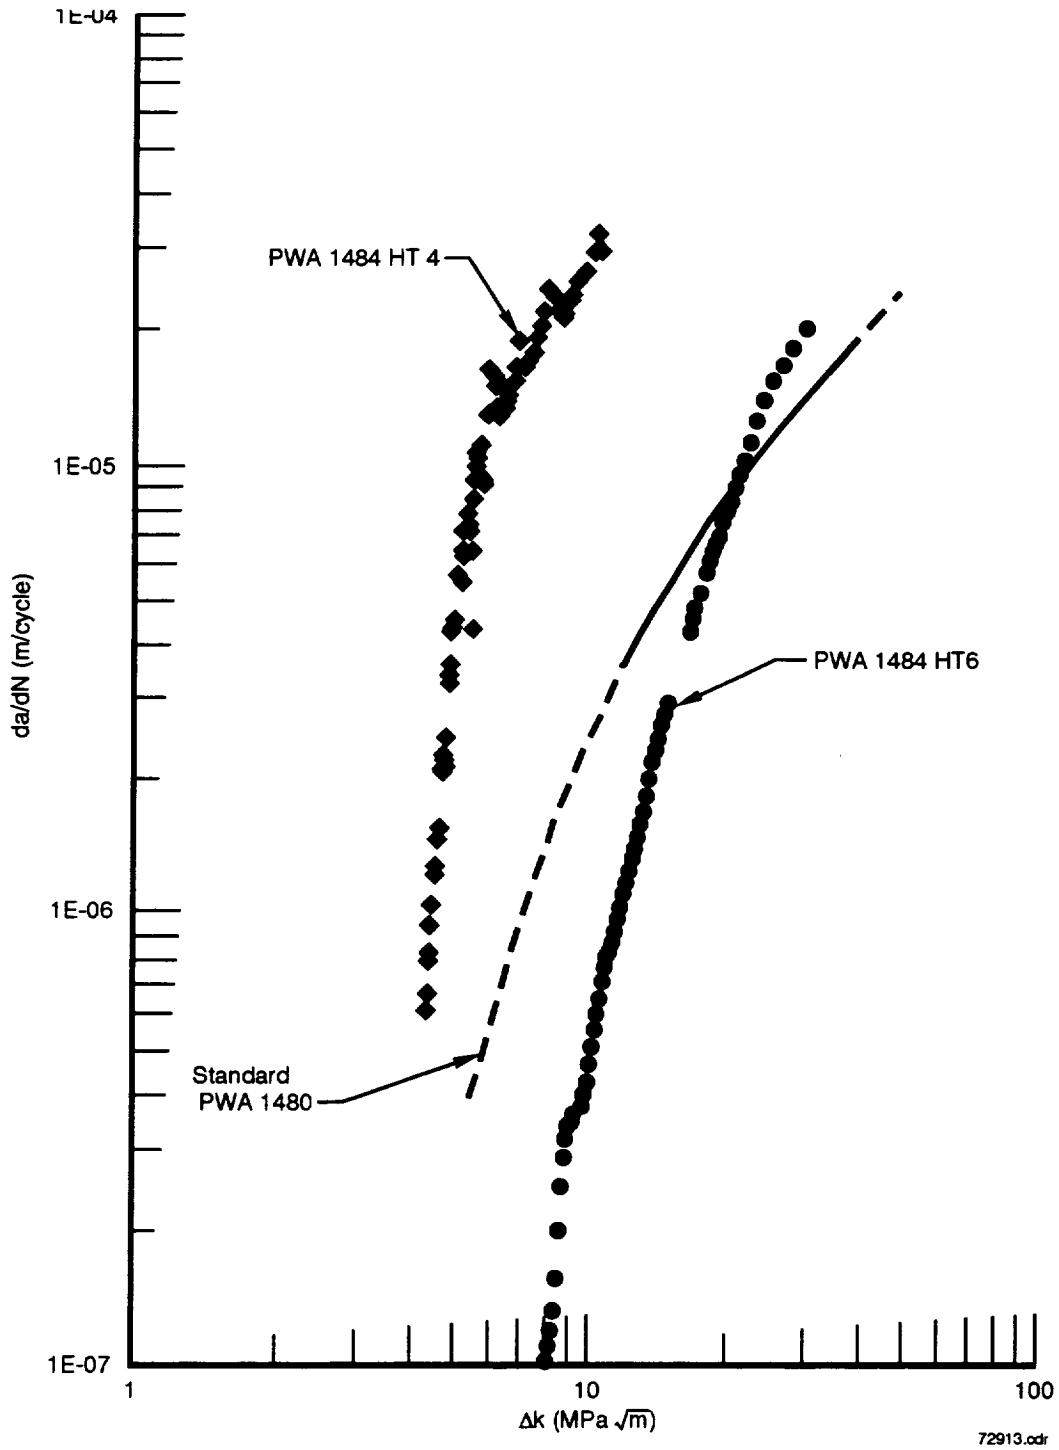
Figure 43. Crack Growth Screening Results for [001] Oriented PWA 1484 Specimens Tested in 34.5 MPa (5 ksi) Hydrogen at 0.167 Hz, 20°C (68°F), $R = 0.05$, $K_I = 2.18$; Comparison of PWA 1484, HTs 4 and 6 with PWA 1480

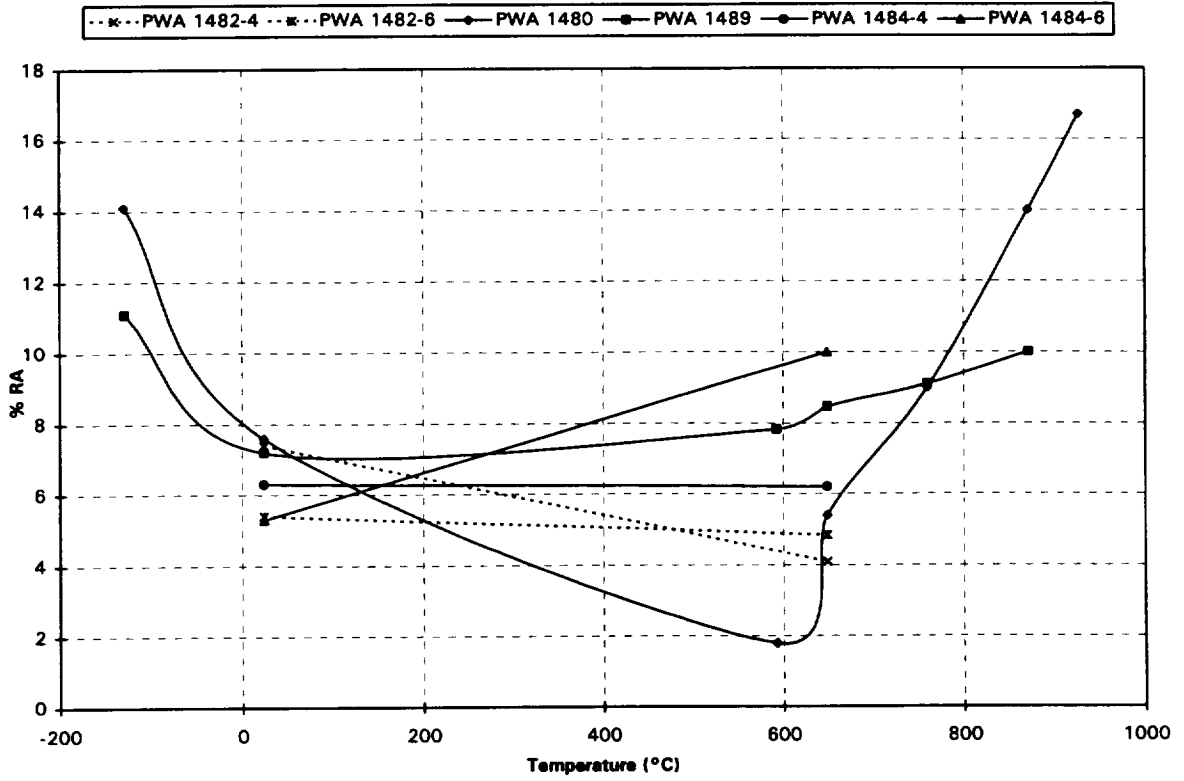
Figure 54. 34.5 MPa (5 ksi) Hydrogen Percent Reduction in Area Versus Temperature for PWA 1489 and [001] Oriented PWA 1480, PWA 1482, and PWA 1484

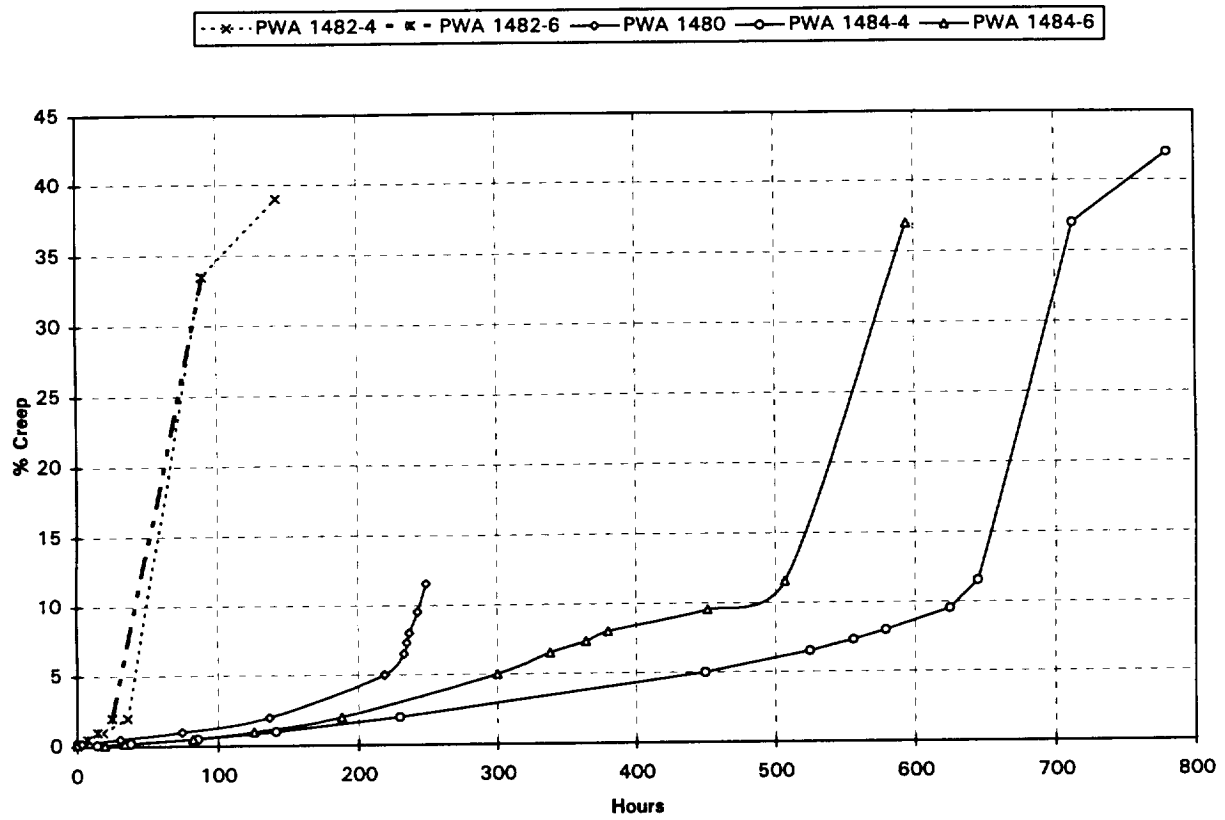
Figure 55. Air 871°C (1600°F) Creep Properties at 413.7 MPa (60 ksi) for [001] Oriented PWA 1480, PWA 1482, and PWA 1484

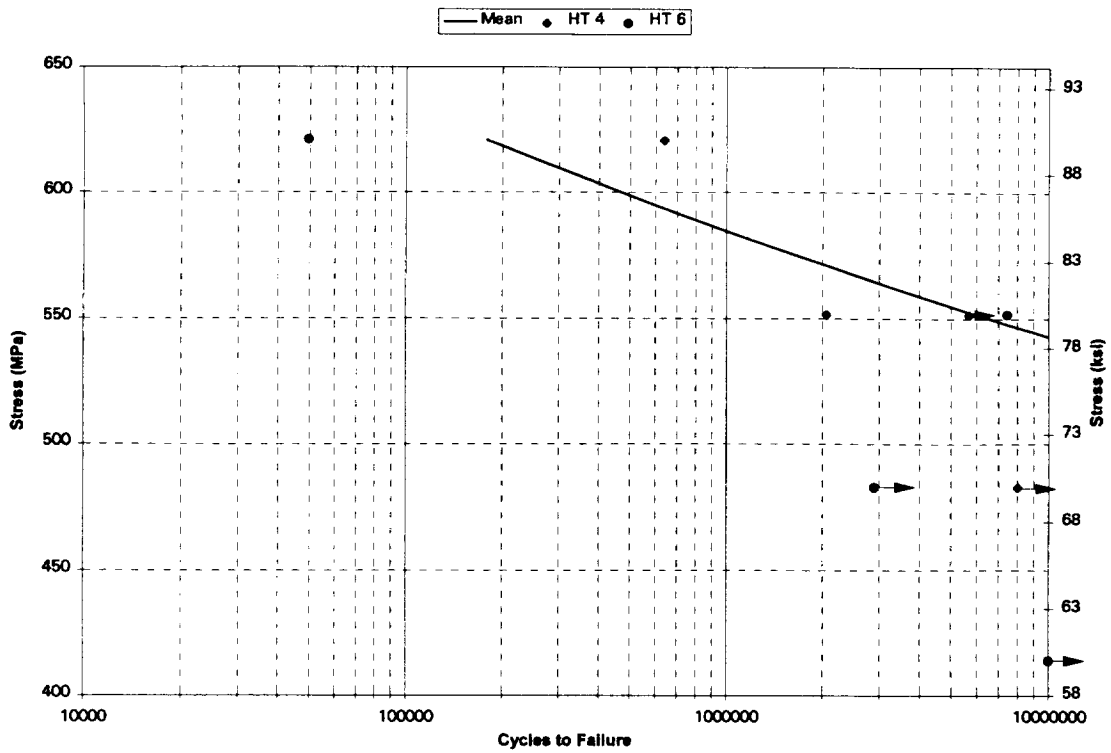
Figure 56. Load Controlled HCF Results for [001] Oriented PWA 1482 Specimens Tested in 34.5 MPa (5 ksi) Hydrogen at 0.167 Hz, 20°C (68°F), R = -1

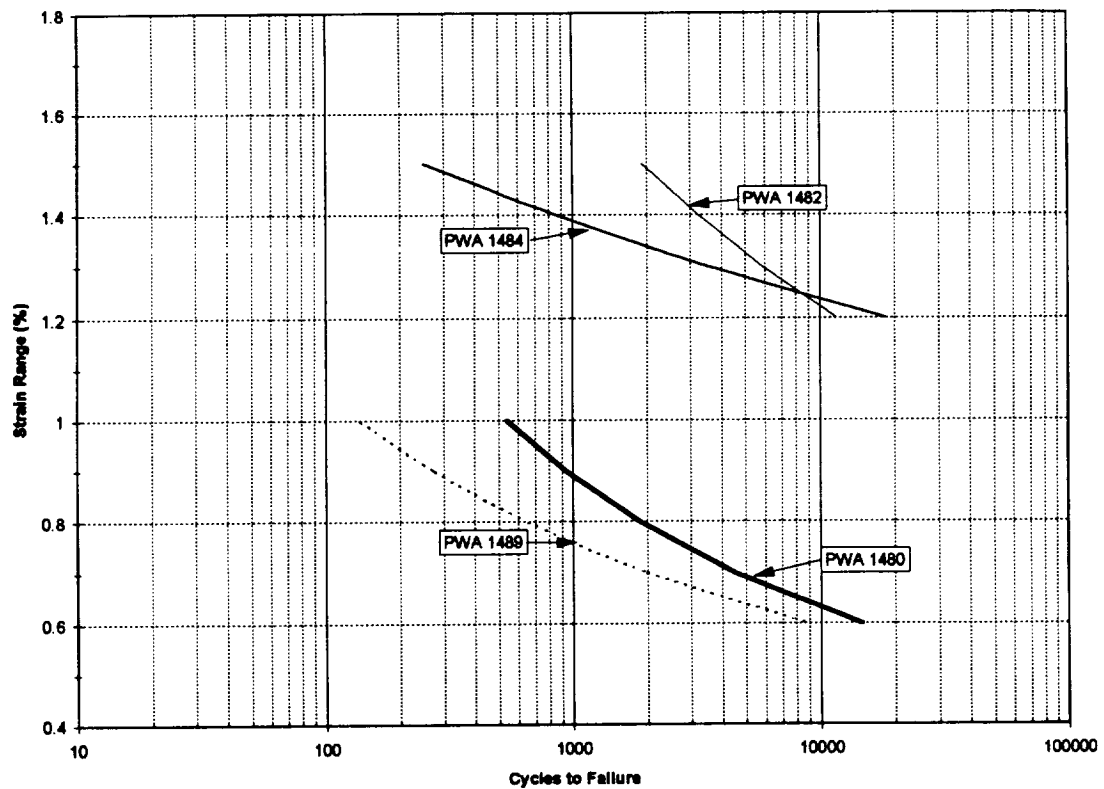
Figure 66. Alloy Comparison of Mean Curves 34.5 MPa (5 ksi) Hydrogen Strain Control LCF Results Smooth Specimens Tested at 0.167 Hz, 20°C (68°F), R = -1

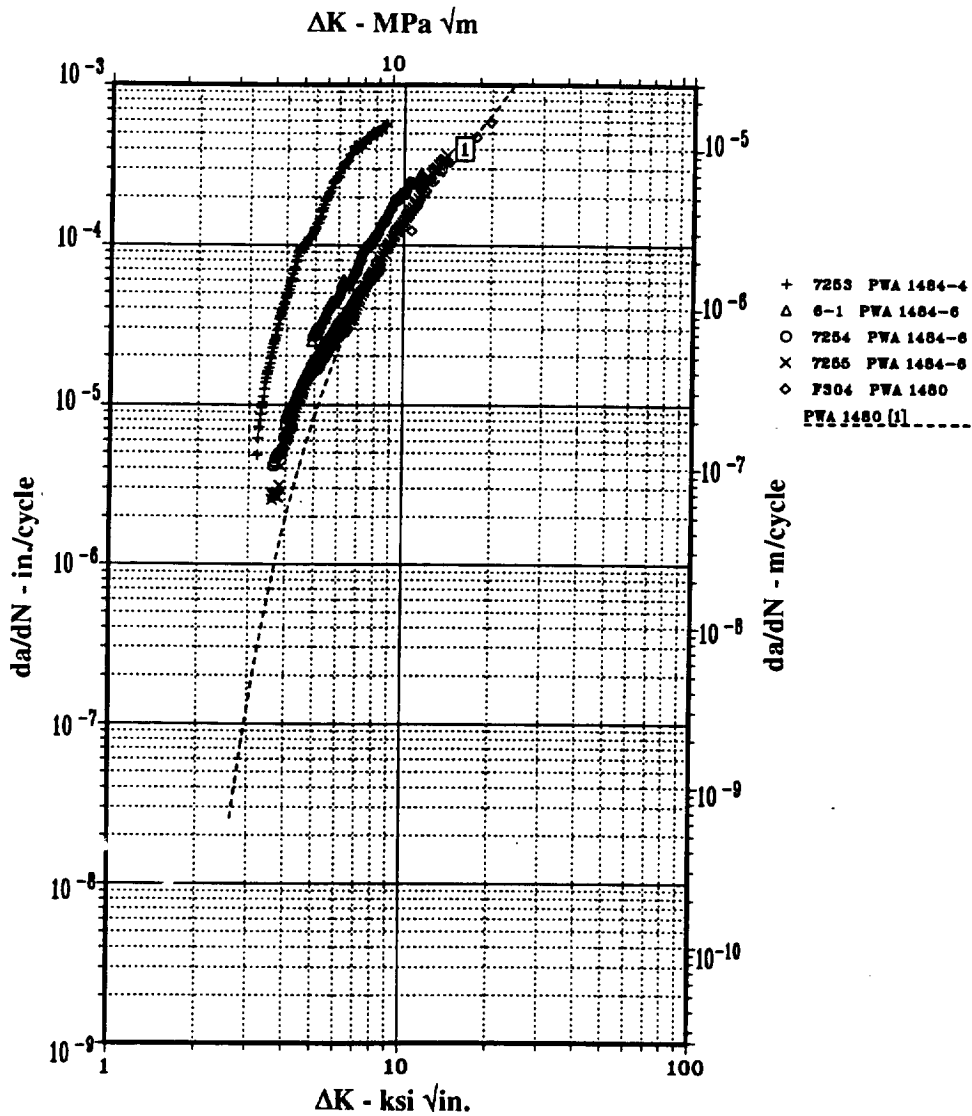
Figure 67. Fatigue Crack Growth Results for [001] Oriented PWA 1484 Tested in 34.5 MPa (5 ksi) Hydrogen at 0.167 Hz, 20°C (68°F), R = 0.1 Compared to PWA 1480 Data and Model for Same Condition

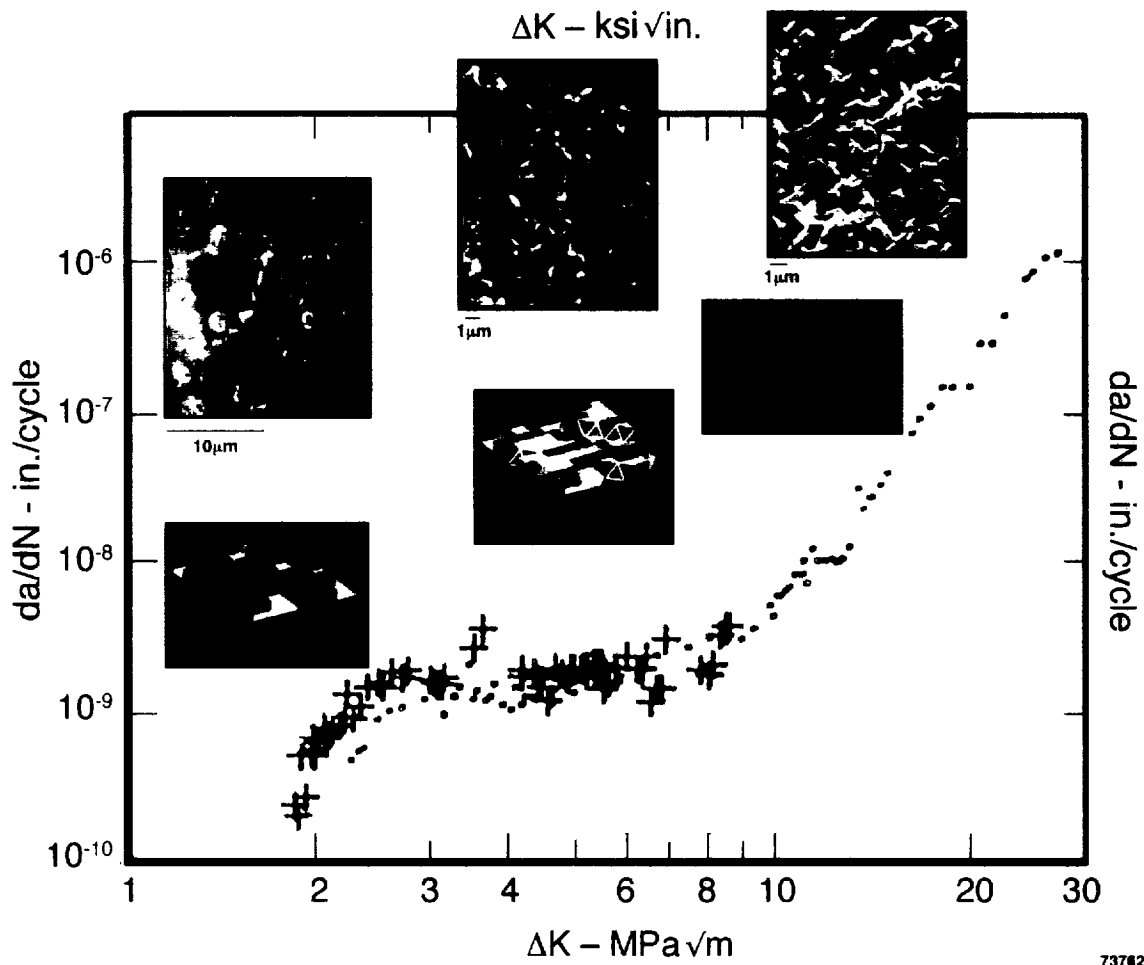
Figure 68. Microscopic Fracture Modes Dictate Crack Growth Behavior in Single-Crystals; Matrix Failure Prevails in Near Threshold Region (Left) and Is Shown Idealized and Fractographically Above the Data; In Region II, Propagation Is by Microscopic (111) Failure On the Size Order of the γ' Precipitate

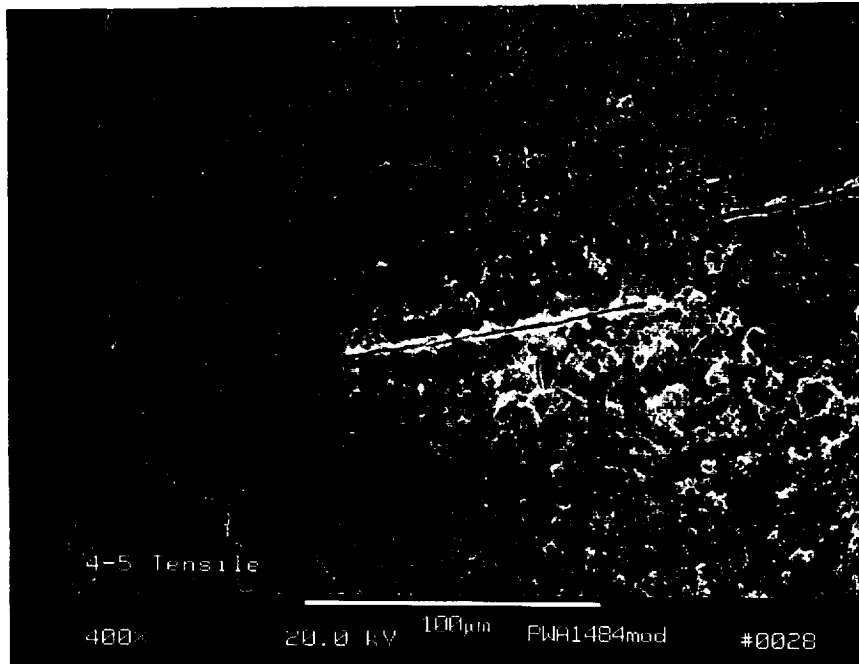
Figure 75. Larger Cracks in Same Specimen; Onset of this Form of Cracking Appears To Be Stress Intensity Dependent; Conditions – PWA 1484 HT 4, 20°C (68°F), 34.5 MPa (5 ksi) Hydrogen, Tensile

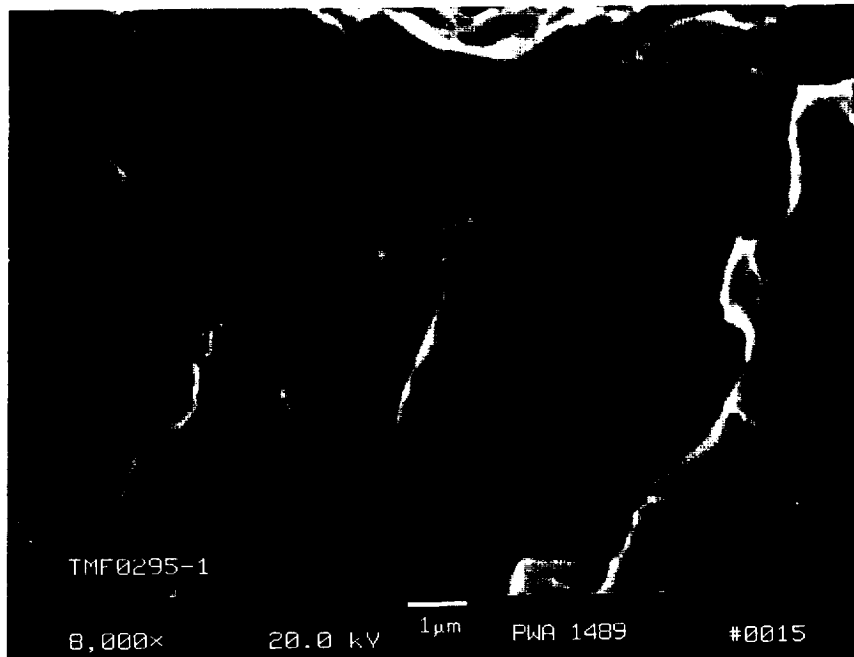
Figure 76. Lenticular Cracking in Cast γ' Superalloys in Hydrogen; This Example is Equiaxed Alloy, HIP Microcast MAR-M-247 (Notched LCF in 34.5 MPa (5 ksi) Hydrogen, 20°C (68°F))

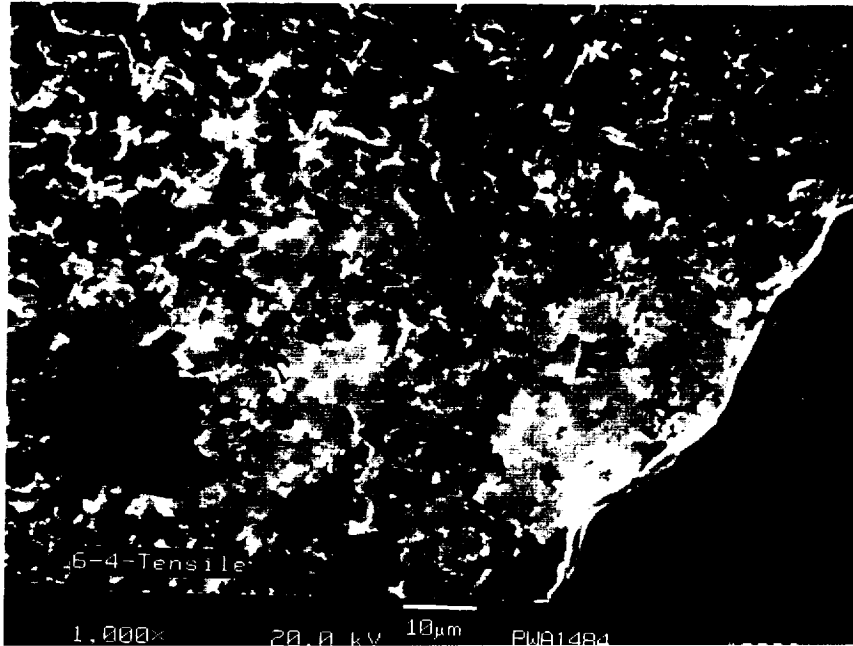
Figure 79. Detail of γ' Fracture Nominally Parallel to (001), But Decidedly Rough (Increased Crack Path Tortuosity). Microscopic (111) Fracture Outlines Primary γ' ; Conditions – PWA 1484 HT 6, 20°C (68°F), 34.5 MPa (5 ksi) Hydrogen, Tensile

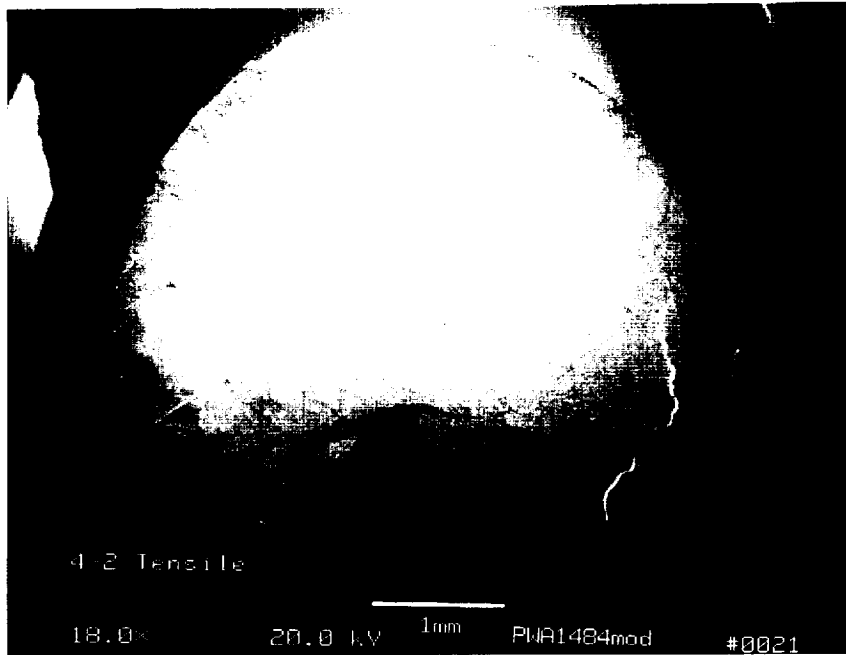
Figure 85. Overall View of PWA 1484 HT 4 Tested in Air at Room Temperature Showing Single (111) Planar Fracture; Conditions – PWA 1484 HT 4, 650°C (1200°F), Air, Tensile

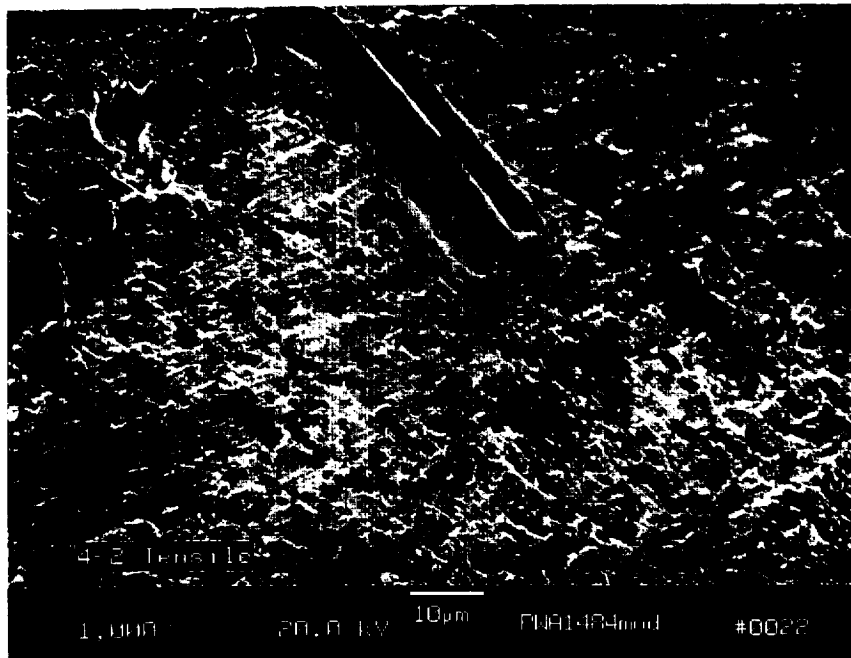
Figure 86. High-Magnification View of (111) Fracture Surface Shows Oxidized γ Phase and Roughness Associated With Bimodal γ' ; Conditions – PWA 1484 HT 4, 650°C (1200°F), Air, Tensile

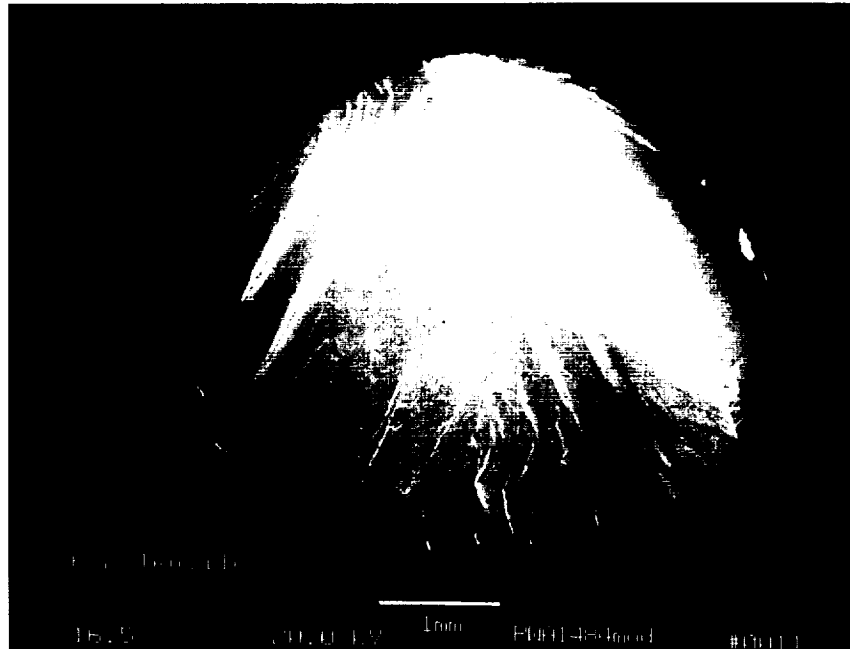
Figure 87. Overall View of PWA 1484 HT 6 Tested in Air at 650°C (1200°F) Showing Two Intersecting (111) Fracture Planes (Typical of Elevated Single-Crystal Tensile Failures); Conditions – PWA 1484 Microstructure HT 6, 650°C (1200°F), Air, Tensile

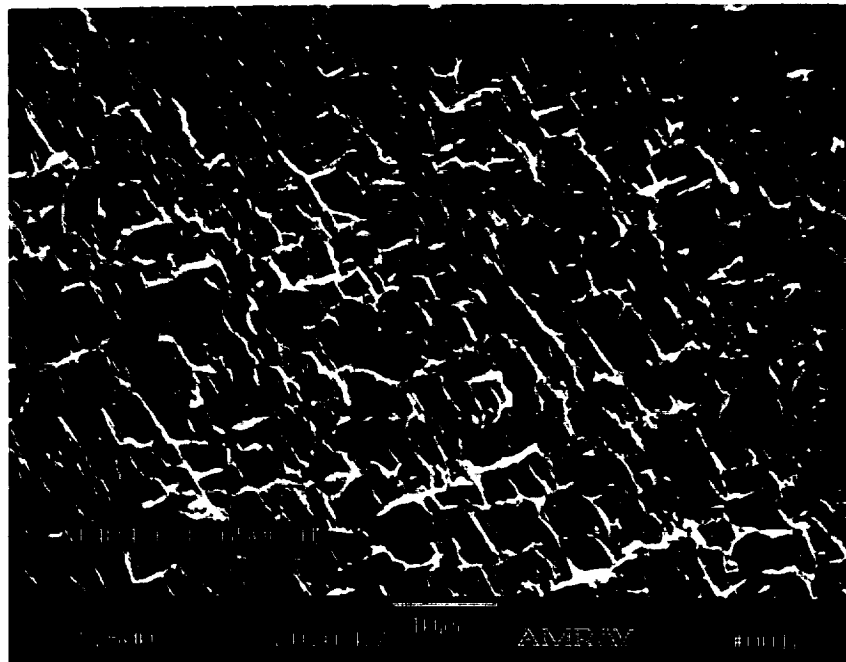
Figure 91. High-Magnification View of (111) Fracture Surface Shows High Degree of Ductility in γ Phase Versus 650°C (1200°F) Air Tests; Conditions – PWA 1484 HT 6, 650°C (1200°F) Hydrogen, Tensile

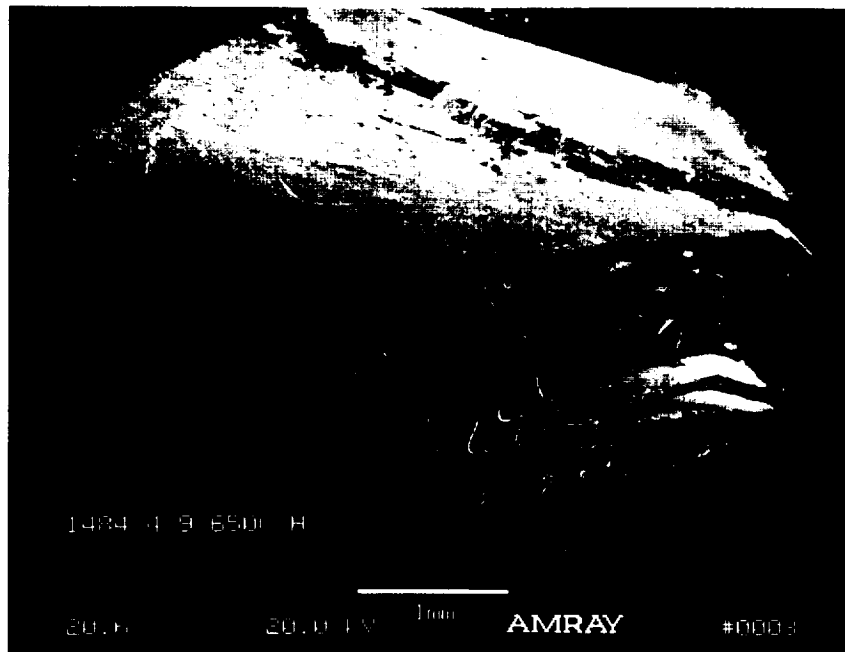
Figure 92. Overall View of PWA 1484 HT 4 Tested in 650°C (1200°F) Hydrogen Showing Prominent Macroscopic (111) Planes and Steps (Detailed in Subsequent Figures; Conditions – PWA 1484 HT 4, 650°C (1200°F), Hydrogen, Tensile
