INVESTIGATION OF ADVANCED PROCESSED SINGLE-CRYSTAL TURBINE BLADE ALLOYS

**United Technologies Corporation
Pratt & Whitney
Government Engines & Space Propulsion
P.O. Box 109600
West Palm Beach, FL 33410-9600**

December 1995

Under Contract: NAS8-39050

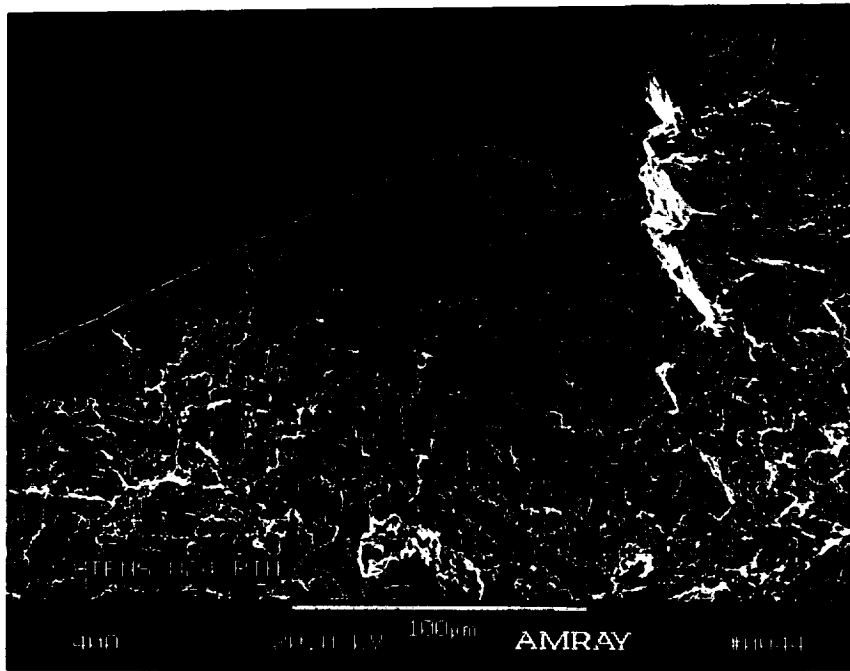
Figure 97. At 400X, Microstructure Can Be Discerned Because of Differential Fracture Modes in Primary Versus Fine Cuboidal γ' ; At low stress intensity (ΔK), Fracture Is Nearly All Nominally (001); As ΔK Increases, Fine Cuboidal Precipitates Begin To Fracture Along (111) Planes Delineating Larger Primary γ' ; Conditions – PWA 1482 HT 4, 20°C (68°F), Hydrogen, Tensile.

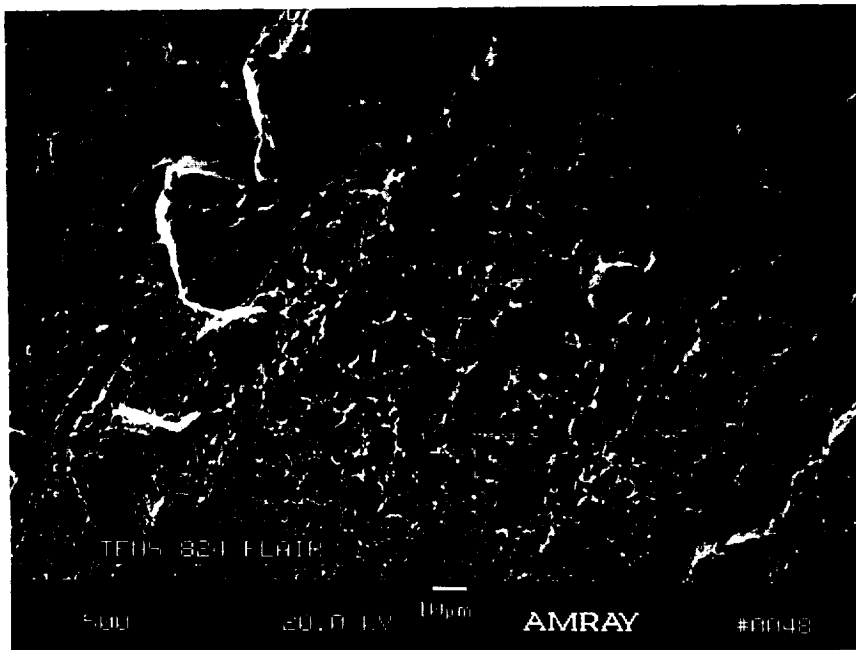
Figure 100. Cellular Appearance of (111) Fracture Plane Is a Result of Microstructure and Appears To Be Associated With Unusual Roughness (Presumed Beneficial Under Conditions Where Octahedral Crack Initiation Is a Concern); Conditions – PWA 1482 HT 4, 650°C (1200°F), Air, Tensile

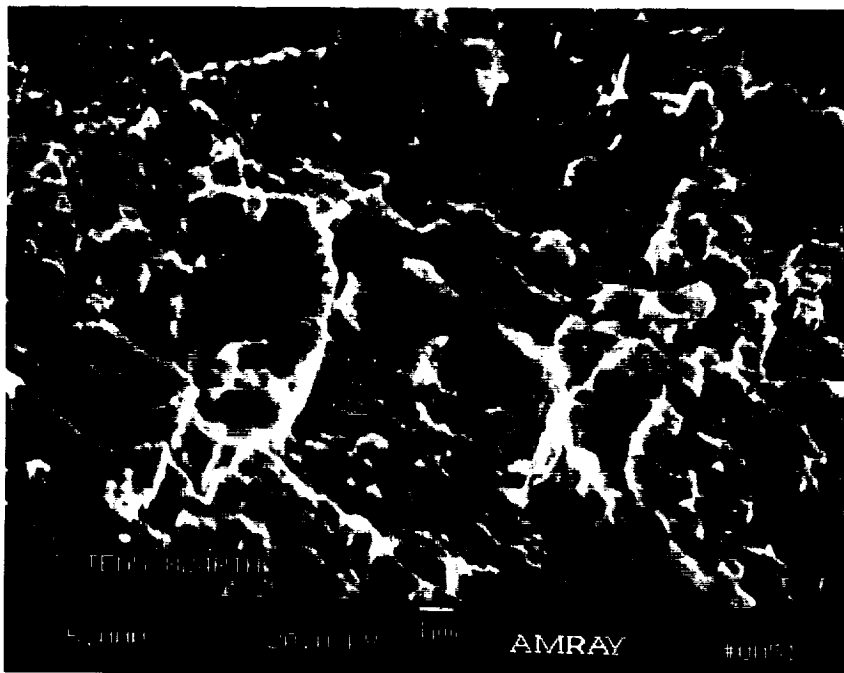
Figure 102. High-Magnification View of (111) Fracture Suggests Some Structure Within Primary γ' ; Conditions – PWA 1482 HT 4, 650°C (1200°F), Hydrogen, Tensile

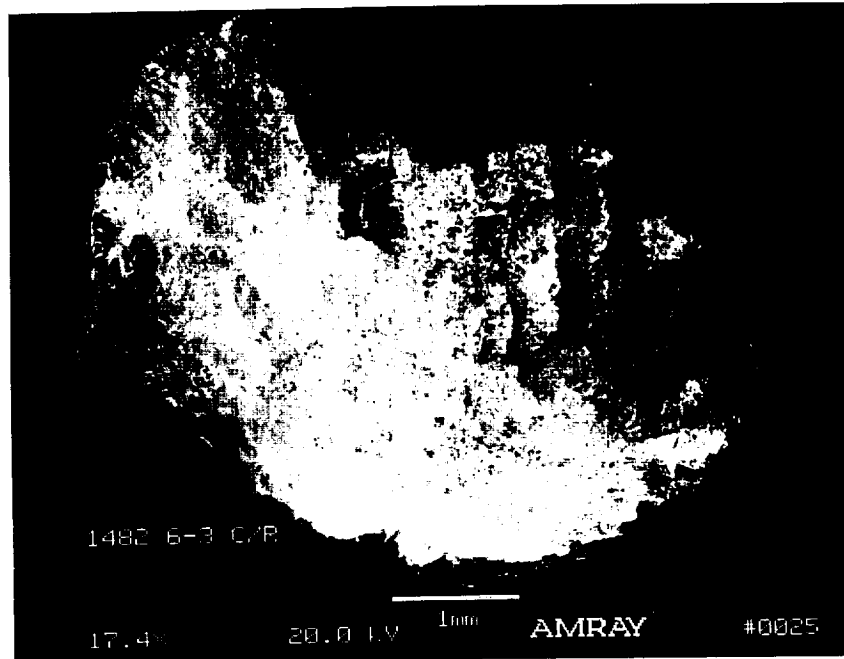
Figure 103. Overall View of Creep/Stress Rupture Fracture Produced in Air Showing Mixed Noncrystallographic and (111) Crystallographic Fracture; Conditions – PWA 1482 HT 6, 871°C (1600°F), Air, Creep/Stress Rupture

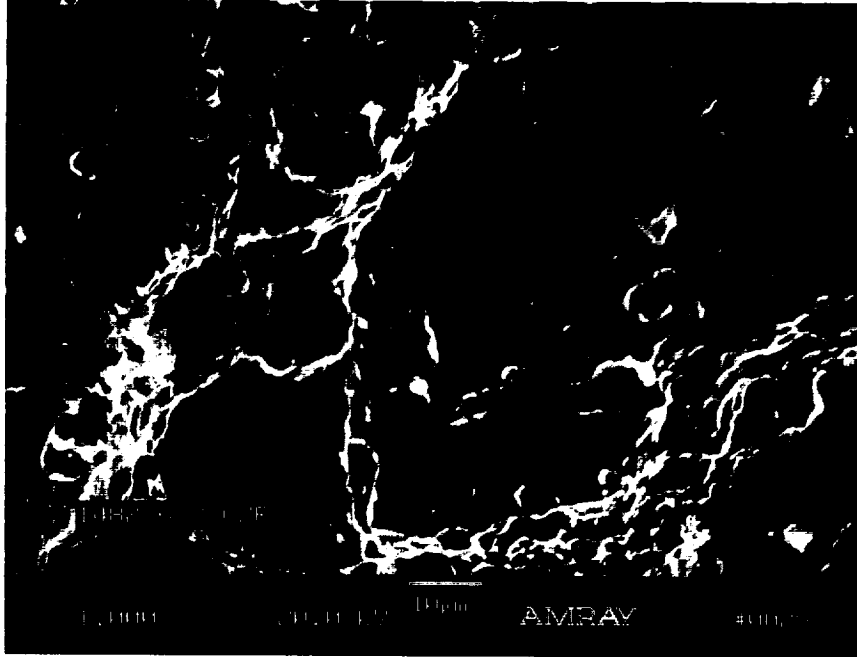
Figure 104. High-Magnification View of Stress Rupture Fracture Details; Conditions – PWA 1482 HT 6, 871°C (1600°F), Air, Creep/Stress Rupture

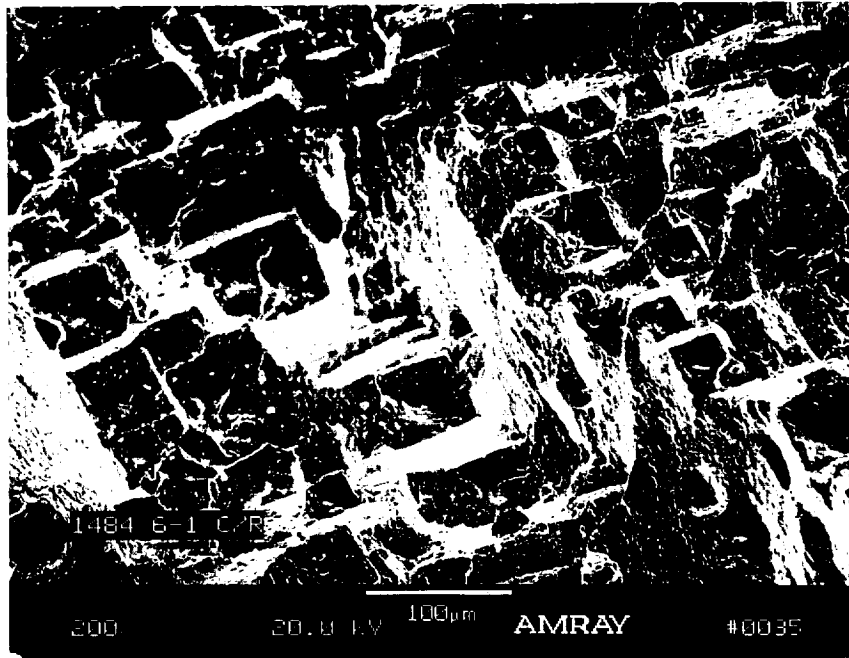
Figure 106. High-Magnification View of Stress Rupture Fracture Details Shows Large Area of (111) Fracture; Conditions – PWA 1484 HT 6, 871°C (1600°F), Air, Creep/stress Rupture

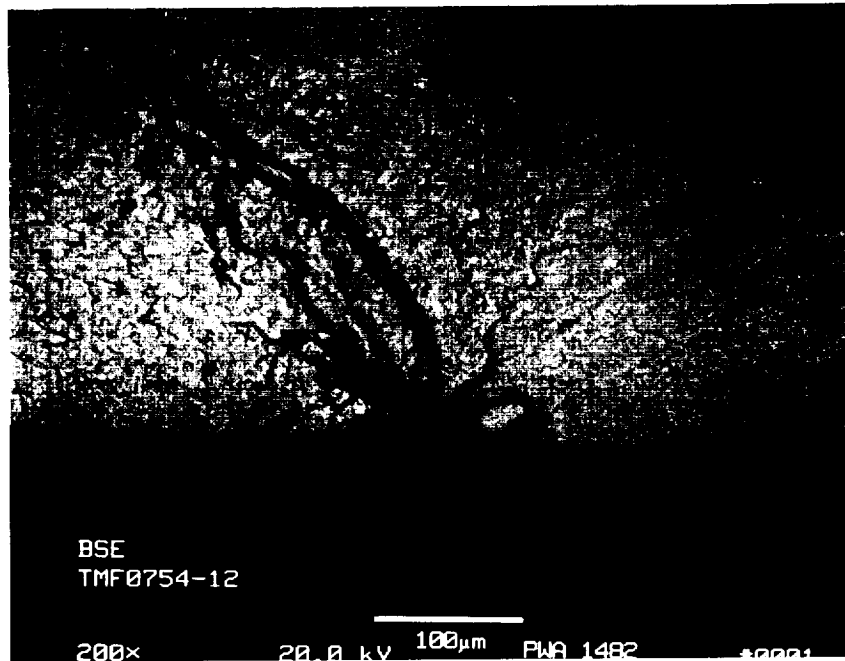
Figure 109. Crystallographic Fatigue Crack Origins and Microscopic (111) Fracture in Fine Cuboidal γ ; Conditions – PWA 1482 HT 4, Notched LCF, 20°C (68°F), 34.5 MPa (5 ksi) Hydrogen

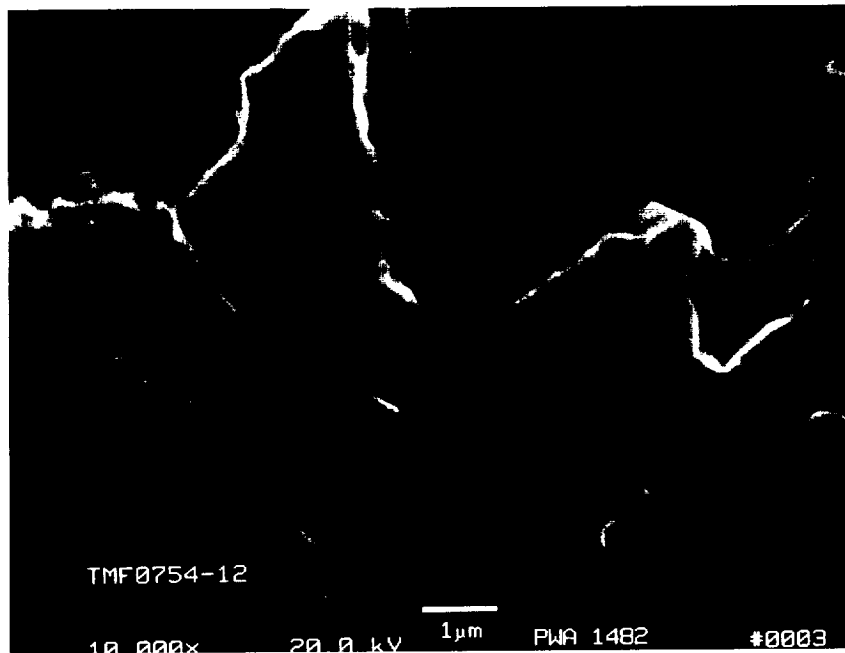
Figure 110. Lenticular (001) Cracking Cutting Large Primary γ ; Conditions – PWA 1482 HT 4, Notched LCF, 20°C (68°F), 34.5 MPa (5 ksi) Hydrogen

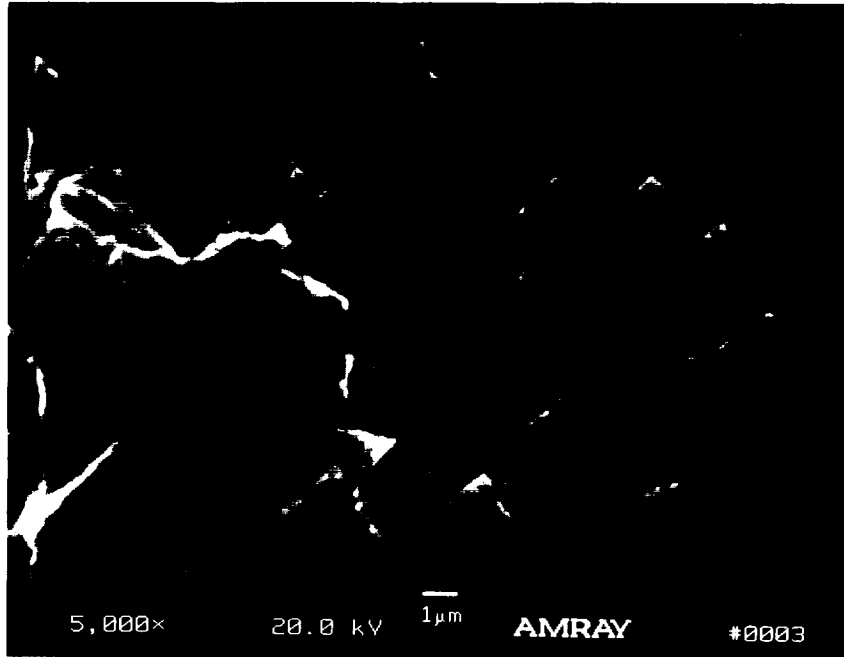
Figure 111. In Some Cases Secondary Cracks Appeared To Be Skirting Primary γ' ; Conditions – PWA 1482 HT 6, Notched LCF, 20°C (68°F), 34.5 MPa (5 ksi) Hydrogen

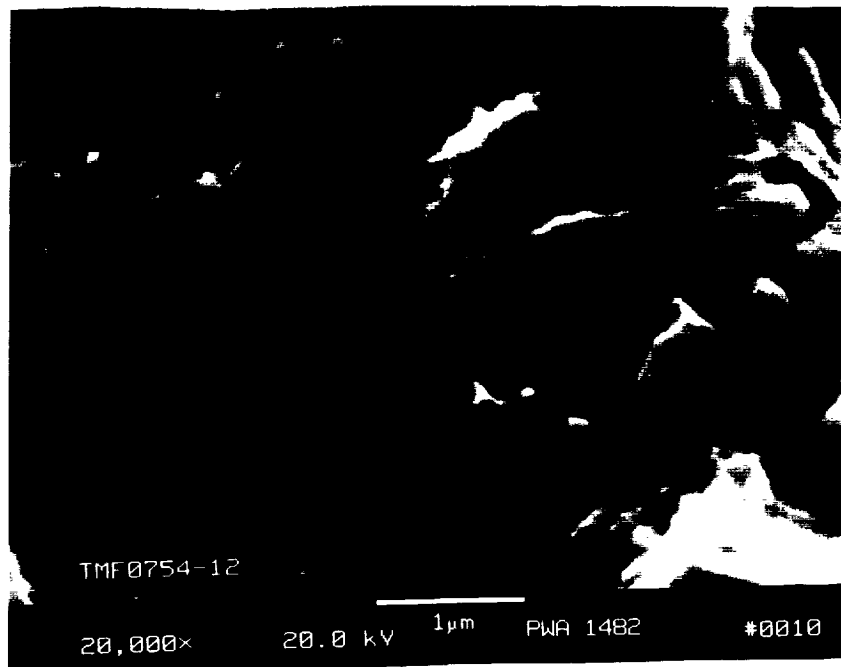
Figure 115. SEM Imagery of Primary γ' Fracture Surfaces Suggests Structure Within Large Primary γ' (Possibly γ Phase Retrograde Solubility)

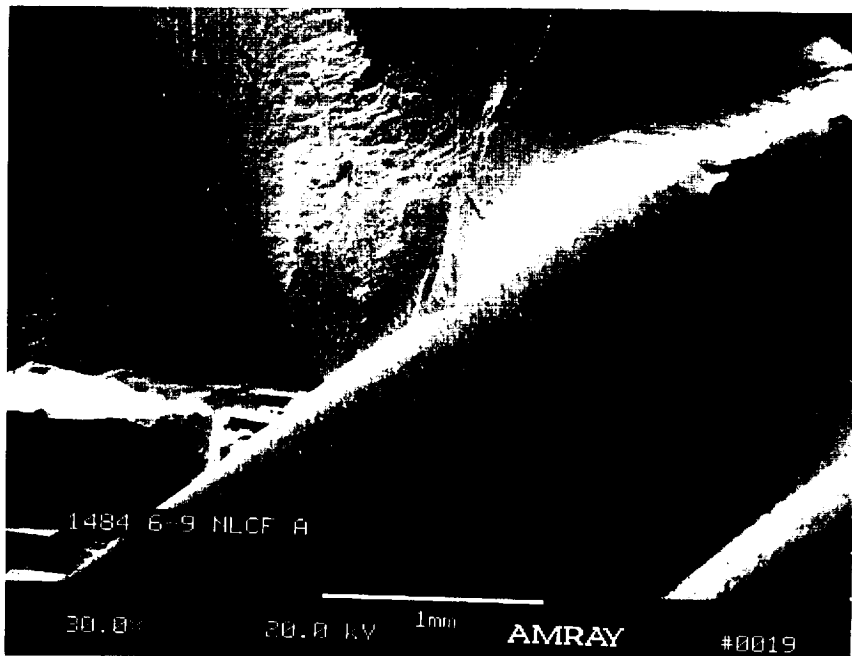
Figure 120. Similar to Previous Fracture in Figure 115; Overall View of Notched LCF Air Fracture Shows Typical (111) Fracture; Conditions – PWA 1484 HT 6, Notched LCF, 20°C (68°F), Air

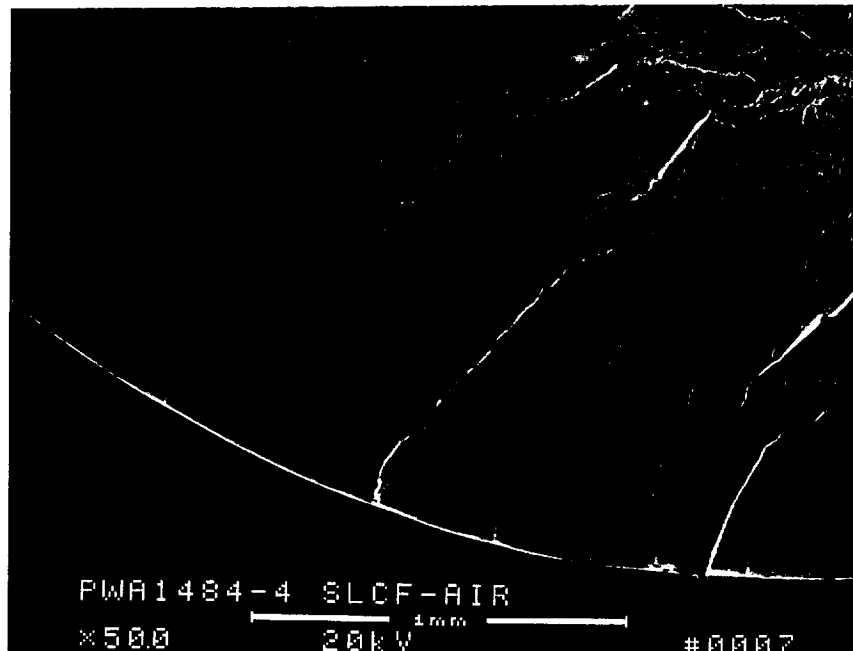
Figure 123. Detail of Origin Area From Figure 122; Conditions – PWA 1484 HT 4, 20°C (68°F), Air, Controlled Strain LCF

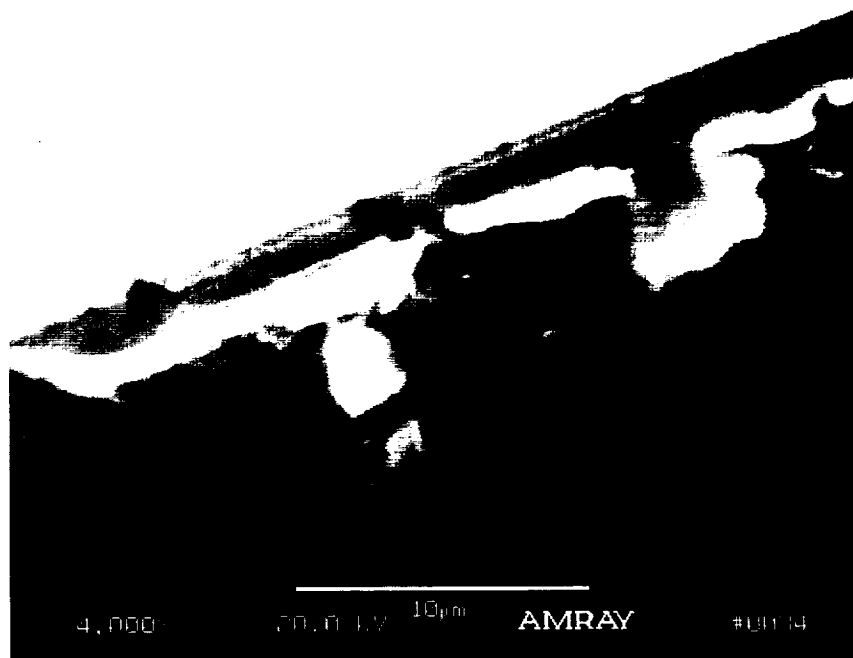
Figure 132. Fatigue Crack Origin From Figure 131 Shows Extremely Flat Fracture and Apparent Machining Marks at Specimen Edge; Conditions – PWA 1482 HT 4, 20°C (68°F), 34.5 MPa (5 ksi) Hydrogen, Controlled Strain LCF

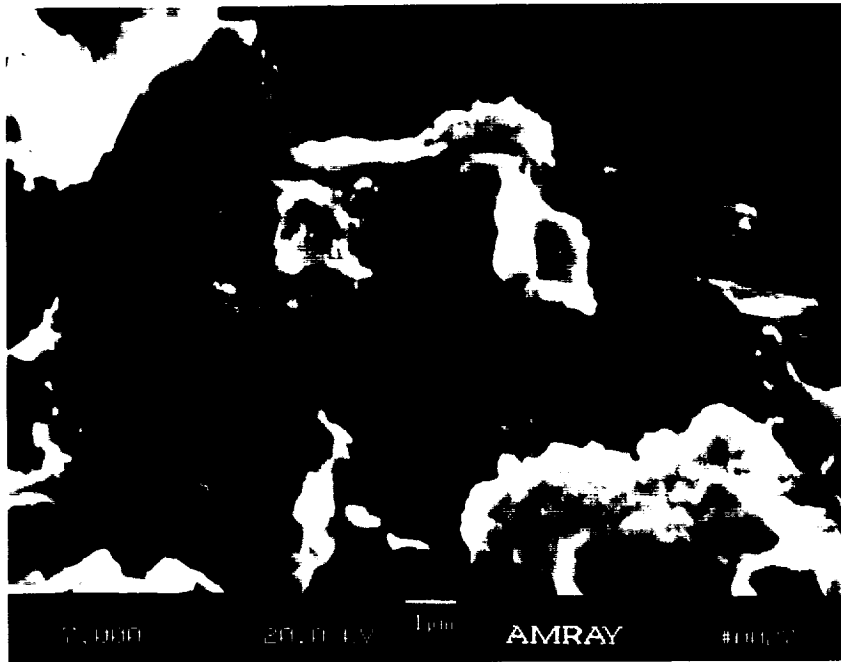
Figure 136. Detail From Lower Right of Figure 134; Interprecipitate (Primary γ') (111) Fracture Mode Is Not Well Resolved and Appears Distorted; Regardless, This Topography Represents More Tortuous Crack Path Than That Offered by Conventional Fine Uniform Cuboidal γ' Structure; Conditions – PWA 1482 HT 6, 20°C (68°F), 34.5 MPa (5 ksi) Hydrogen, Controlled Strain LCF

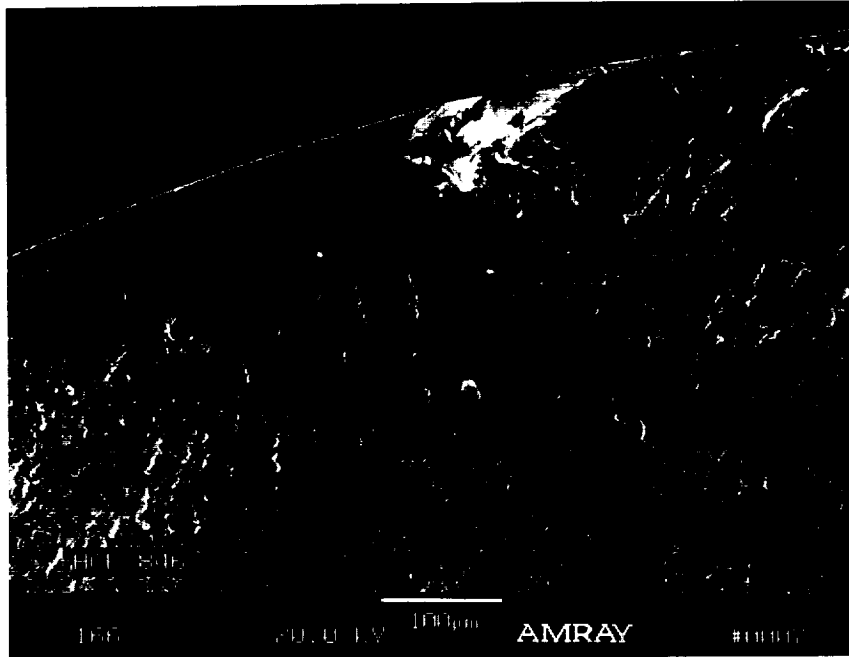
Figure 139. HCF Crack Initiation at 100 μm Long (111) Facet From Figure 135; Conditions – PWA 1484 HT 4, 20°C (68°F), 34.5 MPa (5 ksi) Hydrogen, R = -1.0 HCF

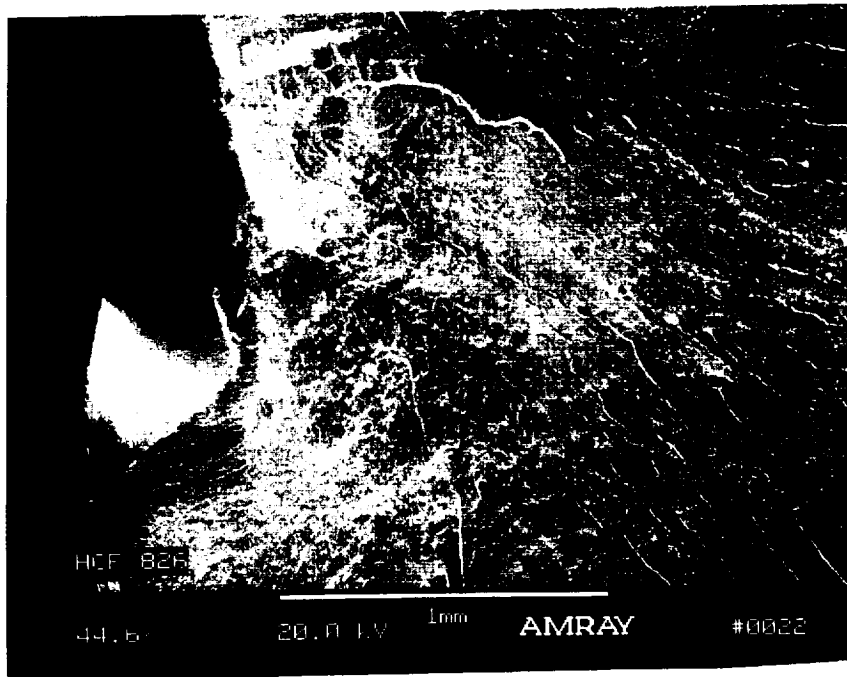
Figure 141. HCF Crack Initiation at 1mm (0.039 in.) Long (111) Facet From Figure 136; Conditions – PWA 1482 HT 6, 20°C (68°F), 34.5 MPa (5 ksi) Hydrogen, R = -1.0 HCF

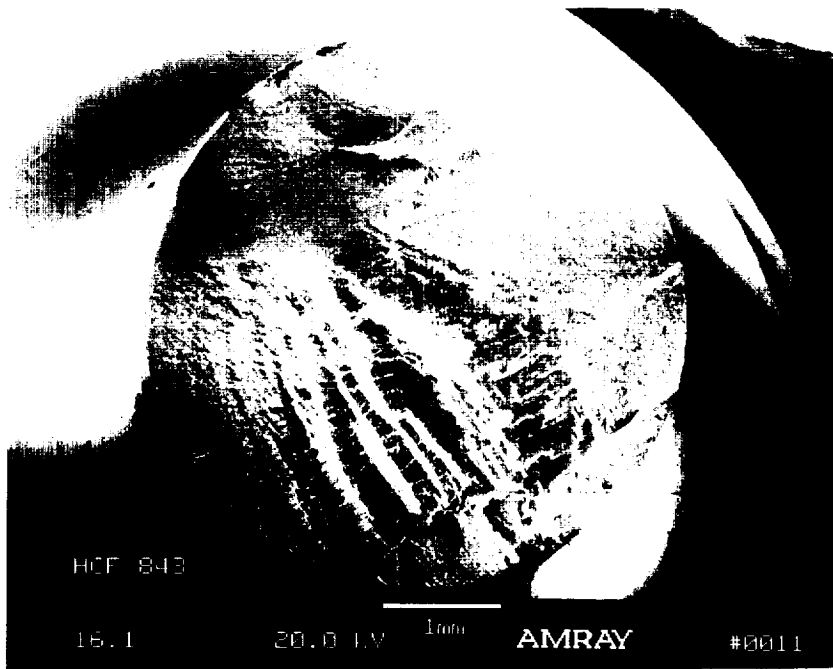
Figure 142. PWA 1484 HT 6 HCF Overall View; Crack Origin Area (At Right) Shows Prominent (111) Fracture; Conditions – PWA 1484 HT 6, 20°C (68°F), 34.5 MPa (5 ksi) Hydrogen, R = -1.0 HCF

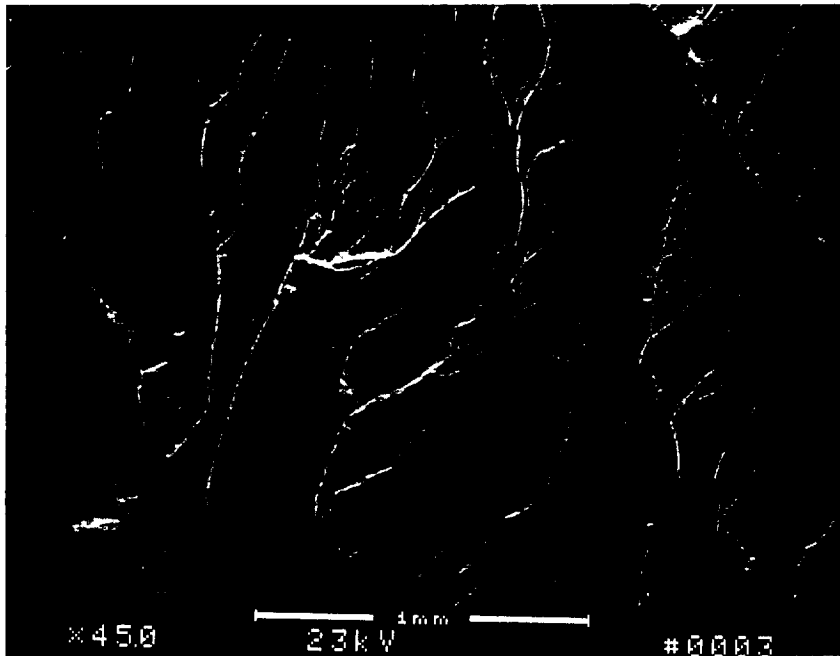
Figure 144. Fatigue Crack Growth in Hydrogen at Low Stress Intensity; Note Crack Front From Air Pre-crack at Top of Micrograph; Micromechanical Damage Was Extensive With Propagation on Multiple Parallel Planes; Crack Advance Was Extremely Rapid; Conditions – PWA 1484 HT 1, Fatigue Crack Growth in 20°C (68°F), 34.5 MPa (5 ksi) Hydrogen, R = 0.1, 0.16 Hz

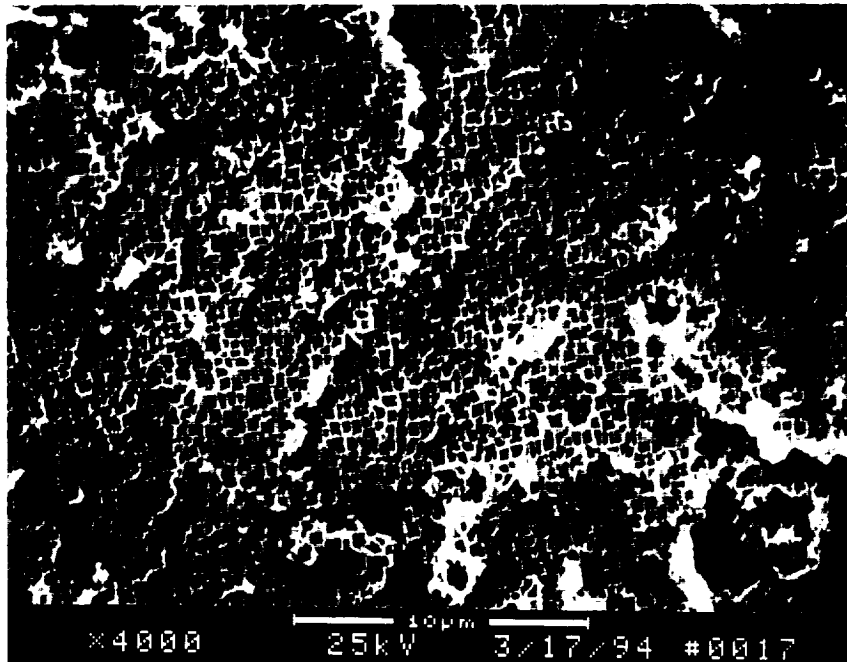
Figure 146. Microscopic Fracture Mode From Figure 145 Etched in This Case Shows Layers of γ Exhibiting "Stepped" Appearance Associated With Matrix Failure; Conditions – PWA 1484 HT 1, Fatigue Crack Growth in 20°C (68°F), 34.5 MPa (5 ksi) Hydrogen, R = 0.1, 0.16 Hz

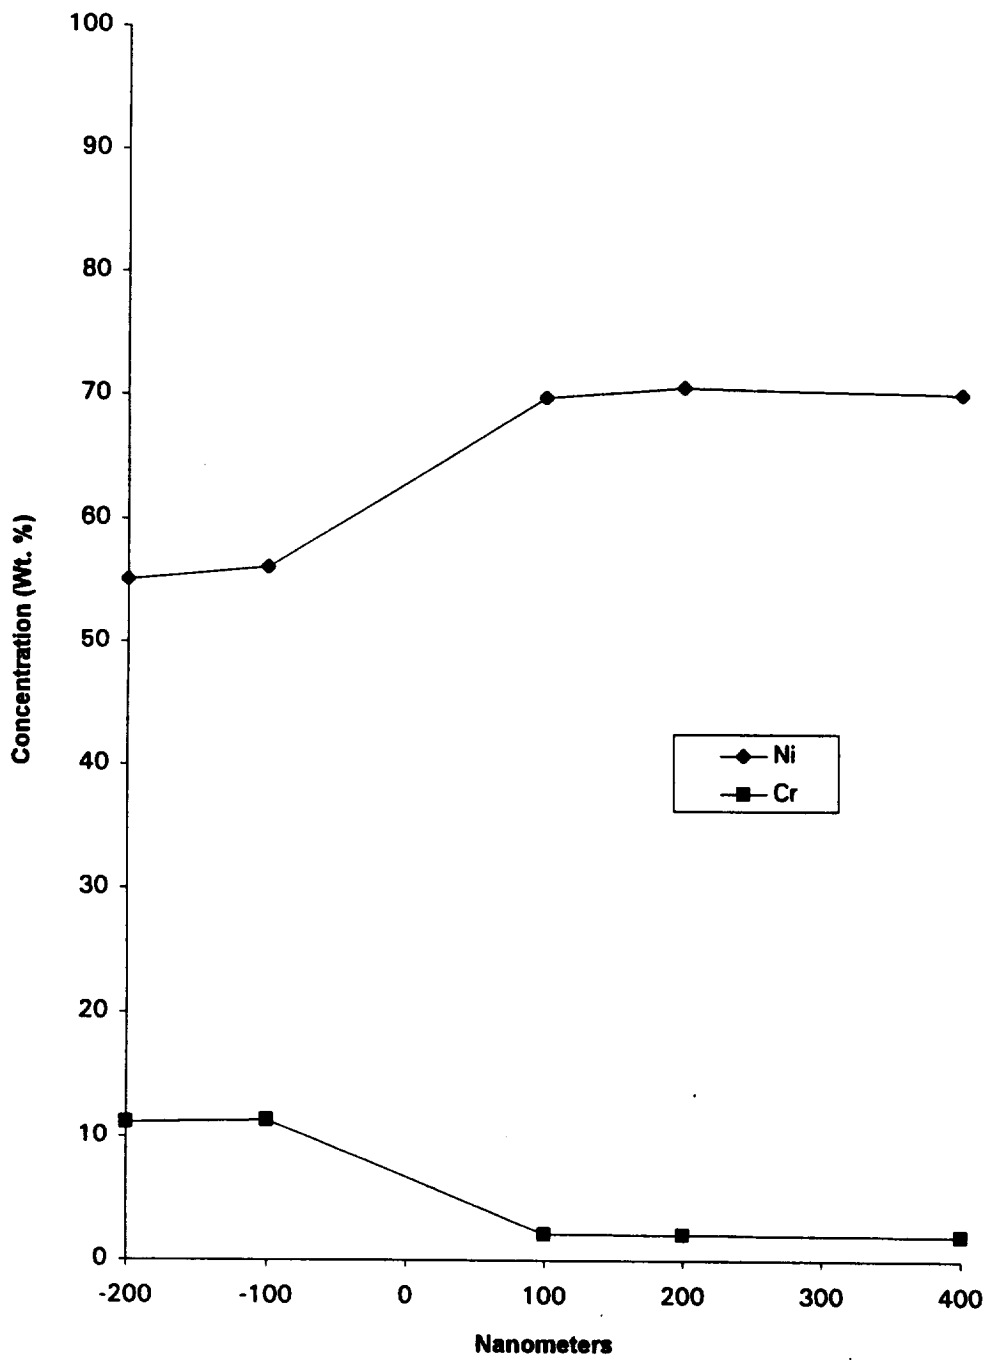
Figure 152. γ/γ' Phase Composition gradients for Ni and Cr in PWA 1484 HT 4; γ/γ' Interface is at zero nanometers

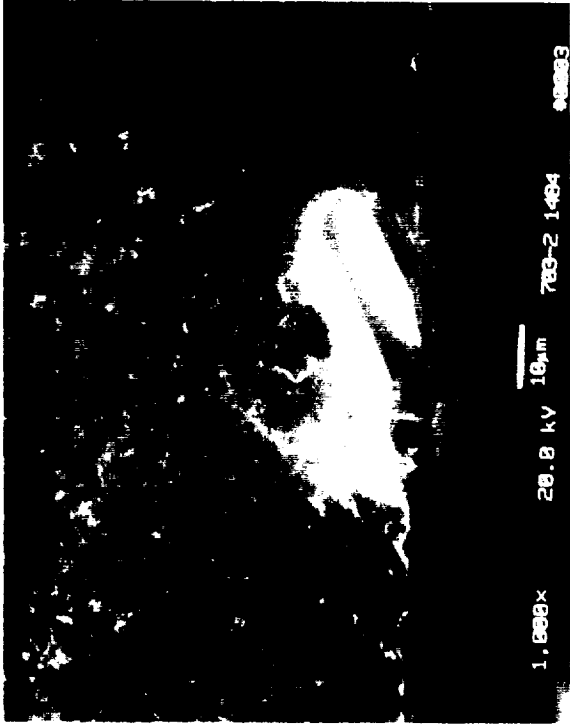
Figure 158. Heat Treatment 2

**APPENDIX C — NOTCHED LOW-CYCLE FATIGUE FRACTURES FROM HEAT TREATMENTS 1
THROUGH 7 PRODUCED AT 20°C (68°F) IN 34.5 MPA (5 KSI) HYDROGEN**
