NASA Contractor Report CR-195395

# Two Rotor Stratified Charge Rotary Engine (SCRE) Engine System Technology Evaluation

**T. Hoffman, J. Mack and R. Mount**  
*Rotary Power International, Inc.*  
*Wood-Ridge, New Jersey*

October 1994

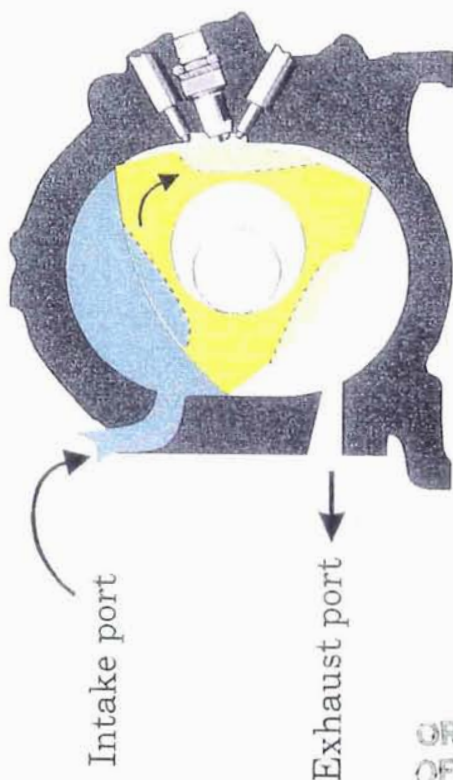
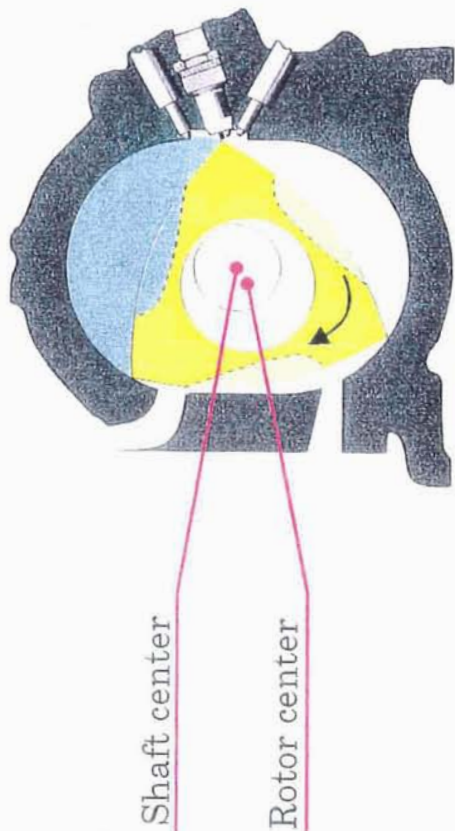
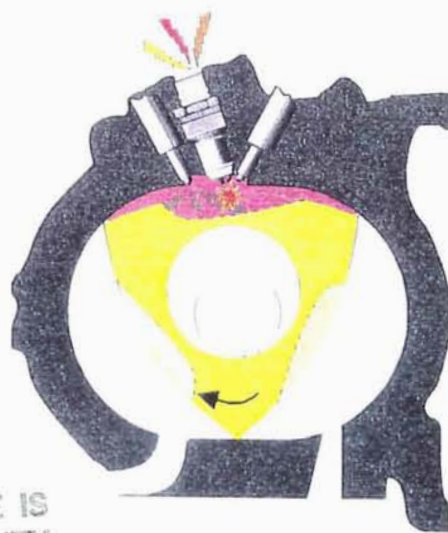
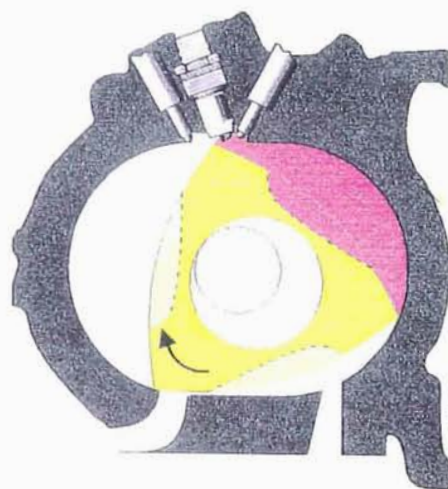
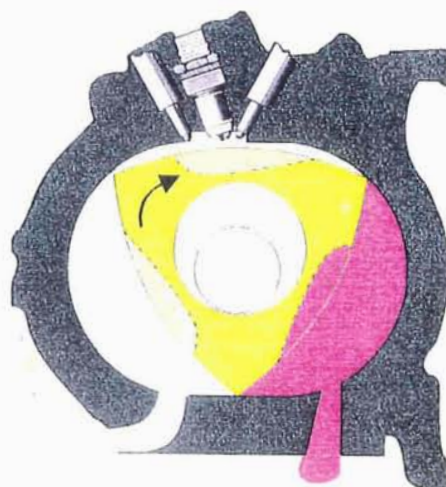
# Direct Injected Stratified Charge Combustion Cycle

Note: Events shown for one flank only for clarity. Other two flanks follow same cycle.

INTAKE

COMPRESSION

IGNITION

EXPANSION

EXHAUST

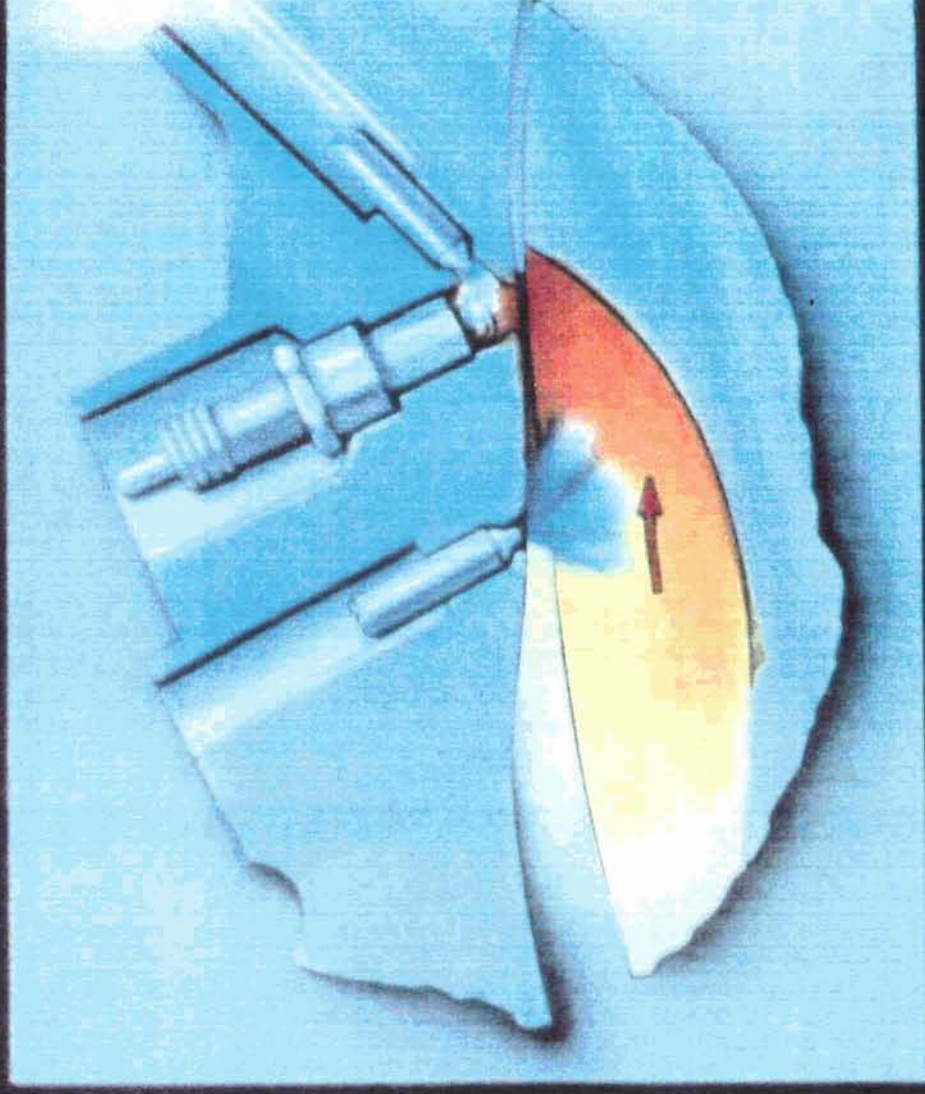
Figure 2.3-2

# Stratified Charge Ignition System

- Competitive fuel consumption
- Cold starting capability
- Broad operating range
- Independent from Cetane number

Figure No. 2.3-2 presents an enlarged view of the basic injection-ignition geometry. The pilot injector provides a small quantify of fuel (less than 5% of the total fuel flow) and maintains a constant volume per stroke. A stoichiometric mixture is created at the spark plug pilot injector region for spark ignitable conditions independent of fuel type. A wide variation in fuel flow as a function of load demand can then be introduced by the main injector into the pilot initiated combustion. This separation of main injector and pilot injector permits optimization of conditions in the light off zone.

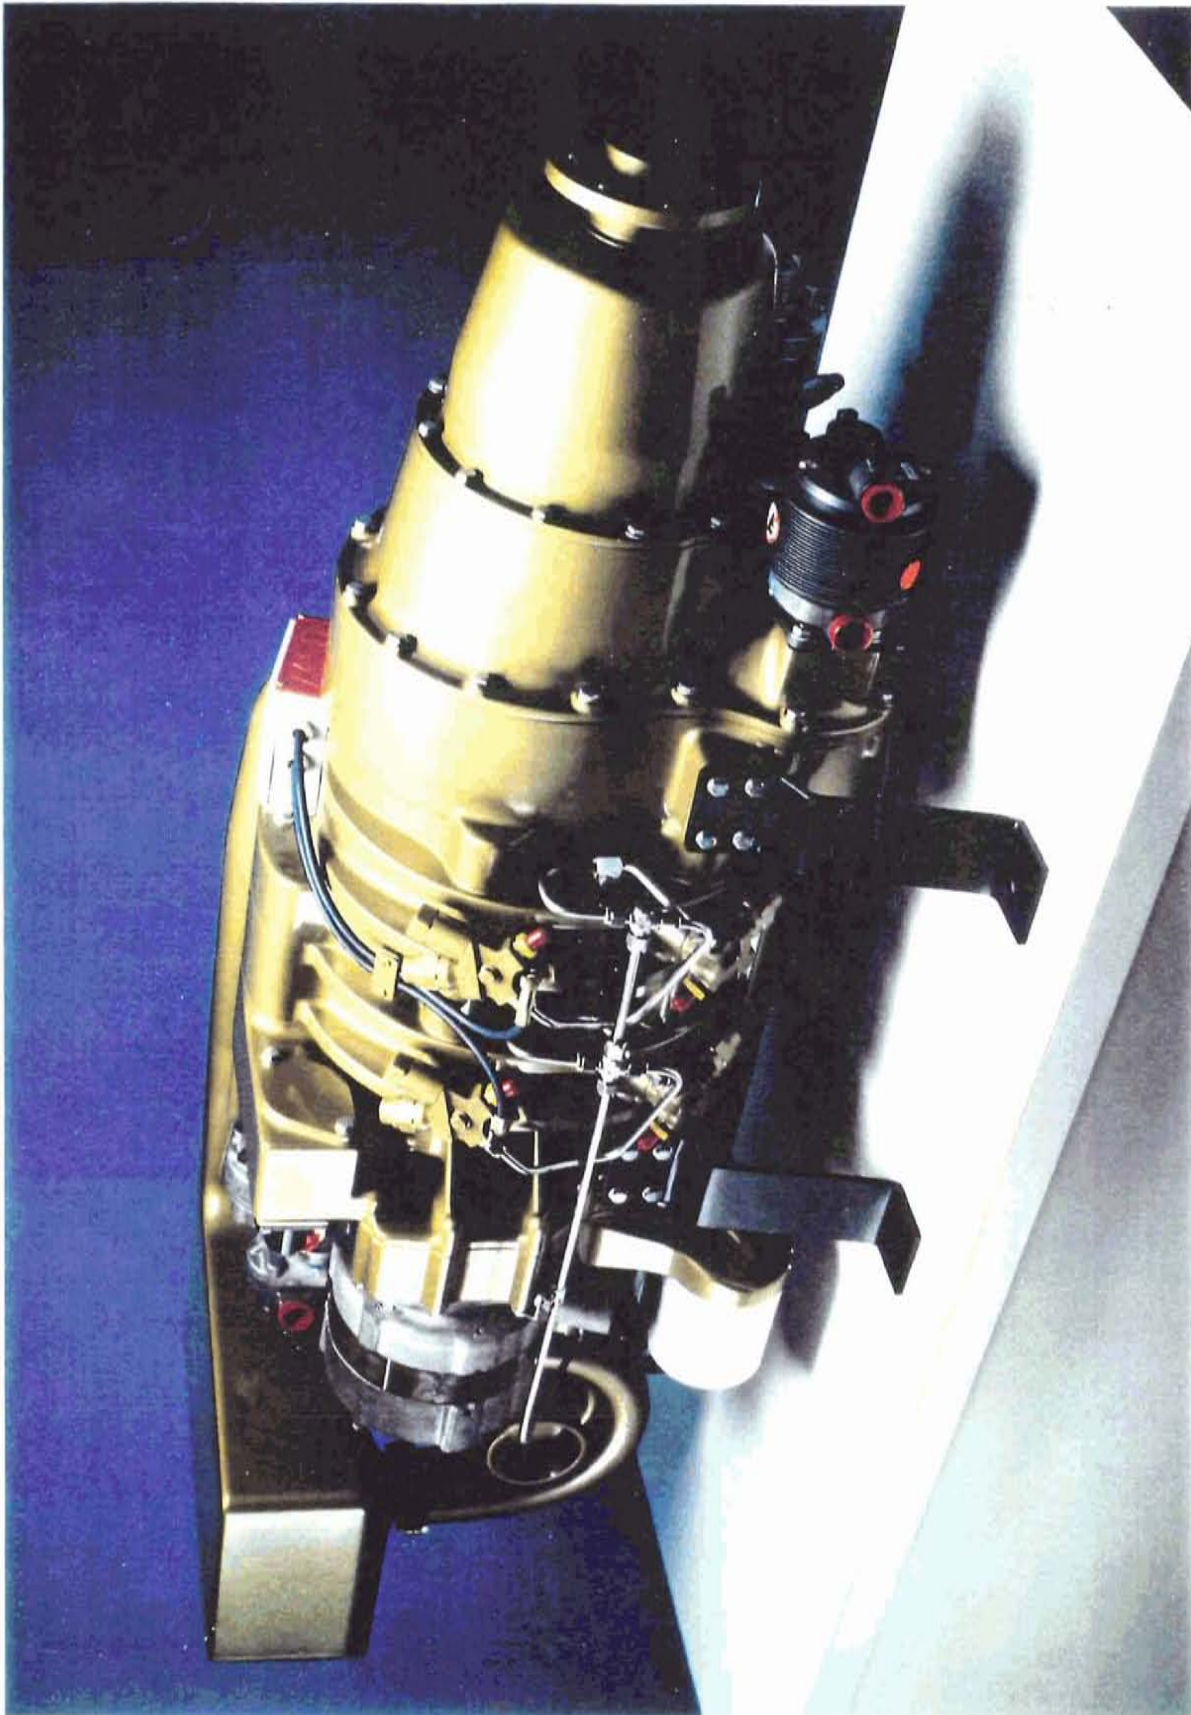
Figure 2.3-3

**2013R AVIATION ENGINE  
GENERAL ARRANGEMENT**

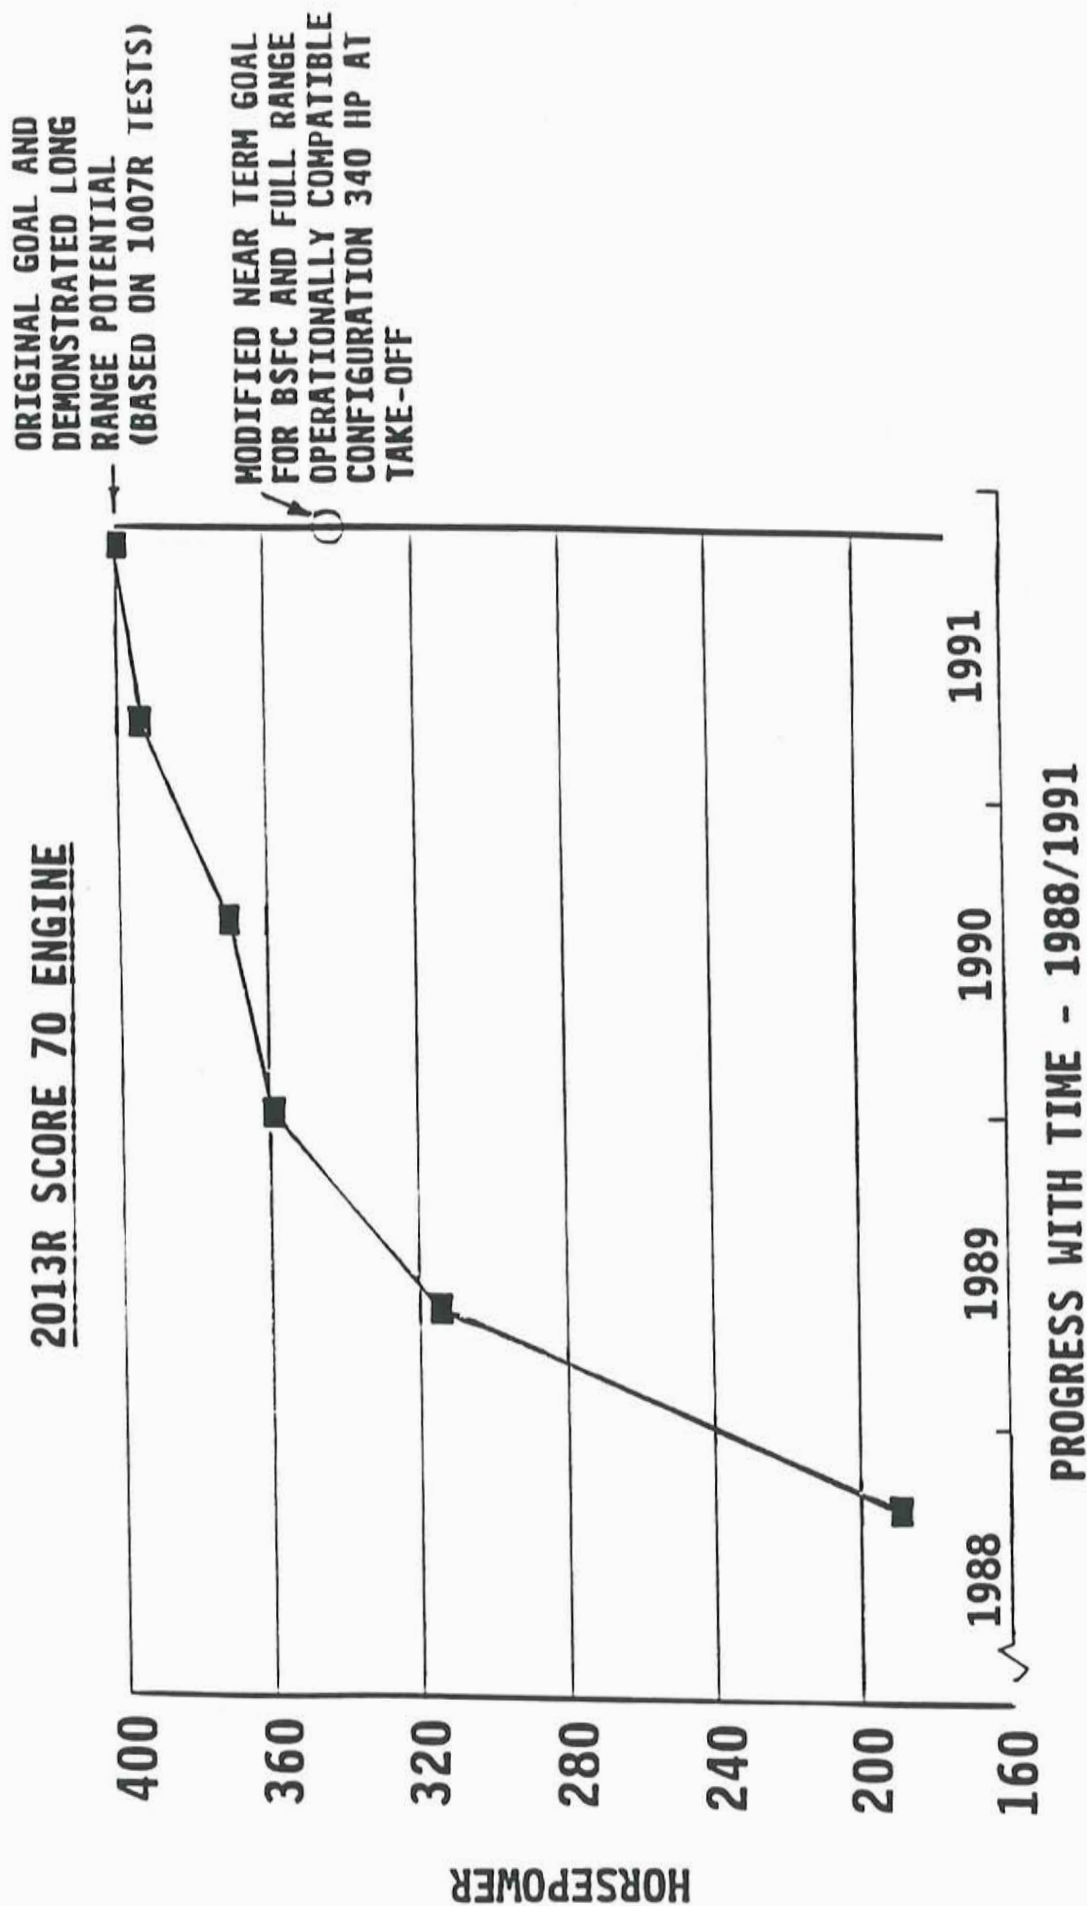
FIG. 2.3-4

## MAXIMUM POWER

### 2013R SCORE 70 ENGINE

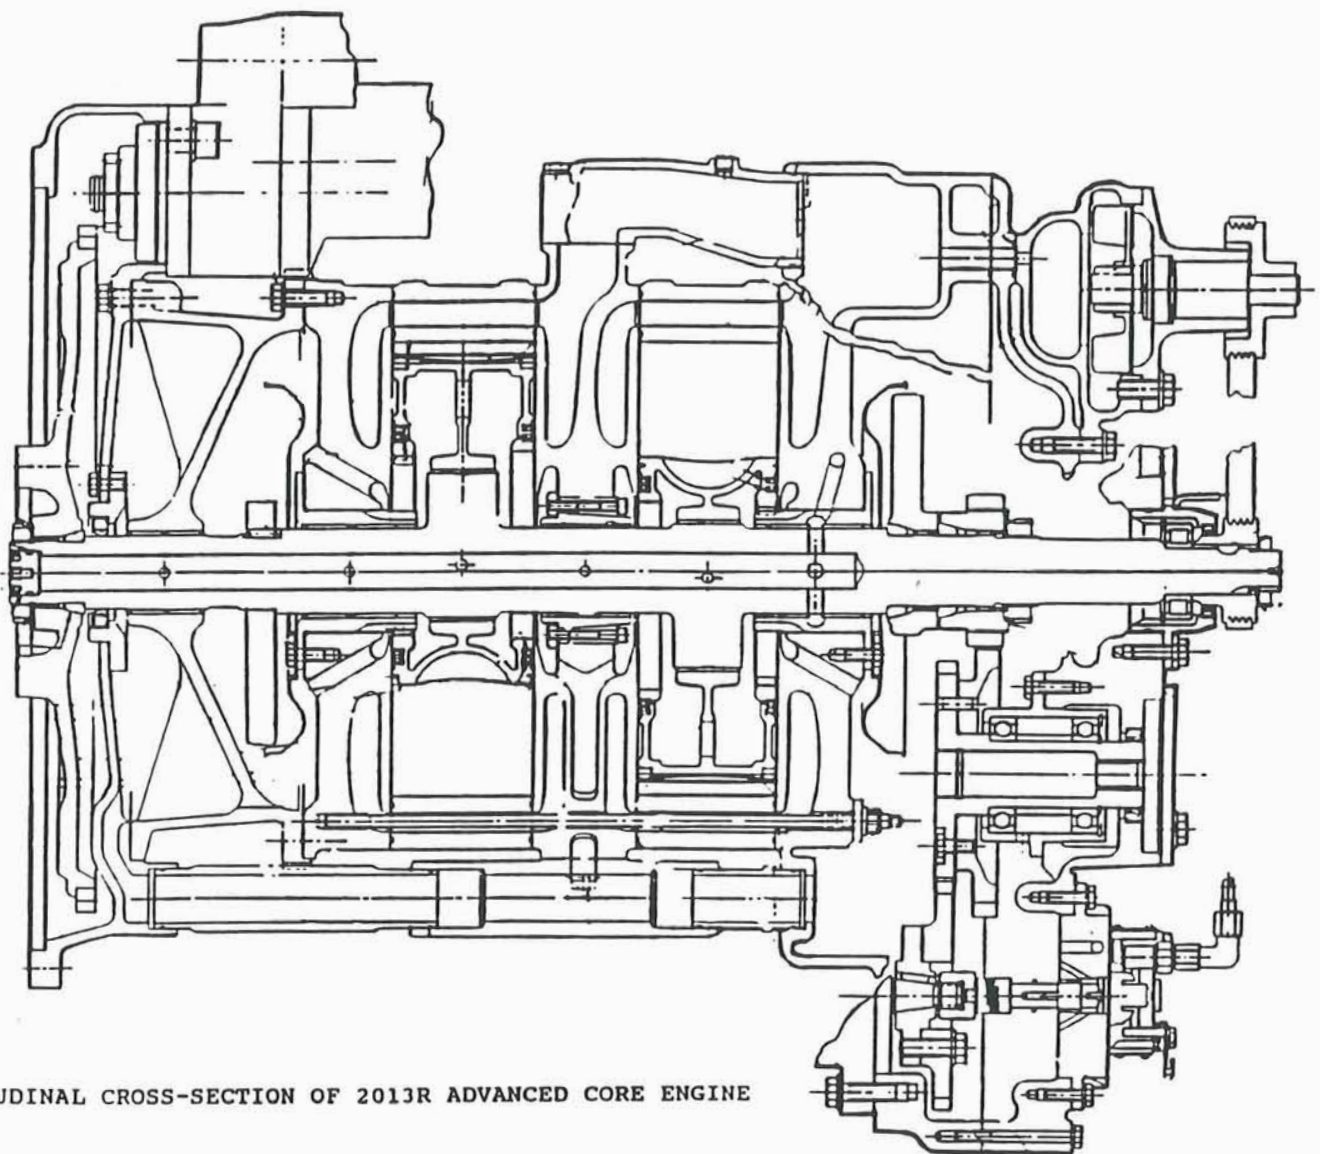
Figure 3.0.2-1

LONGITUDINAL CROSS-SECTION OF 2013R ADVANCED CORE ENGINE

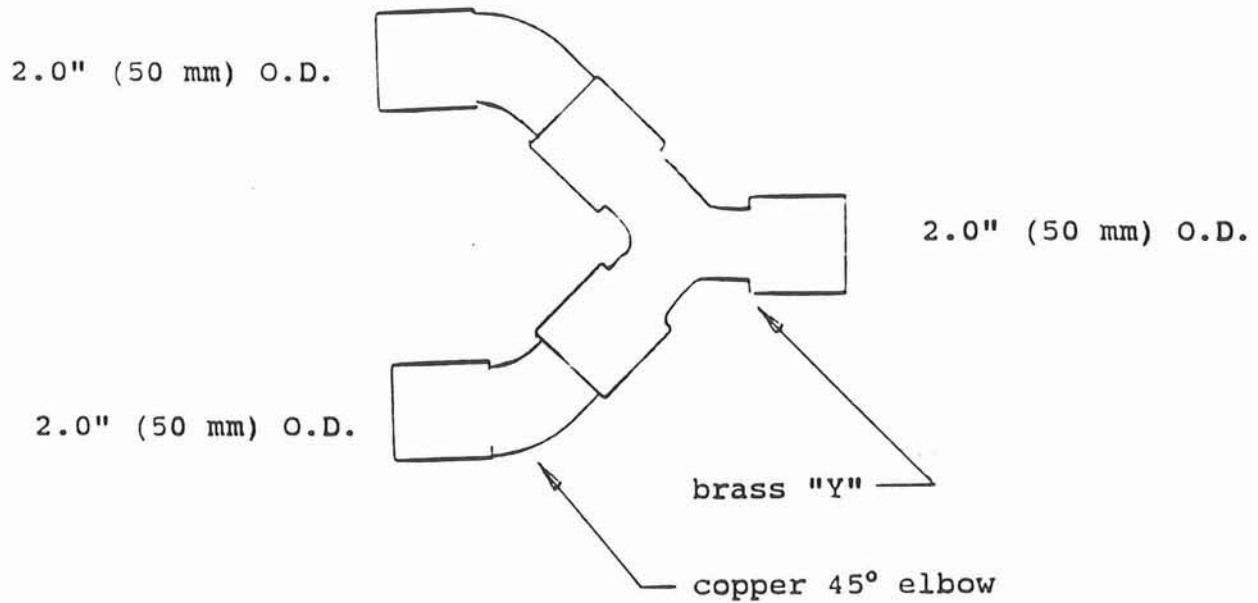
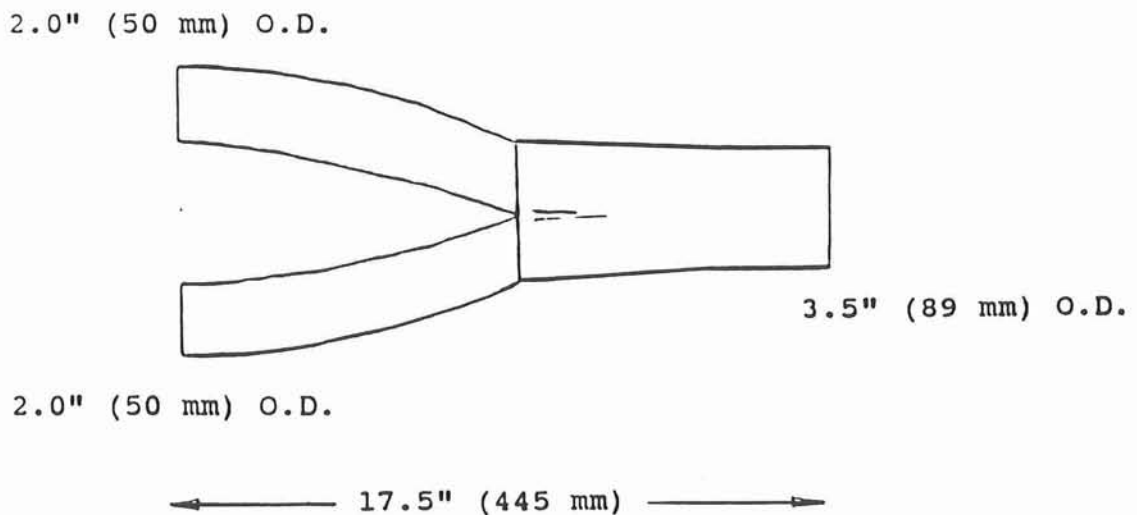
Figure 3.1.4-1 Intake Manifold Configurations - Baseline Engines

Further Testing. The engine was rebuilt and its designation changed to 65201-2. The original intake manifold "Y" was replaced with a larger diameter design, refer to Figure 3.1.4-1. The engine was operated at speeds from 4000 to 7000 rpm at low and moderate loads. The combustion pressure traces showed rates of rise and peak pressures which were higher than expected. This was especially the case when the fuel rack was increased above 75% at which point the main injection timing jumped (advanced) approximately 10° crankangle. This resulted in extremely high combustion pressures, on the order of 1900 psi (131 bar), followed by a condition referred to as "fall-off". The indications of fall-off are higher frequency pressure waves in the intake manifold (audible noise in this instance), a loss of airflow and a loss of power. The generally-accepted mechanism is that the trailing apex seal lifts from the trochoid surface and hot gas from the higher pressure combustion zone

Effects of Larger Intake Manifold. The original manifold "Y" section had a 1.63" (41.4 mm) ID inlet and two outlets of the same size. This restriction resulted in high pressures in the charge air system upstream of the "Y". In particular, the compressor outlet pressure was 52.7 in-Hg at the 7000 rpm 231 BHP (172 kW) condition shown in the table above. It was anticipated that a lower restriction manifold would be beneficial because it would allow operation at a more efficient point on the compressor map.

A larger "Y" section was fabricated having a 3.5" (89 mm) inlet and 2" (50 mm) outlets. The transition is smoother with a substantially smaller included angle. All testing after the first build was accomplished with this larger "Y". The most appropriate means to examine the effect of this change is through volumetric efficiency. To generate the plots presented in Figure 3.1.5-1, the volumetric efficiency was calculated using the engine inlet (or more precisely the intercooler outlet) conditions. The table below summarizes the data of the three plots as well as an additional 6500 rpm data point.

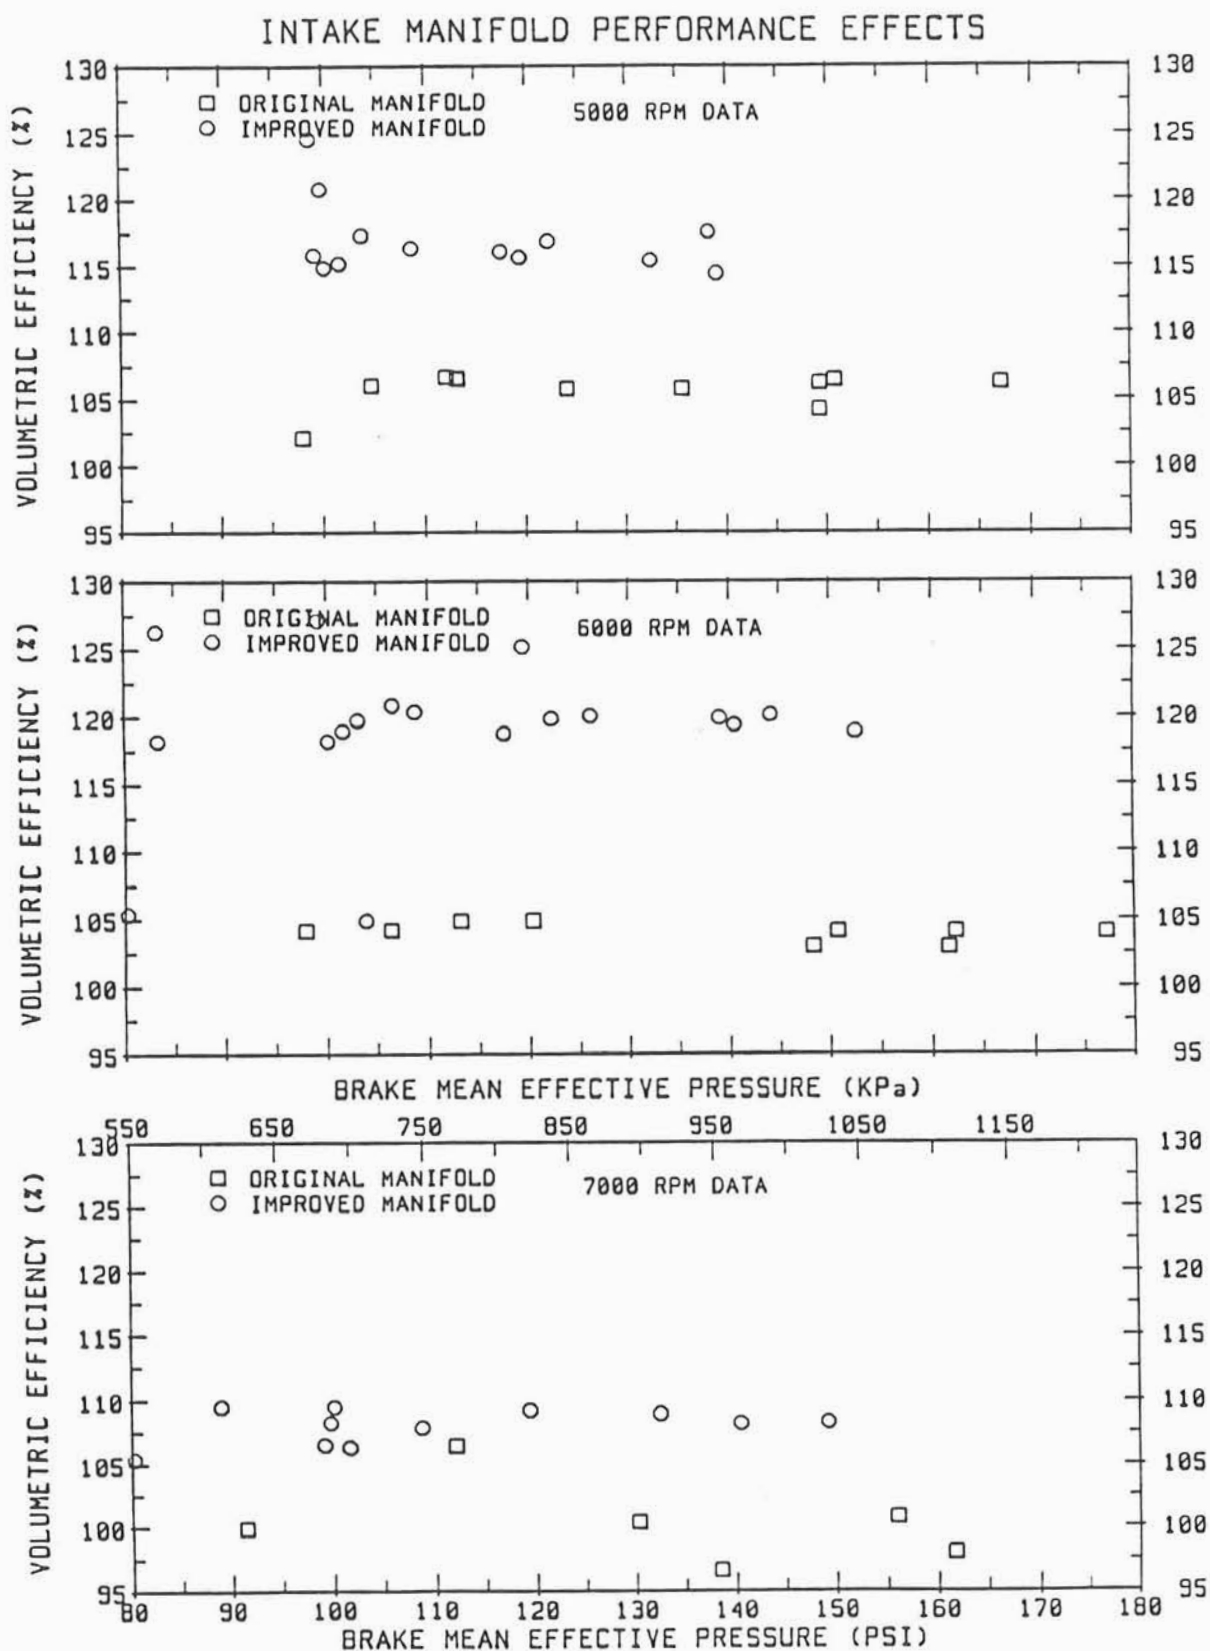
**Figure 3.1.5-1 Volumetric Efficiency Performance of Intake Manifold Configurations**

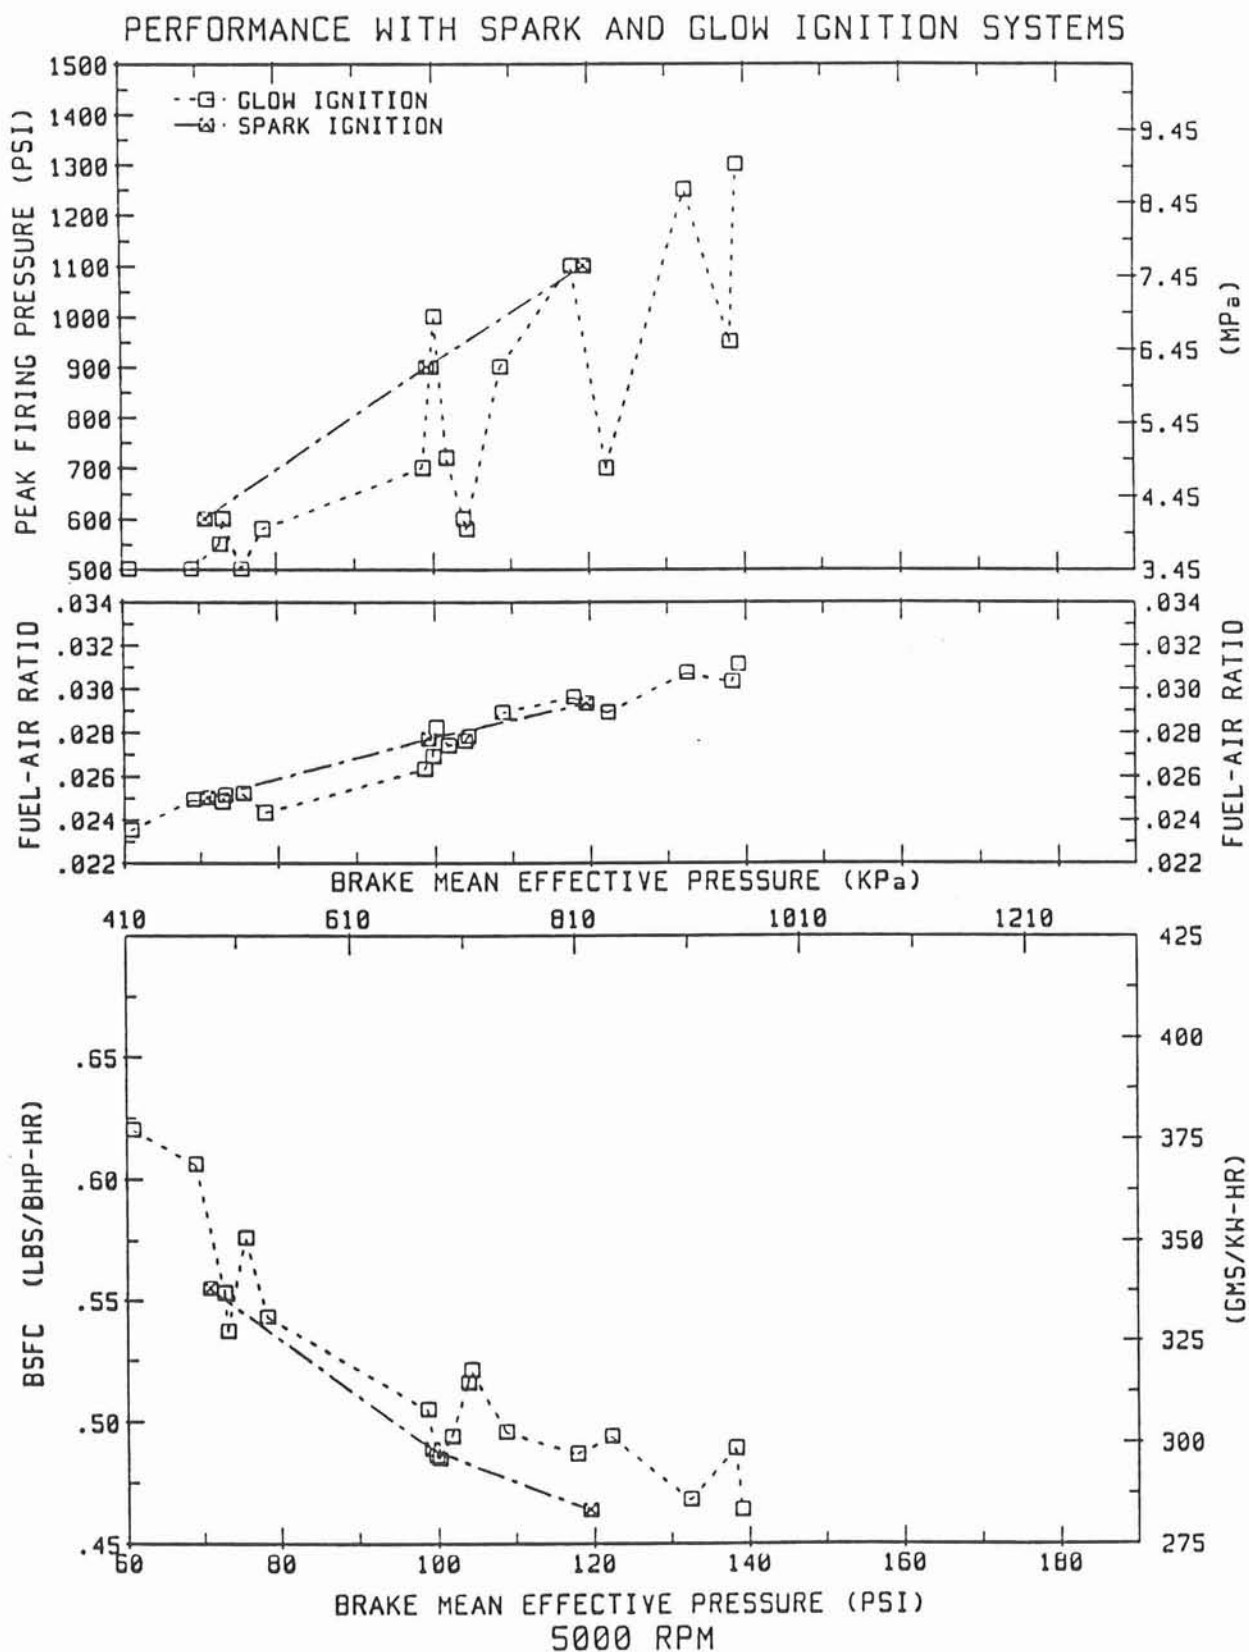
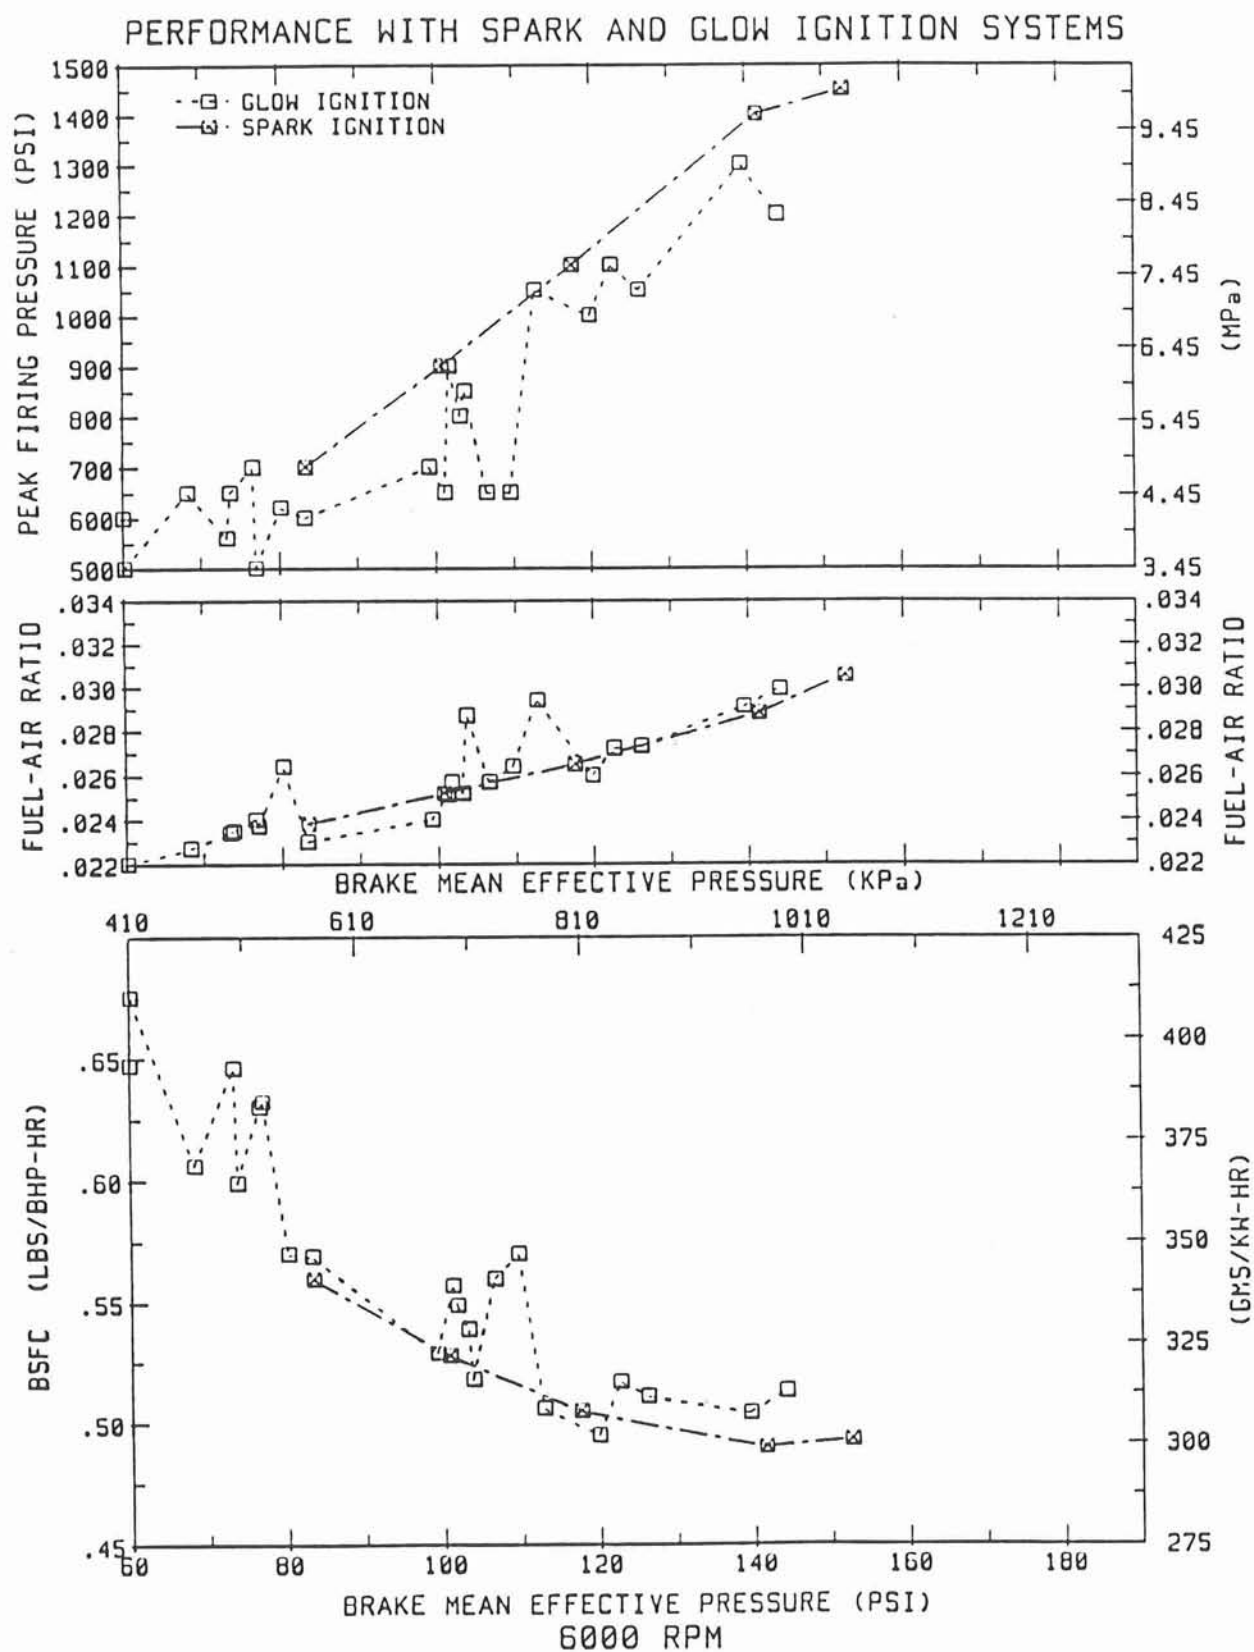
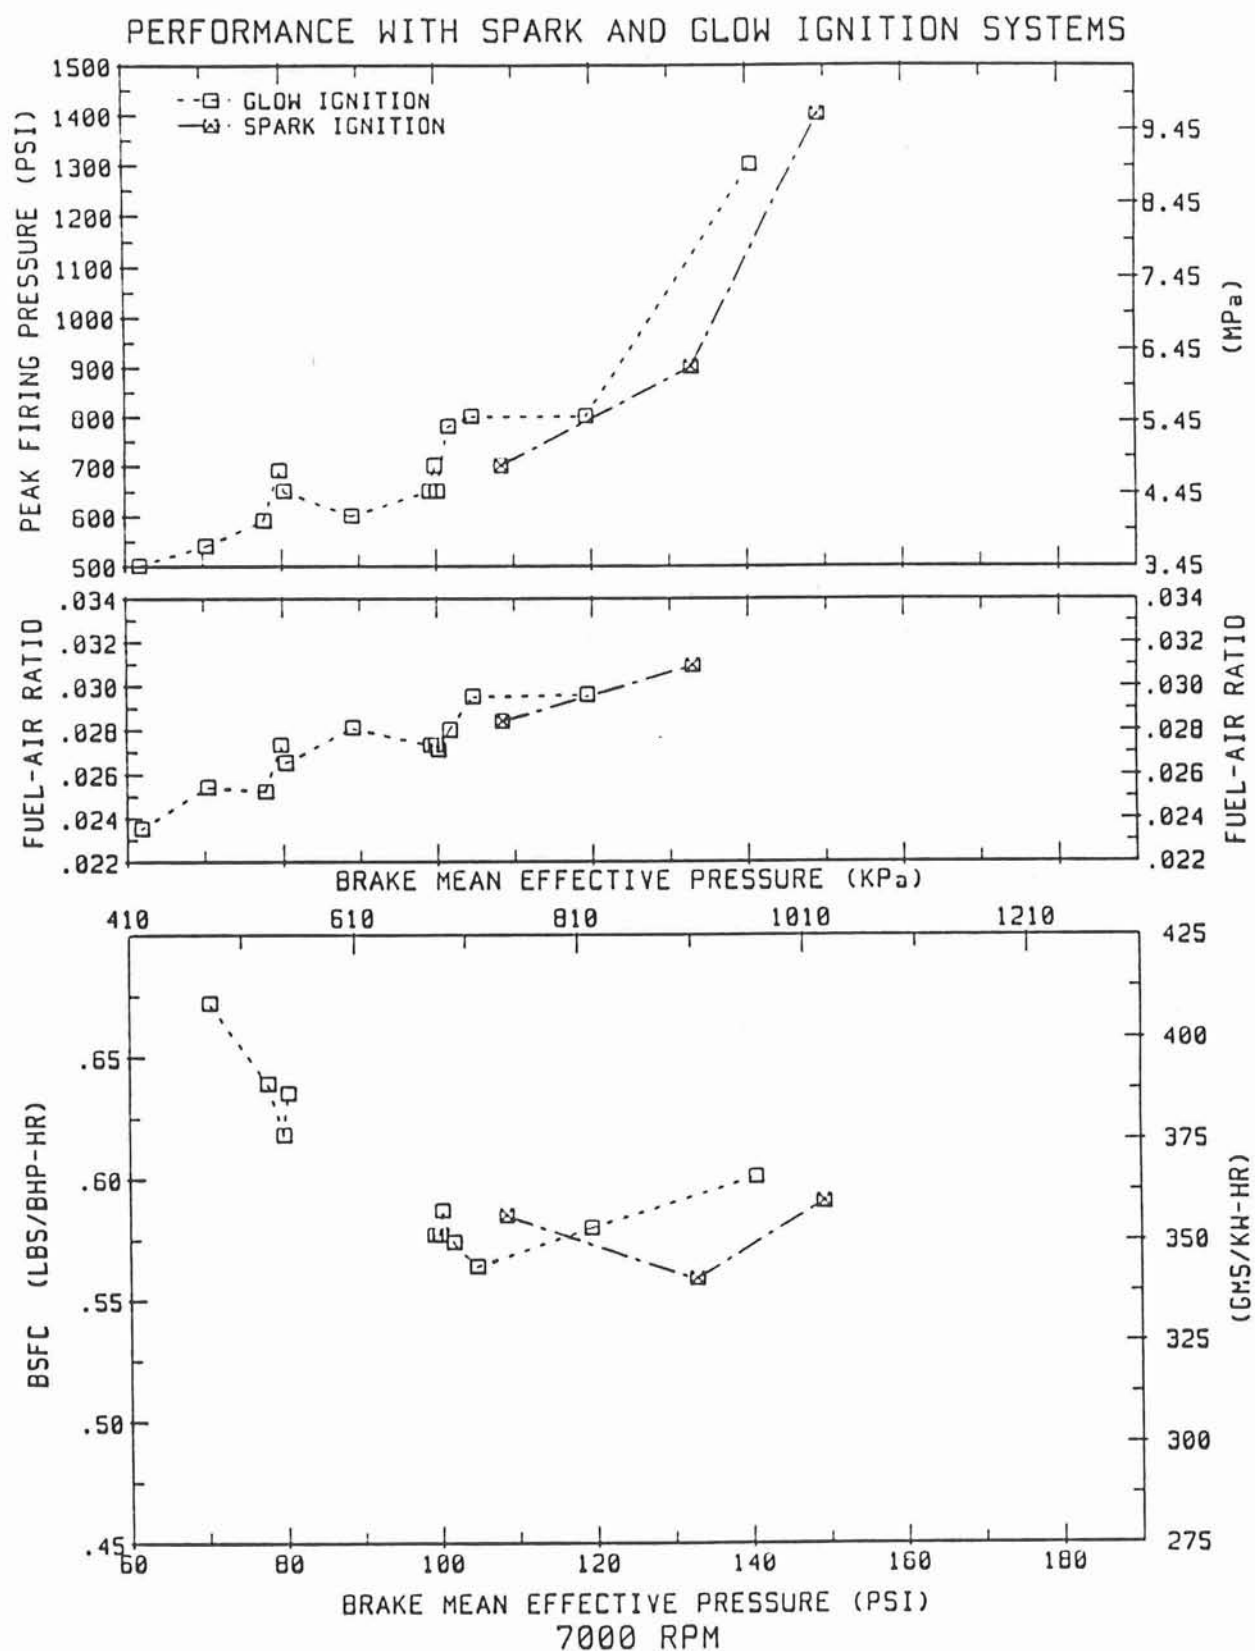
Figure 3.1.5-2 Performance Comparison of Ignition Systems (5000 rpm)

**Figure 3.1.5-3      Performance Comparison of Ignition Systems  
 (6000 rpm)**

Figure 3.1.5-4 Performance Comparison of Ignition Systems (7000 rpm)

The switch to spark ignition resulted in measurable decrease in specific fuel consumption as can be seen in Figures 3.1.5-2 through 3.1.5-4. The observed improvement was as much as 4%.

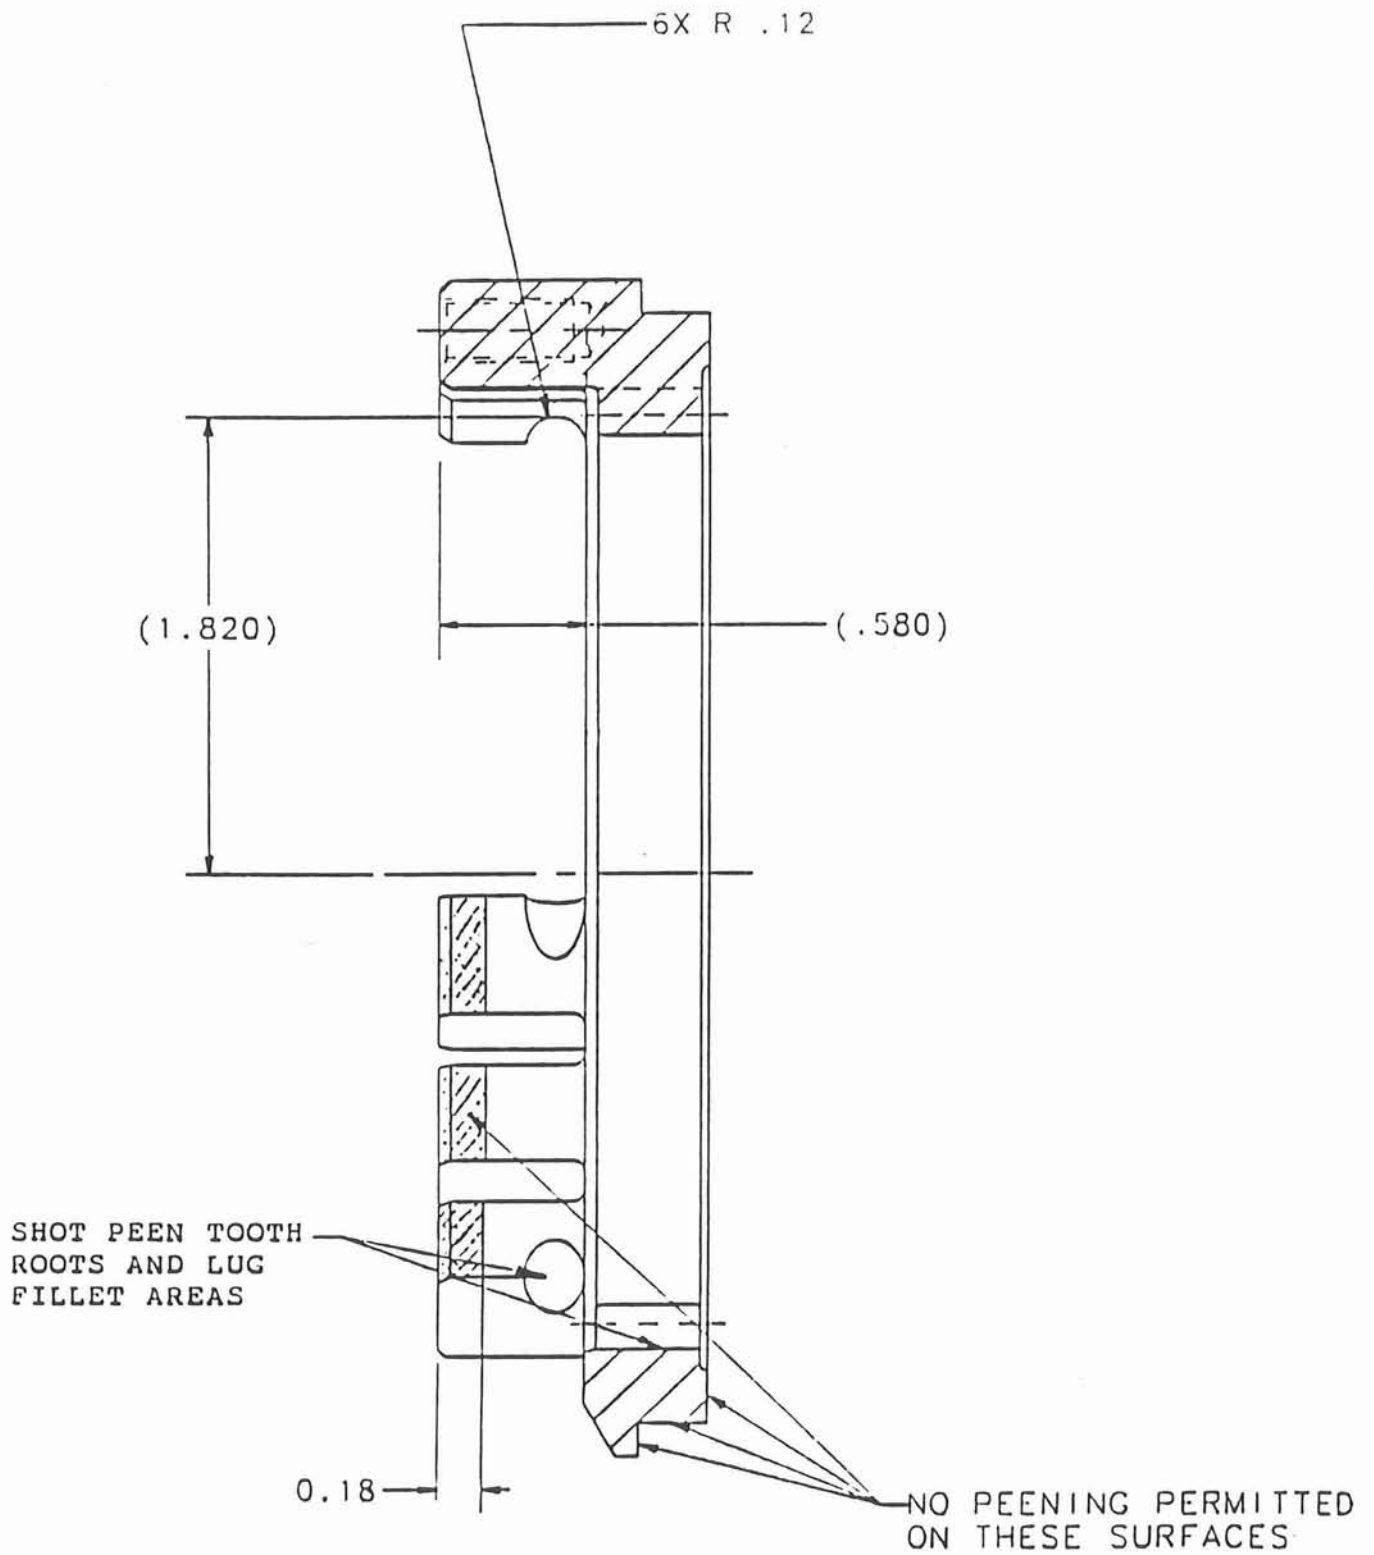
Figure 3.2.3-1 Rotor Gear Rework

Reworked Rotor Gears. To address the two failures of the drive end rotor gear during the baseline test, the rotor gears were reworked to improve the safety factor and material properties of the mounting lug regions of the gear. A partial view of the rework drawing is shown in Figure 3.2.3-1.

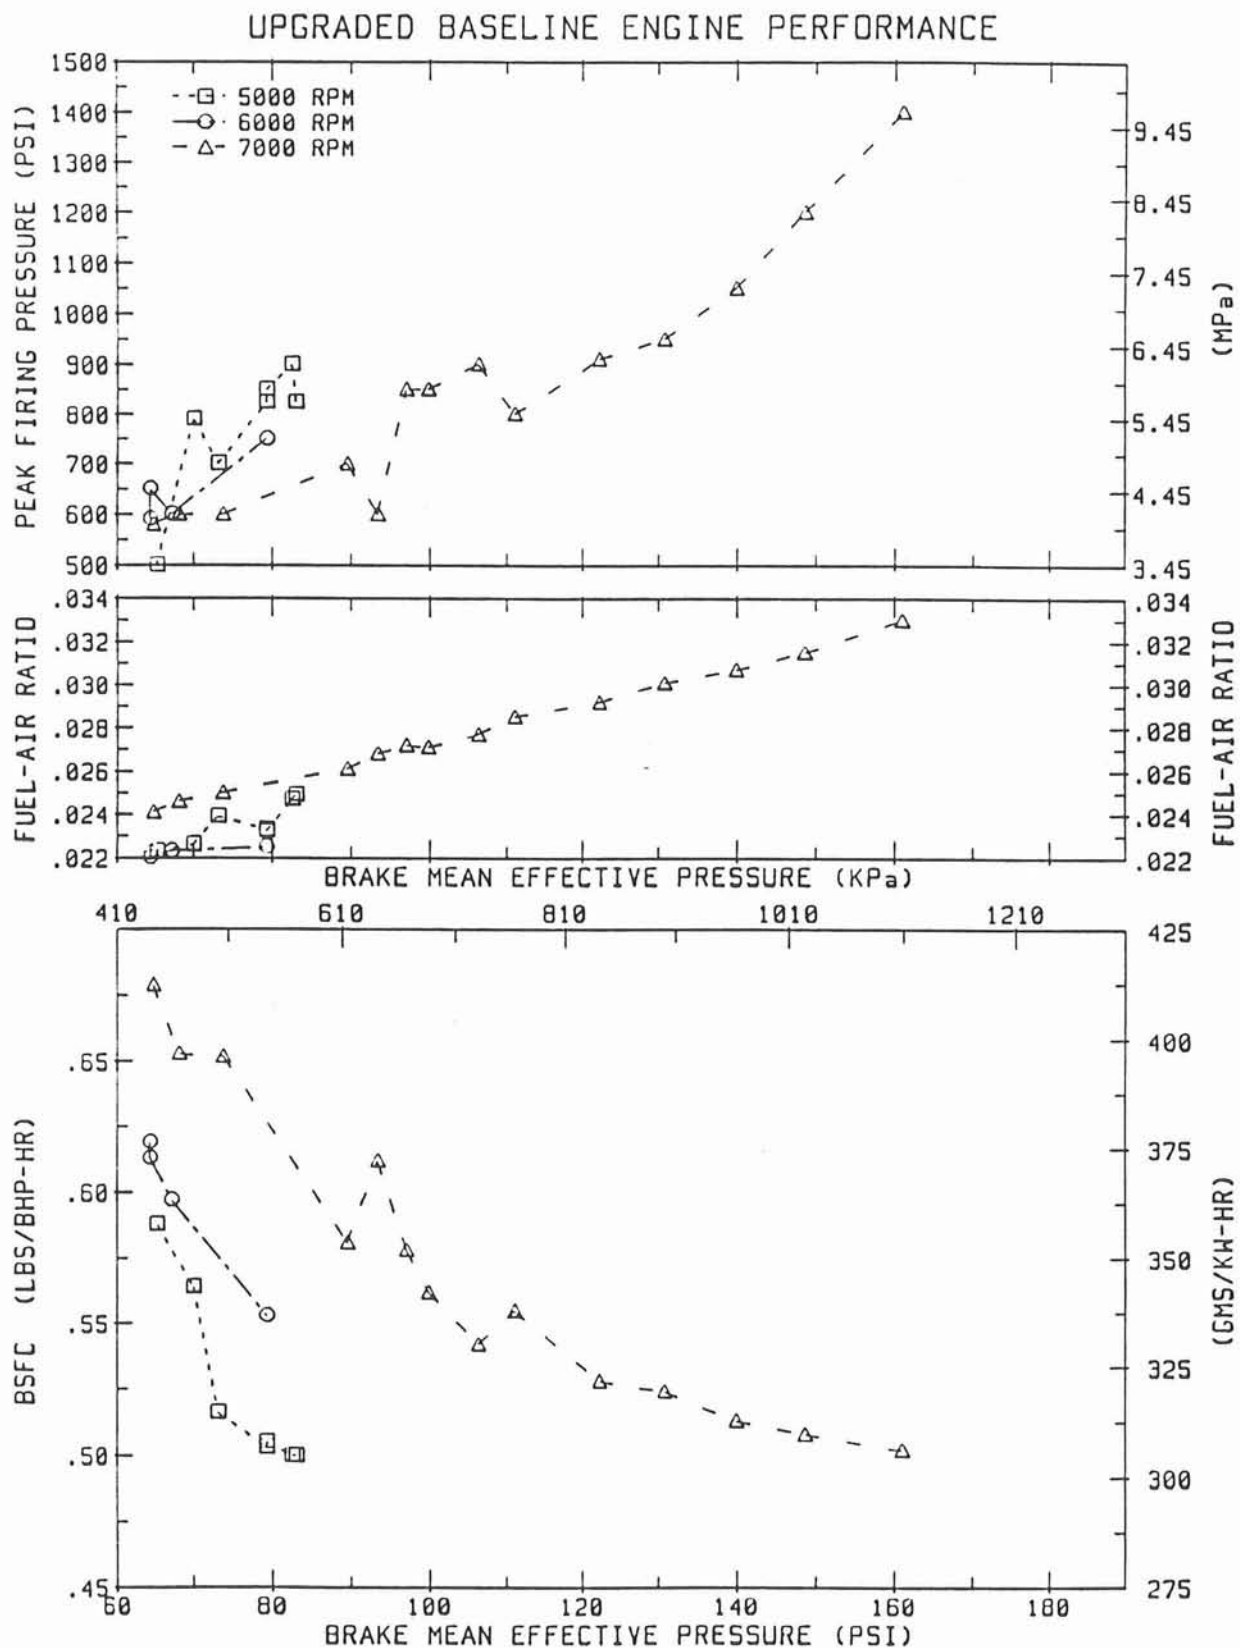
Figure 3.2.4-1 Upgraded Baseline Engine Performance

Rated Speed Testing. The engine was operated at 8000 rpm at two loads, 61 and 77 psi (4.2 and 5.3 bar) BMEP. Prior to recording data at the higher load, the rotor bearing in the anti-drive end bank failed. This particular build was not operated at high loads. The table below illustrates the low load performance as it varies with speed. The 7000 rpm point, identified as run 5-17, is from the subsequent build and is included for completeness.
