NASA Contractor Report CR-195395

# Two Rotor Stratified Charge Rotary Engine (SCRE) Engine System Technology Evaluation

**T. Hoffman, J. Mack and R. Mount**  
*Rotary Power International, Inc.*  
*Wood-Ridge, New Jersey*

October 1994

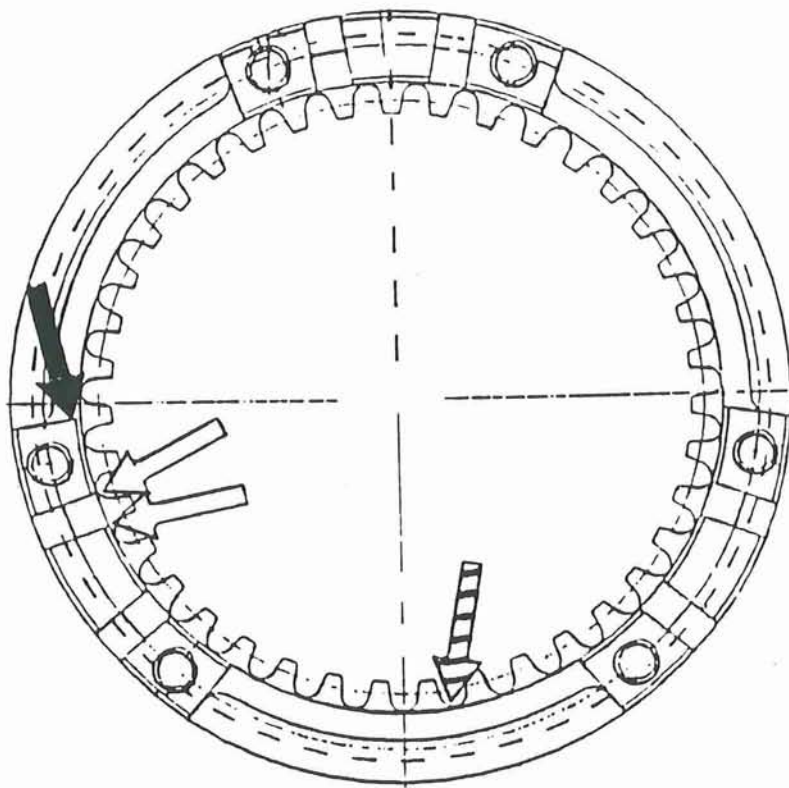
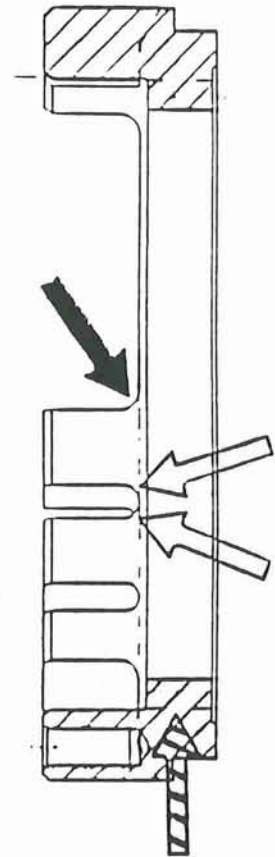
Dark Arrow - Primary Failure @ Mounting Lug

Striped Arrow - Failure @ Tooth Root

Open Arrow - Failure @ Mounting Lug

**Figure 3.2.5-1 Rotor Gear Failure Locations**

A major revision to the rotor gear design was made which increased the critical tooth root and mounting lug radii and extended the case hardening to the mounting lug regions. Portions of this design are shown in Figure 3.2.5-2. The procurement of the NJ12484 Rev. C gears was initiated but due to the time required to manufacture such gears, the upgraded baseline engines used a rotor gear which was reworked. This rework consists of increasing/blending critical radii and shot-peening the region where the failures had occurred. This rework is more fully described on drawing 070X00341A, a portion of which is provided here as Figure 3.2.3-1. In spite of the increased safety factor and material

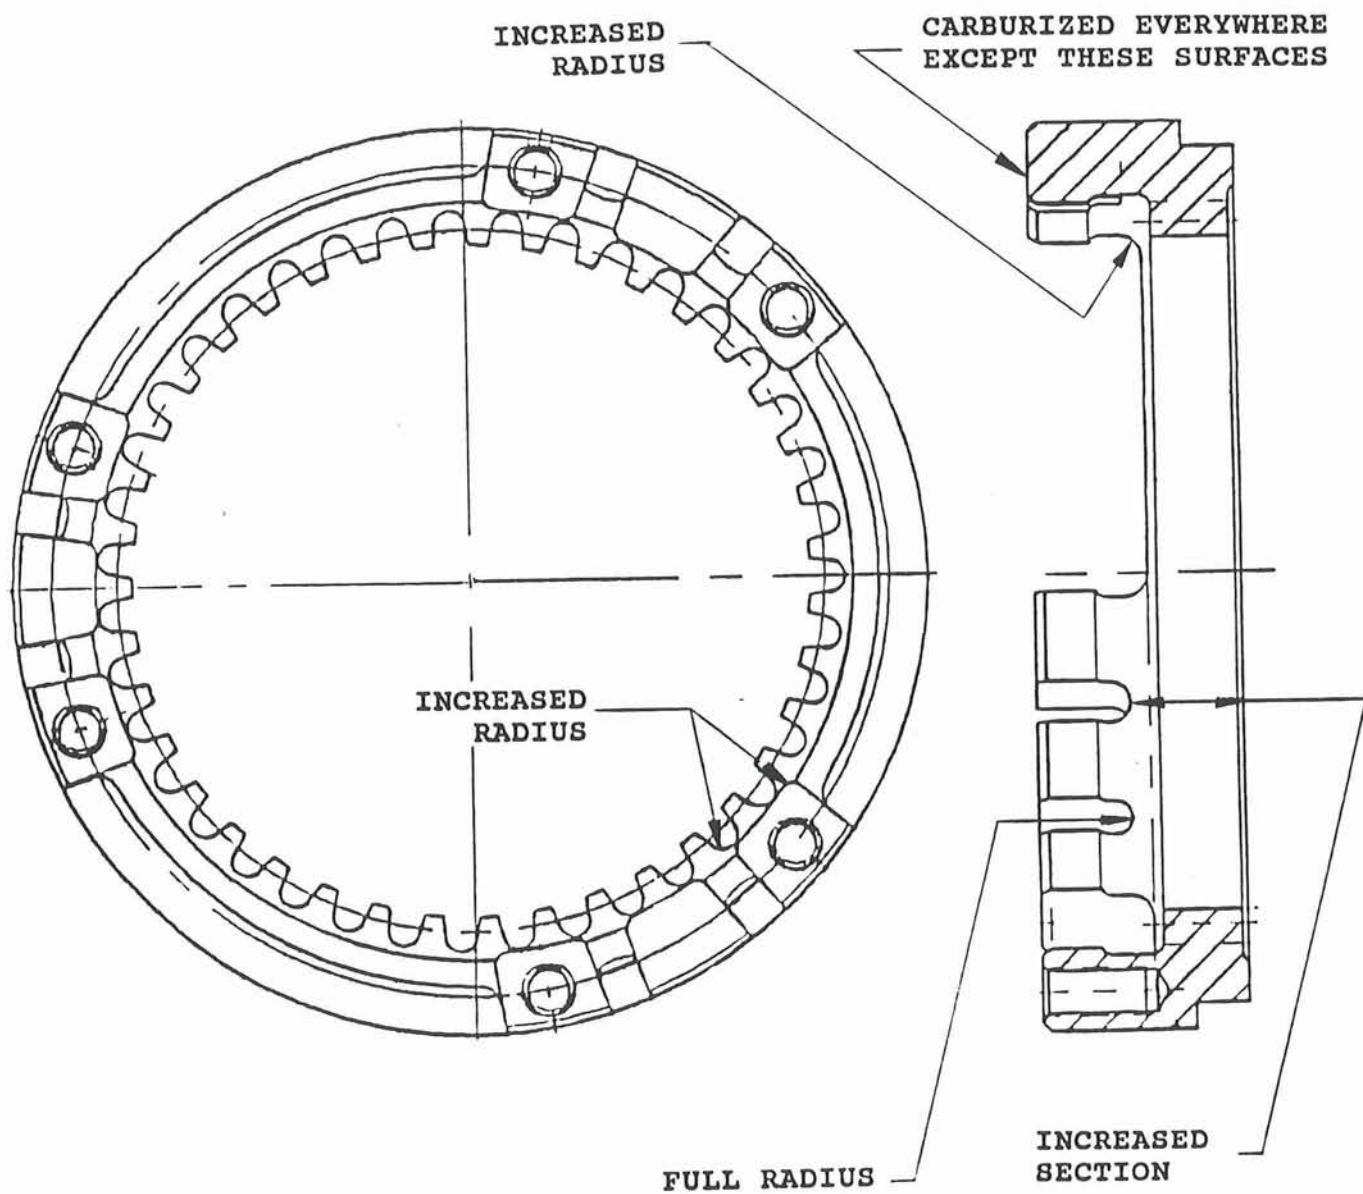
Figure 3.2.5-2 Improved Rotor Gear - NJ12484 Rev. C

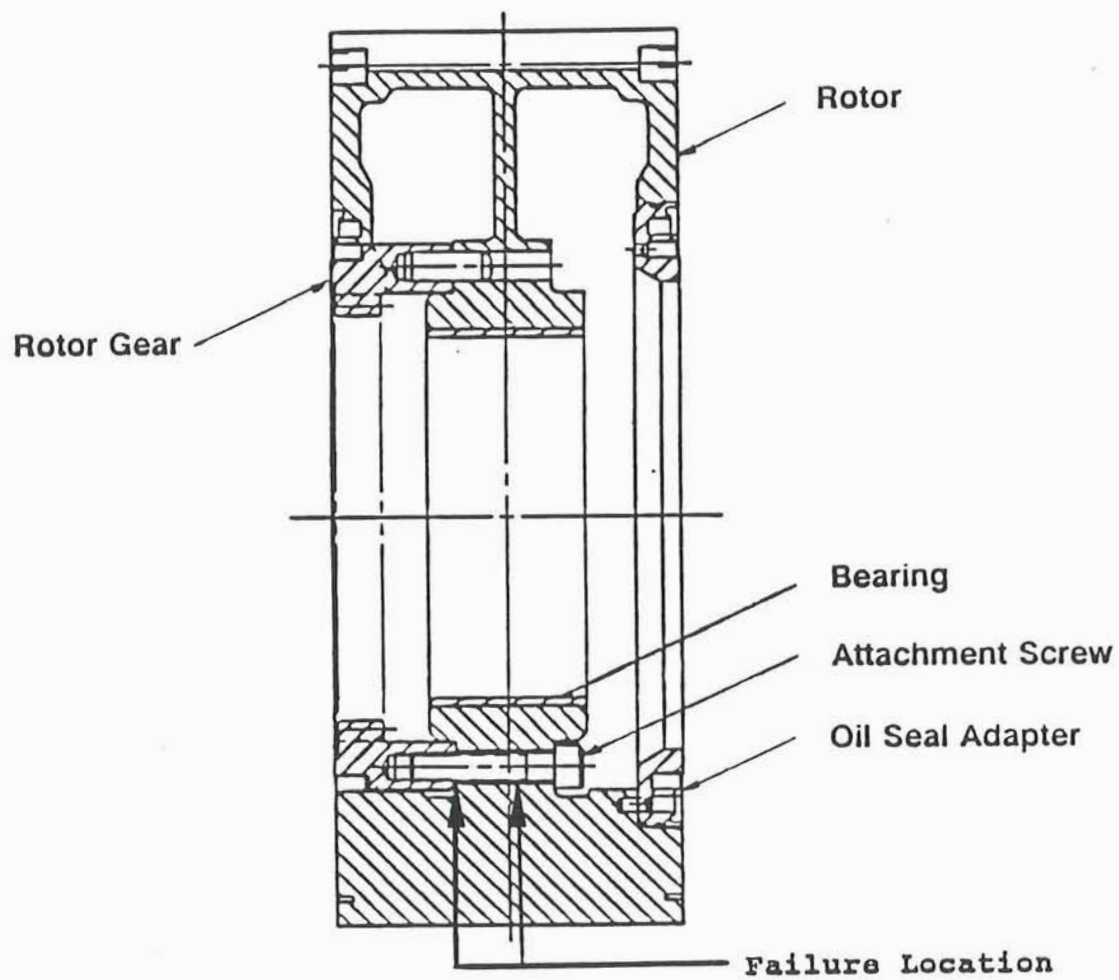
Figure 3.2.5-3 Failure of Rotor Gear Attachment Screw

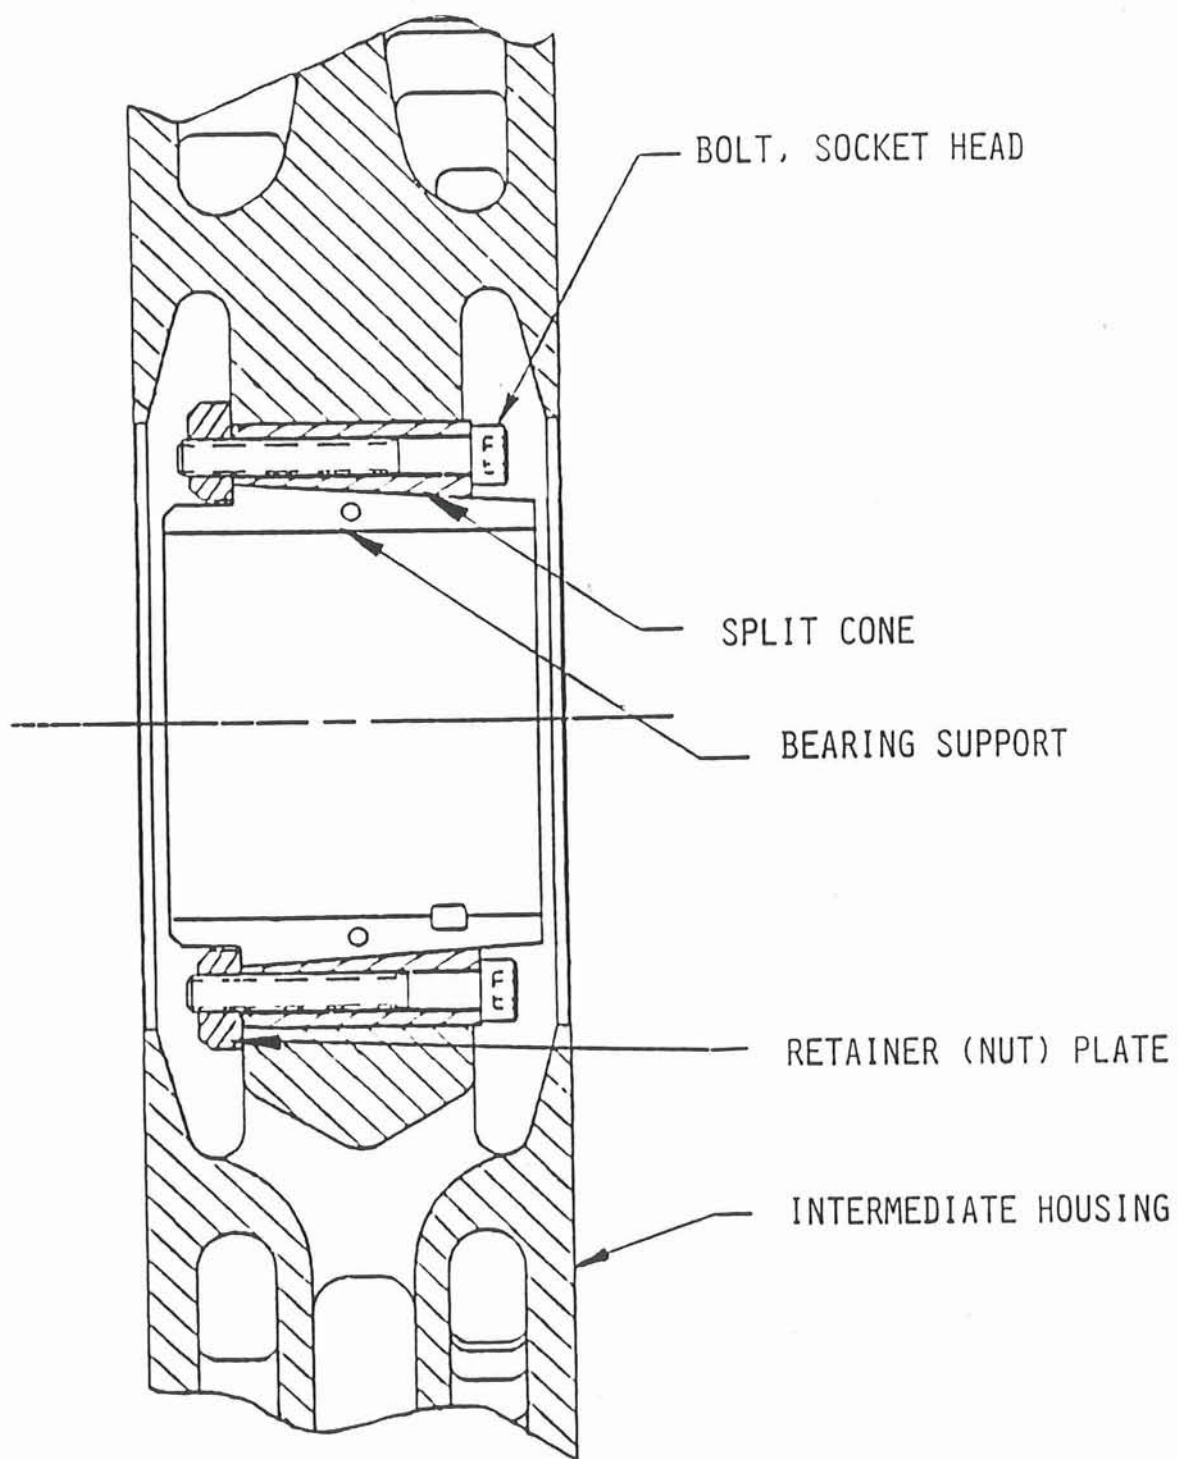
Figure 3.2.5-4 Center Main Bearing and Support Assembly

cycle under-head failures. The surfaces of the bearing support and cone pieces had a relatively thick and uneven coating of dry lubricant. A view of the center main bearing assembly, Figure 3.2.5-4, is included here for reference.

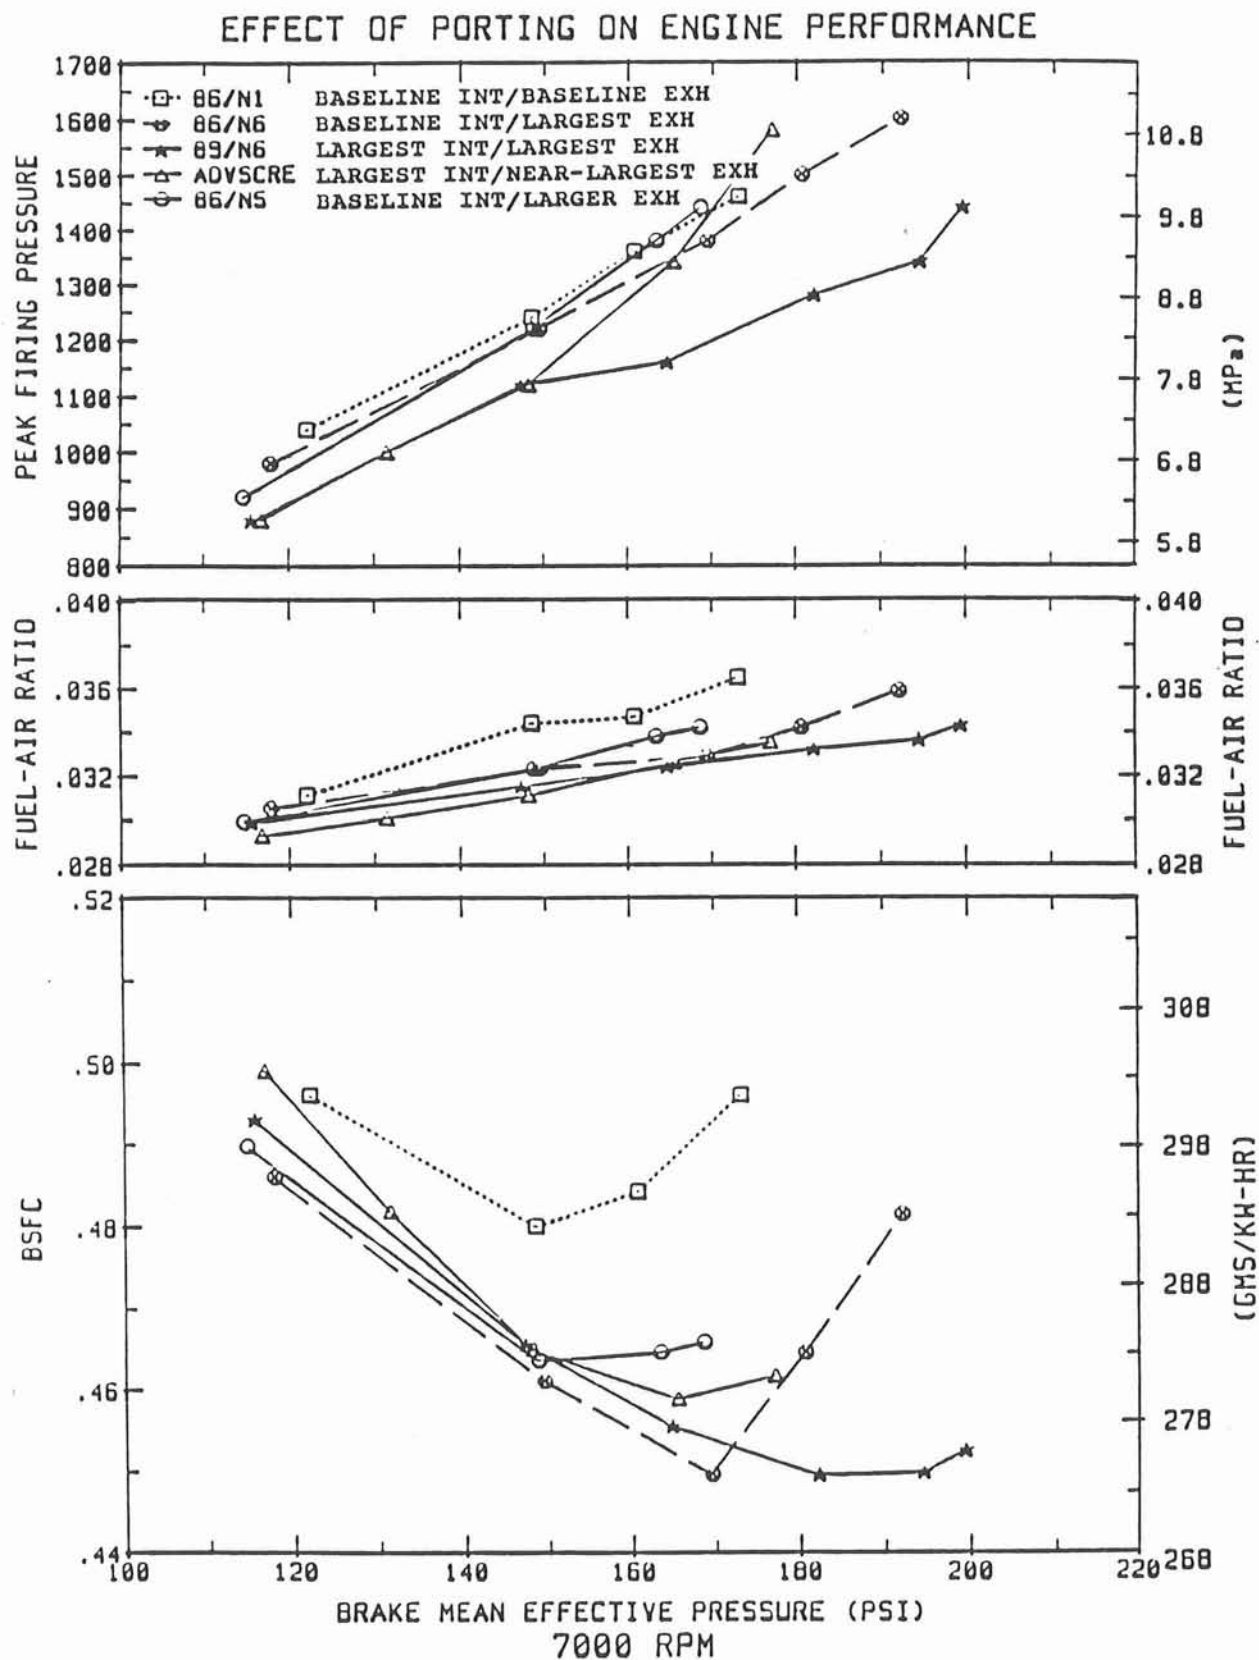
Figure 4.1.3-1 Port/Timing Engine Performance Results - Single Rotor Engine

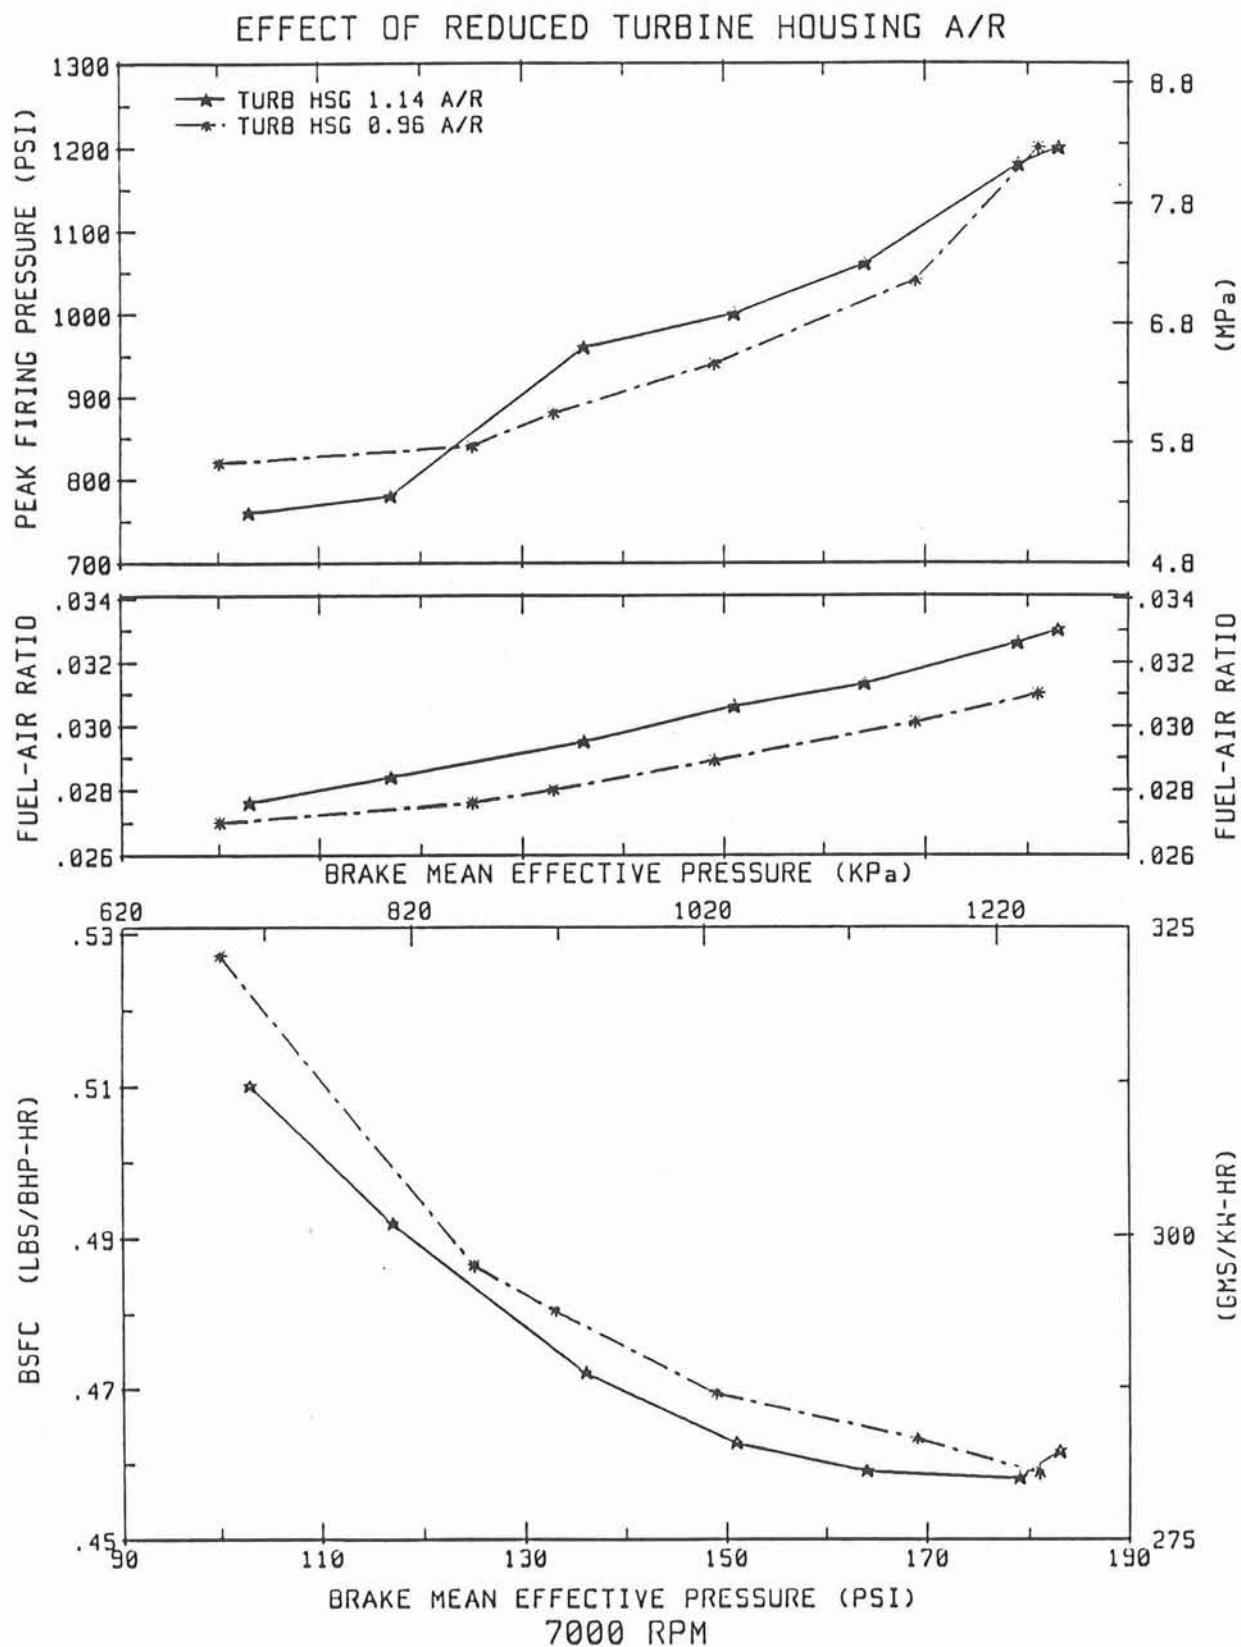
**Figure 4.2.2-1**      **Effect of Reduced Turbine Housing A/R on Single Rotor Engine Performance (7000 rpm)**

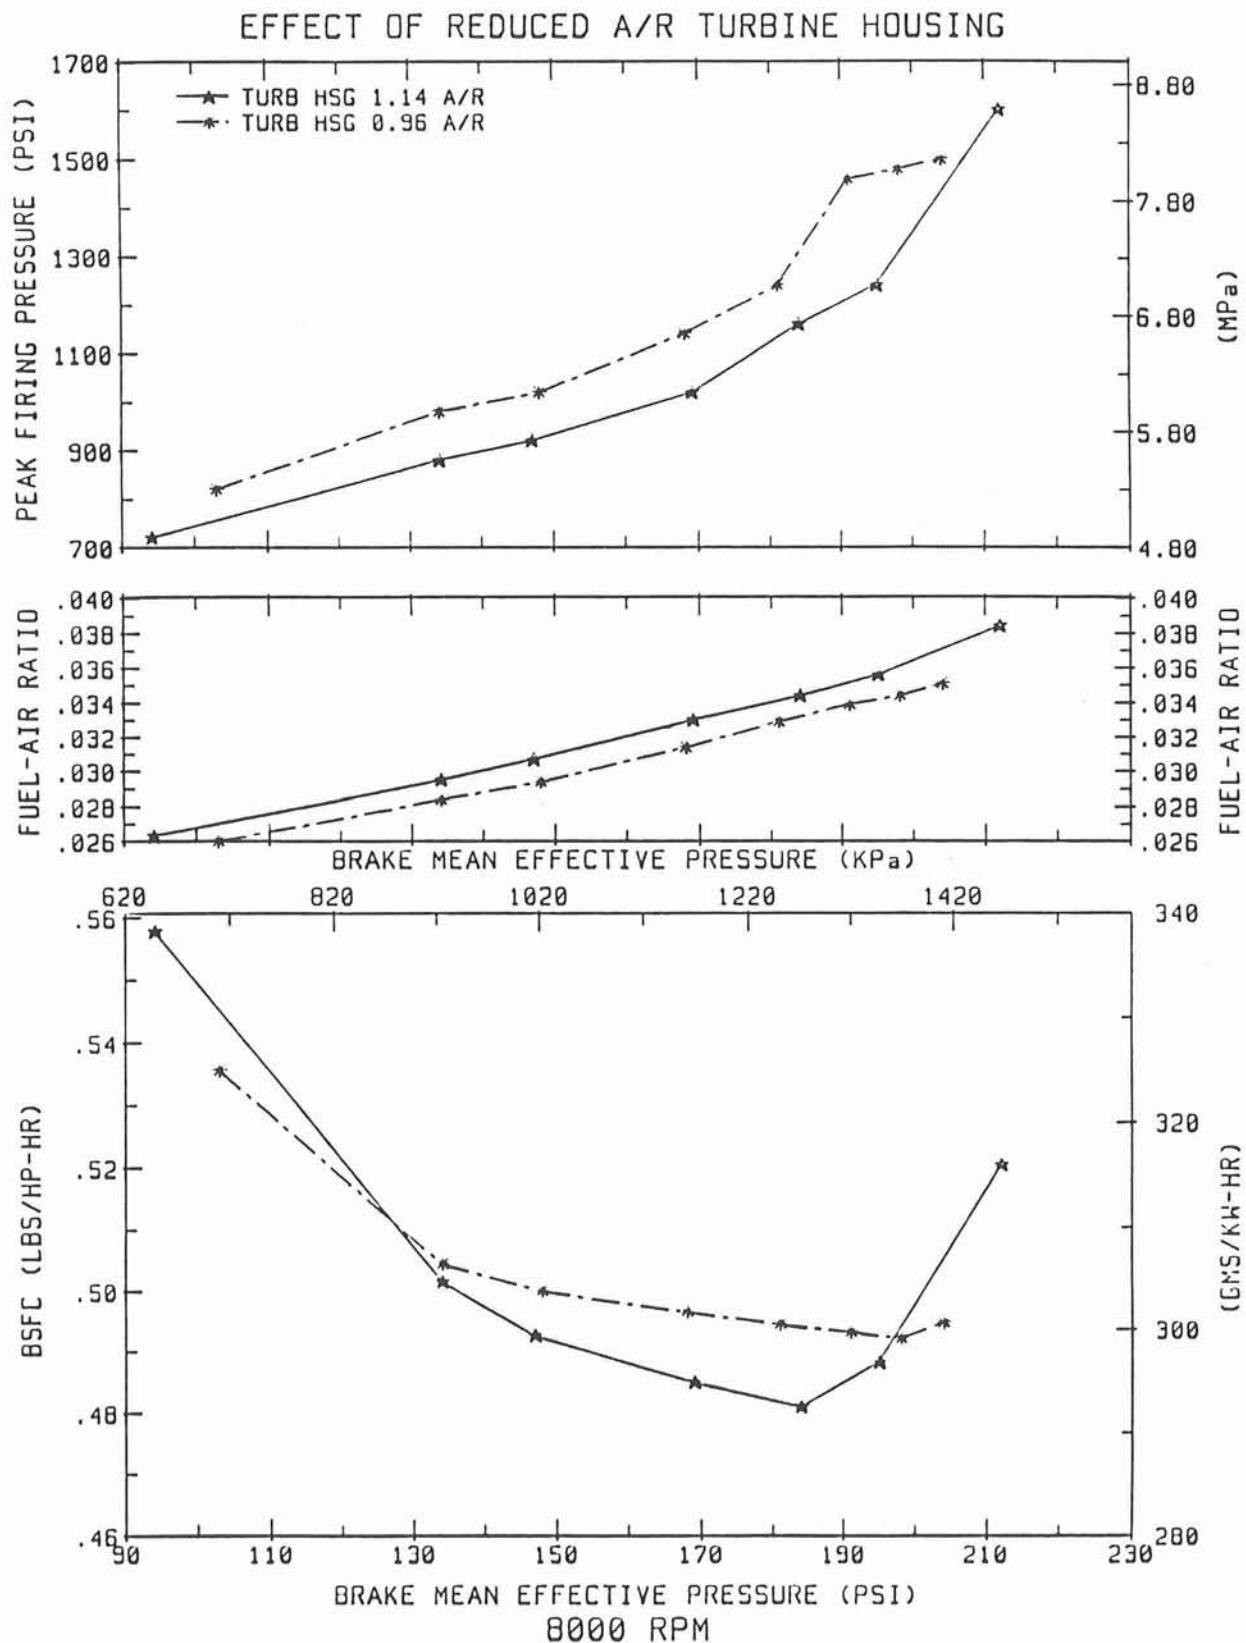
Figure 4.2.2-2 Effect of Reduced Turbine Housing A/R on Single Rotor Engine Performance (8000 rpm)

Testing of the 0.96 A/R turbine housing at the take-off rating indicated a similar increase in delivered airflow and boost. As can be seen in Figure 4.2.2-2, an increase rather than improvement in bsfc was observed at most tested loads at 8000 rpm relative to the 1.14 A/R housing. Test results to date appear to indicate that the 0.96 housing is too restrictive for the required engine airflows (ref. Figures 4.2.2-3 and 4.2.2-4). Portions of this data were provided to several turbocharger manufacturers for guidance in selecting turbomachinery for the two rotor engine. Subsequent testing was performed with the 1.14 A/R turbine housing.

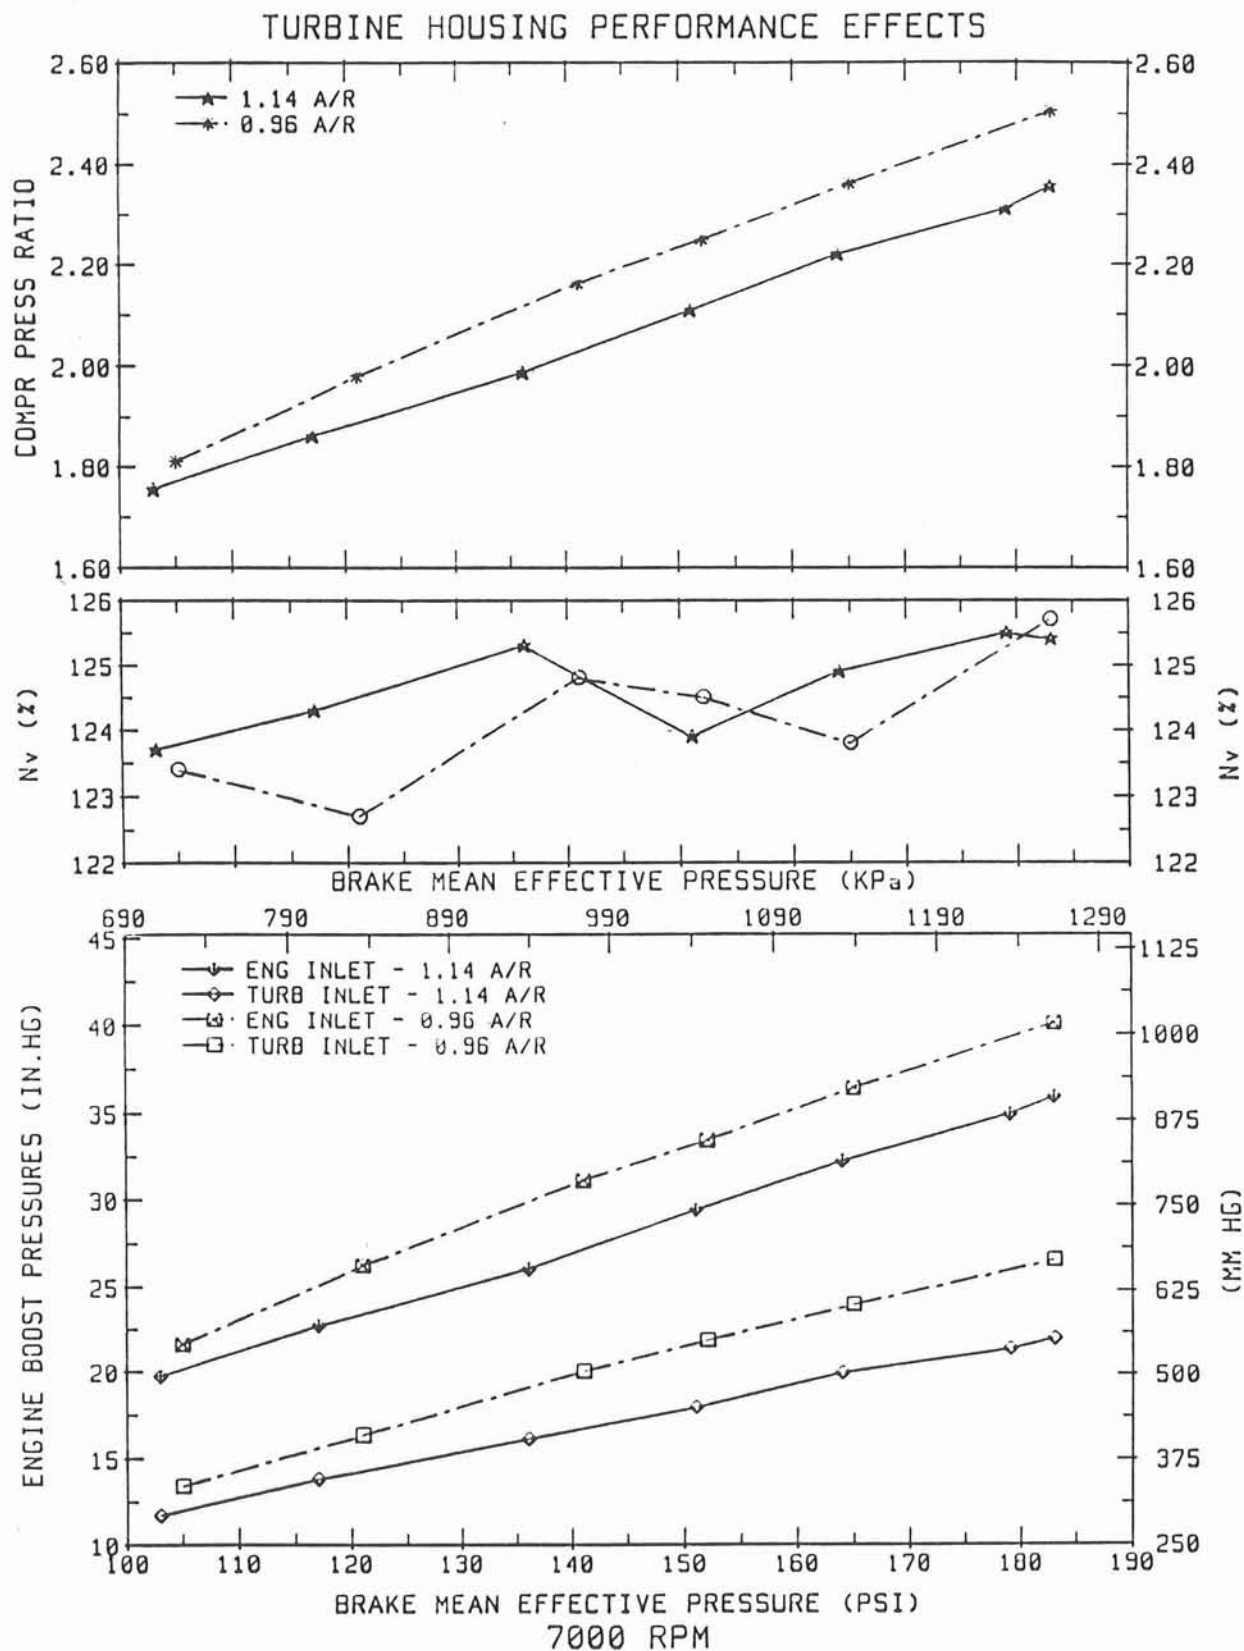
**Figure 4.2.2-3 Turbocharger Performance (7000 rpm) - Single Rotor Engine**

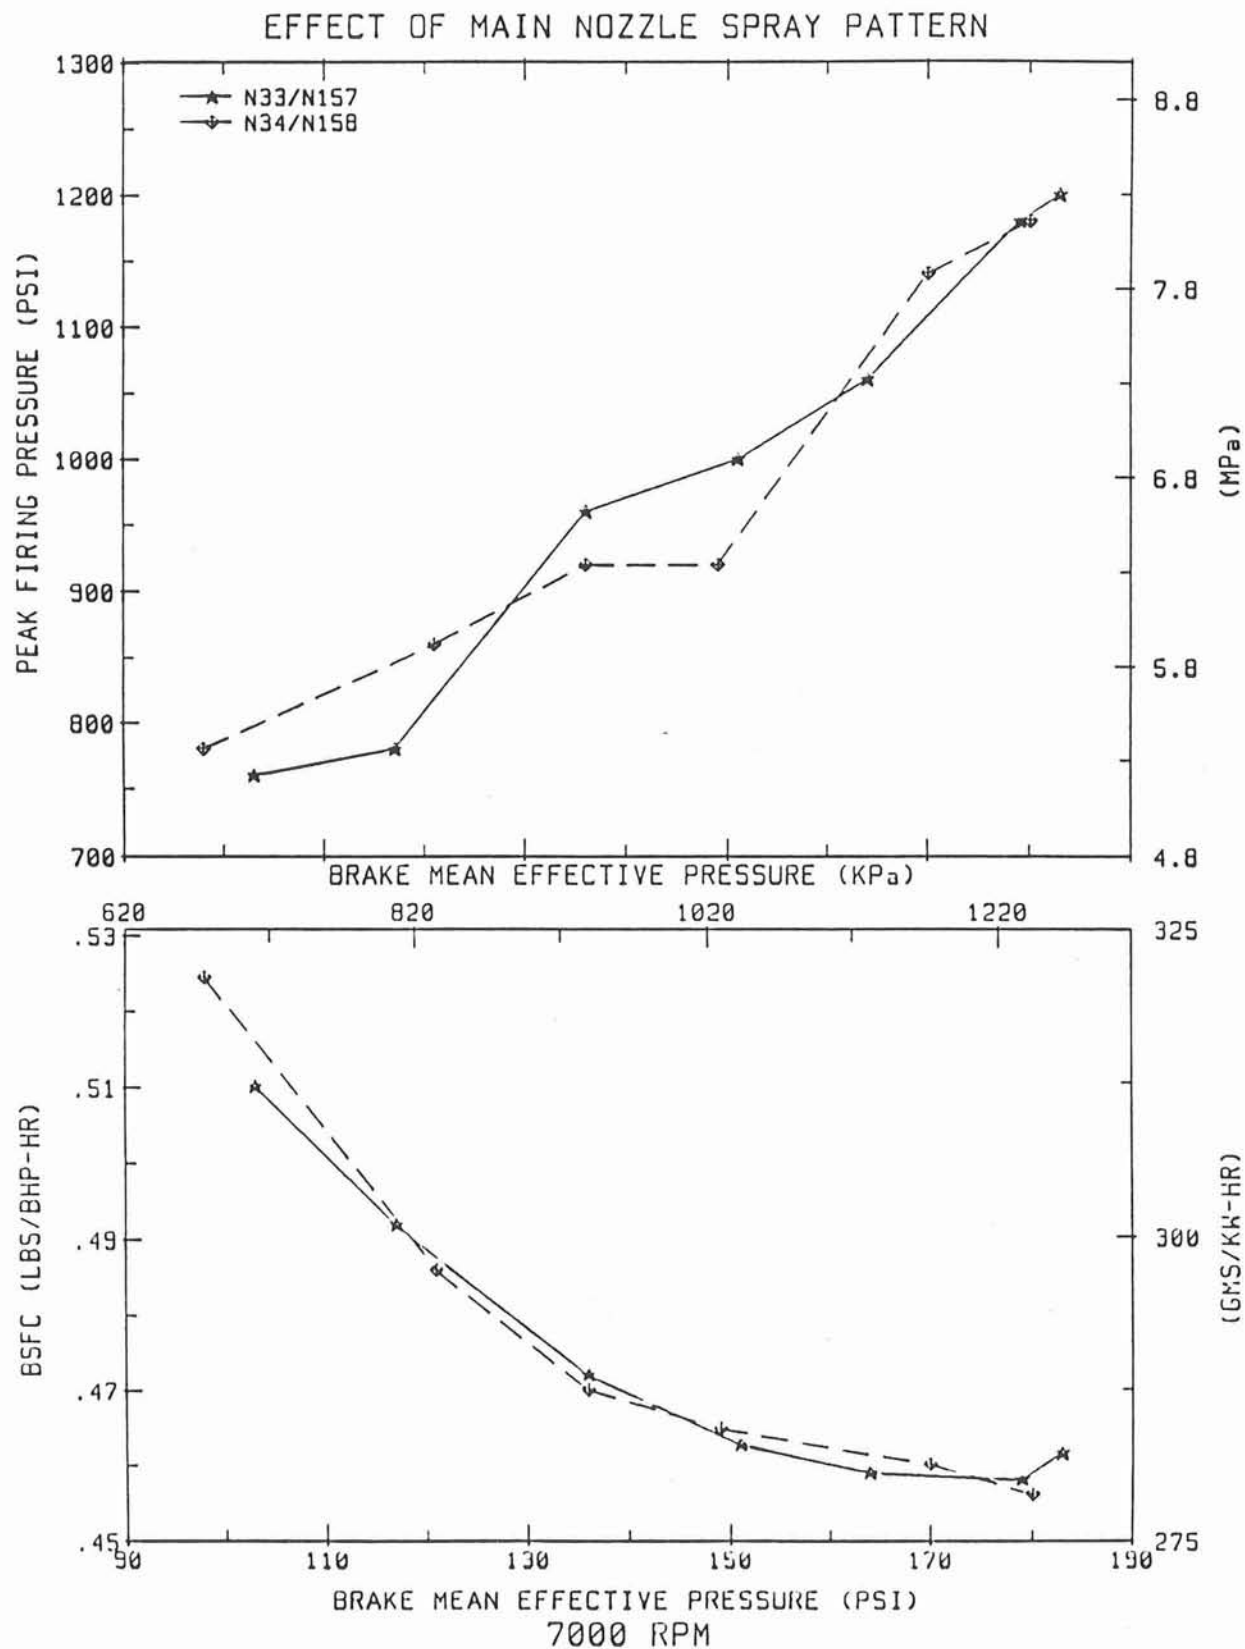
Figure 4.2.2-5 Main Nozzle Spray Pattern Performance (7000 rpm) Single Rotor Engine

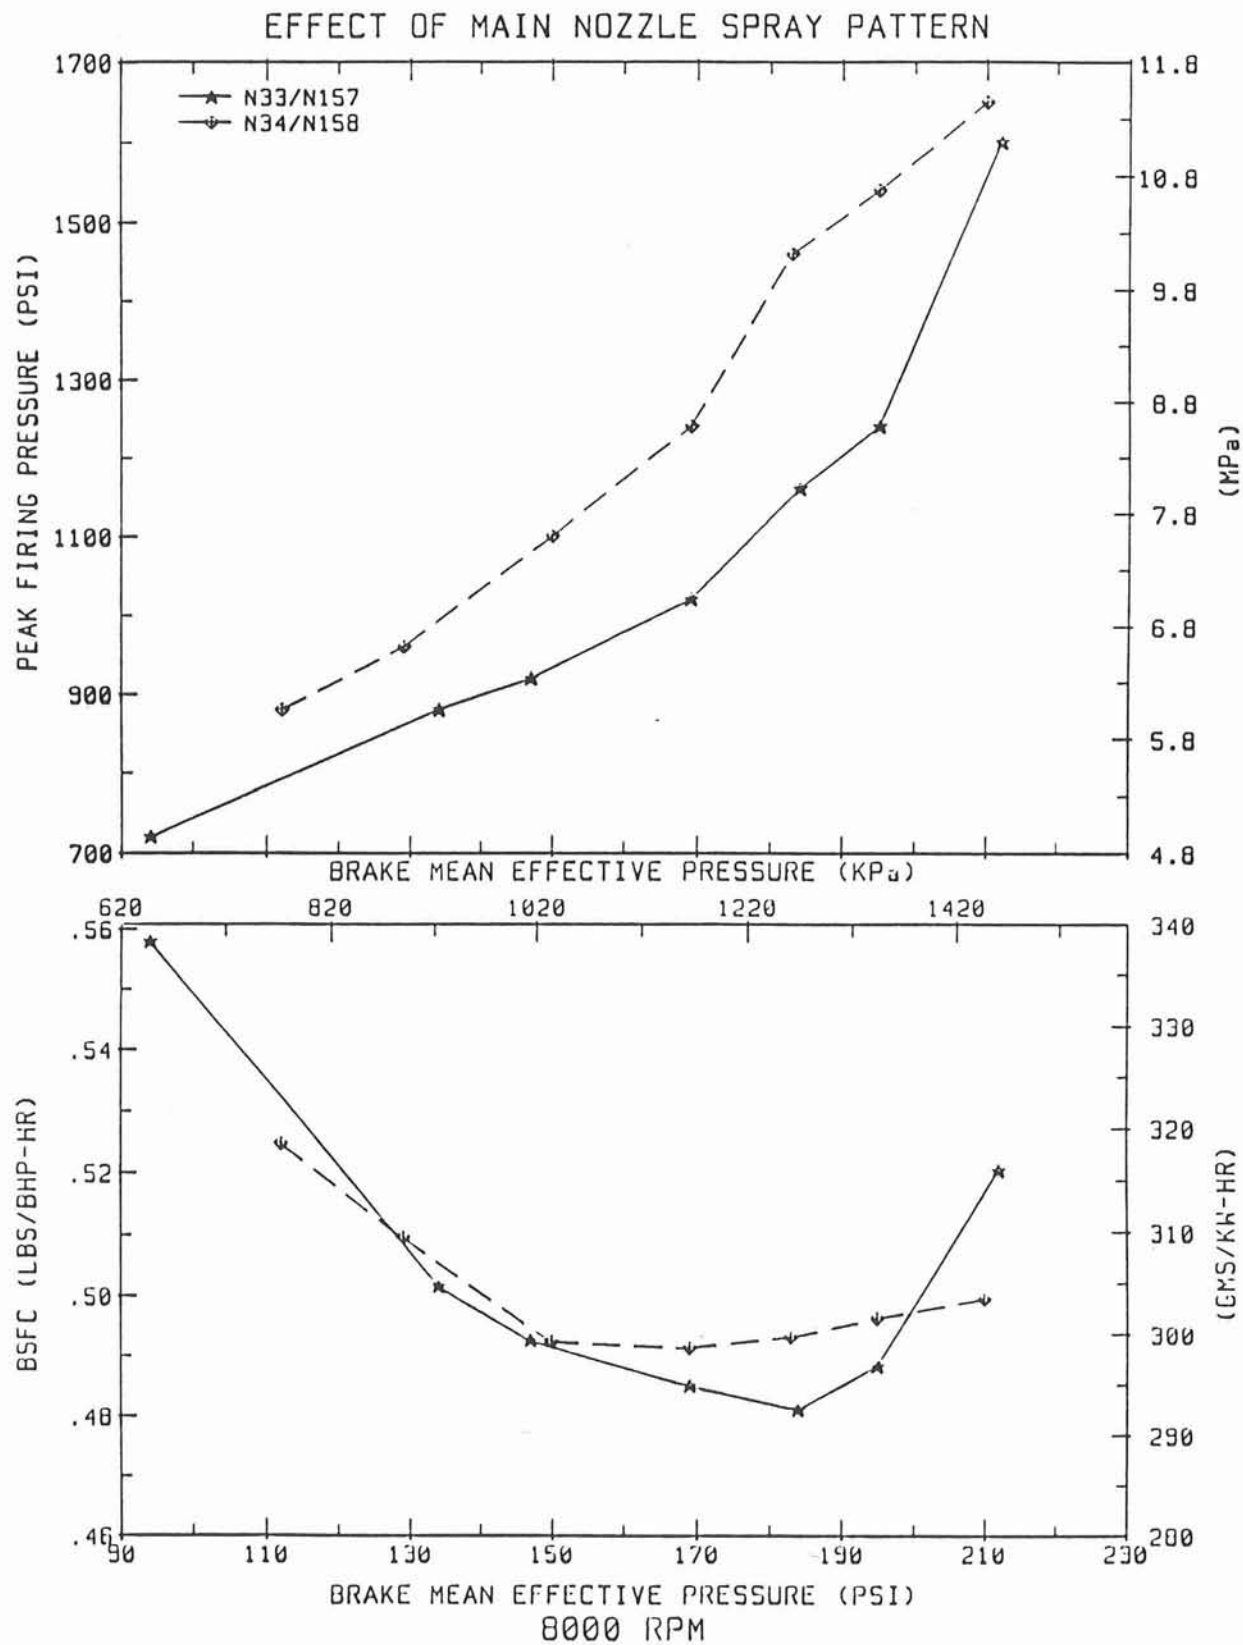
**Figure 4.2.2-6 Main Nozzle Spray Pattern Performance (8000 rpm) Single Rotor Engine**

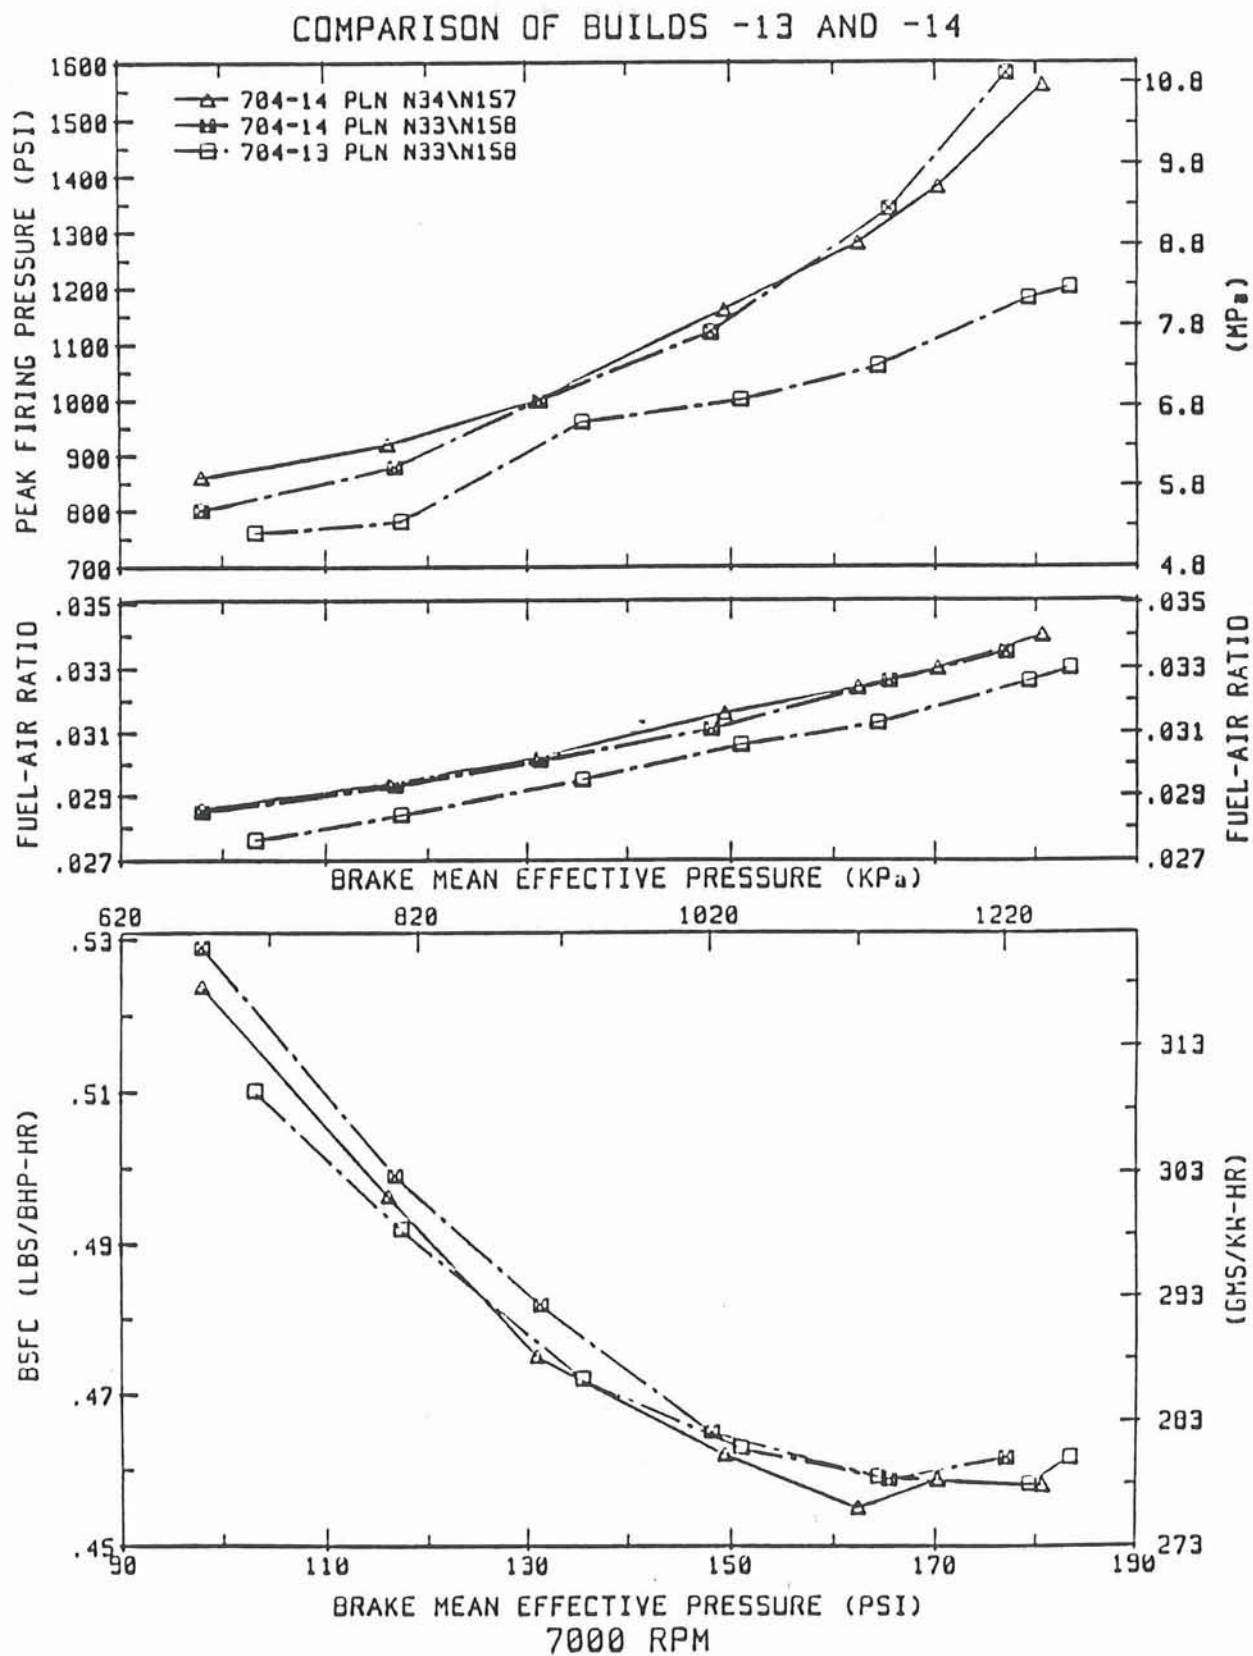
**Figure 4.2.2-7 Single Rotor Engine Performance with the Advanced Rotor Housing**

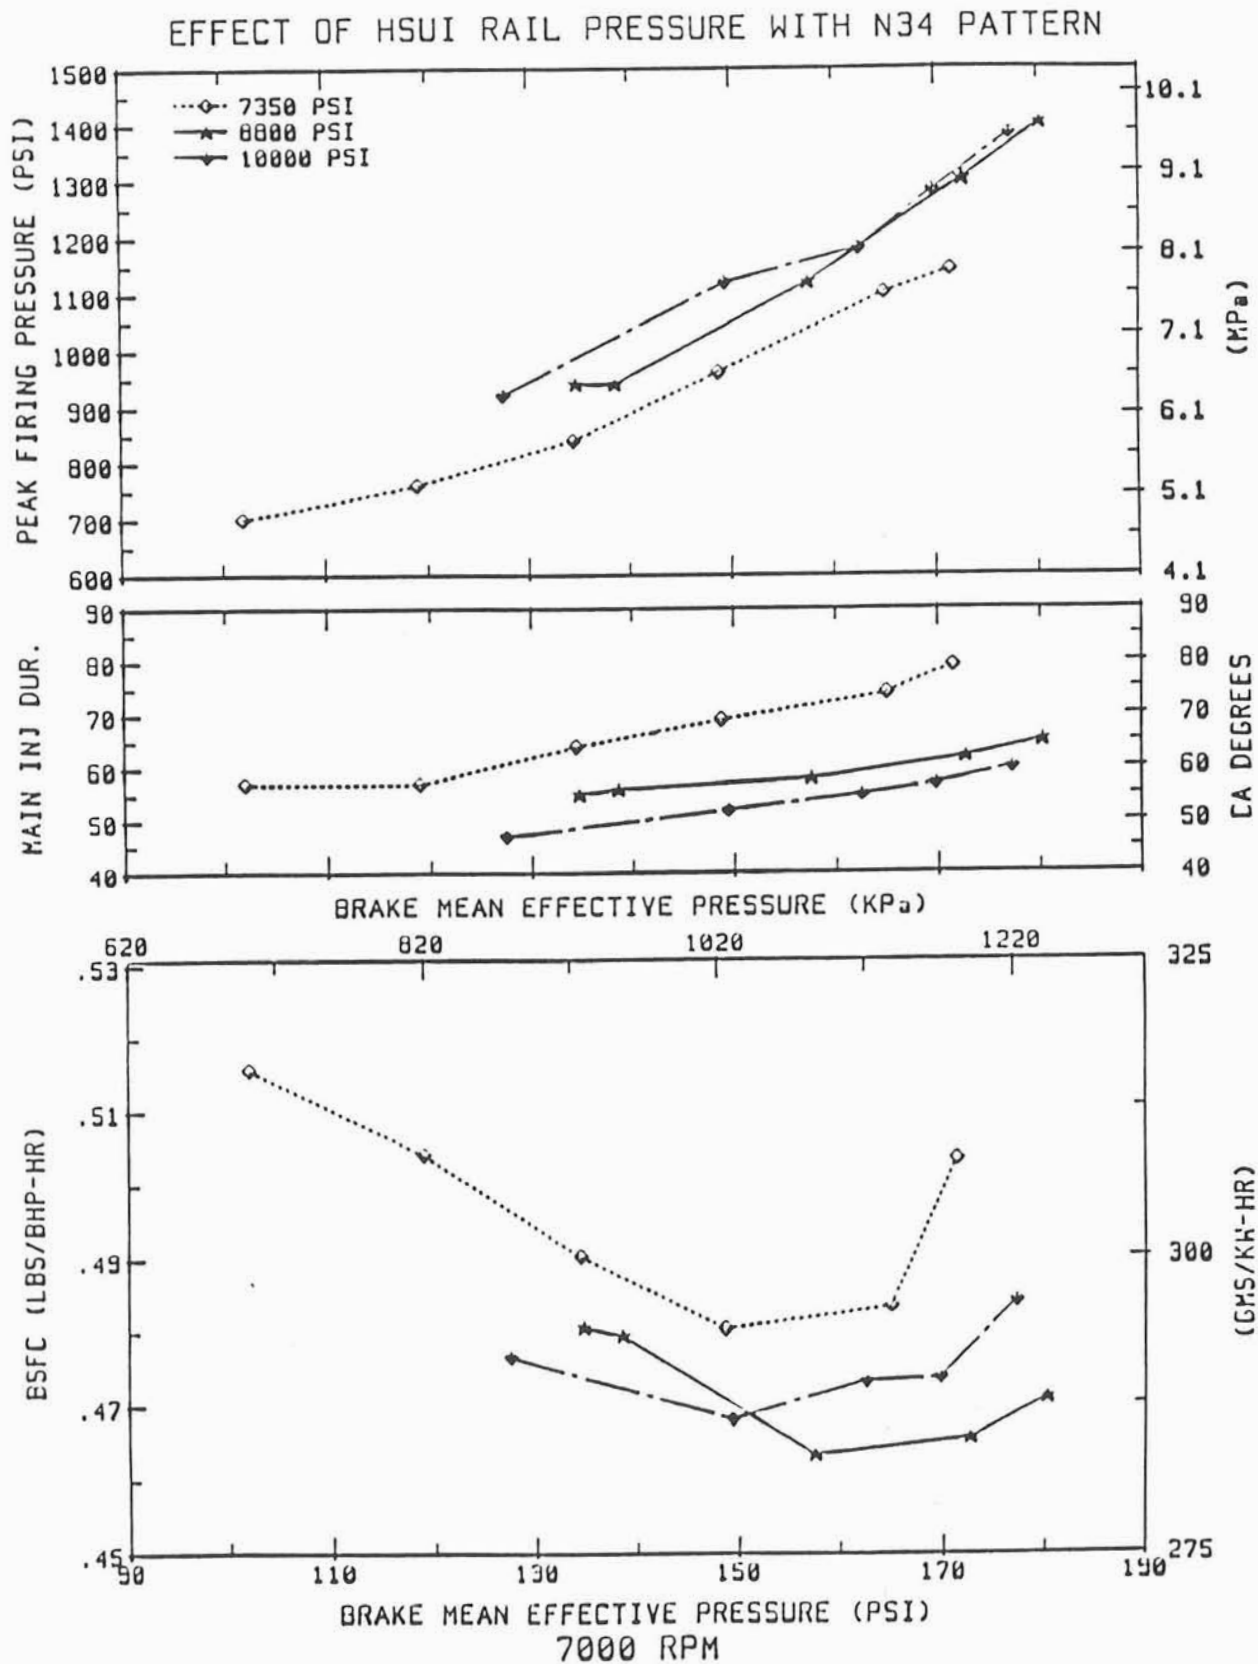
**Figure 4.3.2-1 Performance Sensitivity to HSUI Rail/Accumulator Pressure - Single Rotor Engine**
